# PRACTICAL CONSIDERATIONS IN PLANNING AND BUILDING AN “ACCESSIBLE” TRAIL

**2015 MASSACHUSETTS TRAILS CONFERENCE**

***PRESENTER: DICK O'BRIEN, CONSERVATION WORKS LLC***

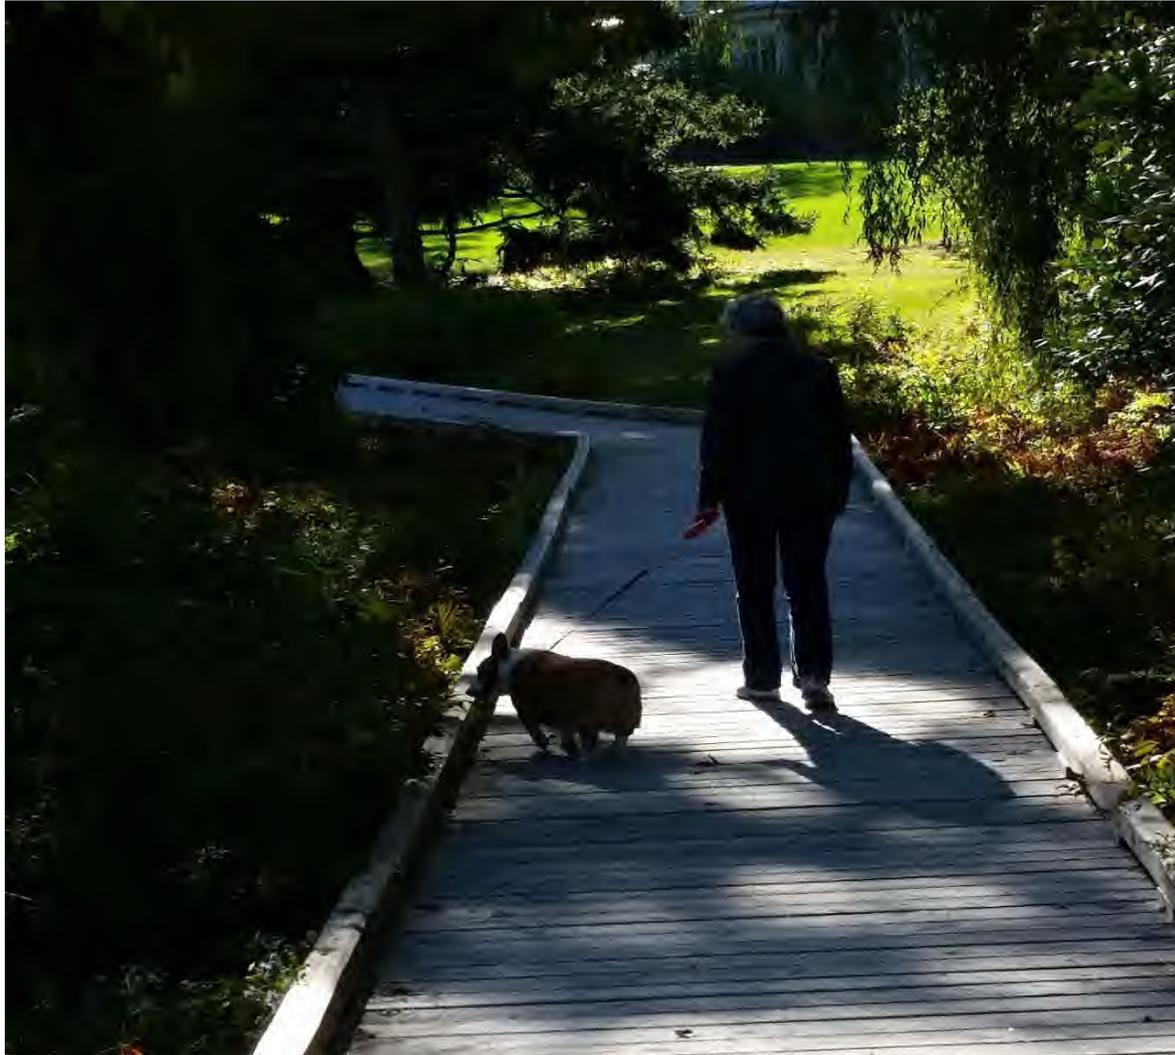
**DOYLE COMMUNITY PARK & CENTER, THE TRUSTEES OF RESERVATIONS, LEOMINSTER, MA**

Accessible trails are good for all pedestrian uses including dog walking. In fact, in many locations, dog walking on these trails has become the #1 user group enjoying the trails. This trail was specifically designed for pedestrian use and it sees walkers, dog walkers, bikers, snow-shoers, cross-country skiers, and a number of parents with strollers and an equal number of senior citizens who enjoy the ease of walking this trail!

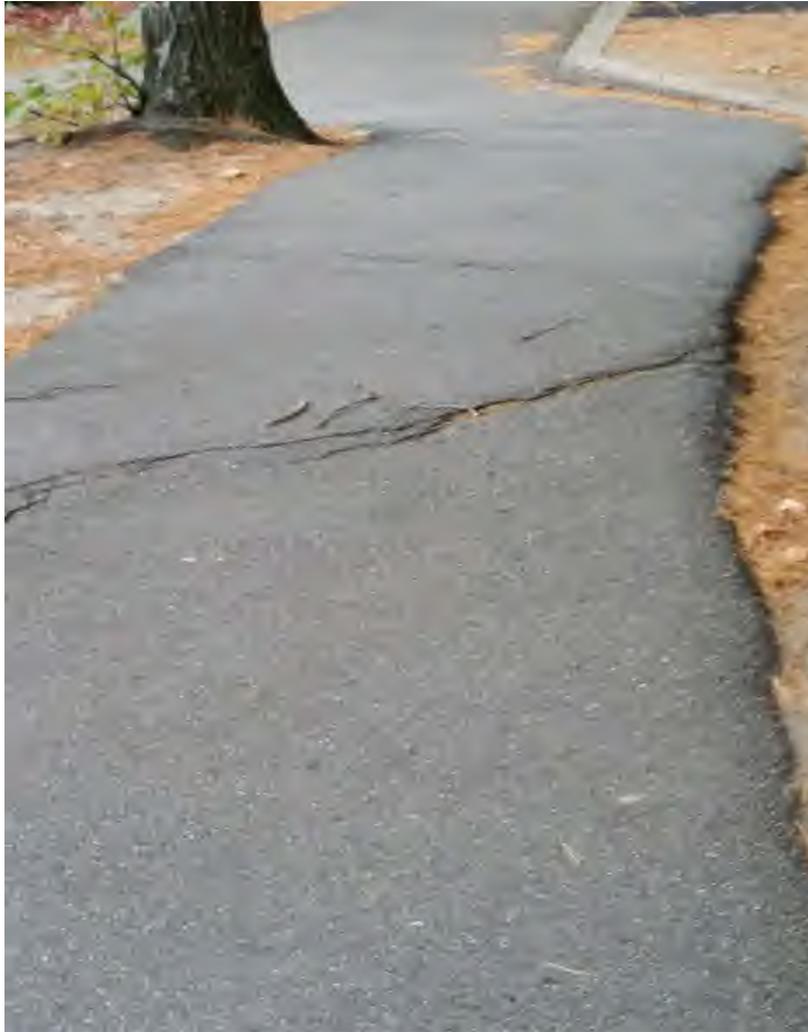
Both photos taken at Dunn State Park showing the use of pavement versus a crusher fine mix. Note the cracks from expanding tree roots in the left photo and the absence of them in the right photo even though both trails are in thickly wooded areas.

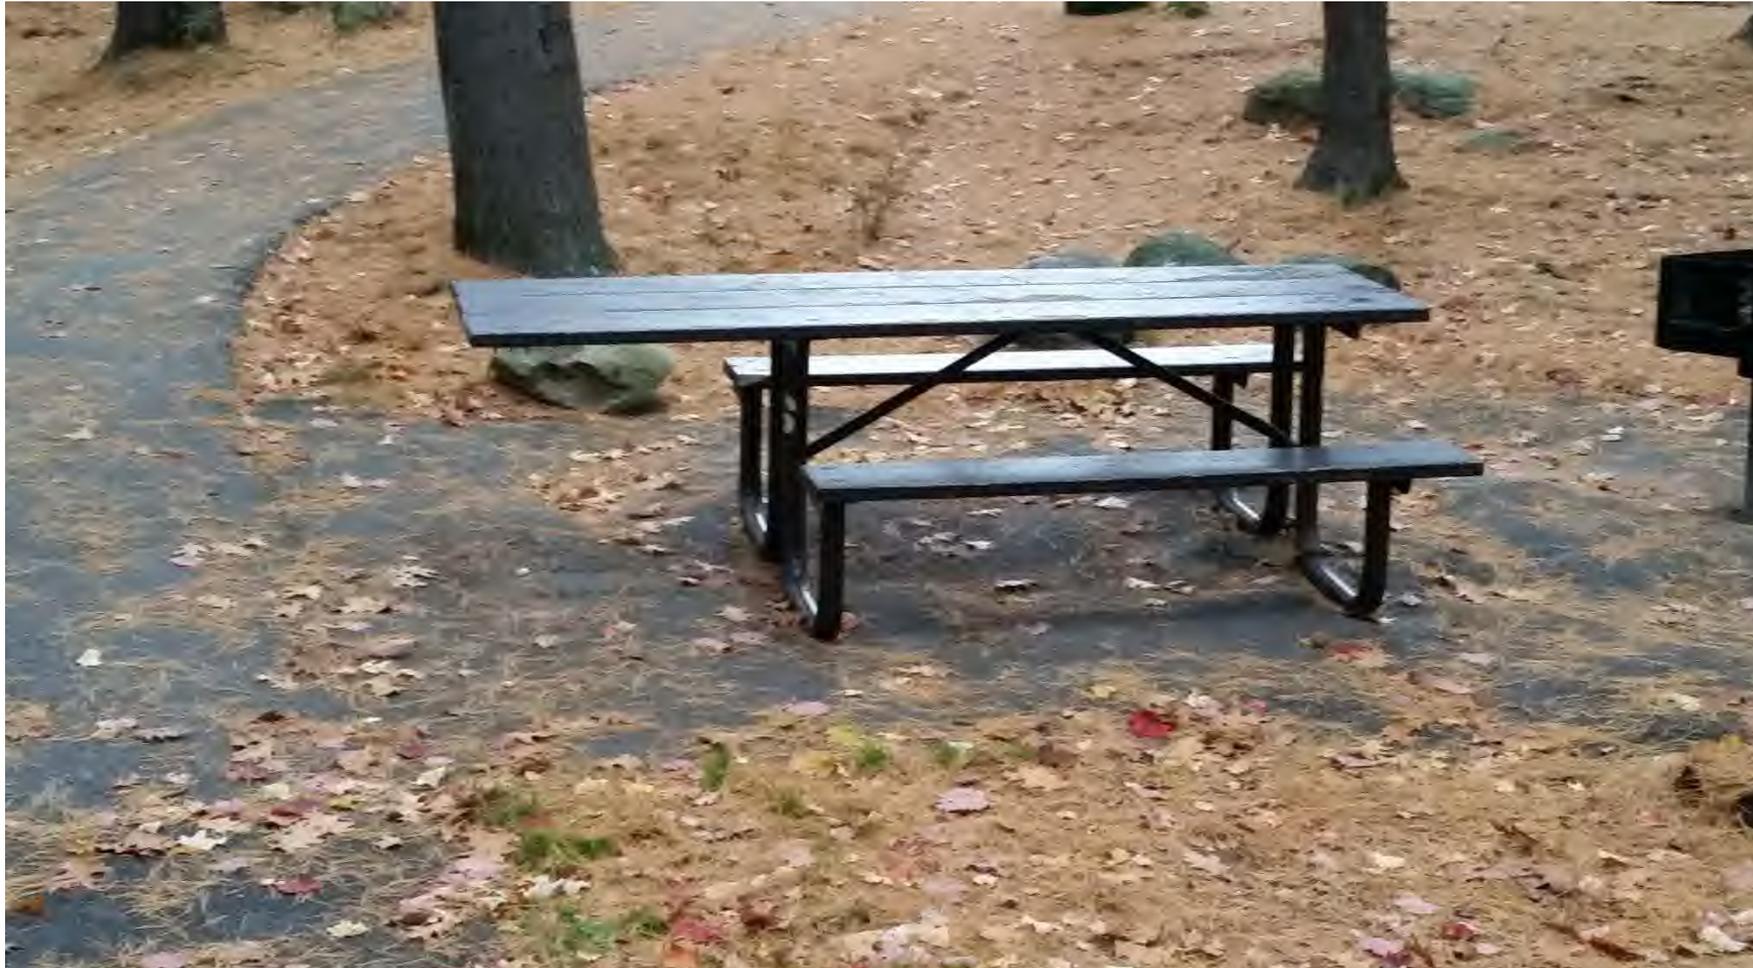
**Dunn State  
Park, Gardner  
Mass.**

Quality picnic site with wheelchair accessible table conveniently located just off the accessible trail. Area around the table is wheel-chair accessible as well, the grill is at a convenient height and accessible by wheel-chair users. There were several of these sites available.

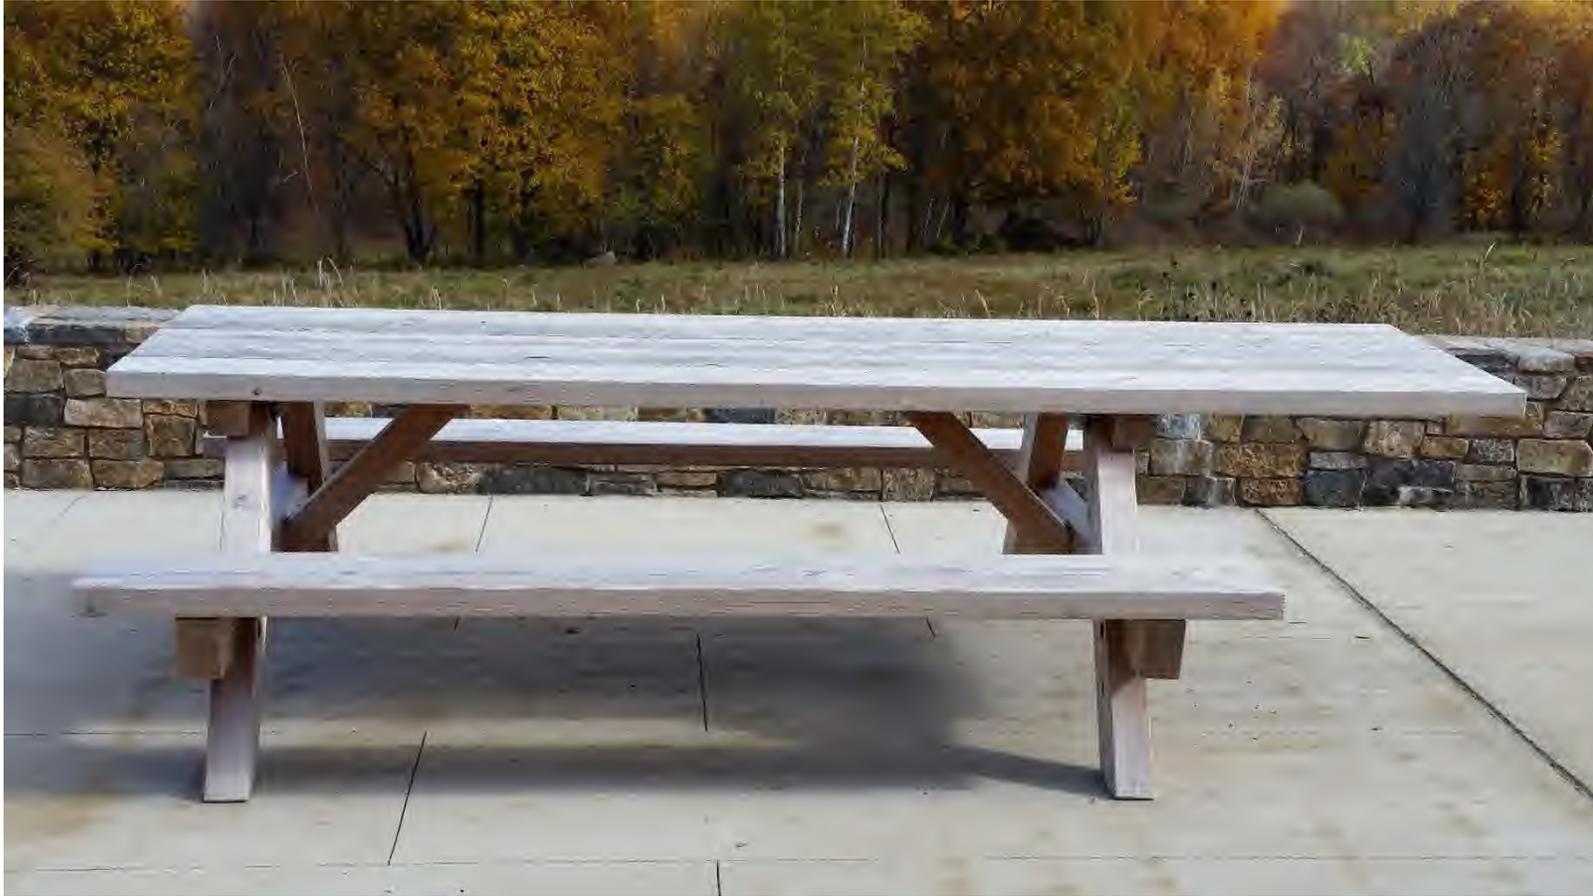
**Mass. DFW Field  
Headquarters,  
Westboro, MA**

Quality visitor amenities: High quality, handicap accessible picnic table made of native lumber. Weight makes it less likely to be stolen, construction makes it durable and long-lasting, native materials support local economies. All surfaces were sanded and edges rounded for smooth, splinter-free use!

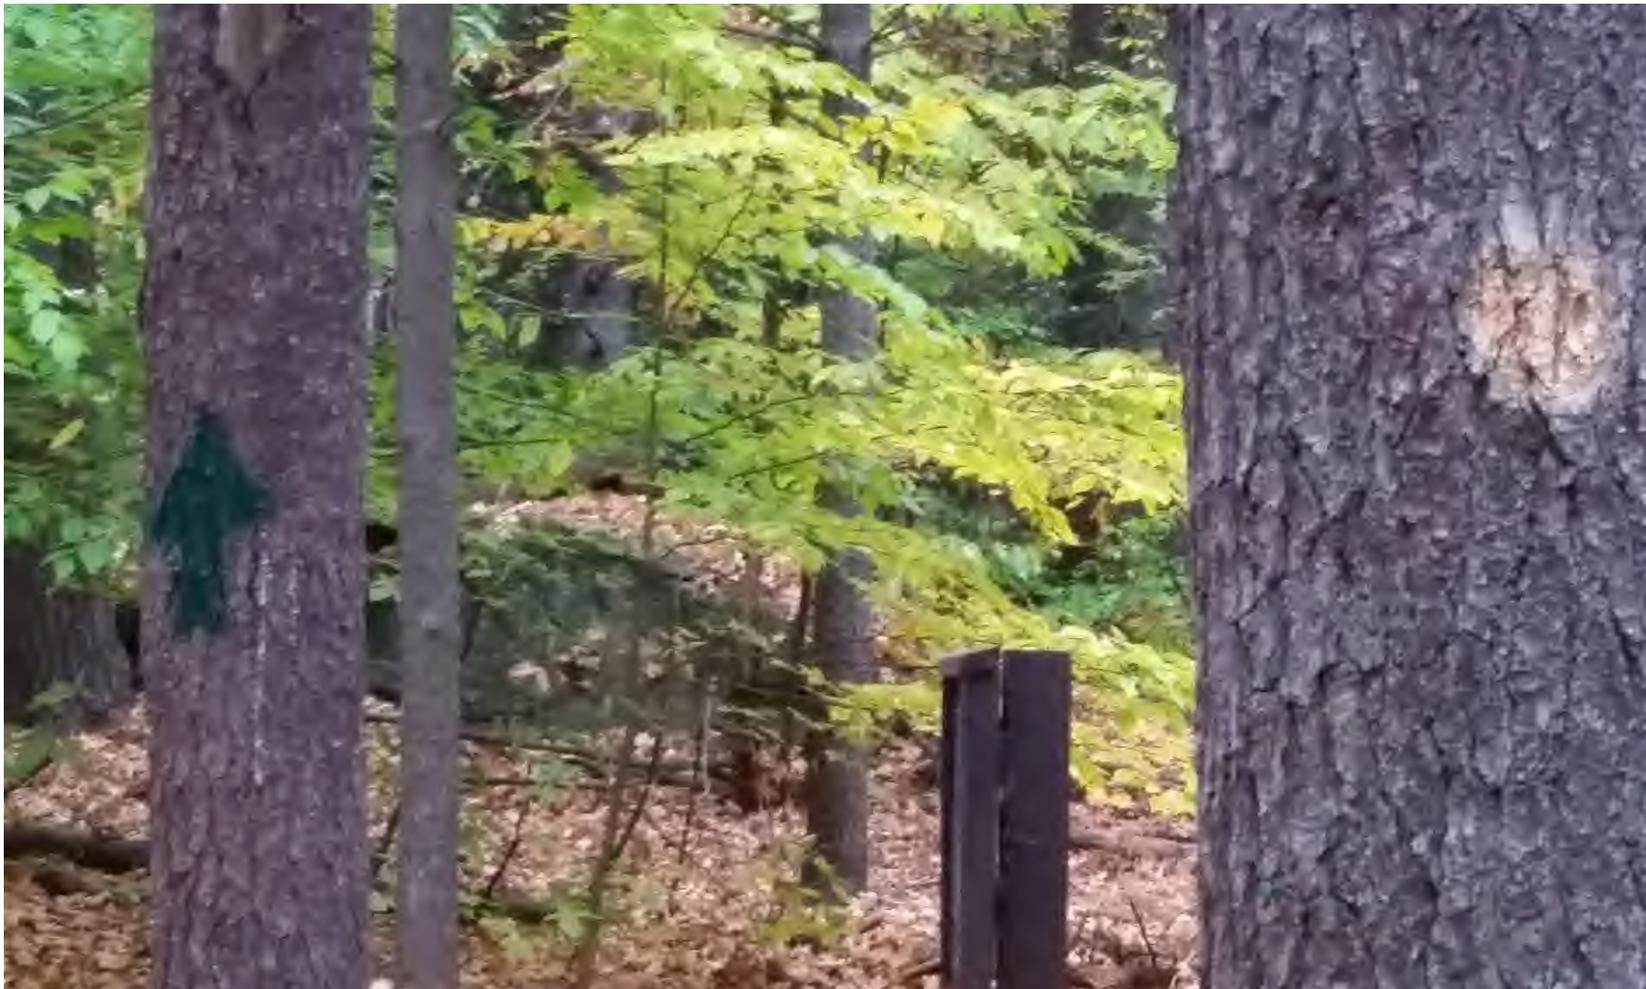
**DCR**  
**Dunn State Park,**  
**Gardner, MA**

**Way-finding Approaches: Trail Blazing.** Here a combination of trail “dots” and “arrows” are used to assist hikers with finding their way around the trail. Both are common, effective methods of providing guidance to users. Typically, brighter colors are used and the area that is blazed is routinely scraped to produce a smoother surface so the blaze stands out more on the trunk of the tree. For Accessible trails, blazing should be applied at about 60” high.

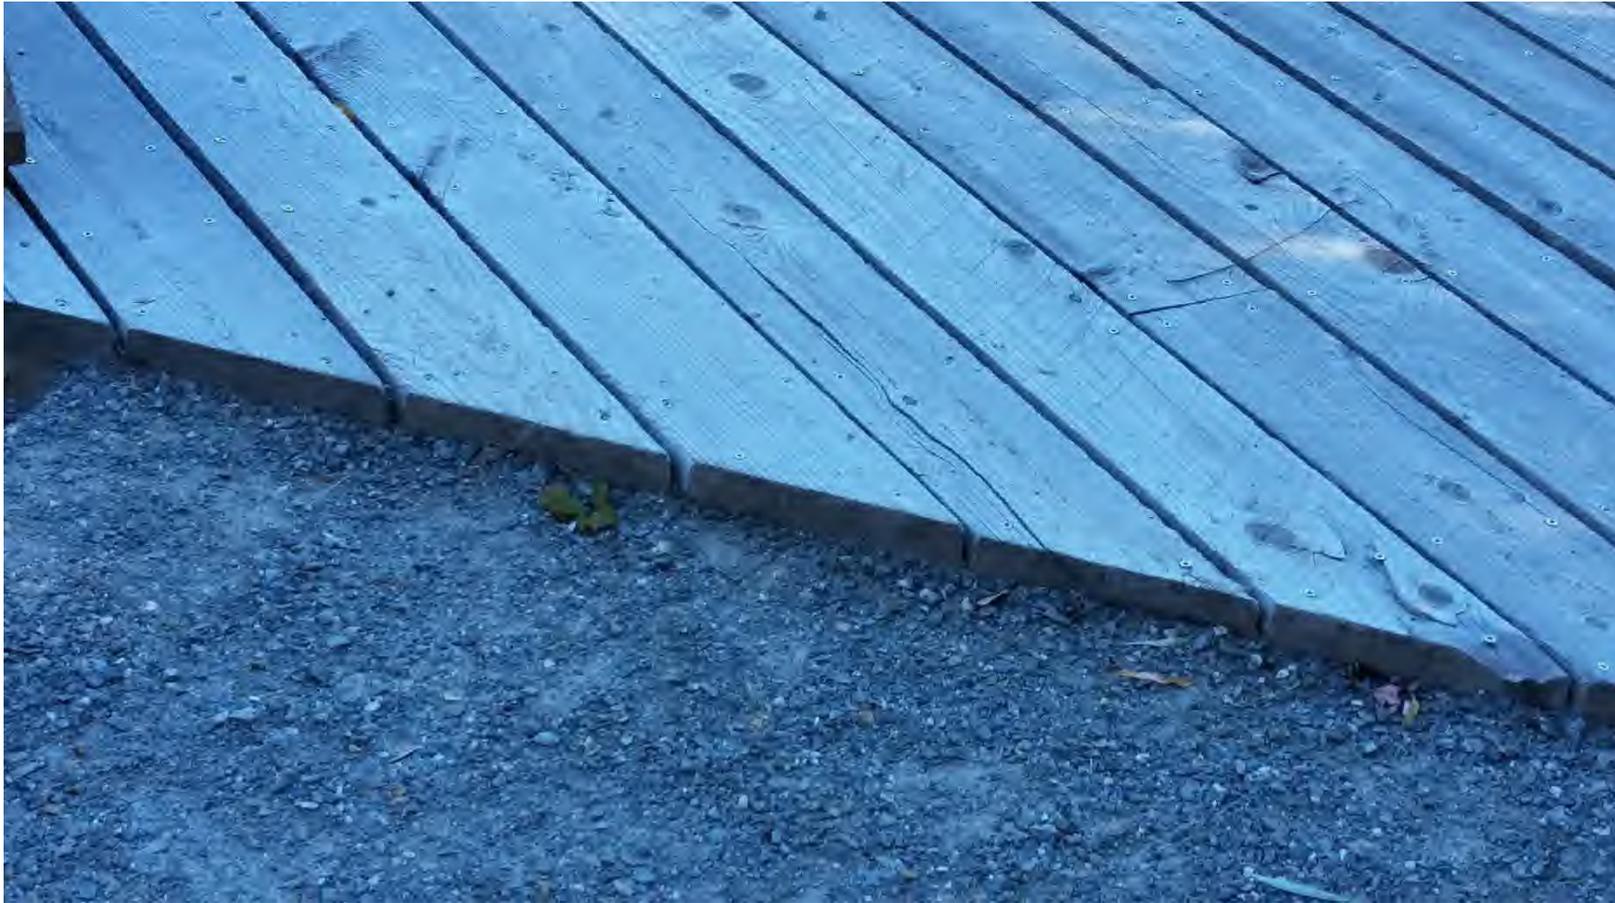
**DOYLE  
COMMUNITY  
PARK & CENTER,  
LEOMINSTER,  
MA TRUSTEES OF  
RESERVATIONS**

**Issue: Elevation change** at transition from trail to viewing platform. A tripping hazard and possible impediment for wheelchair users and others with mobility issues. **Solution:** Add 3/8" crusher fine mix and add transition board that provides a ramped surface from trail to platform so that loss of surfacing material does not create a hazard or impediment.

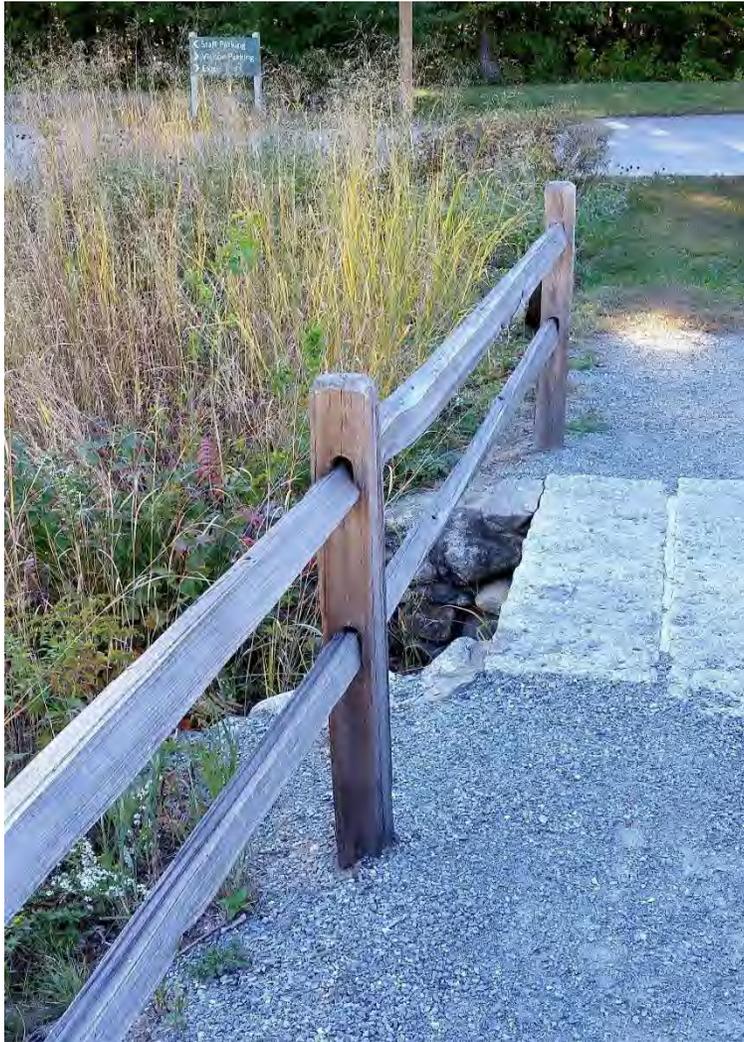
**Problem:** The gap between the fence and the edge of granite block on the bridge. It creates a potential fall situation for wheelchair users and small children. **Solution:** Add a third rail to the bottom of the fence blocking the space to eliminate the chance of a fall from either user or move the fence in to eliminate the gap.

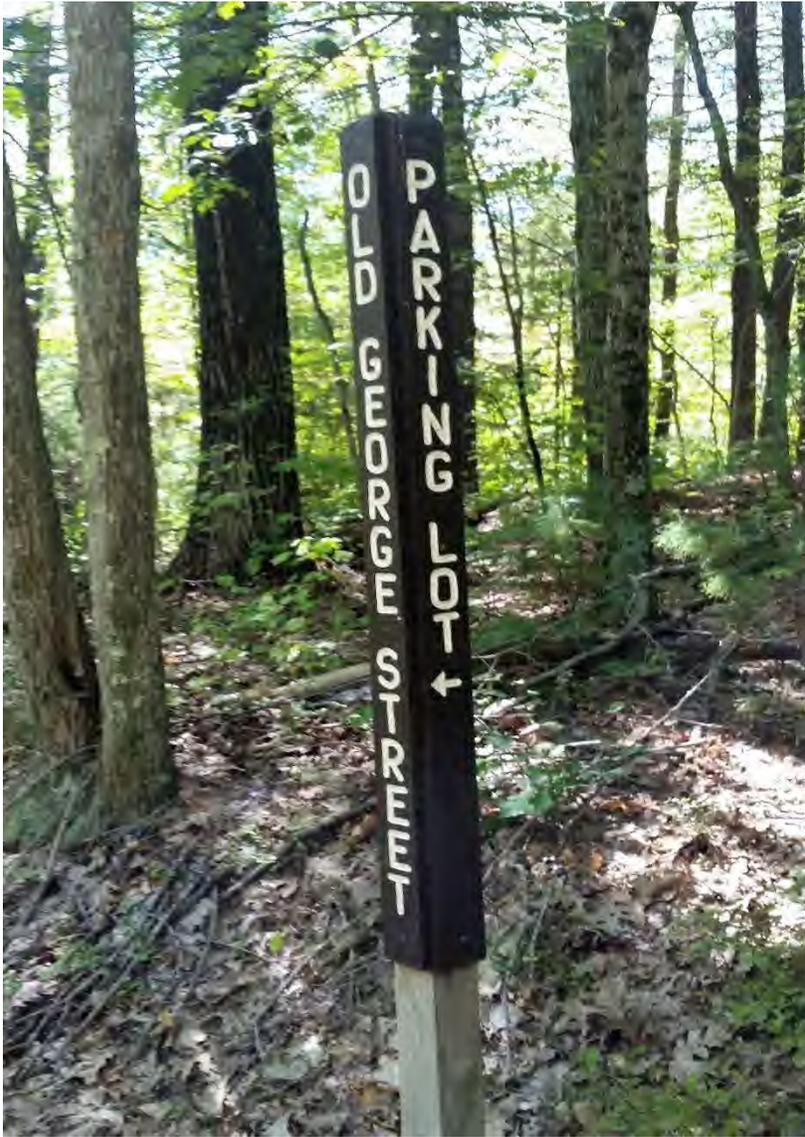
**DCR, Wrentham State  
Forest, Wrentham, MA**

**Problem:** Giving directions to trail users.

**Solution: Wayfinding signage:** Good, creative example of trail signage. Provides name of current location/trail, provides direction to a named and desired feature/location. Could add “mileage” to complete the usual desired information trail users want.

Signs are hand-routed and painted and simply attached to an upright 4x4 post anchored firmly in the ground. Done in-house by the Forest Supervisor.

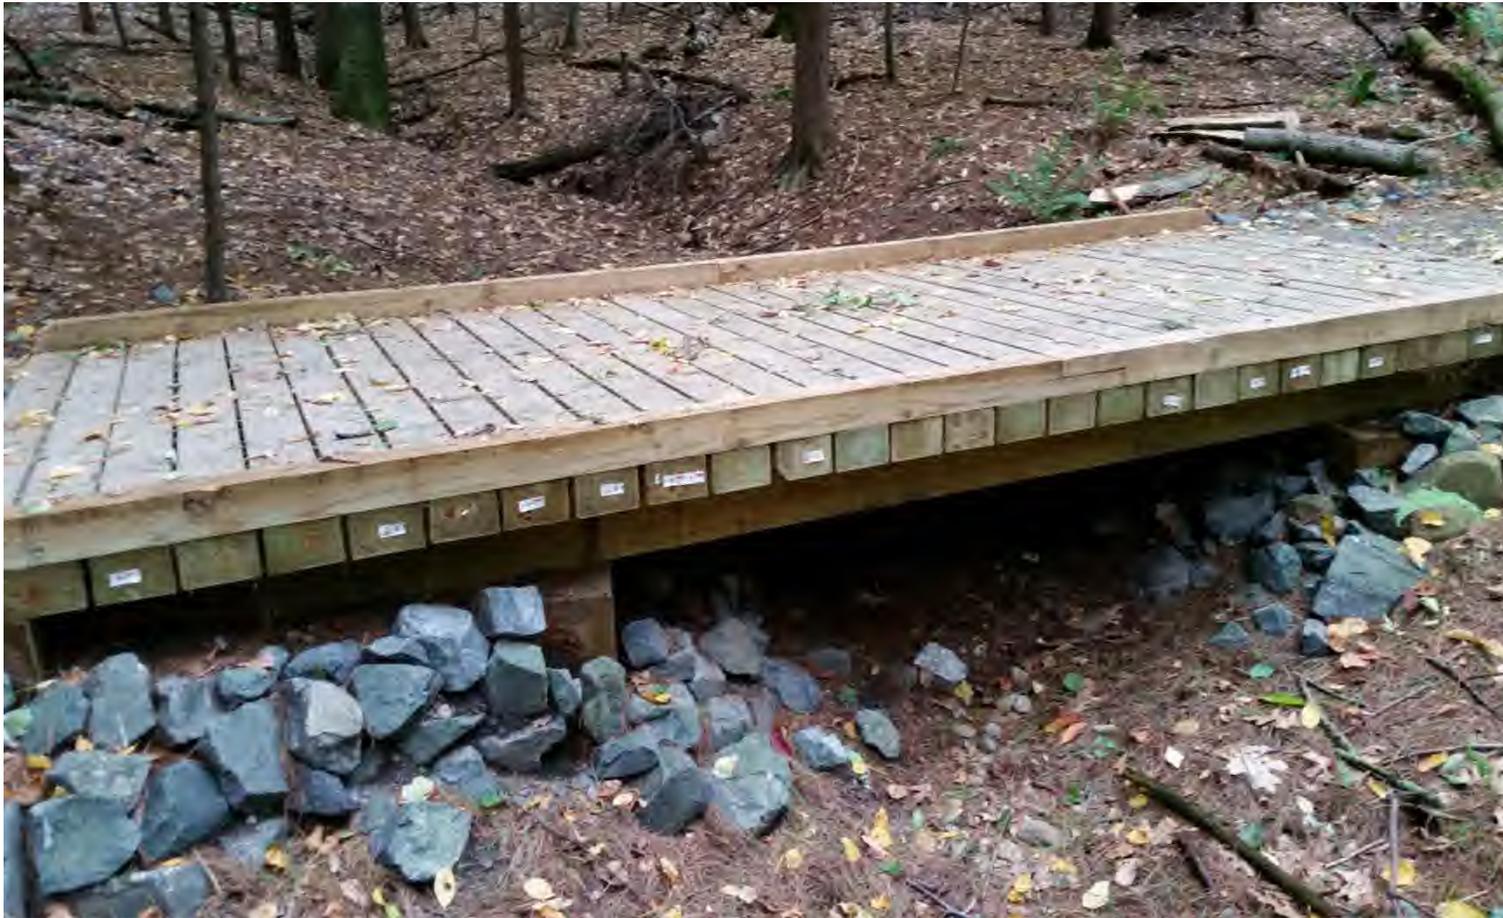
**Problem: Stream Crossing**

**Solution:** Bridge made of PT 4x6 decking and other PT structural materials. Fairly well-executed project. Good, simple design, good abutments and rip-rap on banks of stream. A couple of finish details to work on: Remove the PT tags from the ends of the decking boards. Raise the edge boards 2" off the deck to allow debris to be cleared from the deck by wind or other means.

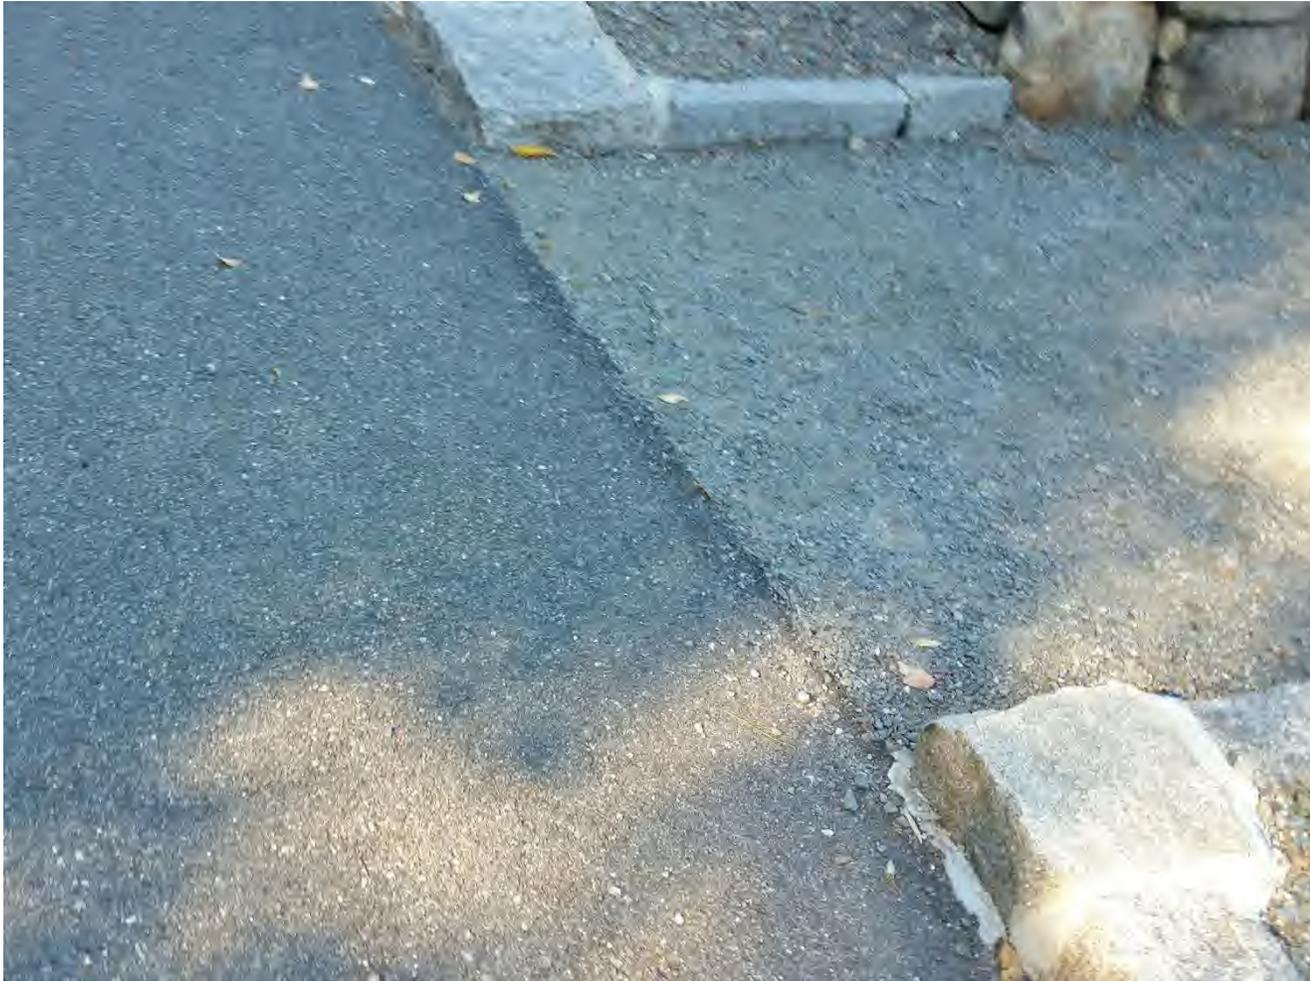
**Problem:** Granite curbstone at entrance to accessible trail

**Solution:** Cut the curb and transition the trail surface to meet the pavement at the same height.

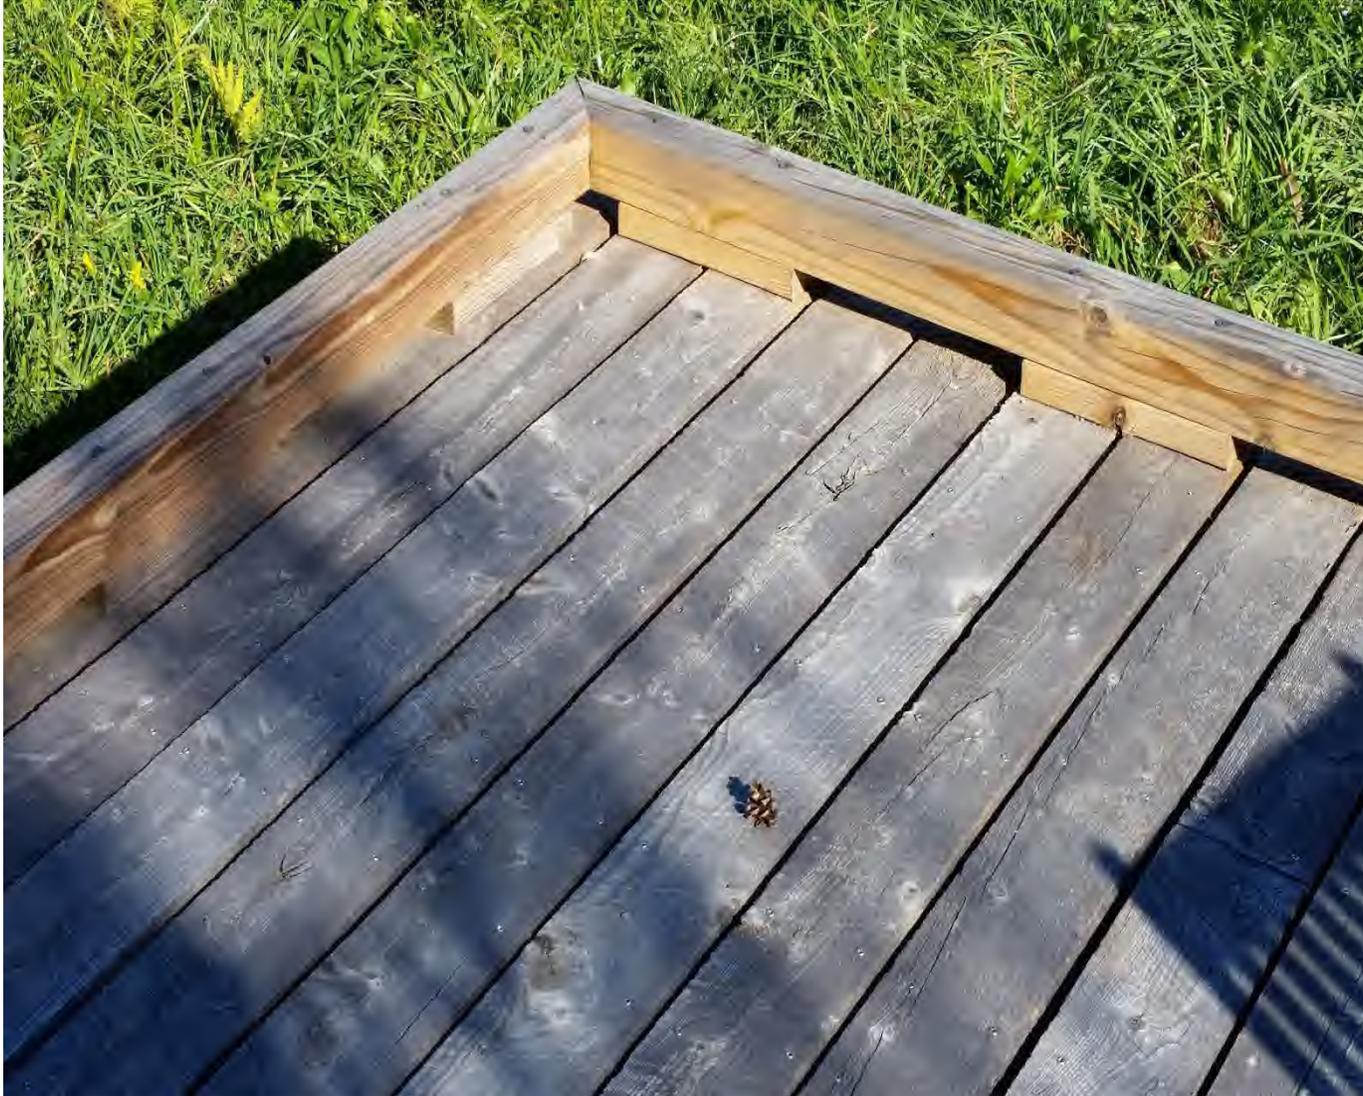
**DOYLE COMMUNITY PARK & CENTER,  
TRUSTEES OF RESERVATIONS, LEOMINSTER,  
MA**

**Details, details, details:** Note the mitered corner on this viewing platform, use of 8" Headlok screws to fasten the 4"x4" PT edging, edging raised off the deck to facilitate cleaning, chamfered edges of edging to reduce splintering, rough-cut, full 2"x6" Hemlock decking to provide better traction, use of clear, low VOC wood preservative to prolong the life of the deck, 1/2" spacing between deck boards, decking attached with 3-1/2" deck screws. Built on a 2"x10" PT frame anchored to the ground using DP-75 Diamond Piers. Built to last and stay where it was built.

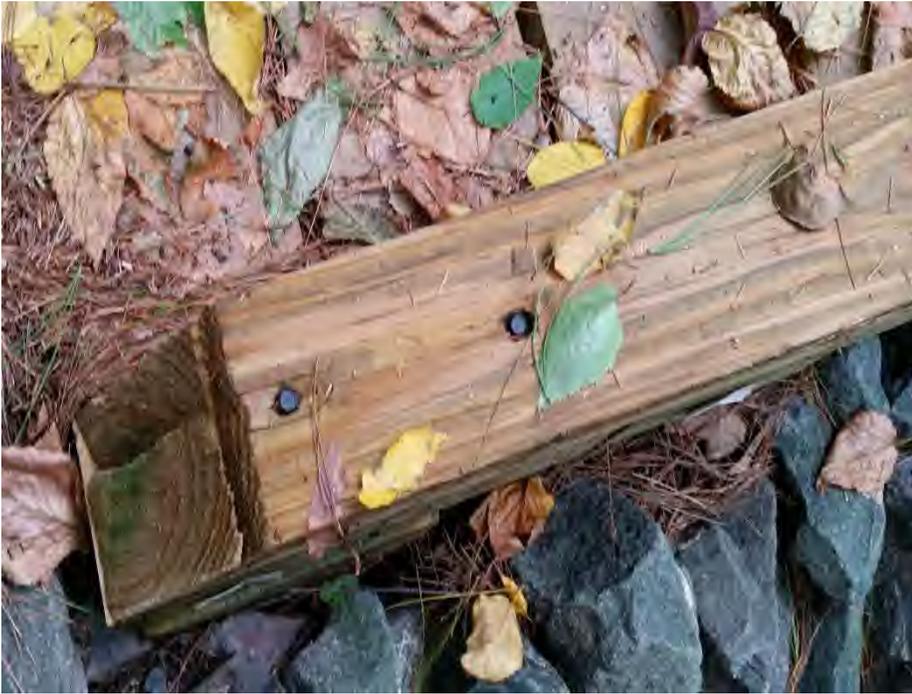
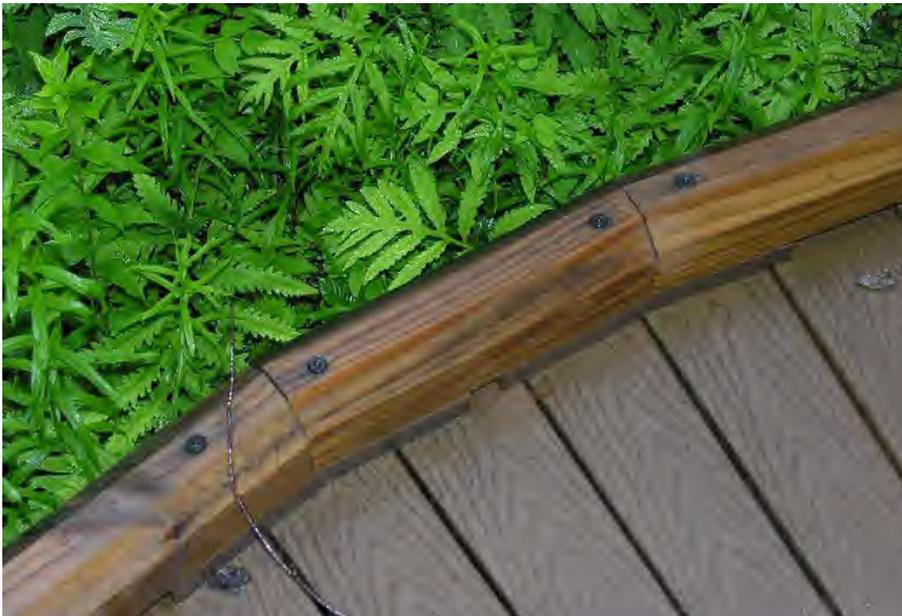
**Best Practices:** The use of Treadlok screws to secure the edge boards in the top photo is not the best practice. Headlock screws used in the lower photo have a broader head and do not create a well in the wood to hold water.

The multiple cuts on the end of the edge board do not convey a sense of “quality” and retain more moisture to rot the board quicker.

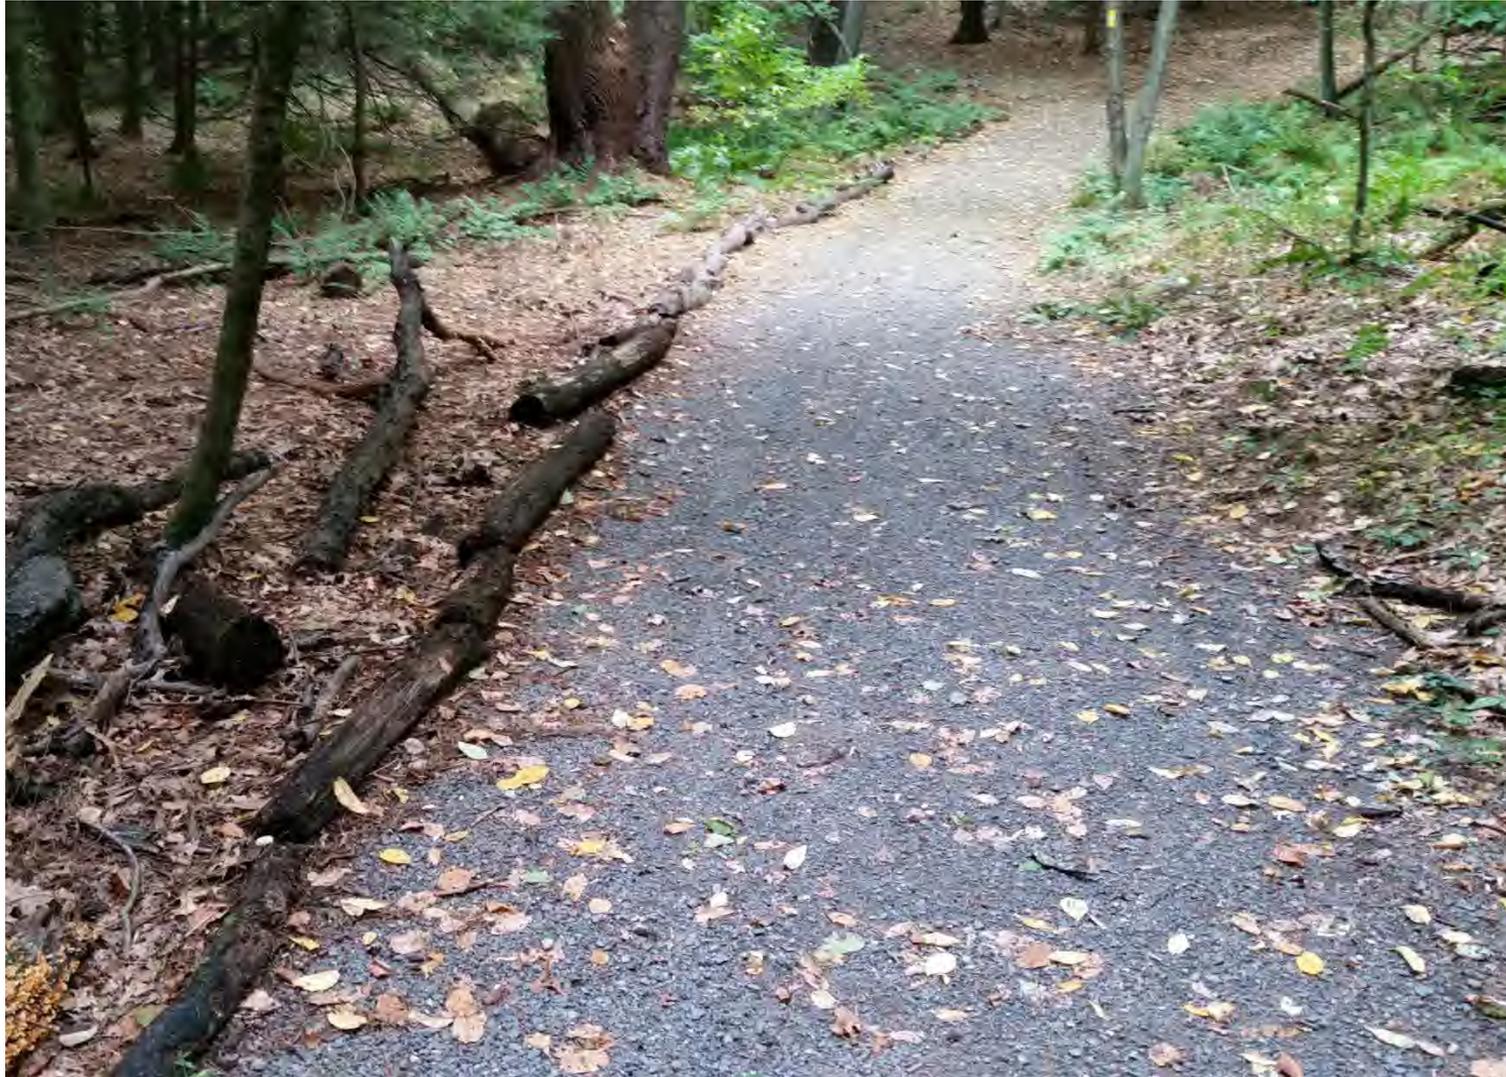
**Details, details, details:**

The Boy Scout tradition of lining trails with logs is not a good practice. The logs collect debris on the side of the trail and form a dam that keeps water on the trail and in this instance it flows down the trail causing erosion and keeping the tread soft. It is better for the trail not to have this edging effect in the long run as it allows for rain water to sheet flow over and off the trail.

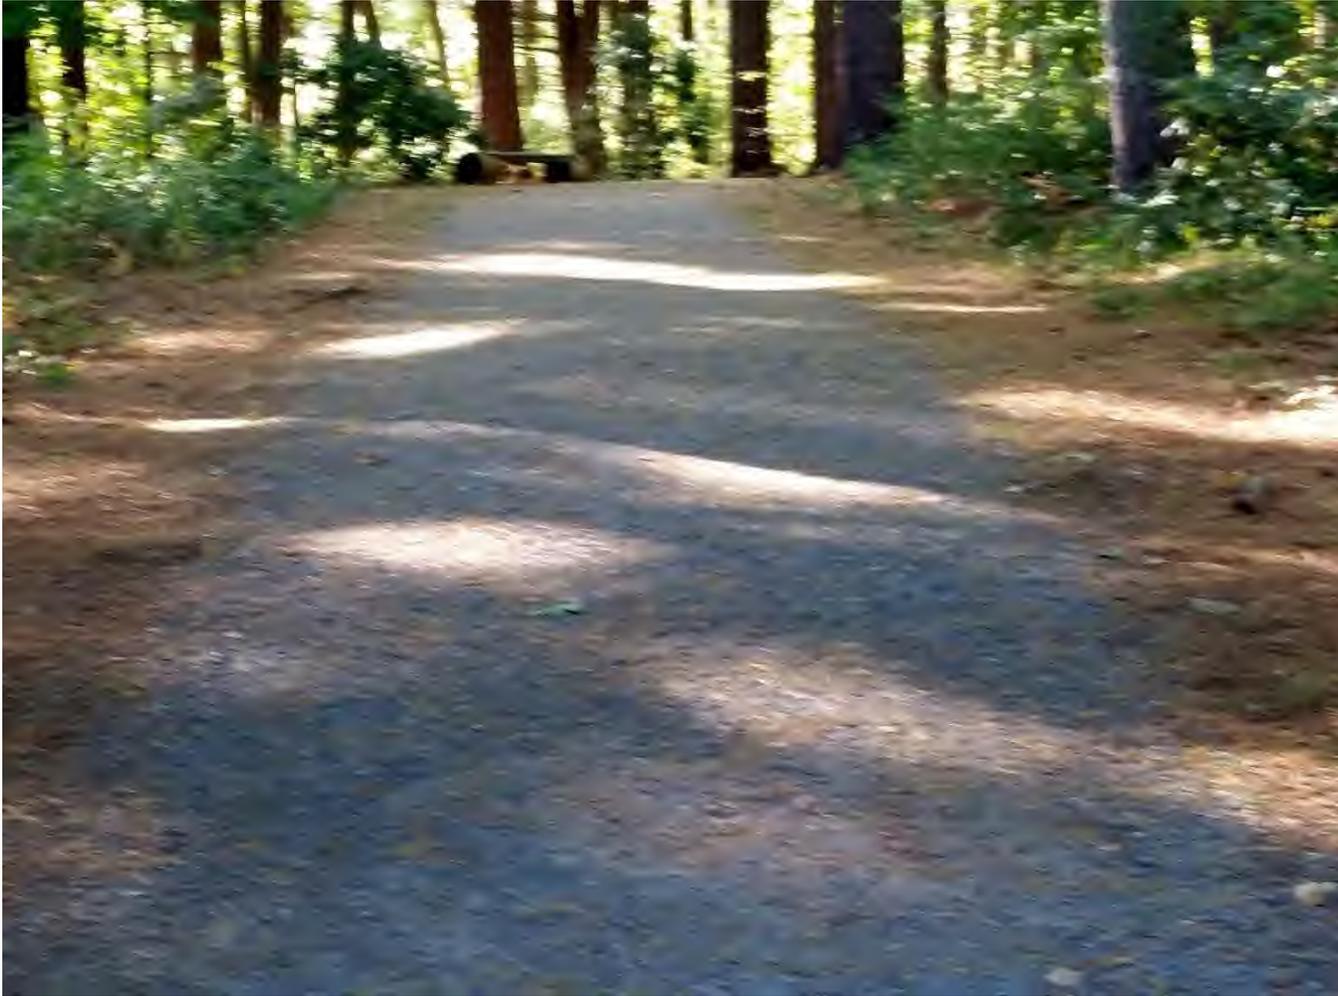
**DCR, Mt. TOM RESERVATION, EASTHAMTON, MA**

**BEST PRACTICE:** This accessible trail is 6' wide and blends nicely into the surrounding woodlands. The edges are very slightly above the surrounding ground level so water flows off the trail. The trail was very carefully crowned so that the center of the path is higher than the edges. This is the ideal configuration for a sustainable tread. Periodically, the owner could re-compact the trail using a vibratory roller and after a light rain event. (Every 5-10 years as needed) If using volunteers to do this work, careful supervision is needed to ensure that the proper crowning of the trail is performed and that the level of the tread at the trail edge is not too low or too high. This section of trail was done by the trail contractor and Trustees staff.

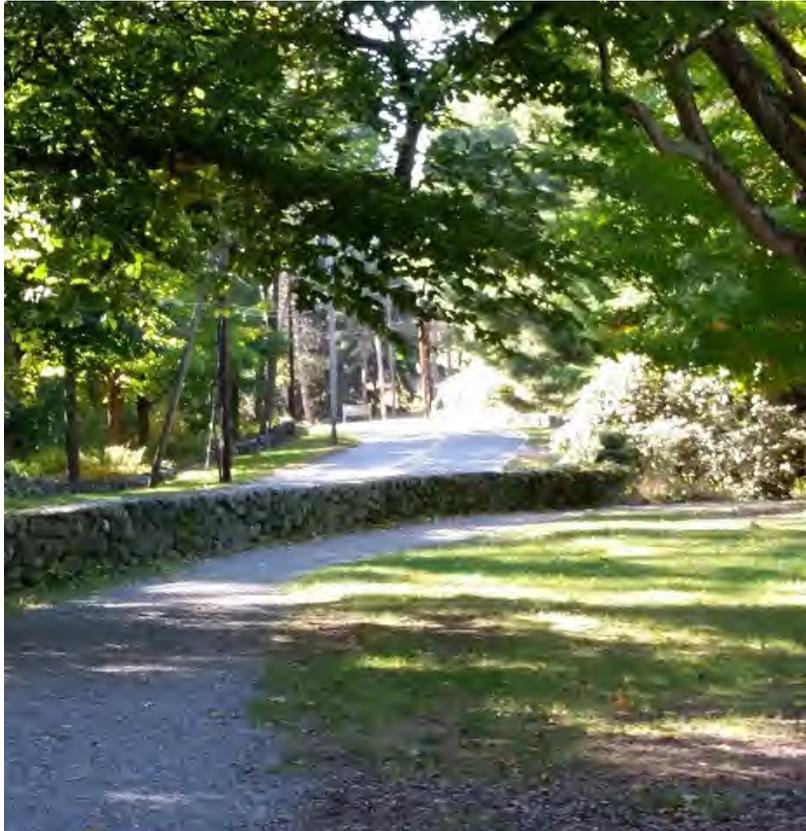
**DCR, MT. TOM RESERVATION,  
EASTHAMPTON, MA**

**Best Practice:** Use of control points (key features or characteristics along the trail) was a key factor in locating the trail along this pleasant stone wall. It provides a built in seating area for users and provides pleasant views down the road and of the main estate home. Additionally, the attention to the elevation of the trail and the surrounding ground was

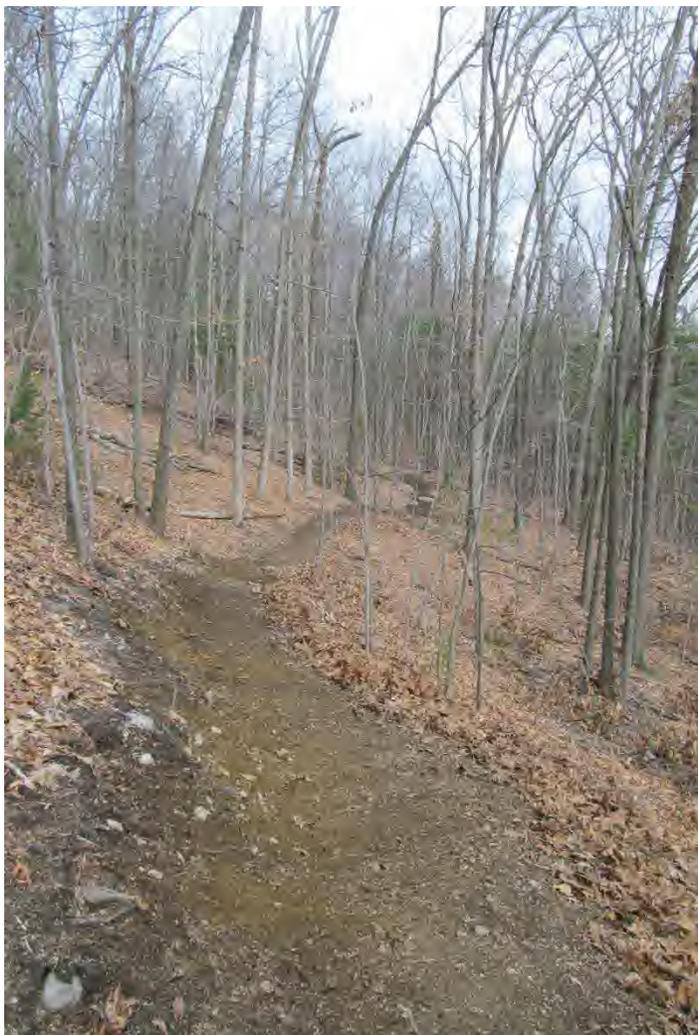
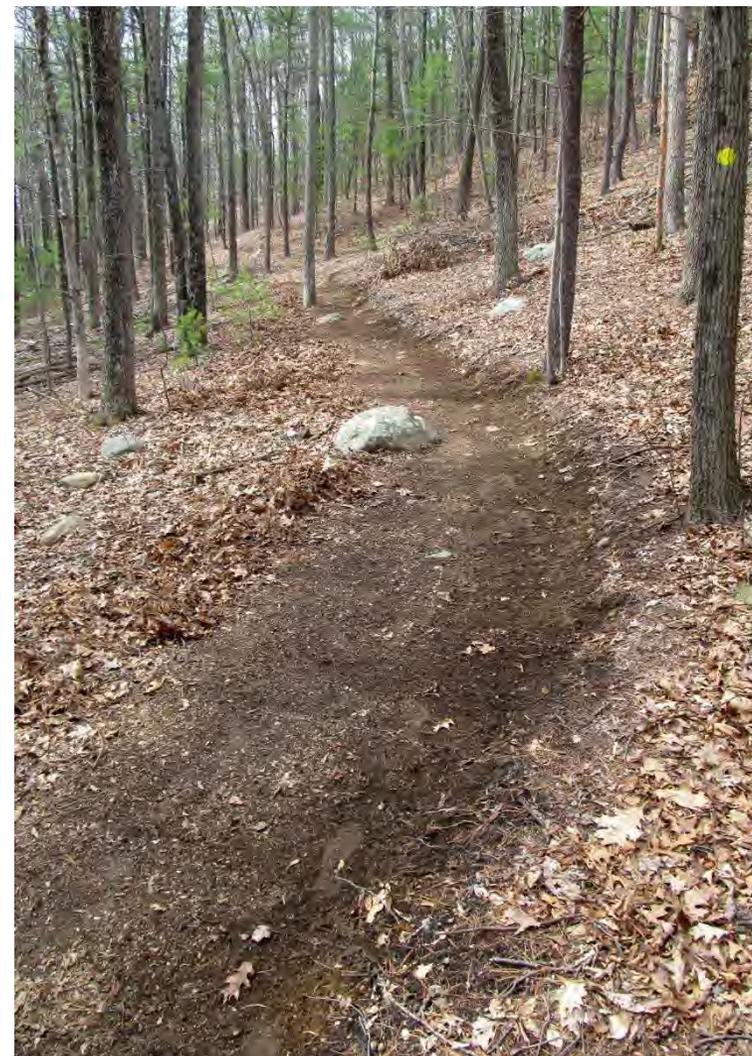
**Best Practice:** the left photo shows a typical **rolling contour layout for a natural surface hiking trail** with grade dips to help manage run-off. The right photo shows the classic **full bench cut** on a side hill trail. Note the back slope on the hill. The presence of the large rock to keep hikers on the trail, the slight cross-slope to promote sheet flow of storm water off the trail. Both of these are standard trail practices and essential for creating sustainable trails!
