# PRACTICAL CONSIDERATIONS IN PLANNING AND BUILDING AN “ACCESSIBLE” TRAIL

**2015 MASSACHUSETTS TRAILS CONFERENCE**

***PRESENTER: DICK O'BRIEN, CONSERVATION WORKS LLC***

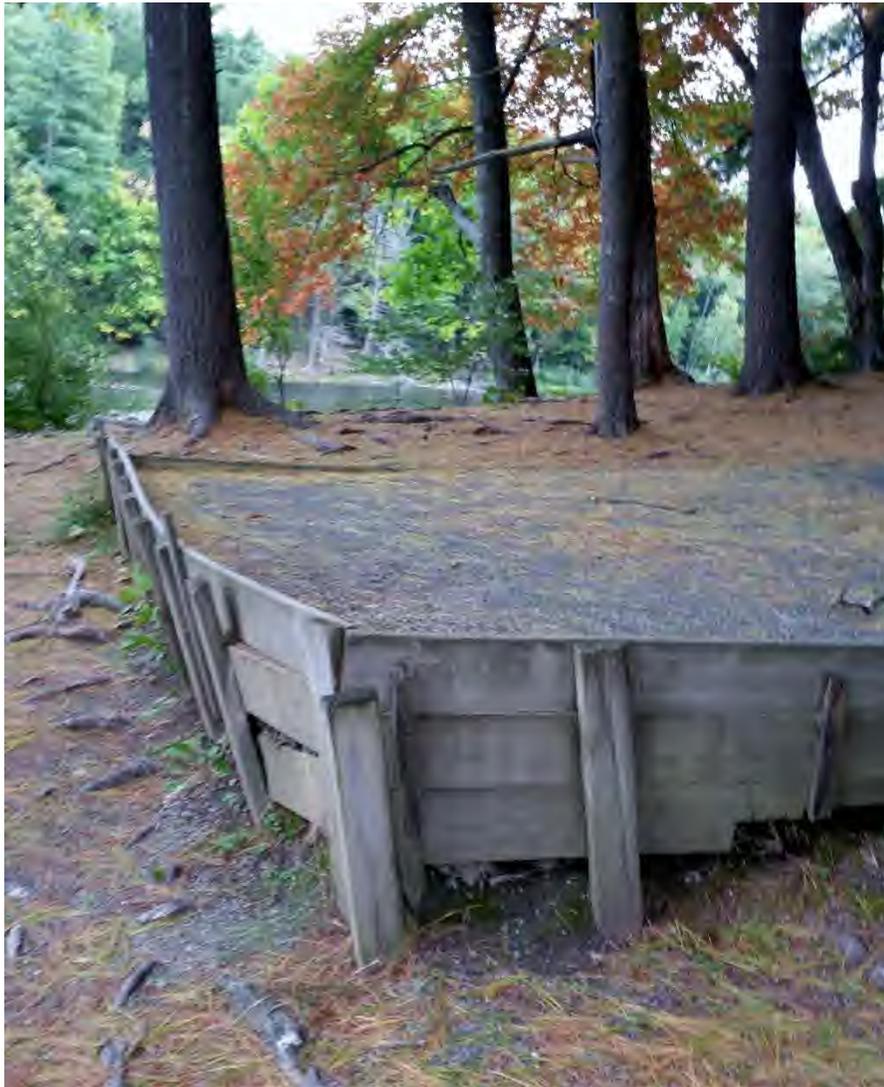
**LEOMINSTER RECREATION DEPT., BARRETT PARK, LEOMINSTER, MA**

**Questionable Practice:** This was an easier, quicker and cheaper approach to creating a viewing area along this trail, but it is obvious that it will fail in the near future.

A more permanent approach would have been to “plant” some large boulders into the ground to form a retention wall for the soil/trail mix. This form of “cribbing” is used frequently on the downhill side of partial bench cutting on side hill trails. While much more labor intensive, if there were native stone on site, it may not have been much more expensive. The viewing platform created in this manner would survive for generations!

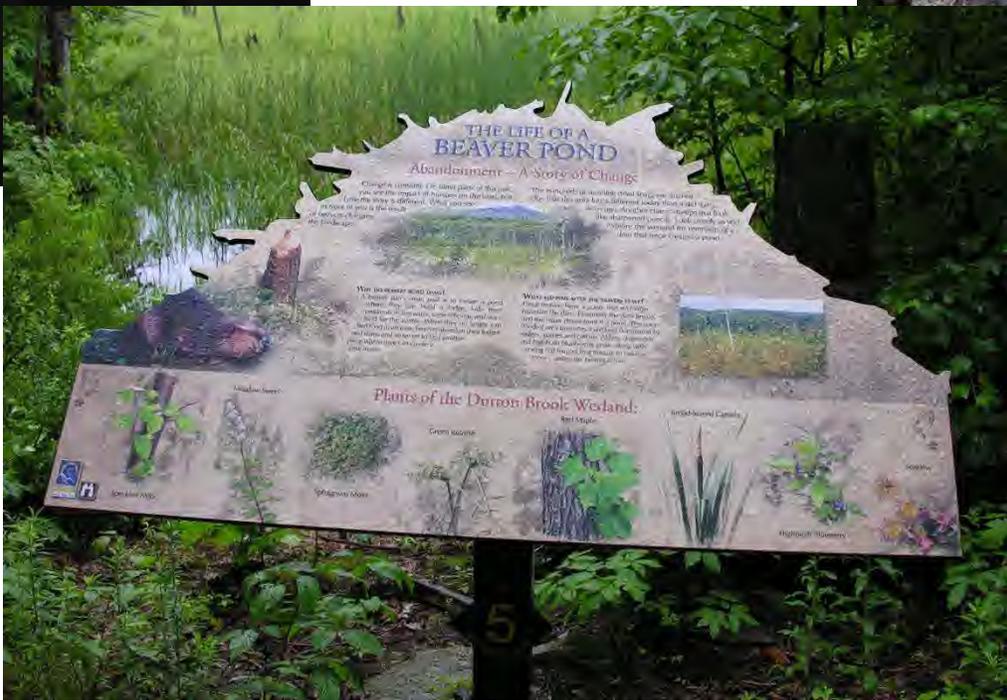
**Best Practice:** These examples of interpretive signs are extremely informative, colorful, creative, durable, easy to read and well placed.

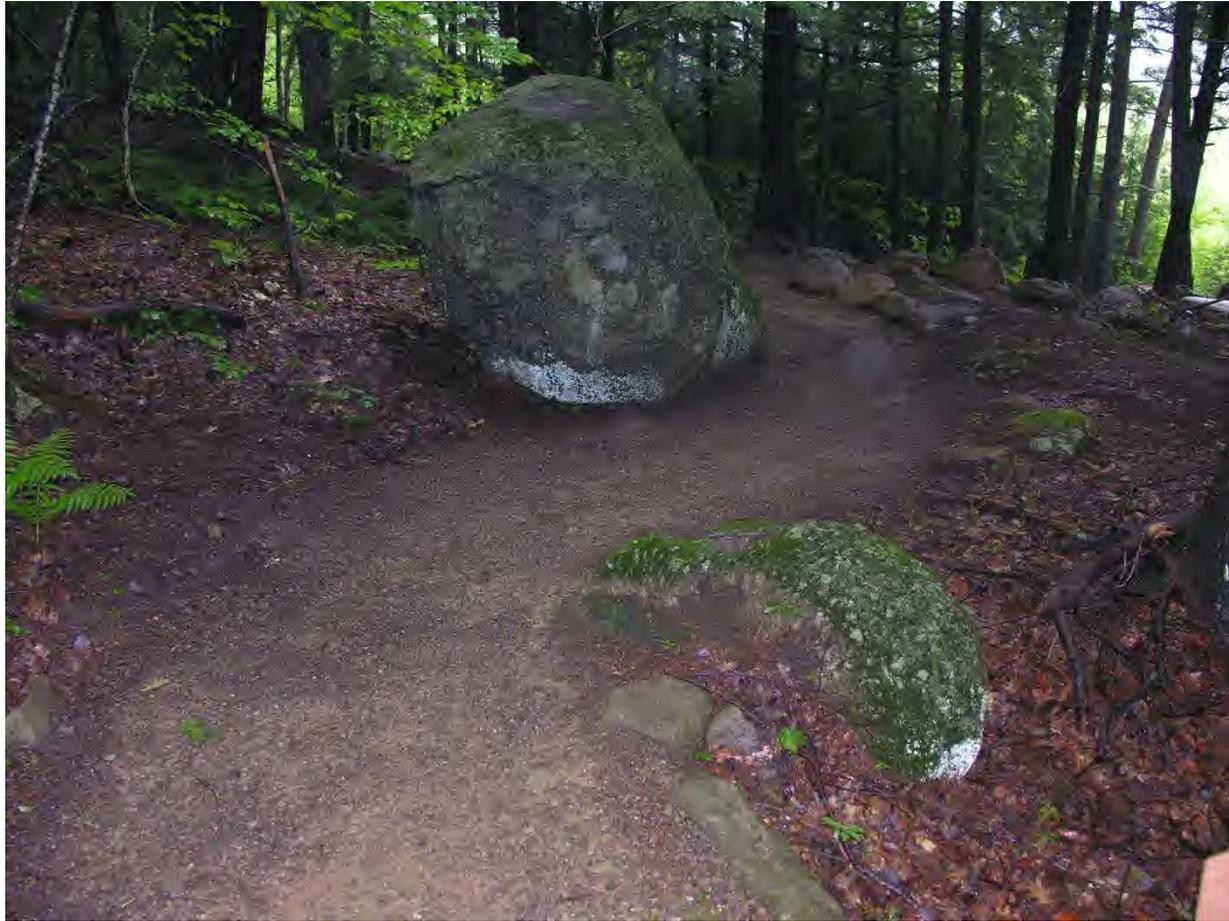
**Best Practice:** Trail Layout takes advantage of features like this glacial erratic and runs the trail around it. Note the cribbing stones further along the trail as the trail switches back as it descends the mountain.

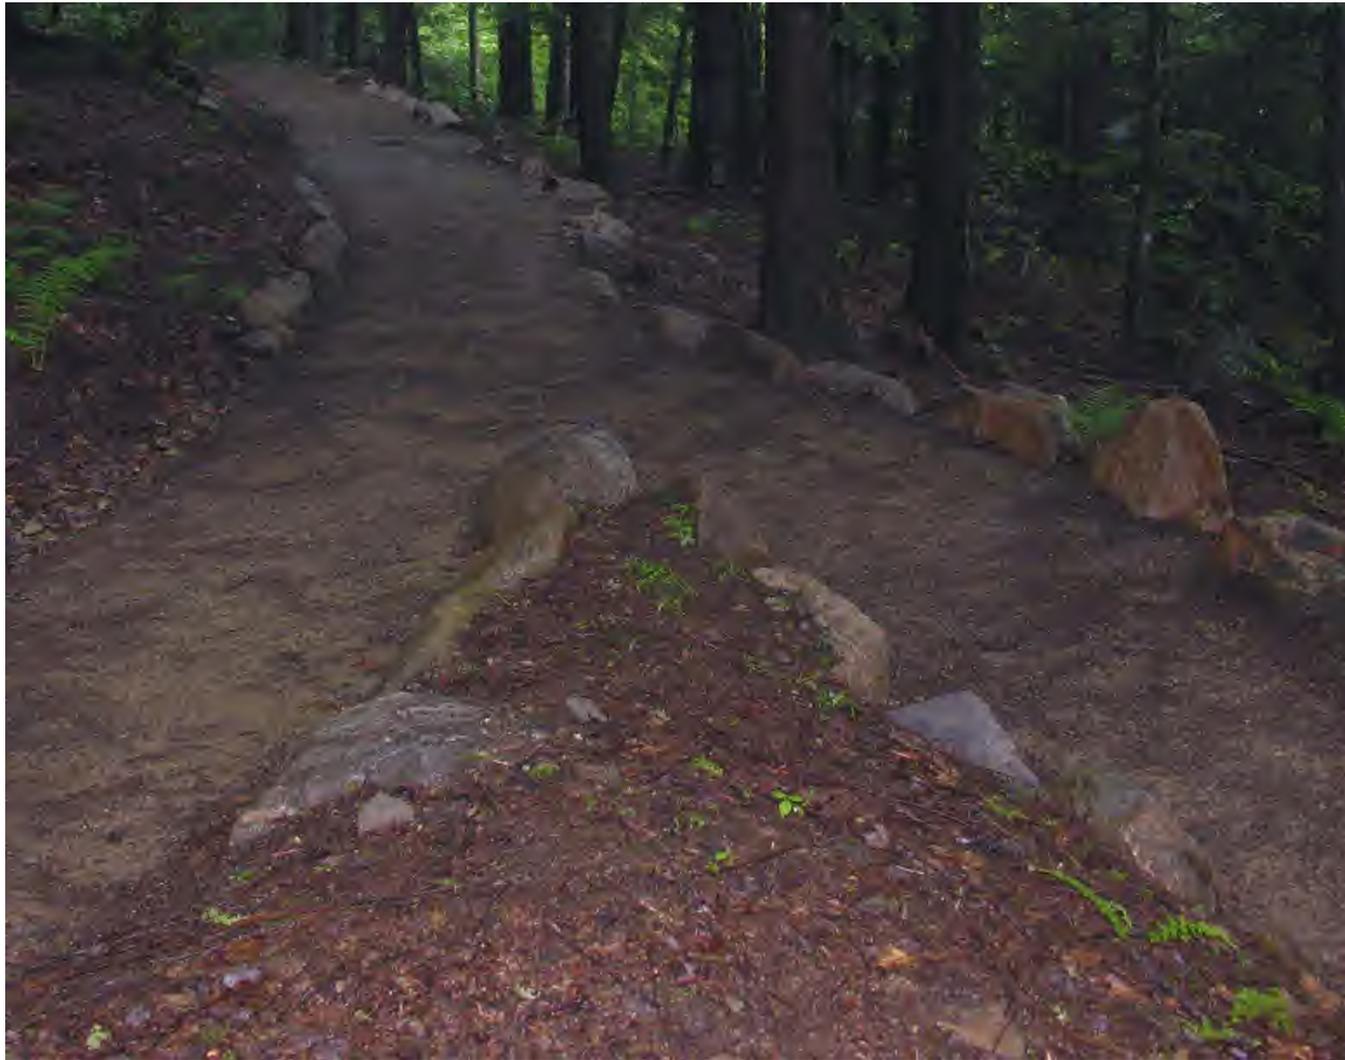
**CROTCHED MT. ACCESSIBLE TRAIL, GREENVILLE, NH**

**Best Practice:** Cribbing stones on the downhill side of this trail are chosen so that users do not feel inclined to step on them. They are dug into the ground so they are stable and will not fall out of place if someone does step on them. They are large enough so it is difficult for any one user to move them. The stone at the intersection of the two trails helps keep users from “cutting the corner”

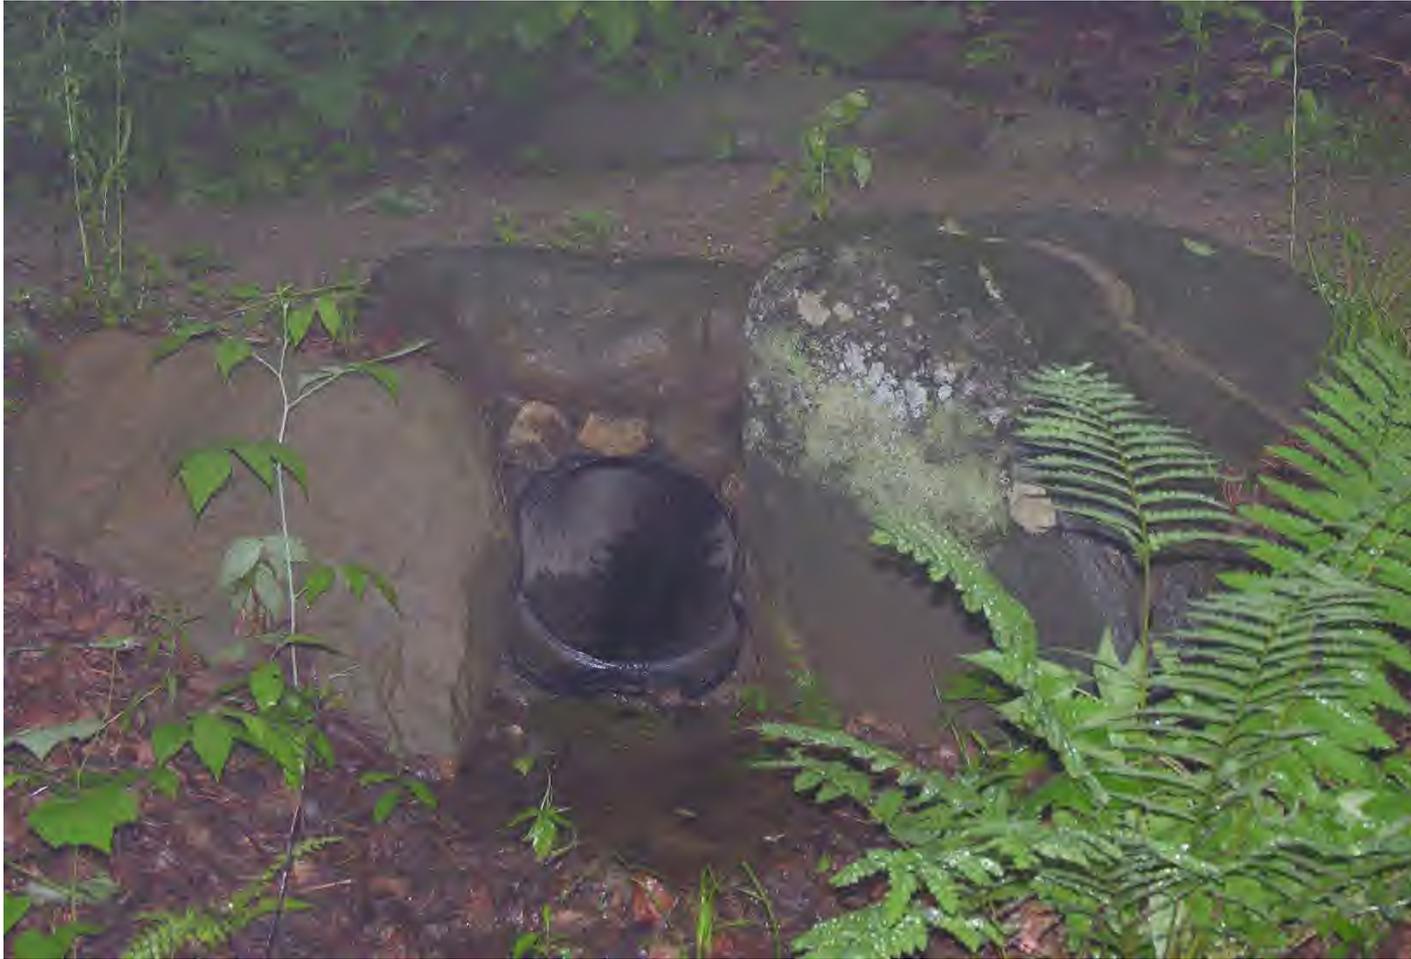
**CROTCHED MT. ACCESSIBLE TRAIL, GREENVILLE, NH**

**Best Practice:** This 8” plastic corrugated culvert is sized and located properly to handle the amount of run-off during normal storms. It has also been covered with sufficient fill so that the culvert will not be crushed by traffic on the trail. Finally, both ends are encased with large stone to hide the openings and enhance the aesthetics of the trail

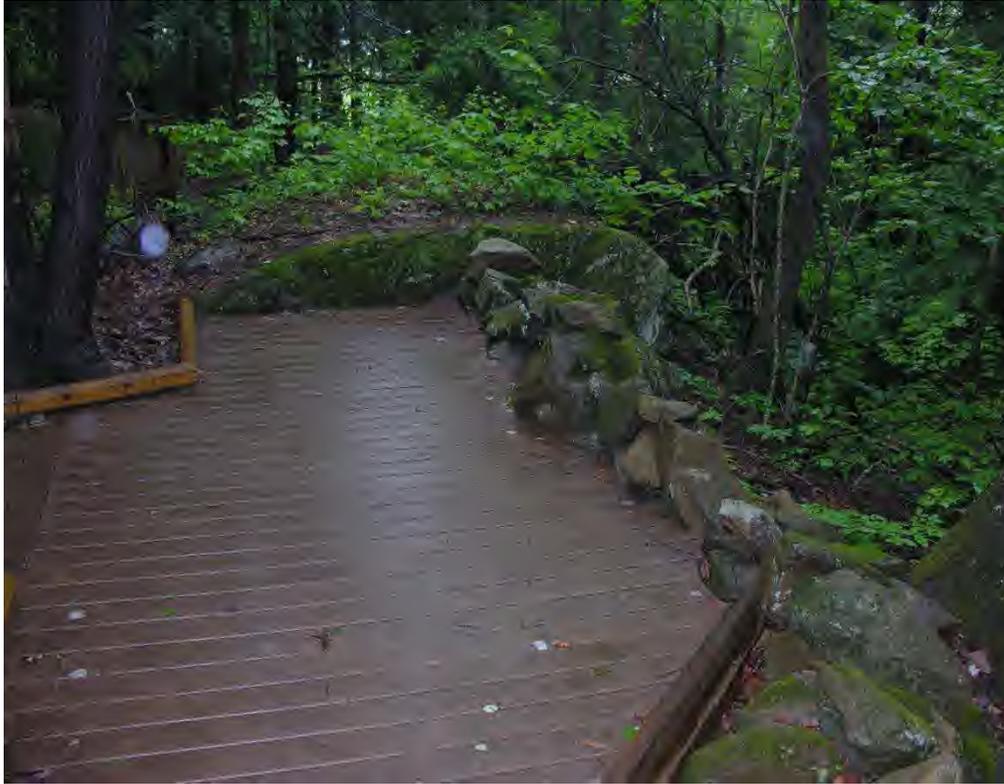
**CROTCHED MT ACCESSIBLE TRAIL, GREENVILLE, NH**

**Best Practice:** An example of work that depicts High-quality craftsmanship and pride in the product you are giving the client. Here, the crew scribed the decking boards up to the stone wall as though they grew together over time. The designer is going beyond just getting the trail built, but adding to the experience by given the user something to admire and respect.

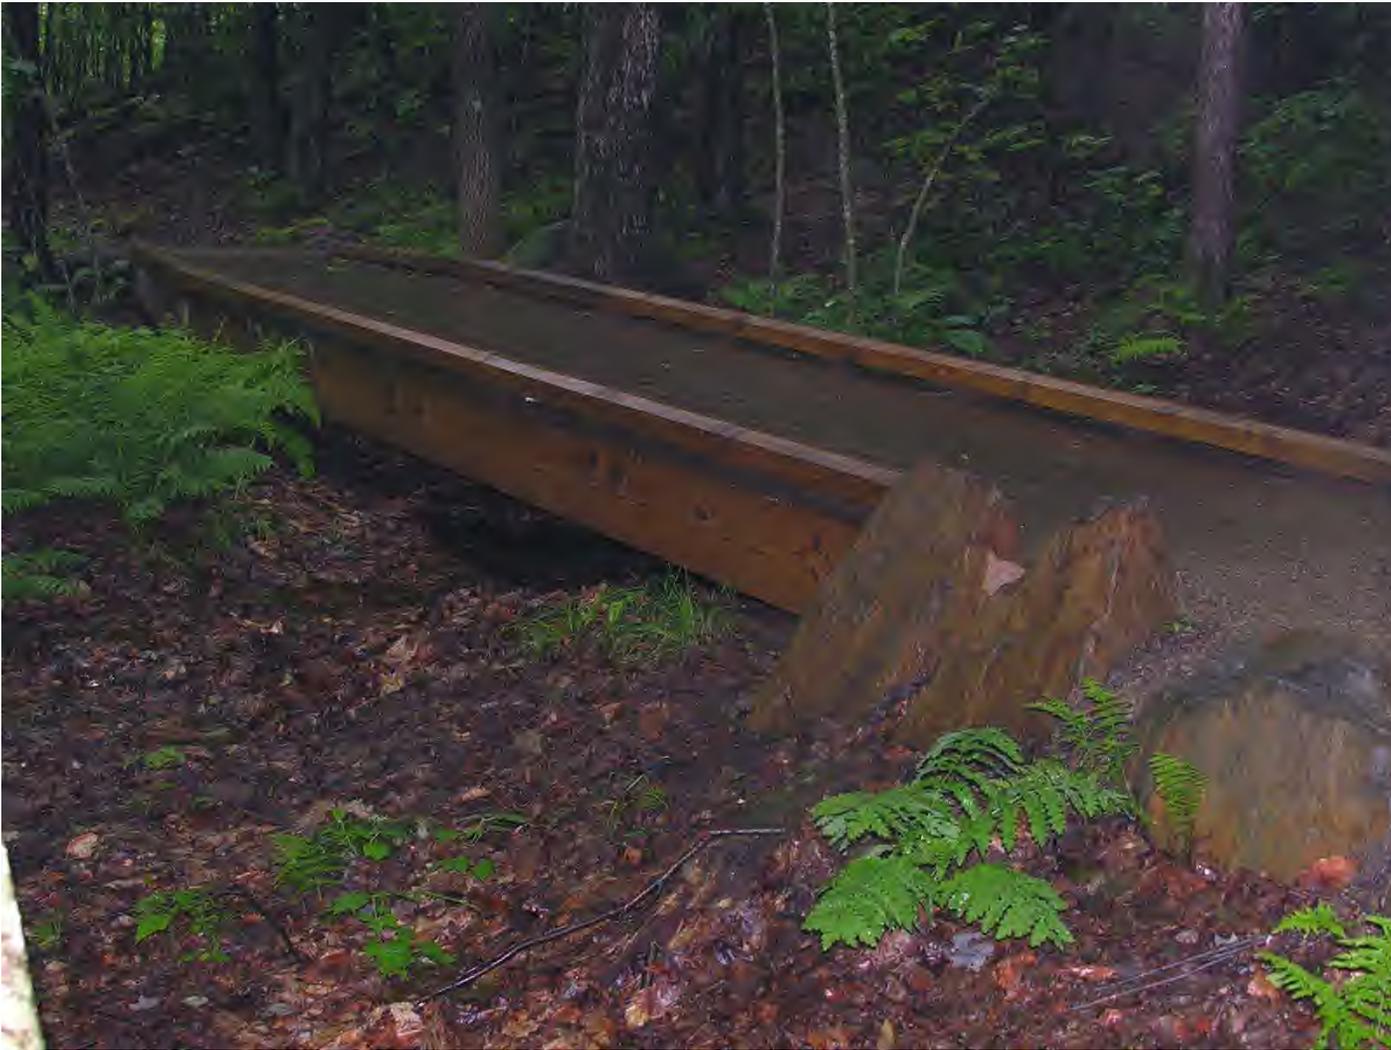
**CROTCHED MT ACCESSIBLE TRAIL,  
GREENVILLE, NH**

**Best Practice:** The stone used in the bridge abutment on the near side of the photo looks like it has been there forever. It has, in fact, been dug in there by the trail crew and acts as a retaining element for the tread surface to the bridge. It has been placed there deliberately so that its sharp points keep folks from stepping on it and unknowingly guides them and keeps them on the trail.
