June 2011

Newman Road Tidal Assessment Newbury, Massachusetts

Project Background

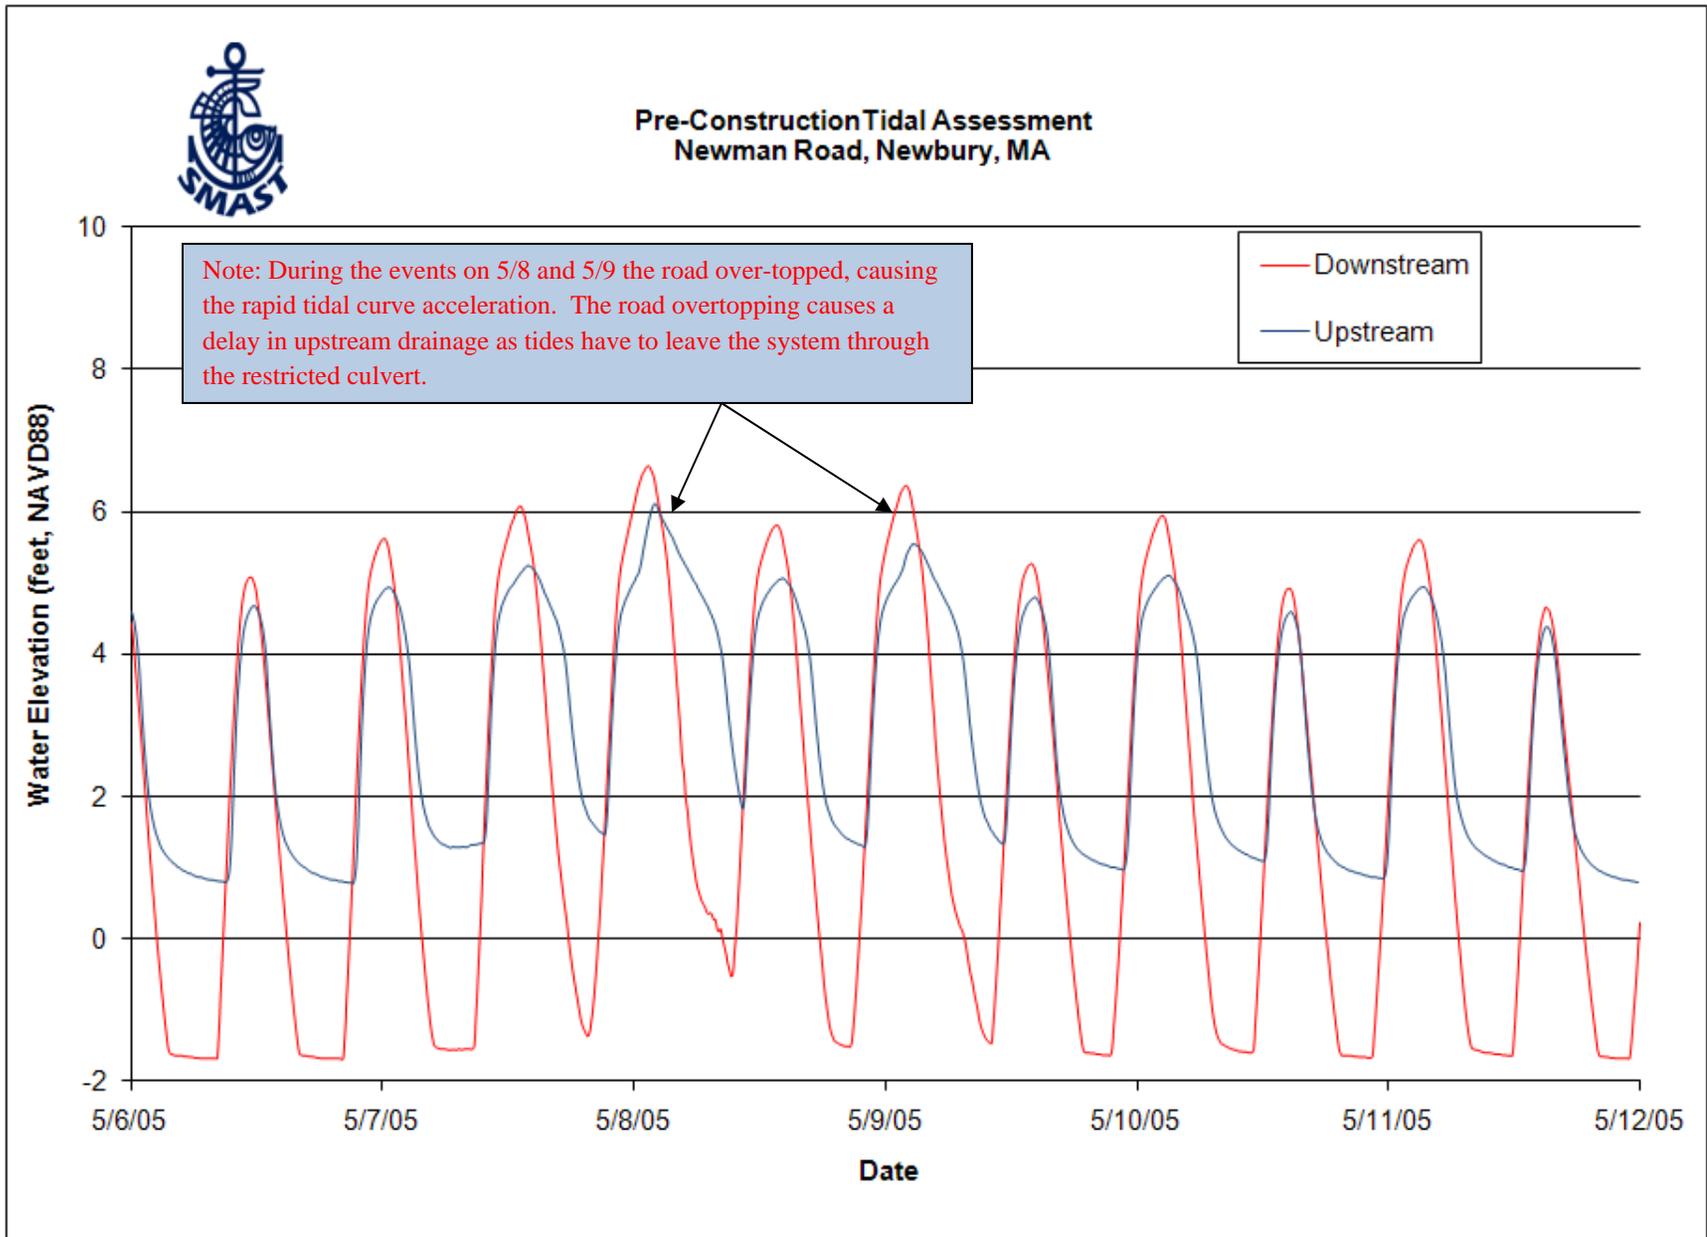
Figure 1. Pre-construction tidal assessment at Newman Road.

UMASS Dartmouth School for Marine Science and Technology (SMAST) collected pre-construction data at Newman Road for 11-days from May 3 to May 14 of 2005 (data was provided by Massachusetts Division of Ecological Restoration). Figure 1 is a plot of 7-days of pre-construction data for the Site. The data shows that the upstream marsh functions differently than the downstream. From the pre-construction data it appears that the upstream marsh was restricted and did not have enough time between tide cycles to effectively drain through the former 48-inch pipe. Also, based on the existing conditions survey it appears that the upstream channel is impounded by a perched culvert (i.e., outlet elevated above the downstream water surface, allowing a freefall condition). During large storms events, water overtops the road and then causes a drainage lag due the large volume of water on the upstream side draining through the small culvert.

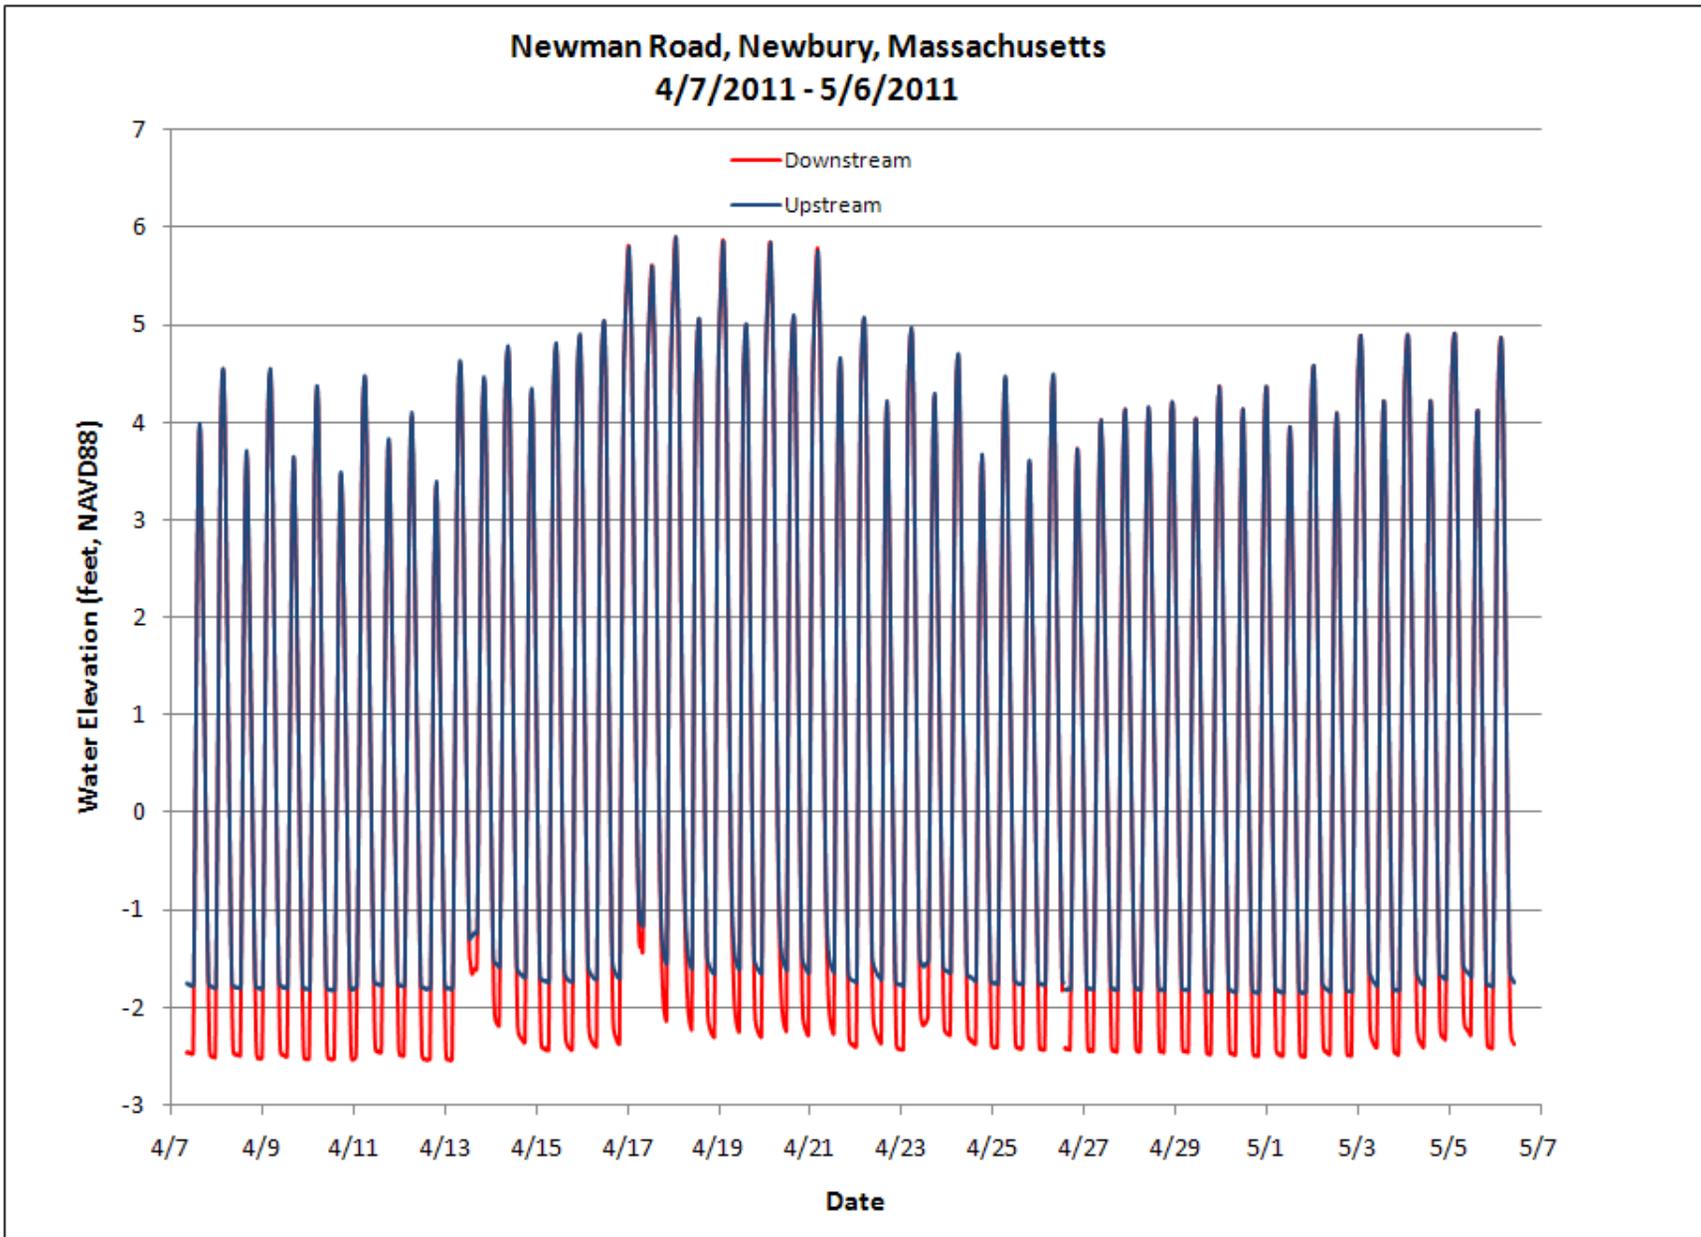
Figure 2. Post-construction restoration data from April 7th to May 7th of 2011.

Geosyntec Consultants, Inc. (Geosyntec) collected post-construction restoration data at the Site for 30-days from April 7 to May 7 of 2011. Figure 2 is a plot of water elevation data over the complete tidal assessment period and Figure 3 is a plot of 7-days of water elevation data from April 16 to April 22 of

Figure 2 shows that the post-construction tidal cycles for the upstream (marsh) and downstream tide-gauges are almost identical, indicating that the tidal regime has been altered when compared to the pre-construction condition. Rain events on April 13 (0.1 inches) and April 17 (0.3 inches) of 2011 are recorded in the hydrograph and are evidenced by the elevated height of low tide recorded on those days.

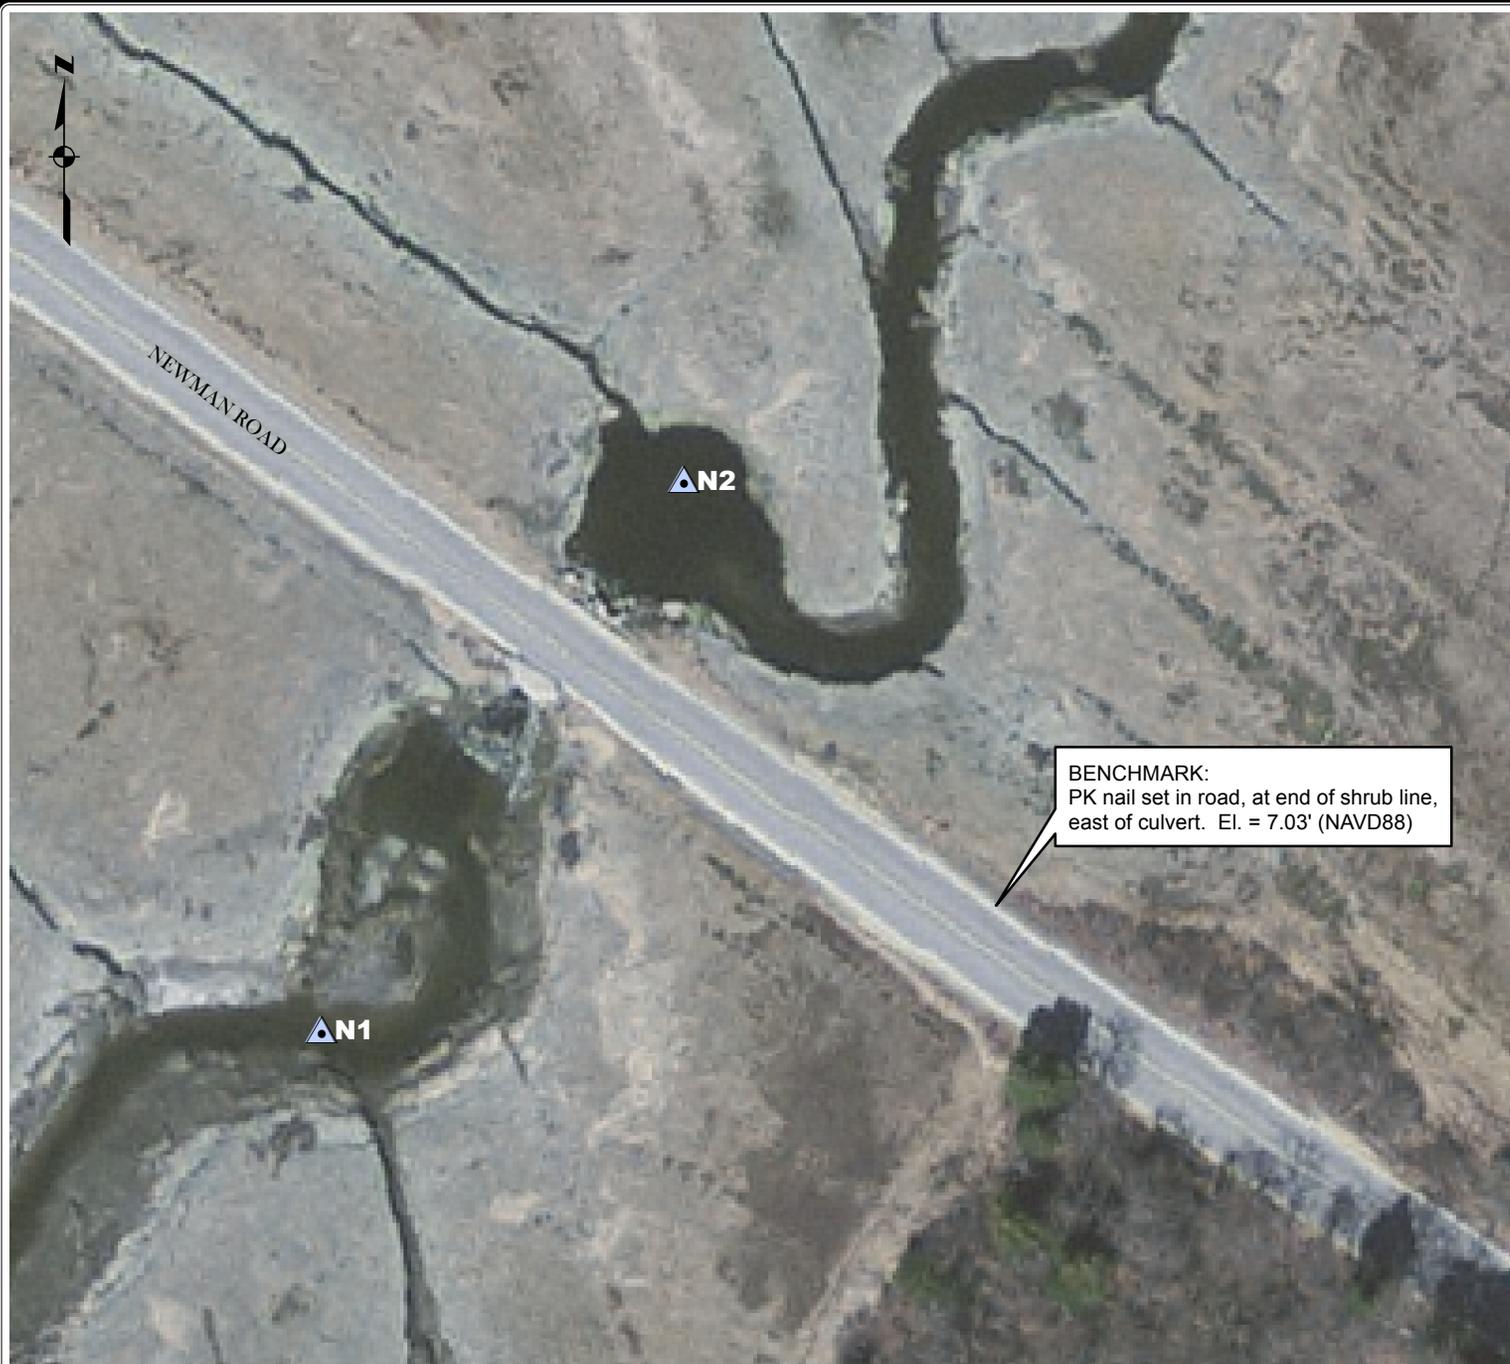
Tide-gauge Locations

▲ Tide-gauge Location (Geosyntec, 2011)

1. Aerial image via MassGIS, 2008.
2. Elevations of transducers included in survey data sheets included in this report.
3. Elevations refer to NAVD88.
