Damde Meadows Tidal Assessment Post-Construction Hingham, Massachusetts

Project Background

Tidal Survey

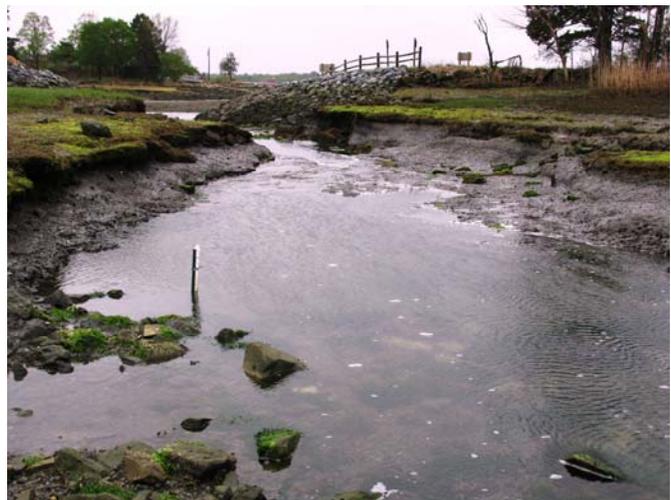
Photo 1. Mid marsh tide-gauge location.

To assess the post-construction restoration at the Site, three tide-gauges were installed on May 11, 2011. Tide-gauges consisted of Onset® HOBO U20 Water Level Data Loggers that have operational range from 0 to 30 feet with ± 0.02 ft accuracy. One tide-gauge was installed in the Damde Meadows marsh (Damde Meadows) (D3), one in the channel between the two causeways / dikes (Mid Marsh) (D2) (Photo 1), and one downstream in Martin's Cove (D1) (locations are shown in Attachment A). The tide-gauges were deployed to collect continuous water level data at 6-minute intervals for 28 days,

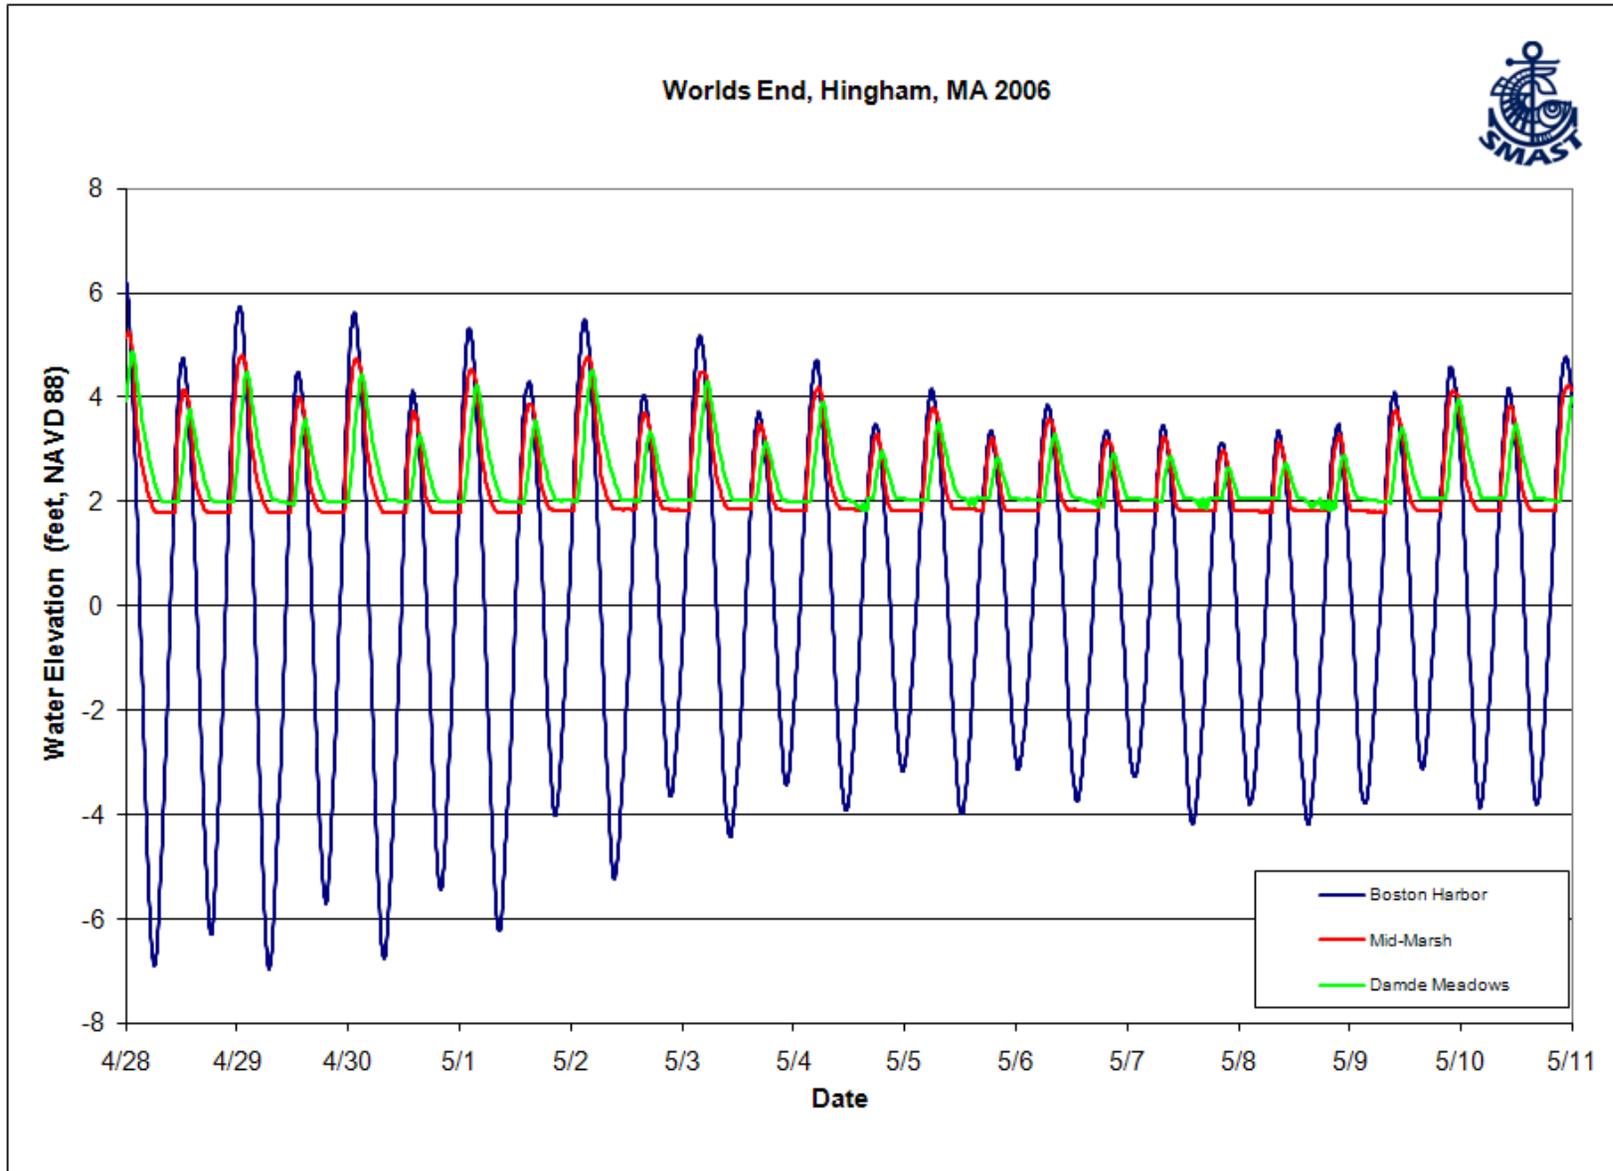
Pre-construction data at Damde Meadows was collected by UMASS SMAST for 13-days from April 28 to May 10 of 2006, at 10-minute intervals (data was provided by Massachusetts Division of Ecological Restoration). Figure 1 is a plot of the 13-days of pre-construction data for the Site, which includes the spring tide for the Damde Meadows system.

Figure 1. Damde Meadows Pre-construction data from April 28 to May 11 of 2006.

Hydrographs collected in 2006 and published reports illustrate that restoration objectives were not fully achieved with the installation of box culverts in 2003. Damde Meadows remained impounded and the tidal hydrology restricted.

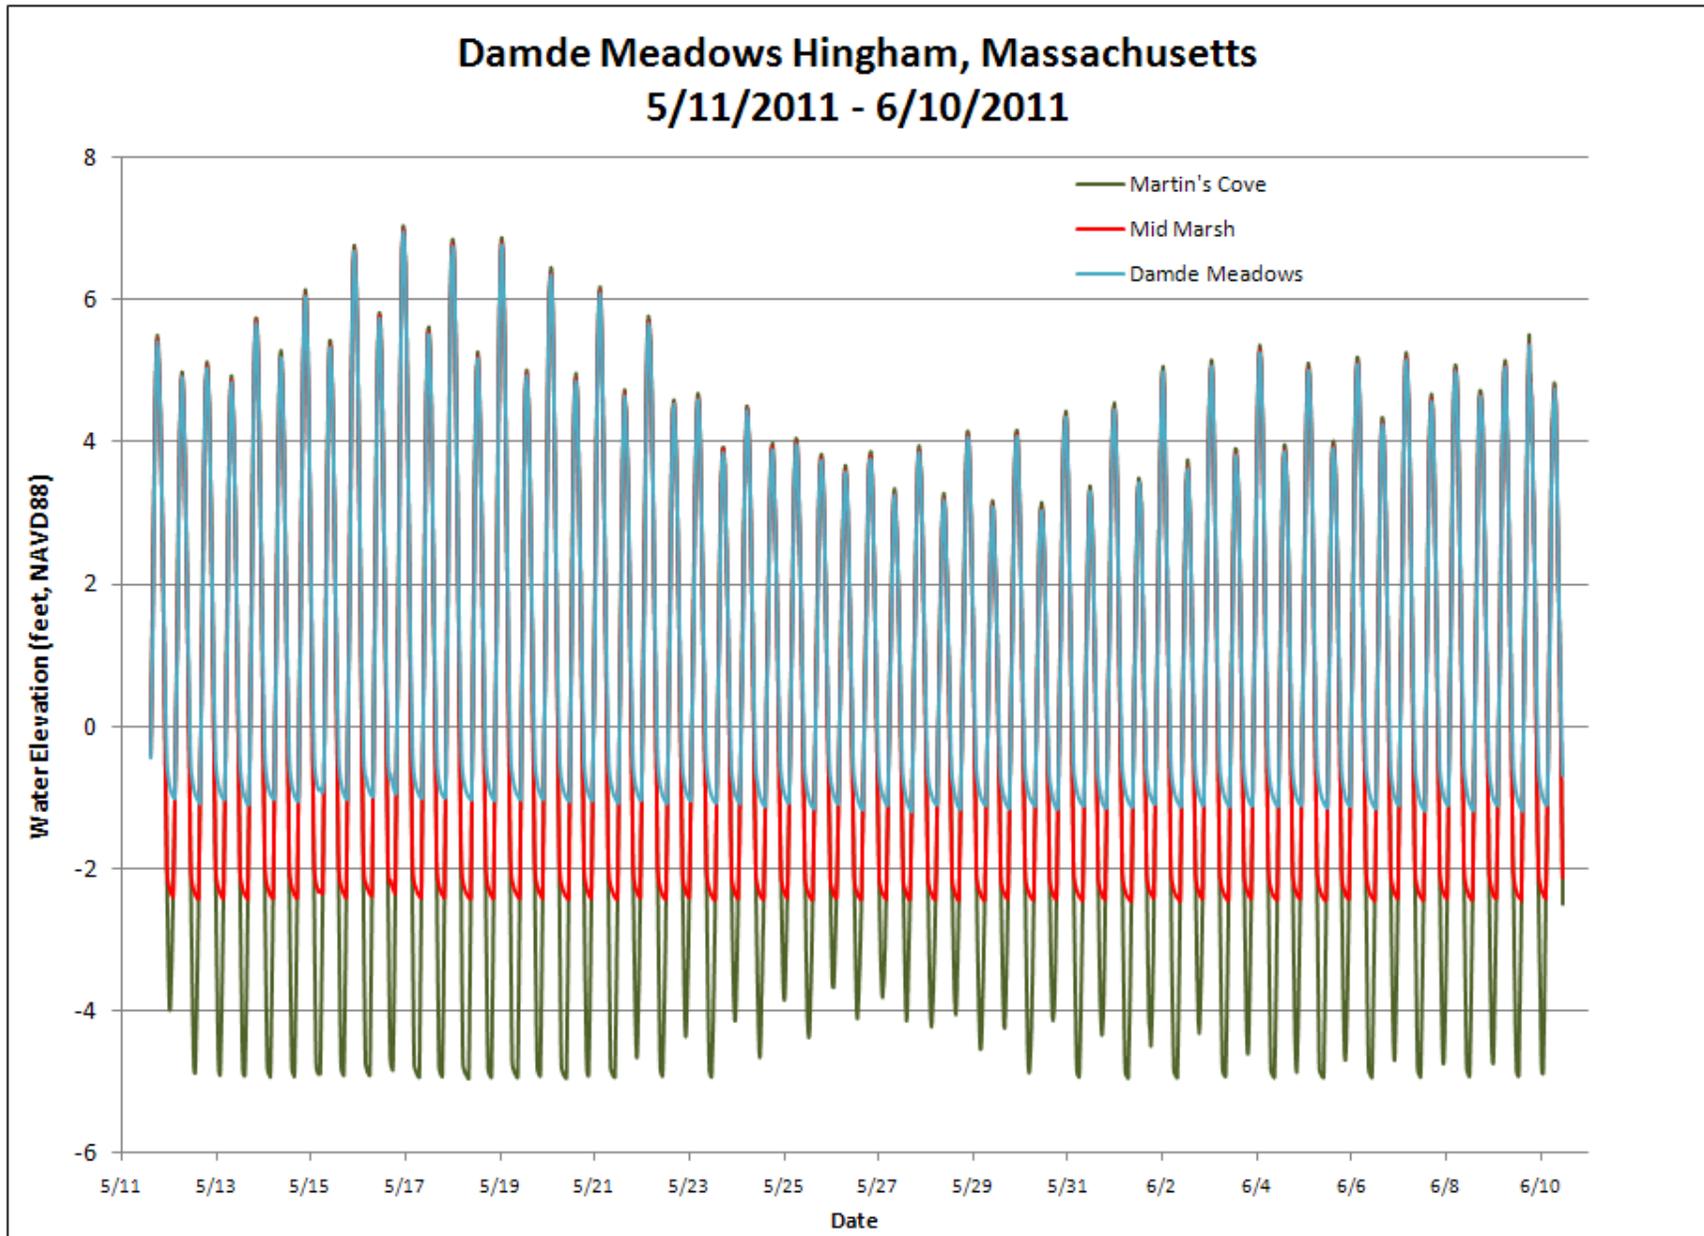
Geosyntec Consultants, Inc. (Geosyntec) collected post-construction restoration data at the Site for 30-days from May 11 to June 10 of 2011. Figure 2 is a plot of water elevation data over the complete tidal assessment period, Figure 3 is a plot of 7-days of water elevation data from May 14 to May 21 of 2011 and Figure 4 is a single day hydrograph on May 17 of 2011. To determine the differences between pre-construction and post-construction and evaluate restoration, tidal metrics were evaluated on the tidal assessment data sets. The tidal metrics include:

Figure 2. Damde Meadows Post-construction data.

- Post construction tidal hydrographs illustrate the complete restoration of tidal flow to the Damde Meadows salt marsh as evidenced by the synchrony among hydrographs for the three study areas. The divergence of the falling limbs in the hydrographs for Damde Meadows and Mid Marsh from that of Martin's Cove is the result of the drop in elevation between Damde Meadows, Mid Marsh and Martin's Cove;

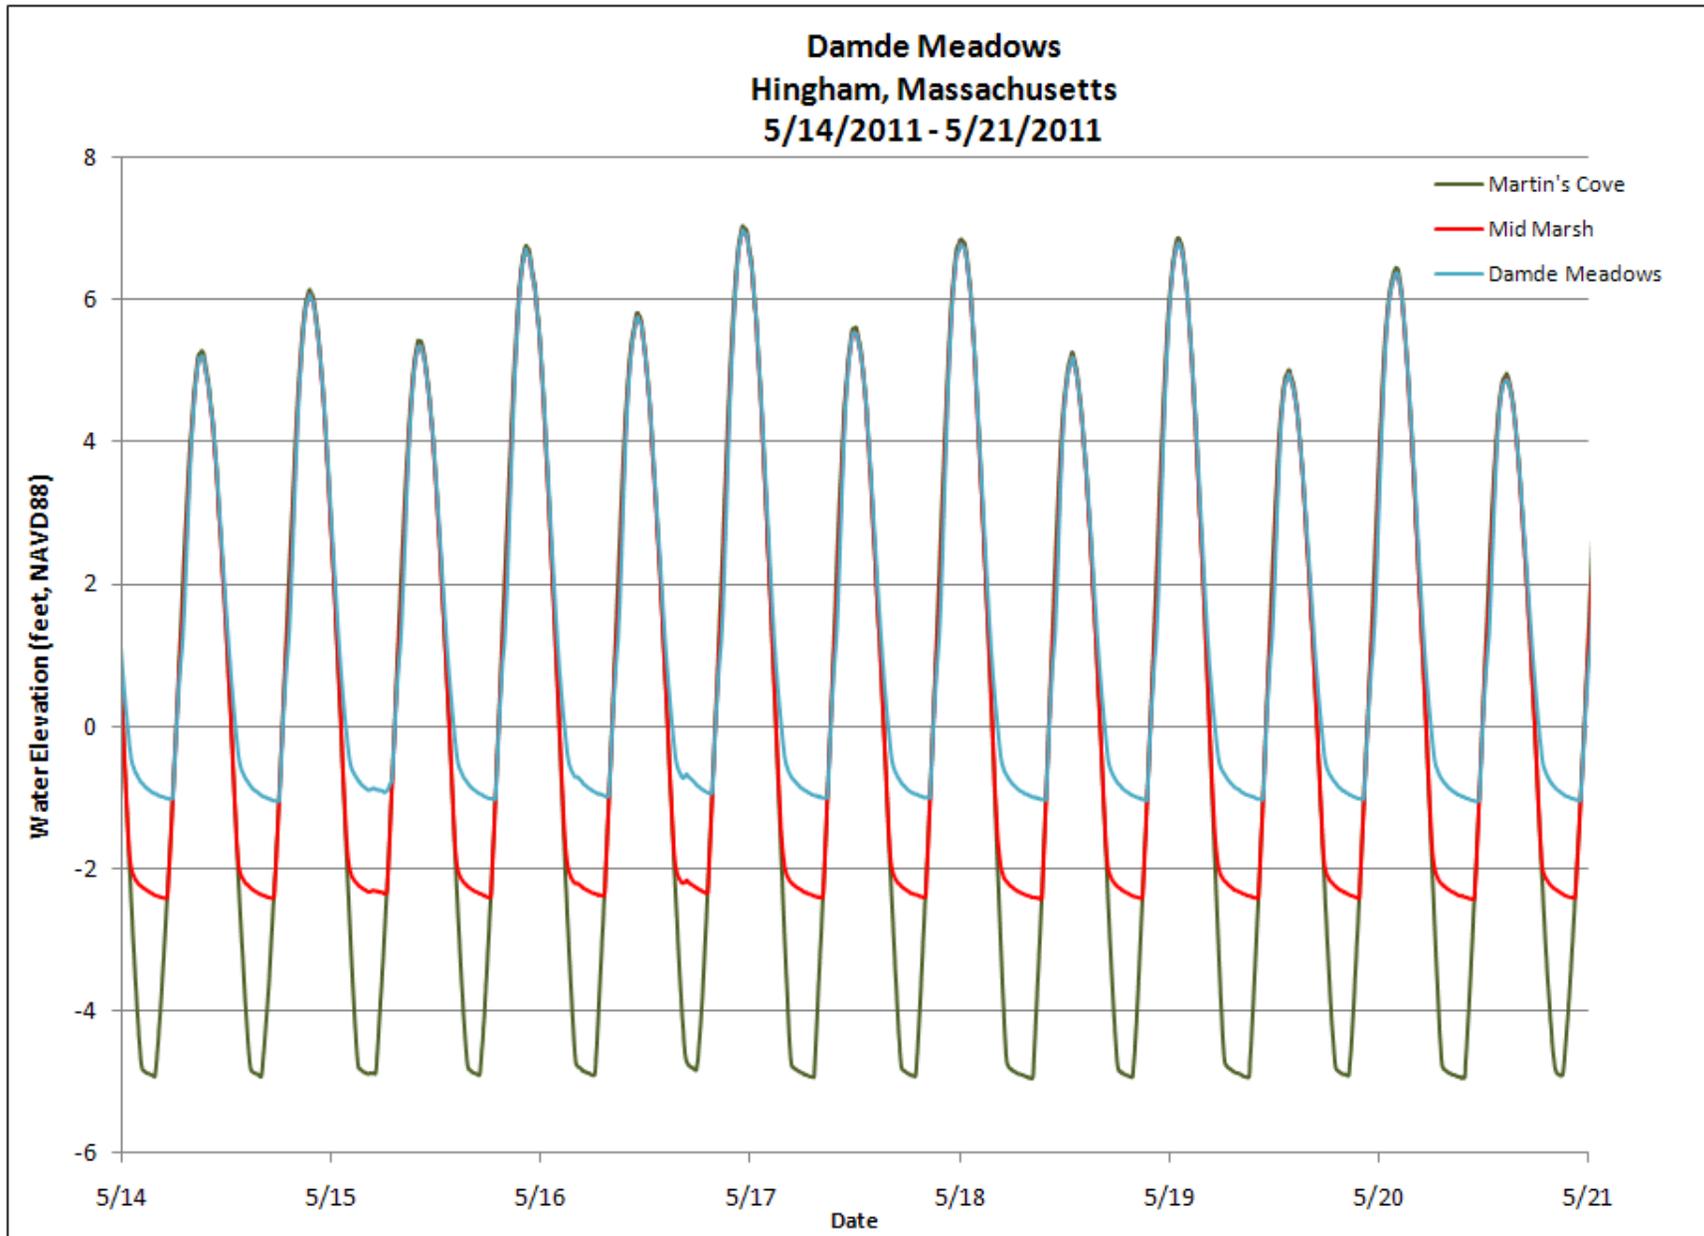
Figure 3. Damde Meadows Post-construction data from May 14 to May 21 of 2011.

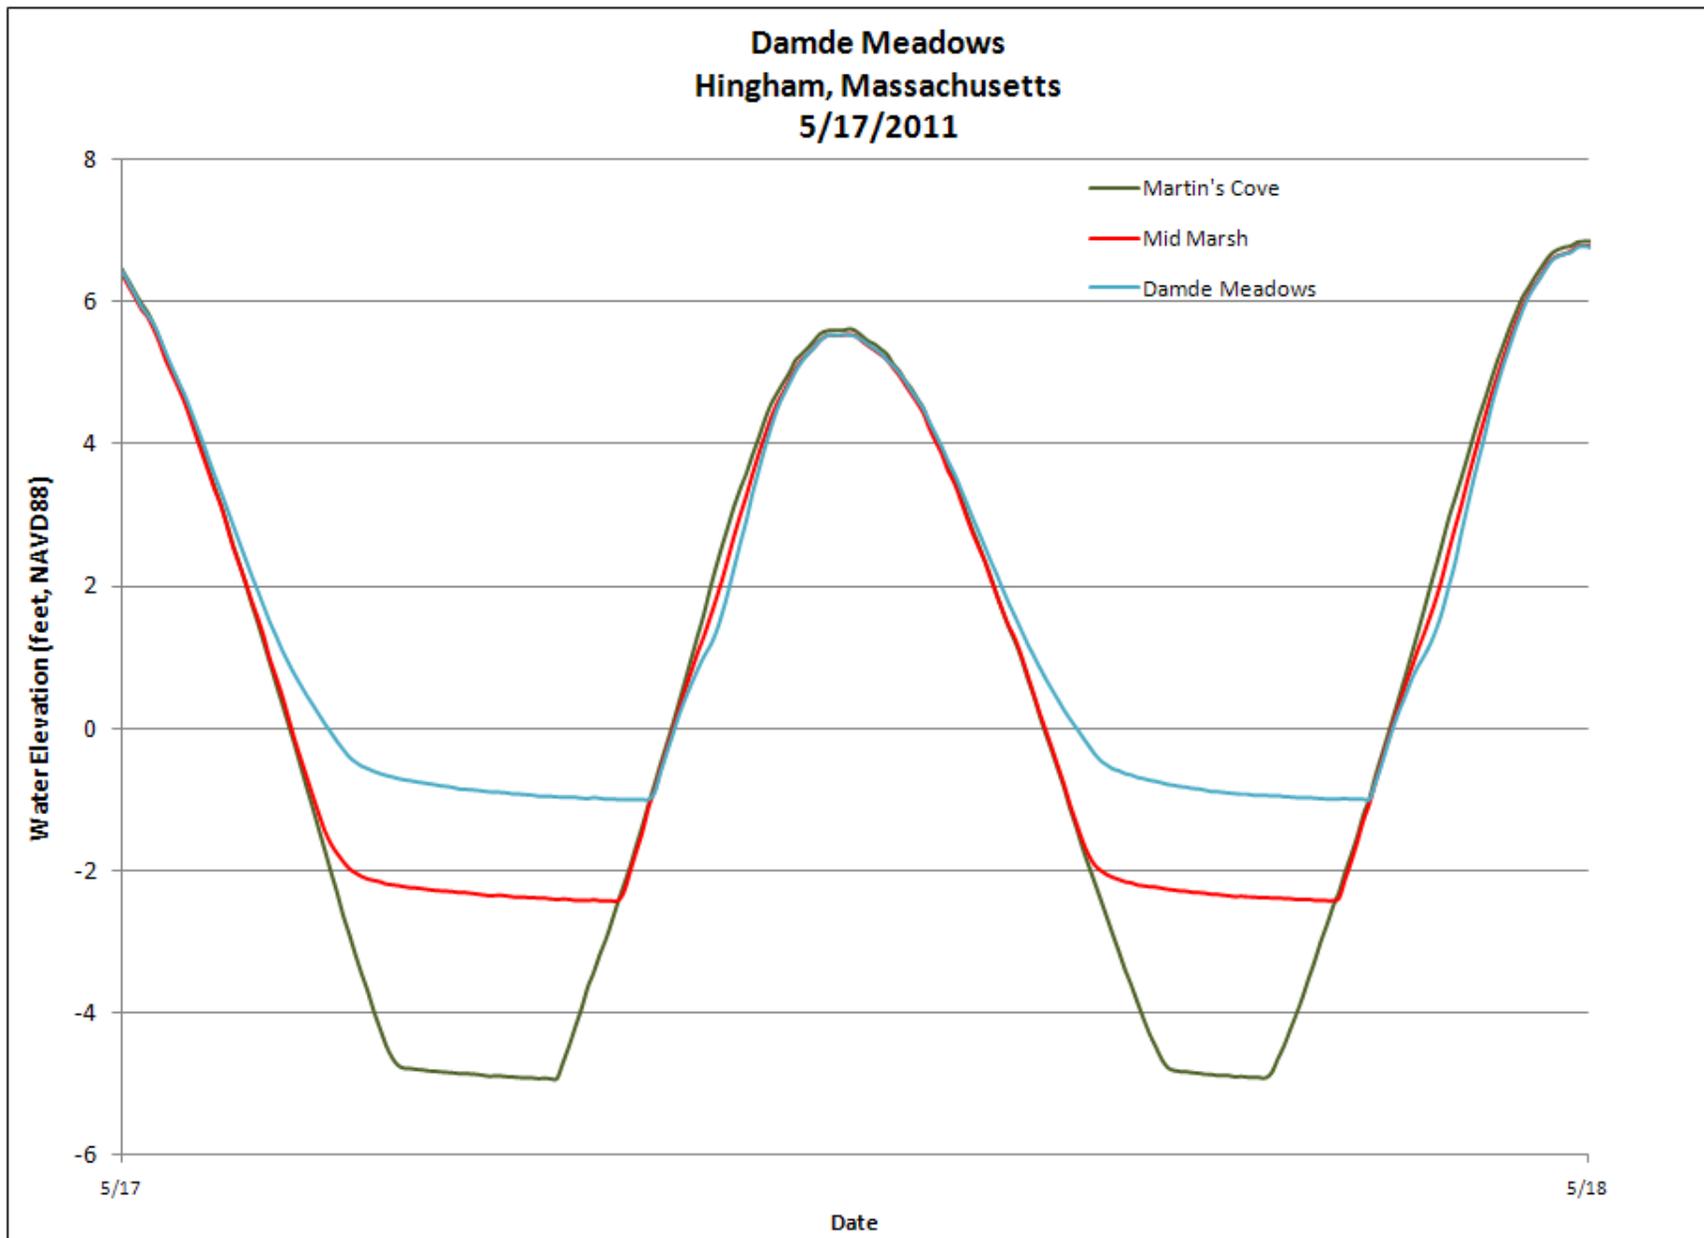
Figure 4. Damde Meadows Post-Construction data on May 17 of 2011.

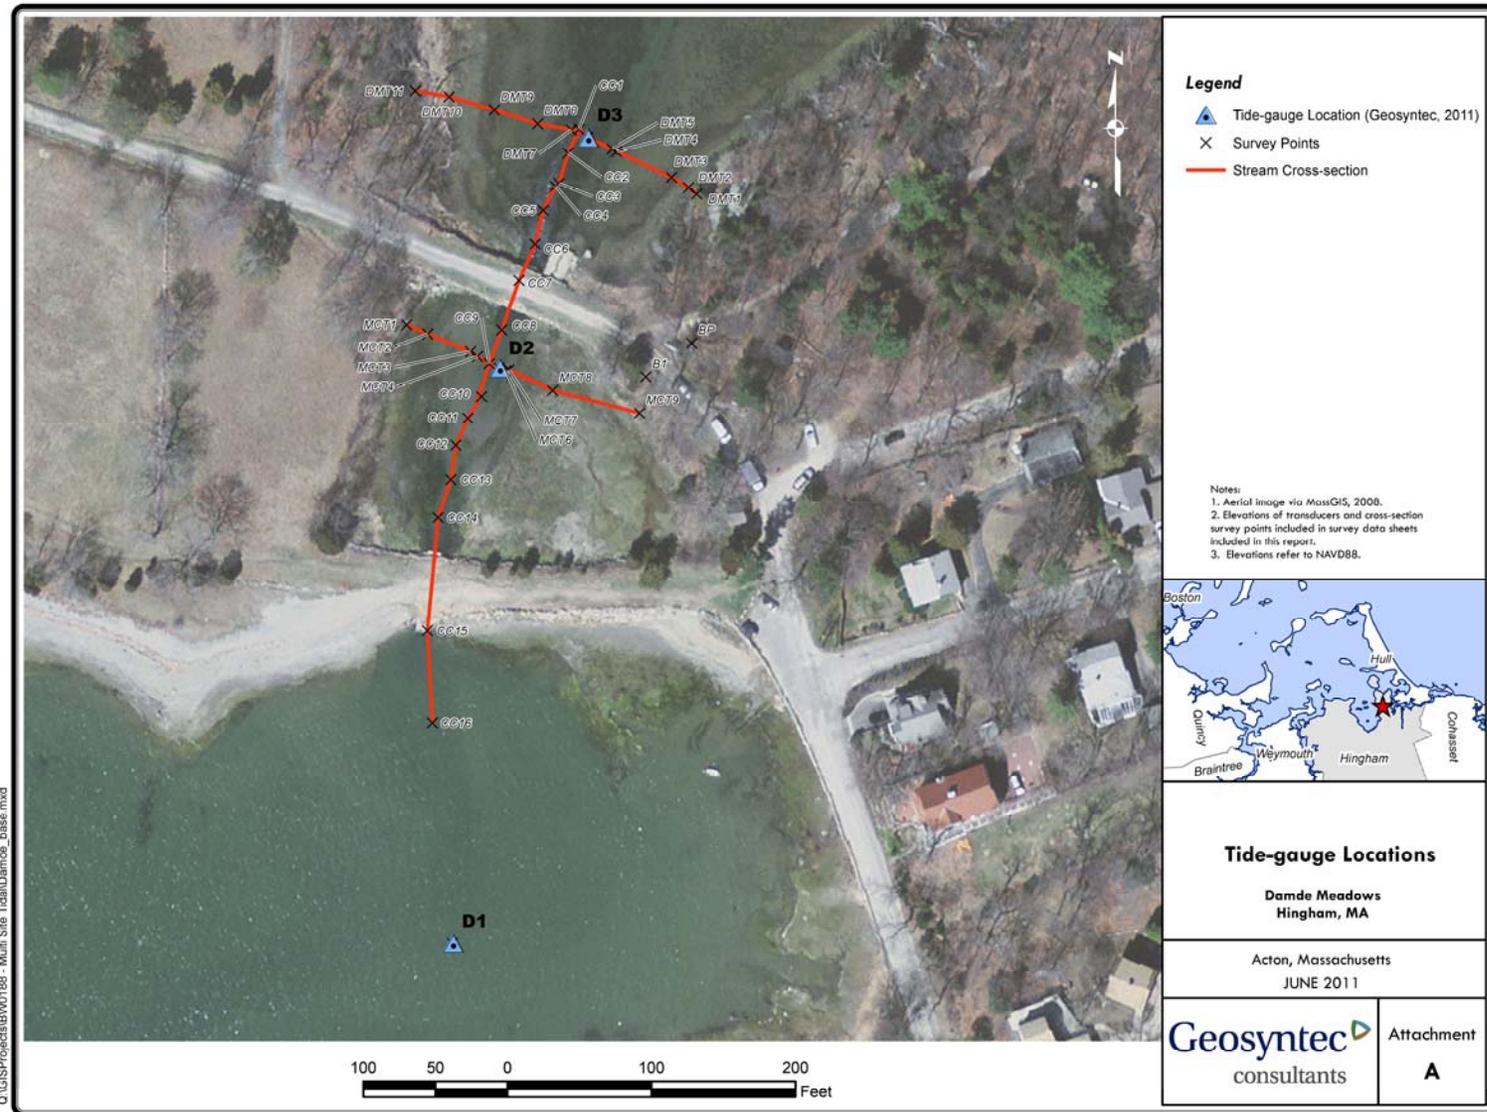
Figure 5. Tide gauge locations

Based on the benchmark elevation of 7.73 feet (NAVD 88) it was determined that the Damde Meadow tide-gauge was installed at an elevation of -2.06 ft NAVD 88, Mid Marsh tide-gauge was installed at an elevation of -4.12 ft NAVD 88 and the Martin's Cove tide-gauge was installed at an elevation of -5.11 ft NAVD 88.
