Trees, Paddlers and Wildlife - Safeguarding Ecological and Recreational Values on the River

Russ Cohen, Rivers Advocate

Mass. Department of Fish and Game

Division of Ecological Restoration (DER)/Riverways Program

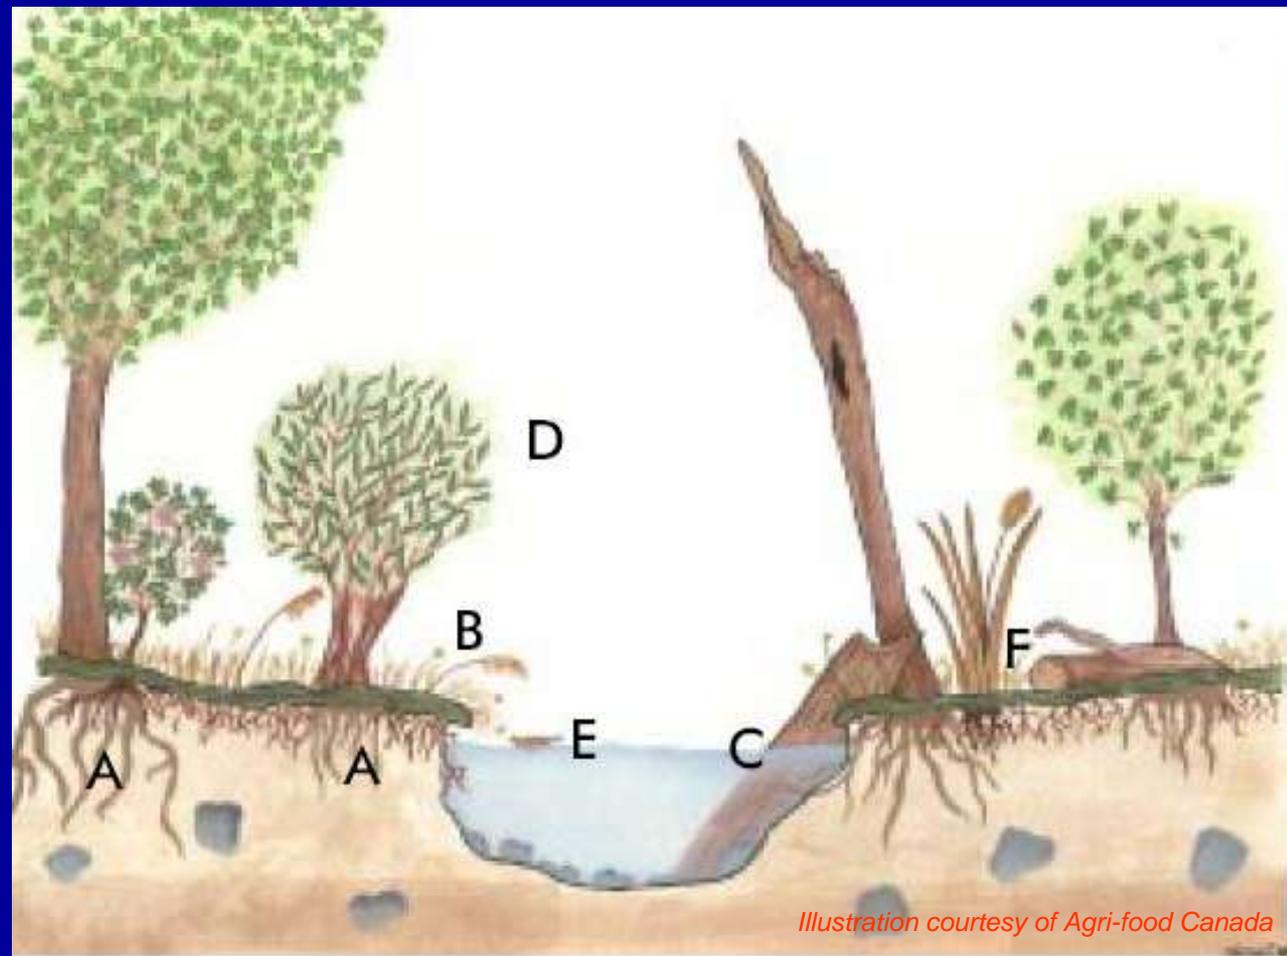
Water Quality Benefits conferred by Riverine Vegetation:

A – plant roots **filter out excess nutrients and other pollutants** before they reach the water

B – living/dead vegetation on the ground **helps slow runoff**, intercepts sediment and reduces erosion

C – Roots, as well as other living and dead vegetation extending into the water, **provide surface areas for pollutant-eating microbes**

D – Trees and other riverine vegetation **provide shade** that helps to keep the water cool and dissolved oxygen levels high enough to support trout and other sensitive organisms. Also, **less algae** grows in shaded streams due to the reduced sunlight

E – Leaves, twigs, insects and other natural items (not lawn clippings!) falling off streamside vegetation and into the water help provide healthy fuel for the aquatic food chain

F – riverine vegetation enhances infiltration of precipitation into the ground, where it can replenish aquifers and streamflow. Higher “baseflows” dilute pollutants and mitigate stream heating

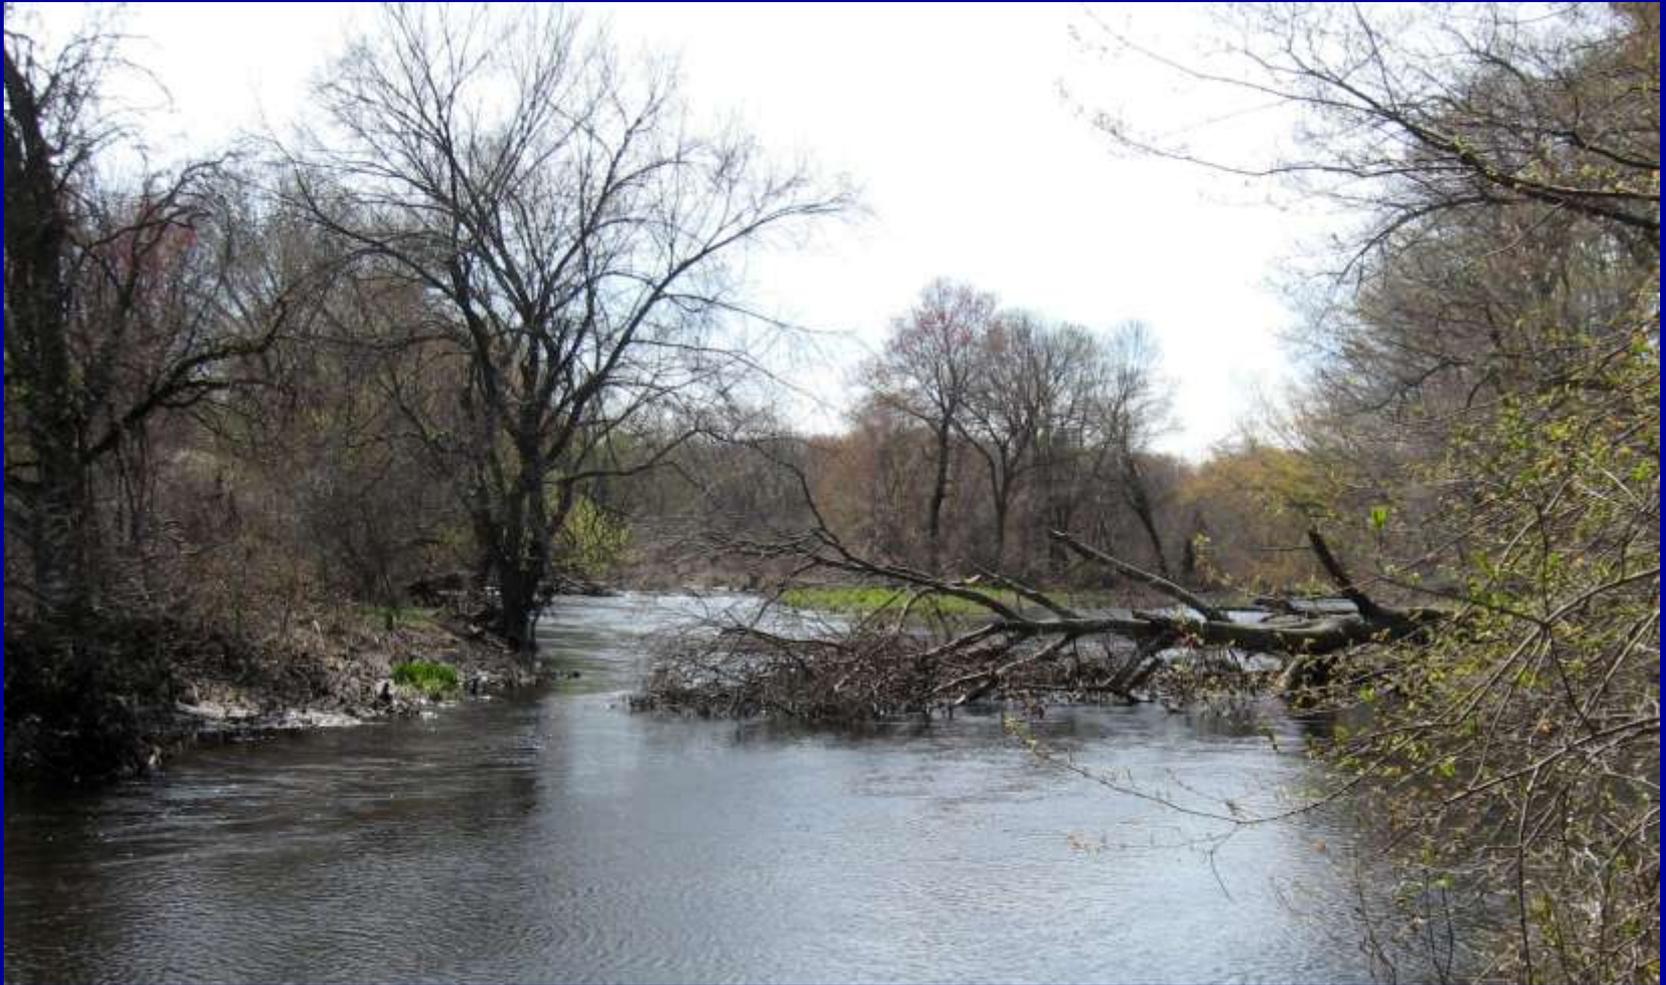
Looking upstream, a large oak tree has fallen almost completely across the Assabet River in Concord. While this tree may back up a bit of water behind it, causing minor flooding, it is also helping to mitigate the velocity and volume of the river's flow, which helps attenuate problems downstream.

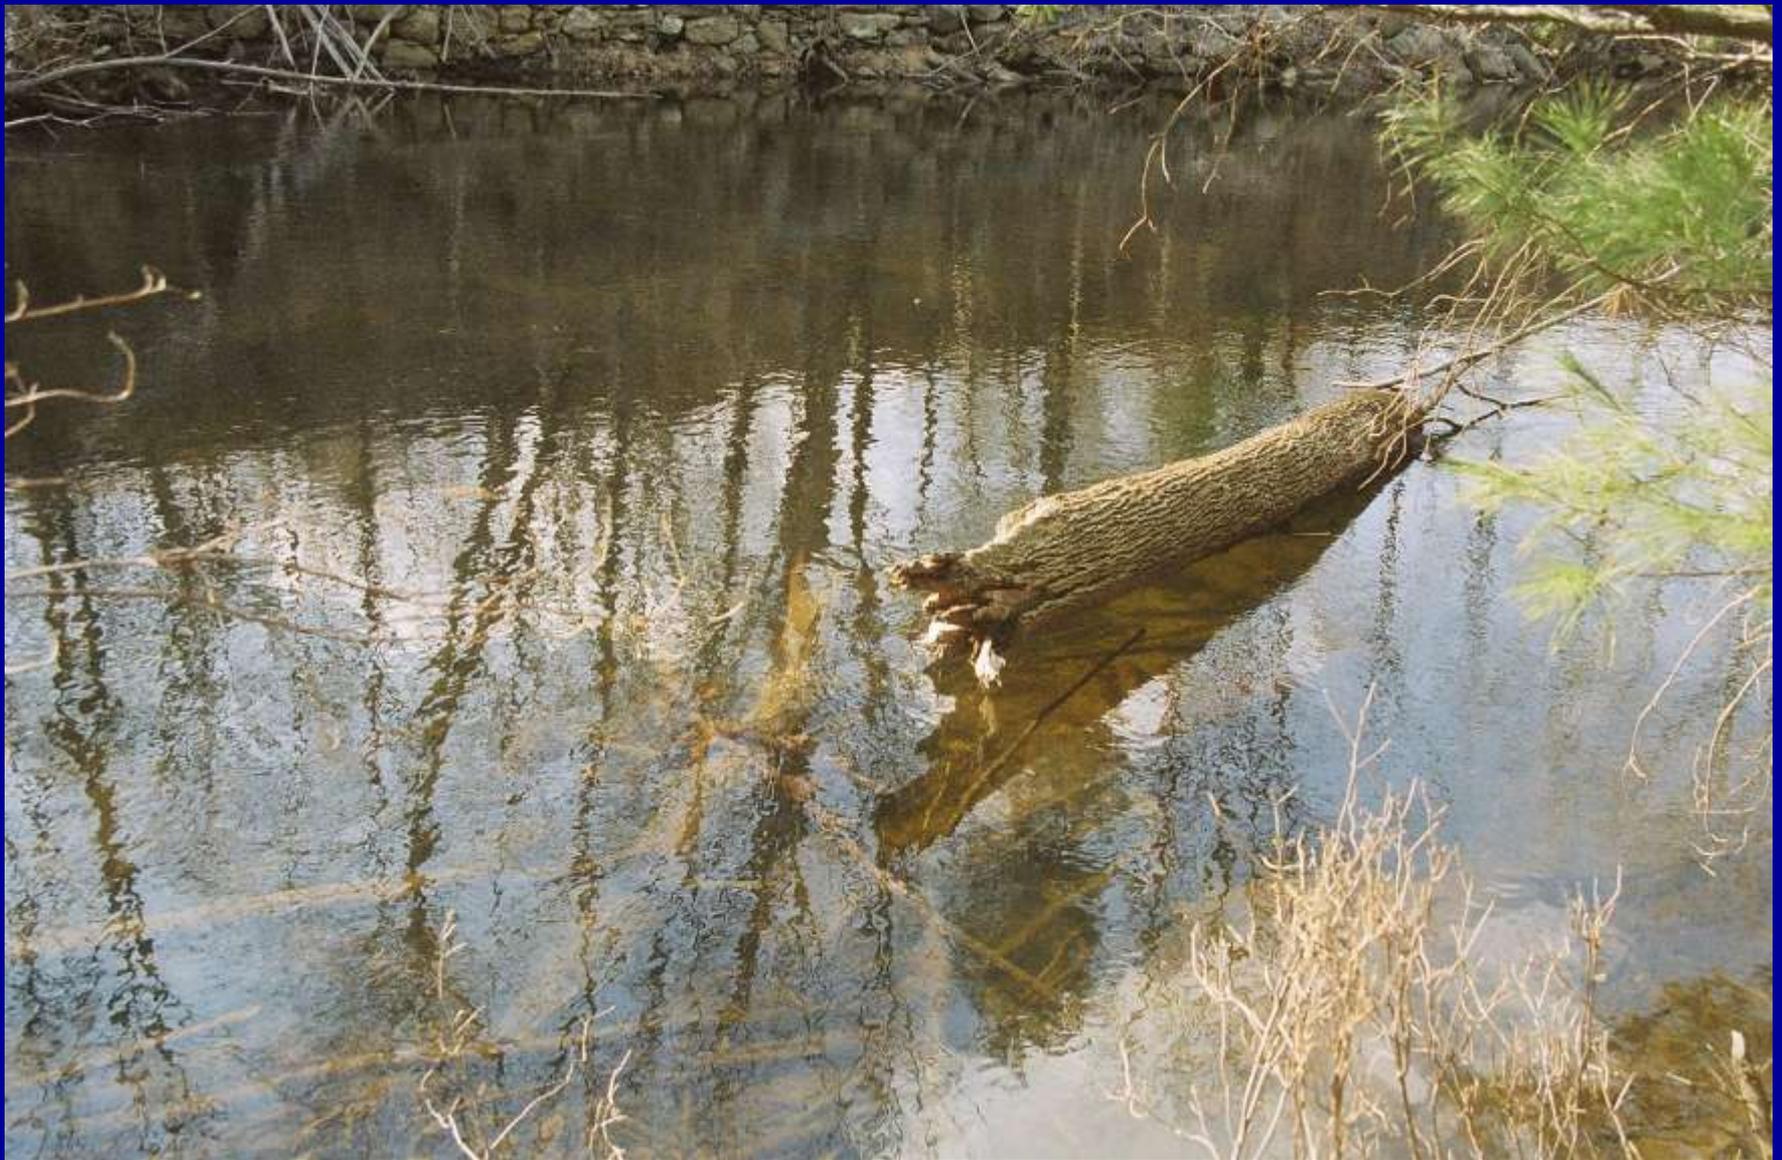
Forested floodplains provide habitat and a place for floodwaters to back up onto instead of rushing downstream and potentially causing problems

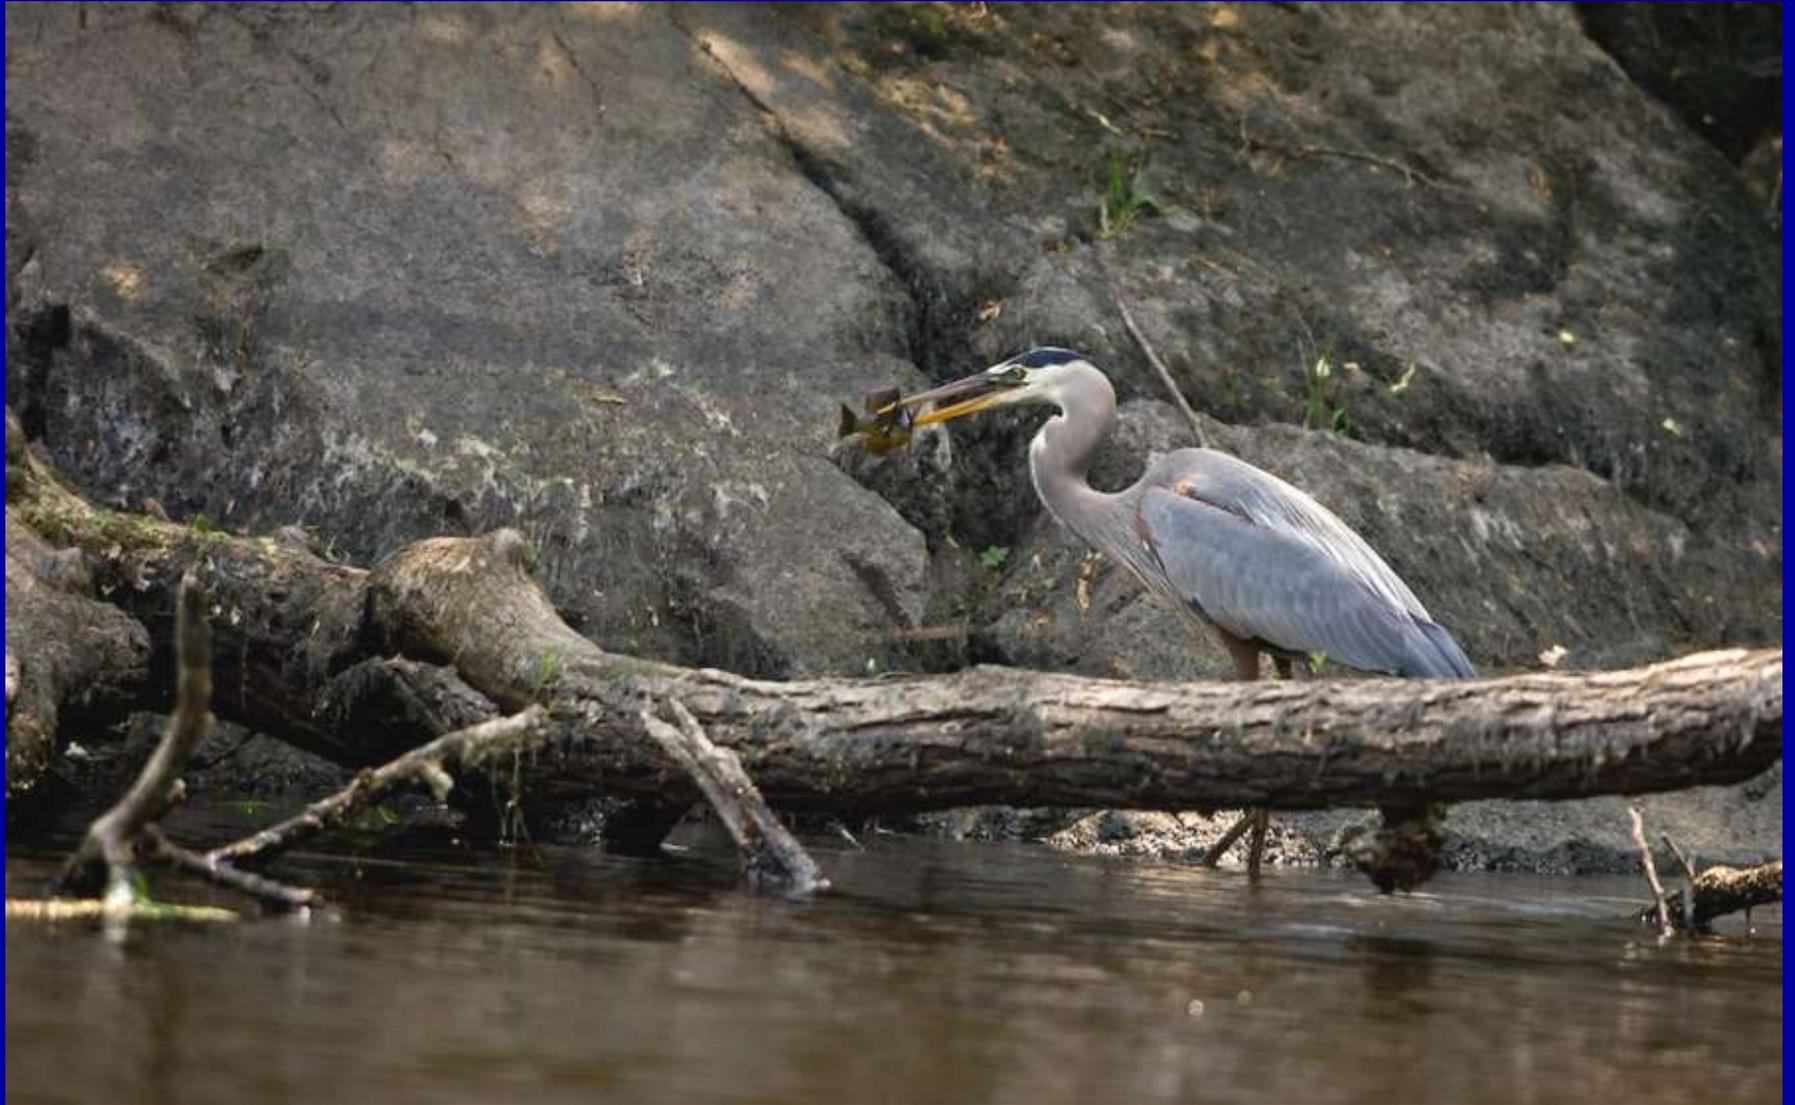
Good example of “structure”: wood above and below the surface of the Quinebaug River in Sturbridge – Anglers know fish are often lurking in such places

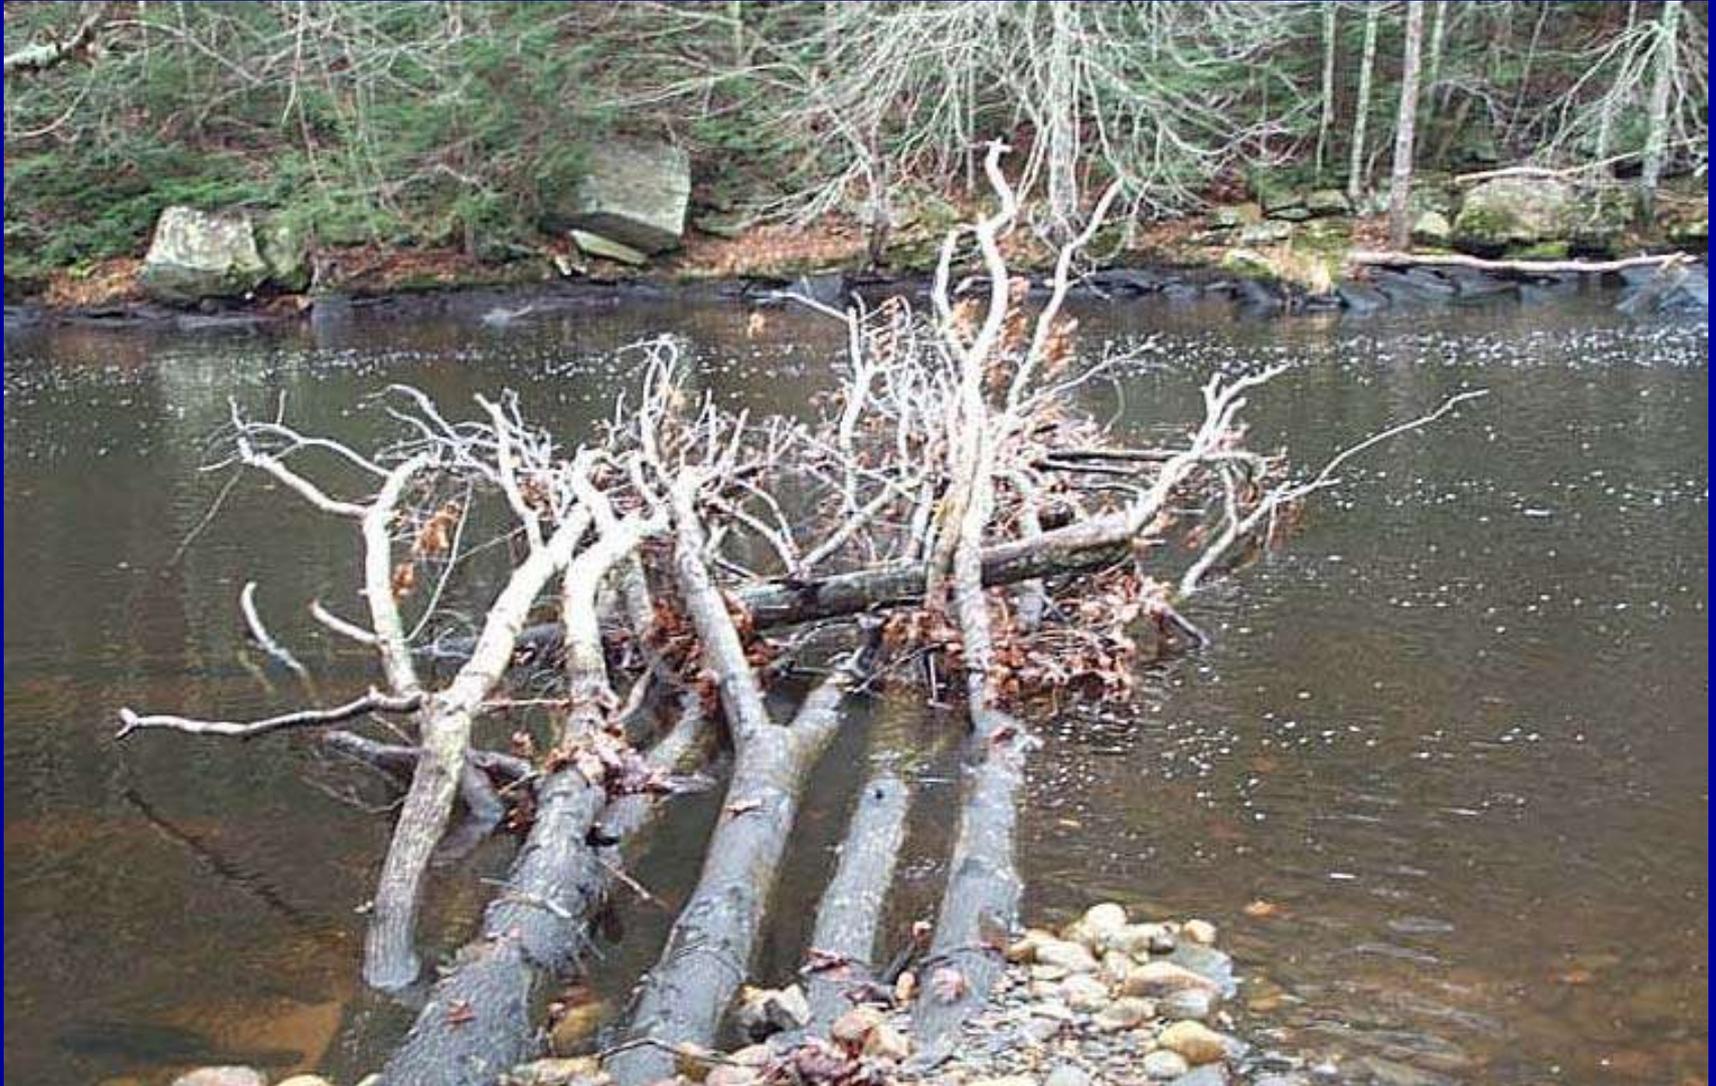
An example from the Shetucket River in Sprague, CT, where the CT DEP installed several “constructed log jams” into the river to enhance fisheries habitat (see <http://www.ct.gov/dep/lib/dep/fishing/restoration/shetucketriver.pdf> for more details)

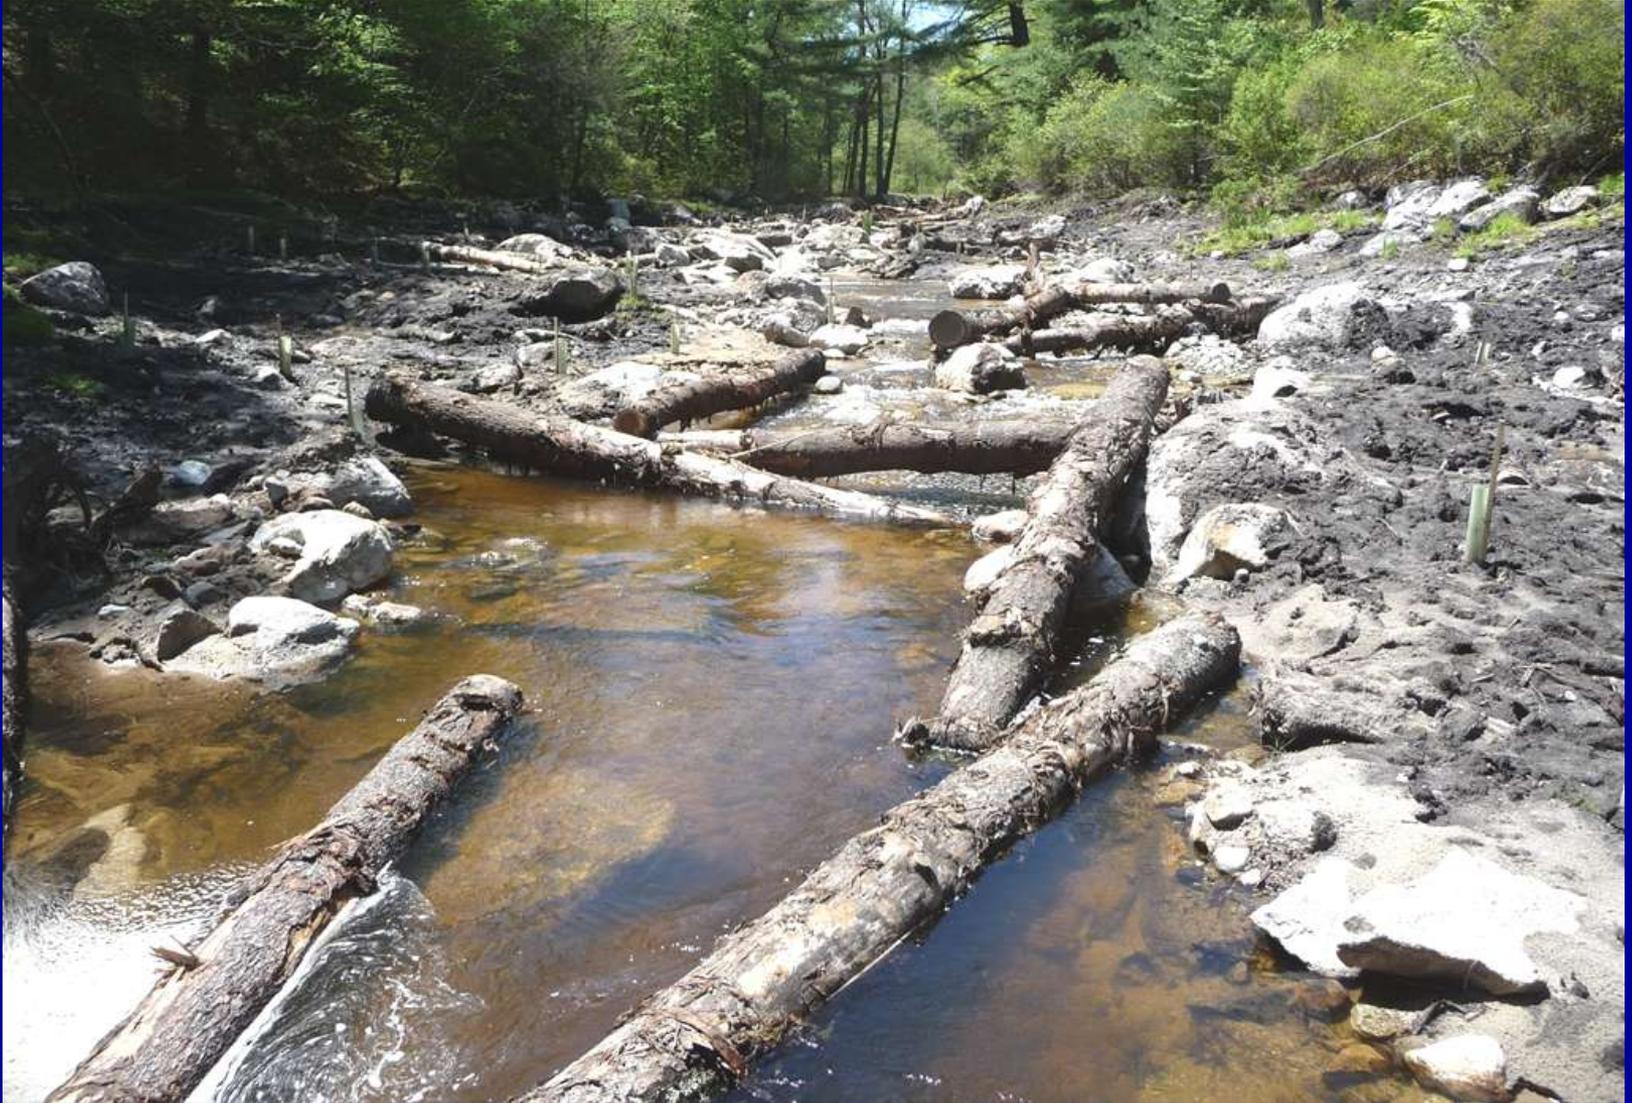
An example from Massachusetts: the Eel River in Plymouth, where the MA Division of Ecological Restoration added logs to a segment of the river flowing through a former impoundment to enhance its habitat complexity (see <http://www.mass.gov/dfwele/der/freshwater/priorityprojects/eelriver.htm> for more details)

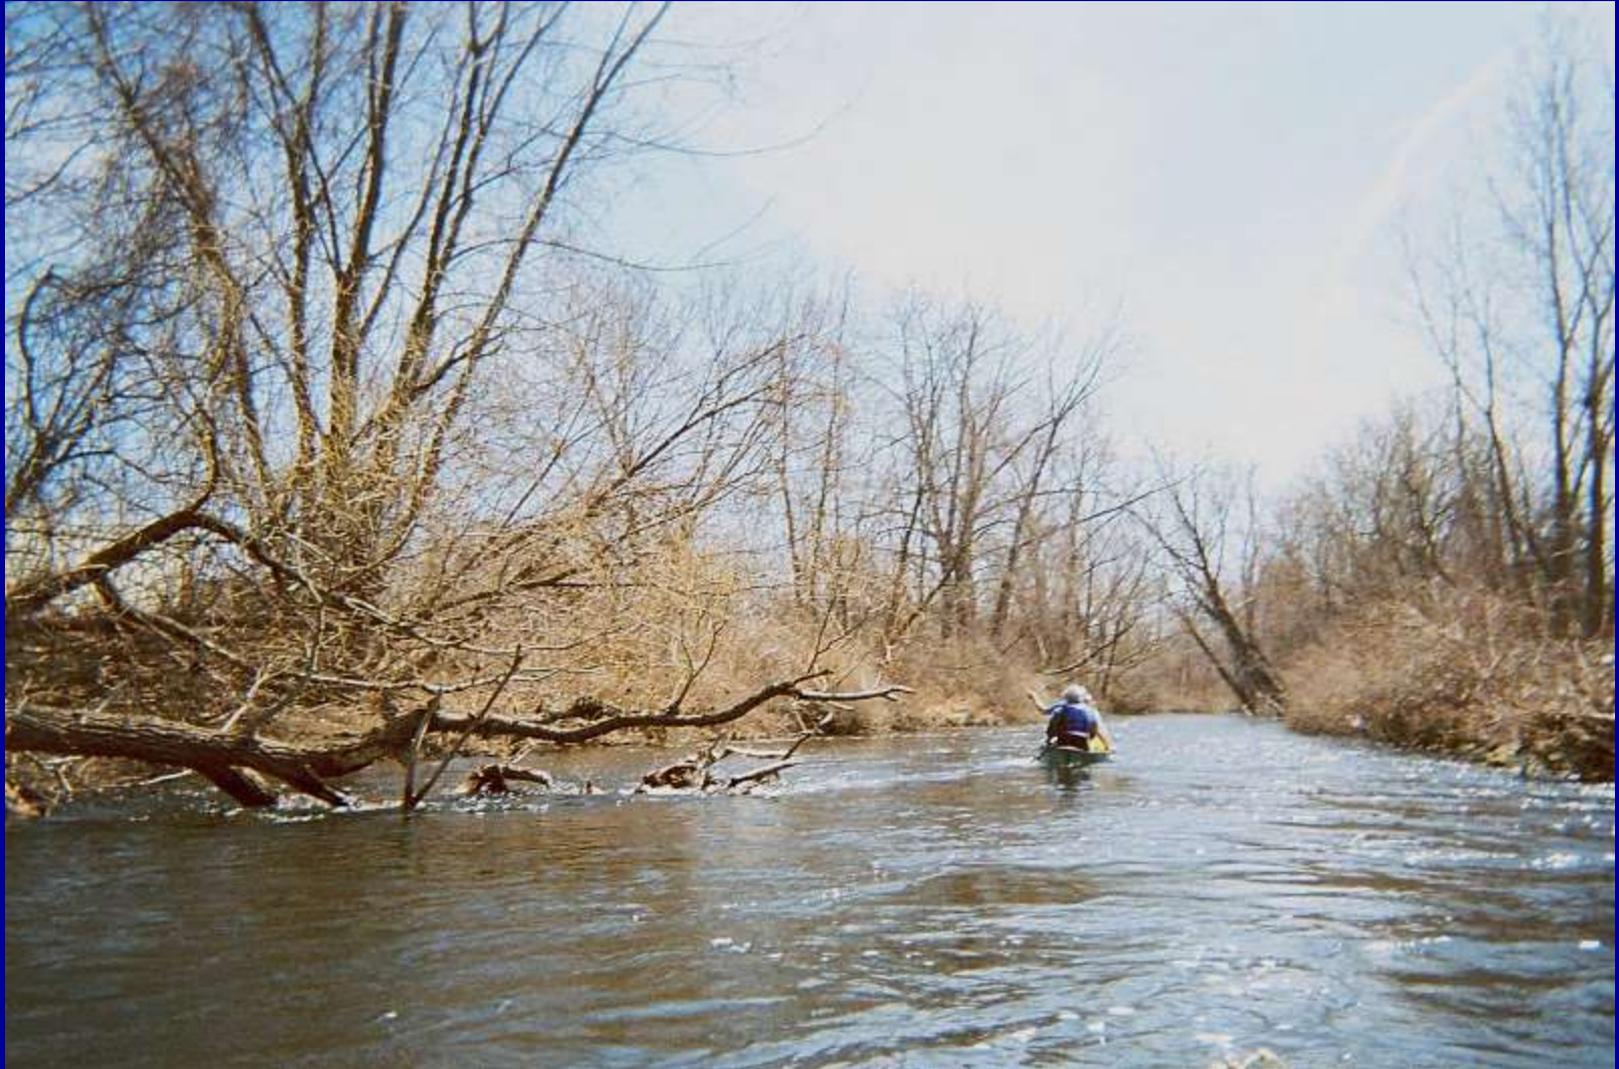
This tree fallen into the water provides good perching opportunities for birds and cover for fish without posing any kind of a safety hazard for paddlers.

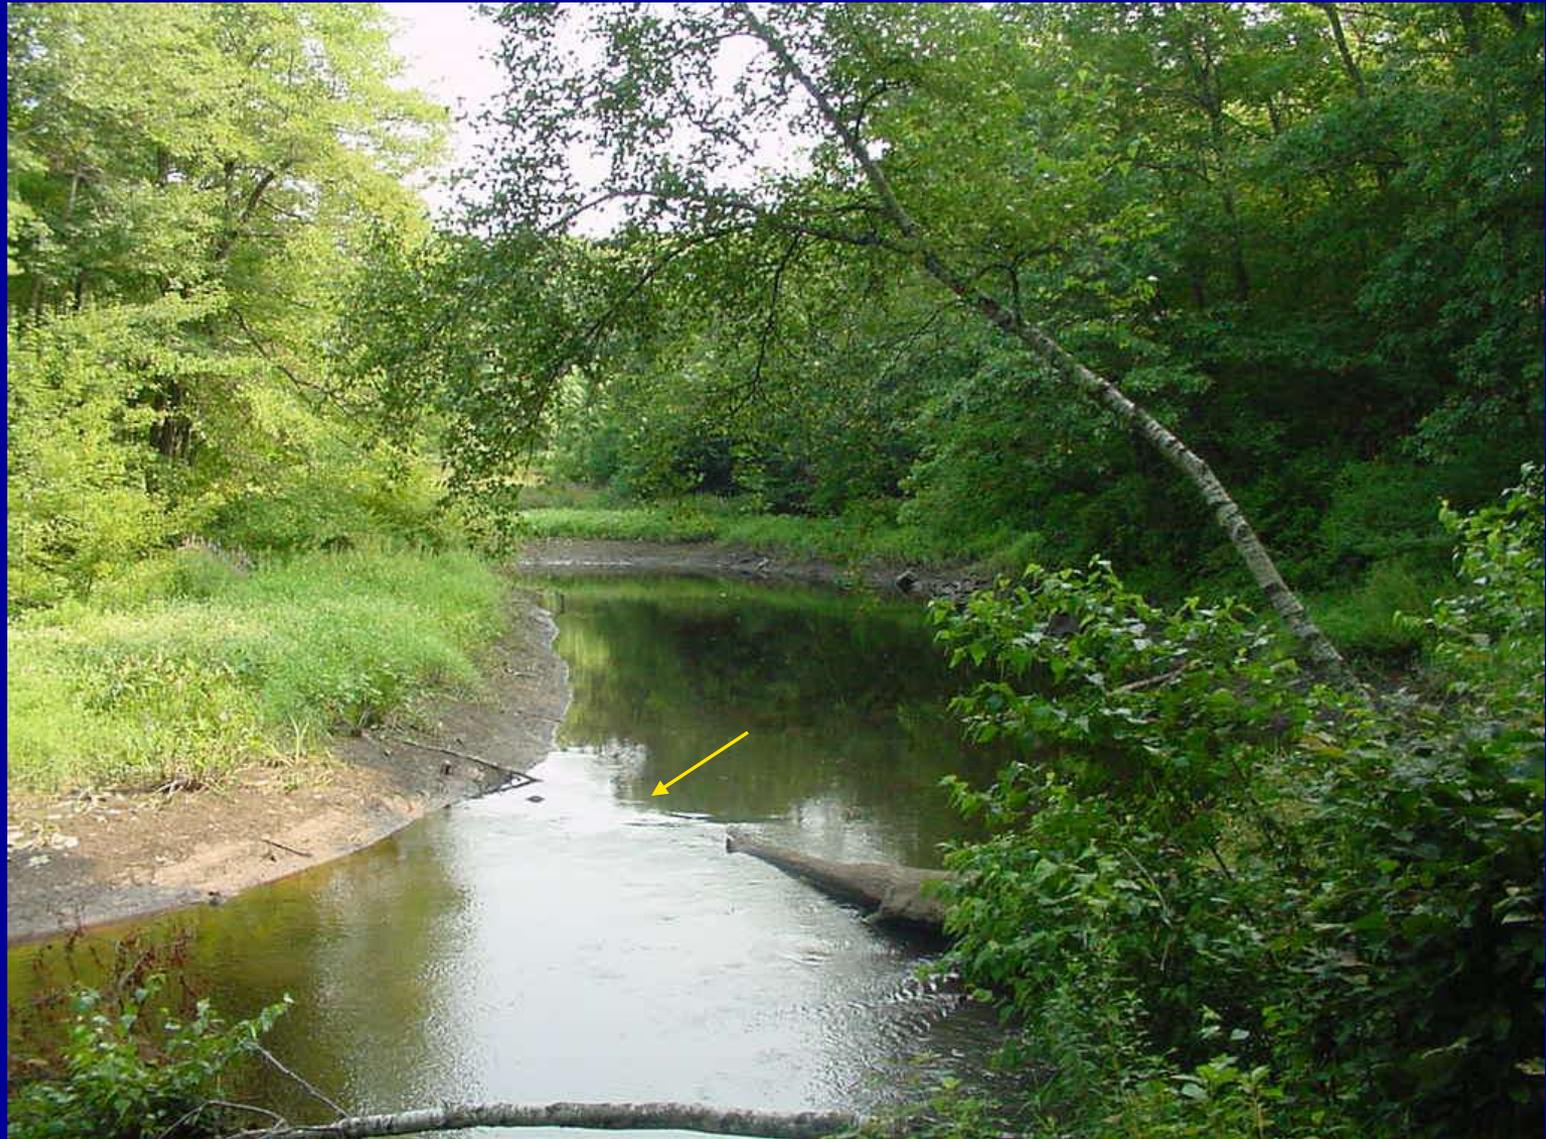
Although a log lies completely across this river, the water level is high enough to paddle over it (see arrow).

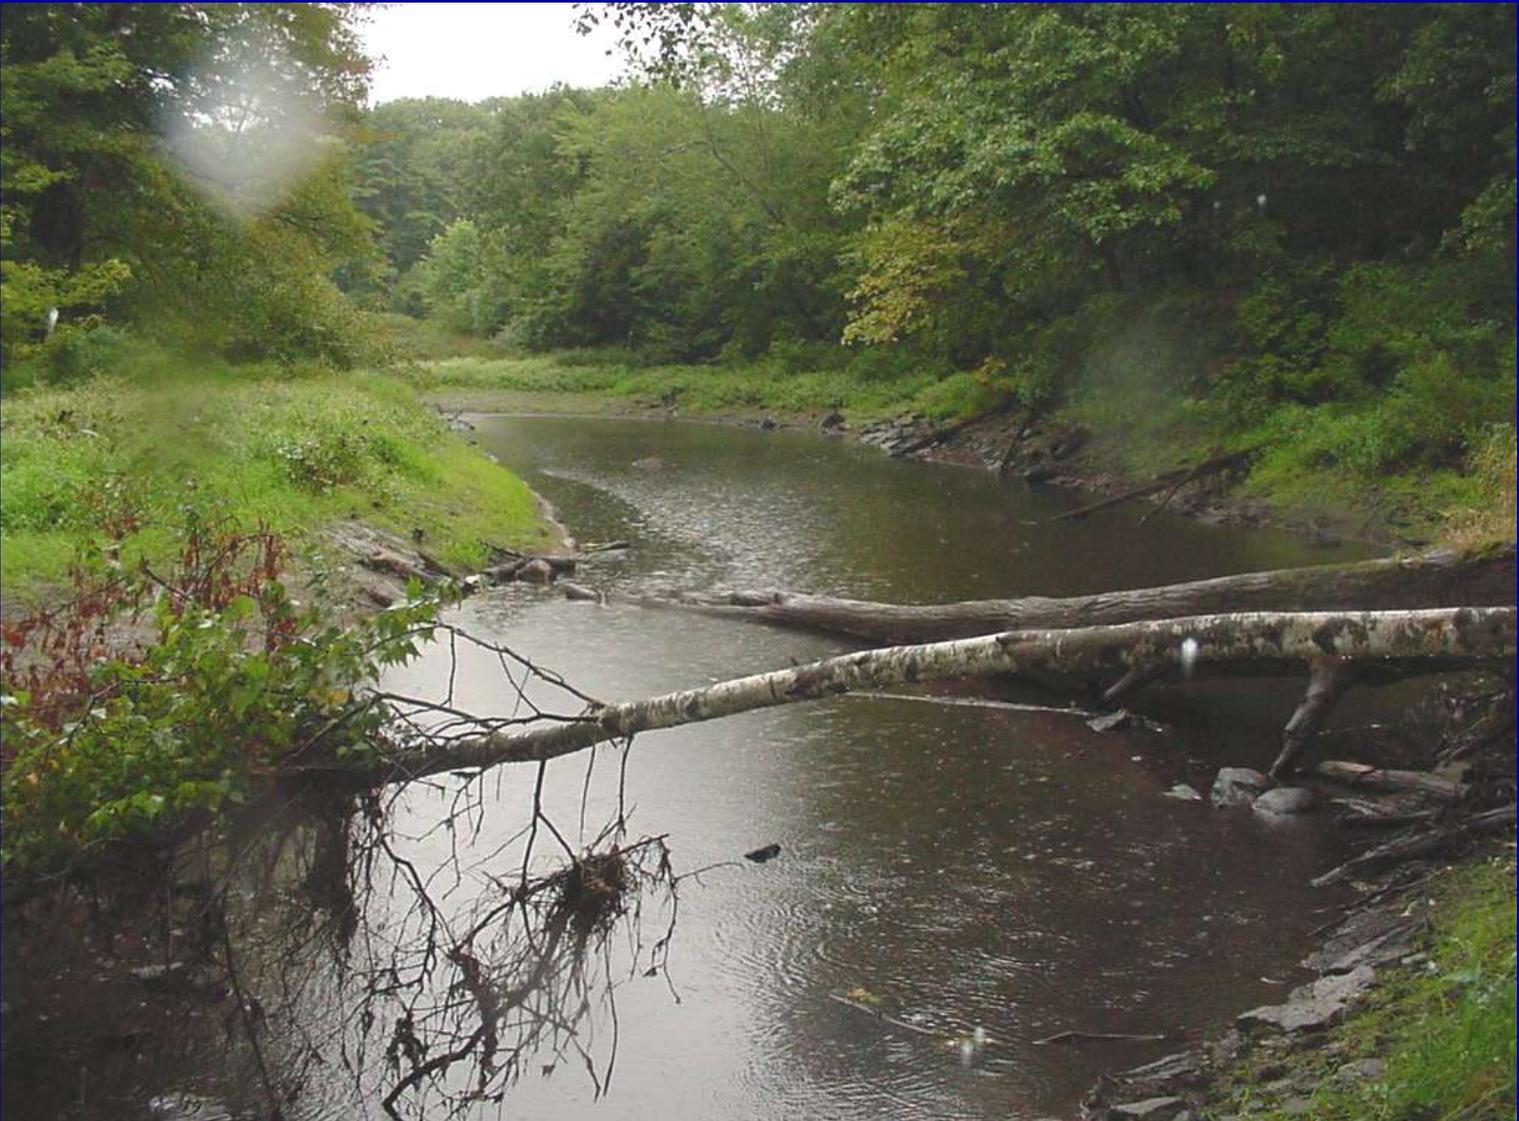
Same spot, but at a lower water level. If the water is too shallow to paddle under or over the log, or to safely drag the boat over the submerged portion of the log, then a (short) portage may be required.

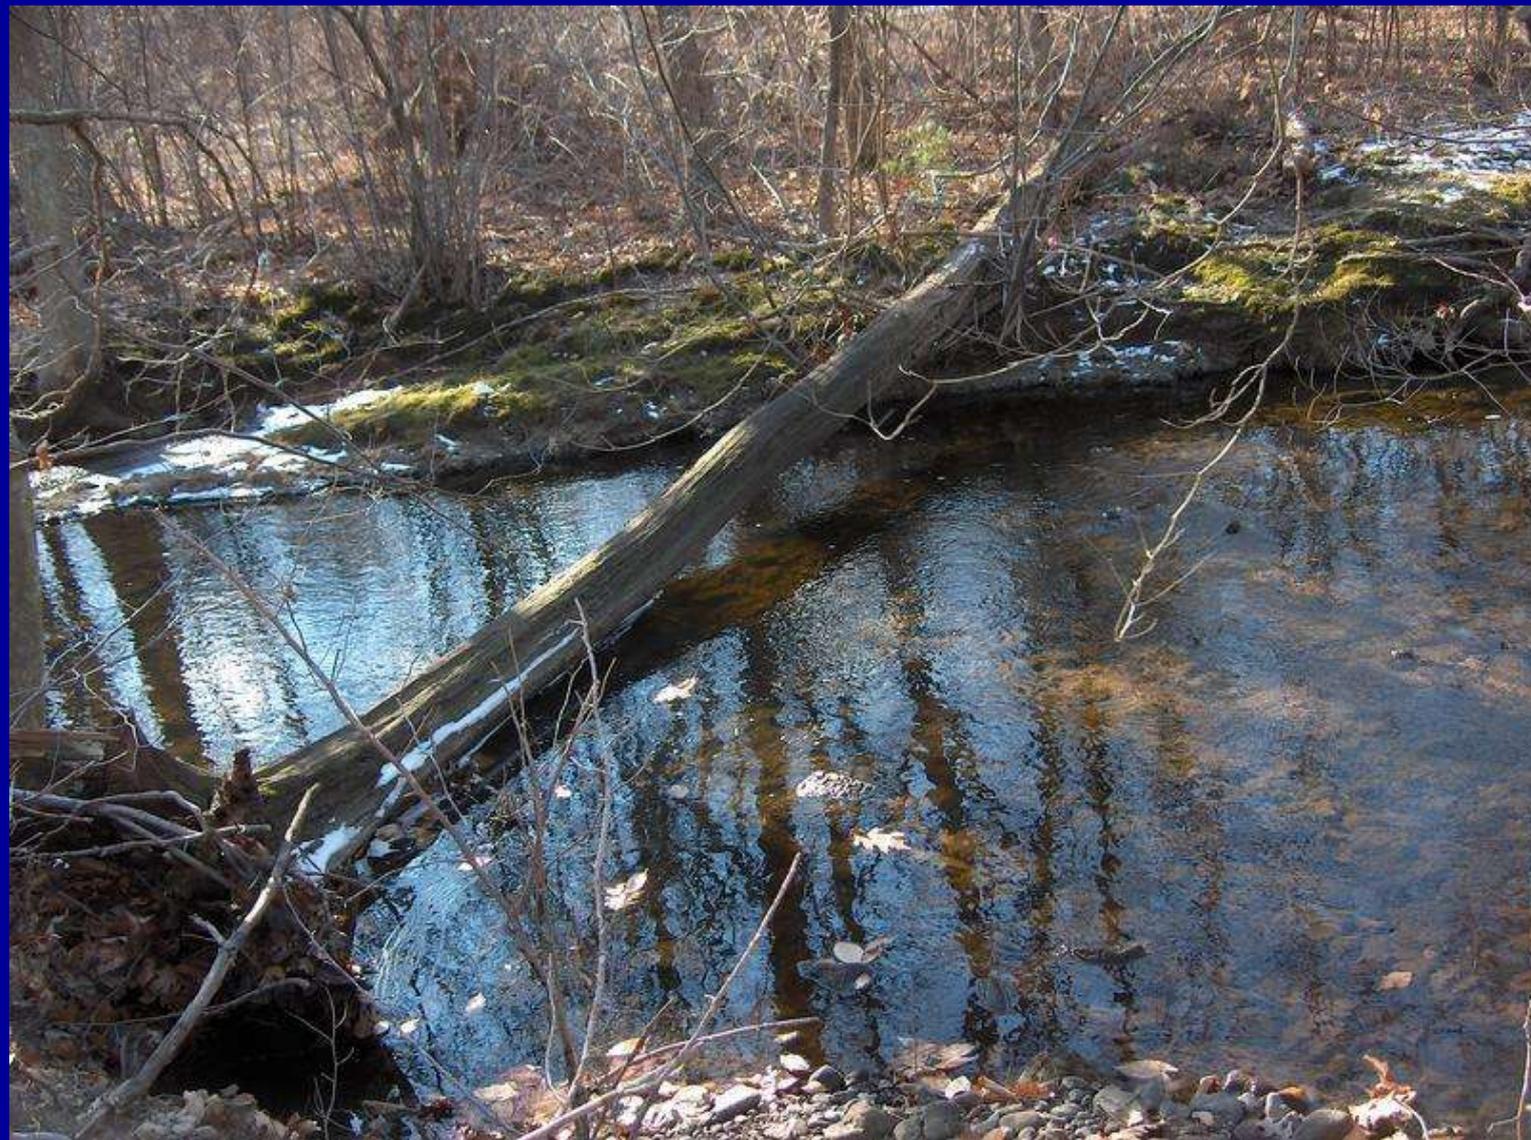
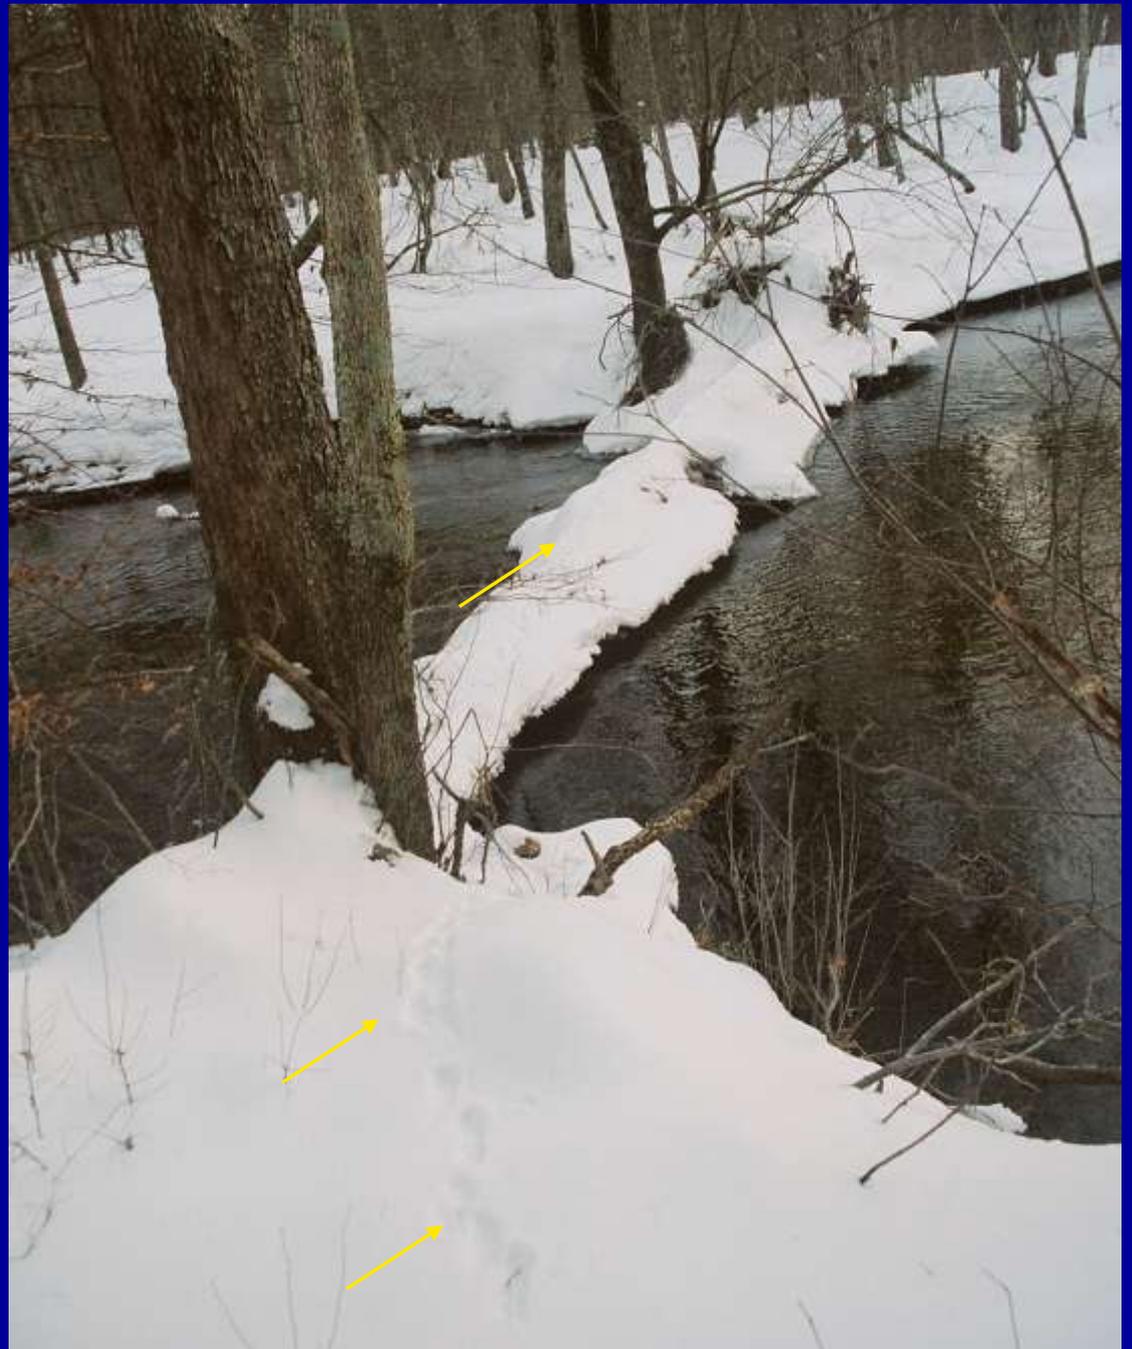
Another view of that same tree

Here's evidence, from the winter, of where an animal (a bobcat?) utilized this same tree fallen completely across the Squannacook River in Townsend to cross the river without getting wet (yellow arrows indicate paw prints heading to and on log)

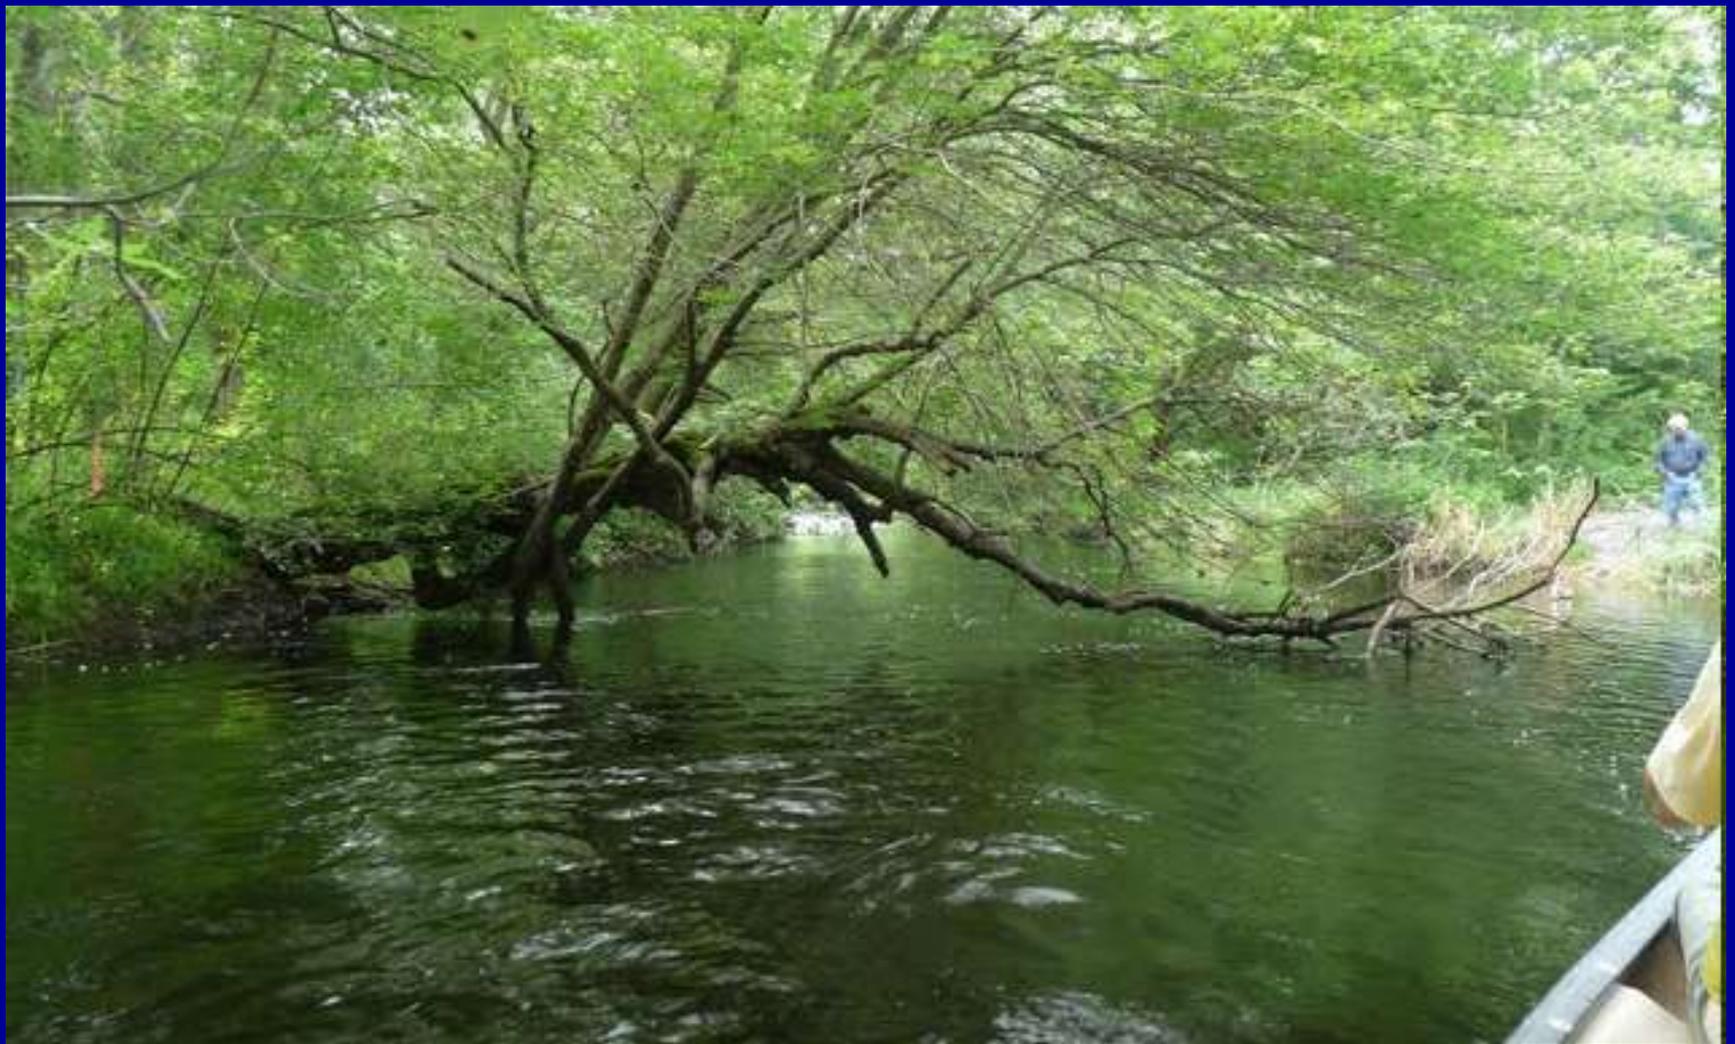
For this tree, overhanging the Town River just upstream from the Bridgewater public access boat launch (where person is standing), the stubby branch remnants under the "arch" portion of the tree could be sawed off to facilitate paddling underneath the arch. Alternatively (or additionally), the last few feet of the branch on the right could be trimmed off, enabling paddlers to paddle around the tree rather than ducking under the arch.

The small branches sticking up in over the submerged portion of the tree trunk in the middle of the channel (see arrow) could be removed to facilitate safe paddling over that portion of the tree without harming the ecological functions of the remainder of the tree.
