Trees, Paddlers and Wildlife - Safeguarding Ecological and Recreational Values on the River

Russ Cohen, Rivers Advocate

Mass. Department of Fish and Game

Division of Ecological Restoration (DER)/Riverways Program

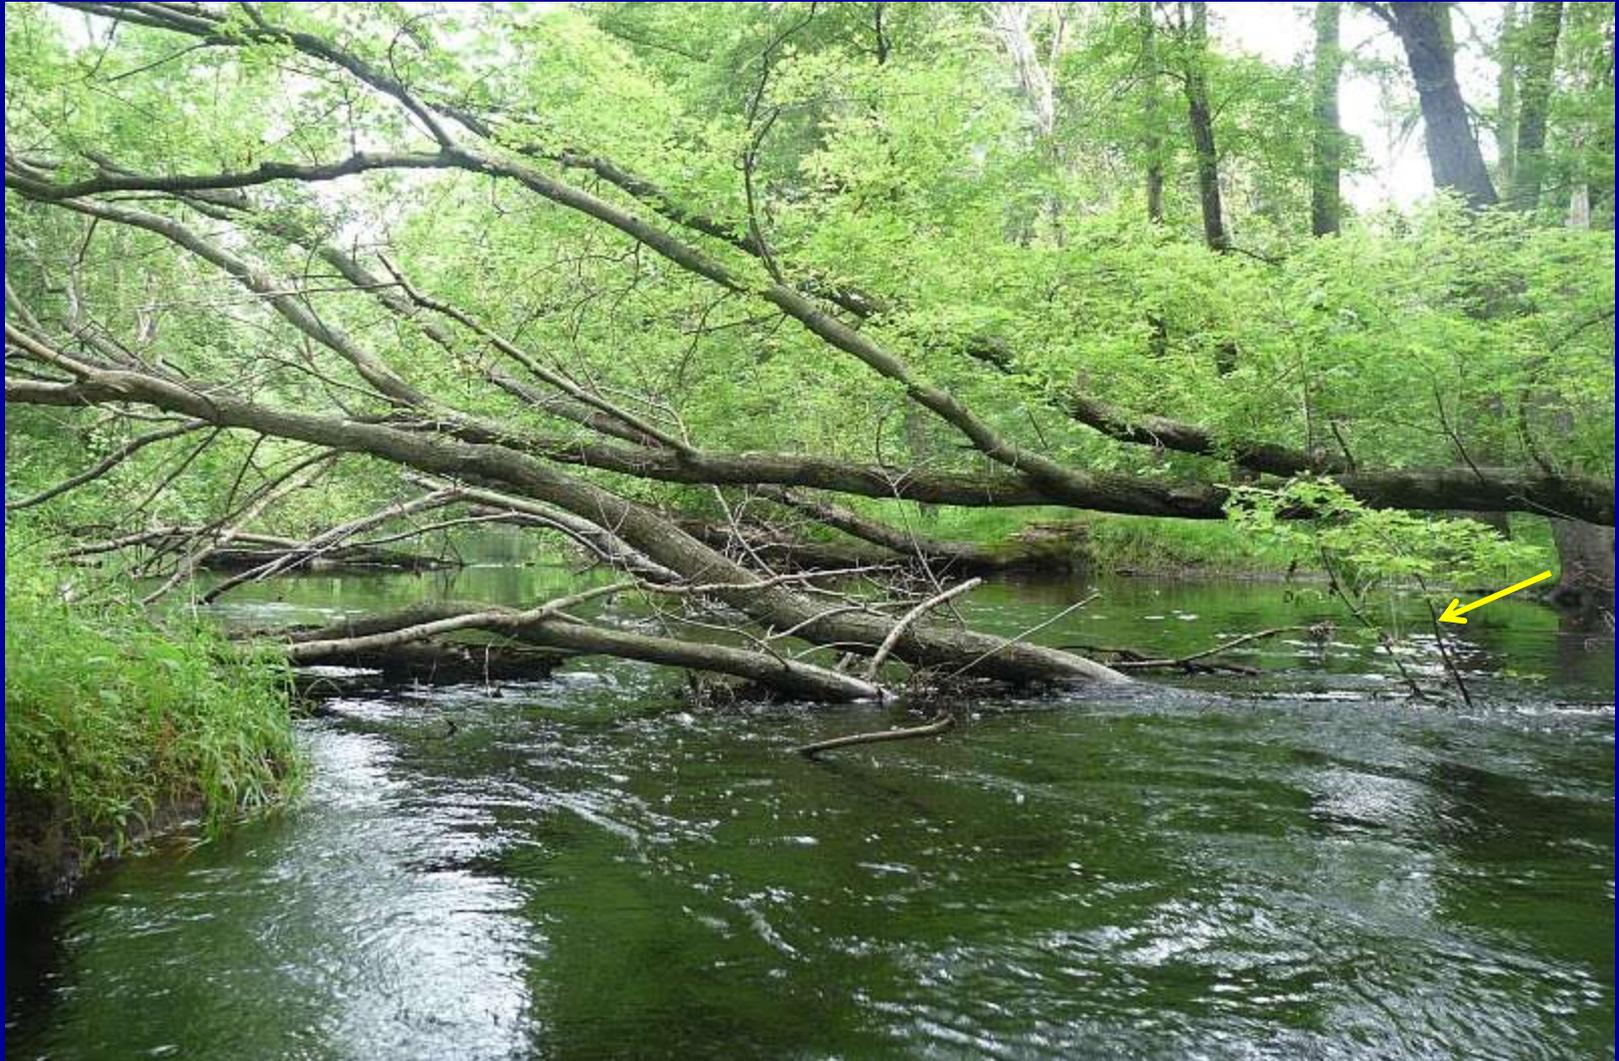
For this tree, overhanging the Town River just upstream from the Bridgewater public access boat launch (where person is standing), the stubby branch remnants under the "arch" portion of the tree could be sawed off to facilitate paddling underneath the arch. Alternatively (or additionally), the last few feet of the branch on the right could be trimmed off, enabling paddlers to paddle around the tree rather than ducking under the arch.

The small branches sticking up in over the submerged portion of the tree trunk in the middle of the channel (see arrow) could be removed to facilitate safe paddling over that portion of the tree without harming the ecological functions of the remainder of the tree.

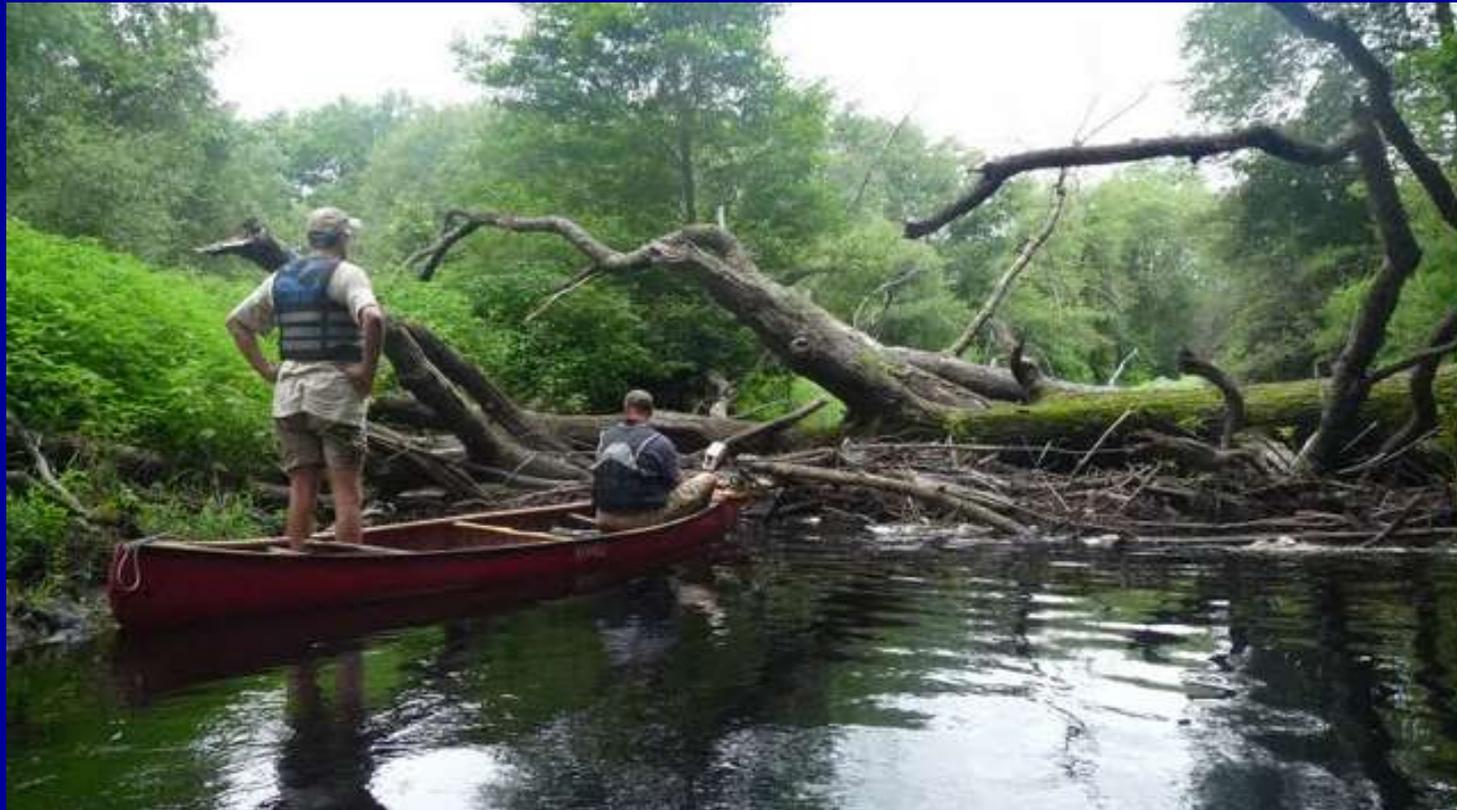
This immense tree completely blocks the channel of the Town River in Bridgewater. It is impossible to duck underneath it or lift a boat over it without getting out of the boat. There are other large branches just downstream from this big trunk that contribute to the fact that removing this obstruction would be a big job, bigger than the capacity of most volunteers to take it on. So what (if anything) should be done? We all agreed that the bank on river right was too steep to enable a safe portage around this massive tree. Fortunately, however, the current is slow, the bank on river left is very low, and an informal portage path around the tree had already been established at this location. Some of us got out and took a look at this portage path, and it looked feasible for others to use. So the decision was made to leave this tree in place and portage around it. One function preserved by retaining this type of large tree extending across the entire river channel is that it enables animals (such as bobcats) and, potentially, humans, to cross the river without getting their feet wet.

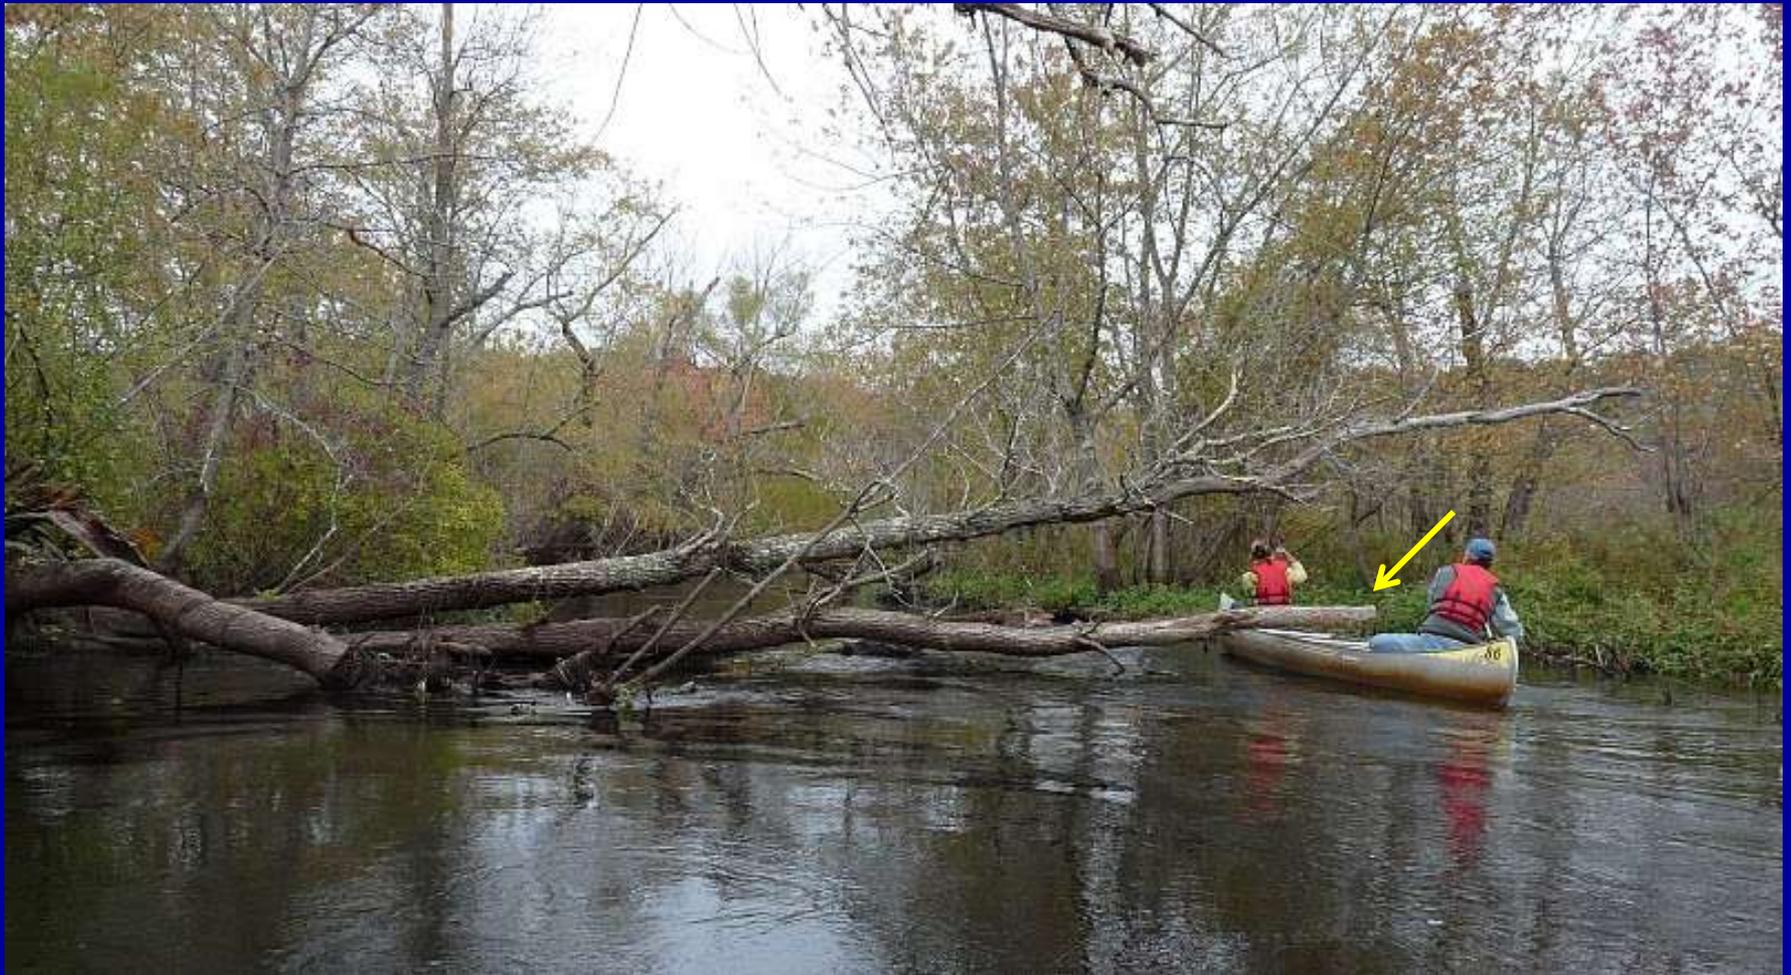
An excellent example of judicious pruning on the Ipswich River in Topsfield, where only a small section of the lower tree limb was cut and removed (see arrow) to enable paddlers to safely avoid the logjam, while leaving the remainder of the fallen trees in place to fulfill their ecological functions and values.

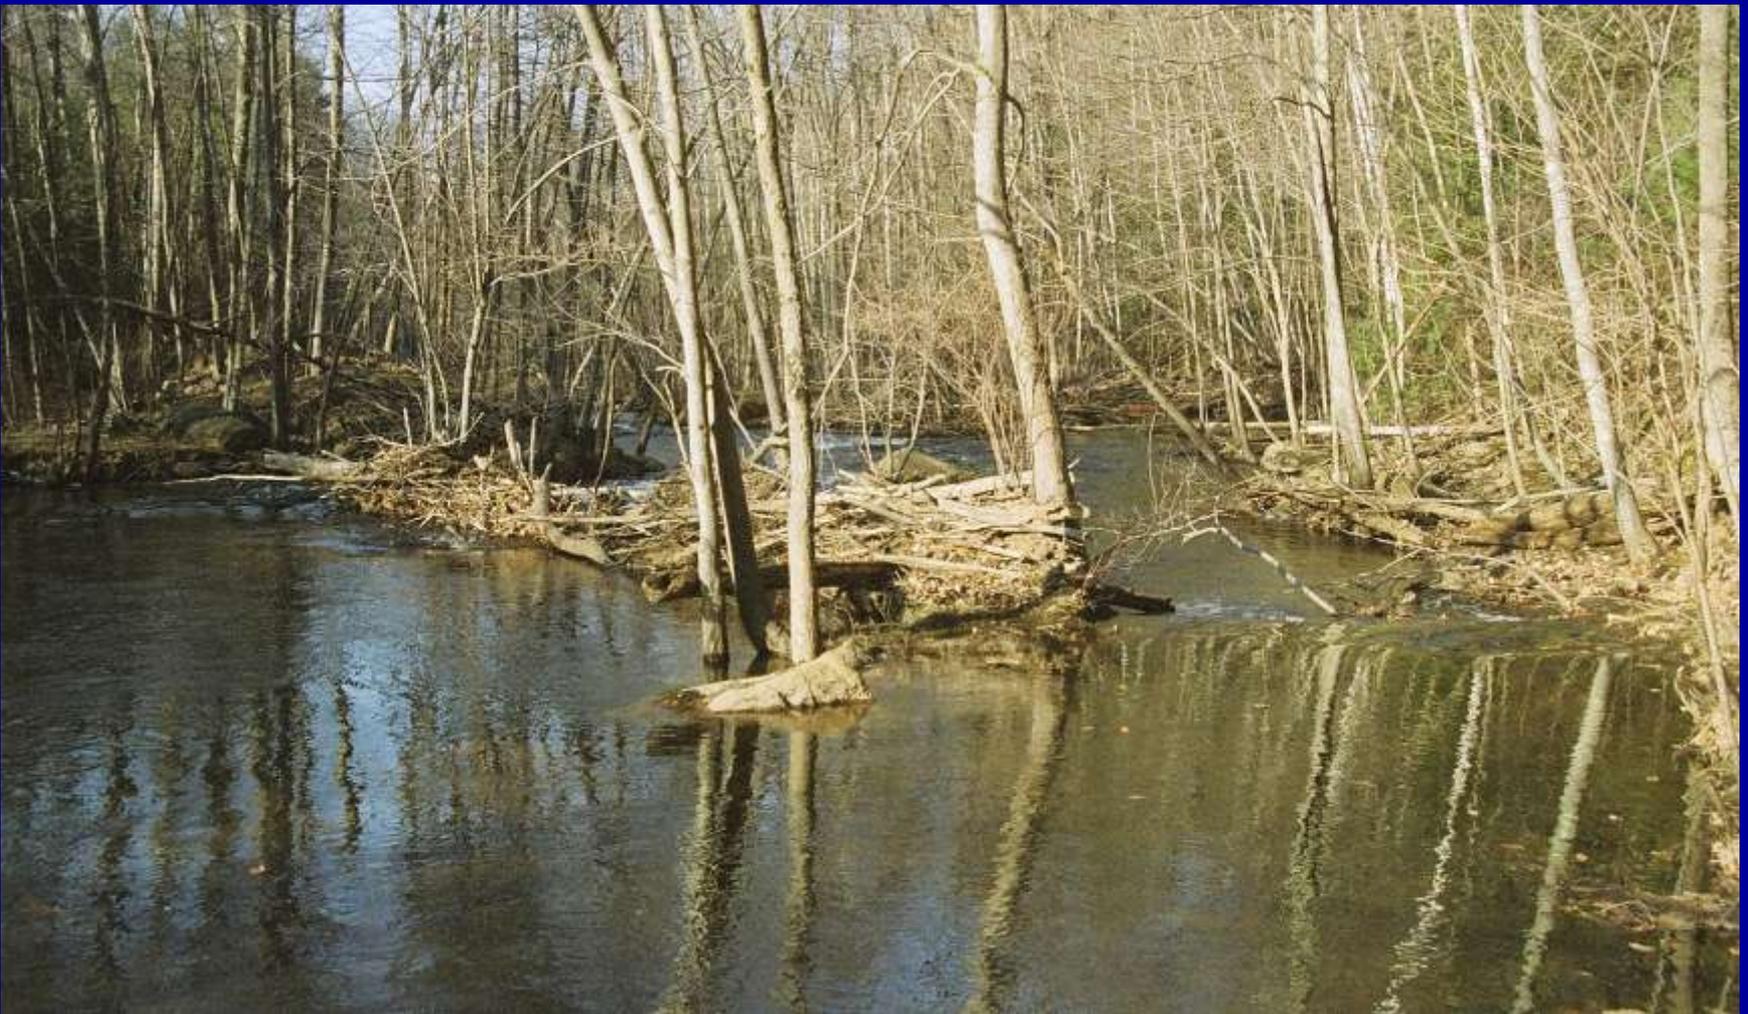
Wood debris jam on a fast-moving section of the Quinebaug River in Sturbridge. Here, some judicious pruning of the small branches extending into the right channel should enable boats to safely squeeze through without affecting the beneficial functions of the jam on riverine habitat and morphology.

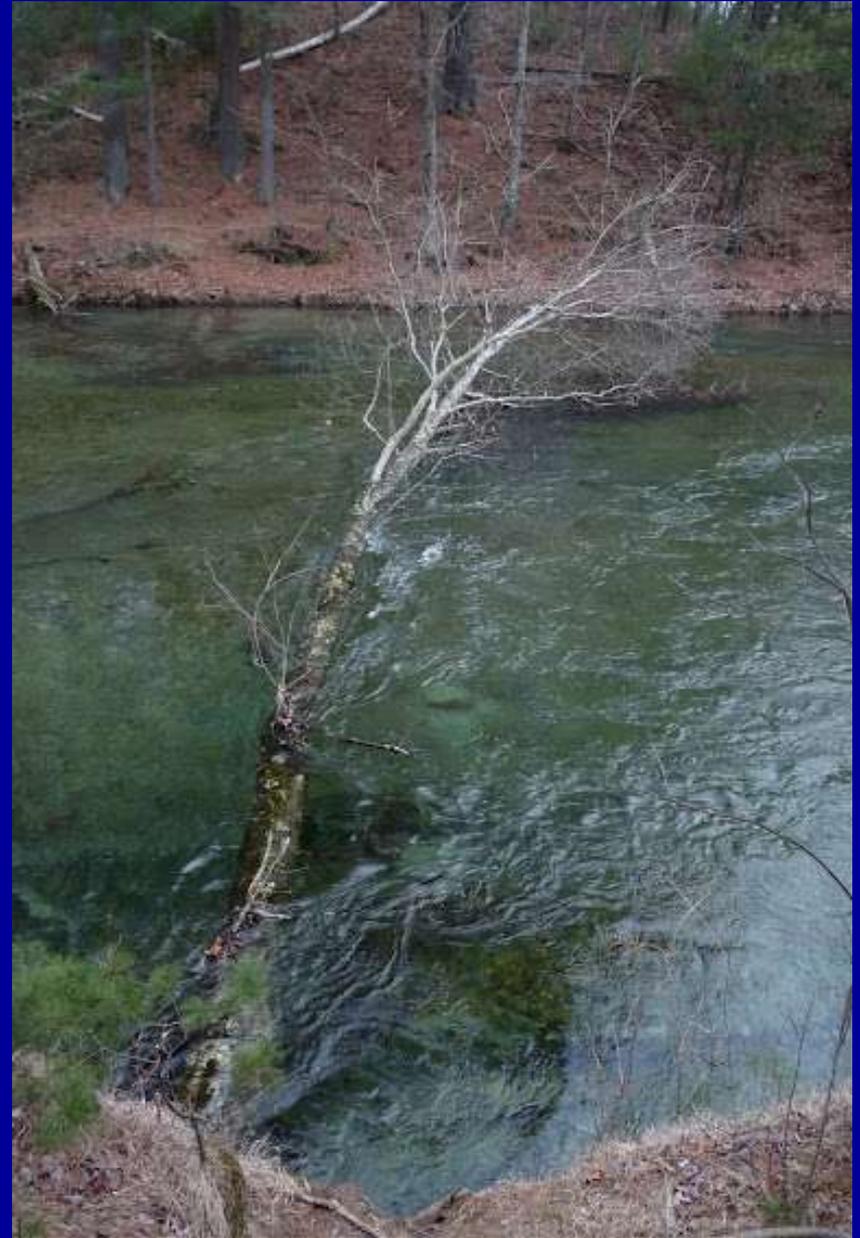
Problem Spot #1 - Looking across the river at a spot where several trees fallen across the river pose a potential challenge for wading anglers accustomed to entering the river at this spot.

Proposed Solution: I agreed with Terry and Gary that some action appeared to be warranted at this spot in order to enable anglers to enter the water safely and cross to the other (east) side of the river. I suggested that if the smaller branches in the center of the river (and photo) were trimmed with pruning shears (i.e., the smaller end (like the last 4-5 feet) of the upper branches of the fallen trees on the left side of the photo), that should provide a clear path for the anglers to safely enter and wade across the river.

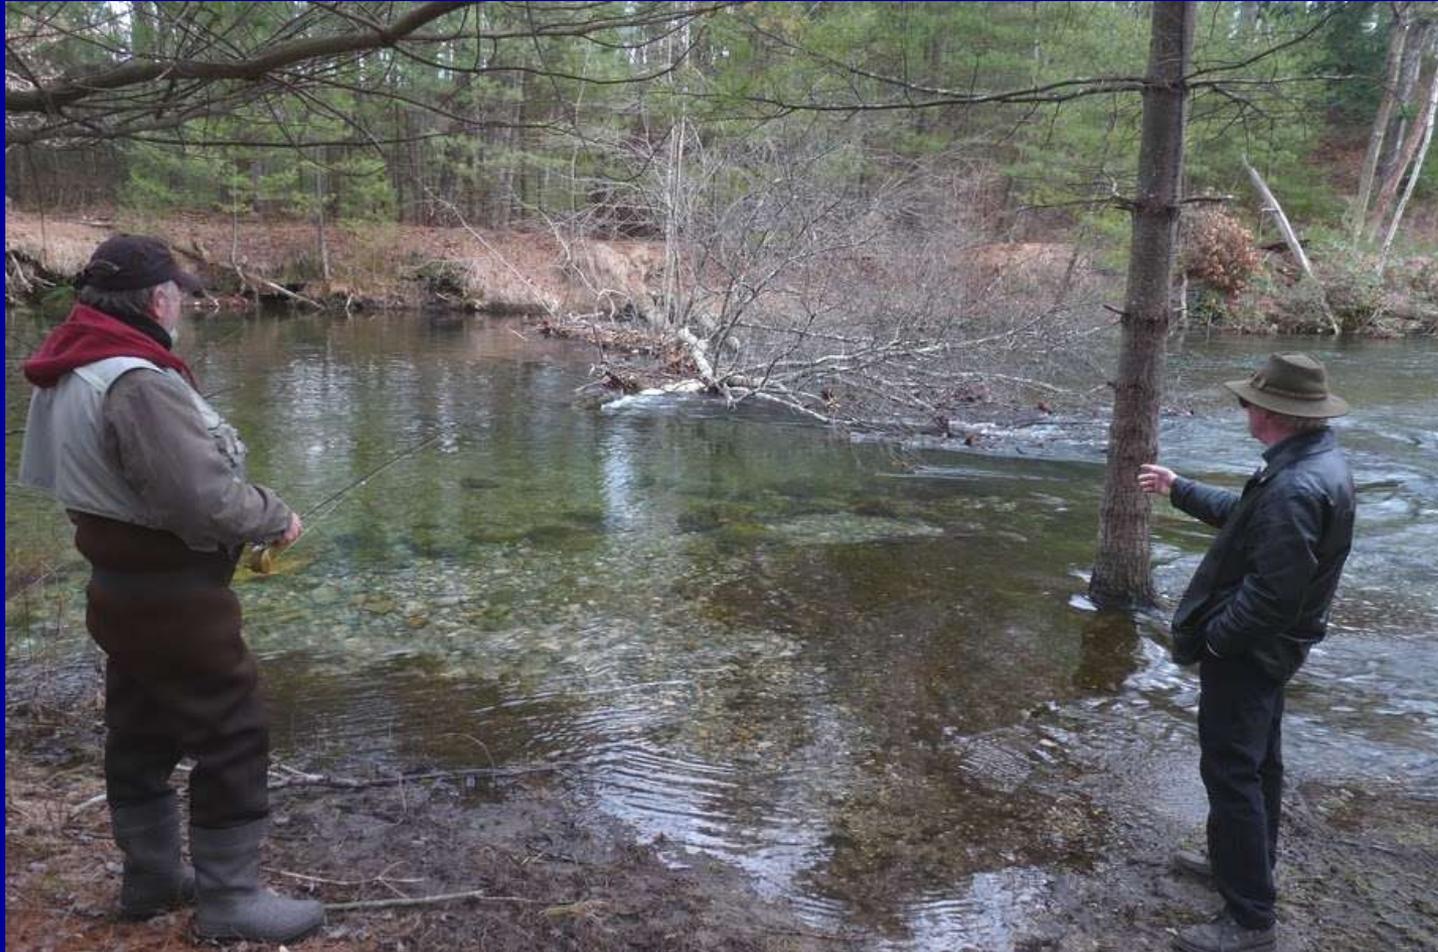
Problem Spot #2 - At this spot, trees fallen across the river have captured floating branches and leaves, constricting the flow of the river into a fast-moving, powerful flow that is potentially hazardous to wading anglers. That's Terry Connolly on the right and Gary Metras on the left side of the photo.

Potential solution: I suggested here a "light touch" technique that could alleviate the problem: clear out the branches and leaves blocked up under the fallen tree (by, e.g., tying the debris to a rope and then pulling the rope from the bank) - once that's done, the river's flow should no longer be as constricted and concentrated, and it should be safer to wade in this location.

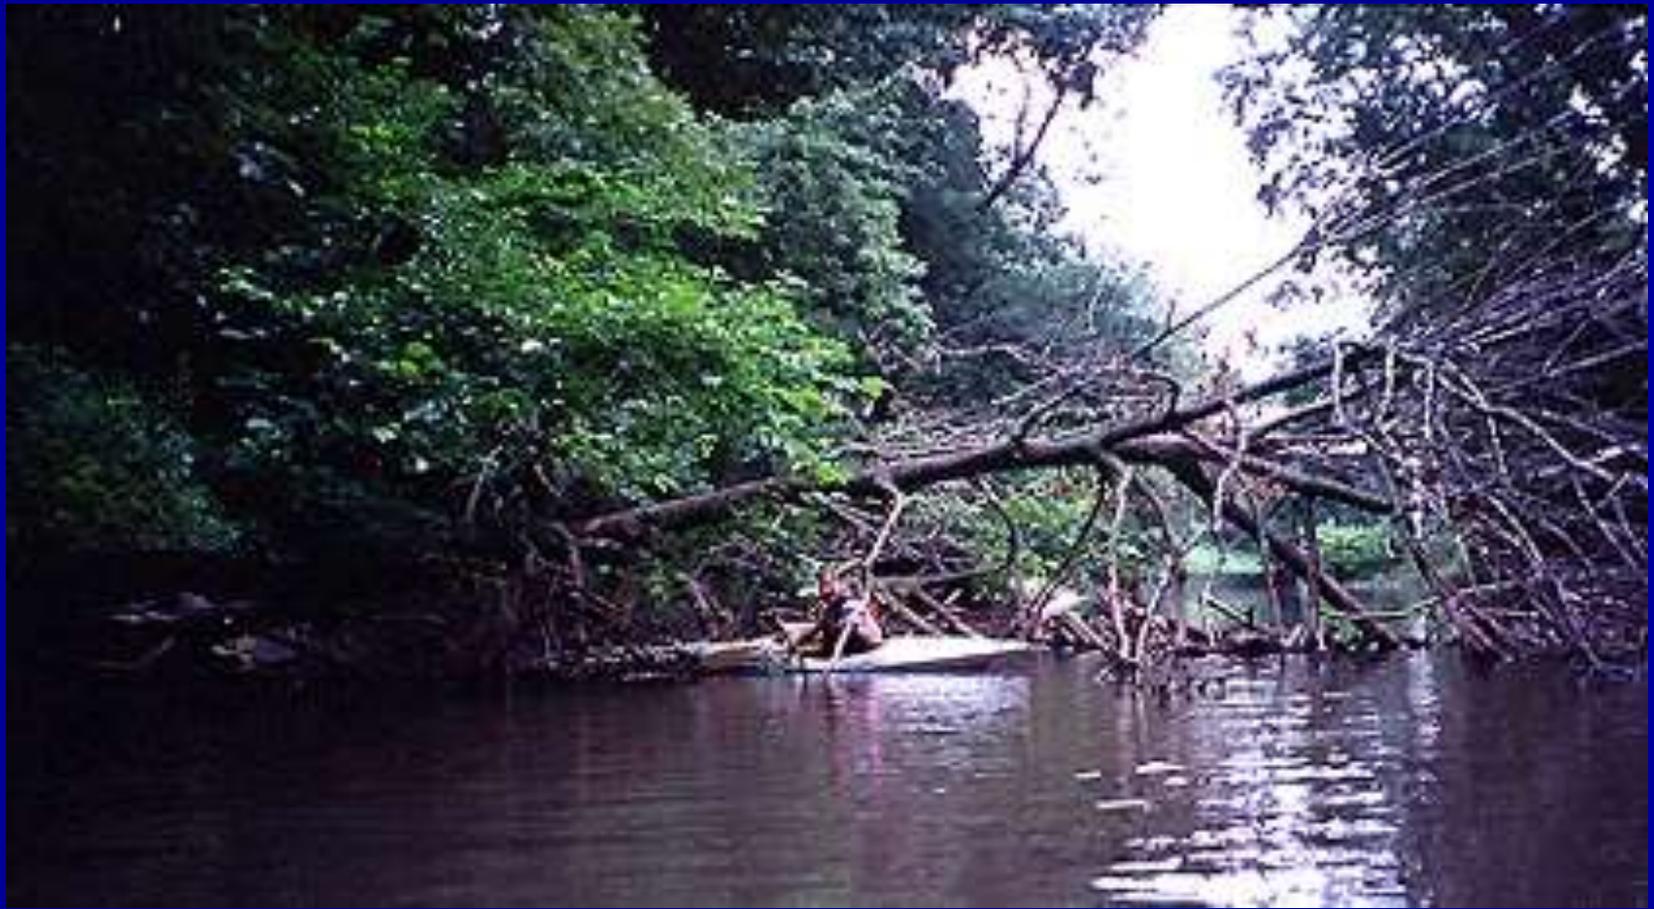
Here a kayaker confronts a “strainer” (a large tree + branches fallen completely across the river). In this situation, it should be OK to judiciously prune a few of the smaller, non-load-bearing branches to enable a boat to squeeze through without adversely affecting the tree’s ecological or other functions and values.

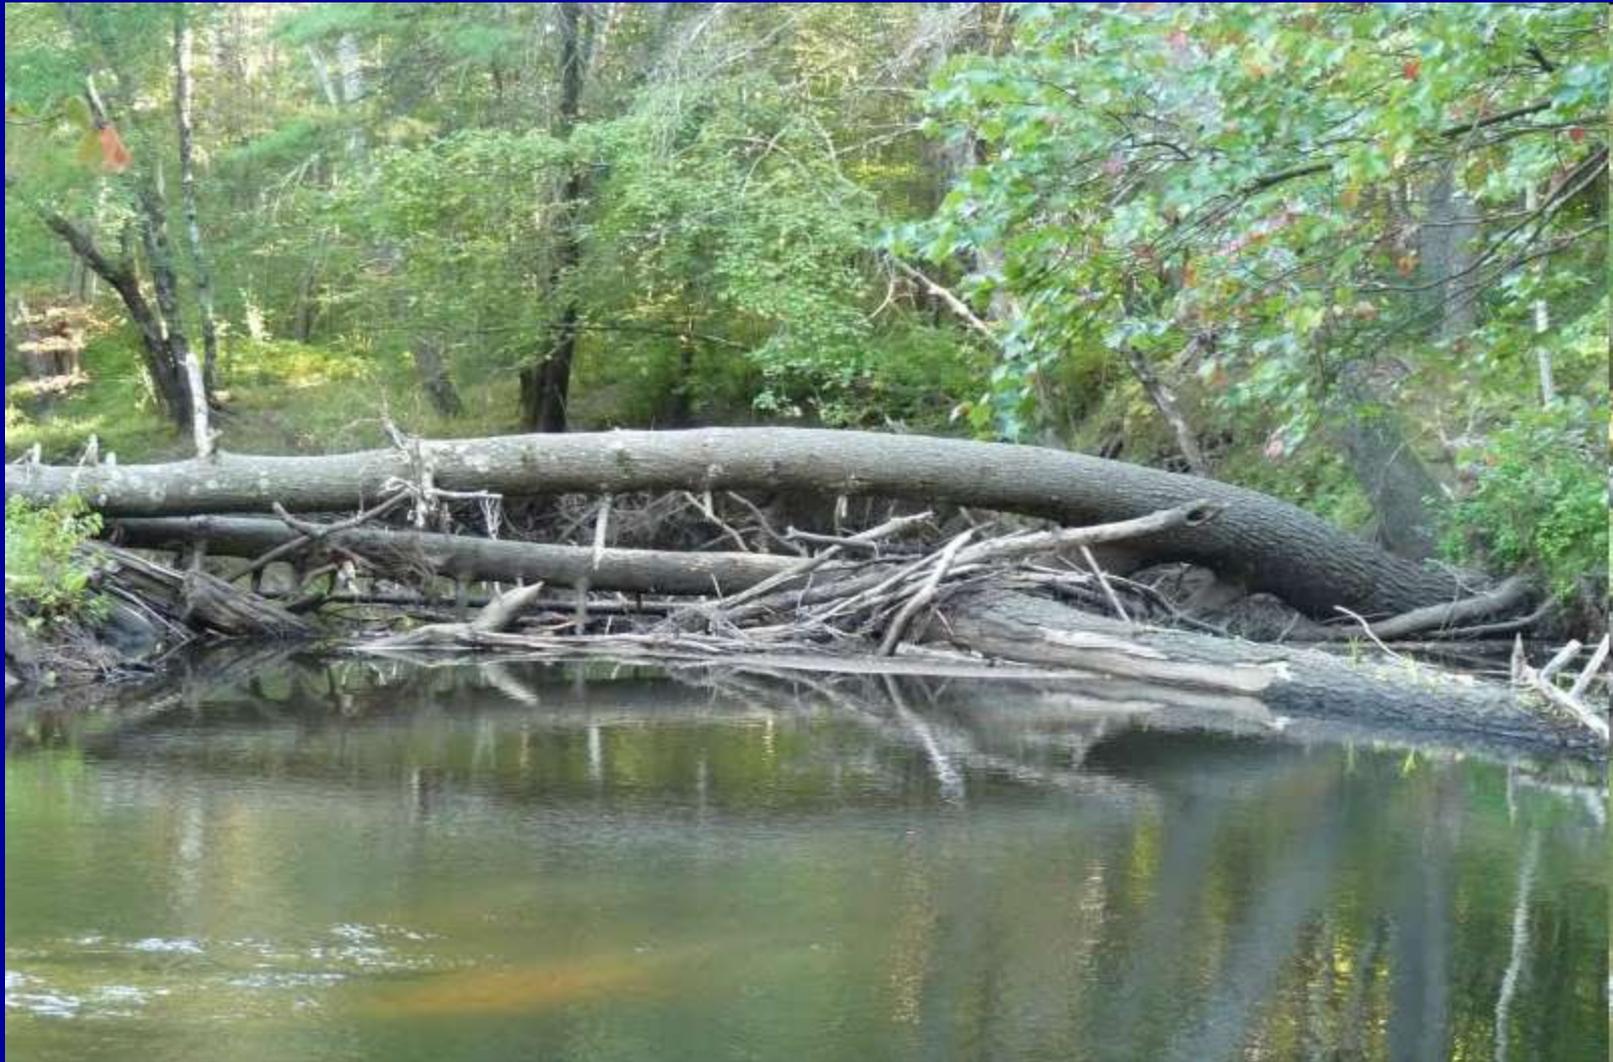
White Pine Tree blocking the entire Squannacook River channel. Here some underneath branches can be trimmed, enabling safe and enjoyable paddling while retaining the scenic “natural arch bridge” of the upper branch and its function for a wildlife river crossing.

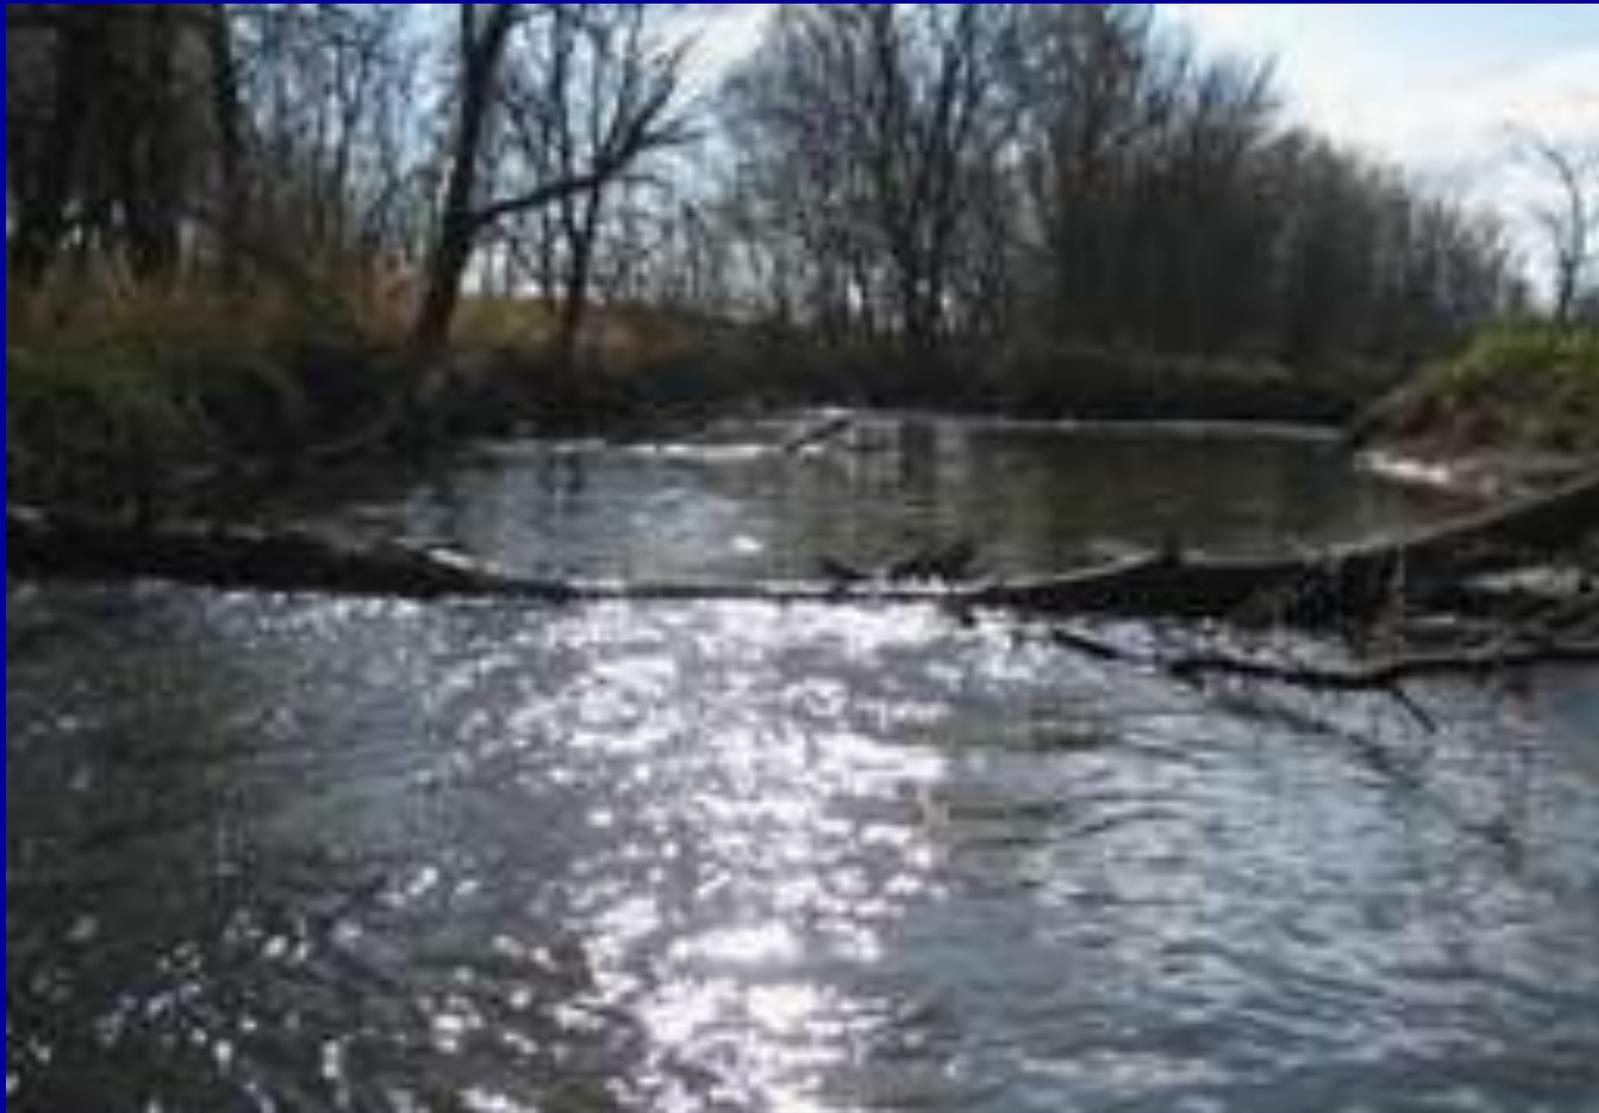
Here's another tree that has fallen completely across the river. While the current is a bit quick here, it still looks feasible at this water level for most paddlers to (with a good head start) paddle over this obstacle.

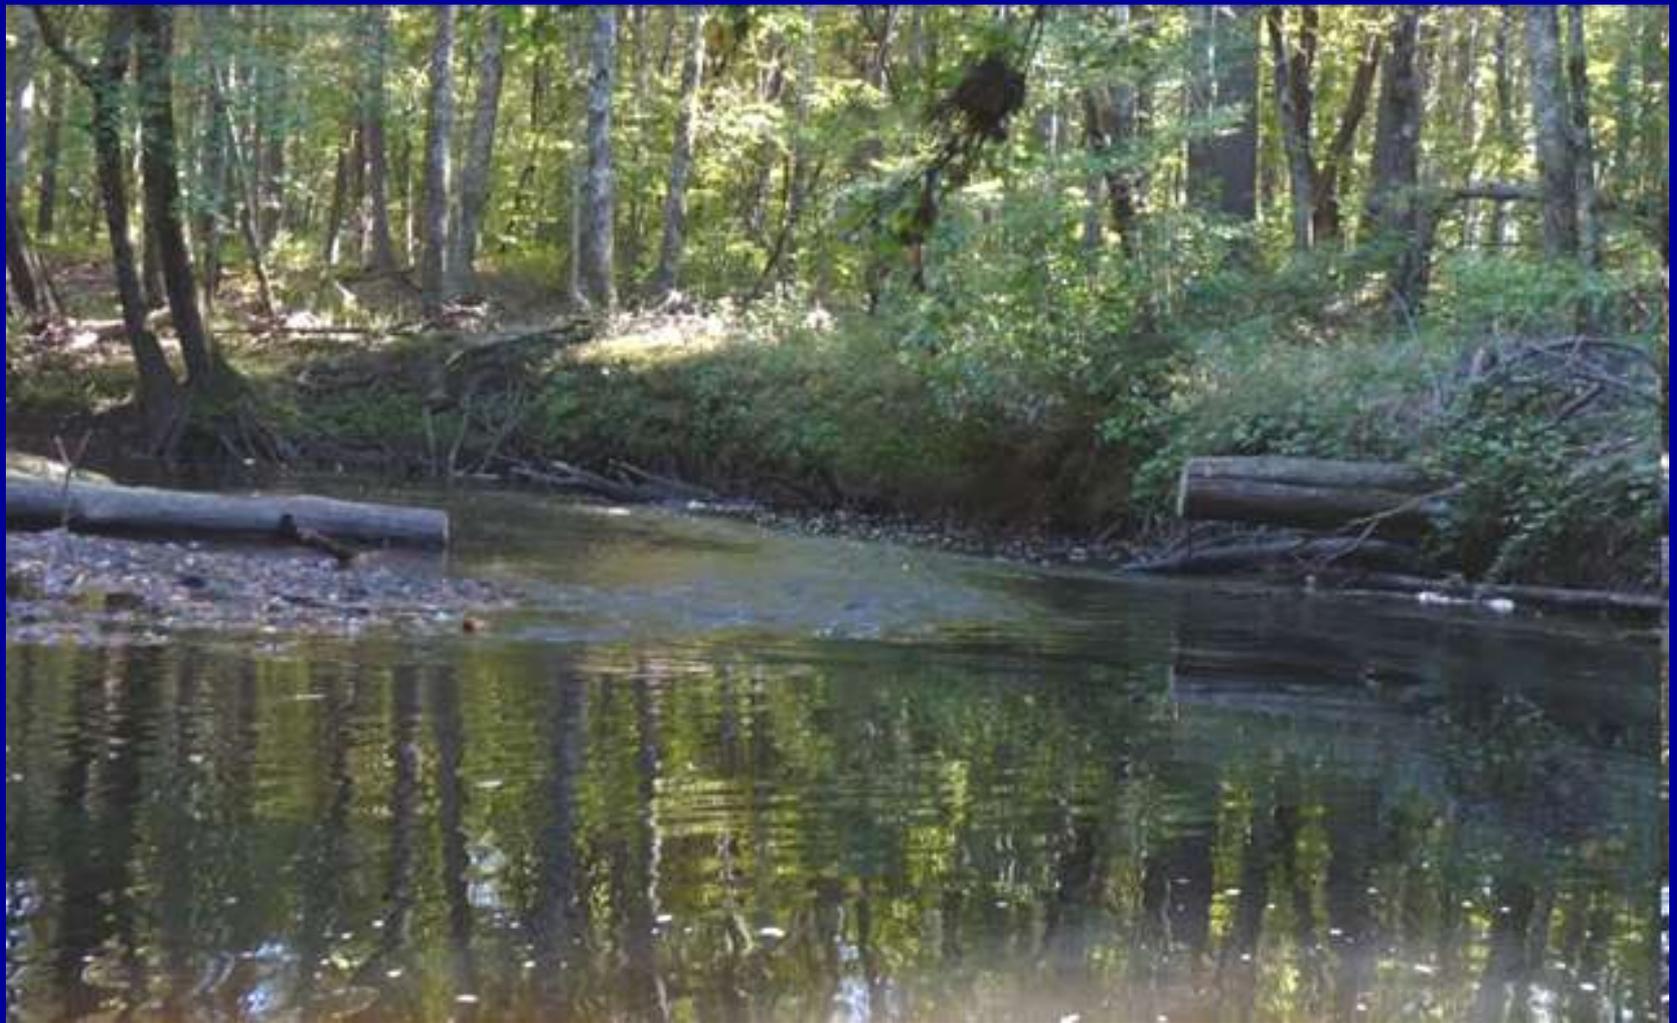
Here's an example where a section of low-hanging tree trunk completely spanning the Squannacook River channel was removed to facilitate safe paddling. This decision was apparently justified, as the log had fallen across a quickwater section of the river, where the faster current could have pinned or flipped a boat hitting the tree trunk. Note that the tree section removed is where the fastest current is.

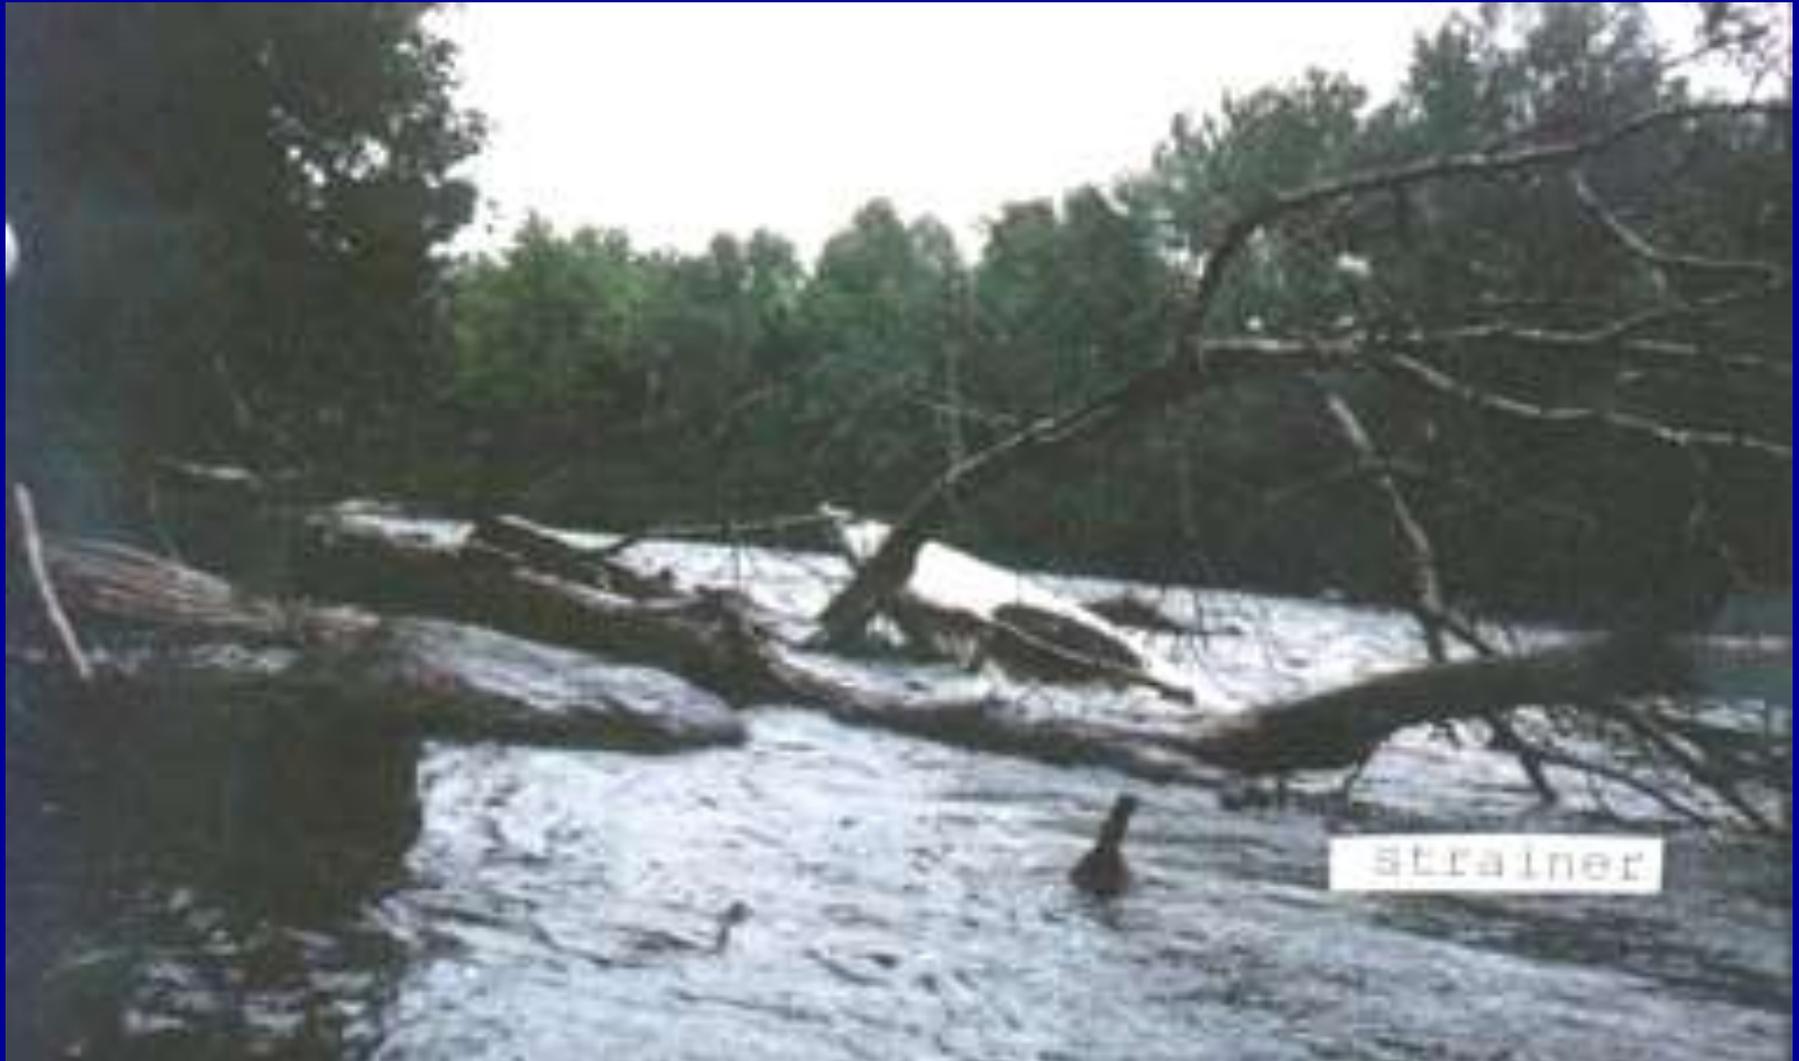
An example of where a boat has hung up on a “strainer”, a tree fallen across a fast-moving stretch of water. If it is not feasible to paddle or portage around this potentially dangerous obstacle, then a section of the tree might need to be removed to mitigate the hazard

Here's someone operating a chainsaw to remove a section of tree that is blocking a fast-moving section of channel. Note the helmets and PFDs worn by the workers, as well as the rope tied on to the other end of the tree to help secure it. People attempting such work must be fully trained in safety procedures. Ideally, it would have been better to have done this work at a lower flow level.

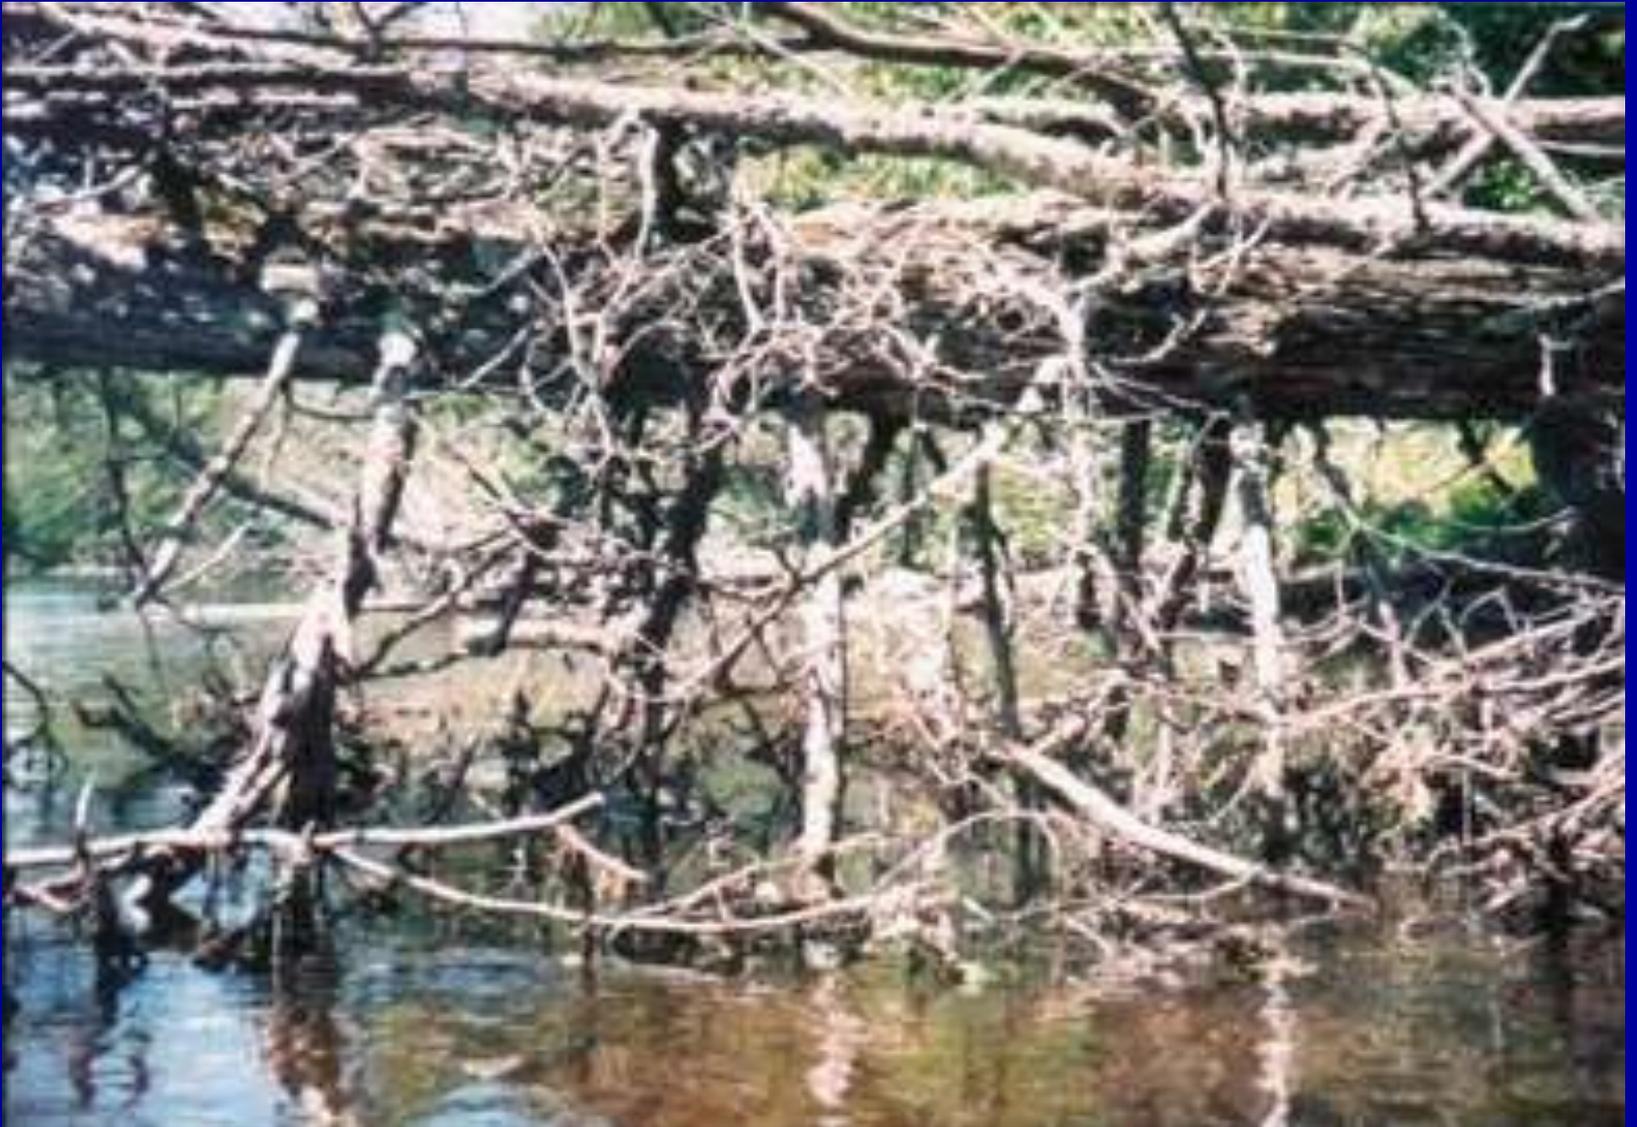
In this case, where the tree has fallen across a fast-moving section of stream and may be hard for paddlers to avoid it, a “come-along” (hand-powered cable winch) could be used to relocate the tree so that it no longer blocks the entire channel and to enable boats to squeeze through an opening

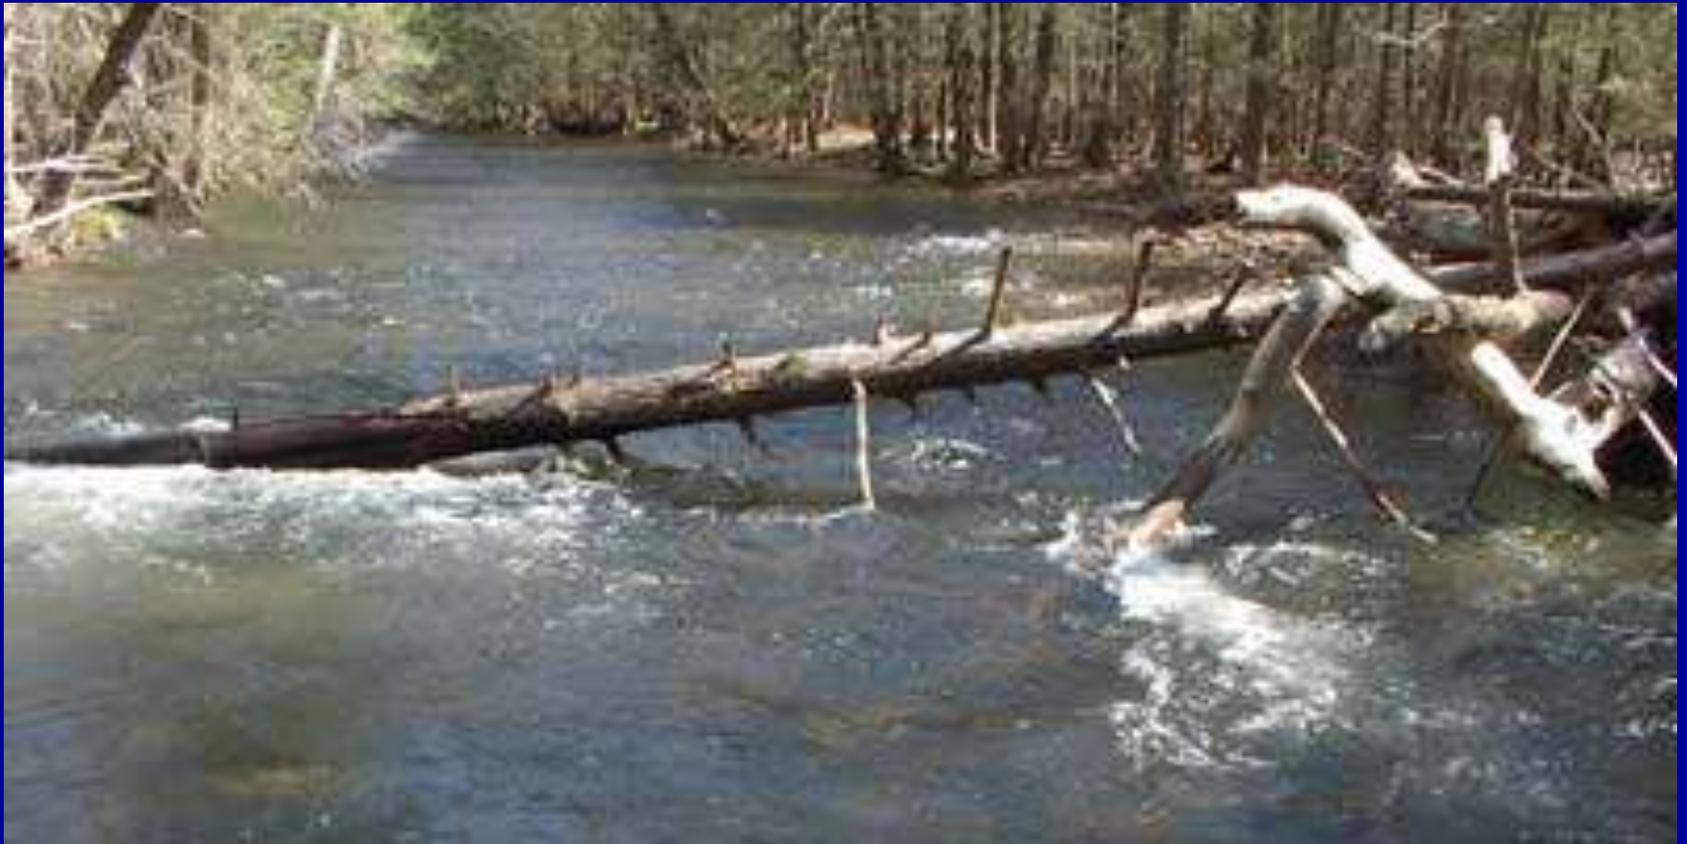
Snags and strainers can accumulate floating trash. The trash isn't the tree's fault. Removing the tree (after first cleaning up the trash accumulated behind it, of course) would only be a short-term solution, and would just enable future trash to float further downstream. Better to reduce the trash at its source (empty/relocate overflowing dumpster near the river, educate citizens not to litter, etc.)
