Trees, Paddlers and Wildlife - Safeguarding Ecological and Recreational Values on the River

Russ Cohen, Rivers Advocate

Mass. Department of Fish and Game

Division of Ecological Restoration (DER)/Riverways Program

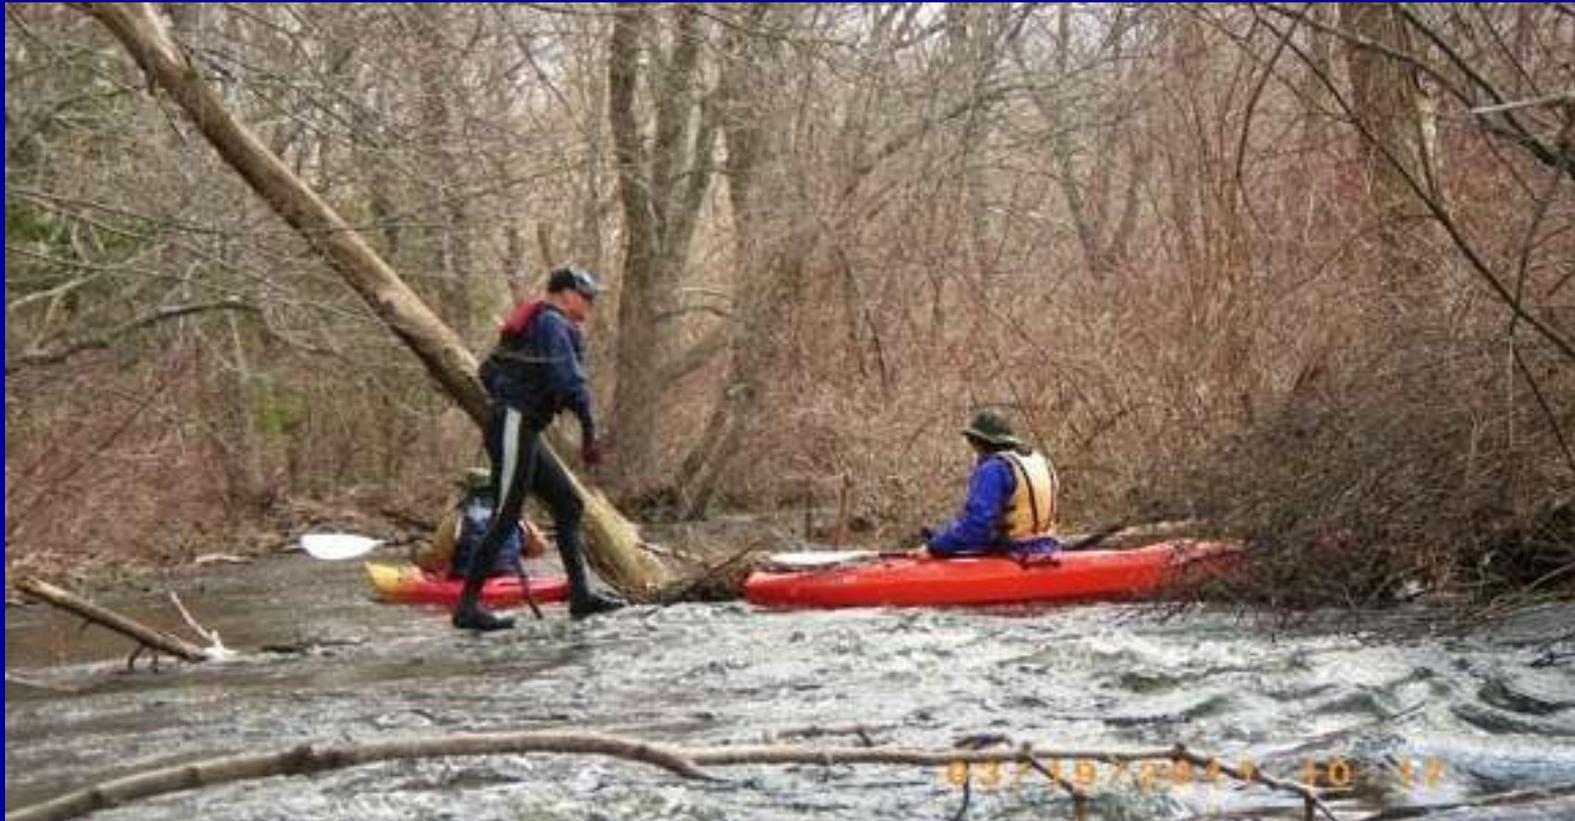
Here's a situation where several large trees and logs have combined to completely block a fast-moving section of river, and the possibility of a boat being pinned against the wood by the current and possibly flipping is significant, so some action here to reduce the safety hazard seems to be warranted.

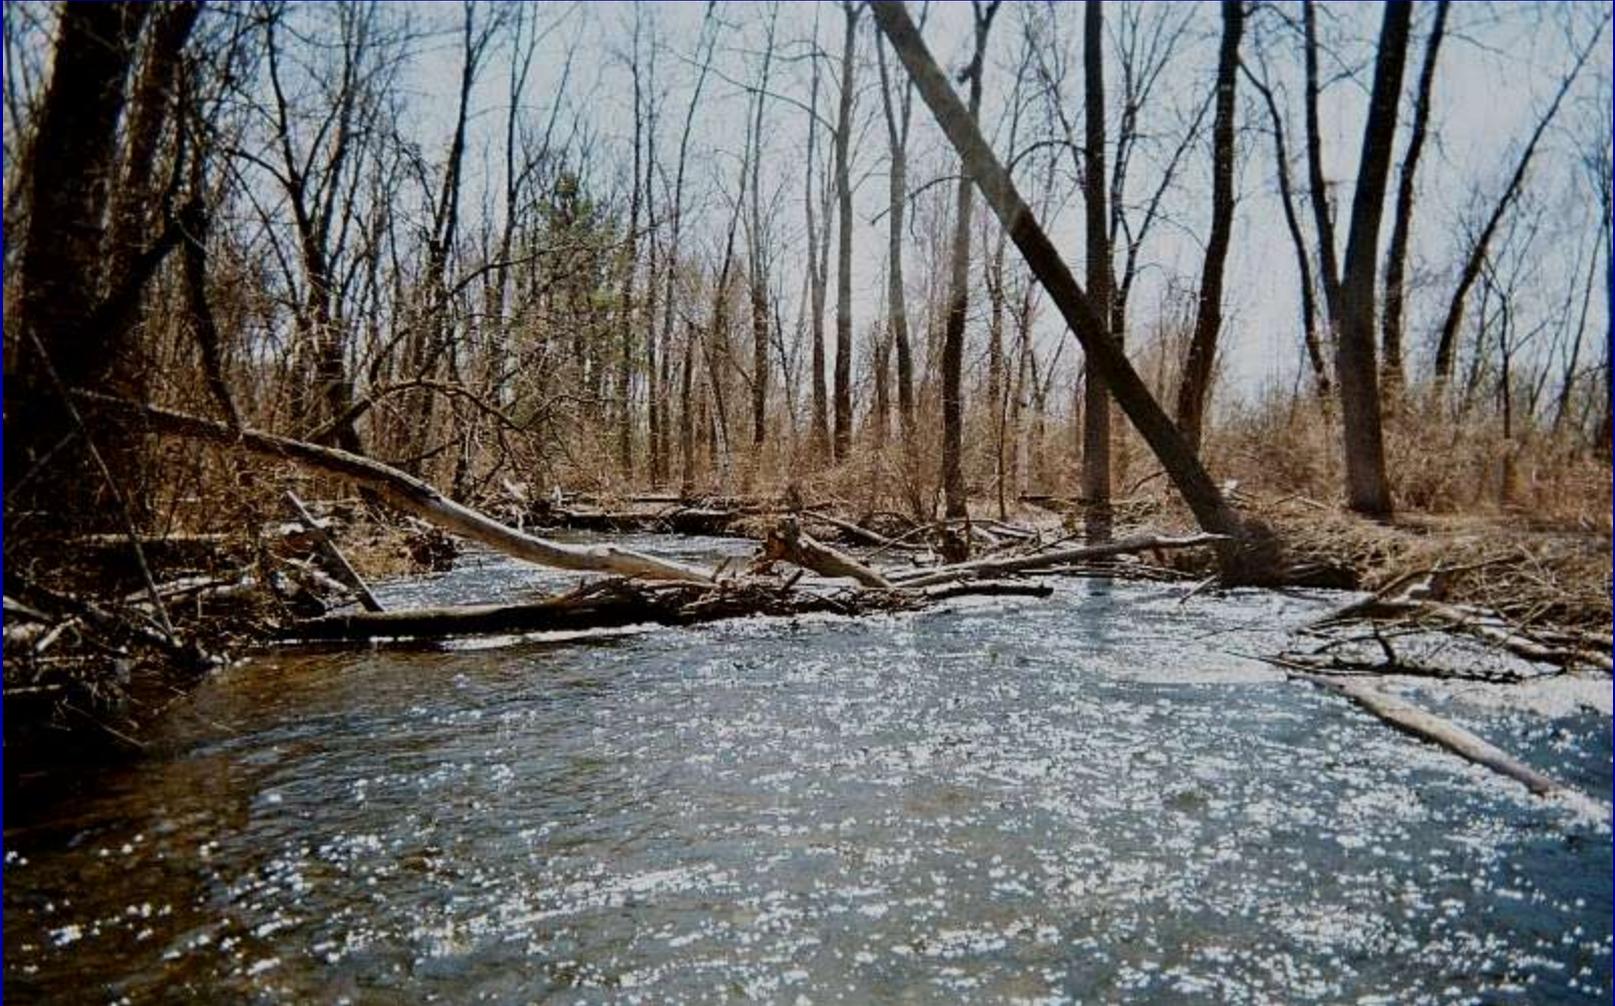
East Branch Housatonic River, Pittsfield, April, 2011

Here's a close-up (in side view) of that same logjam. Note the (barely) submerged log in the foreground, which should also be dealt with if that's the section of the logjam that would be cleared to allow safer passage for boats.

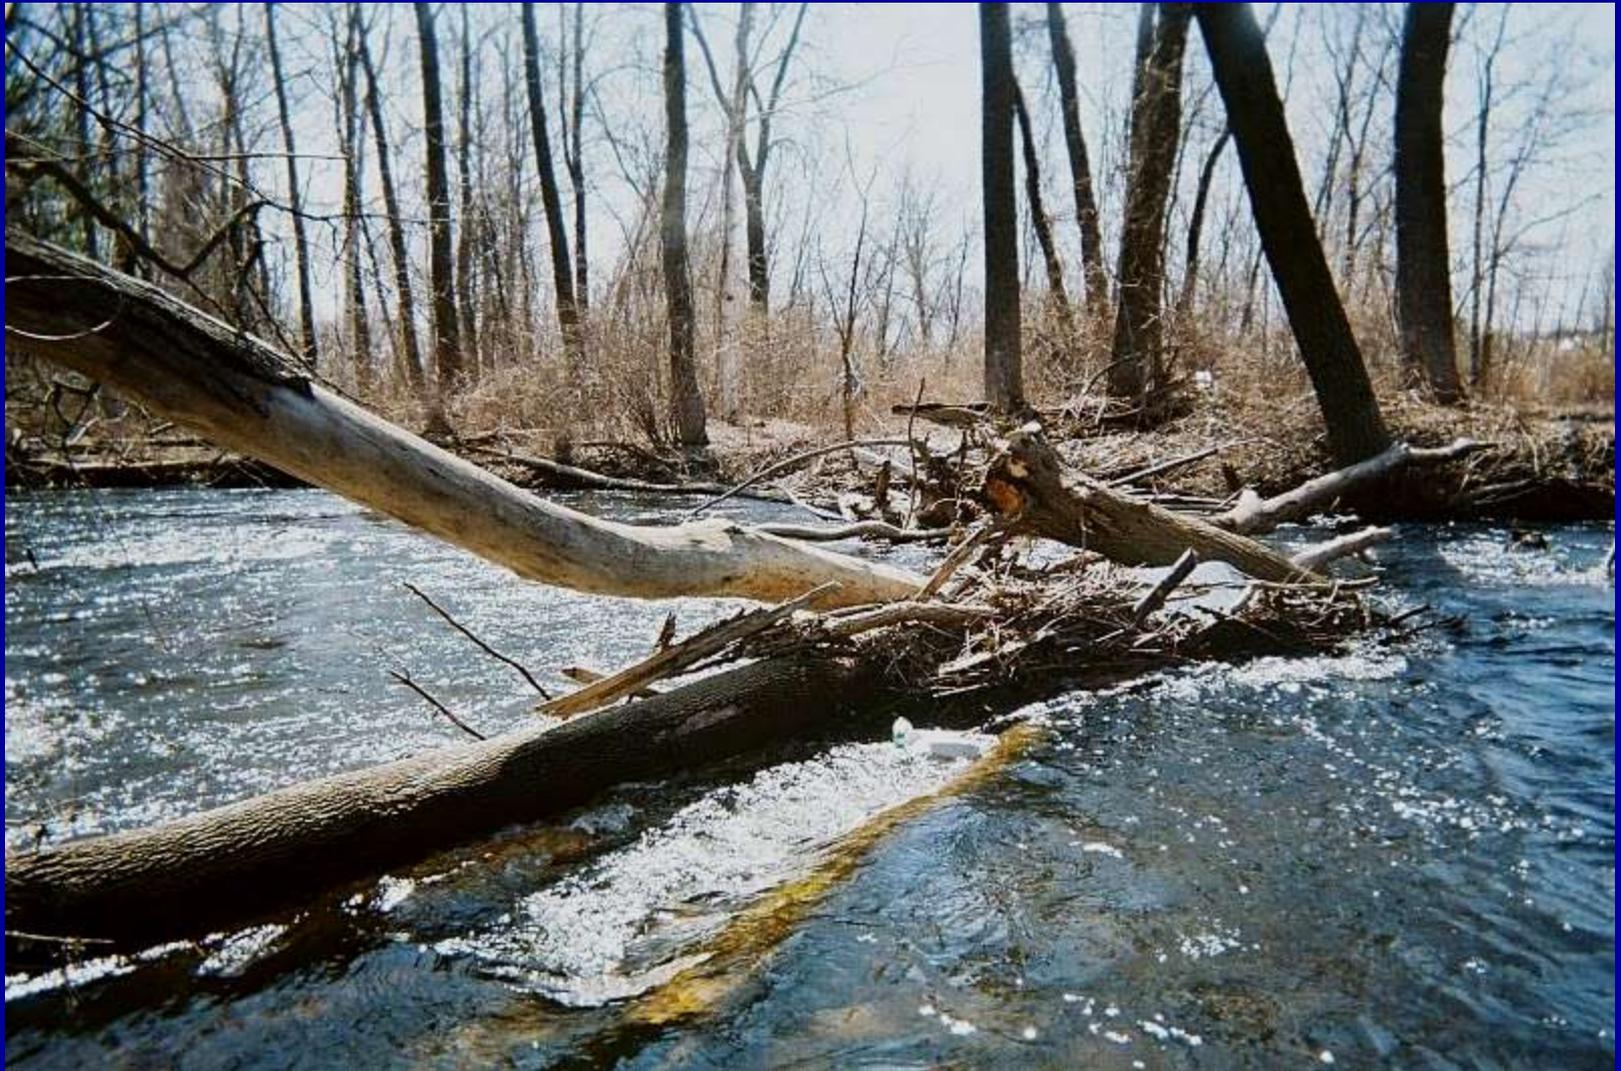
As it happens, there was another channel on river left at this location that was free of obstructions, so the logjam on river right could be easily and completely avoided by paddlers (thus no need to clear out any of that logjam).

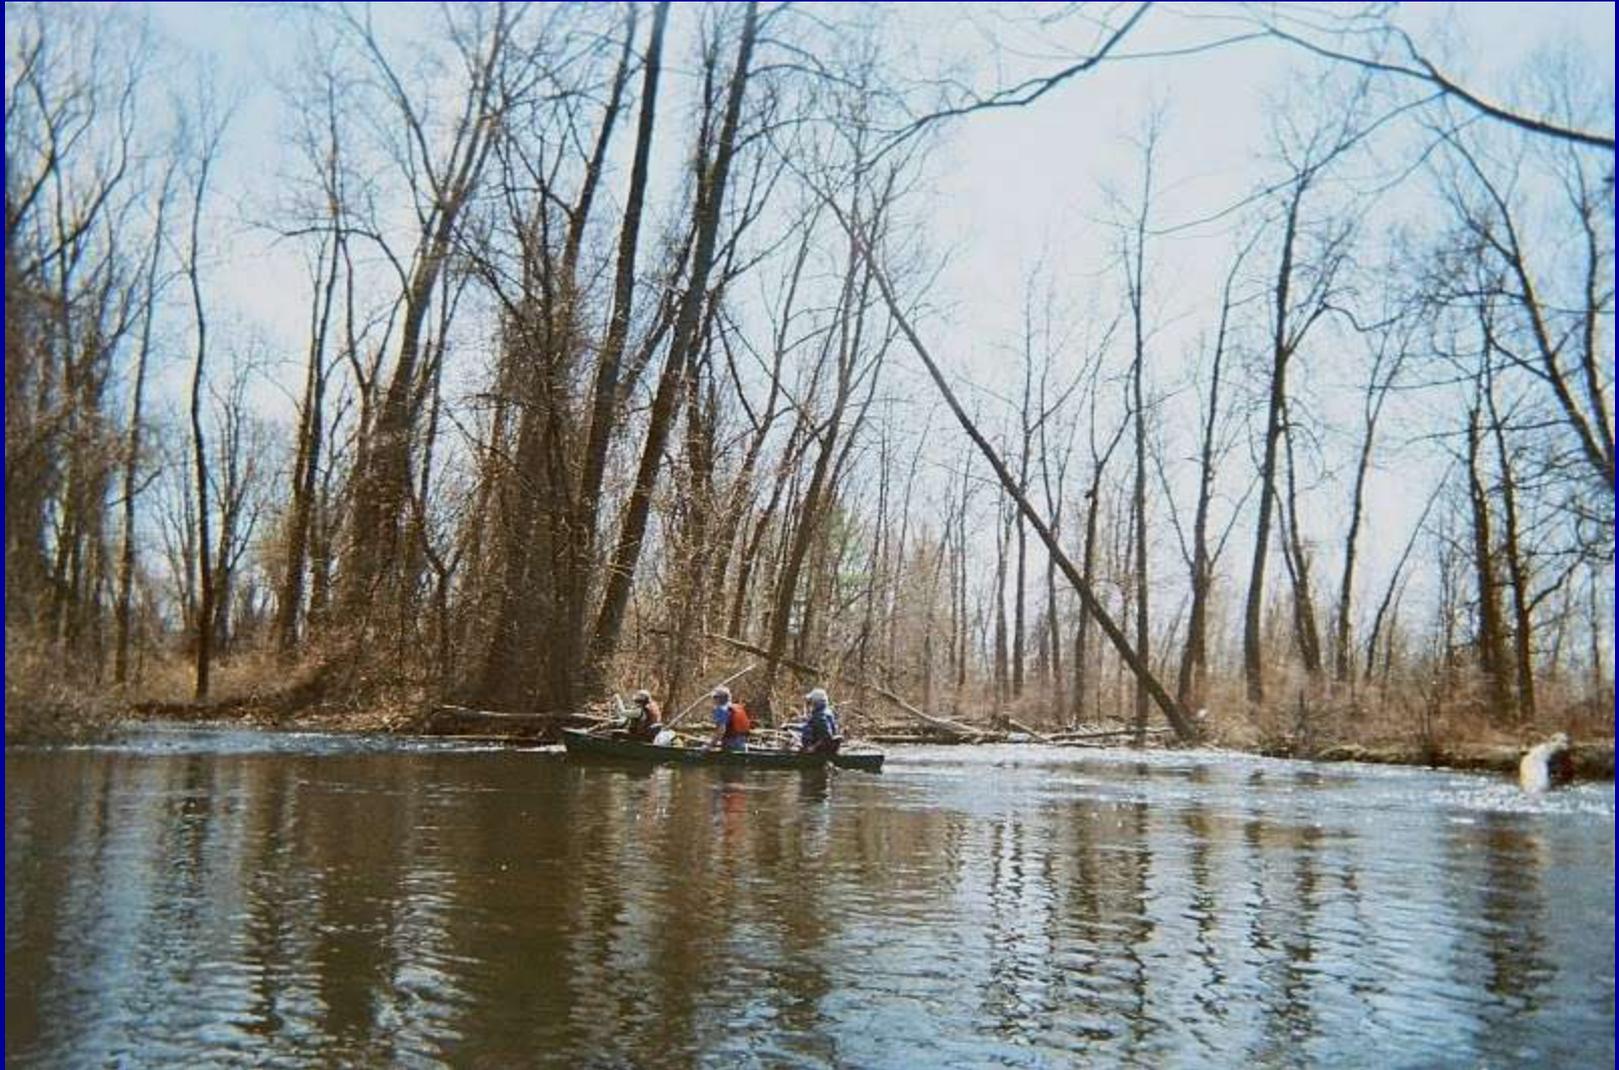
At this spot, a section of very fast-moving current carried a blue canoe directly into a logjam, where it subsequently flipped over (see arrow), discharging most of its contents, and almost got pulled completely underwater underneath the logjam. Here the trees in the river present a clear safety hazard to paddlers.

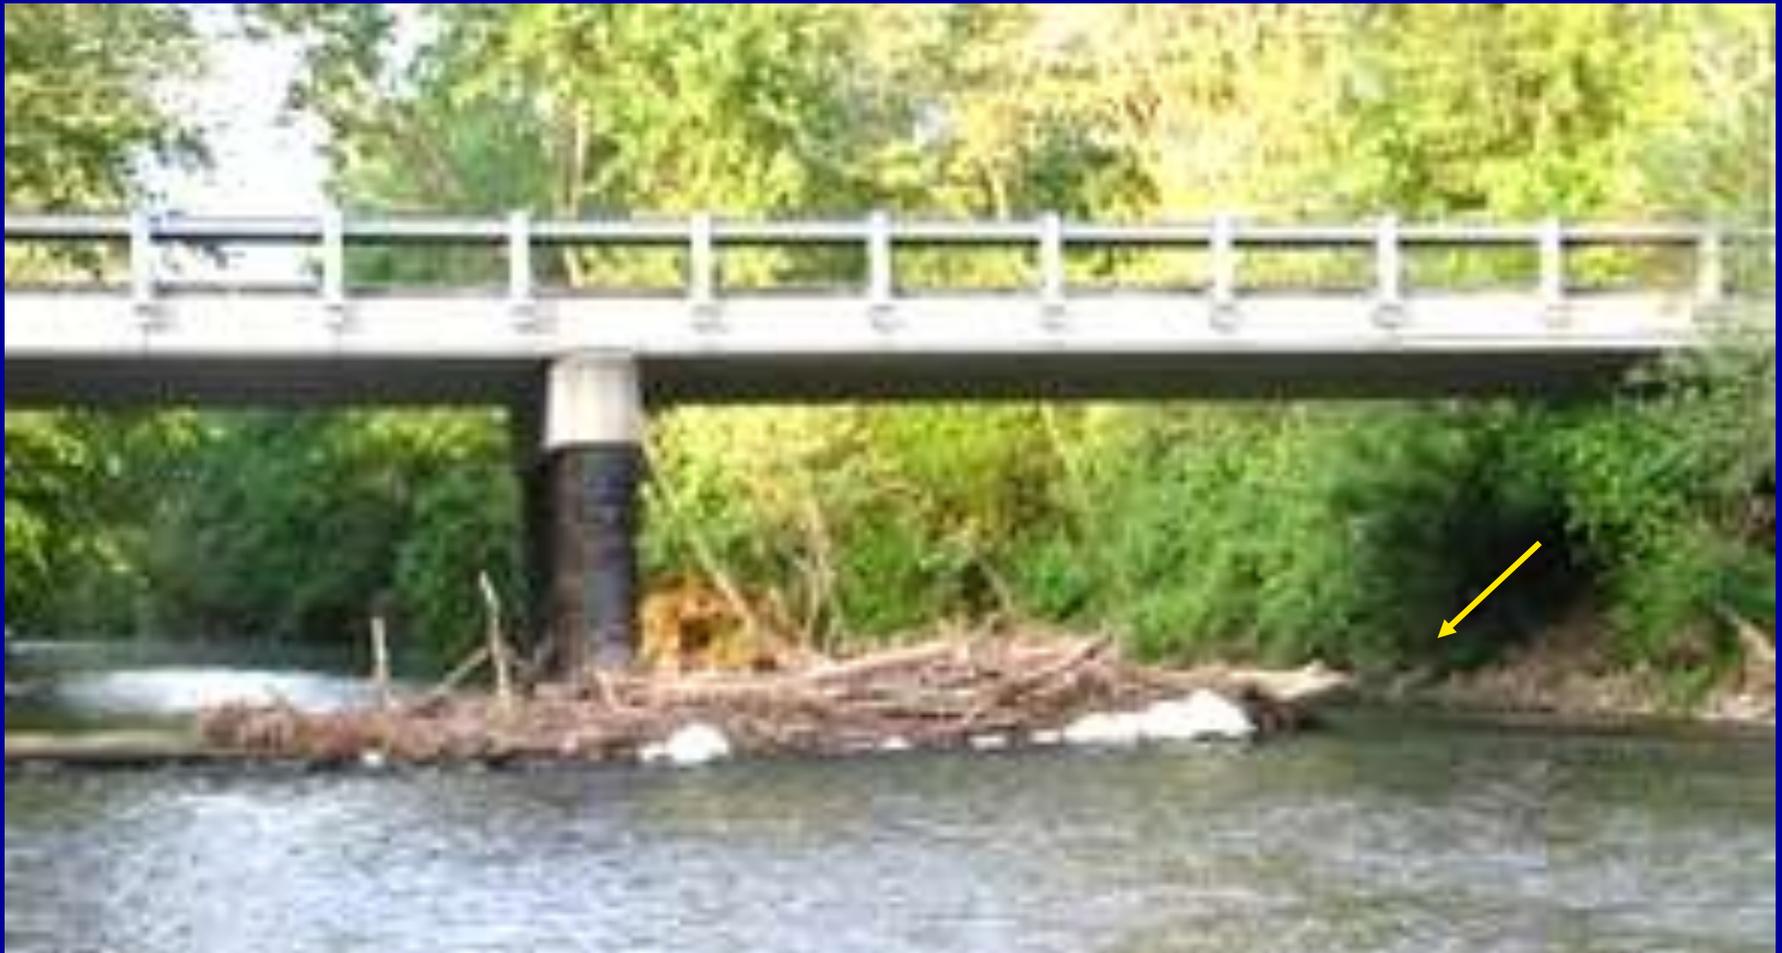
Logs and other debris backing up against a bridge abutment can create a potentially dangerous condition. Although paddlers can currently avoid this obstacle by paddling around it to the right (see arrow), were additional logs or other debris to be backed up here, it could potentially undermine the stability of the bridge and/or cause significant upstream flooding. DPWs may need to act to remove the blockage in such a situation.
