IVA. Eelgrass Restoration Project (July 1, 2004-October 31, 2007)

Completion Report: Alison S. Leschen, Ross K. Kessler, and Bruce T. Estrella

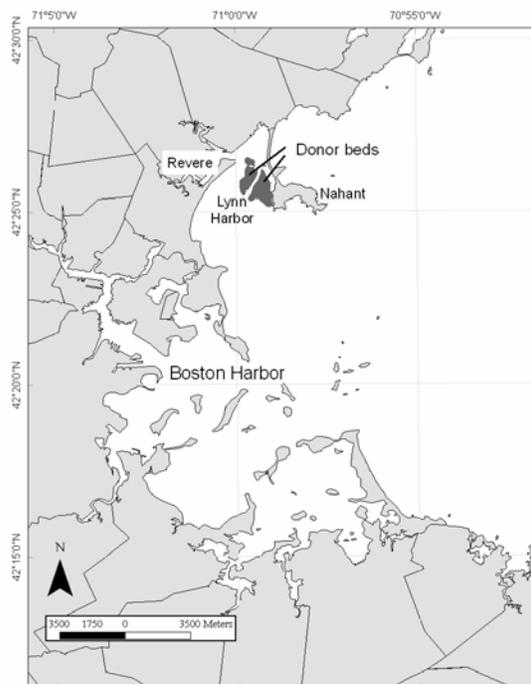
Figure IVA.2. Donor beds in Revere and Nahant.

Harbor, Nahant, was adopted as the primary donor site after investigation confirmed it was extensive and dense (Figure IVA.2). (A bed across the channel in Revere was examined, but eliminated as a donor site since it was not as dense as the Nahant bed).

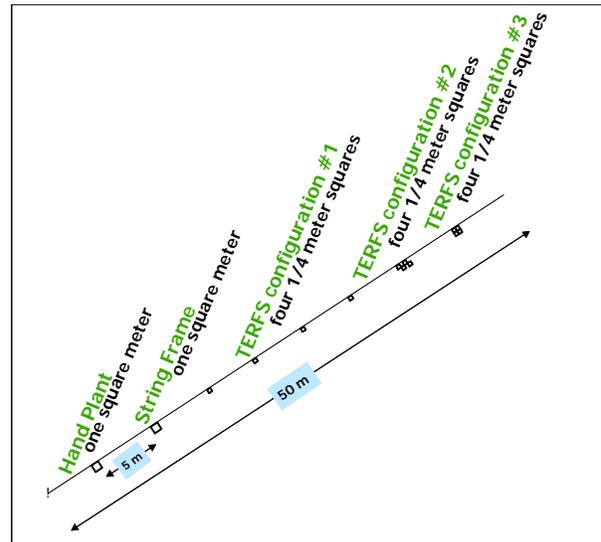
Figure IVA.3. Secondary test transplants in Boston Harbor, 2005. Each site was planted with 1000 shoots in various patterns by different methods.

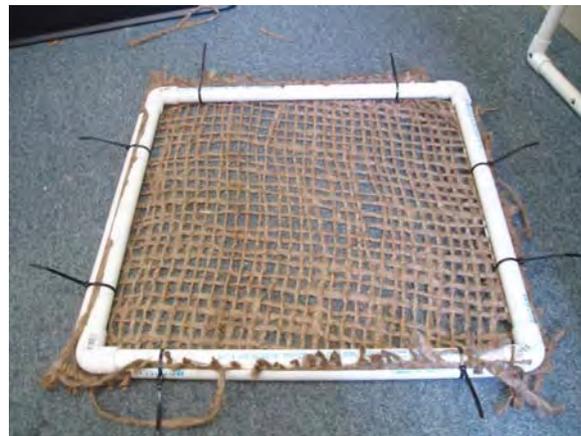
Figure IVA.4. A PVC frame/jute mesh structure was constructed as a lighter-weight alternative to TERFs™.

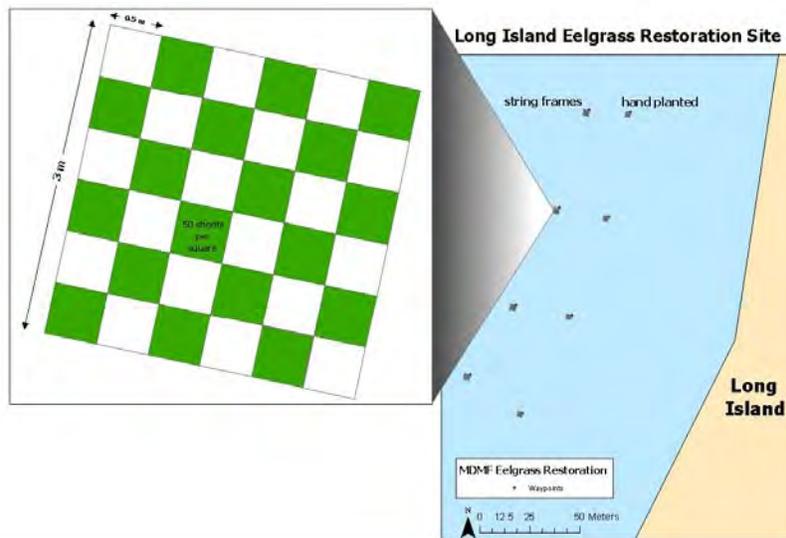
Figure IVA.5. Planting pattern showing alternating planted and unplanted $\frac{1}{4}$ m² quadrats at a typical large-scale transplant site.

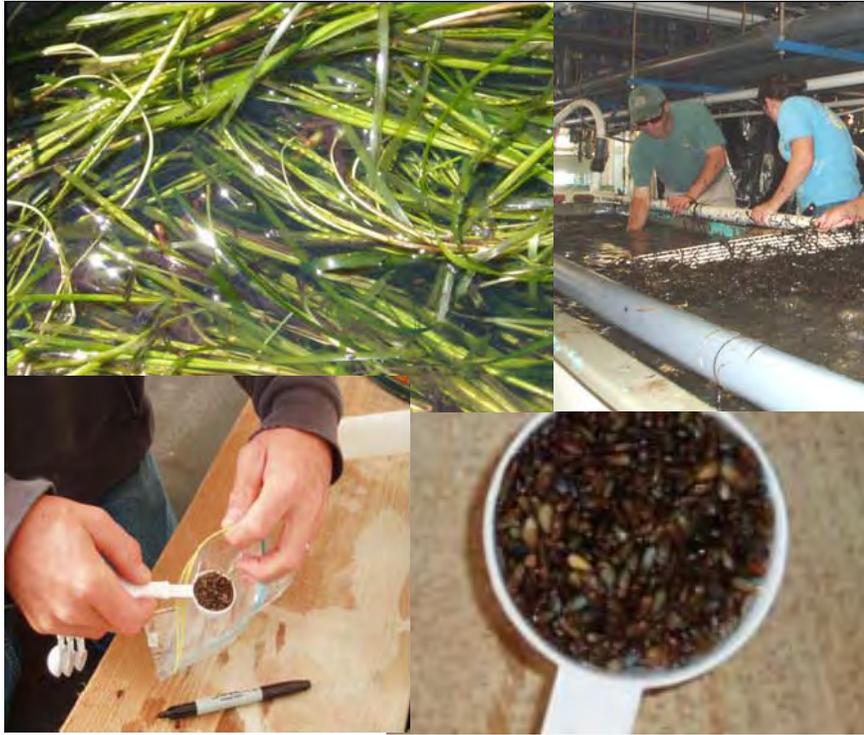
Figure IVA.6. Clockwise from upper left: flowering shoots containing immature seeds; removing vegetation once seeds have dropped out; close-up of mature seeds; measuring seeds into bags for deployment.

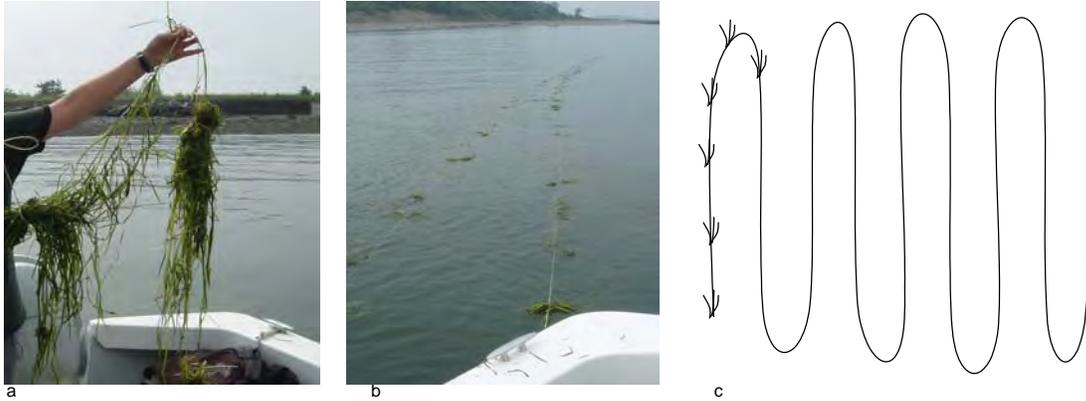
Figure IVA.7. Handfuls of seed shoots tied in bundles along a length of twine (a). String of bundles trailing behind the boat (b). Planting pattern used to stake down bundles (c).

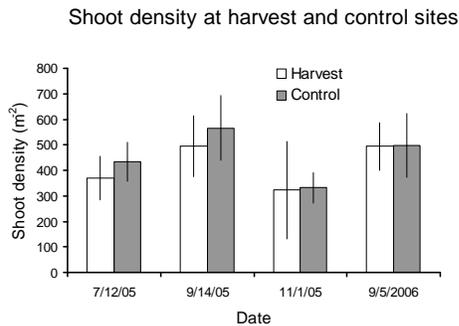
Figure IVA.8. Eelgrass shoot densities at donor site in Nahant in 2005. Control and harvest data on each date were compared using the Wilcoxon signed-rank test. Error bars are \pm SD.

Shoot densities measured at harvest and control sites in the Nahant donor bed are presented in Figure IVA.8. Differences were not significant ($p>0.05$) in all comparisons of control vs. harvest on any date, suggesting that our harvest methods had no detrimental impact on shoot density in donor beds.

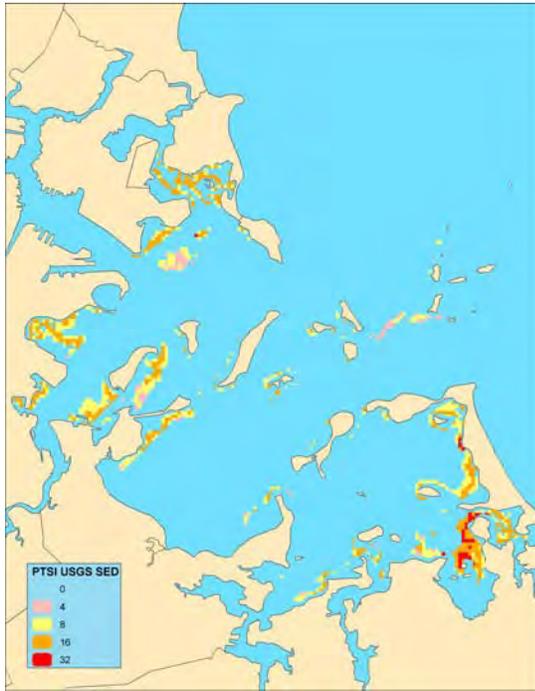
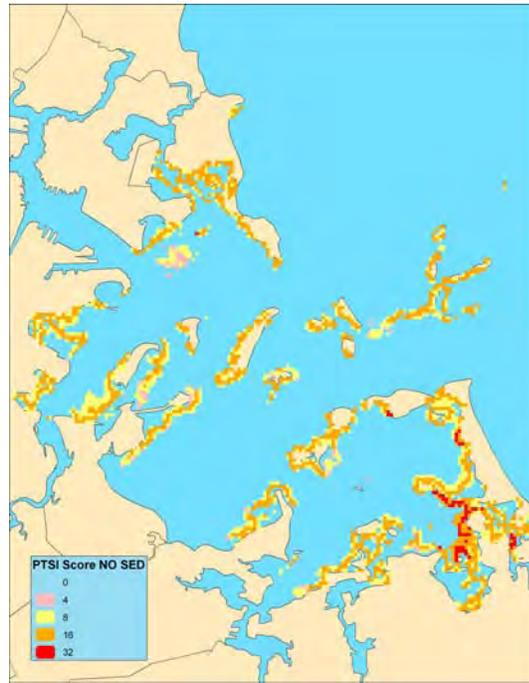
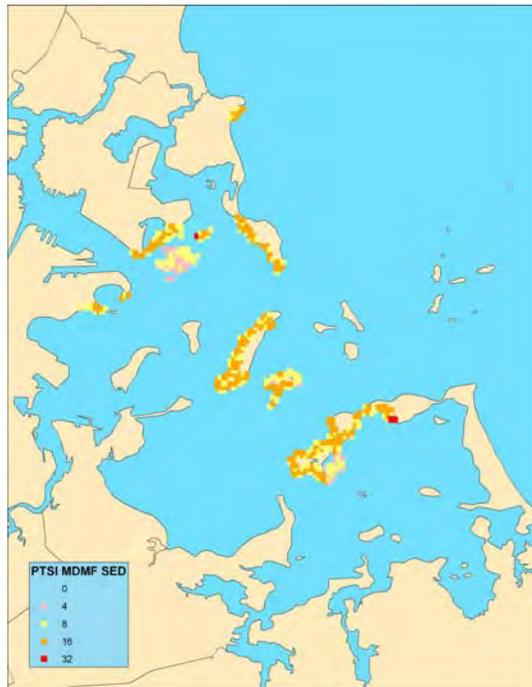
Figure IVA.9. Results of PTISI scoring with USGS sediment layer (A). Higher scores indicate greater suitability for eelgrass growth based on the Short model. PTISI map with problematic USGS sediment layer removed (B) and PTISI scoring with *Marine Fisheries* sediment layer (C).

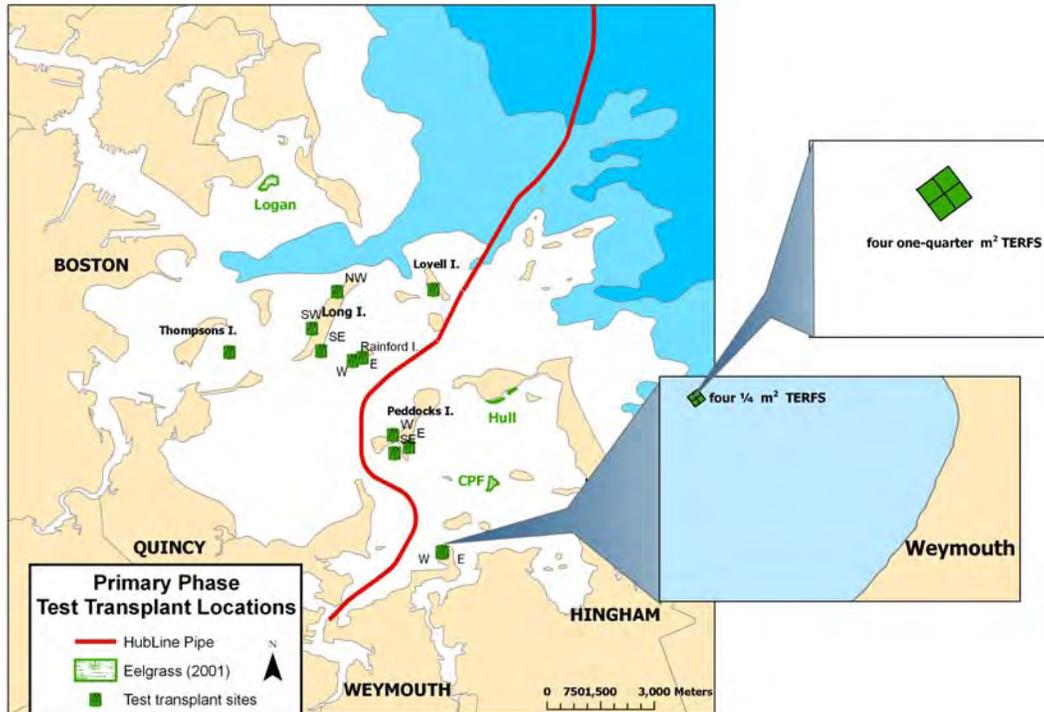
Figure IVA.10. Primary test transplant locations in Boston Harbor, 2005. Each site was planted using four TERFs™ frames arranged in a square; each had approximately 50 eelgrass shoots attached. There are two sites at Rainford Island and Weymouth (they appear as one on the map due to their close proximity). CPF (Crow Point Flats), Hull, and Logan are pre-existing eelgrass beds).

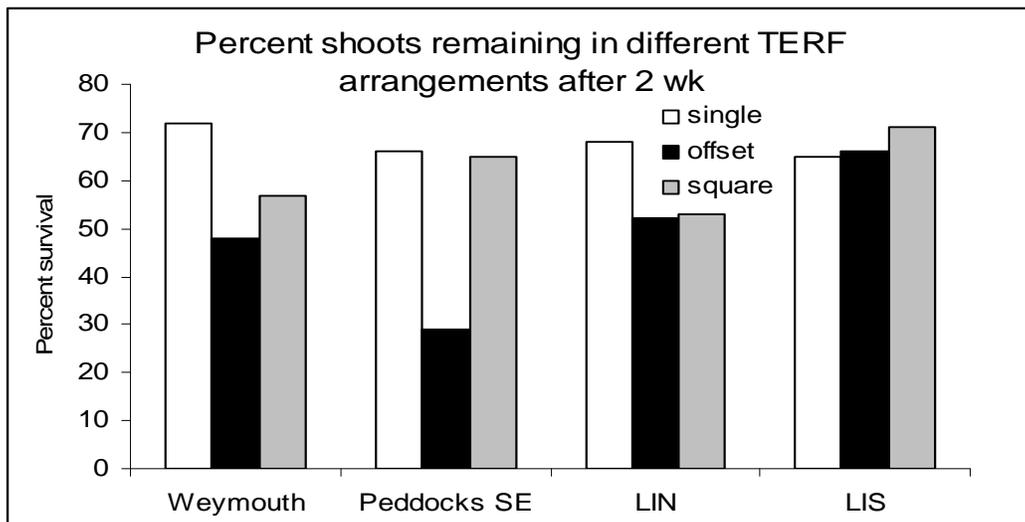
Figure IVA.11. Percent survival of eelgrass shoots planted in various patterns at four sites in Boston Harbor, 2005. In the medium-scale test transplant, four TERFS™ were arranged in each of three patterns at four sites to assess the pattern's effect on survival. "Single" TERFS™ were placed linearly 5 m apart along a transect. "Offset" TERFS™ were laid in a checkerboard pattern. In the "square" pattern, 4 TERFS™ were laid adjacent to each other to form a square. N=12 at each site.

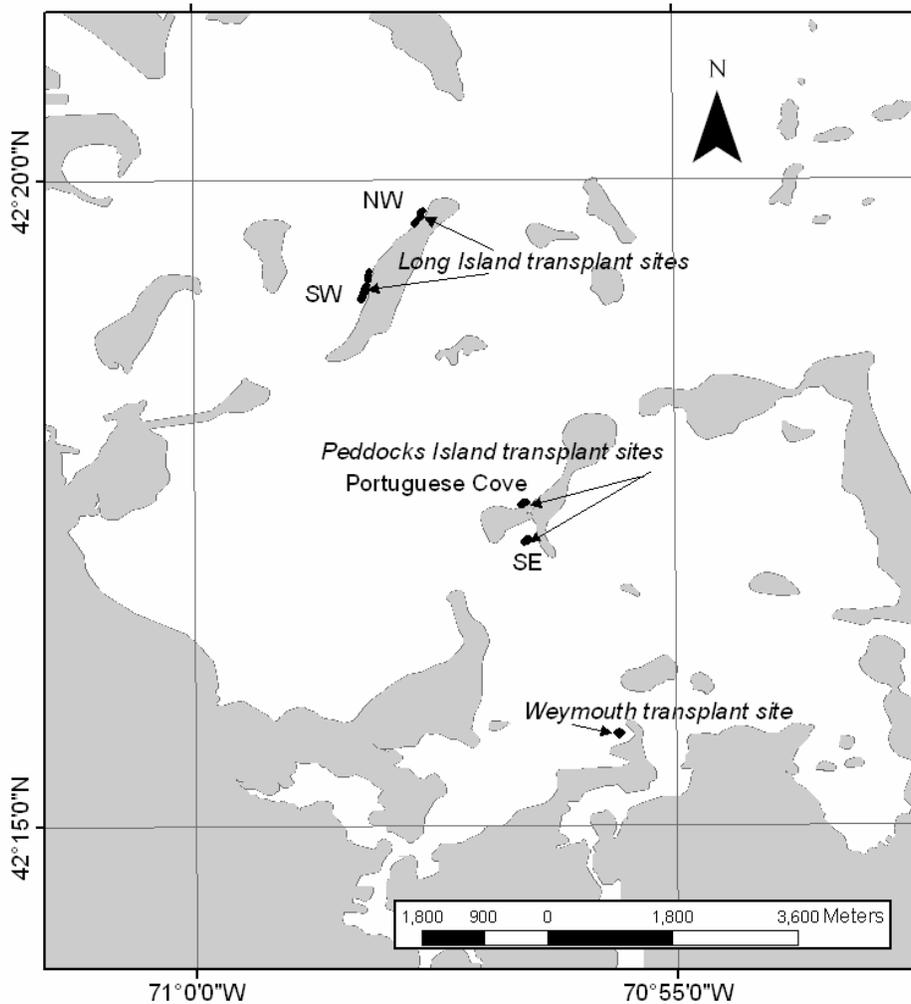
Figure IVA.12. Large-scale transplant sites planted in 2005 and 2006.

LIS, LIN, Weymouth, and Peddocks SE were selected for large-scale planting. Some sites were investigated further which led to additional plantings at Portuguese Cove (Figure IVA.12).

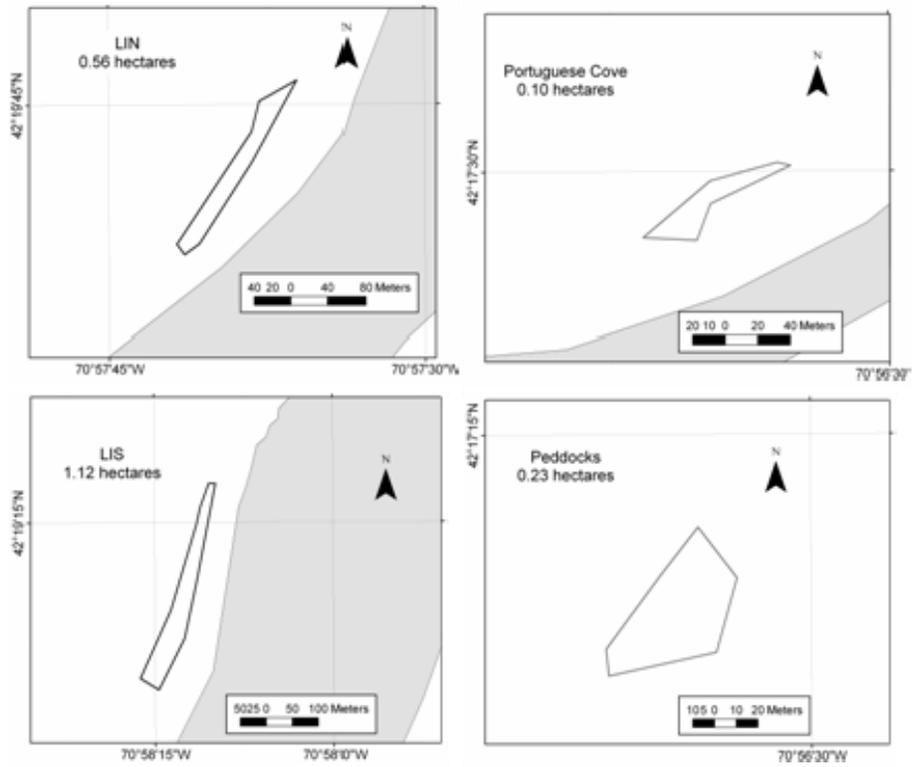
Figure IVA.13. Enlargements of each large-scale transplant site and respective areal coverage.

Eight grid plots were initially planted at LIS in fall 2005, four hand-planted and four with frames, along two 150 m transects, respectively, bounding approximately one acre. Peddocks SE (frames) and Weymouth (hand-plant) were each planted with 4 plots in a square pattern, and encompassed ~ ½ acre per site. In spring 2006, Portuguese Cove and LIN were planted with 6 and 4 plots, respectively (plot size varied at these sites based on amount of eelgrass available from harvest), using a combination of hand- and frame-planting. More plots were added at each site through spring 2007. Figure IVA.13 depicts plot configuration.

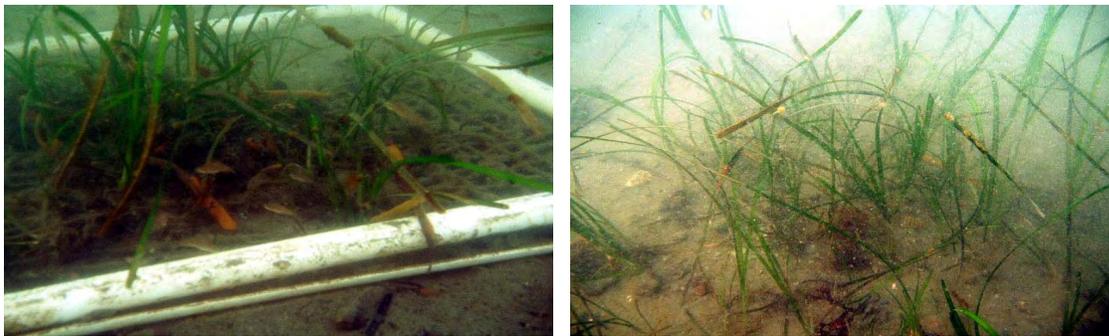
Figure IVA.14. Photos of PVC frame in situ (left) and after frame has been removed (right). Note that jute is silted over.

PVC string frames (Leschen et al. 2006) planted in fall 2005 were left in place during the following winter. Those planted in spring 2006 were retrieved at the end of the summer after eelgrass shoots had rooted. The string frames proved easy with which to work, deploy, and retrieve and their spiked anchoring system effectively prevented frame-shifting (Figure IVA.14).

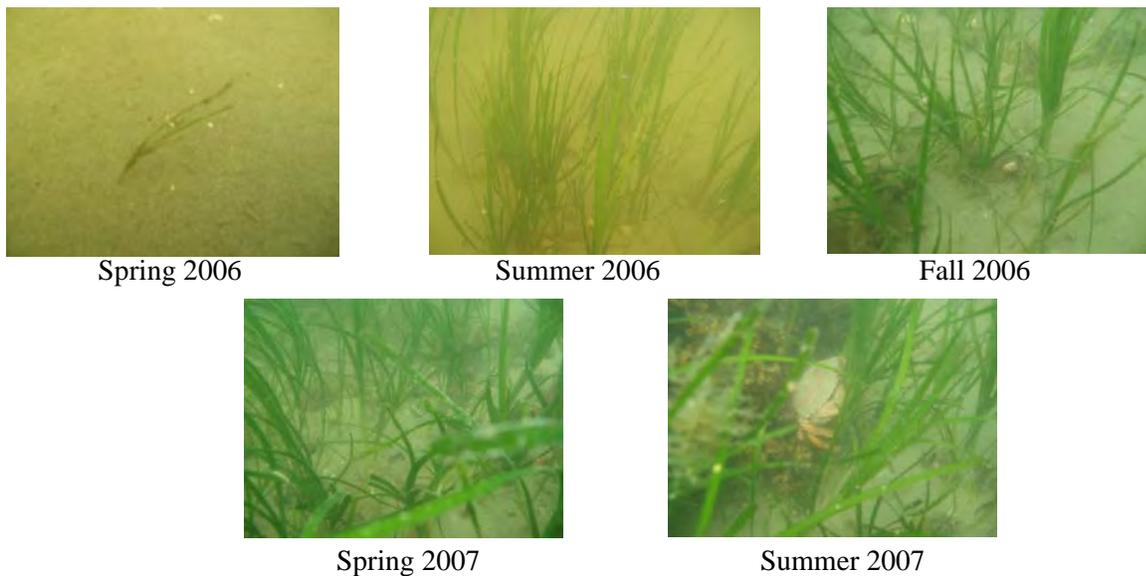
Figure IVA.15. Seed planting progression at LIS; initial sparse germination eventually spread into a large, dense bed.

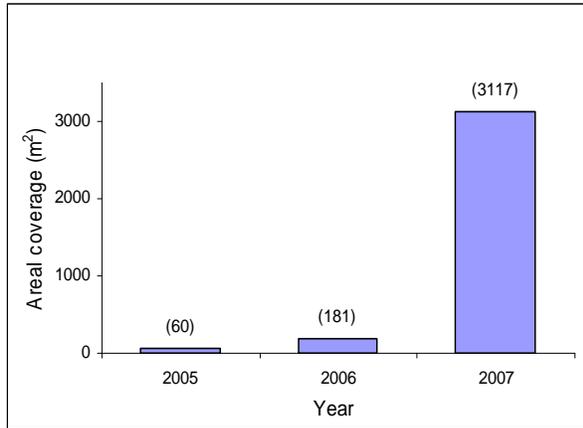
Figure IVA.16. Areal coverage of seeded site at LIS, 2005-2007.

Assessment in spring 2007 revealed an area of 3100 m² harboring at least some tufts or bunches of eelgrass which spread from the original 2005 seed planting (Figure IVA.16); by fall 2007 most of the area exhibited fairly dense growth. Growth at Peddocks from the 2005 seed planting was less extensive and harder to measure due to poor visibility, nevertheless, this site showed promising growth and expansion. The LIN site, where seeds were simply broadcasted, covered approximately 100 m² by fall 2007. This cover was much less than at sites where divers scratched the seeds into the sediment. The additional, minimal effort by divers may have helped to conceal seeds from grazers and facilitated germination.

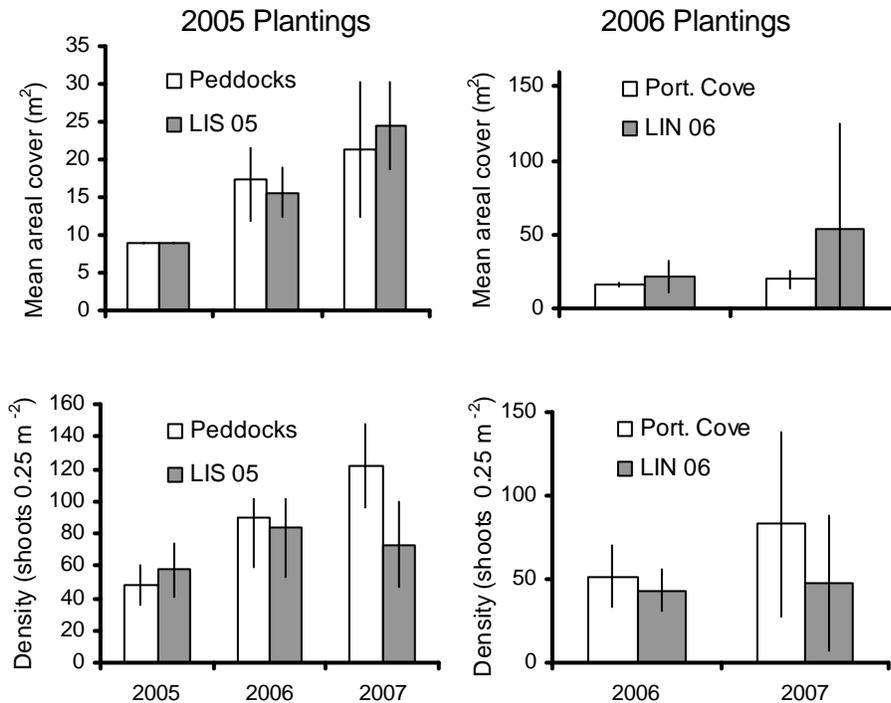
Figure IVA.17. Mean density and areal cover (\pm SD) over the duration of the project (2005-2007) of plots planted in 2005 (LIS and Peddocks SE) and 2006 (Portuguese Cove and LIN).

Both 2005 sites increased significantly in areal coverage each year after planting ($P < 0.05$ in all cases; Figure IVA.17). The difference between Peddocks and LIS 05 sites did not differ significantly in any year. Density at Peddocks increased significantly between 2005 and 2006, and, although it continued to trend upward, 2007 data were not significantly different from 2006. LIS 05 showed the same pattern, except that 2006 and 2007 densities did not trend upward. There was no difference between the two sites in 2005 or 2006, but in 2007 density was significantly higher at Peddocks than LIS 05.

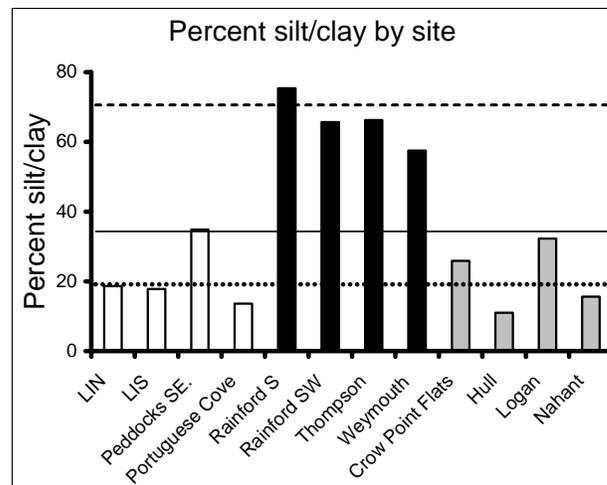
Figure IVA.18. Percent silt/clay at successful (white bars) and failed (black bars) transplant sites, and existing beds (gray bars). Top (dashed) line is recommended maximum per Short model. Middle (solid) line is maximum found at our successful sites. Bottom (dotted) line is maximum recommended by Koch (2001).

Using results from BU's sediment analysis, we compared grain size composition among existing beds, successful transplant sites and 4 that failed: Thompson Island, two at Rainford (preliminary test transplants), and Weymouth (other sites that failed after preliminary transplants for reasons such as gravel, kelp, and boat traffic were excluded from the analysis). Sites with 35% or less silt/clay were successful. Those with >57% silt/clay failed (Figure IVA.18).

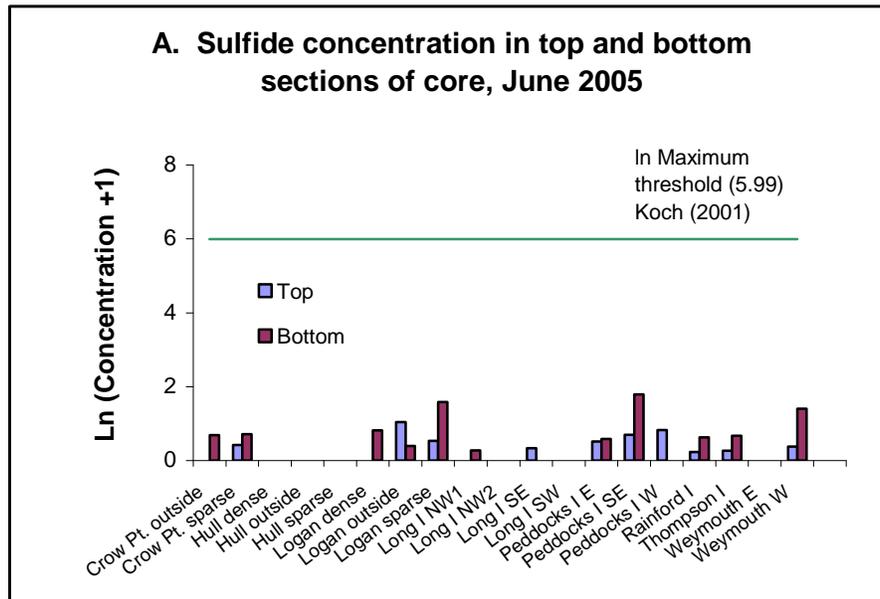
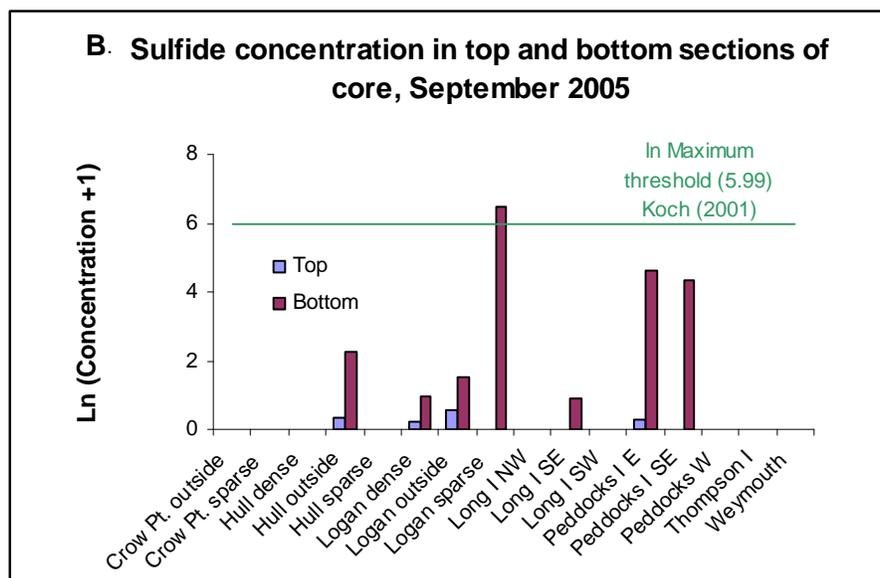
Figure IVA.19. Porewater sulfide concentrations (converted to ln) at existing eelgrass beds and potential transplant sites in Boston Harbor in June (A) and September (B) 2005. In existing beds (Hull, Logan, Crow Pt.—see Figure IVA.10), "dense" and "sparse" refer to a dense, central part of the bed and the sparse edges, respectively. "Outside" refers to just beyond the boundary of the bed where there is no eelgrass. "Top section" = upper 5 cm of the core; "Bottom section" = remainder of core (core length ranged from 9.4 - 17.5 cm due to collection techniques and sediment composition). Sites where concentration is zero either had too little porewater to test (typical of sandy/silty sediment) or tested below the detectable limit of sulfide, 0.21 μM . (The mean of replicate sample values was graphed when the data exhibited anomalously large differences.)

Surprisingly, sulfide and TOC levels did not exceed Koch's recommended levels at any sites except slightly at Thompson Island and Logan (pre-existing bed; Figures IVA.19 and IVA.20). However, levels at our Peddocks sites were higher than the LI sites. TOC levels there were close to those at Weymouth and Thompson, and sulfide levels at the Peddocks sites exceeded those at Weymouth and Thompson.

The exact mechanism by which high silt/clay content renders an area unsuitable for eelgrass transplant is unclear. Our sulfide analytical results (Figure IVA.19) do not implicate sulfide toxicity per se as the cause for eelgrass decline and death, unless thresholds are less than Koch (2001) recommends (although in that case we might have expected Peddocks SE to do poorly). TOC levels were also acceptable at most sites. Sediment at established eelgrass beds can be rich in organics and have low redox potential without adversely affecting the plants (Smith et al. 1988; Klug 1980; Thayer et al. 1984). It is possible, however, that eelgrass transplants become stressed in reducing environments often found in very fine-grained sediment. Much of the sediment at our failed sites was black-colored with a shallow redox layer indicating anoxic conditions.

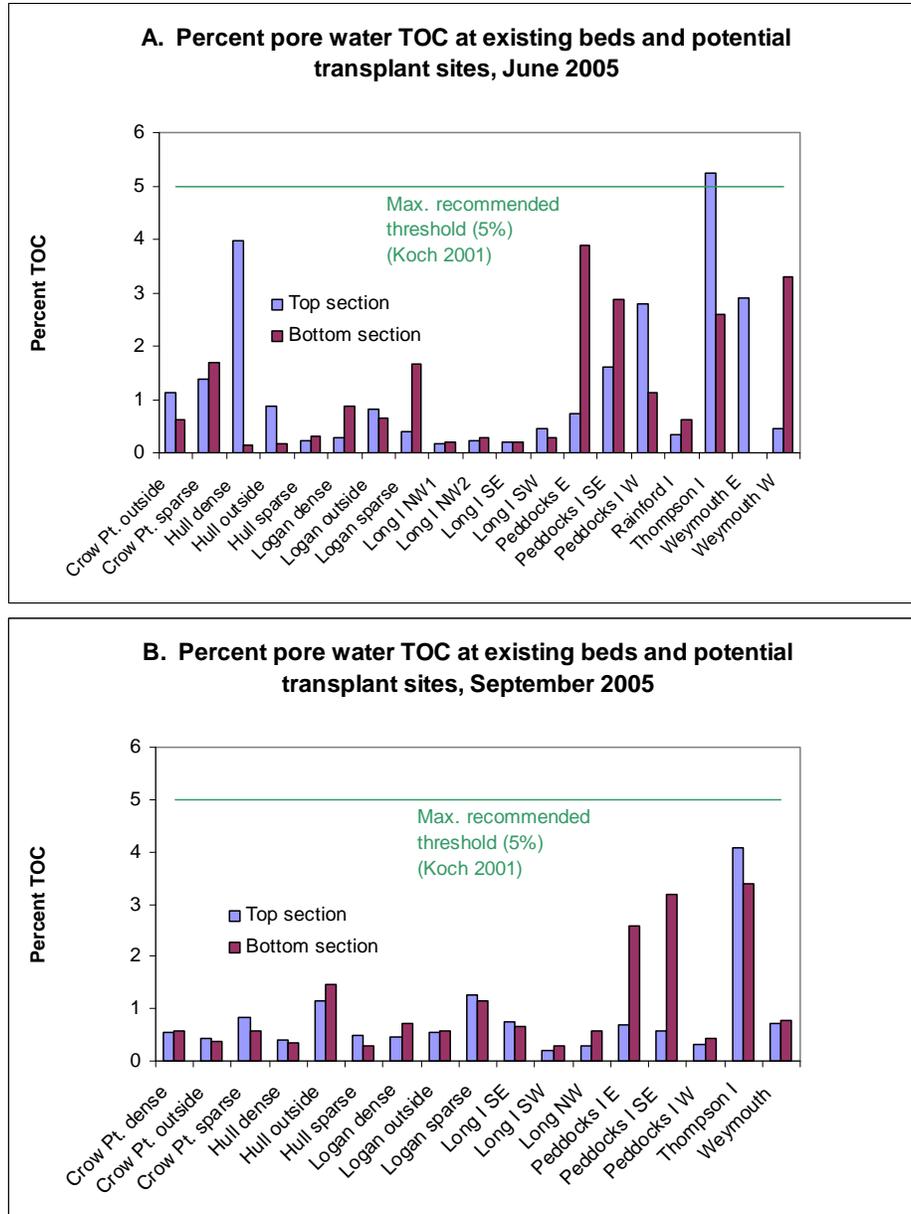
Figure IVA.20. Percent Total Organic Carbon (TOC) at existing beds and potential transplant sites in Boston Harbor in June (A) and September (B) 2005. The length of the core from the Weymouth E site in June did not permit a bottom section analysis.

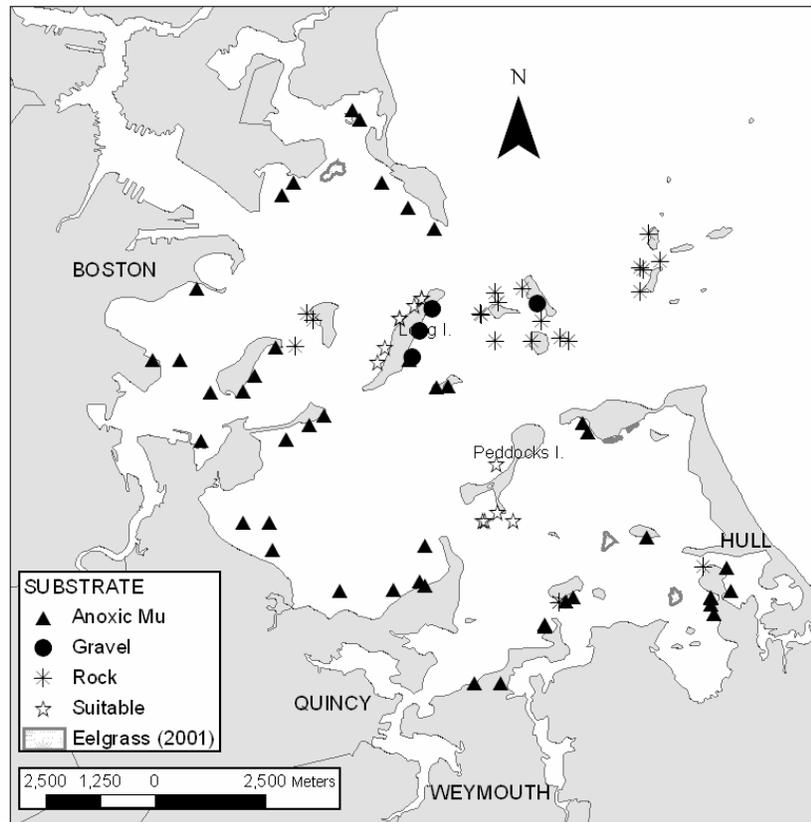
Figure IVA.21. Sediment type observed in Boston Harbor. Data were gathered using an underwater camera, Ponar grab, or by divers taking cores. Note the prevalence of anoxic mud around the shoreline and the limited areas of suitable sediment.

The prevalence of unsuitable sediment throughout much of Boston Harbor five years after the offshore outfall became operational (Figure IVA.21) raises concerns about the future possibilities for eelgrass restoration in estuaries degraded by eutrophication. In areas where low flushing rates result in long-term deposition of organic matter, it may take years for sediment to recover enough to support eelgrass, even when water quality has improved. This issue will require further study as improvements are made to coastal water quality in other locations.

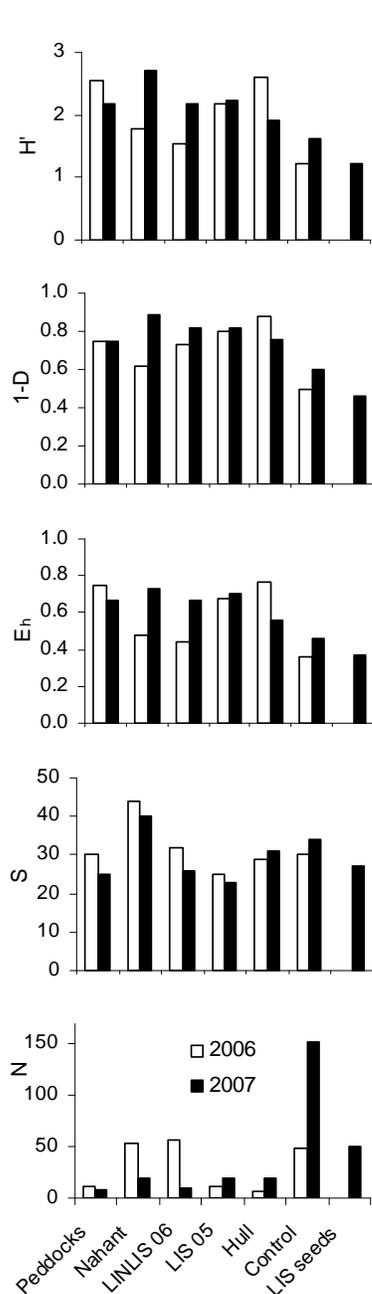
Figure IVA.22. Indices of species diversity, abundance, evenness, and richness for epibenthic and demersal fish and invertebrates, 2006 and 2007. Sites on x-axis are: Peddocks, Nahant, LIS & LIN 06, LIS 05, Hull, Control, and LIS seeds. LIS seeds was not monitored until 2007. H' is Shannon diversity index; $1-D$ is Simpson diversity index; E_H is Shannon Equitability; S is number of species found at site; N is mean number of individuals per m^2 .

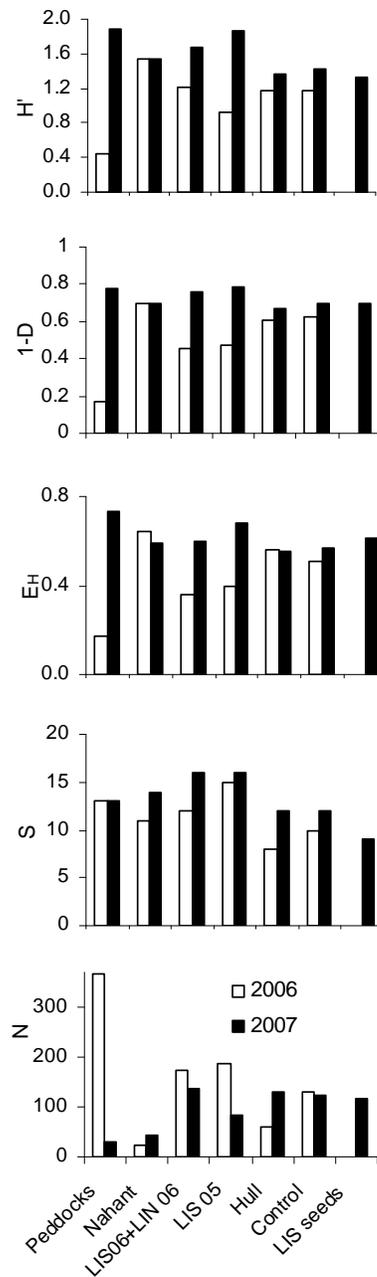
Figure IVA.23. Indices of species diversity, abundance, evenness, and richness for benthic infauna, 2006 and 2007. Sites on x-axis are: Peddocks, Nahant, LIS & LIN 06, LIS 05, Hull, Control, and LIS seeds. LIS seeds was not monitored until 2007. H' is Shannon diversity index; $1-D$ is Simpson diversity index; E_H is Shannon Equitability; S is number of species found at site; N is mean number of individuals per core.

comprised 63% of the top 3 dominants. Control and LIS seed sites exhibited the largest number of individuals (N) in 2007 (Figure IVA.23); they also had the highest dominance index, indicating that these N's were in large part due to the presence of just 2 species. This dominance is reflected in the lower evenness and diversity indices for these 2 sites. Highest number of species, evenness, and diversity were found at Nahant. These indices were slightly lower at our planted sites.

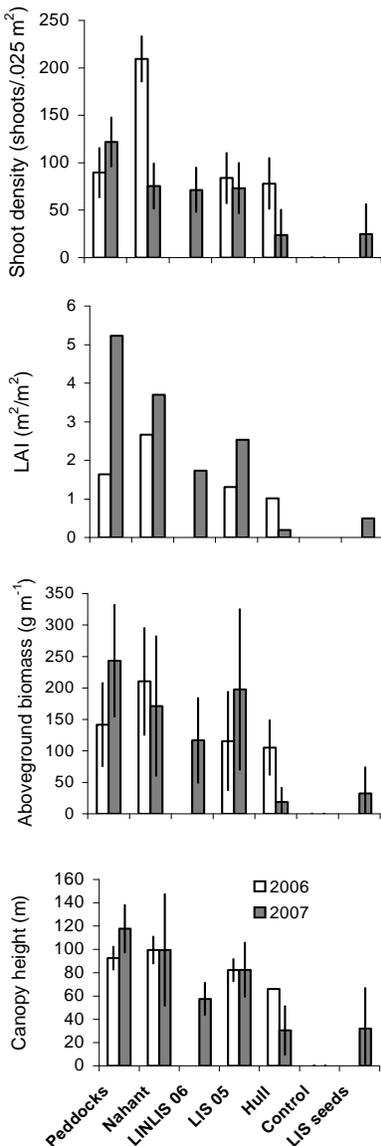
Figure IVA.24. Measures of 3-D habitat function in areas monitored in 2006 and 2007. Control site = unvegetated. Nahant = healthy reference bed outside Boston Harbor; Hull = reference bed inside Boston Harbor. LIS seeds was seeded in fall 2005. LIS 05 and Peddocks were planted in 2005. LIN/LIS 06 were planted in 2006; data from these areas were combined. Error bars are \pm SD. Because of the method used to calculate LAI, SD was not computed. Note: the drop in density at Nahant is likely due to the extraordinarily dense area randomly selected in 2006, rather than a decrease in density of the bed as a whole in 2007.

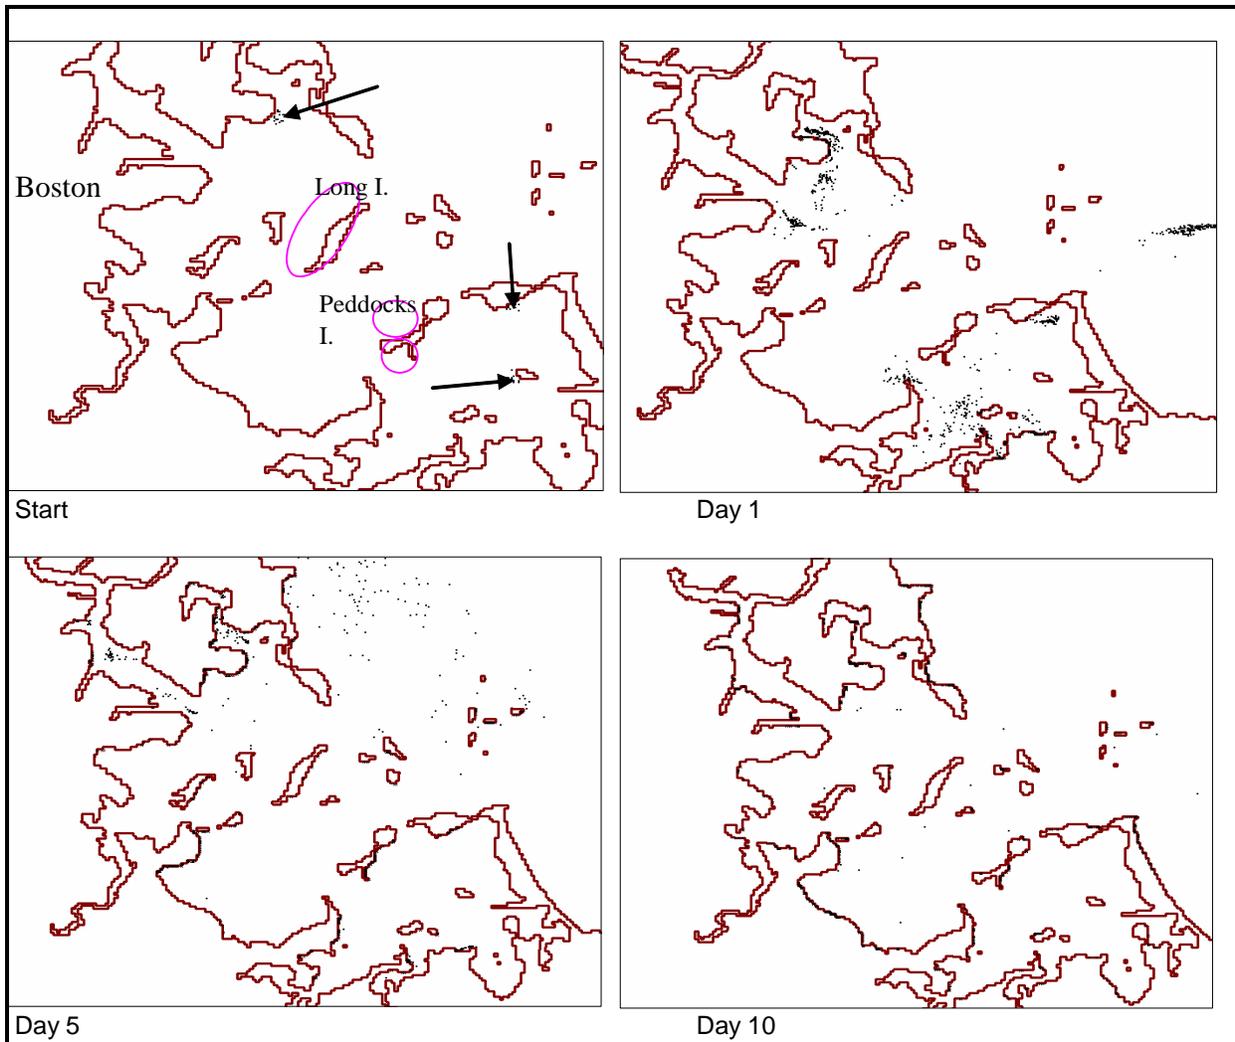
Figure IVA.25. Selected output from GNOME™ model run for 14 days. "Shoots" (black dots) were "spilled" at remnant eelgrass beds (indicated by arrows) in Boston Harbor to ascertain if they would spread over areas identified in the site selection process as suitable for eelgrass (purple ovals).

Peddocks Islands, the only locations where we found suitable sediment in the Harbor (Figure IVA.25). According to the model output, the likelihood that floating reproductive shoots will pass over good eelgrass habitat is low. Furthermore, the probability that those few shoots which approach good sites actually sink and/or drop seeds there, and that those seeds go on to germinate and survive, decreases with each step. Since natural re-colonization appears unlikely,

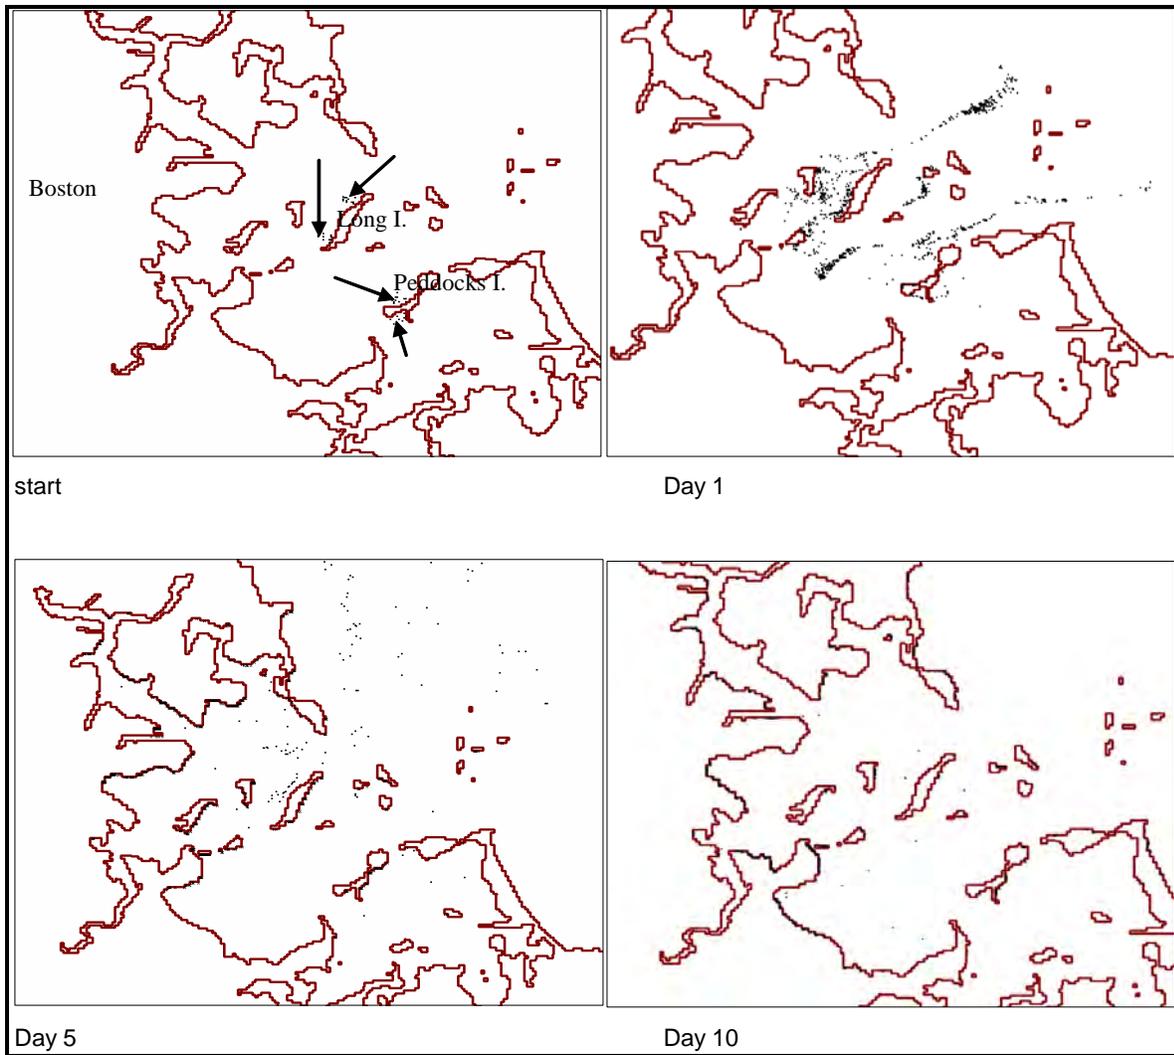
Figure IVA.26. Selected output from GNOME™ model run for 14 days. "Shoots" (black dots) were "spilled" at our transplant sites (indicated by arrows) at Long and Peddocks Islands in Boston Harbor to ascertain if they would spread throughout those areas.

In contrast, when the simulation was re-run using our successful transplant sites as starting points, shoots were delivered throughout the Harbor, including a large number along the western coast of Long Island, in the Peddocks SE cove, and some in Portuguese Cove (Figure IVA.26).
