Division of Marine Fisheries HubLine Eelgrass Restoration

2013 Progress Report

Massachusetts Division of Marine Fisheries

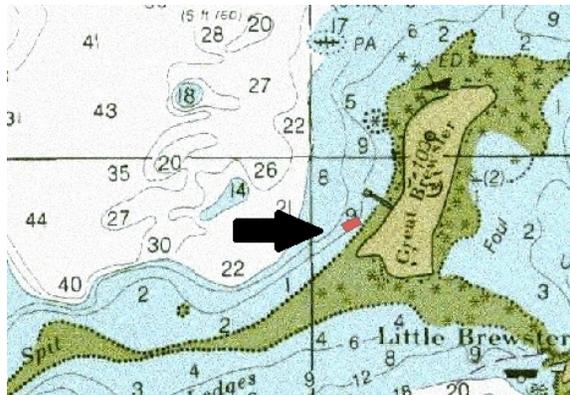
Figure 1. Great Brewster Island restoration

We field screened a sandy area on the west side of Great Brewster Island in 2012 (Figure 1). The site depth ranges from 5 ft to 9 ft MLW. The area is a mix of coarse and fine sand with small sand waves, approximately 1 cm – 2 cm high, indicating that the site experiences some wave and current energy. The site is protected to the south, east, and north with exposure to the west.

Overall site conditions met our planting criteria so a test plot was planted there in spring 2013. The test plot was successful and we continued to plant the entire 1/3 acre plot in September 2013 using the Pickerell Burlap Disk method.

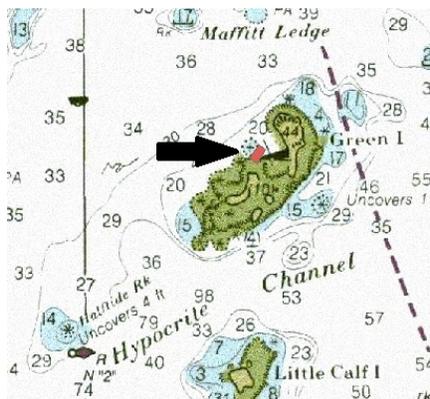
Figure 2. Green Island restoration

A protected cove on Green Island was investigated for planting suitability (Figure 2). The site is fairly shallow, ranging in depth from about 3 ft to 8 ft MLW. The bottom is mostly gravel and cobble with some large boulders. The bottom type is suitable for a modified Pickerell Burlap Disk method/ Rock Method, where the disks are buried and secured with rocks. Due to its location among the Boston Harbor Outer Islands, the site receives good flushing but is also well protected on the north, south and east sides. A test plot was planted in May 2013 and full restoration planting was completed by October 2013. The site was planted with five plots spaced throughout the 1/3 acre instead of the usual six plots at other sites due to the presence of boulders. A sixth plot will be planted at a different location at the site in 2014, if the existing plantings are progressing well.

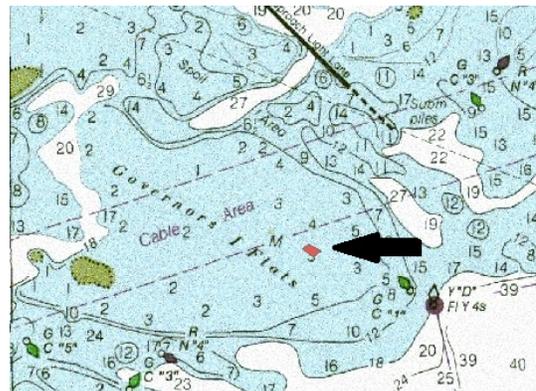
Figure 3. Governor’s Island Flats Restoration site.

An area on Governors Island Flats adjacent to one of Battelle’s original test plots was selected for full scale planting (Figure 3). Reconnaissance of the site was performed and a test plot was planted in June 2013. The substrate is silty and at times there is high current causing poor visibility. The depth throughout the site is 5– 6 ft MLW. After the reconnaissance, and based on the success of Battelle’s test plot and the *Marine Fisheries*’ test plot, we planted the site in a full

scale restoration. Volunteers from the New England Aquarium Live Blue Ambassadors program assisted us in weaving eelgrass shoots onto burlap disks in August 2013. Plants were harvested and woven on the same day and stored overnight in lobster cars underwater. Planting of the entire site occurred over the following two days. Due to the amount of disks woven by the volunteers, a smaller seventh plot was added to the site.

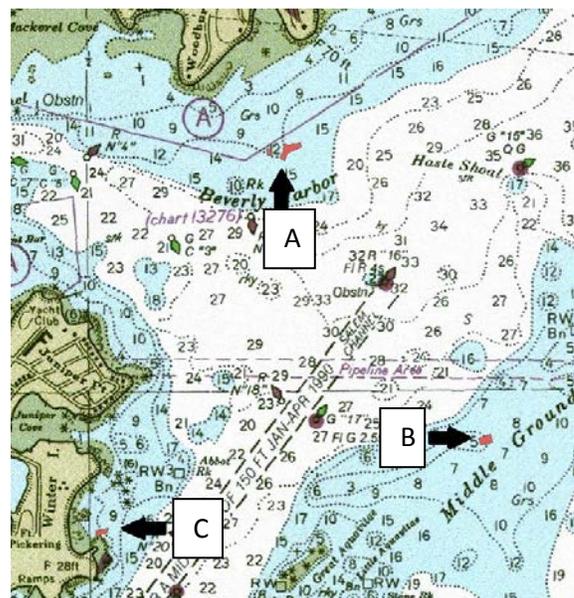
Annual monitoring in Salem Sound took place in July 2013. The monitoring included the restoration sites at Woodbury Point, Middle Ground, and Fort Pickering (Figure 4), as well as at reference beds at the SeagrassNet site in Manchester and a reference bed off Peach’s Point in Marblehead.

Figure 4. Salem Sound restoration sites. A) Woodbury Point; B) Middle Ground; and C) Fort Pickering. Planting areas shown in red

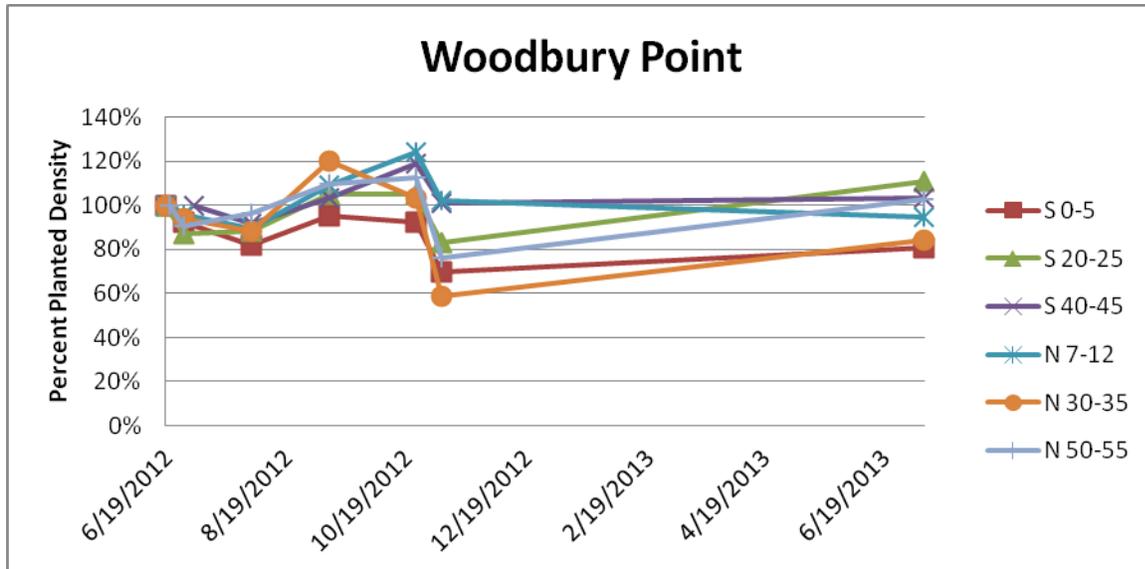
The final monitoring at Woodbury Point in 2012 showed a sharp decline in shoot density in October, coincident with Hurricane Sandy. By 2013, eelgrass shoot density at 5 of the 6 plots had increased. The annual monitoring in 2013 revealed a 14% increase overall in shoot density at Woodbury Point compared to the previous year. In 2013 individual plots at the site ranged from 81% of the original shoot density to 111% with three of the six plots above 100%. The plot that did not rebound in 2013 was on the deeper north transect (Figure 5).

Figure 2. Monitoring data for the Woodbury Point restoration site. S and N refer to the transect planted and the corresponding number refers to the meter mark planted along the transect.

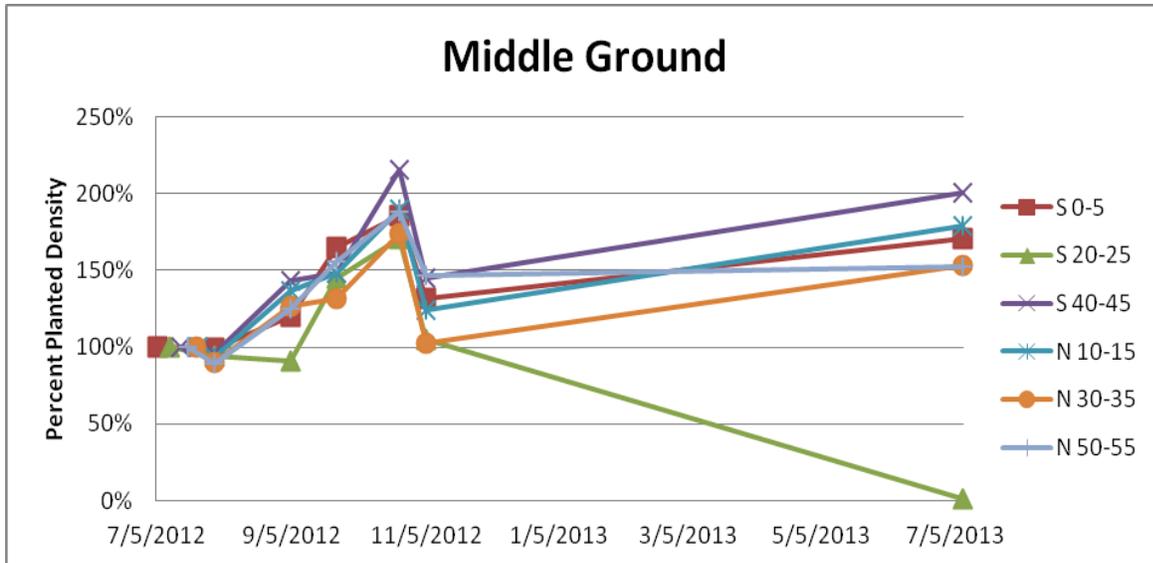
As with Woodbury Point, the final monitoring of Middle Ground in 2012 showed a large decline in shoot density likely due to storm damage from Hurricane Sandy. The 2013 annual monitoring showed an increase in density for five plots with one plot showing a decline to 2% survival. The five healthy plots range from 153% of the original shoot density to 171% with the overall site showing a 143% of the original planted shoot density despite the failed plot (Figure 6). The failure of the sixth plot could potentially be due to lobster gear that is often seen throughout the area. Overall Middle Ground has been a successful site so far.

Figure 3. Monitoring data for the Middle Ground restoration site. S and N refer to the transect planted and the corresponding number refers to the meter mark planted along the transect.

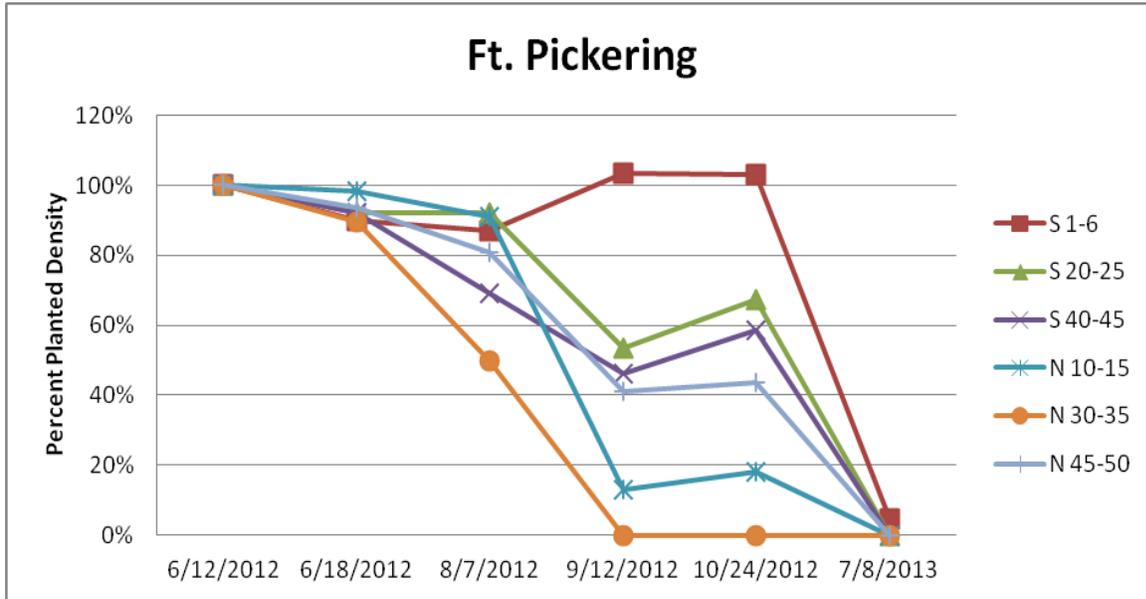
Fort Pickering is the final restoration site planted in Salem Sound in 2012. Unfortunately, by summer 2013, all but one of the plots was completely gone and the remaining plot only showed a 5% survival (Figure 7). Self-established eelgrass adjacent to the restoration site also appeared to be in decline. Large algae mats were present on the north transect and a lobster trawl was stretched across both transects at the deep end of the site. There was no grass remaining in the test plot areas.

Figure 4. Monitoring data for the Fort Pickering restoration site. S and N refer to the transect planted and the corresponding number refers to the meter mark planted along the transect.

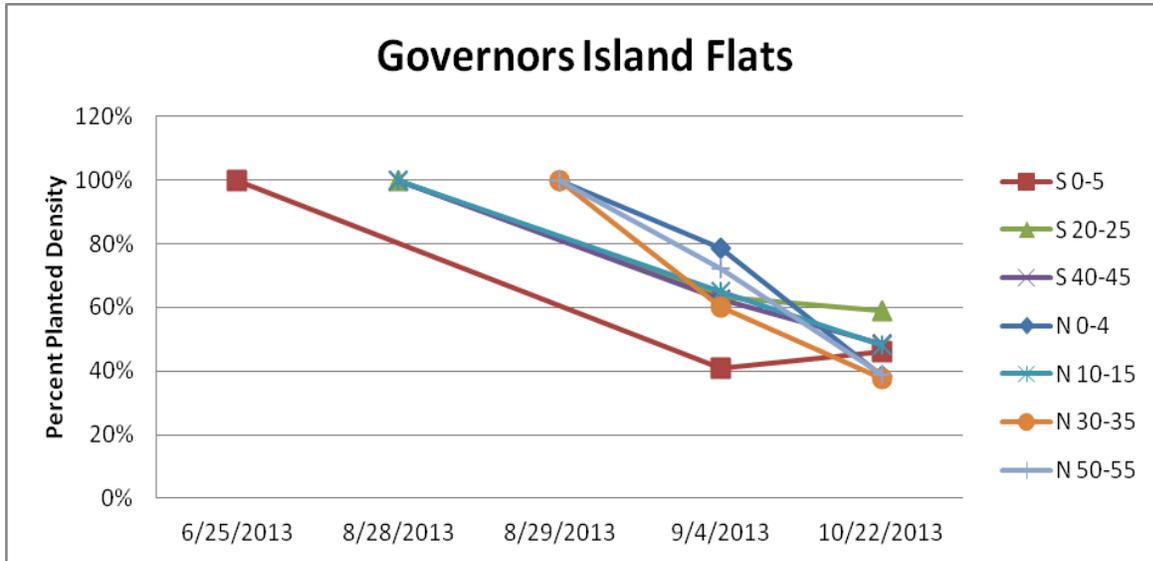
The Governors Island Flats site shows a range of 38% to 59% survival (Figure 8). Annual monitoring will begin in the summer of 2014.

Figure 5. Monitoring data for the Governors Island Flats restoration site. S and N refer to the transect planted and the corresponding number refers to the meter mark planted along the transect.

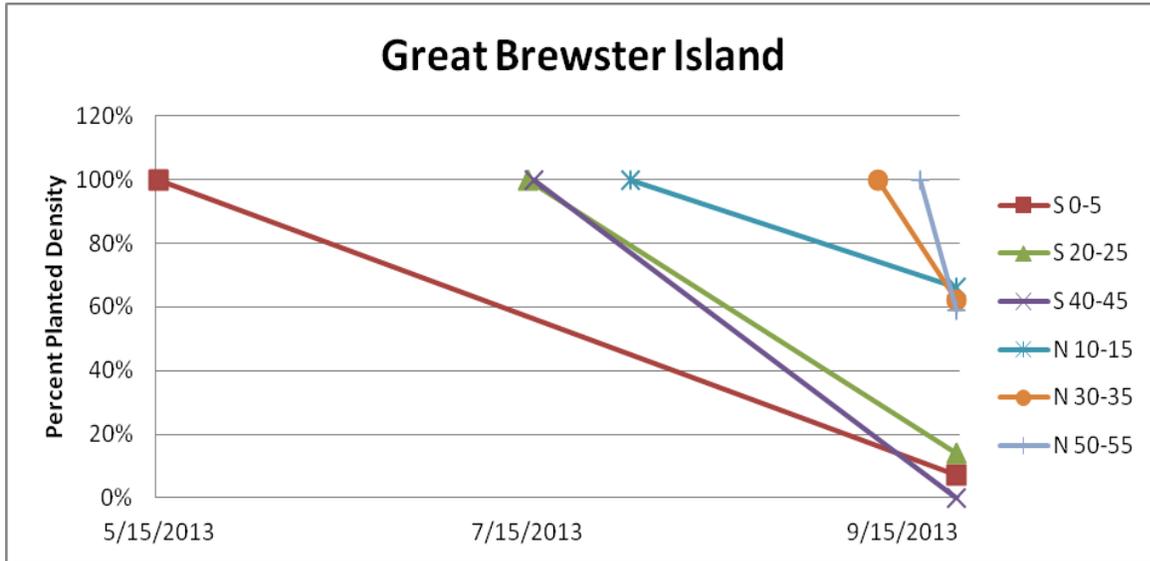
Great Brewster Island was only monitored once after planting was completed. While the north transect shows the expected decline after transplanting, the three south plots show drastic decline and one plot was completely devoid of plants (Figure 9). This site will be monitored in 2014 and assessed further at that time.

Figure 6. Monitoring data for the Great Brewster Island restoration site. S and N refer to the transect planted and the corresponding number refers to the meter mark planted along the transect.

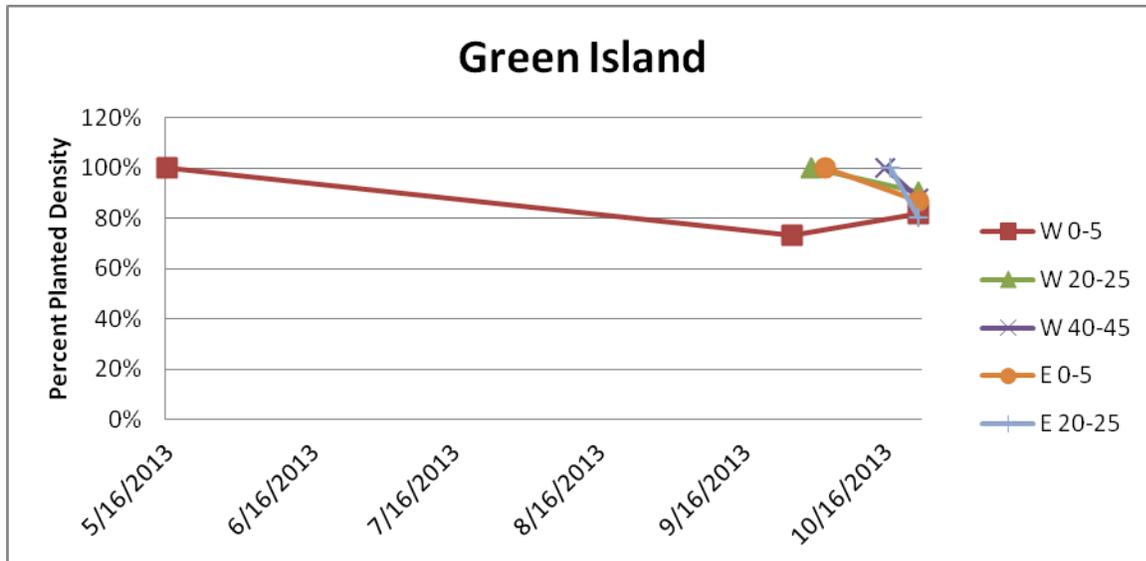
The Green Island site was monitored approximately one month after planting of the site was complete. All of the plots showed a slight decline between 10%-20% that can be attributed to normal decline after transplanting (Figure 10).

Figure 7. Monitoring data for the Green Island restoration site. W and E refer to the transect planted and the corresponding number refers to the meter mark planted along the transect.
