Creating the Basis for Successful Restoration: An Eelgrass Habitat

Suitability Model in GIS for Plum Island Sound, Massachusetts

University of New Hampshire
Jackson Estuarine Laboratory

December 31, 2012

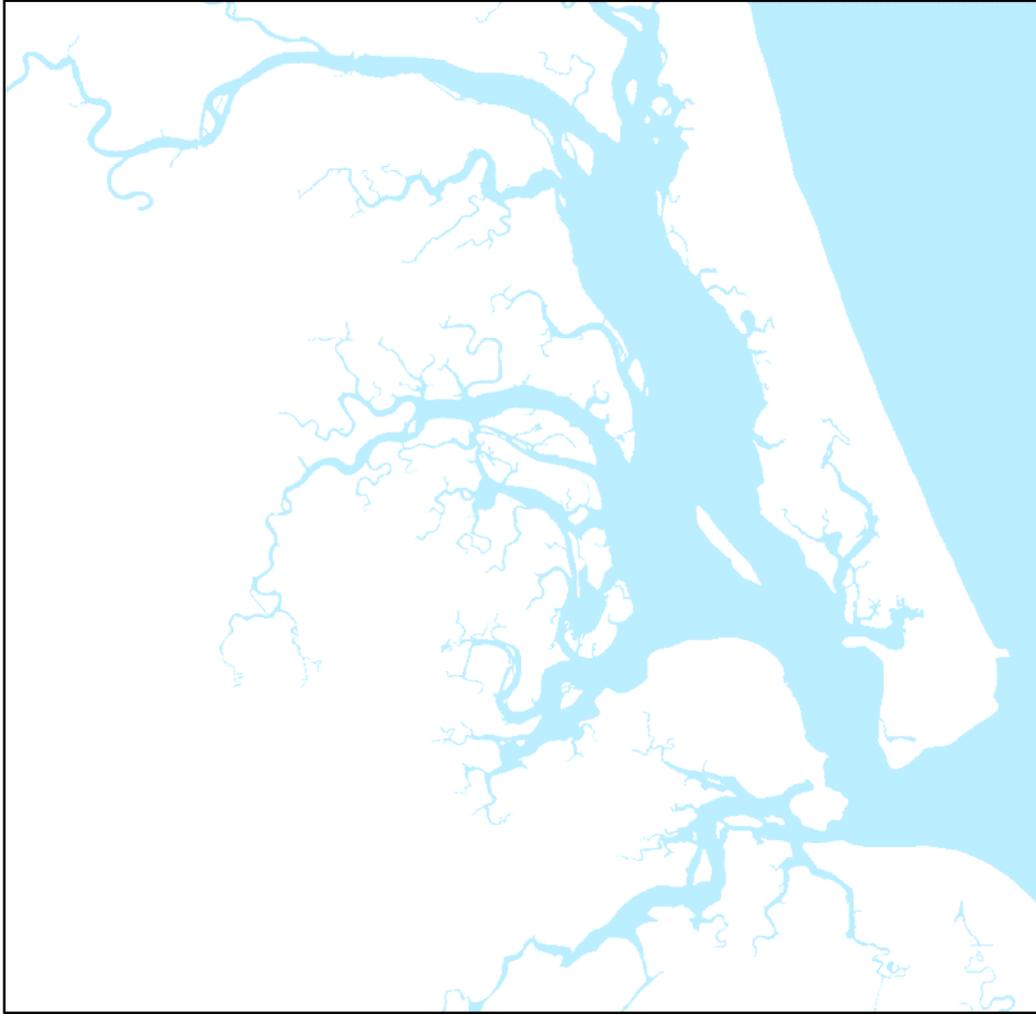
Figure 2. Map defining the area of interest (in blue) for the Plum Island Sound Eelgrass Habitat Suitability Model.

Base Map: A base map grid of the aquatic area in Plum Island Sound was created using the Mass GIS statewide shoreline map. To establish the area of interest, the map water areas received a value of 1 while areas of land were classified as No Data (Figure 2).

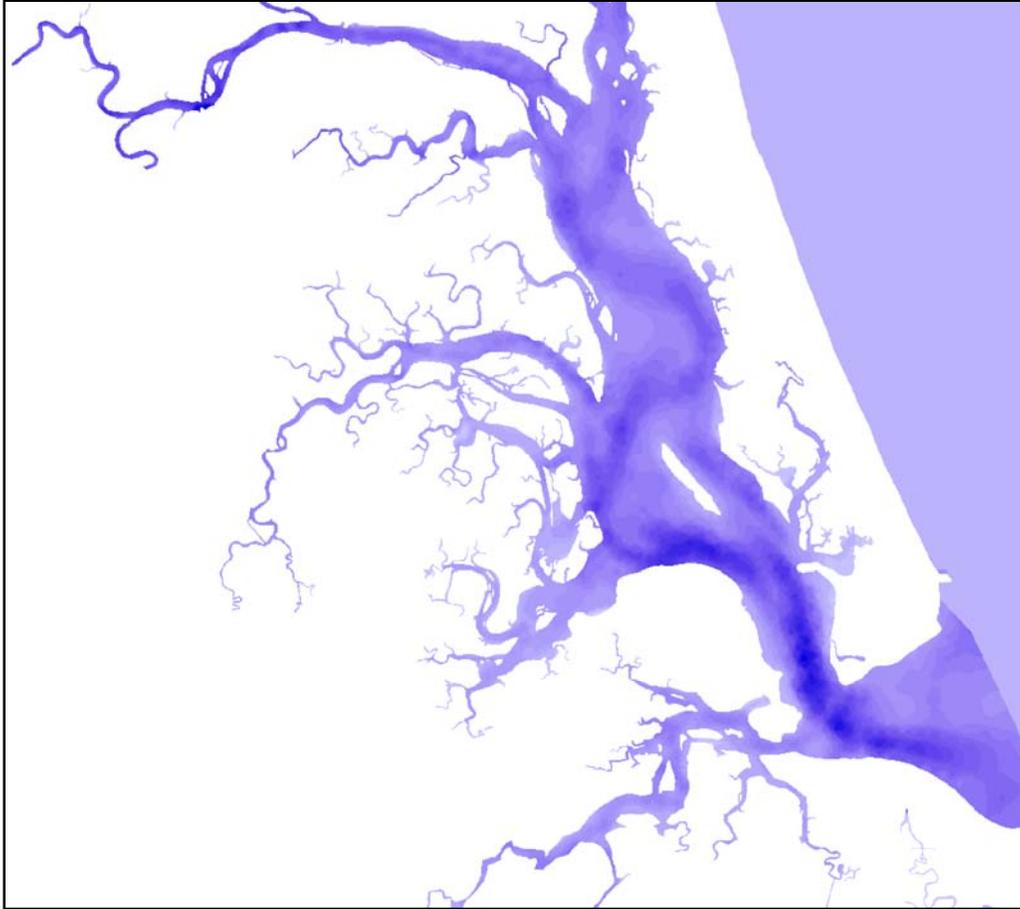
Figure 3. Bathymetry map for Plum Island Sound and the connecting water bodies. Darker areas are deeper.

Bathymetry: Information on depth in Plum Island Sound and the connecting water bodies was provided by Joseph Vallino from the Marine Biological Laboratory in Woods Hole. The bathymetry data was obtained from LIDAR, NOAA NGDC surveys, and by pairing a kinematic GPS survey to a depth sounder (ref to NADV88). The original data was a point data set in MA State Plane with depth in meters and ± 10 cm accuracy. For the model, we created a bathymetric surface map from the point data by using the inverse distance weighting function (IDW) in ArcMap 10.0 (Figure 3). The data was then reclassified and ranked using information on eelgrass depth ranges (Dennison, 1998; Short et al., 2002) and the tidal amplitude in the Sound (2.9 m average; 2.6 to 3.6 m neap-spring cycle; Figure 4) as follows:

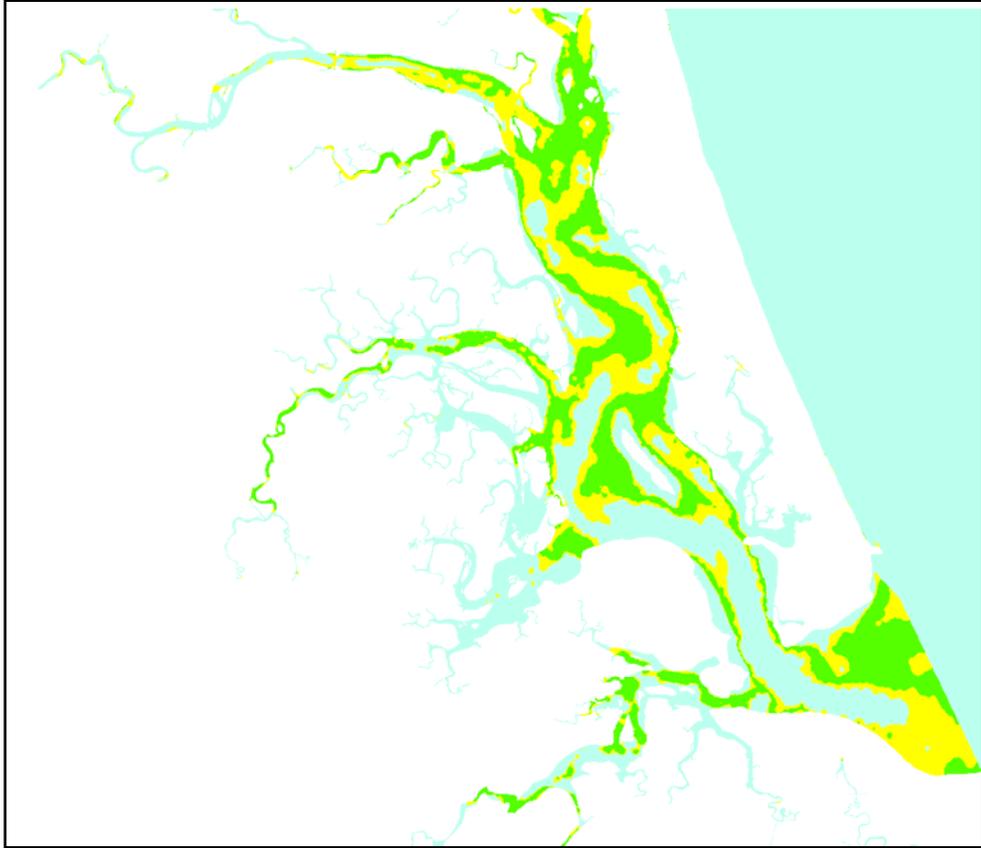
Figure 4. Reclassified bathymetry map for Plum Island Sound and the connecting water bodies. The map shows areas with fair (yellow) and good (green) depths for transplanting eelgrass, as well as areas outside the range suitable for transplanting (blue).

- 1) 0 to 1.8 m (No Data; Exposed at MLW and/or neap-spring cycle)
- 2) 1.8 to 2 (1; Depths similar to the shallow edge of eelgrass; Fair conditions)
- 3) 2 to 3 (2; Good conditions for eelgrass establishment and growth)
- 4) 3 to 4 m (1; Depths similar to the deep edge of eelgrass; Fair conditions)
- 5) >4 m (No Data; Exceeds average depth limit of deep edge of eelgrass)

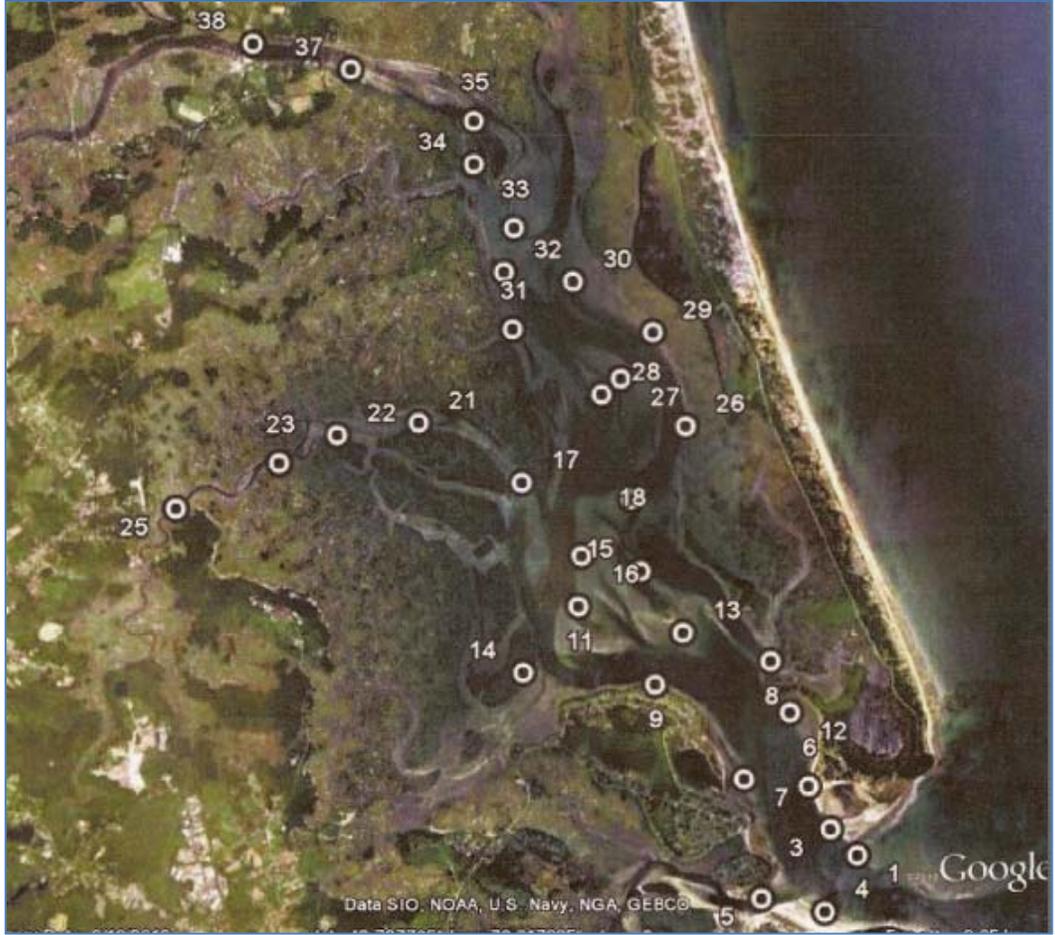
Figure 5. Location of sediment sampling sites. Map provided by Sergio Fagherazzi at Boston University.

Sediment: Information on sediment type and grain size for Plum Island Sound and the connecting water bodies was provided by Sergio Fagherazzi. The data is based on 38 sampling points from 2011 that were collected within the Sound and the Parker and Rowley Rivers (Figure 5). The sediment type and grain size data suggest that the entire Sound has substrate that is suitable for eelgrass growth since it is <70% silt/clay and is sandy (Short, 1987; Short et al., 2002). The entire Sound and the connecting water bodies received a rating of 2 (good) for sediment suitability (Figure 6).

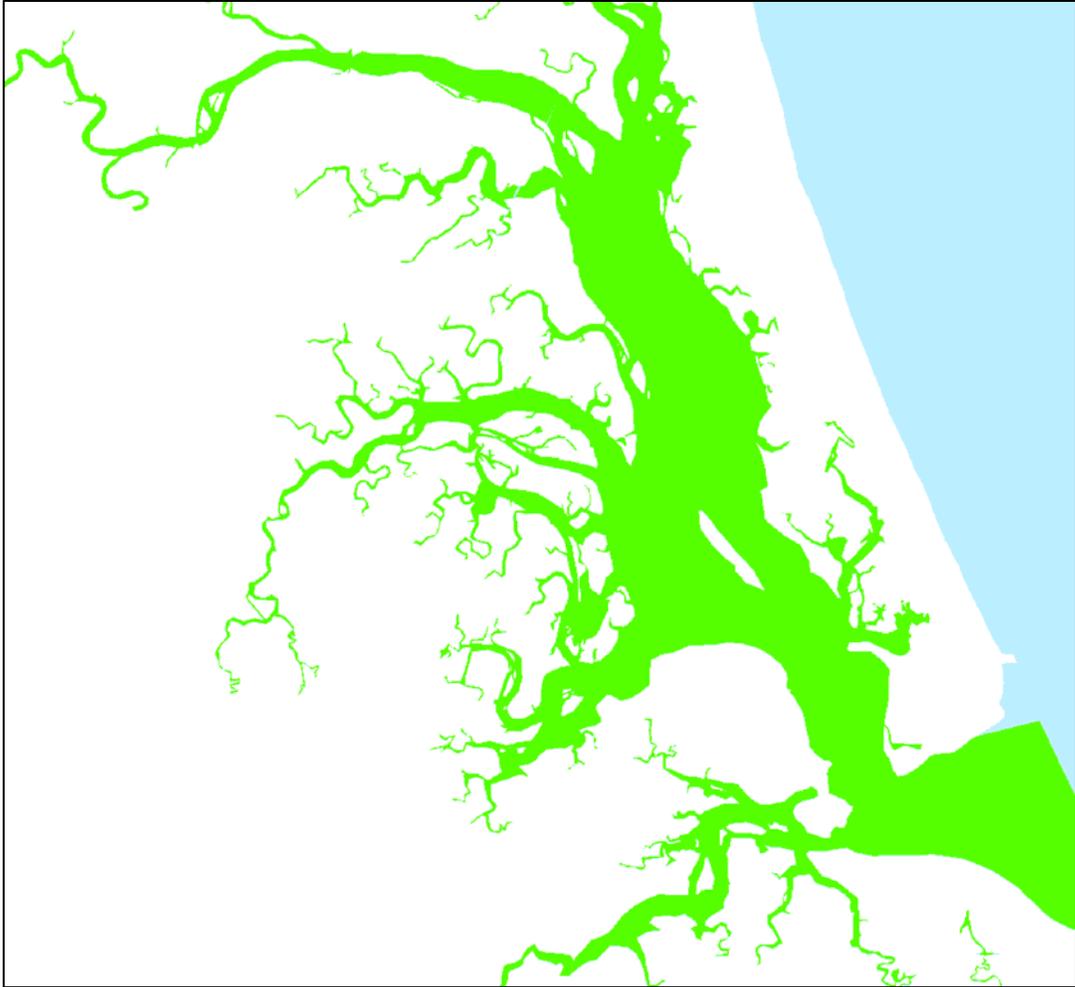
Figure 6. Sediment map for Plum Island Sound and the connecting water bodies. The map shows that the entire Sound has substrate that is suitable for transplanting eelgrass (green). Please note that sediment samples were only collected for the Sound and the Parker and Rowley Rivers and suitability for other rivers and tidal creeks may not be accurate.

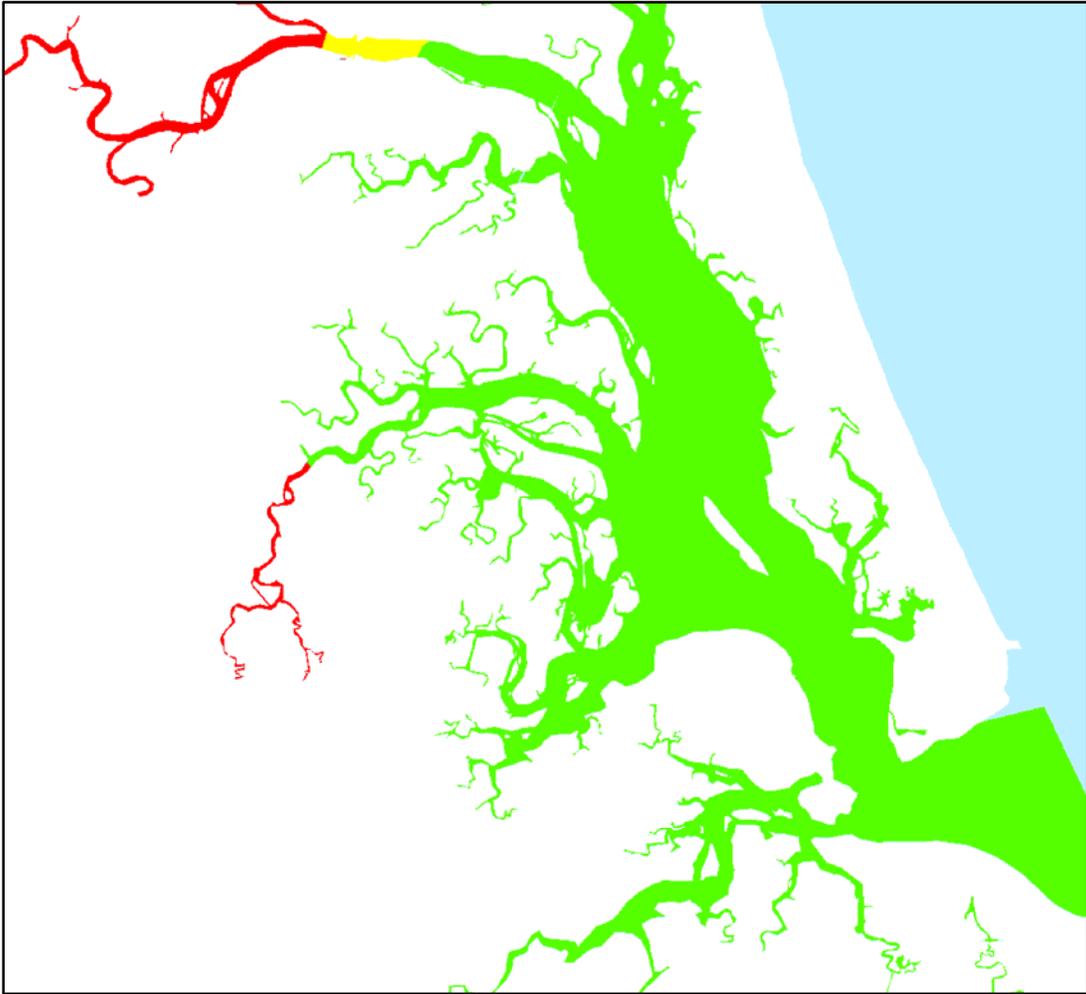
Figure 7. Water quality information for Plum Island Sound and the connecting water bodies. The map is based on TDN, SS, Chl *a* and salinity data and shows areas with poor (red), fair (yellow) and good (green) water quality.

Water quality: Information on total dissolved nitrogen (TDN), suspended solids (SS), Chl *a*, and salinity was obtained from Plum Island Estuary (PIE) Long-term Ecological Research Network (LTER) (ecosystems.mbl.edu/PIE/data/EST/EST-PR-NUT.html). The datasets are based on 15 years of information taken from 25 sampling points located in Plum Island Sound, as well as the Parker, Rowley and Ipswich Rivers. Each dataset was averaged at each sampling point for the 15-year time period and National Estuarine Eutrophication Assessment standards were used to define areas with poor, fair, and good conditions relating to concentrations of TDN, SS, and Chl *a*. Salinity information was also used to define relative boundaries of freshwater inputs and areas with salinities unfavorable for eelgrass (<10 psu). The information from each dataset was then combined in a multiplicative rating to create one water quality data set showing areas with poor (0), fair (1), and good (2) water quality (Figure 7).

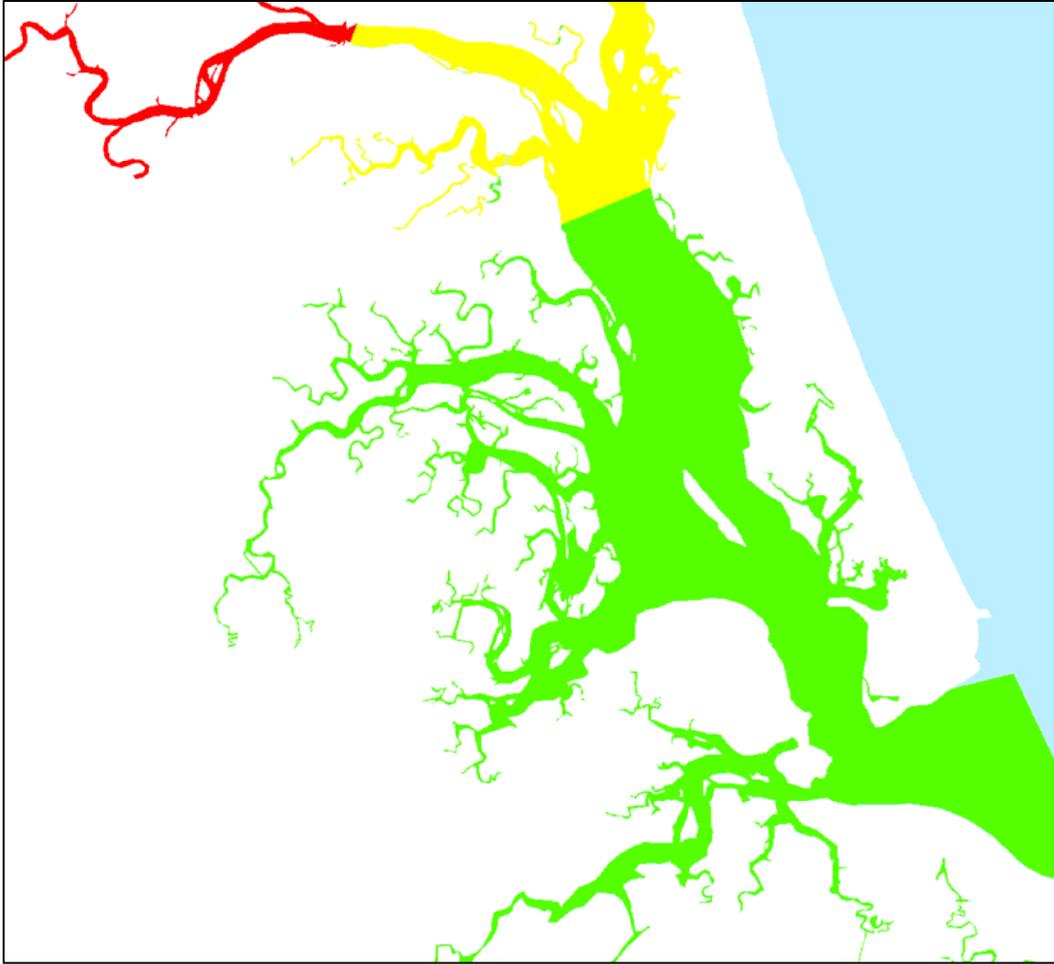
Figure 8. Water clarity information derived from light data for Plum Island Sound and the connecting water bodies. The map shows relative boundaries of areas with poor (red), fair (yellow) and good (green) water clarity.

Water Clarity: Light information was obtained from PIE- LTER (ecosystems.mbl.edu/PIE/data/EST/EST-PR-NUT.html) to assess water clarity. The dataset is based on 15 years of information taken from 25 sampling points located in Plum Island Sound, as well as the Parker, Rowley and Ipswich Rivers. Light extinction coefficients at each sampling point were averaged over the 15 year time period and used to identify and rank areas with light limited (> 2.0 ; rating = 0), fair ($1.0-2.0$; rating= 1) and good (<1.0 ; rating= 2) conditions for eelgrass growth, with value ranges derived from eelgrass light requirement information presented in Dennison (1987), Short et al. (1995) and Ochieng et al. (2010; Figure 8).

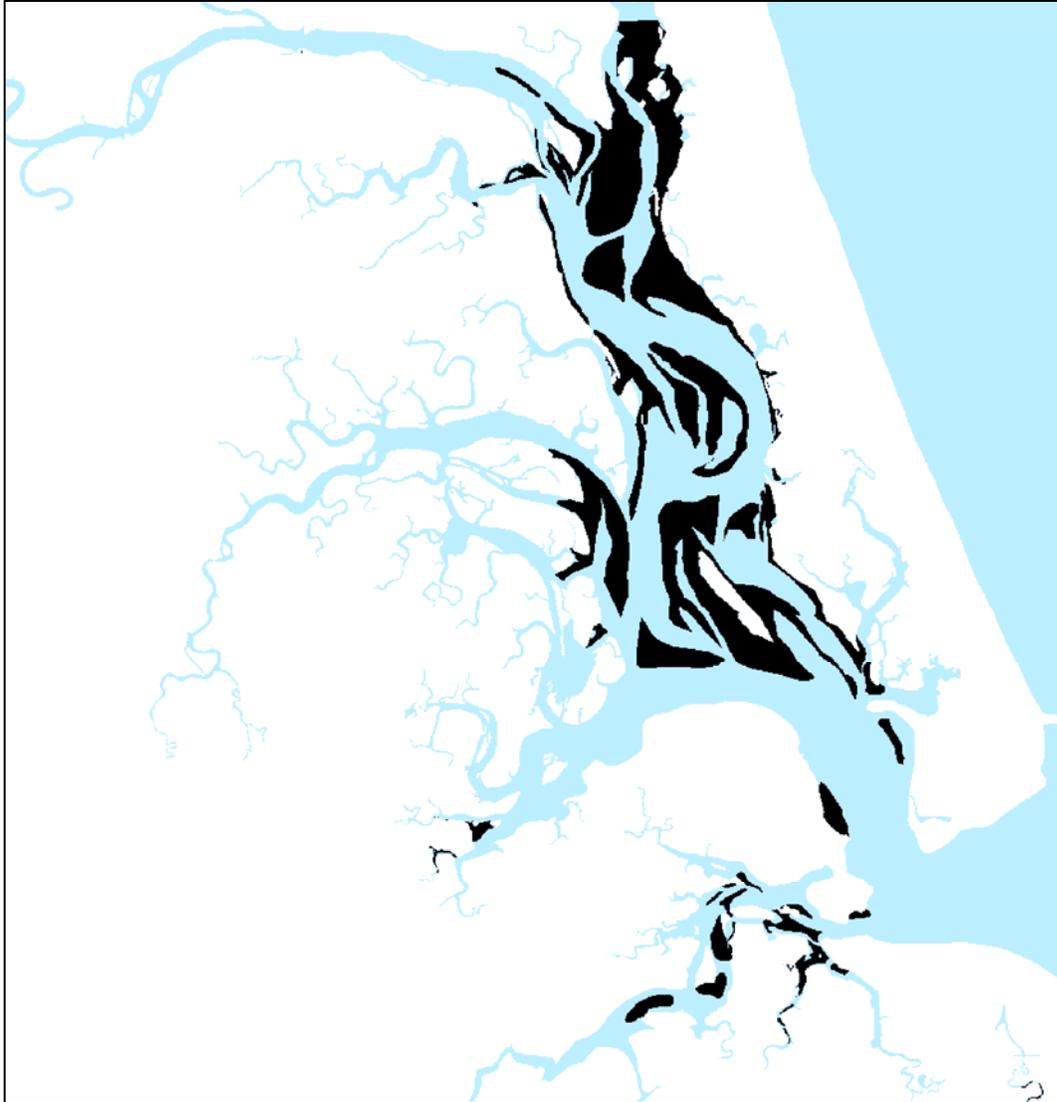
Figure 9. Location of intertidal flats in Plum Island Sound and the connecting water bodies (black). Intertidal flats are unsuitable locations for transplanting eelgrass and were eliminated from consideration.

Intertidal Flats: Information on the location of intertidal flats was obtained from MassGIS (2009), Google Earth, and field observations. The intertidal flats dataset was needed because the bathymetry dataset did not identify all areas that could be potentially exposed during low tides and the neap-spring cycle. Intertidal flats are not suitable habitat for transplanting eelgrass and were eliminated from consideration (Figure 9).

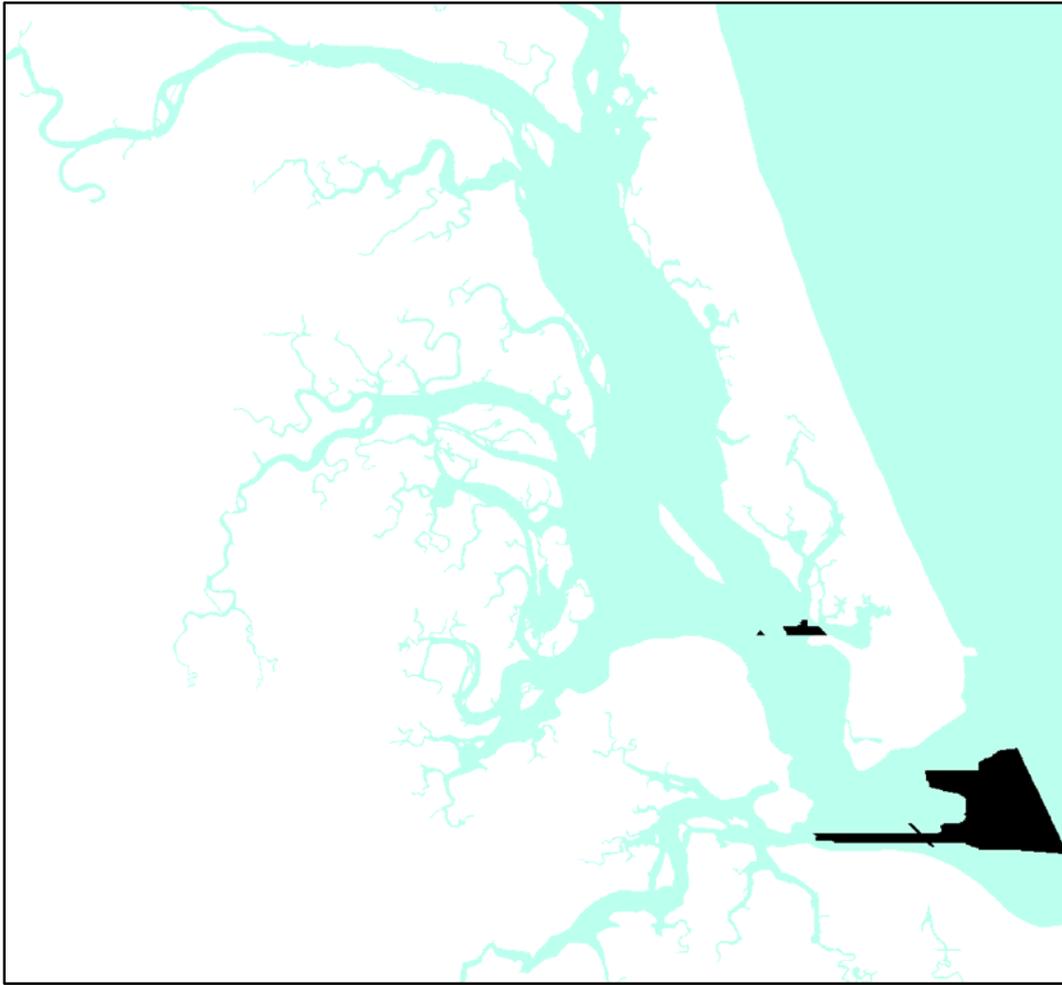
Figure 10. Areas with high wave exposure ($\pm 2SD$) are unsuitable for eelgrass establishment and growth and were eliminated from consideration (black).

Exposure: Wave exposure was determined from wind direction and velocity information (obtained from NOAA Climatic Data Archives) using the method of Murphey and Fonseca (1995). Areas greater than ± 2 SD from the mean were considered unsuitable for eelgrass growth and were eliminated from consideration since wave energy can break eelgrass leaves and uproot plants (Kopp, 1999; Figure 10).

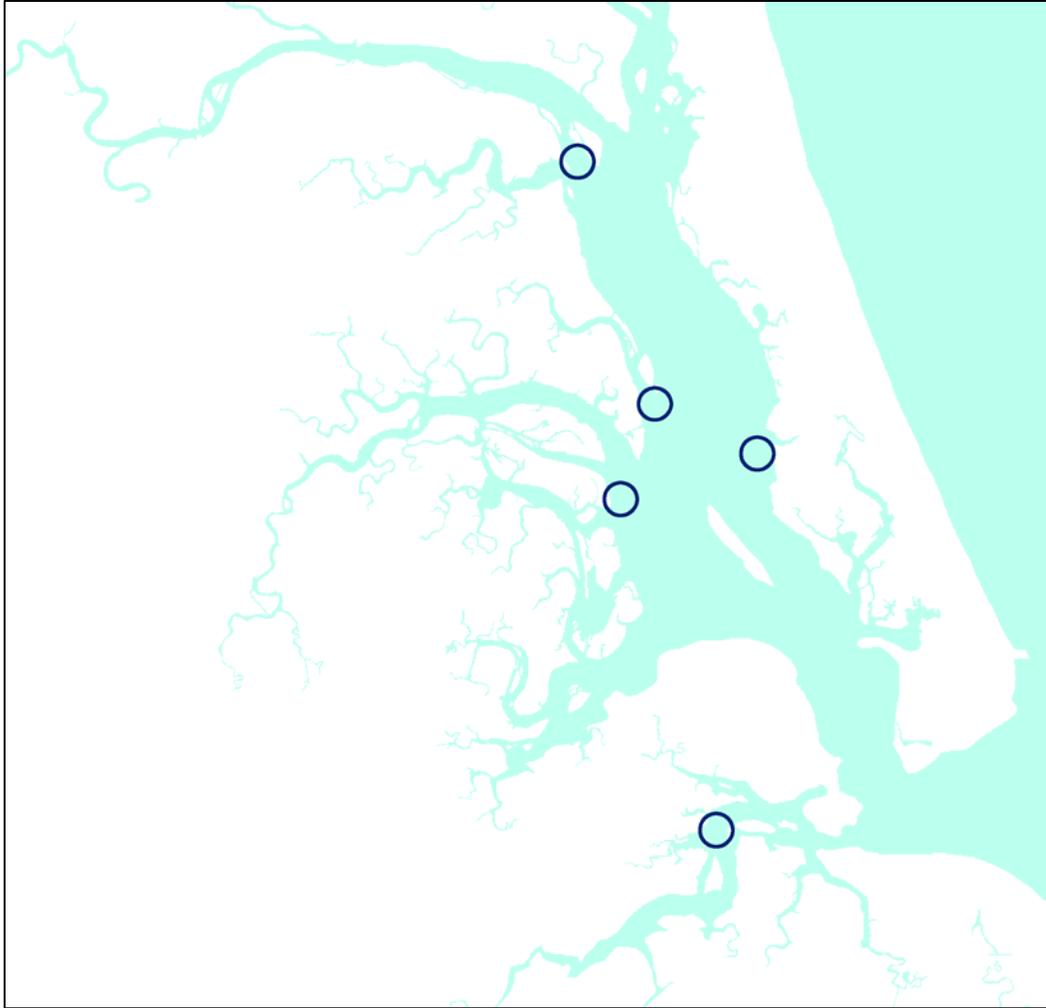
Figure 11. Approximate locations of historical eelgrass beds in Plum Island Sound and the connecting water bodies (blue circles) based on Addy and Aylward (1944) and personal communication with a local fisherman (Geoff Walker).

Historical eelgrass: Information on the approximate location of historical eelgrass sites in Plum Island Sound and the surrounding water bodies was acquired from Addy and Aylward (1944), as well as from local fisherman (pers. comm. Geoff Walker; Figure 11). We also contacted N. Tay Evans at the Department of Marine Fisheries (DMF) and visited special collections at the State Library in Boston to review historical maps from 1600 to 1940. DMF was unable to provide us with any additional information and suggested that notes on eelgrass in Plum Island Sound may have been lost in a fire some years ago. Maps at the State Library provided no additional information.

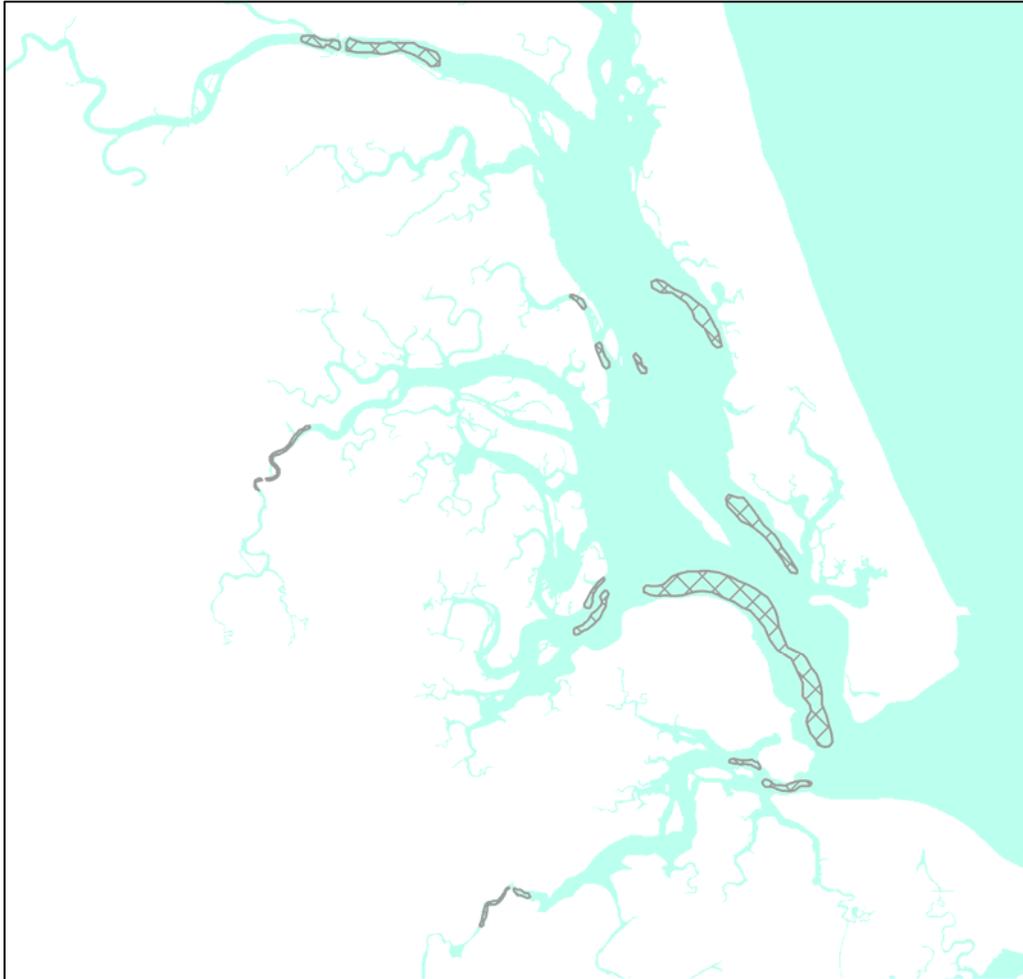
Figure 12. Locations of mooring fields in Plum Island Sound and the connecting water bodies (gray). Transplanting eelgrass in areas with moorings is not recommended since mooring chains can uproot plants.

Mooring fields: Information on the location of moorings was obtained from MassGIS (2009) and from field observations. Mooring fields are considered unsuitable habitat for transplanting eelgrass since boat mooring chains can uproot transplants (Figure 12).

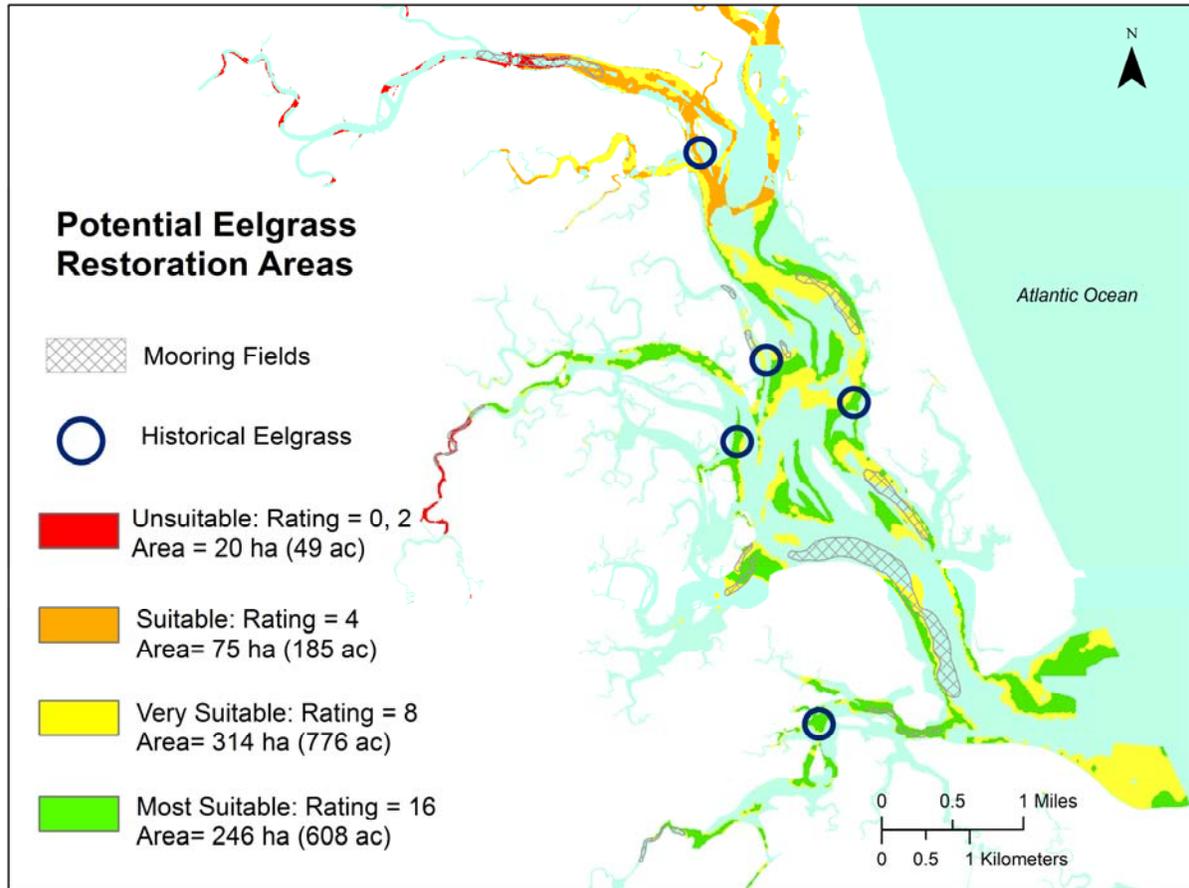
Figure 13. Eelgrass Habitat Suitability Map for Plum Island Sound and the connecting water bodies. Areas in green are the most suitable sites for the establishment and growth of eelgrass and should be the focus of test transplanting efforts and ultimately of eelgrass restoration.

The overall eelgrass habitat suitability score for Plum Island Sound (we also included the connecting water bodies) was calculated in ArcMap 10.0 by multiplying the ratings of each parameter listed above in Map Calculator (in Arc). Higher scores indicate greater eelgrass habitat suitability, as well as a better likelihood of eelgrass transplant success. The maximum possible rating is 16. Areas in the output layer with the highest values are considered the "Most Suitable" for undertaking eelgrass restoration. Areas with high-to-moderate values are considered "Very Suitable" and areas with moderate-to-low values are considered "Suitable." Areas with the lowest values are rated "Unsuitable" for eelgrass restoration.

In this study, we developed a model using the formulation of Short et al., (2002) to identify and prioritize sites in Plum Island Sound that could support eelgrass habitat. The model identified a number of sites with good eelgrass habitat suitability, having scores of 8 (total area of 314 ha (776 ac)) and 16 (total area 246 ha (608 ac)). The model also identified sites with fair suitability having a score of 4 (total area of 75 ha (185 ac)), and sites with poor suitability having scores of 2 and 0 (total area of 20 ha (49 ac); Figure 13). Most areas with good eelgrass habitat suitability were found toward the center of the Sound, near the Rowley and Ipswich Rivers. Areas with fair and unsuitable eelgrass habitat potential were primarily confined to northern section of the Sound near the mouths of the Parker and Plum Island Rivers (Figure 13). For eelgrass restoration purposes, sites with scores of 8 and 16 have the best potential for successful restoration. Sites with a score of 4 could be considered for restoration, and sites with a rating of 2 or 0 should not be selected. Hence, there is a total area of 655 ha (1618 ac) in the Sound and the connecting water bodies that are suitable for restoration.
