# **INDOOR AIR QUALITY ASSESSMENT**

**Malcolm L. Bell Lower School  
40-42 Baldwin Road  
Marblehead, MA 01945**

Prepared by:  
Massachusetts Department of Public Health  
Bureau of Environmental Health  
Emergency Response/Indoor Air Quality Program  
July 2007

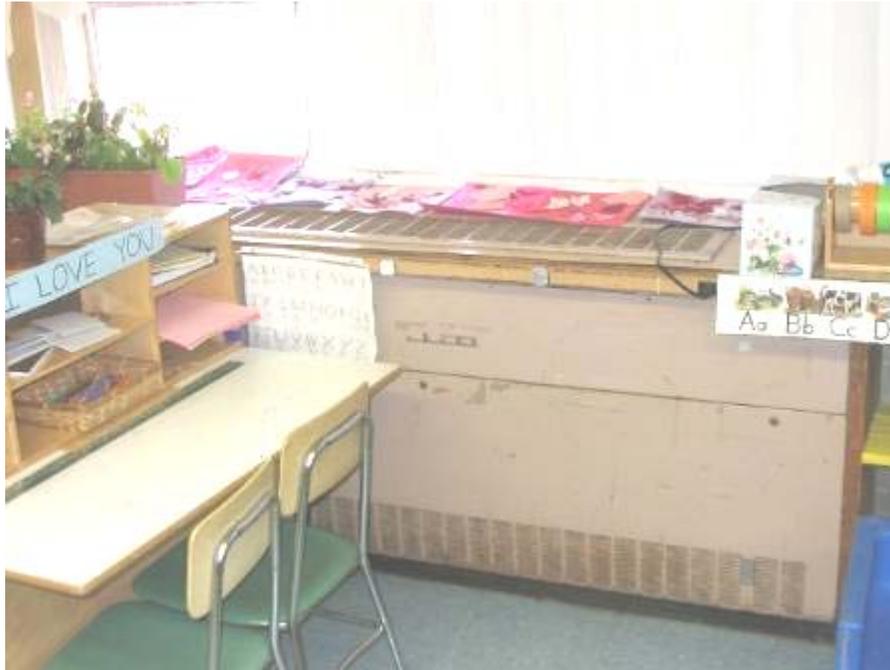
**Picture 1**

It can be seen from Table 1 that carbon dioxide levels were elevated above 800 parts per million (ppm) in three of nine areas, indicating adequate ventilation in two-thirds of the areas surveyed the day of the assessment. Fresh air in classrooms is supplied by unit ventilator (univent) systems (Picture 1). A univent draws air from the outdoors through a fresh air intake located on the exterior wall of the building and returns air through an air intake located at the base of the unit ([Figure 1](#), Picture 2). Fresh and return air are mixed, filtered, heated and provided to classrooms through an air diffuser located in the top of the unit. One univent was found deactivated, reportedly by the room occupant. Obstructions to airflow, such as papers and books stored on univents and bookcases and carts and desks located in front of univent returns, were also observed in a few classrooms (Picture 3). In order for univents to provide fresh air as designed, these units must remain activated and allowed to operate while rooms are occupied. In addition, univent intakes and diffusers must remain free of obstructions.

Several classrooms had a number of plants. Moistened plant soil and drip pans can be a source of mold growth. Plants should be equipped with drip pans; the lack of drip pans can lead to water pooling and mold growth on windowsills. Plants are also a source of pollen. Plants should be located away from the air stream of ventilation sources to prevent the aerosolization of mold, pollen or particulate matter throughout the classroom (Picture 1).

**Classroom univent, note plant near air diffuser**

9. Ensure plants have drip pans. Examine drip pans periodically for mold growth and disinfect with an appropriate antimicrobial where necessary. Remove plants from the air stream of mechanical ventilation.

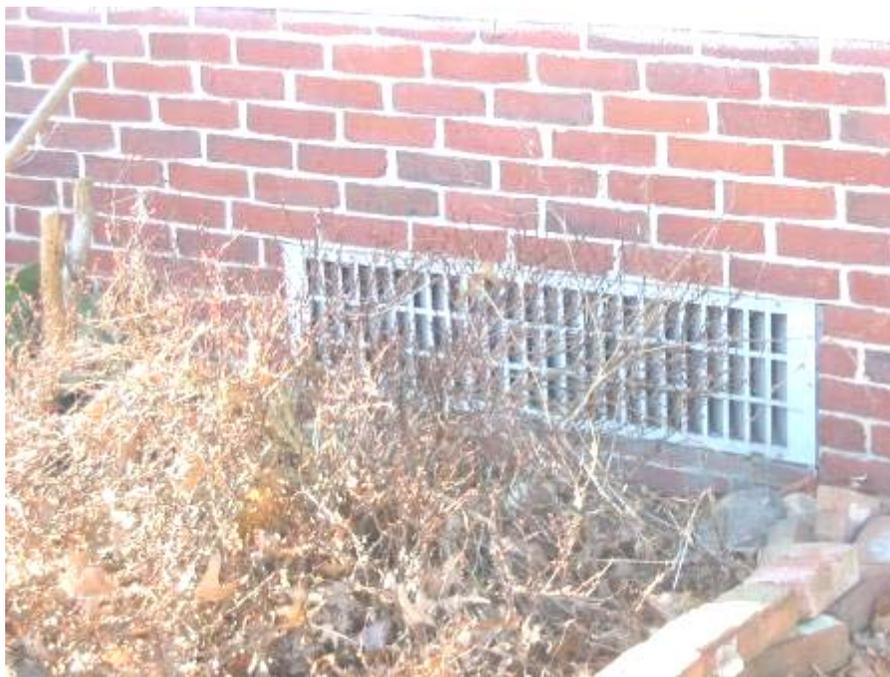
**Picture 2**

Shrubbery and other plants were also observed to be growing in cracks and crevices in close proximity to the foundation walls (Picture 2). The growth of roots against the exterior walls can bring moisture in contact with wall brick and eventually lead to cracks and/or fissures in the foundation below ground level. Similarly, clinging plants were observed growing against the building exterior (Picture 5). Clinging plants can cause damage to brickwork through the insertion of tendrils into brick and mortar. Water can penetrate into the brick along the tendrils, which can subsequently freeze and thaw during the winter. This freezing/thawing action can weaken bricks and mortar, resulting in damage.

**Fresh air intake, note plant growth in close proximity**

10. Remove shrubs, plants and clinging plant growth from the building exterior and perimeter to prevent damage to masonry
11. Repair/replace elbow extensions on downspouts to direct rain water away from the building.

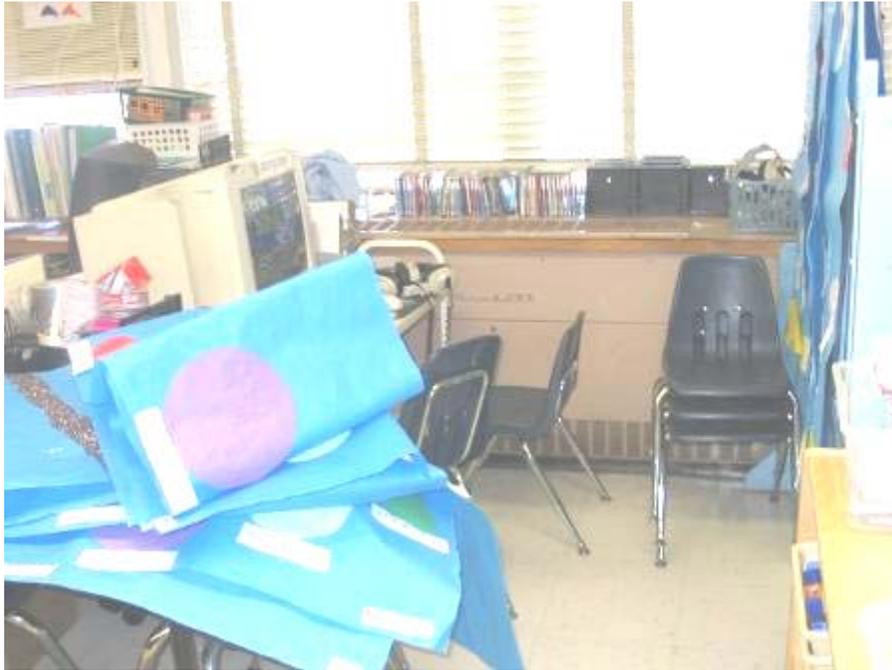
**Picture 3**

**Classroom univent partially obstructed**

2. Ensure supply and exhaust vents are free of obstructions to facilitate airflow.
3. Consider having the ventilation system balanced by an HVAC engineer every five years (SMACNA, 1994).

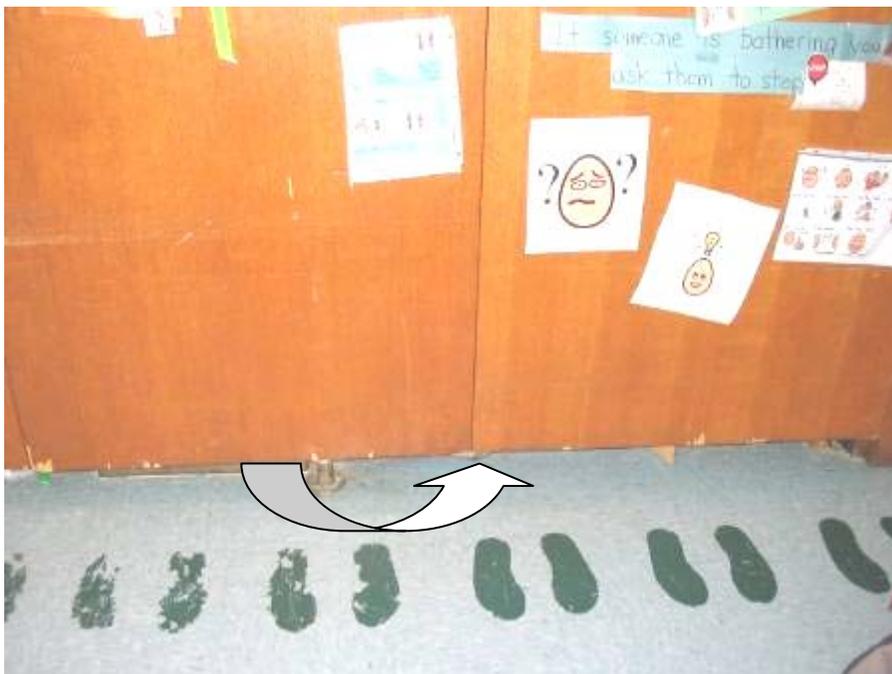
**Picture 4**

Exhaust ventilation is provided by a mechanical exhaust vent box located in the closet. Air is drawn into the closet via undercut doors and removed from the building

(Picture 4). The exhaust fan was not operating in one classroom at the time of assessment. The location of these exhausts allows them to be easily blocked by stored materials. Without sufficient supply and exhaust ventilation, indoor air pollutants can build up, leading to indoor air quality/comfort complaints.

**Undercut closet for exhaust**

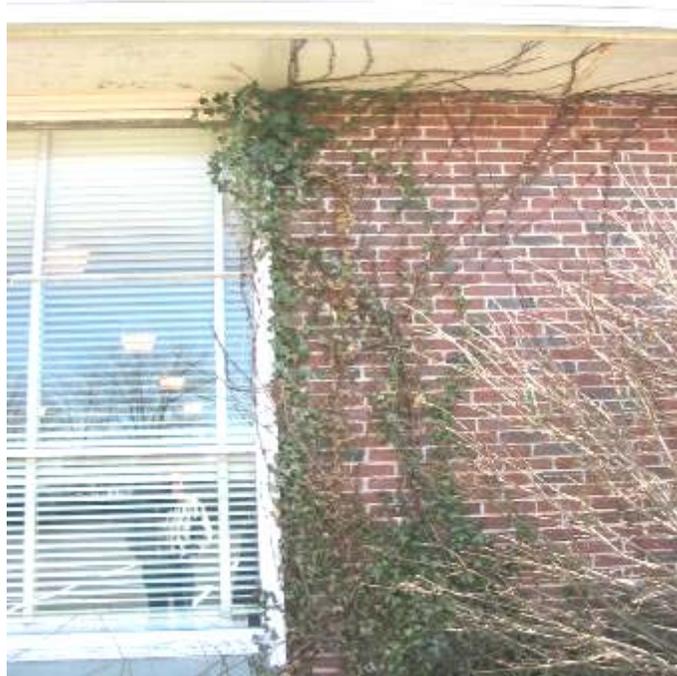
**Picture 5**

**Clinging plant growth on building exterior**

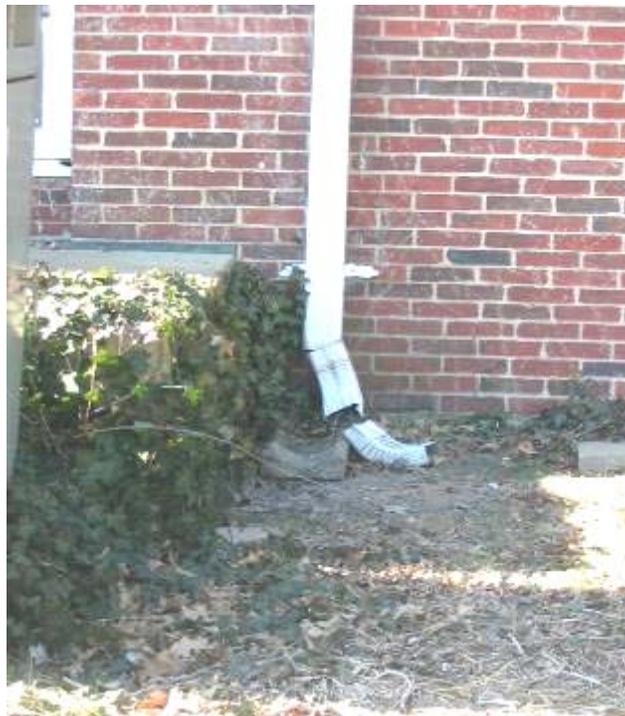
**Picture 6**

A damaged downspout was observed on the exterior of the building (Picture 6). Excessive exposure of exterior brickwork to water can result in structural damage. Over time, these conditions can undermine the integrity of the building envelope and provide a means of water entry into the building through capillary action through foundation concrete and masonry (Lstiburek & Brennan, 2001).

**Damaged downspout**

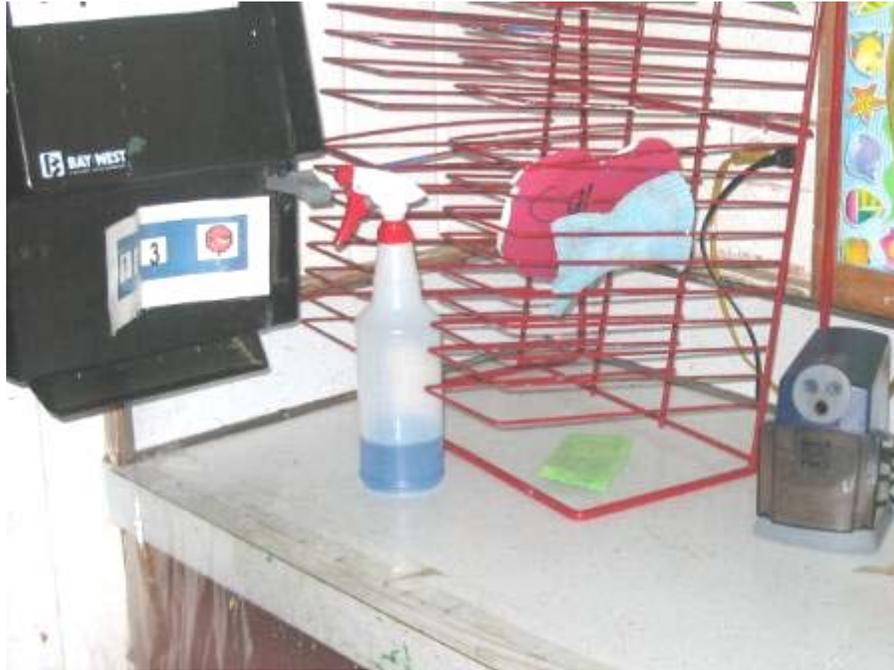
**Picture 7**

Cleaning products were found on countertops and in unlocked cabinets beneath sinks in some classrooms (Picture 7). Like dry erase materials, cleaning products contain VOCs and other chemicals that can be irritating to the eyes, nose and throat of sensitive individuals.

**Unlabelled cleaning bottle**

12. Store cleaning products properly and out of reach of students. Ensure spray bottles are properly labeled. *All* cleaning products used at the facility should be approved by the school department with MSDS' available at a central location.

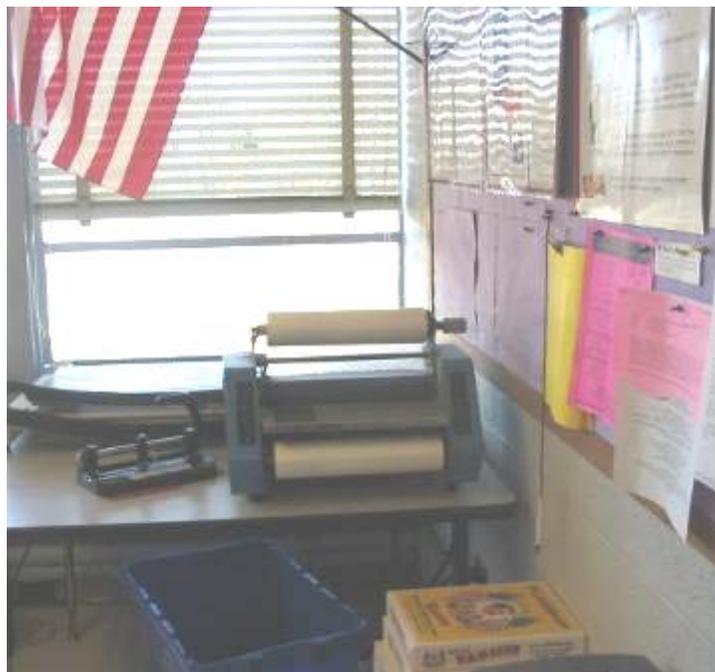
**Picture 8**

Lamination machines can give off waste heat and odors. As reported by Mr. Dunkley, the school experienced an instance where a laminator had remained 'on' for an extended period of time. As a result, a strong burning plastic odor was produced. These odors migrated from the teachers' room, where the laminator is located (Picture 8), to the front hallway of the building. The teacher's room does not have mechanical exhaust ventilation to help remove excess heat and odors. According to Mr. Dunkley, the window immediately behind the laminator was opened following the incident; however, the odors from the machine lingered for some time.

**Laminator in teachers' room**

14. Ensure laminator is deactivated after use. Open windows to create air exchange and reduce odors during operation. Consider installing a local exhaust fan in the teachers' lounge.
