INDOOR AIR QUALITY ASSESSMENT

**Joseph H. Downey Community School
55 Electric Avenue
Brockton, Massachusetts 02302**

Prepared by:
Massachusetts Department of Public Health
Bureau of Environmental Health
Indoor Air Quality Program
September 2008

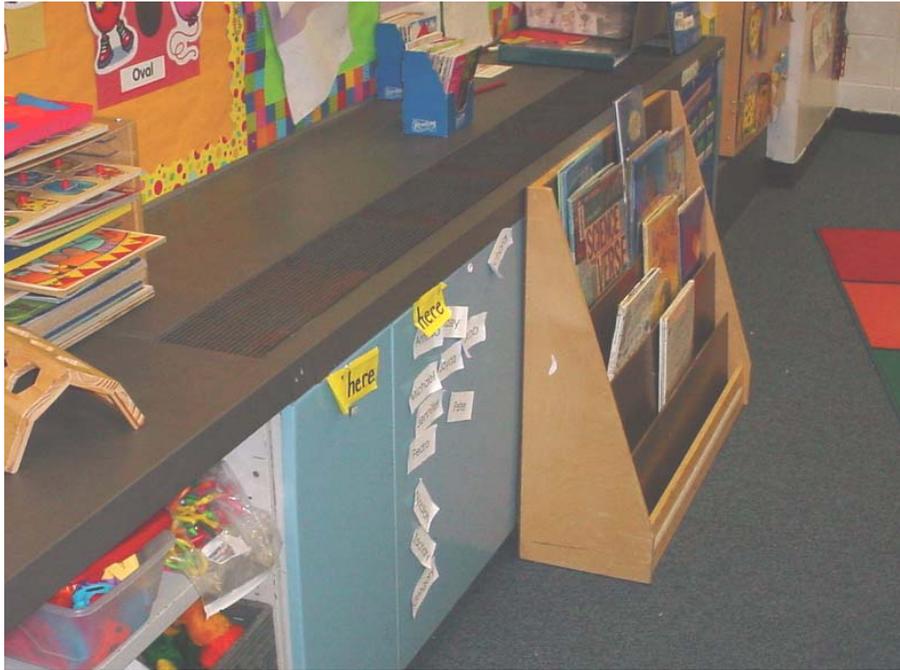
Picture 1

Fresh air is supplied to pod classrooms by unit ventilator (univent) systems (Picture 1). A univent draws air from the outdoors through a fresh air intake located on the exterior wall of the building (Picture 2) and returns air through an air intake located at the base of the unit ([Figure 1](#)). Fresh and return air are mixed, filtered, heated and provided to classrooms through an air

Classroom Univent

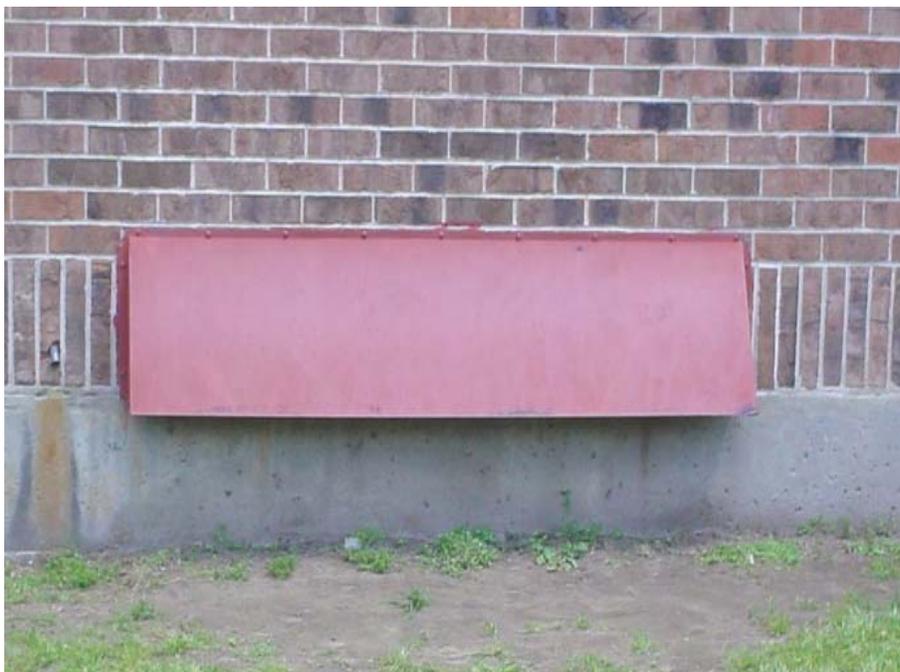
Picture 2

Univent Fresh Air Intake, Note Sheet-Metal Protective Hood

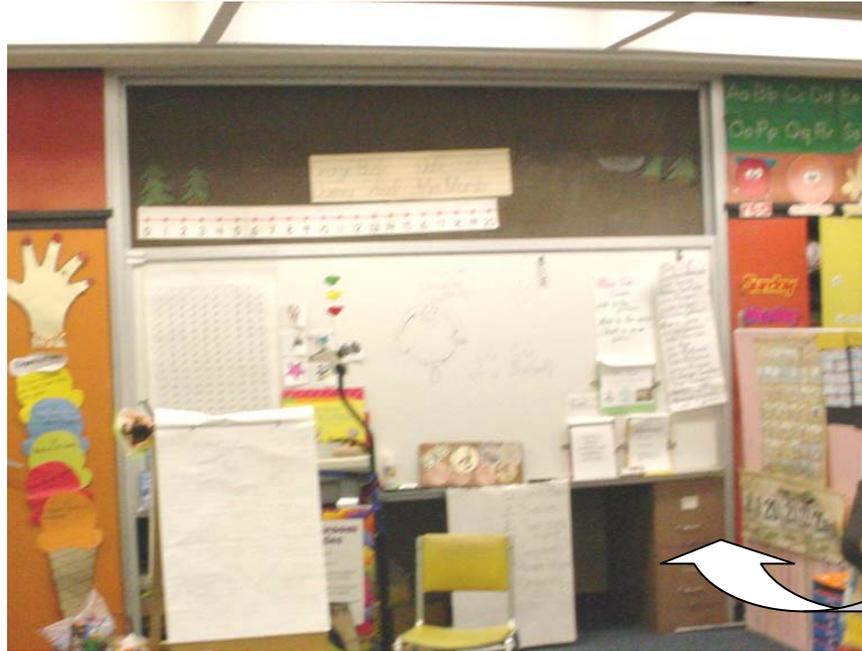
Picture 3

Exhaust ventilation is provided by wall-mounted vents located in/near the ceiling of storage closets (Pictures 3 through 5); the majority were not operating or were found deactivated at the time of the assessment. In addition, due to their location these vents are prone to blockage by storage of items in closets (Pictures 4 and 6). Without adequate supply and exhaust ventilation, excess heat and environmental pollutants can build up and lead to indoor air/comfort complaints.

**Front Wall of Classroom, Note Open Storage Area below White Board
Used to Draw Exhaust from Classroom**

2. Inspect exhaust motors and belts periodically for proper function. Repair and replace as necessary.
3. Remove all blockages from exhaust vents to ensure adequate airflow.

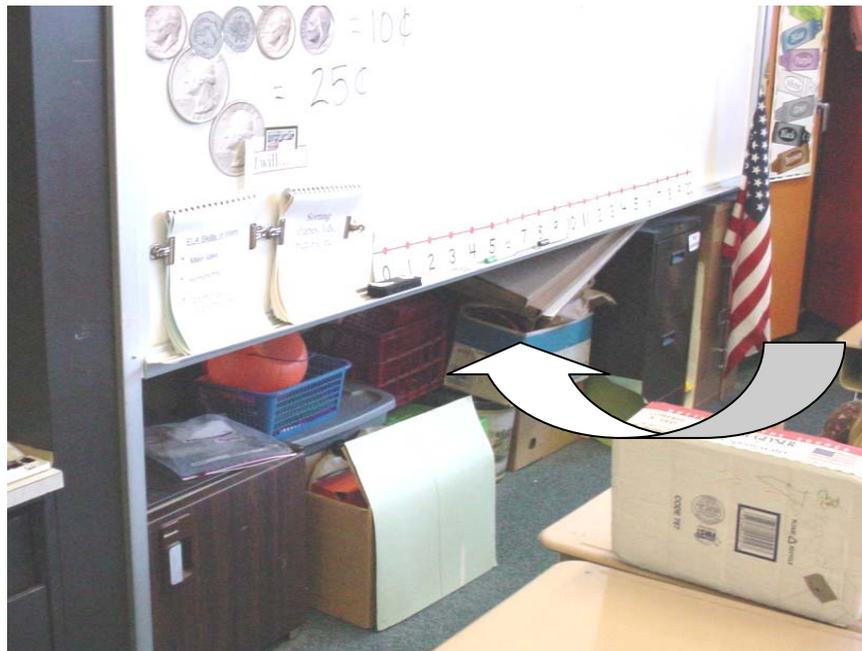
Picture 4

**Close-Up of Open Storage Area at Front of Classroom
Used to Draw Exhaust from Classroom**

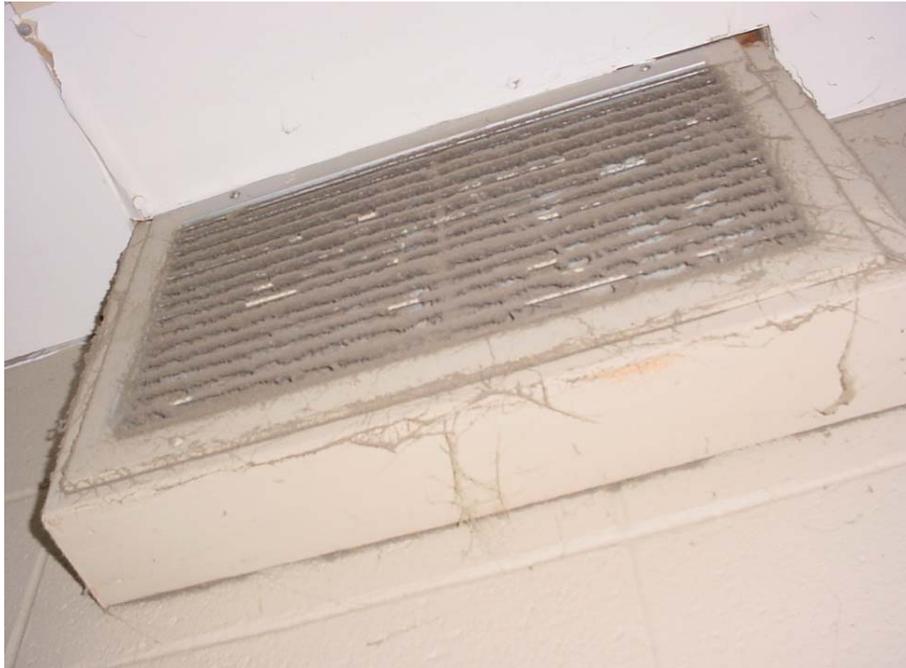
Picture 5

A number of supply and exhaust/return vents as well as personal fans were observed to have accumulated dust/debris (Pictures 5 and 8). If exhaust vents are not functioning, backdrafting can occur, which can re-aerosolize accumulated dust particles. Re-activated supply vents and fans can also aerosolize dust accumulated on vents/fan blades.

Exhaust Vent Located in/near the Ceiling of Storage Closets, Note Heavy Dust/Debris Accumulation

21. Clean personal fans, univent air diffusers, return vents and exhaust vents periodically of accumulated dust.
22. Clean chalk trays and areas around pencil sharpeners to prevent accumulation of materials.

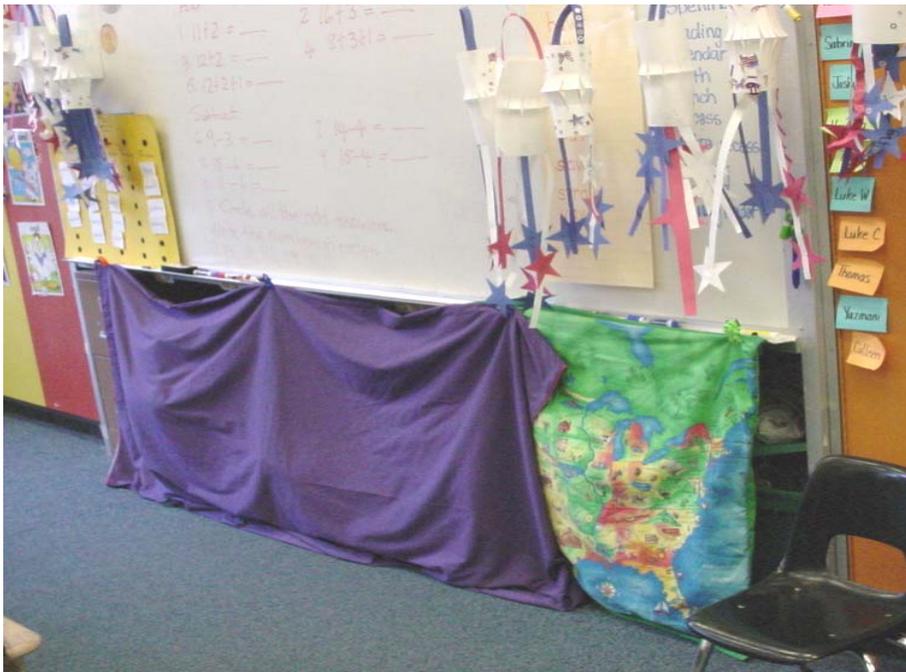
Picture 6

Storage Area at Front of Classroom Obstructed with Sheets, Limiting Airflow

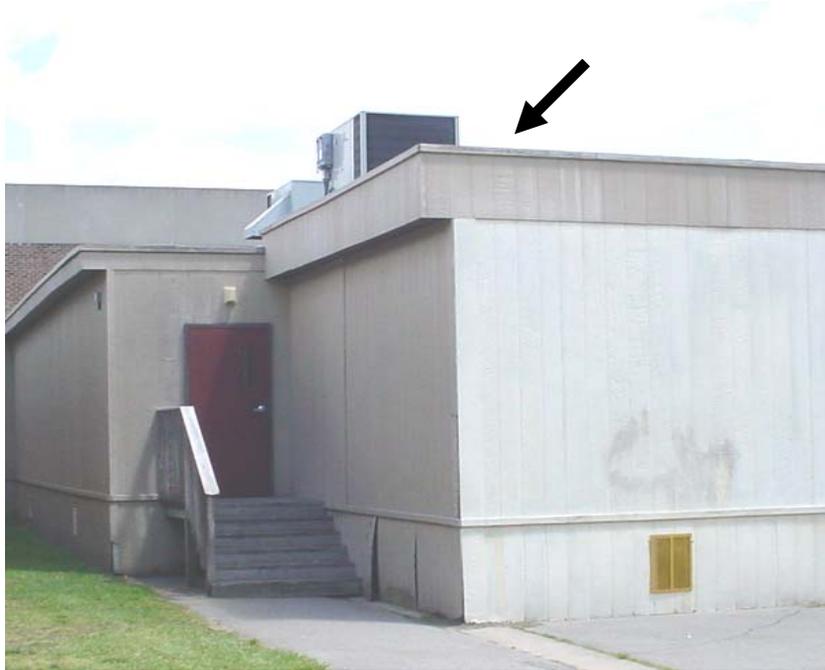
Picture 7

Ventilation for modular classrooms is provided by rooftop AHUs (Picture 7). Fresh air is drawn in through an air intake on the side of the AHU and distributed to classrooms via ceiling-mounted air diffusers (Picture 8) and drawn back to the AHUs through ceiling-mounted return grills (Picture 9). Thermostats control each AHU. Thermostats for both AHUs were set to the fan “auto” setting (Picture 10), which deactivates the HVAC system at a preset temperature. Therefore, no mechanical ventilation is provided until the thermostat re-activates the system.

Rooftop AHU for Modular Classroom

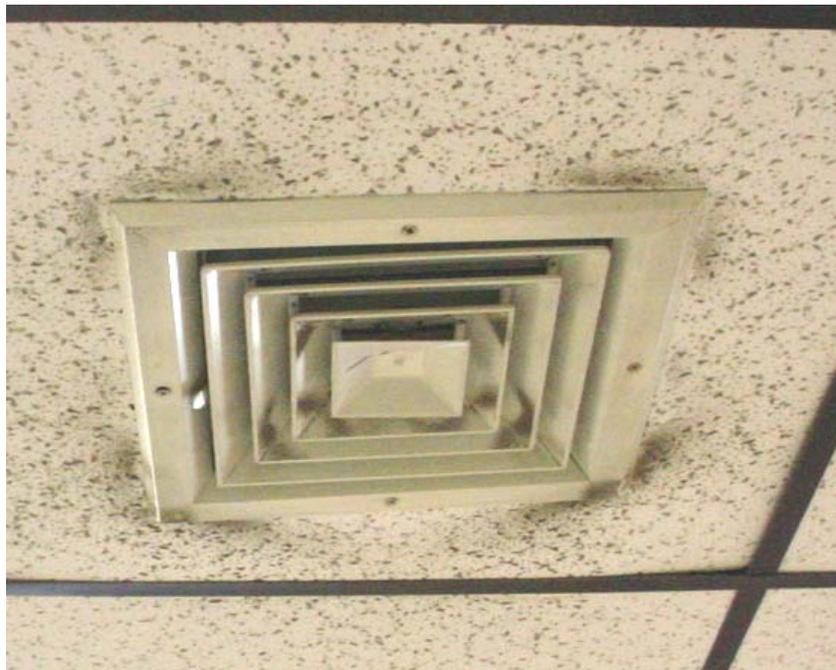
Picture 8

Ceiling-Mounted Air Diffusers in Modular Classroom, Note Dust/Debris Accumulation on/around Vent/Ceiling Tiles

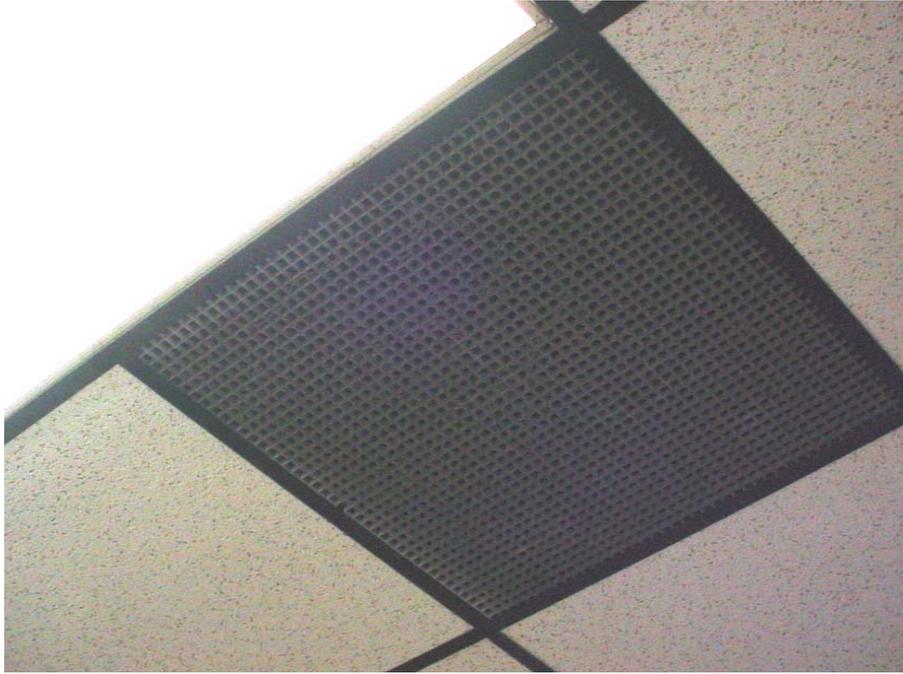
Picture 9

Ceiling-Mounted Return Vent in Modular Classroom

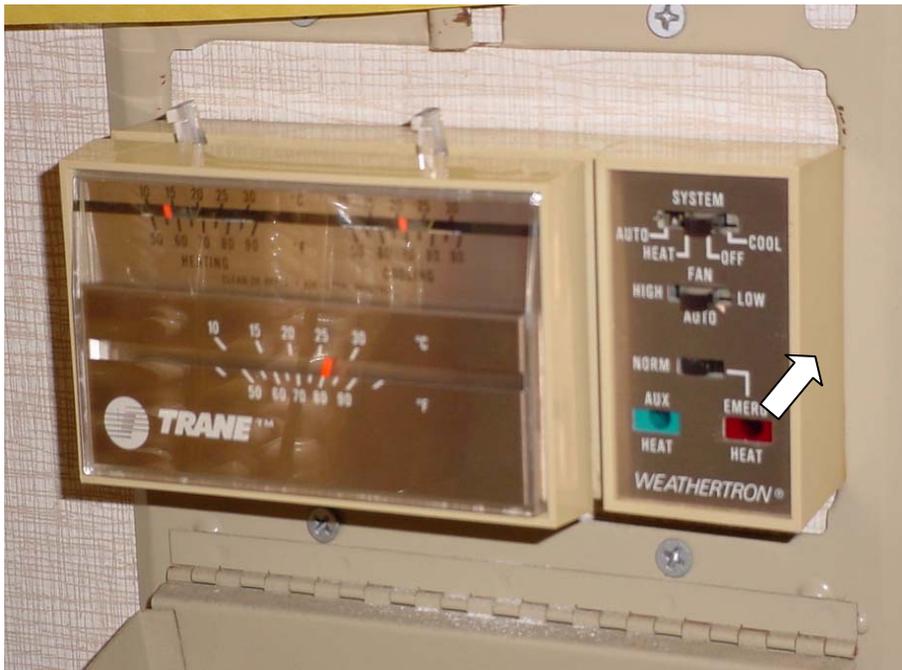
Picture 10

Thermostat for Modular Classroom, Note Fan Switch in “Auto” Position

1. Operate all ventilation systems throughout the building (e.g., gym, cafeteria, classrooms) *continuously* during periods of school occupancy and independent of thermostat control. Set thermostat controls in modular classrooms to fan “on” during occupied hours.

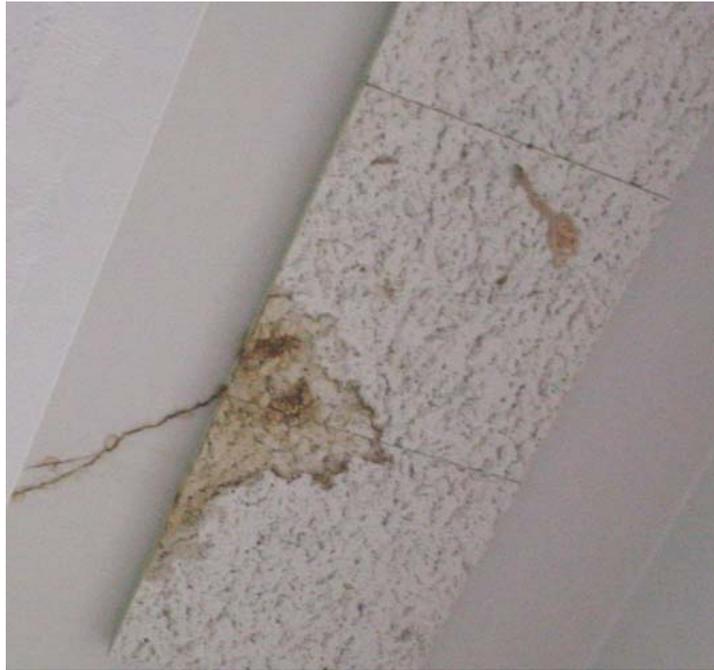
Picture 11

Several areas showed signs of water damage, as evidenced by stained ceiling tiles, concrete ceilings and wall, peeling paint and efflorescence. Such damage can indicate leaks from the roof, building exterior or plumbing system (Pictures 11-14/Table 1). Efflorescence is a characteristic sign of water damage to brick and mortar, but it is not mold growth. As moisture penetrates and works its way through mortar, brick or concrete, water-soluble compounds dissolve, creating a solution. As the solution moves to the surface of the material, the water evaporates, leaving behind white, powdery mineral deposits. The water damage observed in the original building appears to be historic; no current/active leaks were reported in those areas. Active roof leaks were reported in modular classroom 2; the leak is most likely associated with the rooftop AHU (Picture 15).

Water Stained Ceiling Tiles and (Discolored) Crack in Concrete Ceiling, Indicating Water Penetration

8. Encourage staff to monitor their classrooms for active leaks/water damage and report to school maintenance staff for prompt remediation.
9. Clean, prepare, and re-paint ceiling/walls in water damaged areas once leaks are repaired.

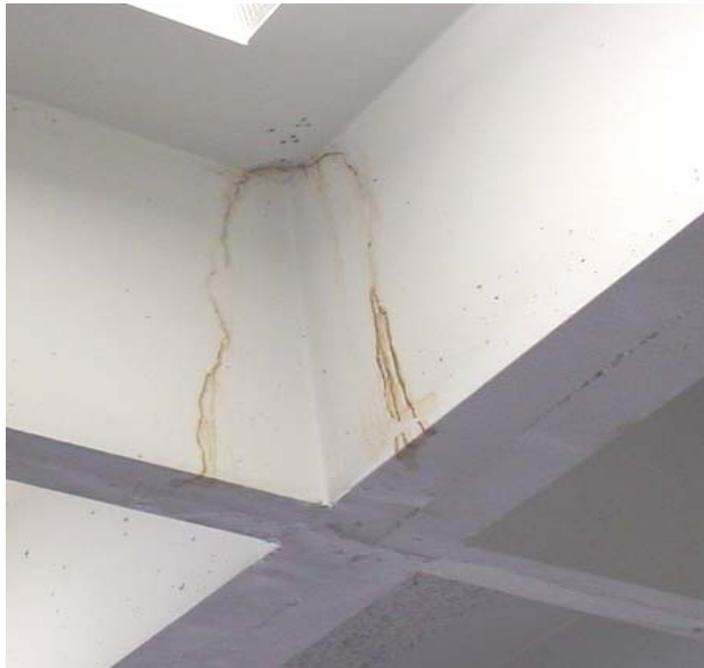
Picture 12

Water Stained Concrete Ceiling, Indicating Water Penetration from Crack

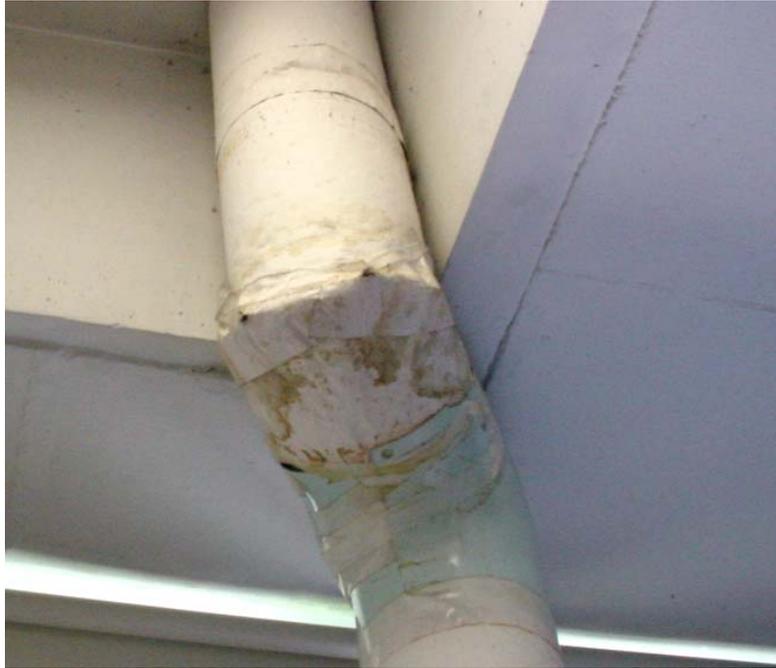
Picture 13

Water Damaged Pipe Insulation

10. Replace water-damaged pipe insulation (Picture 13).
11. Install weather stripping around exterior doors (e.g., modular classroom wing, library) to prevent drafts, water penetration and pest entry.

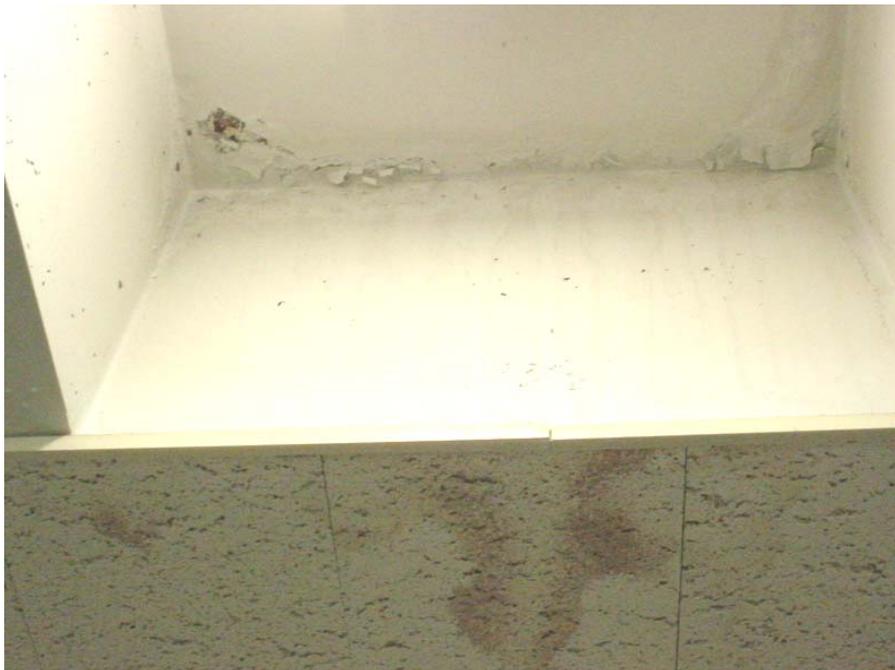
Picture 14

Water Stained Concrete/Ceiling Tiles and Peeling Paint

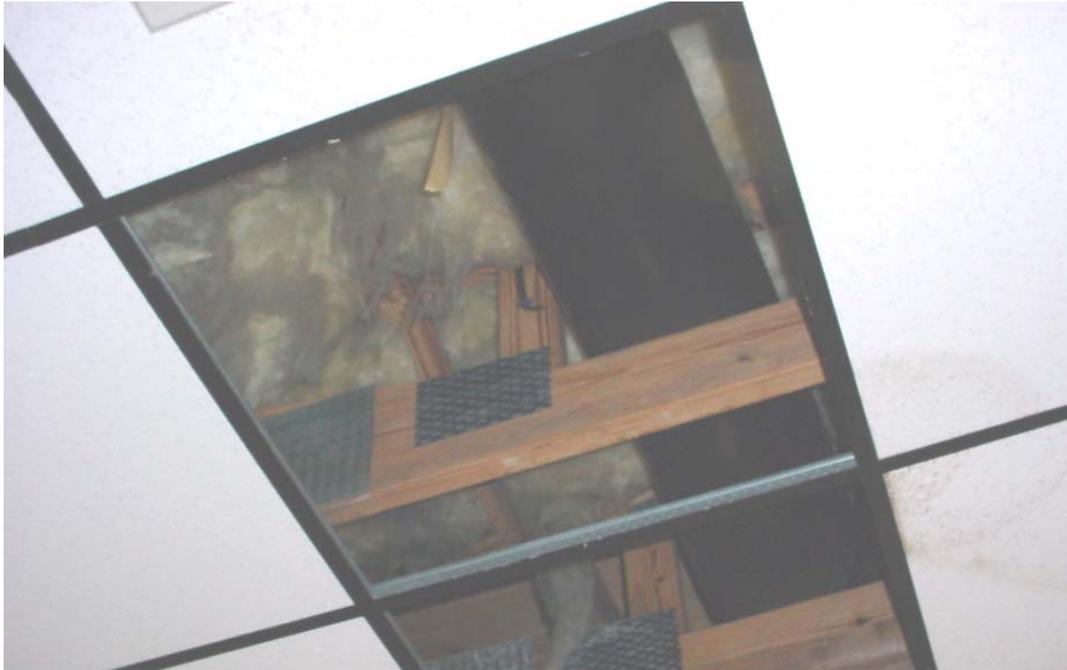
Picture 15

Finally, exposed fiberglass insulation was observed in modular classroom 2 due to ceiling damage from roof leaks (Picture 15). Fiberglass insulation can provide a source of skin, eye and respiratory irritation.

**Missing Damaged Ceiling Tiles Due to Roof Leaks in Modular Classroom 2,
Note Exposed Fiberglass Insulation**

7. Ensure leaks are repaired, primarily in modular classroom 2. Remove/replace any water damaged ceiling tiles and insulation. Examine beneath carpet in this area and make repairs or replace building materials if moldy.

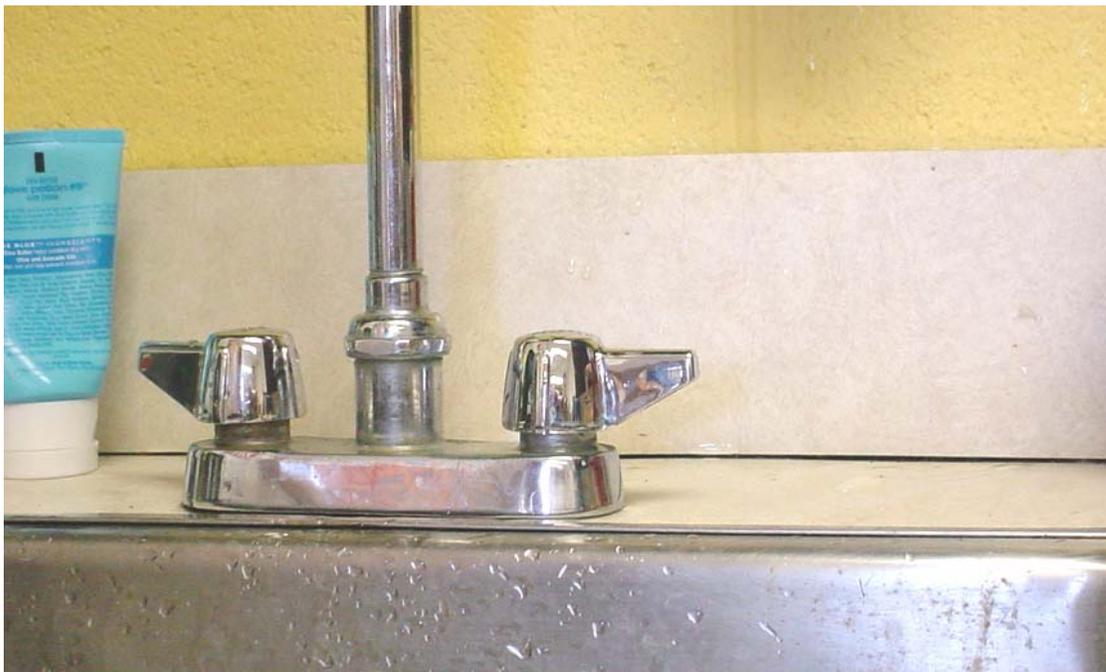
Picture 16

Open seams between sink countertops and walls were observed in several rooms (Picture 16). Improper drainage or sink overflow can lead to water penetration into the countertop,

cabinet interior and areas behind cabinets. If not watertight, moisture can penetrate through the seam, causing water damage and potential mold growth.

Spaces between Sink Countertop and Backsplash

12. Examine all strip caulking around windows and make repairs as needed to prevent drafts, water penetration and pest entry.
13. Seal areas around sinks to prevent water damage to the interior of cabinets and adjacent wallboard. Inspect wallboard for water damage and mold growth, repair/replace as necessary. Disinfect areas with an appropriate antimicrobial, as needed.

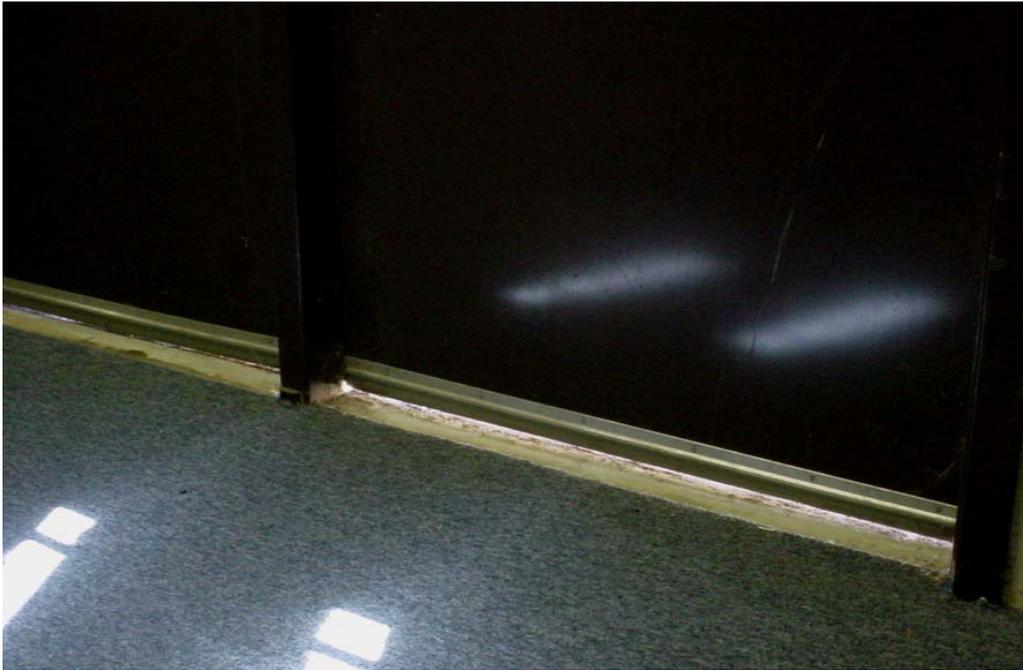
Picture 17

Exterior doors in the library and modular classroom wing had damaged/missing weather stripping, and light could be seen penetrating through the spaces around/underneath doors (Picture 17 and 18). Missing/damaged strip caulking was observed around windows in several areas (Pictures 19 and 20). Missing/damaged caulking and spaces around exterior doors and windows can serve as sources of drafts and/or water penetration into the building, causing water damage and potentially leading to mold growth. In addition, these spaces can serve as pathways for insects, rodents and other pests into the building.

Light Penetrating from beneath Modular Classroom Exterior Doors

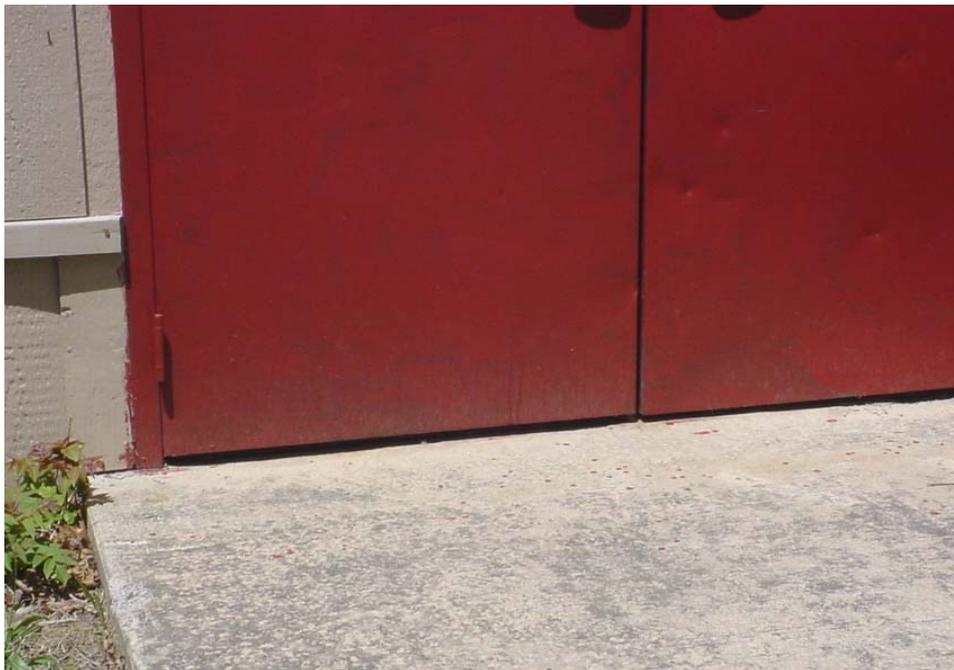
Picture 18

Spaces beneath Modular Classroom Exterior Doors

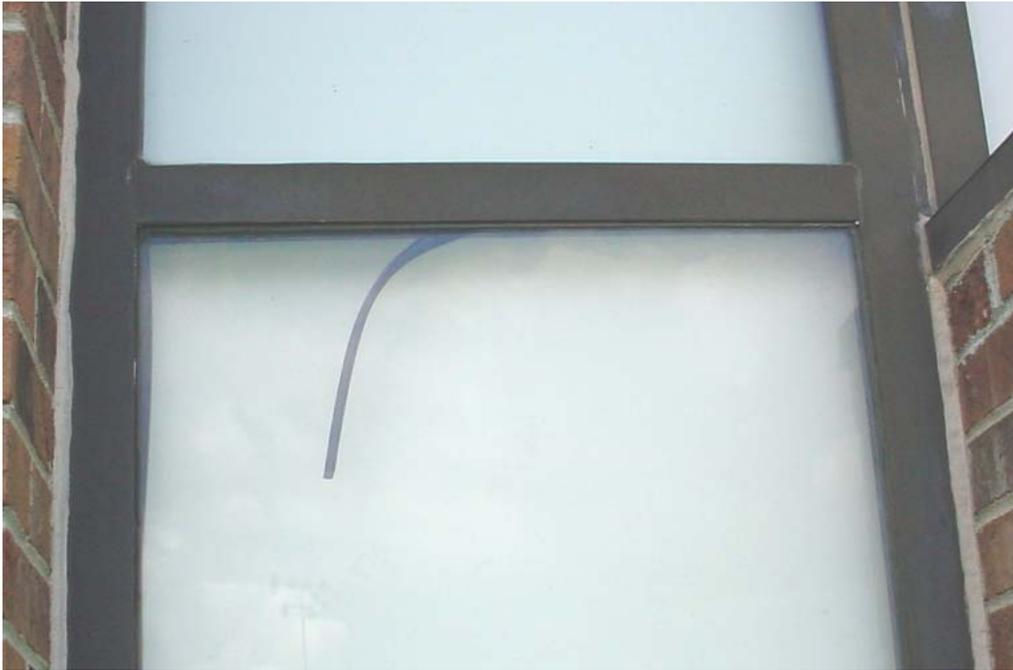
Picture 19

Loose Strip Caulking in Window

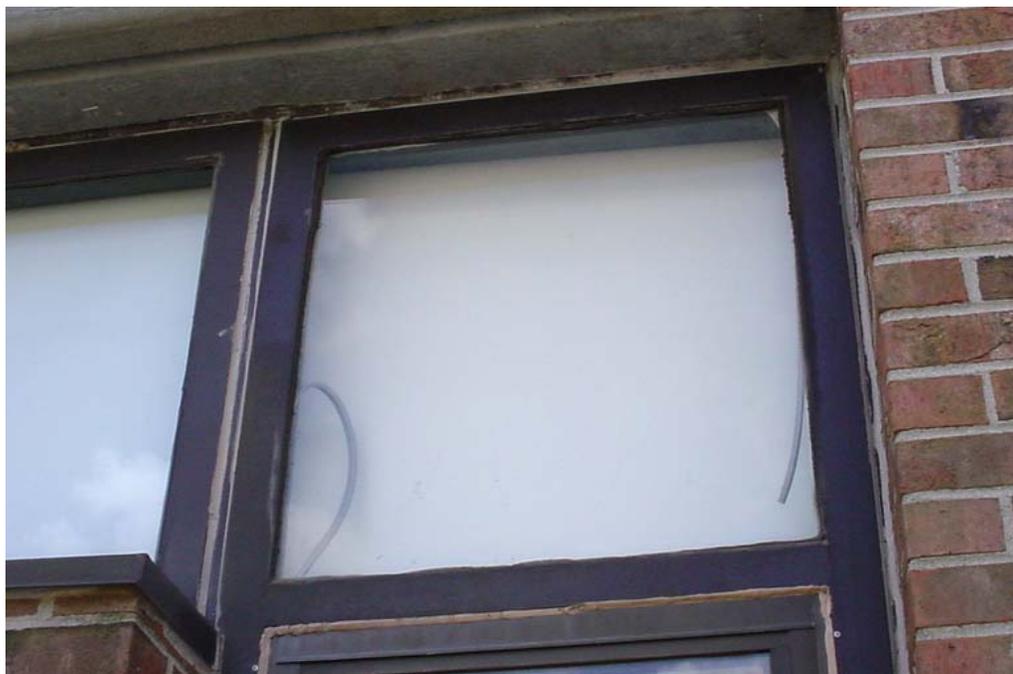
Picture 20

Loose Strip Caulking in Window

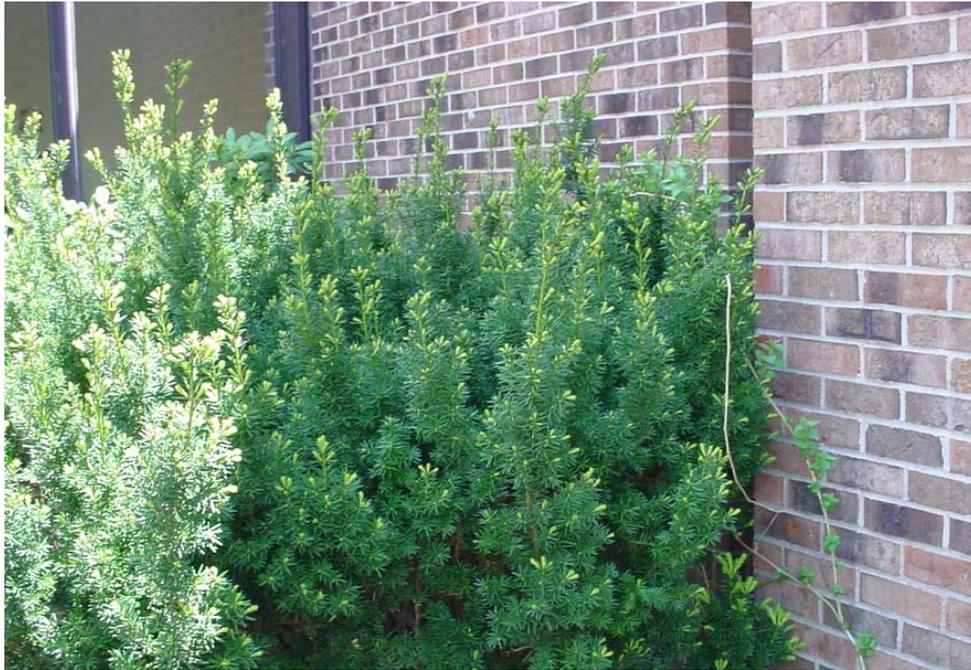
Picture 21

- Shrubbery/trees growing in close proximity to the building (Pictures 21 and 22), which holds moisture against exterior brick and prevents drying;
- Missing/damaged mortar and exterior brick (Pictures 23 and 24);
- Missing/damaged joint compound (Picture 25); and
- Missing/damaged elbows/downspouts on modular classroom wing (Pictures 26).

The aforementioned conditions represent potential water penetration sources. Over time, these conditions can undermine the integrity of the building envelope and provide a means of water entry into the building via capillary action through foundation concrete and masonry (Lstiburek & Brennan, 2001). In addition, these breaches may provide a means for pests/rodents to enter the building.

Shrubbery in Contact with Exterior Brick

16. Avoid over-watering plants and examine drip pans periodically for mold growth. Disinfect with an appropriate antimicrobial where necessary.
17. Trim shrubbery/trees back approximately 5-feet to prevent water impingement on exterior brick.

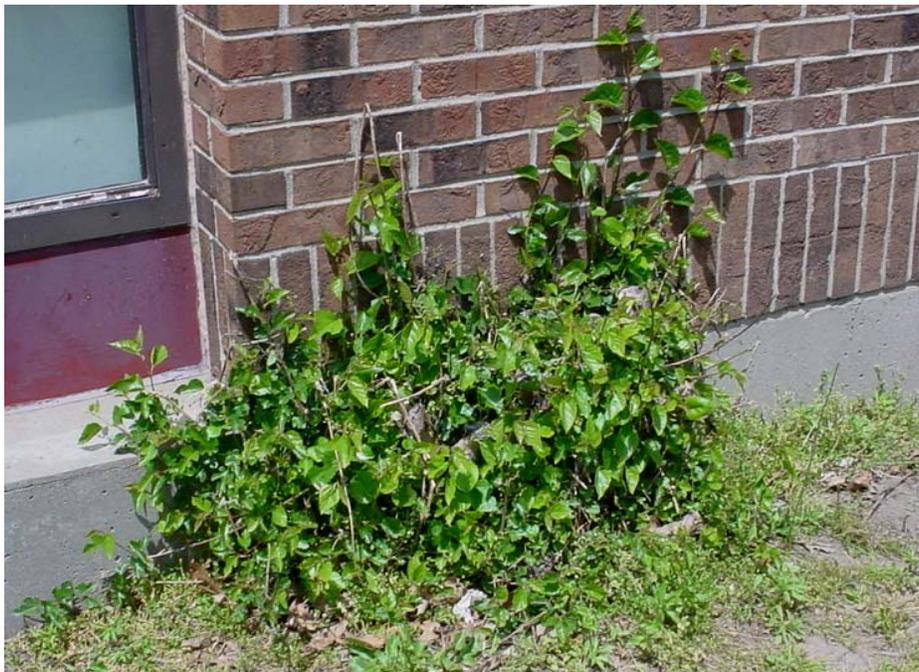
Picture 22

Shrubbery/Roots in Contact with Exterior Brick/Foundation

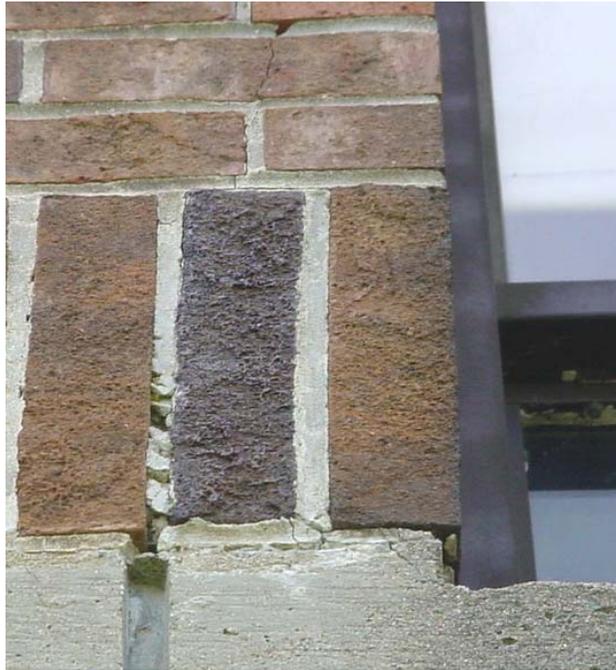
Picture 23

Missing/Damaged Mortar around Exterior Brick

14. Make repairs to missing/damaged gutter/downspout system on modular classroom wing.
15. Re-point missing/damaged mortar around exterior brick to prevent further damage and water intrusion.

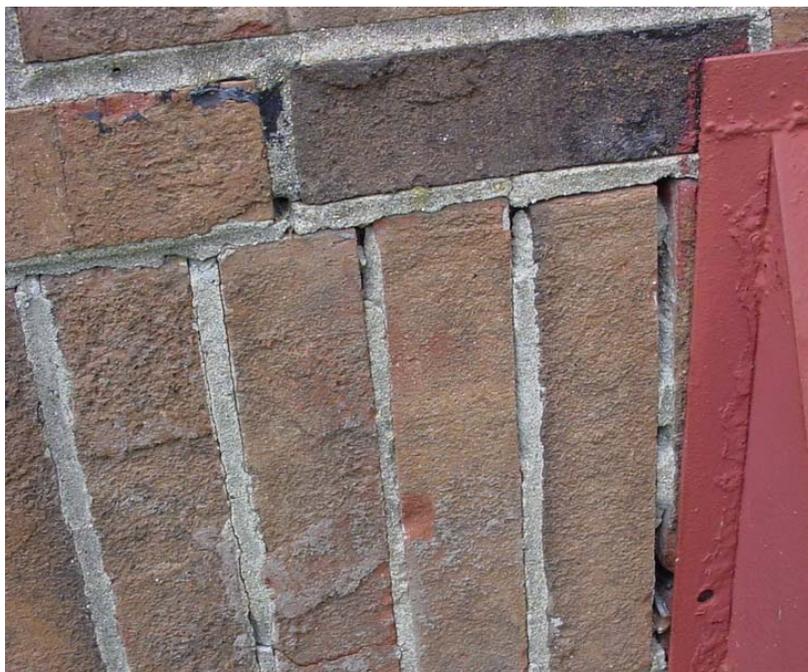
Picture 24

Missing/Damaged Mortar around Exterior Brick

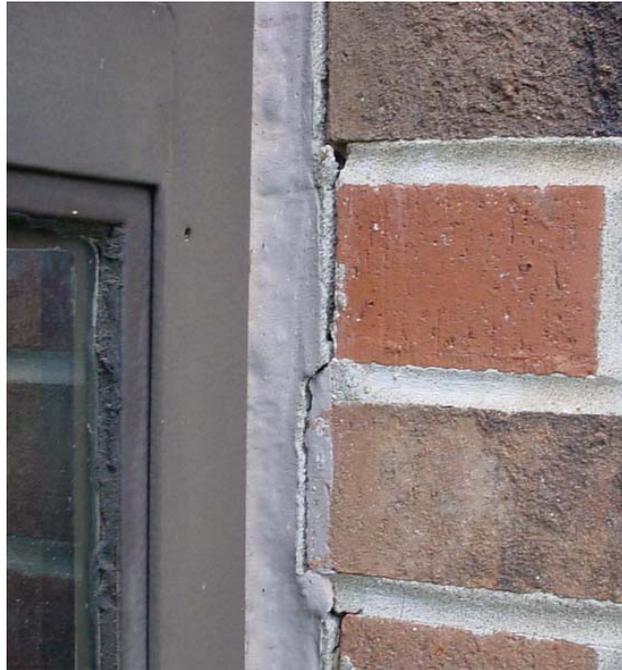
Picture 25

Missing/Damaged Joint Compound/Sealant

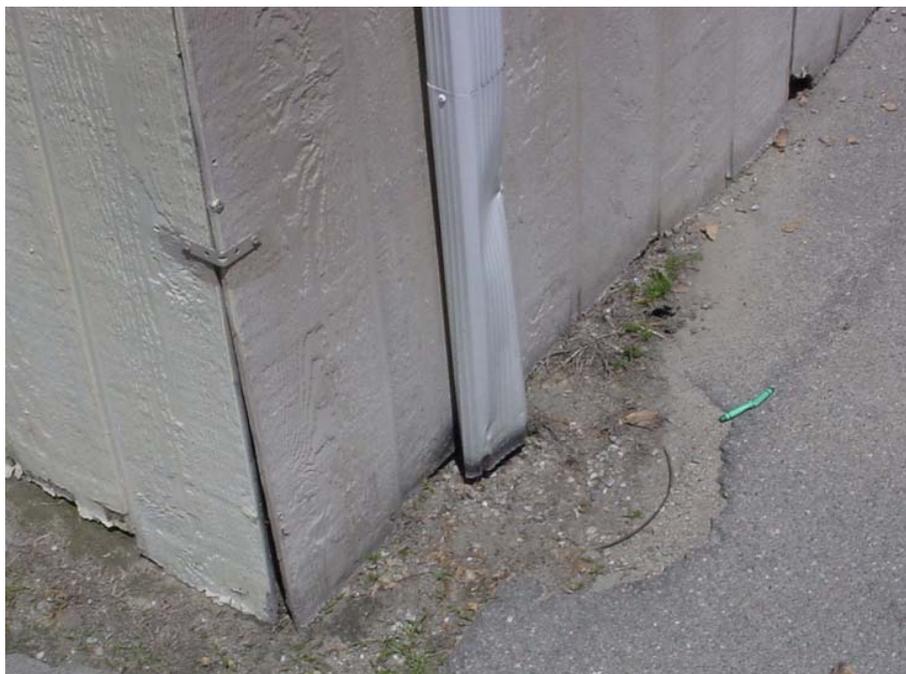
Picture 26

Downspout on Modular Classroom Missing Elbow Extension

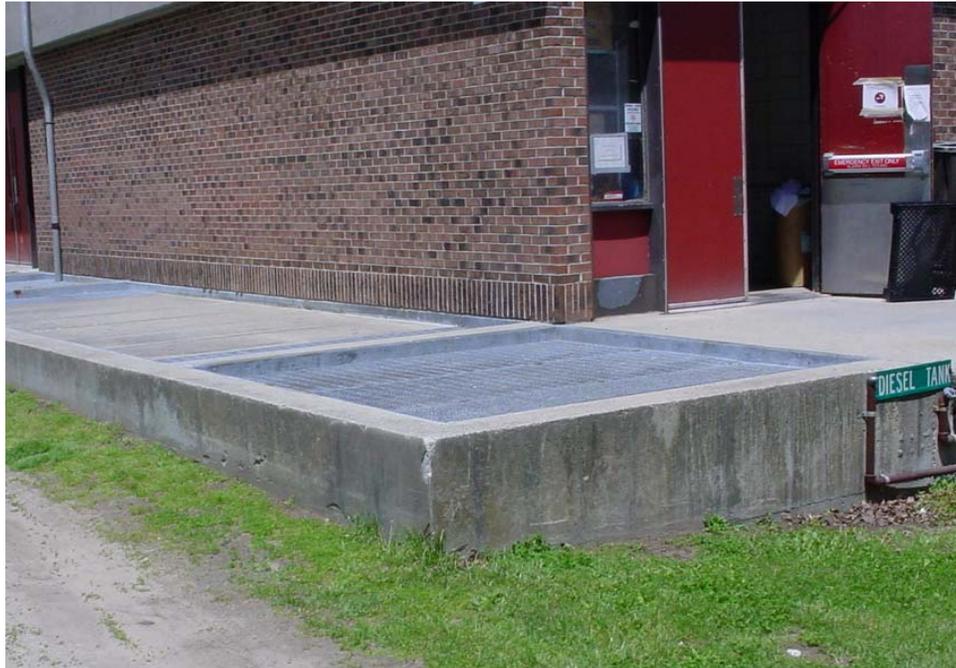
Picture 27

Also noted on the exterior of the building was stagnant water in a concrete-lined pit at the rear of the building (Picture 27 and 28); this is the result of inadequate drainage. The freezing and thawing of water during winter months can lead to damage to exterior walls and subsequent water penetration into the building. Pooling water can also become stagnant, which can lead to mold/bacterial growth and associated odors and serve as a breeding ground for mosquitoes.

Cement-Lined/Grated Pit at Rear of the Building

18. Examine the feasibility of installing drainage in the concrete-lined pit at rear of building. If not feasible use portable pump (as needed) to prevent the stagnation of standing water.

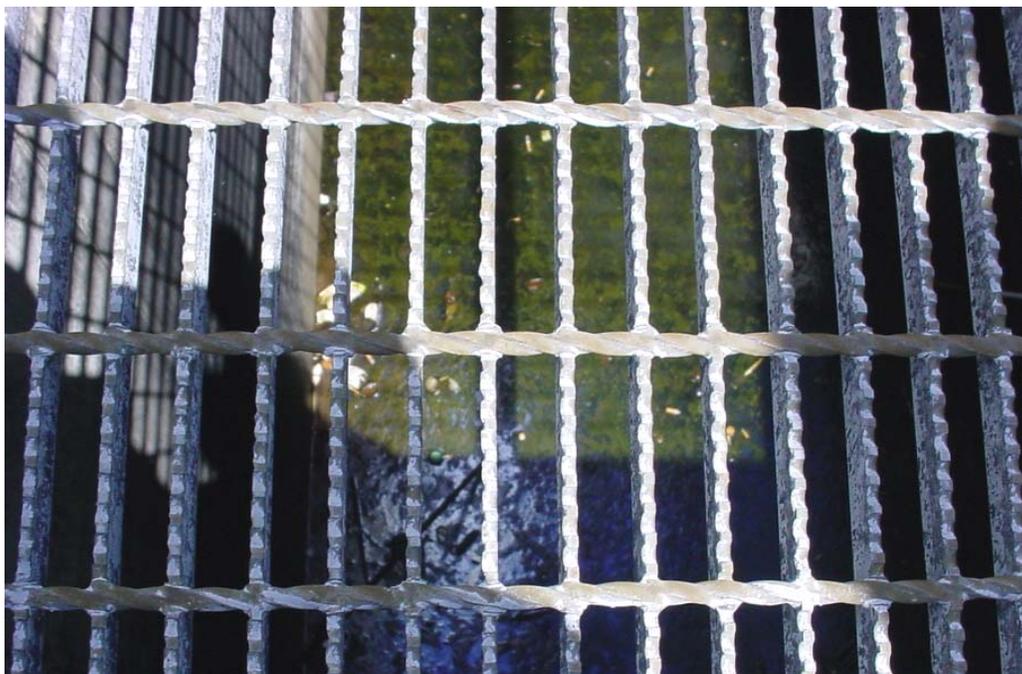
Picture 28

Standing Water at Bottom of Cement-Lined/Grated Pit
