ODOR INVESTIGATION/ INDOOR AIR QUALITY ASSESSMENT

**Center Elementary School
11 Ash Street
Hopkinton, Massachusetts**

Prepared by:
Massachusetts Department of Public Health
Bureau of Environmental Health
Indoor Air Quality Program
April 2008

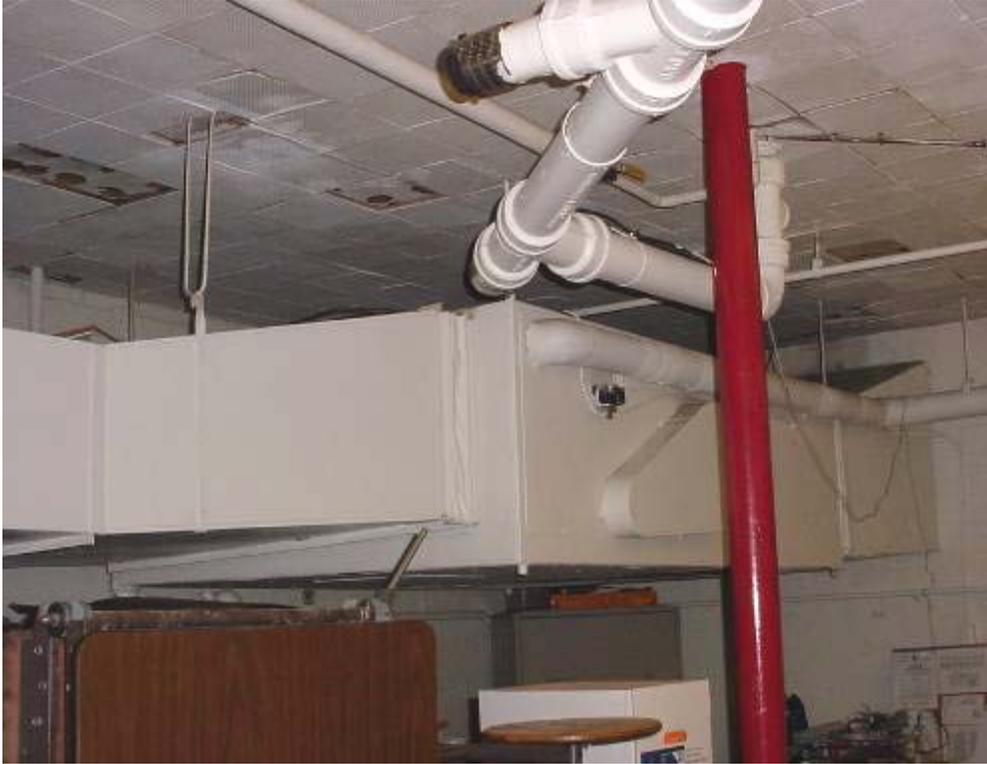
Picture 1

The cafeteria was designed to be ventilated by a ceiling-mounted air handling unit (AHU) (Picture 1). The AHU draws fresh outside air from an air intake on the exterior of the building (Picture 2) and heats and filters it prior to distributing via ducted vents to the kitchen and cafeteria (Pictures 3 and 4). The AHU was not operating during the assessment and appeared to

have been deactivated for some time. At the time of the assessment, the cafeteria had no means of mechanical supply ventilation but relies solely on openable windows for air exchange. All windows were closed during the assessment.

Ceiling-Mounted AHU in Cafeteria

1. Contact an HVAC engineering firm for a ventilation systems assessment, primarily for the kitchen/cafeteria and classrooms. Based on the age, physical deterioration and availability of parts for ventilation components, such an evaluation is necessary to determine the operability and feasibility of repairing/replacing the equipment.

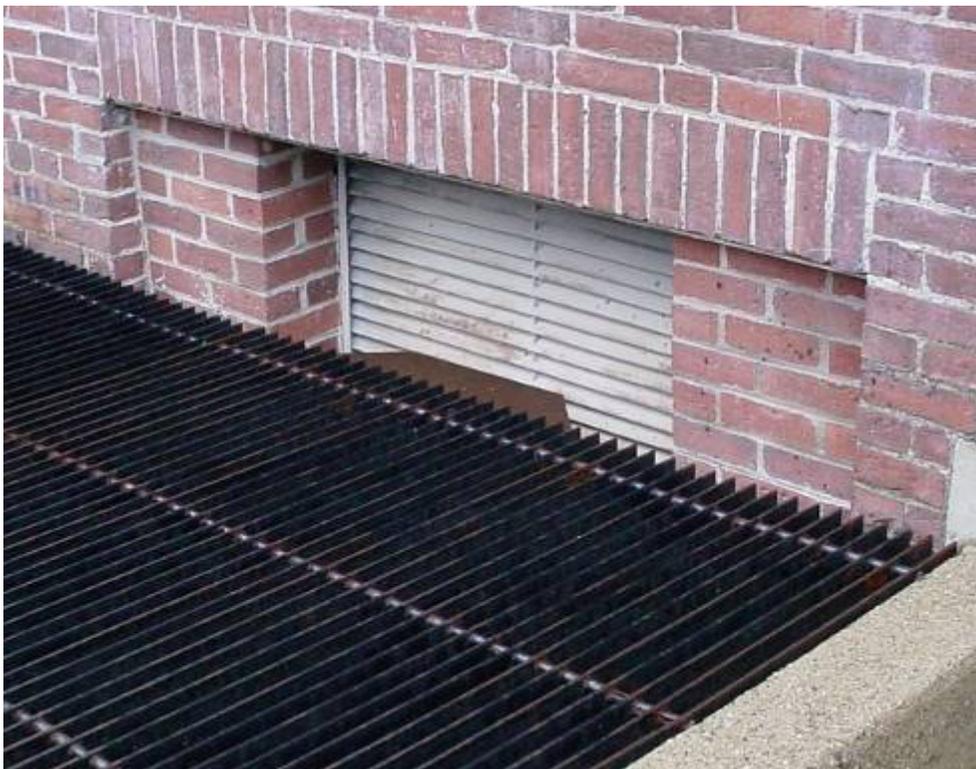
Picture 2

Fresh Air Intake for Cafeteria AHU

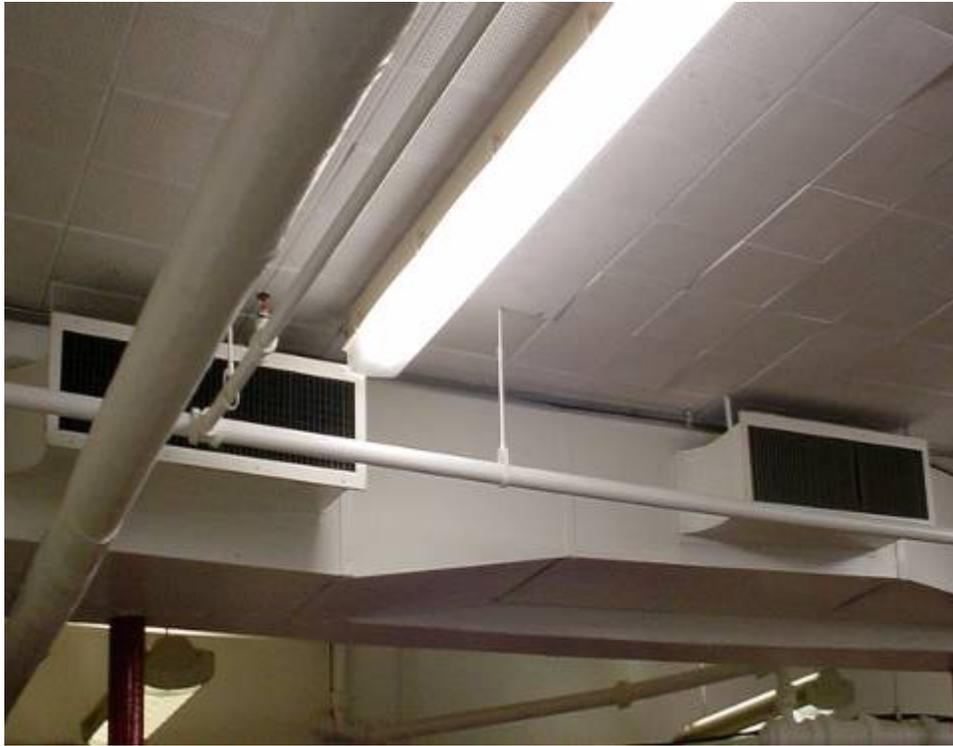
Picture 3

Ducted Supply Vents for Cafeteria

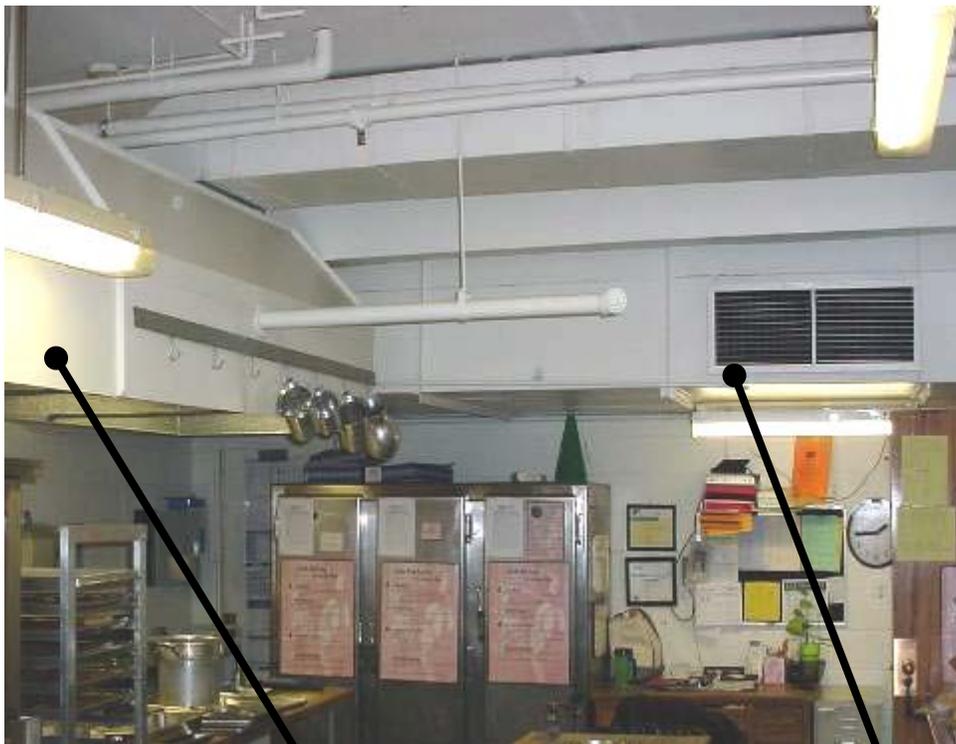
Picture 4

Exhaust ventilation in the kitchen is provided by a local exhaust hood (Picture 4). Exhaust ventilation for the cafeteria is drawn into a large wall-mounted vent (Picture 5), where it is ducted to a motor located in the attic and exhausted out of the building (Picture 6). These exhaust vents were operating during the assessment.

Local Exhaust Hood (left) and Ducted Supply Vent for Kitchen (right)

2. Contact an HVAC engineer to determine if existing supply vent in kitchen (Picture 4) is sufficient to provide make-up air for kitchen local exhaust hood. Develop a preventative maintenance program for this equipment.

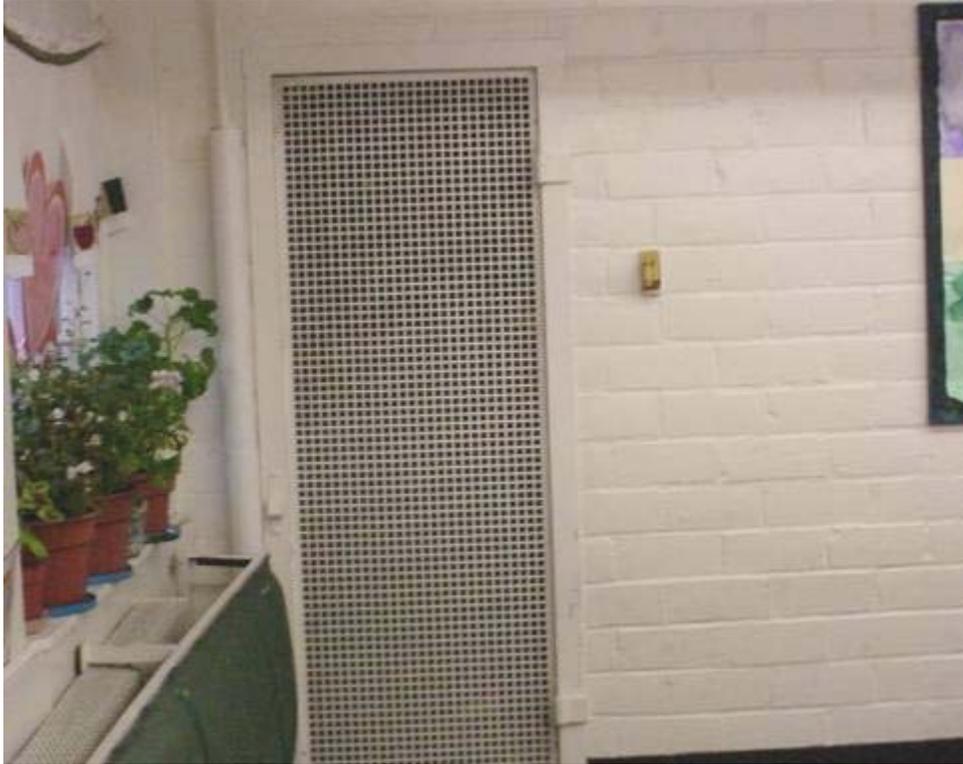
Picture 5

Wall-Mounted Exhaust Vent for Cafeteria

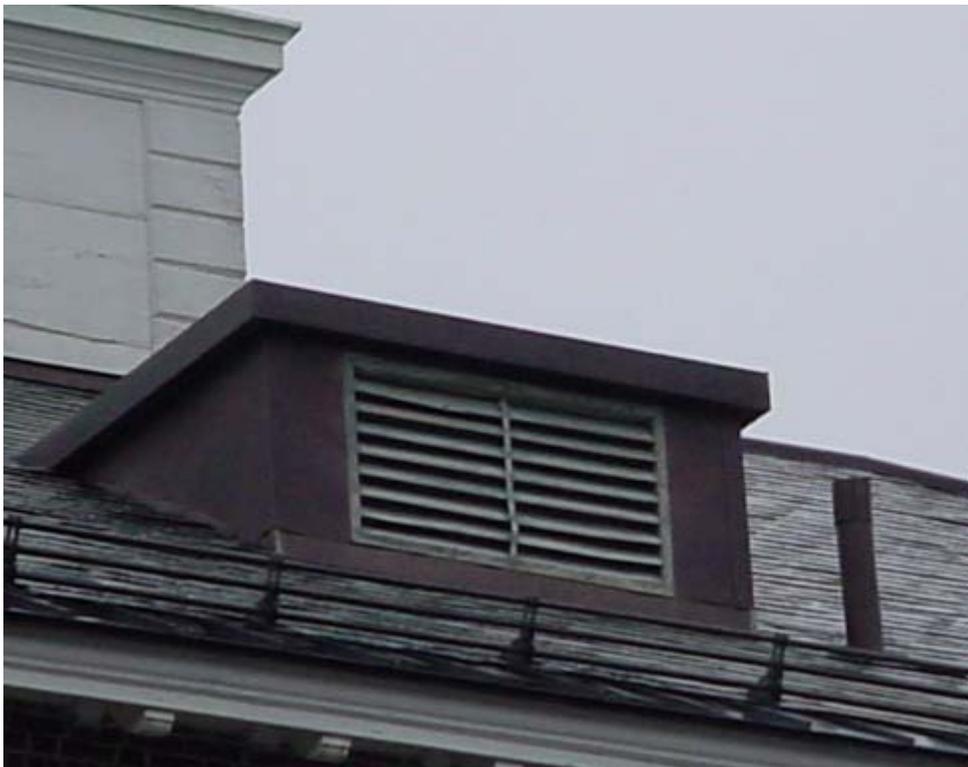
Picture 6

Rooftop Exhaust Vent

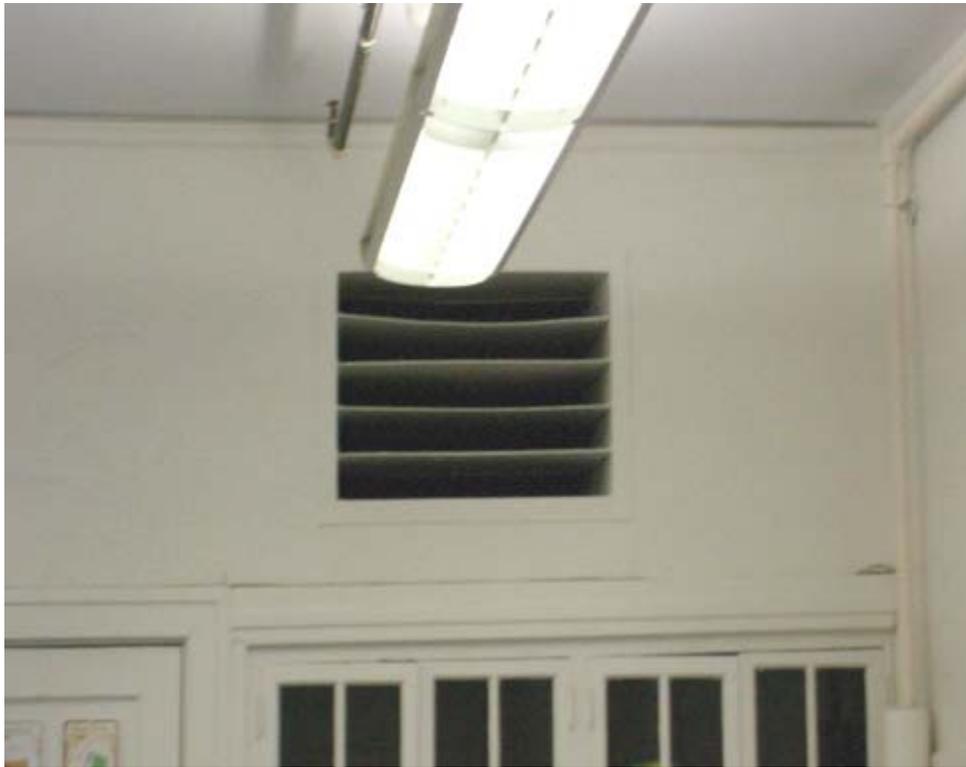
Picture 7

The school's original ventilation system consists of a series of louvered wall vents (Picture 7). Each classroom has a louvered air diffuser approximately 3 feet by 3 feet in size, located near the center of an interior wall in proximity to the ceiling. Ductwork connects the classroom air diffusers to a large axial fan located in a basement mechanical room (Picture 8); this fan creates air movement. The system is designed to draw fresh air from an air intake on the exterior wall of the lower level (Picture 9). Fresh air is mixed in the mechanical room prior to being drawn into the heating elements (Picture 10) and up the shaft. Fresh air is then mixed in the basement prior to being drawn into the heating elements. The percentage of fresh air is controlled by the hinged louver system (Picture 11). Unfortunately, this system was also not operating during the assessment and appeared to have been deactivated for some time, due to mechanical issues with the fan. Therefore, the only method to introduce fresh air into classrooms was via openable windows. During the assessment, all but one classroom had windows shut, further limiting air exchange.

Louvered Supply Vent in Classroom

6. Ensure breaches/holes in attic exhaust ductwork are properly sealed to eliminate potential pollutant paths of odor migration.
7. Examine the feasibility of restoring mechanical supply ventilation to classrooms. If feasible:

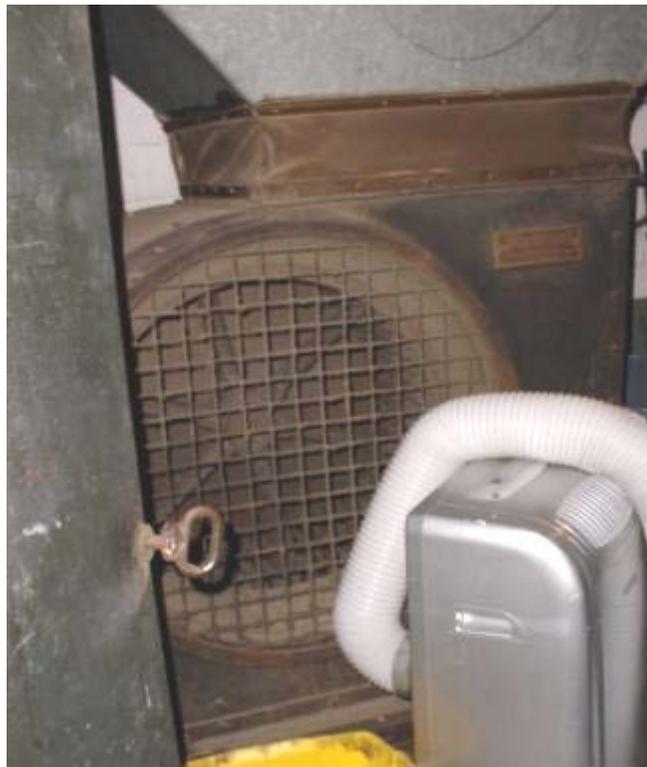
Picture 8

Vintage 1920s Axial Fan in Lower Level Mechanical Room

- Make repairs or replace axial fan in the air mixing room,
 - Restore fresh air intake/louver system, and
 - Remove stored items and conduct a through cleaning of air mixing room and surrounding areas.

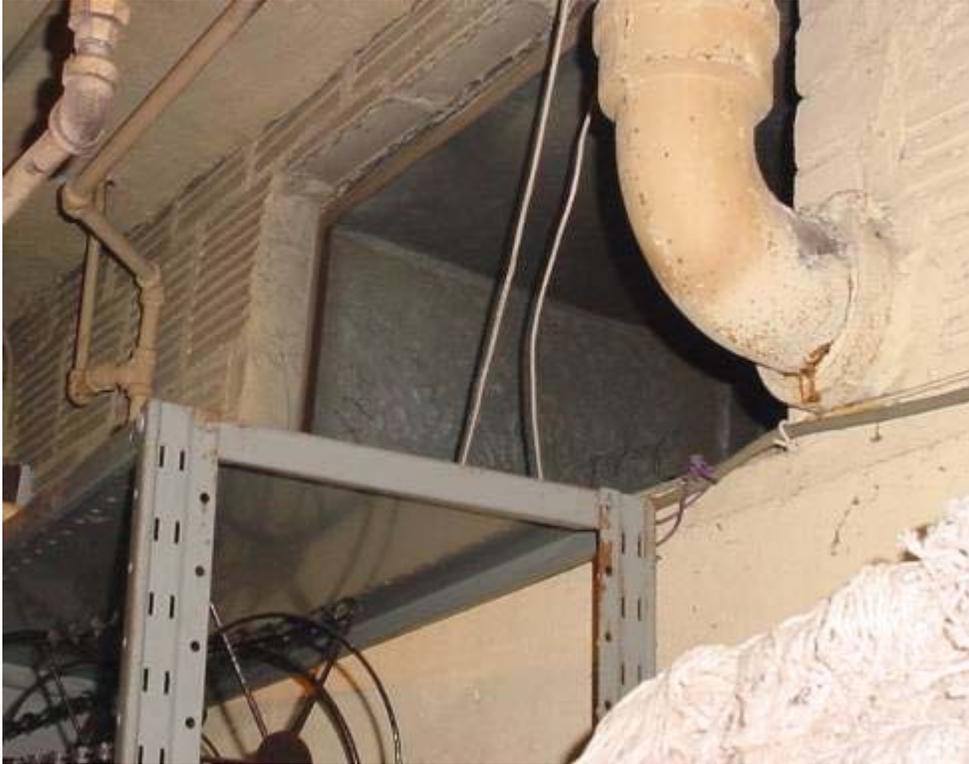
Picture 9

Fresh Air Intake Shaft for Mechanical Ventilation System in Lower Level Mechanical Room

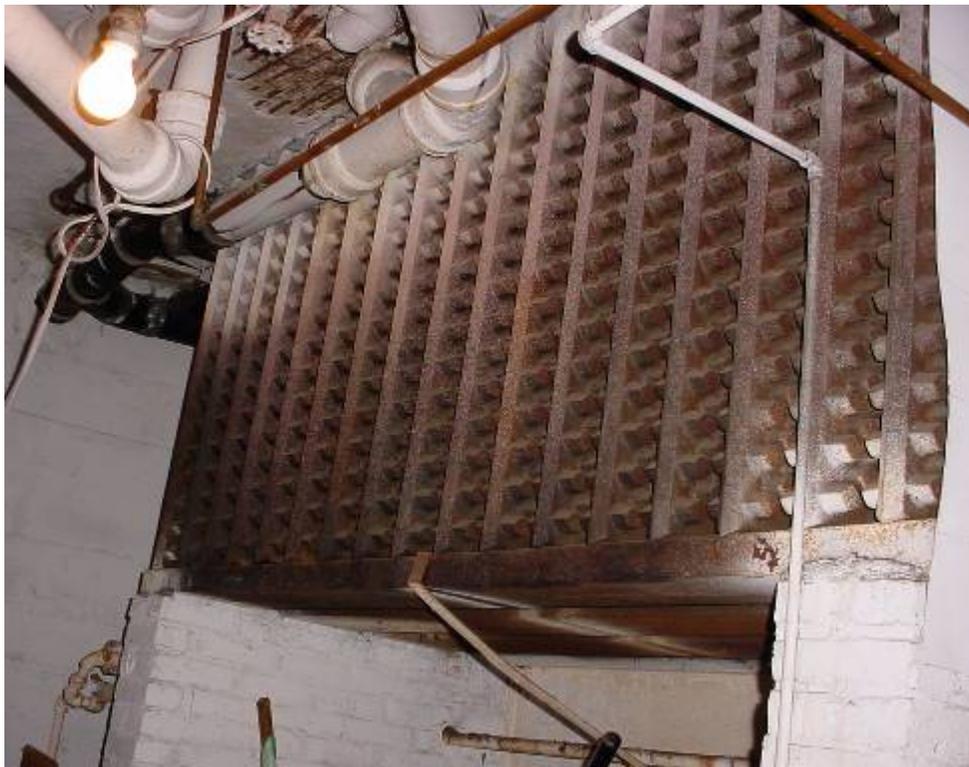
Picture 10

Large Radiant Heating Element for Mechanical Ventilation System in Lower Level Mechanical Room

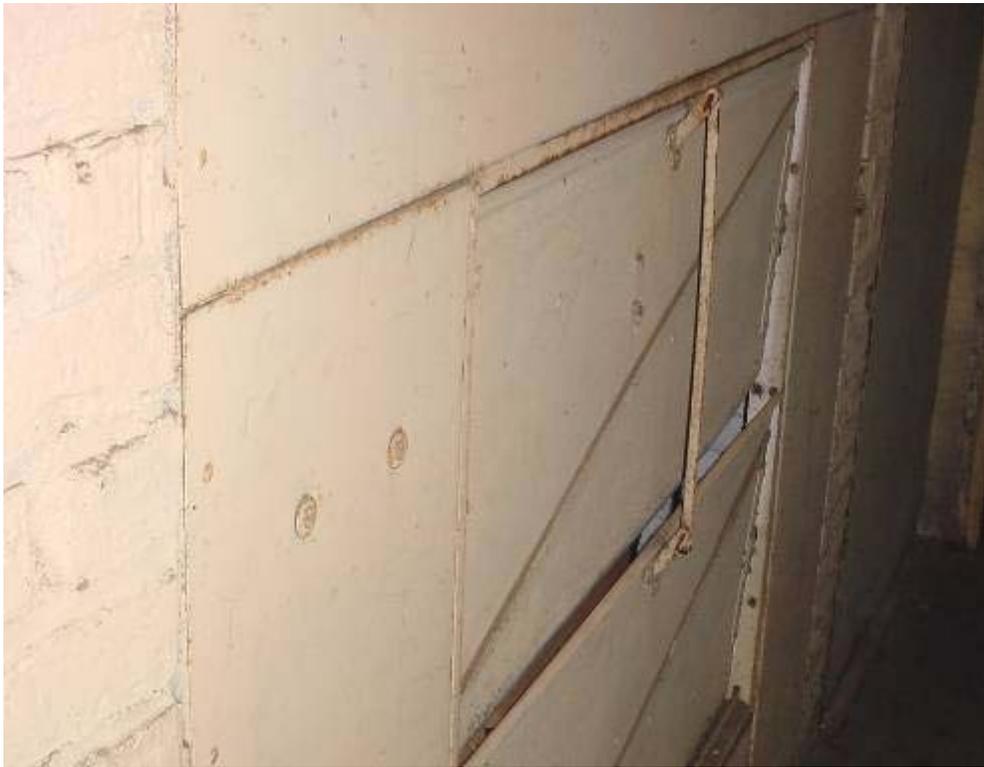
Picture 11

Louvered Vents Controlling Percentage of Fresh outside Air into Lower Level Mechanical Room

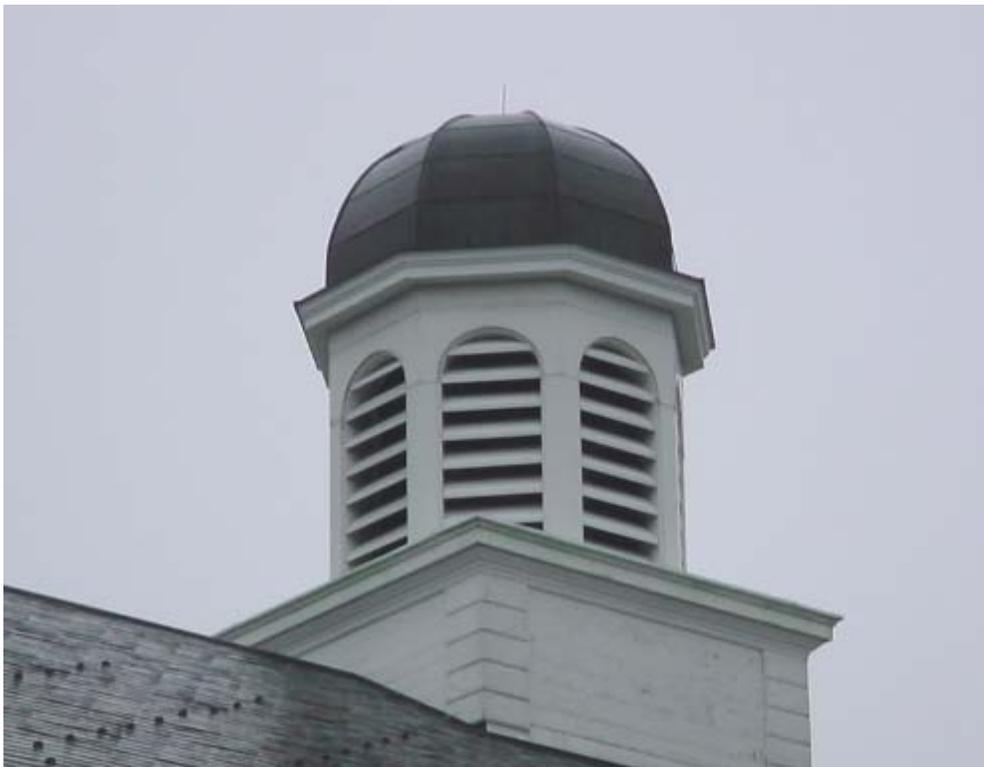
Picture 12

Exhaust ventilation is provided by a natural gravity system. This system draws air into a ducted ventilation shaft through ungrated “cubby” holes located at floor level in classrooms (Picture 12). Air is exhausted at the top of the shaft through vents located in a cupola (Picture 13). These vents were drawing air at the time of the assessment, however, without the introduction of fresh air via the supply system the rooms were essentially operating with half of the intended ventilation. Classrooms are designed to be under slight pressurization, in this case rooms were depressurized, which can draw air and odors from other parts of the building (e.g., the kitchen/cafeteria).

Cupola Exhaust Vents

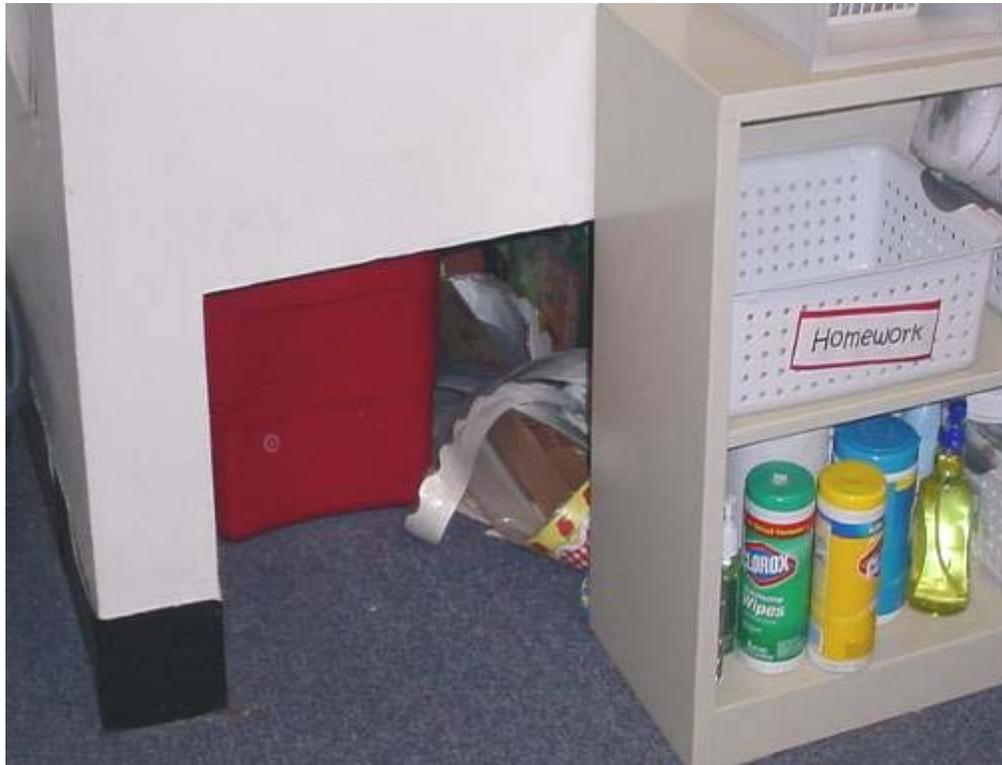
Picture 13

“Cubby” Exhaust Vent in Classroom, Note Items Stored in Vent and Cleaning Products on Open Shelf in Reach of Children

8. Remove stored items from exhaust cubbies to facilitate airflow.
9. Use openable windows in conjunction with classroom exhaust vents to increase air exchange. Care should be taken to ensure windows are properly closed at night and weekends to avoid the freezing of pipes and potential flooding.

13. Store cleaning products properly and out of reach of students.
14. Consider adopting the US EPA (2000) document, “Tools for Schools”, as an instrument for maintaining a good indoor air quality environment in the building. This document is available at: <http://www.epa.gov/iaq/schools/index.html>.
15. Refer to resource manual and other related indoor air quality documents located on the MDPH’s website for further building-wide evaluations and advice on maintaining public buildings. These documents are available at:
<http://www.state.ma.us/dph/MDPH/iaq/iaqhome.htm>.

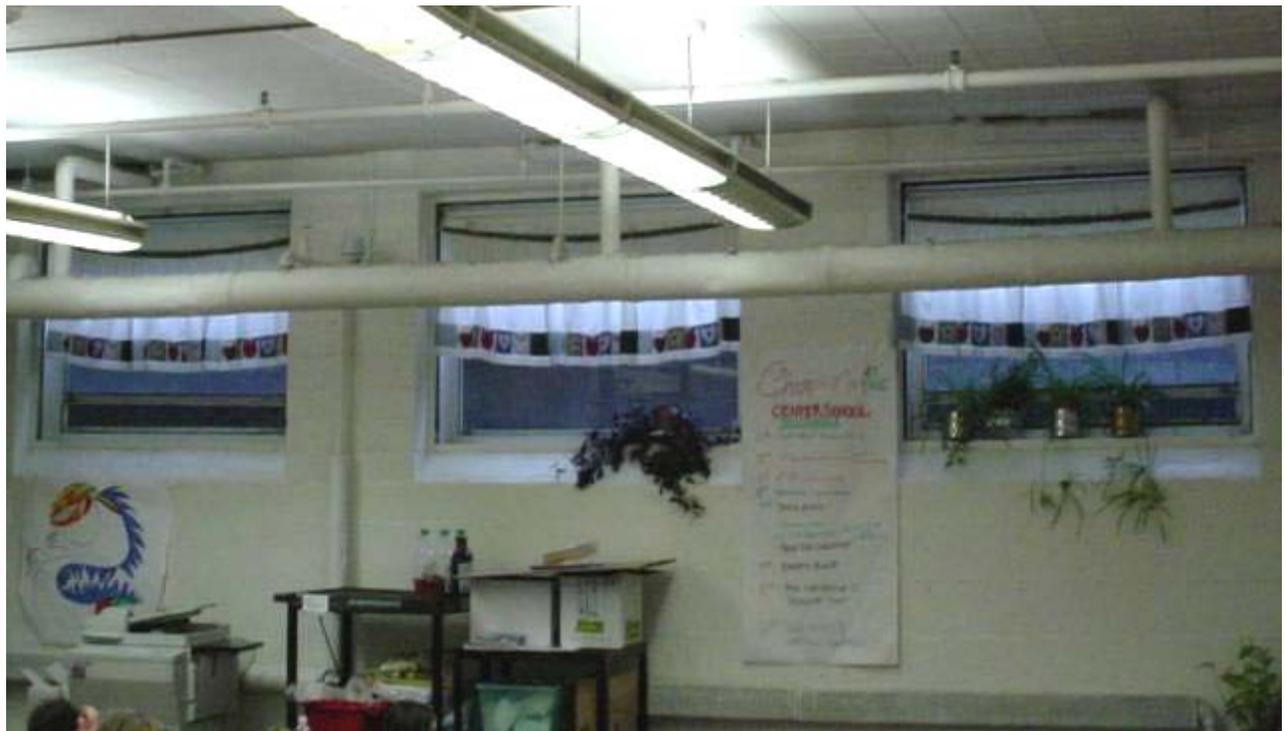
Picture 14

Openable Windows in Cafeteria

3. Continue to open cafeteria windows prior to/during hours of food preparation until a mechanical source of make-up air can be provided to the kitchen.

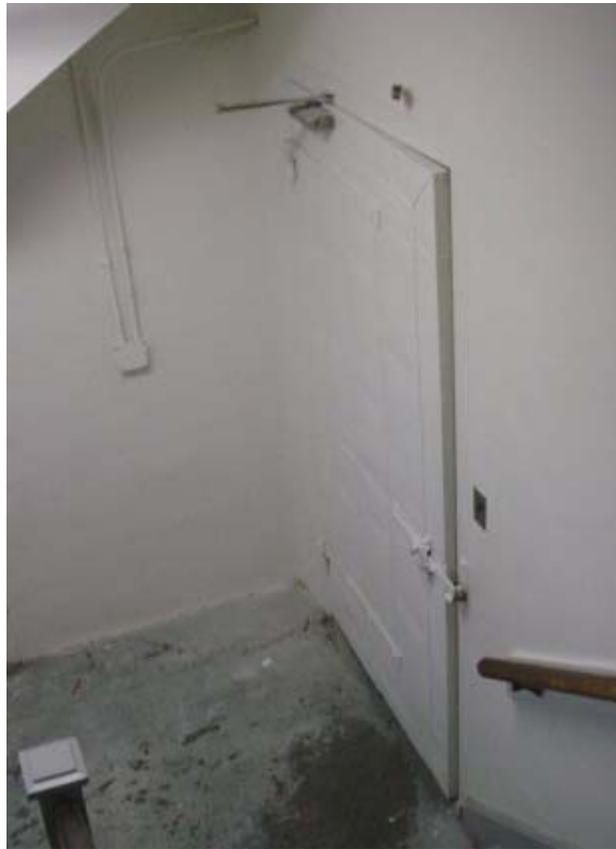
Picture 15

- The door between the cafeteria and stairwell, which was ajar (Pictures 15 and 16);
- The stairwell, which itself acts as a shaft to transport odors (Pictures 17 and 18);
- classroom doors that are open (Pictures 17 through 19);

Ajar Door between Cafeteria and Stairwell

4. Ensure all doors to the cafeteria and classrooms remain closed during hours of operation/preparation.
5. Ensure cafeteria doors fit completely flush with threshold. Seal doors on all sides with foam tape, and/or weather-stripping. Consider installing weather-

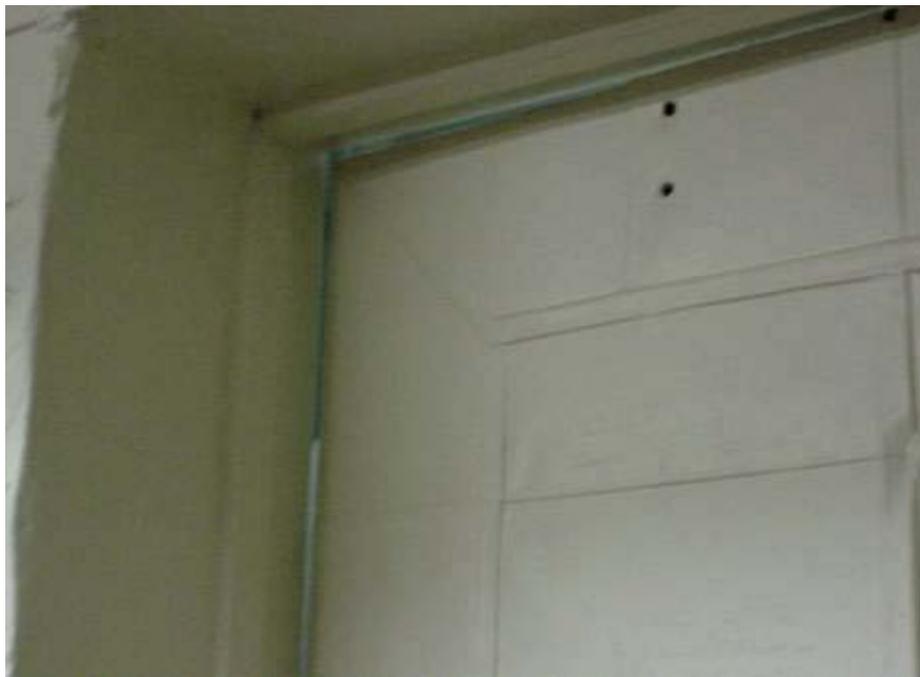
Picture 16

Ajar Door between Cafeteria and Stairwell, Note Space/Light around Door/Threshold

stripping/door sweeps on both sides to provide a dual barrier. Ensure tightness of doors by monitoring for light penetration and drafts around doorframes.

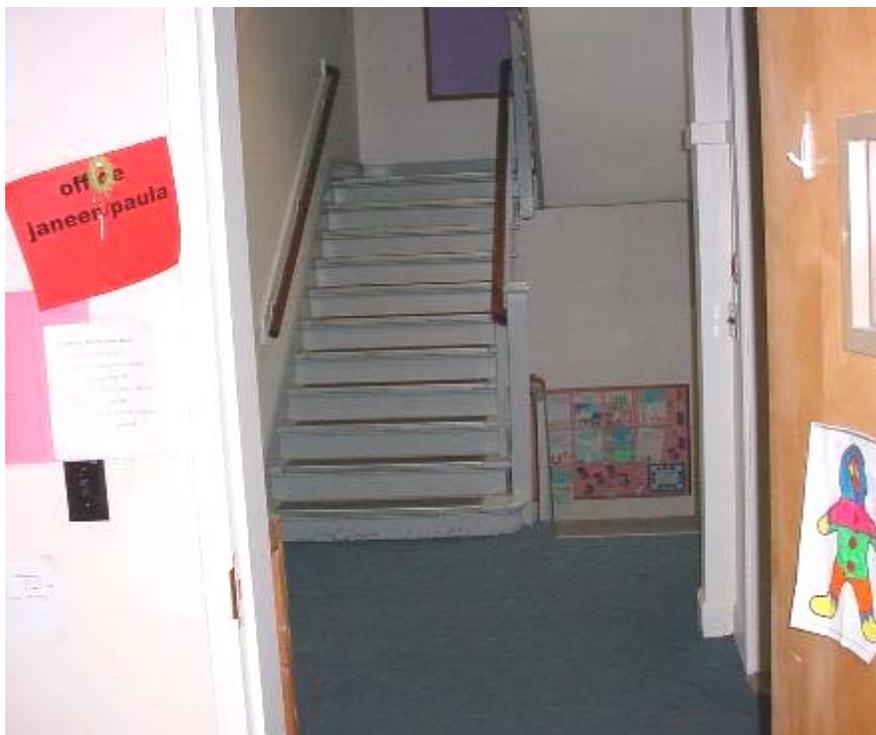
Picture 17

Main Stairwell to Cafeteria, Note Open Door

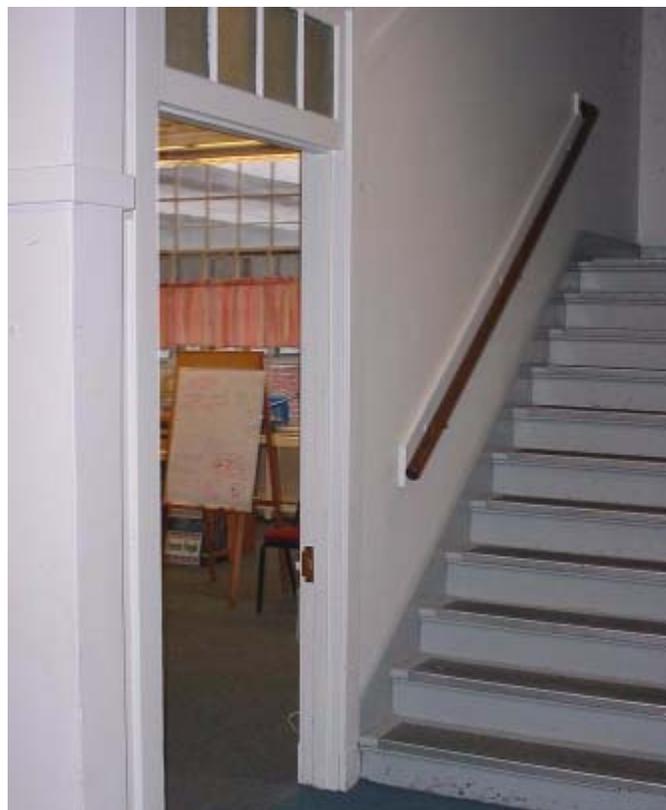
Picture 18

Open Classroom Door on Main Level to Cafeteria Stairwell

10. Ensure classroom doors are closed, to maximize air exchange.
11. Consider adopting a balancing schedule of every 5 years for all mechanical ventilation systems, as recommended by ventilation industrial standards (SMACNA, 1994).

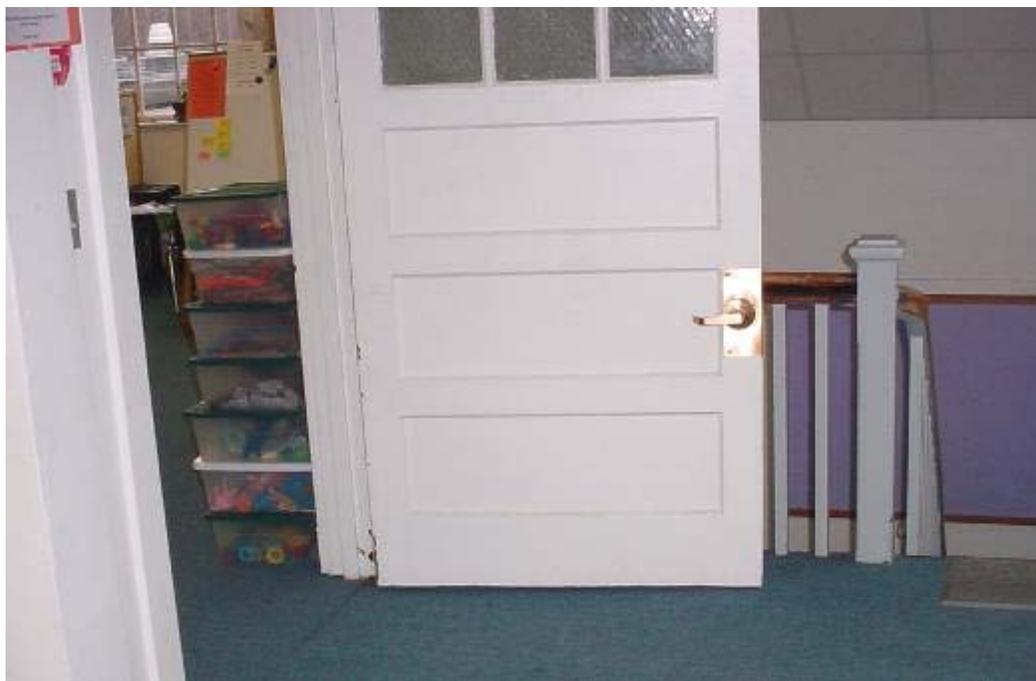
Picture 19

Open Classroom Door on Upper Level to Cafeteria Stairwell

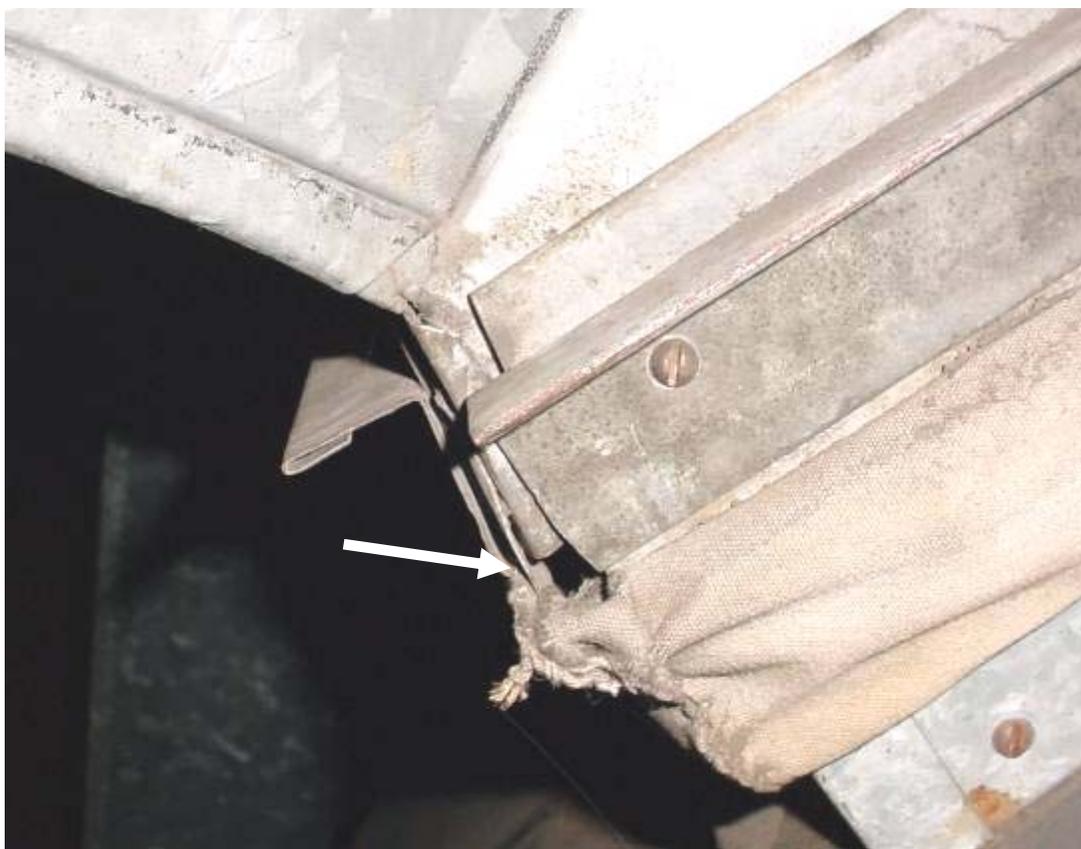
Picture 20

- Breaches in kitchen exhaust ductwork in the attic (Picture 20), which pressurizes and empties cooking odors into the attic, which can then migrate into classrooms via utility holes and or other spaces in ceilings and walls.

Hole/Breach in Kitchen Exhaust Ductwork (Attic)

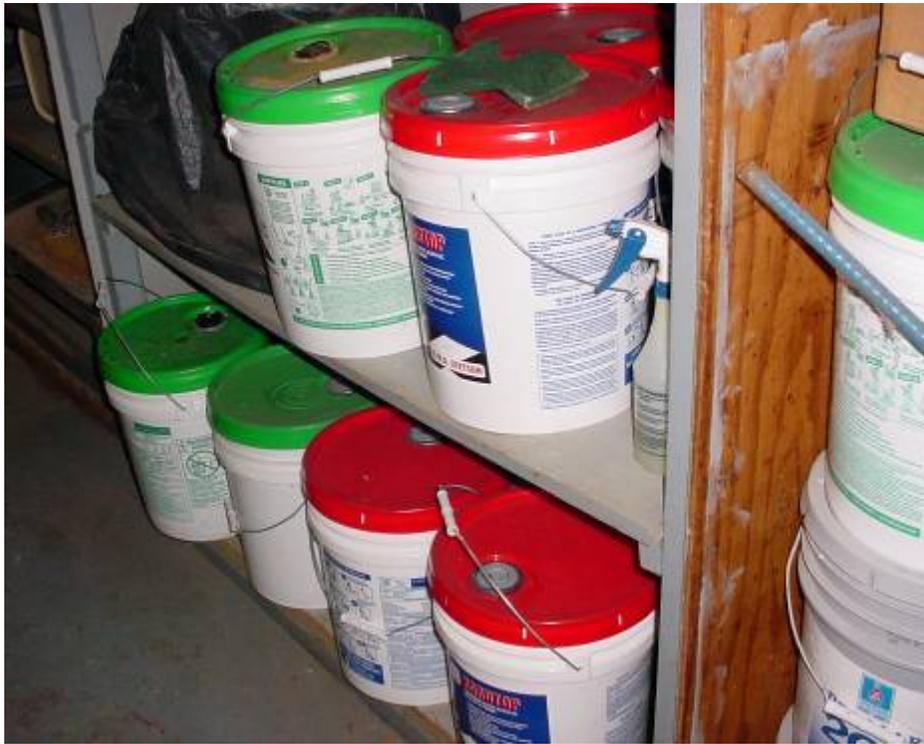
Picture 21

Other conditions that can affect indoor air quality were observed during the assessment. The air mixing room and surrounding area was being used for storage of items and cleaning chemicals (Pictures 21 and 22). Unless the ductwork/shafts are completely abandoned and properly sealed, the shafts can serve as pathways for cleaning/chemical odors to migrate into classrooms and other adjacent areas.

5-Gallon Containers of Cleaning Chemicals Stored near Air Mixing Room, Lower Level

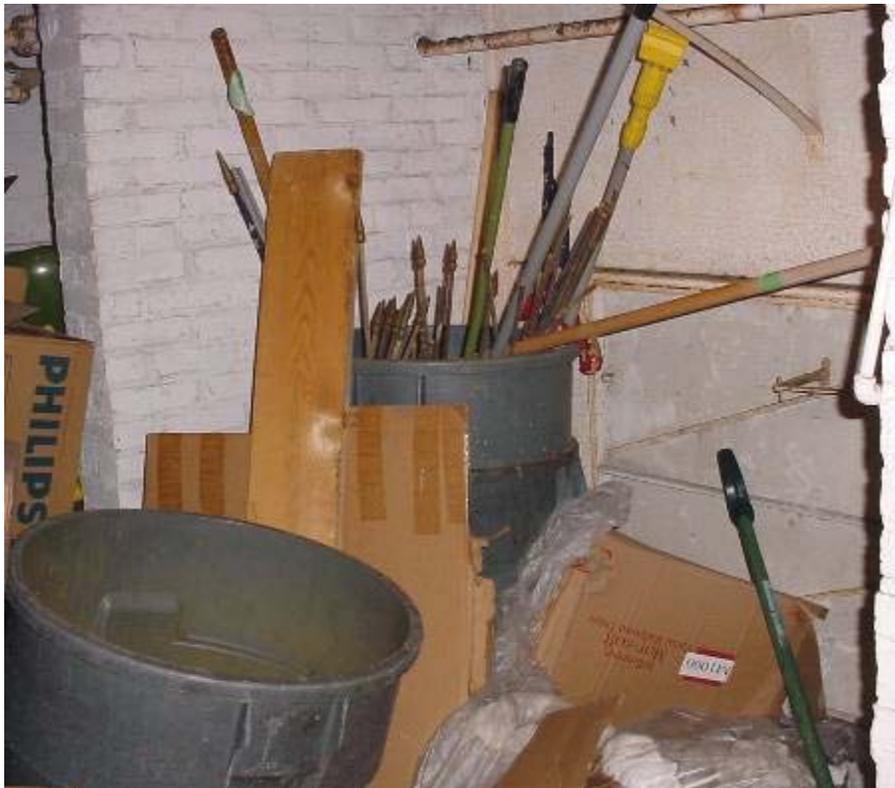
Picture 22

Various Items Stored in Air Mixing Room, Lower Level
