INDOOR AIR QUALITY ASSESSMENT INCIDENT RESPONSE

**J.S. Sullivan Elementary School
151 Kemp Avenue
North Adams, Massachusetts 01247**

Prepared by:
Massachusetts Department of Public Health
Bureau of Environmental Health
Indoor Air Quality and Environmental Toxicology Programs
October 2008

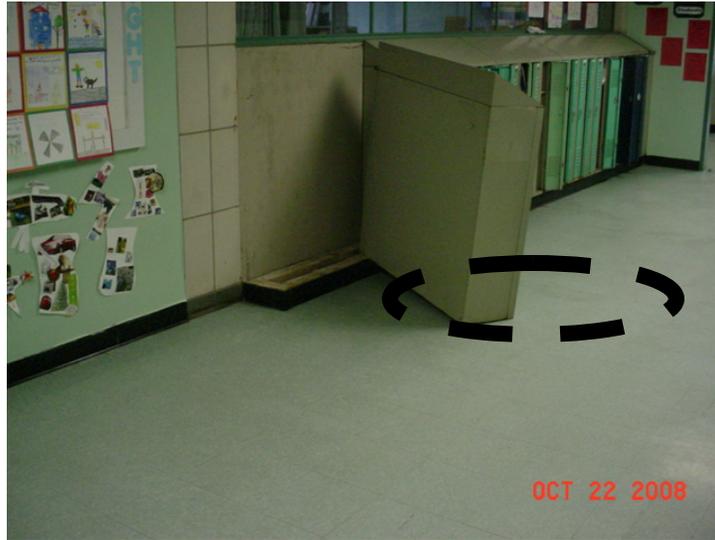
Picture 1

On October 21, 2008, school staff found the remains of a broken mercury thermometer in a hallway outside a locker in the lower wing of the building (Picture 1). Shortly after this discovery was made, the North Adams Board of Health, North Adams Fire Department, Massachusetts Department of Environmental Protection (MDEP) and State Hazardous Materials (HazMat) Team were contacted and the building was closed. The State HazMat Team conducted mercury air sampling, and evaluated/remediated contaminated materials. The HazMat team removed the lockers to clean up the spill in and around the locker. Mercury beads were removed and broken glass was picked up. The area was then cleaned with soap and water. The hallway was ventilated overnight to remove mercury vapors.

**Moved Locker Section Where Mercury Beads Were Discovered
(Circle Indicates Reported Local of Thermometer Break on Floor)**

In view of findings at the time of assessment, no further recommendations were made concerning mercury contamination clean up nor in relation to concerns over human exposure.

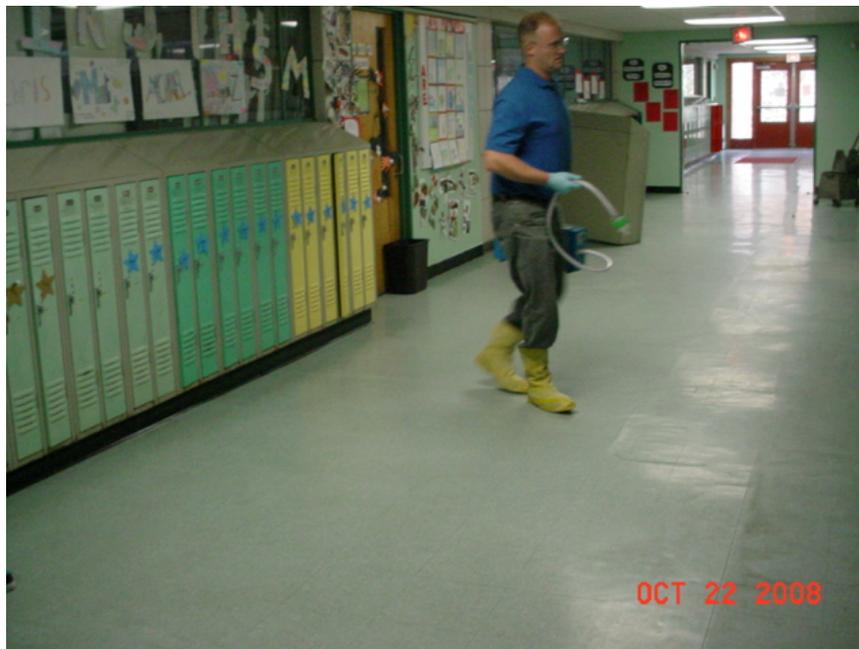
Picture 2

While it is helpful to determine if acute hazards exist, the Jerome meter does not have the capacity to measure levels less than $1 \mu\text{g}/\text{m}^3$ ($1,000 \text{ ng}/\text{m}^3$), the Agency for Toxic Substances and Disease Registry (ATSDR) Suggested Action Level (SAL) for mercury clean up air (ATSDR, 2001). In order to determine if mercury concentrations in the NACH were below the ATSDR SAL, North Adams city staff requested the MDEP conduct air sampling using a LUMEX (Picture 2). The LUMEX has a detection limit of $0.002 \mu\text{g}/\text{m}^3$ ($2 \text{ ng}/\text{m}^3$) for measuring mercury vapor (LUMEX, 2008). All samples measured on the floor and locker using the LUMEX were below the ATSDR SAL for mercury (Table 1).

DEP Staff Conducting Air Sampling With LUMEX Mercury Vapor Analyzer
