INDOOR AIR QUALITY ASSESSMENT

**Bridgewater Middle School
166 Mount Prospect Street
Bridgewater, MA 02324**

Prepared by:
Massachusetts Department of Public Health
Bureau of Environmental Health
Indoor Air Quality Program
February 2009

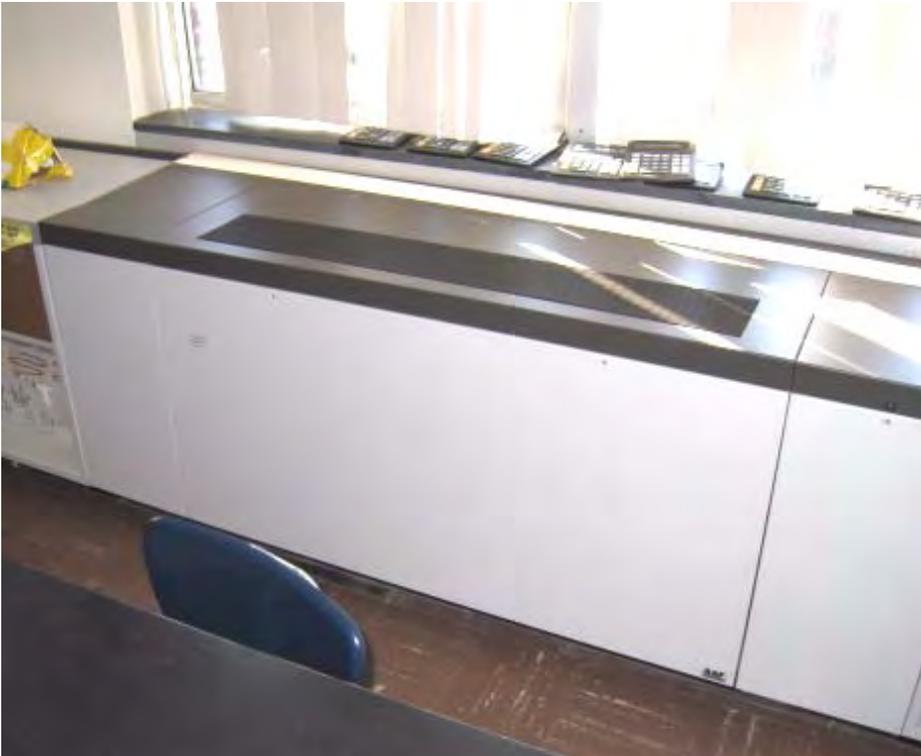
Picture 1

Classrooms have a ventilation system consisting of unit ventilators (univents) (Picture 1) and unit exhaust ventilators (unit exhaust; Picture 2) located on the exterior wall of the classrooms. The univents were operating in all but a few classrooms (Table 1). A univent is designed to draw air from outdoors through a fresh air intake located on the exterior wall of the building (Picture 3). Return air is drawn through an air intake located at the base of the unit ([Figure 1](#)). Fresh and return air are mixed, filtered, heated and provided to classrooms through an air diffuser located in the top of the unit. Unit exhausts operate in a similar fashion, drawing air into vents located along the bottom front of the unit and exhausting air to the outdoors. Unit exhaust vents were obstructed by furniture in some rooms (Table 1), which can limit air exchange.

Unit Ventilator (Univent)

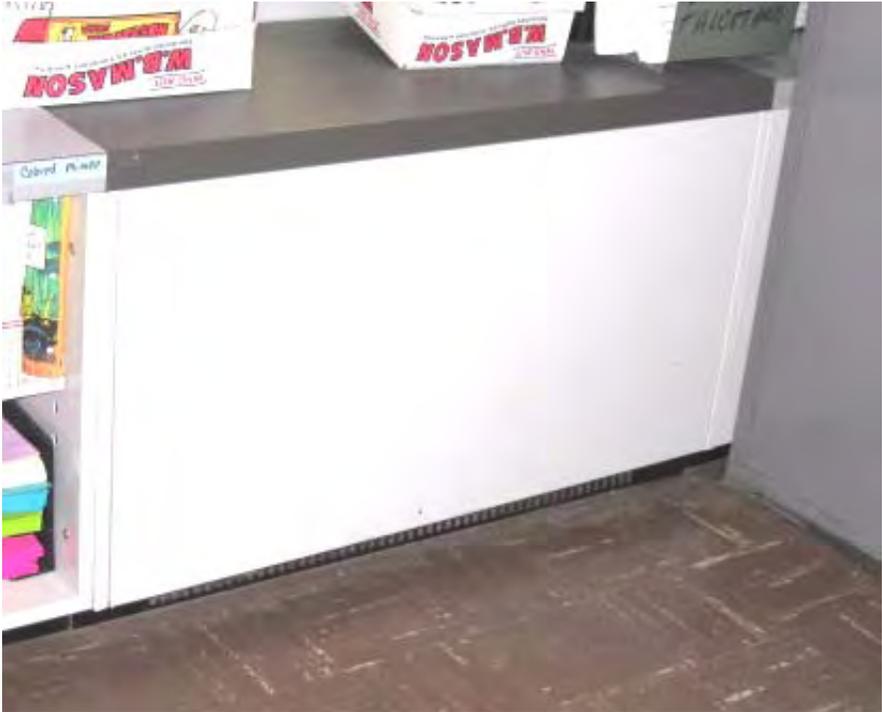
Picture 2

Unit Exhaust Ventilator

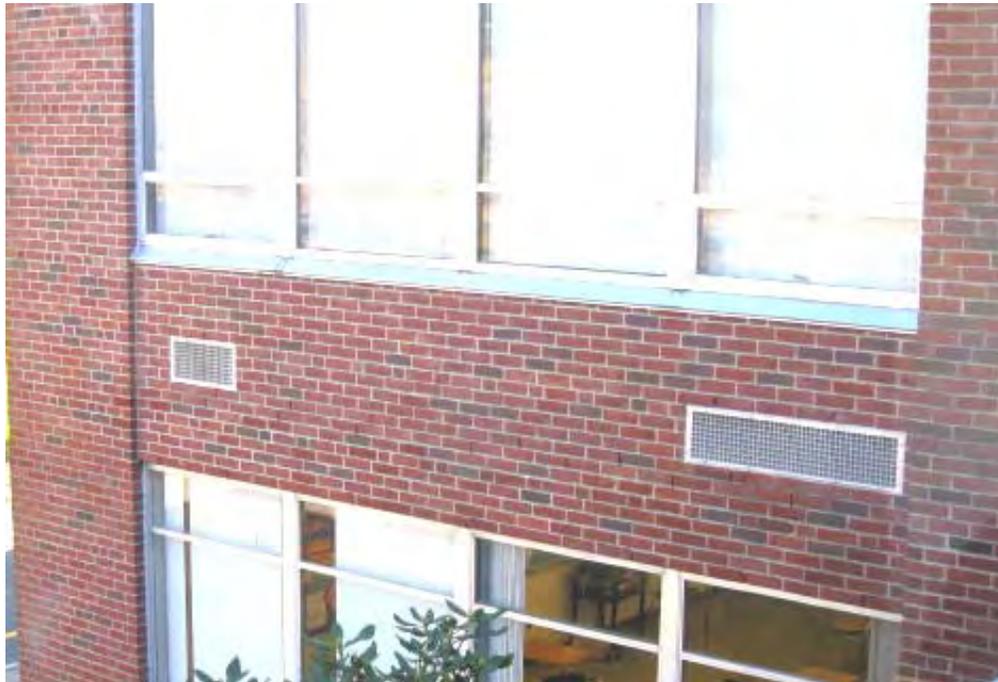
Picture 3

Univent Fresh Air Intake (Right) Unit Exhaust Vent (Left)

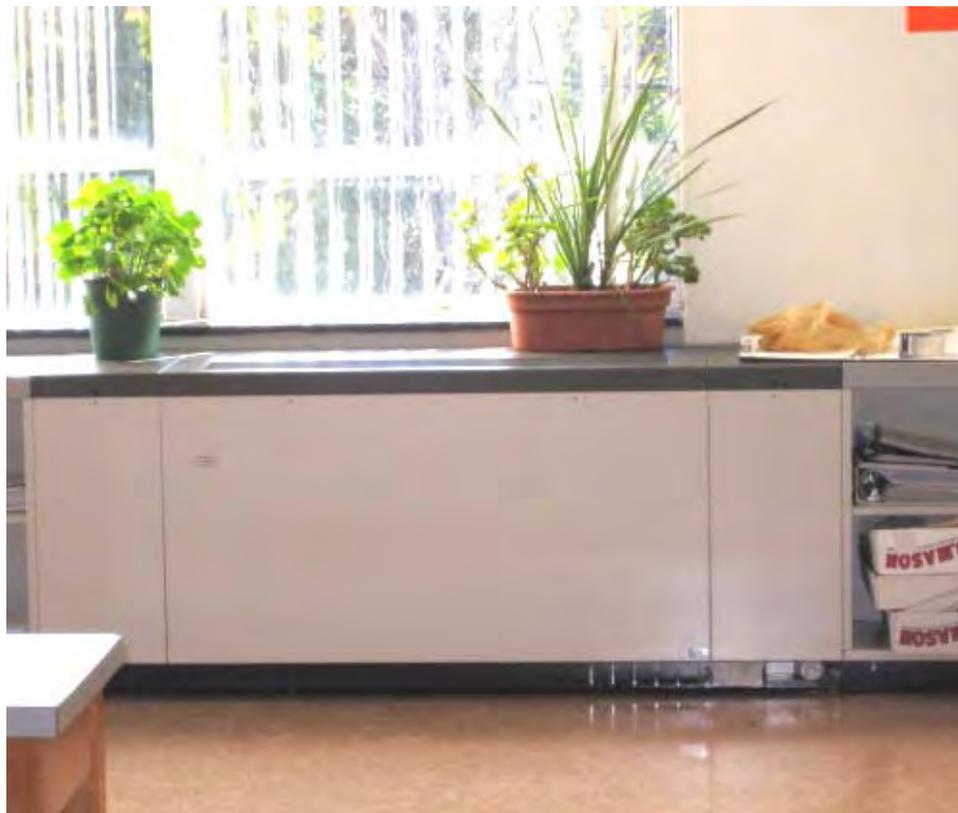
Picture 4

Plants were noted in several classrooms. Plants can be a source of pollen and mold, which can be respiratory irritants for some individuals. Plants should be properly maintained and equipped with drip pans to prevent water damage to porous building materials, which can lead to mold growth. Plants should also be located away from ventilation sources (e.g., air intakes, univent diffusers) to prevent the entrainment and/or aerosolization of dirt, pollen or mold (Picture 4).

Plants Located on/near Univent Air Diffuser

8. Ensure plants have drip pans. Examine drip pans periodically for mold growth and disinfect with an appropriate antimicrobial where necessary. Remove plants from the air stream of mechanical ventilation.

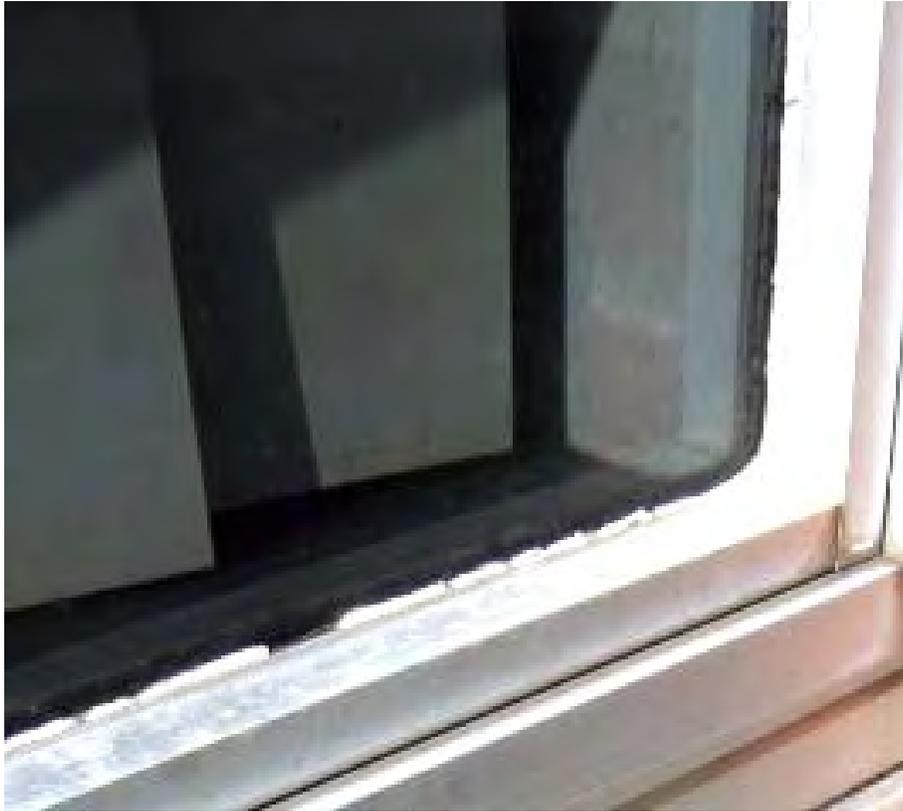
Picture 5

BEH staff examined conditions on the exterior of the building for potential sources of water pooling/penetration. Missing/damaged caulking around windows (Pictures 5 and 6) and missing/damaged mortar around exterior brick (Pictures 7 and 8) was observed. These breaches in the building envelope represent potential water penetration sources. Over time, these conditions can undermine the integrity of the building envelope and provide a means of water entry into the building via capillary action through foundation concrete and masonry (Lstiburek & Brennan, 2001). Such breaches can also provide a means of egress for drafts, as well as pests/rodents.

Missing/Damaged Caulking around Windows

9. Seal around windows/frames to prevent drafts and water penetration.
10. Repoint/repair exterior walls/foundation to prevent water penetration and pest entry.

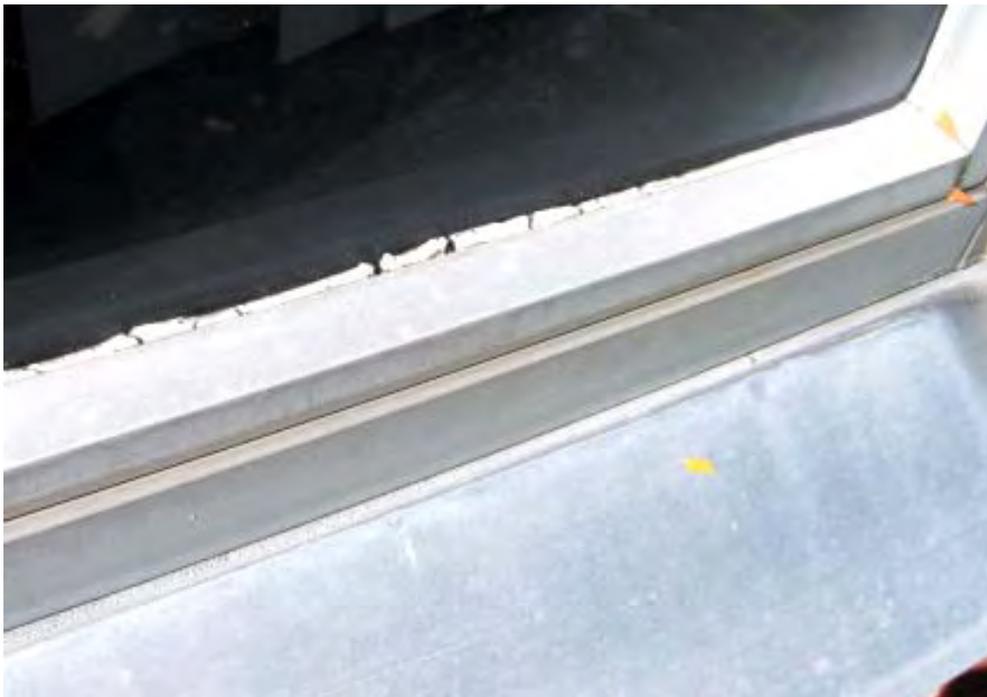
Picture 6

Missing/Damaged Caulking around Windows

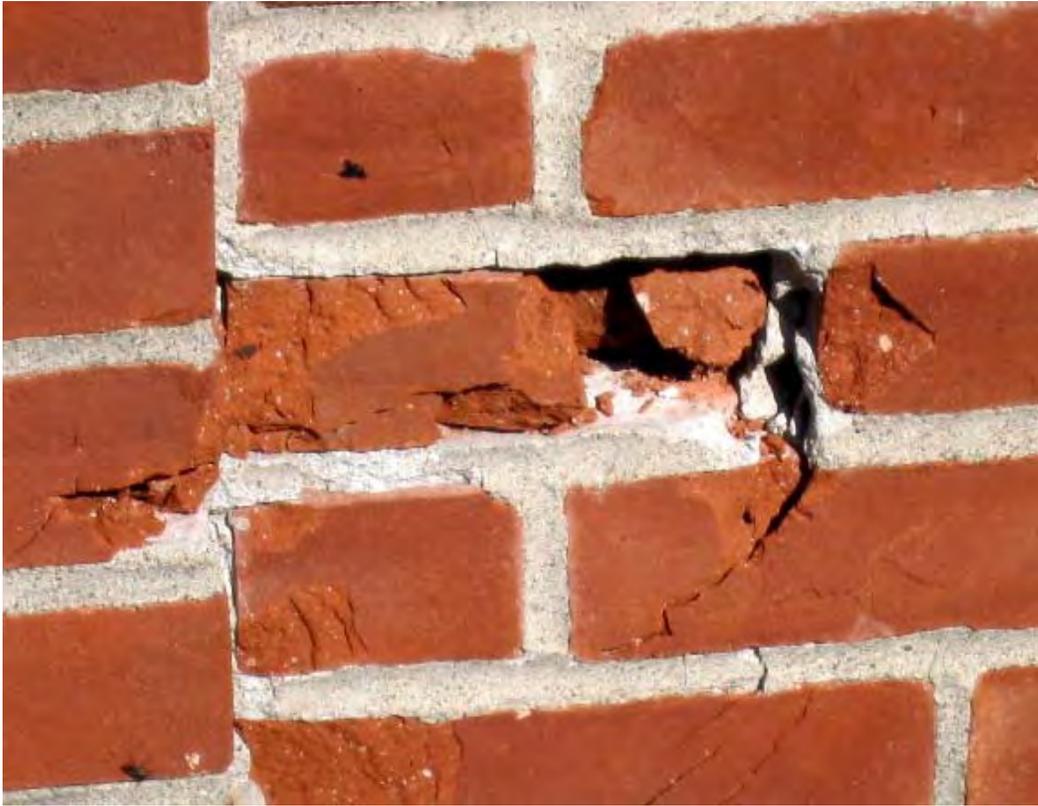
Picture 7

Damaged Exterior Brick/Mortar

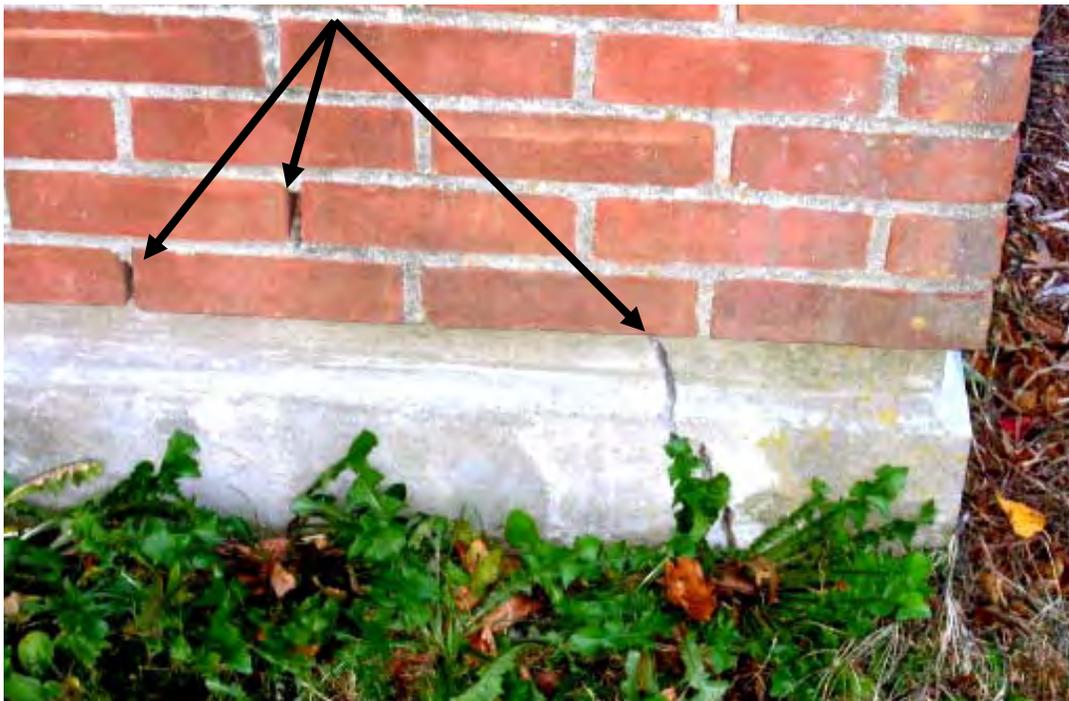
Picture 8

Crack in Foundation, Missing/Damaged Mortar around Brick

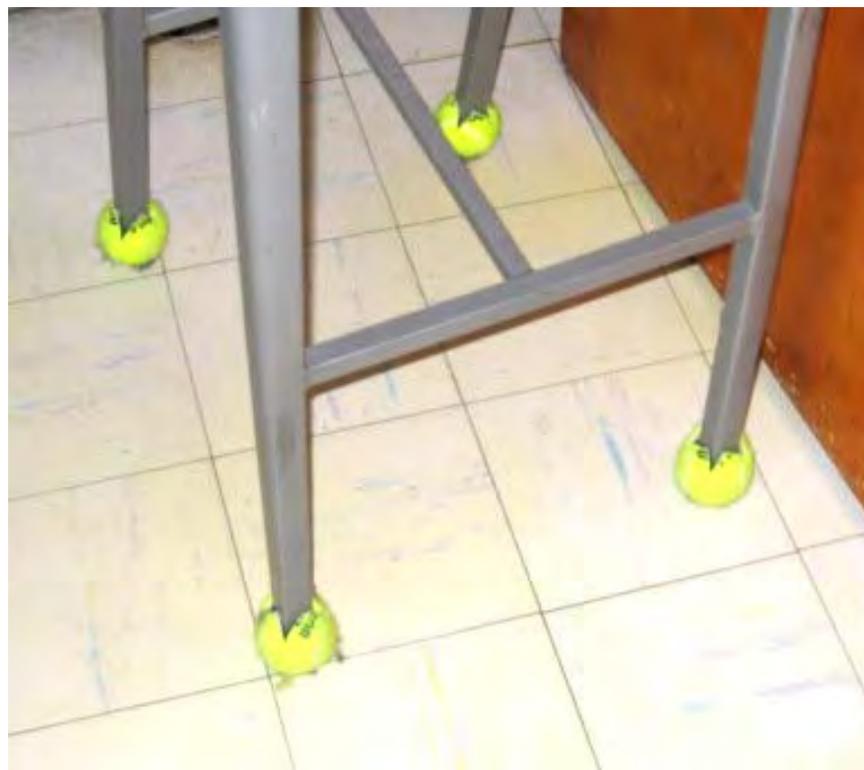
Picture 9

In an effort to reduce noise from sliding chairs, tennis balls had been sliced open and placed on chair legs (Picture 9). Tennis balls are made of a number of materials that are a source of respiratory irritants. Constant wearing of tennis balls can produce fibers and cause TVOCs to off-gas. Tennis balls are made with a natural rubber latex bladder, which becomes abraded when used as a chair leg pad. Use of tennis balls in this manner may introduce latex dust into the school environment. Some individuals are highly allergic to latex (e.g., spina bifida patients) (SBAA, 2001). It is recommended that the use of materials containing latex be limited in buildings to reduce the likelihood of symptoms in sensitive individuals (NIOSH, 1997). A question and answer sheet concerning latex allergy is attached as [Appendix B](#) (NIOSH, 1998).

Tennis Balls on Chair/Desk Legs

16. Replace latex-based tennis balls with latex-free tennis balls or glides.
17. If the locker rooms are to be used in the future, make repairs or consider replacing mechanical ventilation components and repair/replace water damaged building materials.

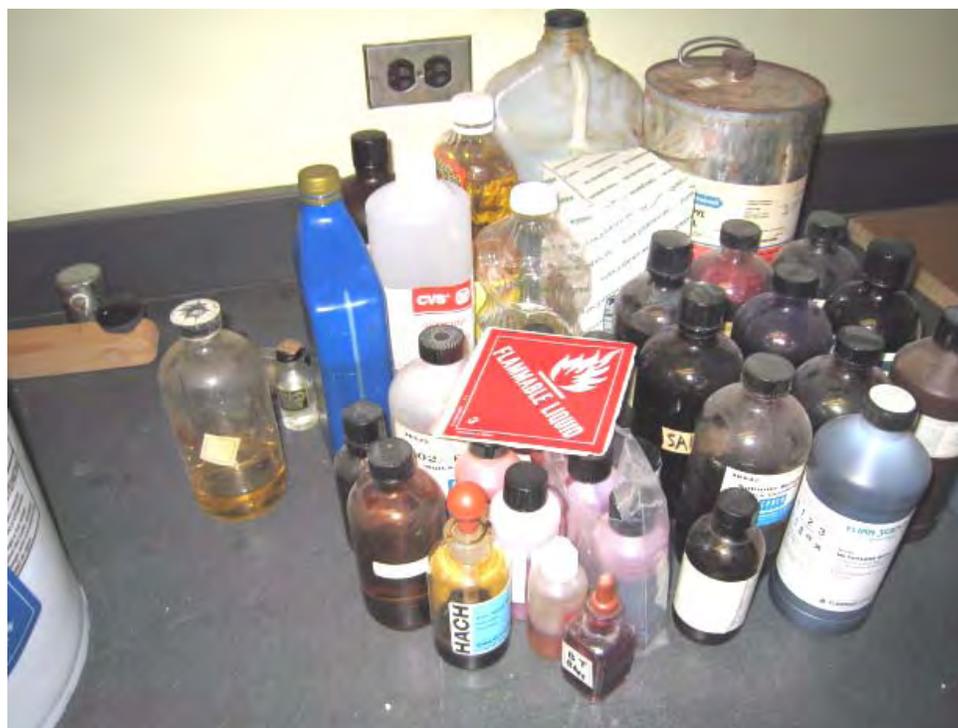
Picture 10

Several faculty members expressed concern with the presence of science chemicals in the prep room (Pictures 10 and 11). BEH staff were told by Principal Watson and Mr. Baroncelli, that the chemicals had been

Chemicals in Science Prep Room Waiting for Removal

14. Continue with plans for chemical removal in science prep room. Ensure doors to prep room locked to prevent student access.
15. Consider installing local exhaust ventilation in workrooms with photocopiers to remove excess heat and odors.

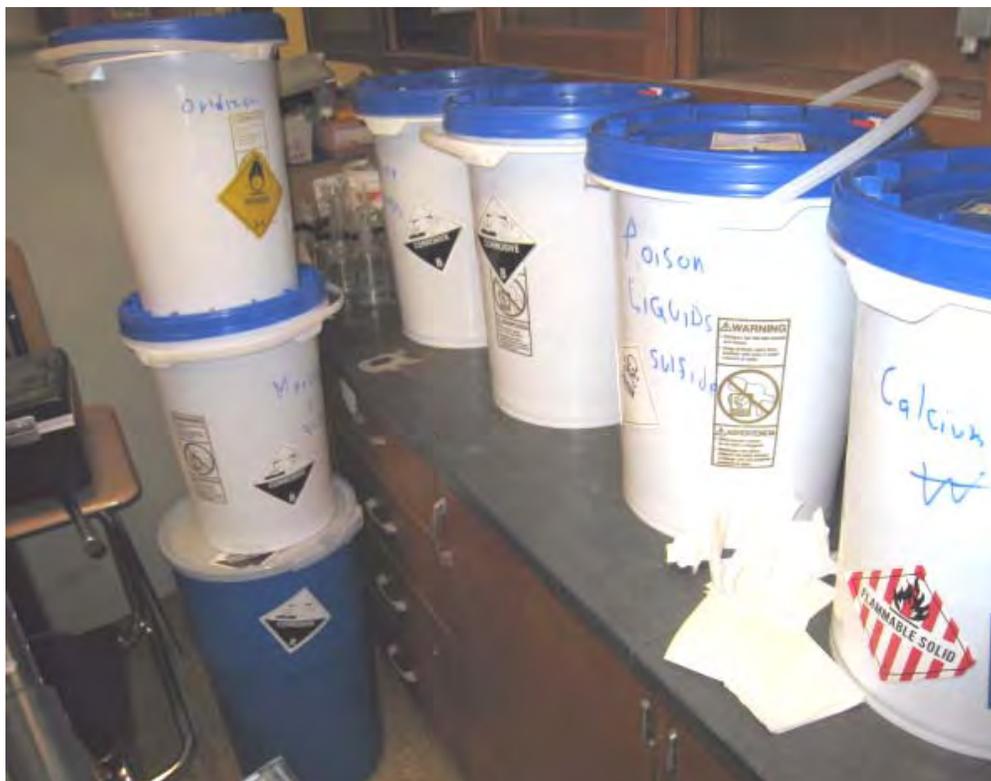
Picture 11

Chemicals in Science Prep Room Reportedly Waiting for Removal

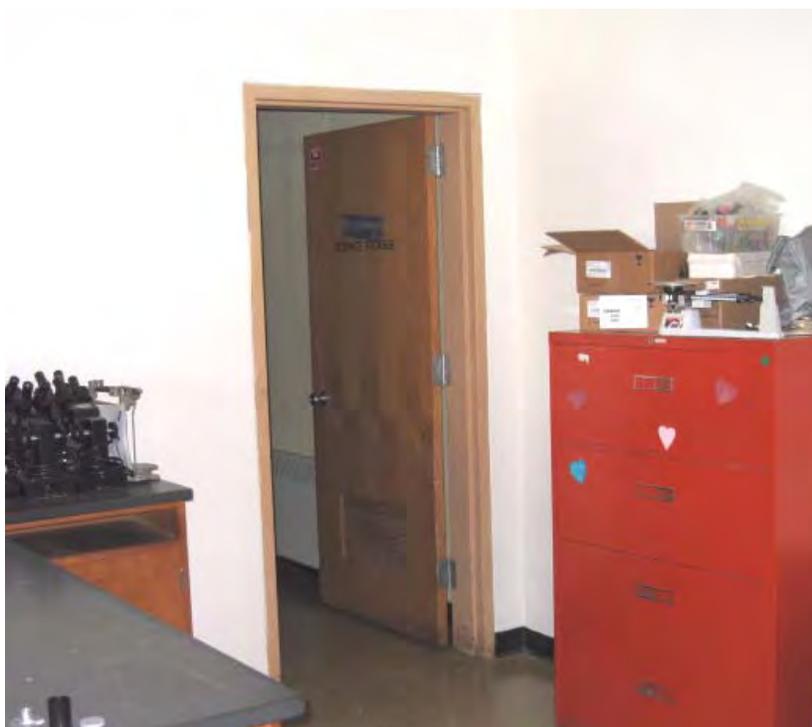
Picture 12

previously inventoried and were awaiting removal by a hazardous waste firm. BEH staff recommended that the doors to the prep room, which were found open and unlocked during the assessment (Picture 12), be kept closed and locked to prevent access by students.

Doors to Prep Room Unlocked and Open

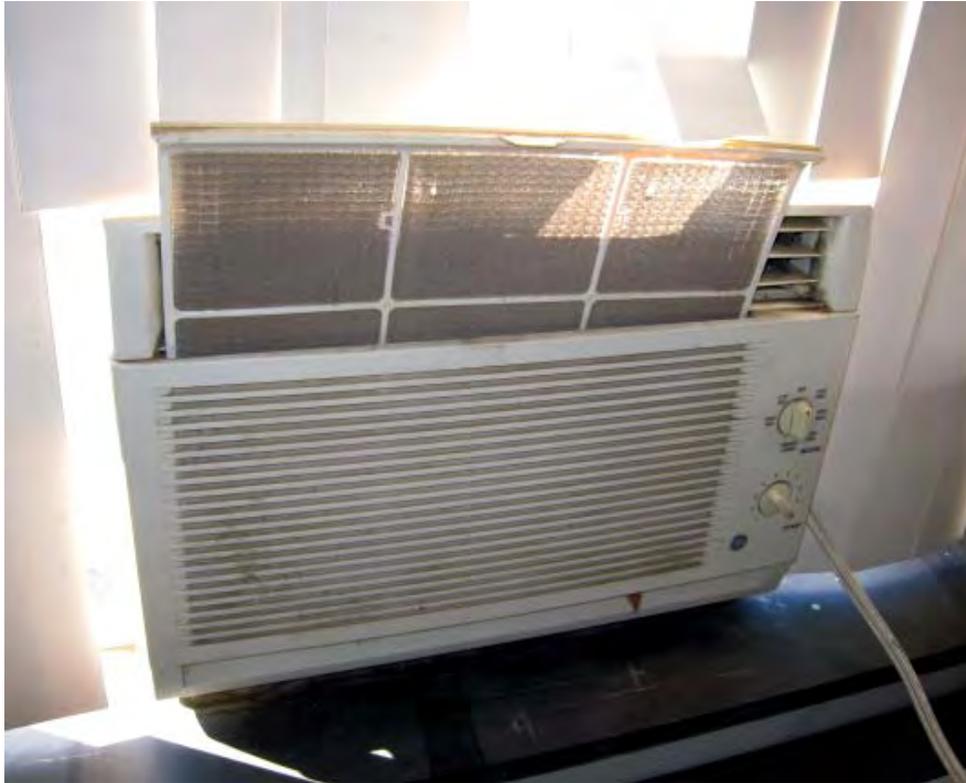
Picture 13

Other conditions that can affect indoor air quality were observed during the assessment. Many rooms contained air conditioners that had filters occluded with dust and debris, which can be re-aerosolized when activated (Picture 13). However, occupants reported that the ACs were not being used anymore due to the inaccessibility of outlets.

AC in Classroom, Note Filter Occluded With Dust and Debris

13. Clean/change filters of ACs per the manufacturer's instructions or more frequently if needed.

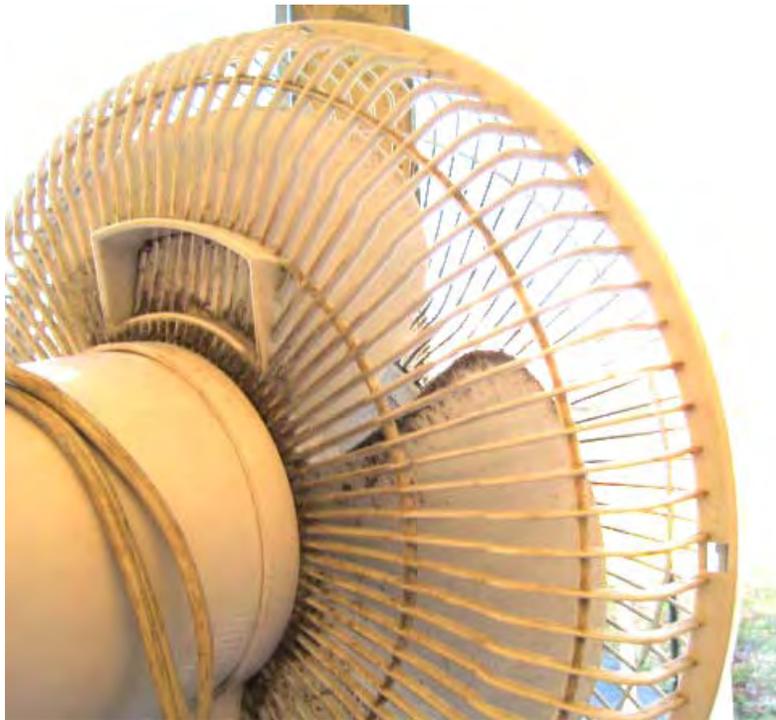
Picture 14

A number of classrooms contained personal fans that had accumulated dust (Picture 14) and/or chalk treys with accumulated chalk dust, dry erase particulate and/or pencil shavings (Pictures 15 and 16). These materials can be aerosolized during operation of the mechanical ventilation system or opening of windows and provide a source of eye, nose and respiratory tract irritation.

Accumulated Dust/Debris on Fan Blades

11. Clean accumulated dust and debris periodically from chalk/dry erase trays and blades of personal fans.
12. Store cleaning products properly and out of reach of students.

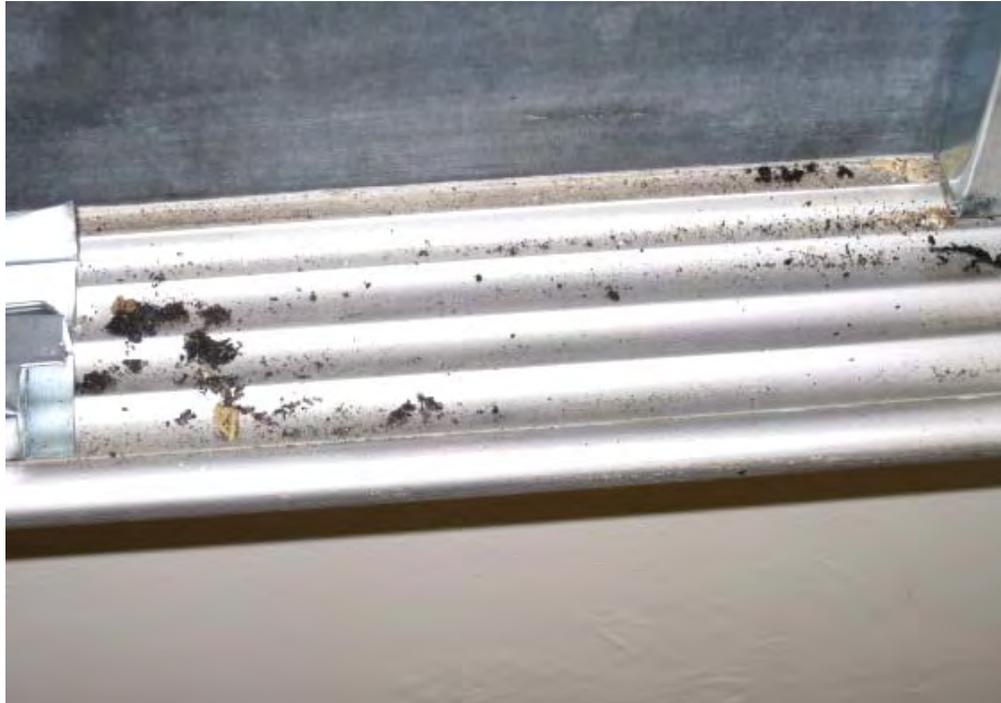
Picture 15

Accumulated Dry Erase Particulate

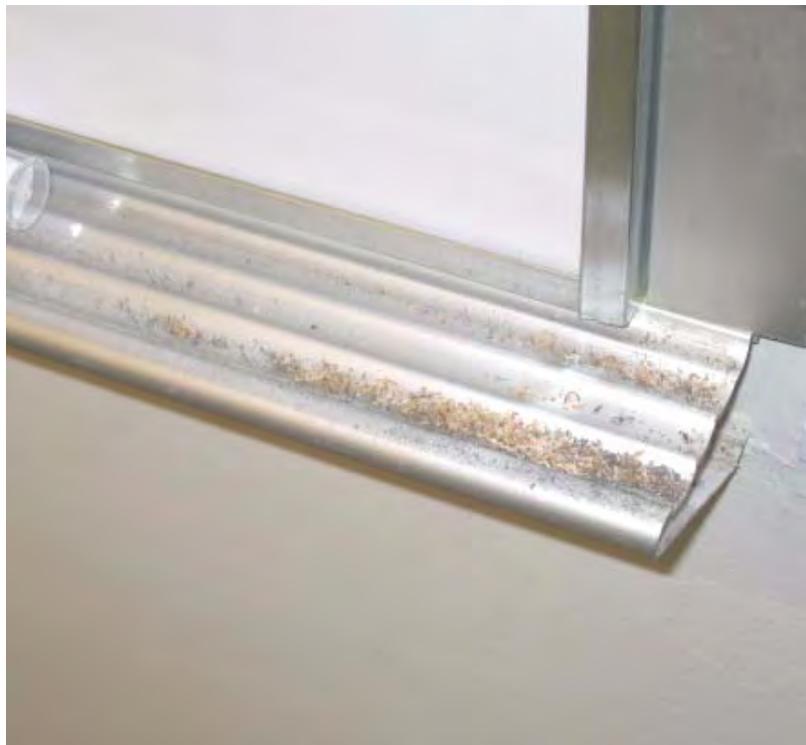
Picture 16

Accumulated Pencil Shavings
