INDOOR AIR QUALITY ASSESSMENT

**Williams Intermediate School
200 South Street
Bridgewater, Massachusetts 02324**

Prepared by:
Massachusetts Department of Public Health
Bureau of Environmental Health
Indoor Air Quality Program
January 2009

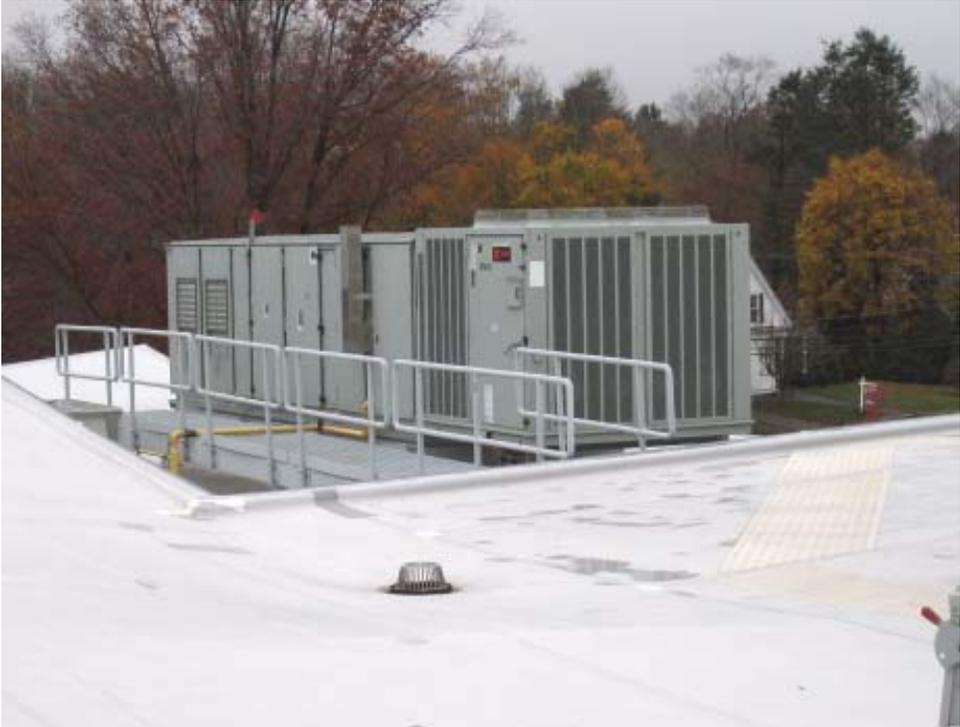
Picture 1

Fresh air for common areas such as the gymnasium, cafeteria, library and administrative areas is provided by rooftop or ceiling-mounted air handling units (AHUs). AHUs draw in air from outdoor air intakes; filter, heat and/or cool the air, then distribute it to occupied areas via ceiling or wall-mounted air diffusers. Exhaust air is returned back to the AHUs via ceiling-mounted return vents. These systems appeared to be operating during the assessment.

Rooftop Air Handling Unit

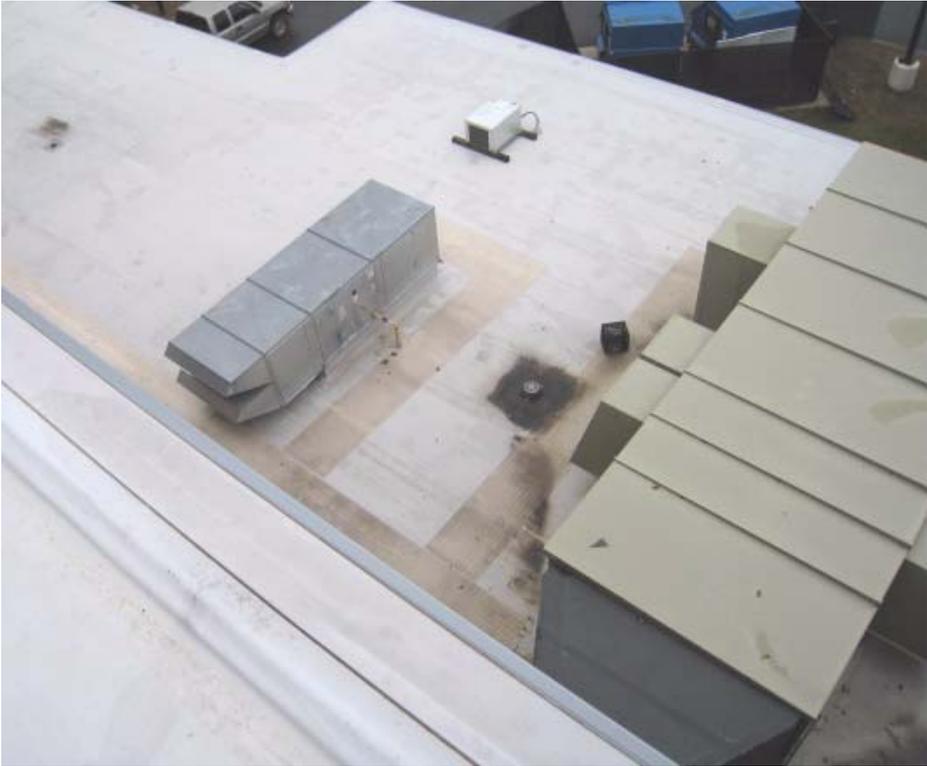
Picture 2

Rooftop Air Handling Units

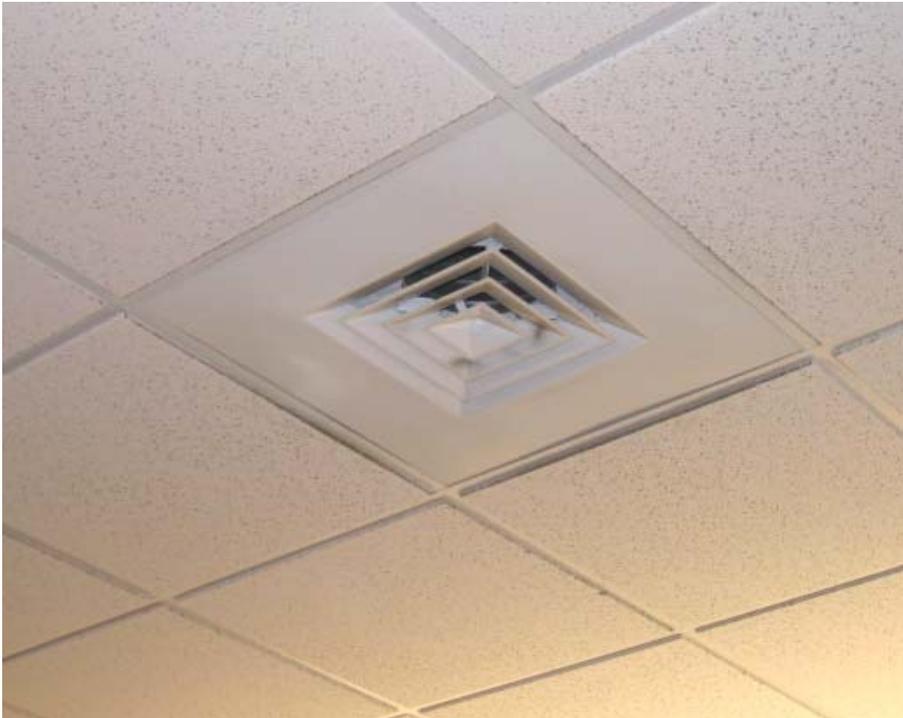
Picture 3

Ceiling-Mounted Supply Diffuser

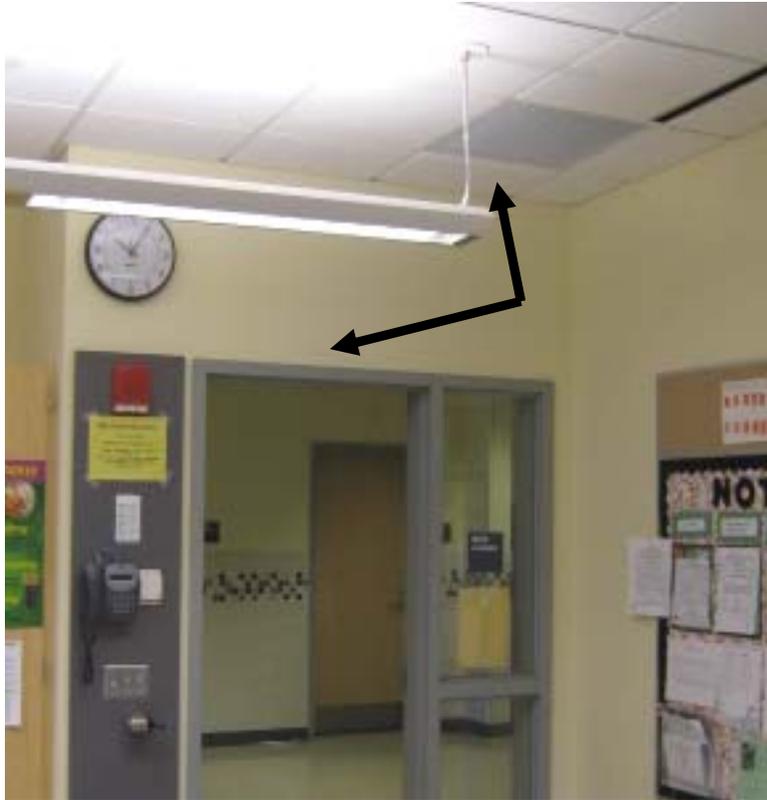
Picture 5

It can be seen from Table 1 that carbon dioxide (CO₂) levels were above 800 parts per million (ppm) in 9 of 42 areas surveyed in the north wing, indicating adequate ventilation in the majority of areas surveyed during the assessment (Table 1). However, it is worthwhile to note that a number of rooms were sparsely populated, which generally results in lower CO₂ levels. Mechanical ventilation in the north wing is provided by rooftop air handling units ducted to ceiling-mounted supply and return vents (Pictures 1 through 5). Some exhaust vents are located near classroom doors (Picture 5). Due to their location, the exhaust capabilities of these vents can be diminished when the doors are left open (Picture 5). With the classroom doors open, the return/exhaust vent tends to draw air from the hallway *into* the classrooms instead of stale air *out* of the classroom.

Proximity of Return Vent to Open Classroom Door

4. Continue with plans to repair rooftop exhaust vents.
5. Remove all blockages from univents and exhaust vents to ensure adequate airflow.
6. Close classroom doors to facilitate air exchange.

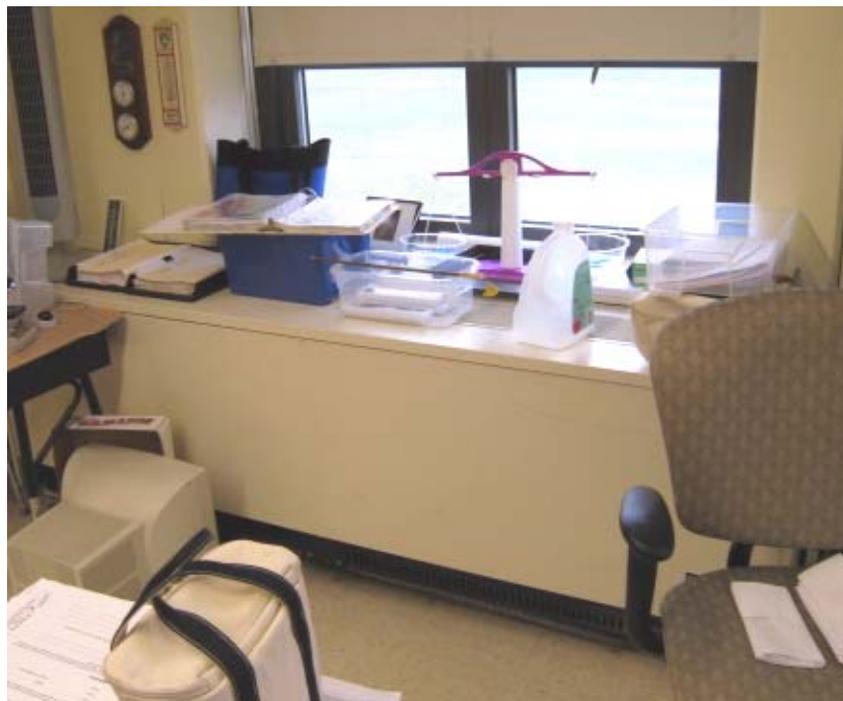
Picture 6

Classrooms in the south wing have a ventilation system consisting of unit ventilators (univents) (Pictures 6 and 7). A univent is designed to draw air from outdoors through a fresh air intake located on the exterior wall of the building (Picture 8). Return air is drawn through an air intake

located at the base of the unit ([Figure 1](#)). Fresh and return air are mixed, filtered, heated and provided to classrooms through an air diffuser located in the top of the unit. Univents were deactivated in a few rooms (Table 2); in others, air diffusers were obstructed by various items (Picture 6) that can limit air exchange. The univents in classroom S-148 and S-321 were making a “rattling” noise, which can indicate a mechanical issue.

Typical Unit Ventilator (Univent) in Classroom, Note Items on Air Diffuser

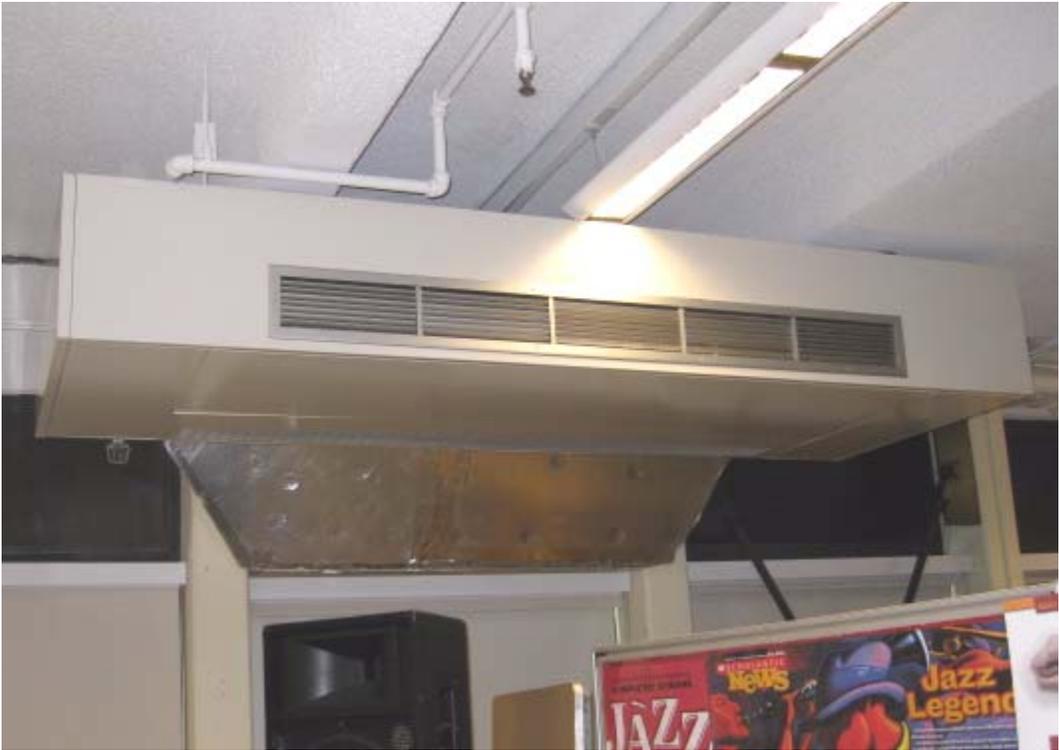
Picture 7

Ceiling –Mounted Univent

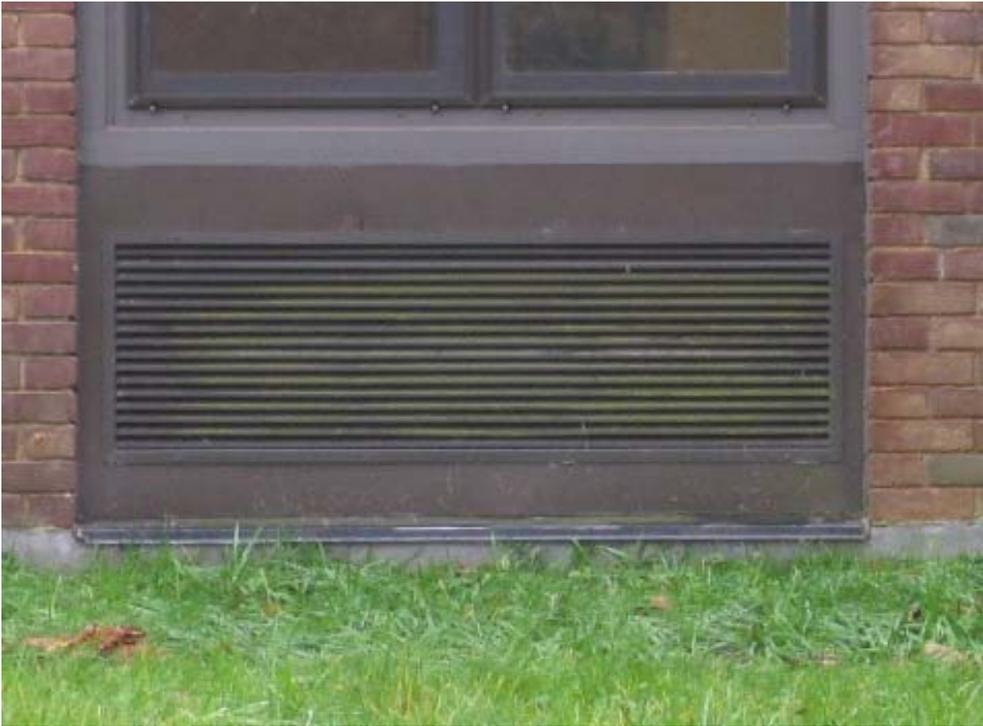
Picture 8

Univent Fresh Air Intake

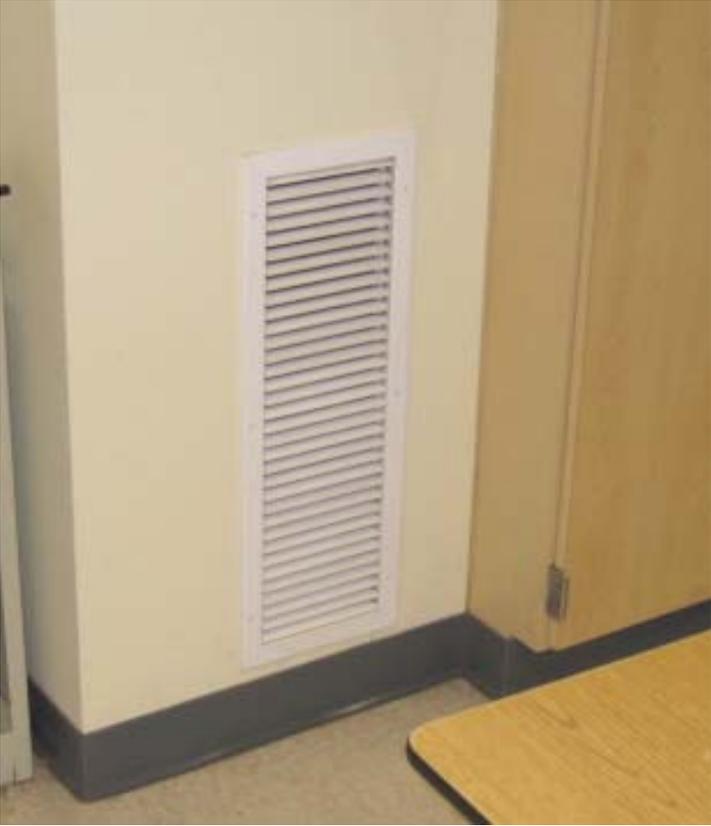
Picture 9

Exhaust ventilation in south wing classrooms is provided by wall vents ducted to rooftop motors. At the time of the assessment, building maintenance staff reported that two of the exhaust motors were inoperable and that replacement parts were on order. Exhaust vents in several classrooms were partially obstructed by furniture and other items (Picture 10). As with univents, in order to function properly, exhaust vents must be activated and allowed to operate free from obstructions while rooms are occupied.

South Classroom Exhaust Vent

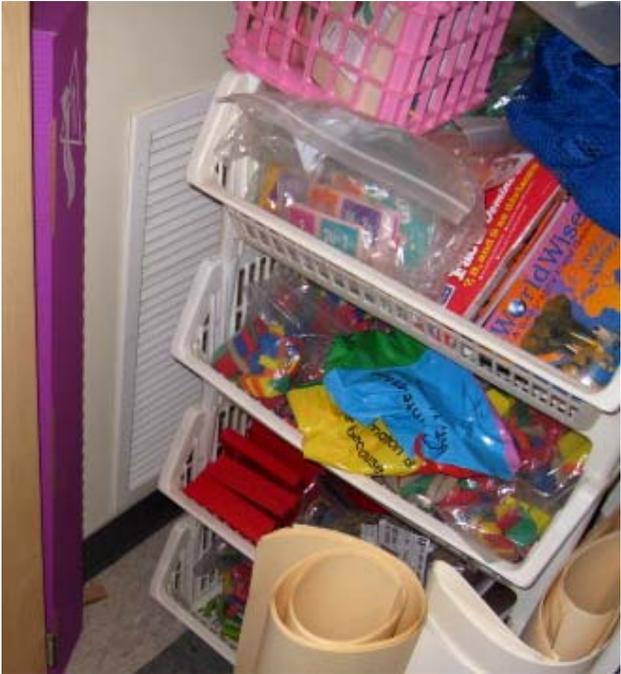
Picture 10

Partially Obstructed South Classroom Exhaust Vent

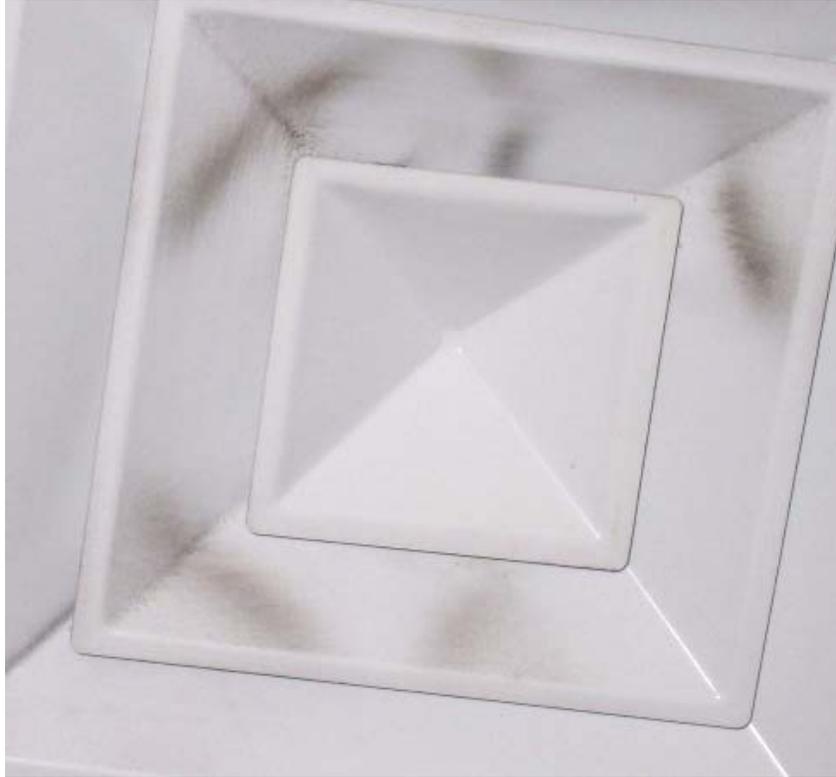
Picture 11

Finally, a number of supply diffusers, exhaust/return vents and personal fans (Pictures 11 and 12) were observed to have accumulated dust. If exhaust vents are not functioning, backdrafting can occur, which can re-aerosolize accumulated dust particles. Re-activated univents and fans can also aerosolize dust accumulated on vents/fan blades.

Accumulated Dust/Debris on Supply Diffuser

11. Clean accumulated dust and debris periodically from supply diffusers, return/exhaust vents and personal fans.
12. Relocate or consider reducing the amount of materials stored in classrooms to allow for more thorough cleaning of classrooms. Clean items regularly with a wet cloth or sponge to prevent excessive dust build-up.
13. Consider adopting the US EPA (2000) document, “Tools for Schools”, to maintain a good indoor air quality environment on the building. This document can be downloaded from the Internet at: <http://www.epa.gov/iaq/schools/index.html>.
14. Refer to resource manuals and other related indoor air quality documents for further building-wide evaluations and advice on maintaining public buildings. Copies of these materials are located on the MDPH’s website: http://mass.gov/dph/indoor_air

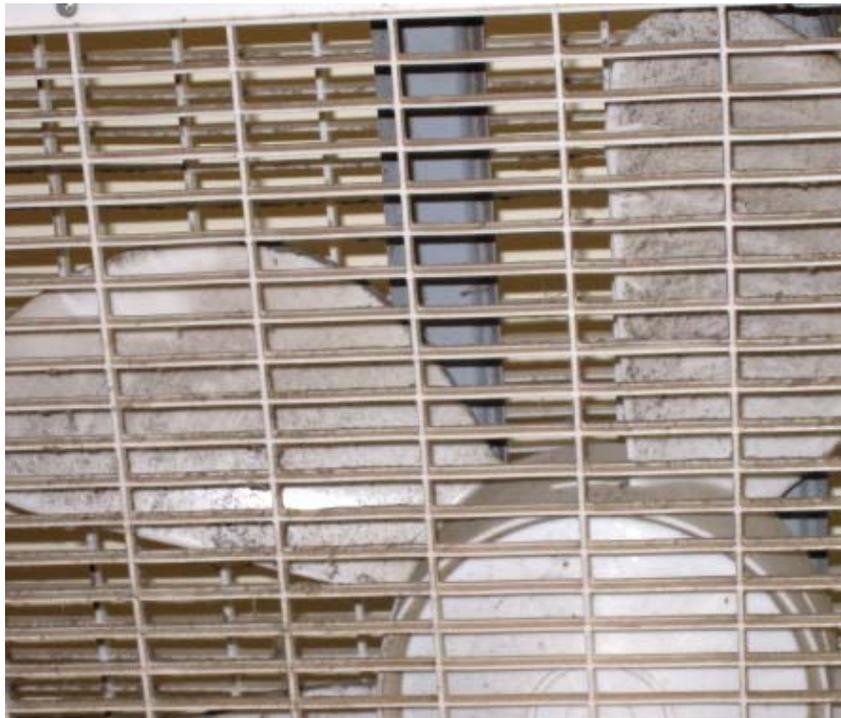
Picture 12

Accumulated Dust/Debris on Personal Fan
