INDOOR AIR QUALITY ASSESSMENT

**Georgetown Middle/High School
11 Winter Street
Georgetown, Massachusetts 01833**

Prepared by:
Massachusetts Department of Public Health
Bureau of Environmental Health
Indoor Air Quality Program
August 2009

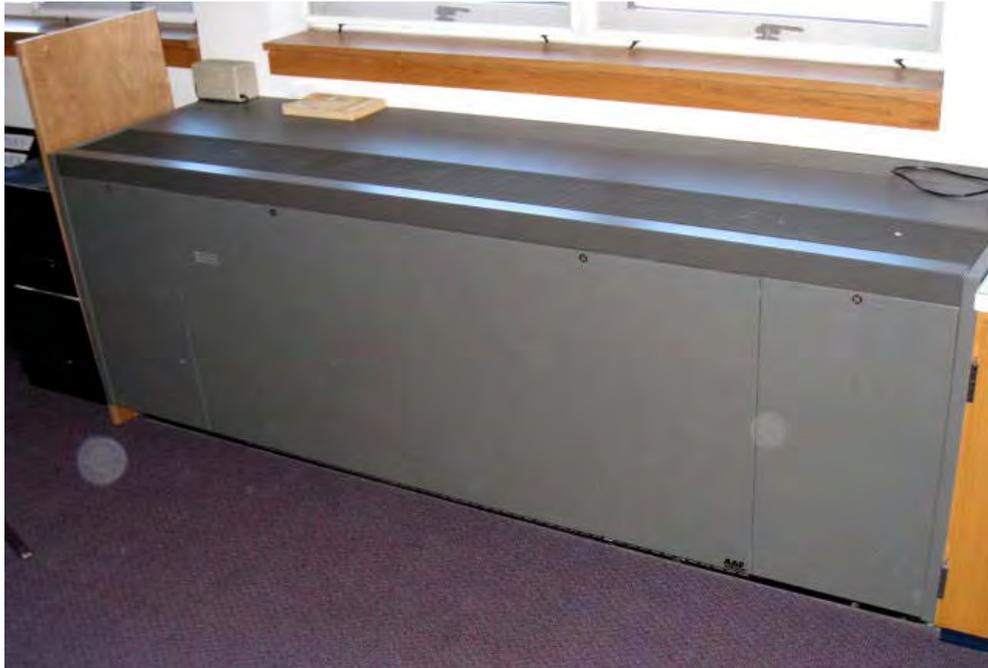
Picture 1

Fresh air for classrooms is supplied by unit ventilator (univent) systems (Pictures 1 and 2). A univent draws fresh, outdoor air through an air intake located on the exterior wall or roof of the building ([Picture 3](#)), and return air from the room through an air intake located at the base of the unit ([Figure 1](#)). Fresh and return air are mixed, filtered, heated and provided to occupied areas through an air diffuser located in the top of the unit.

Classroom Univent

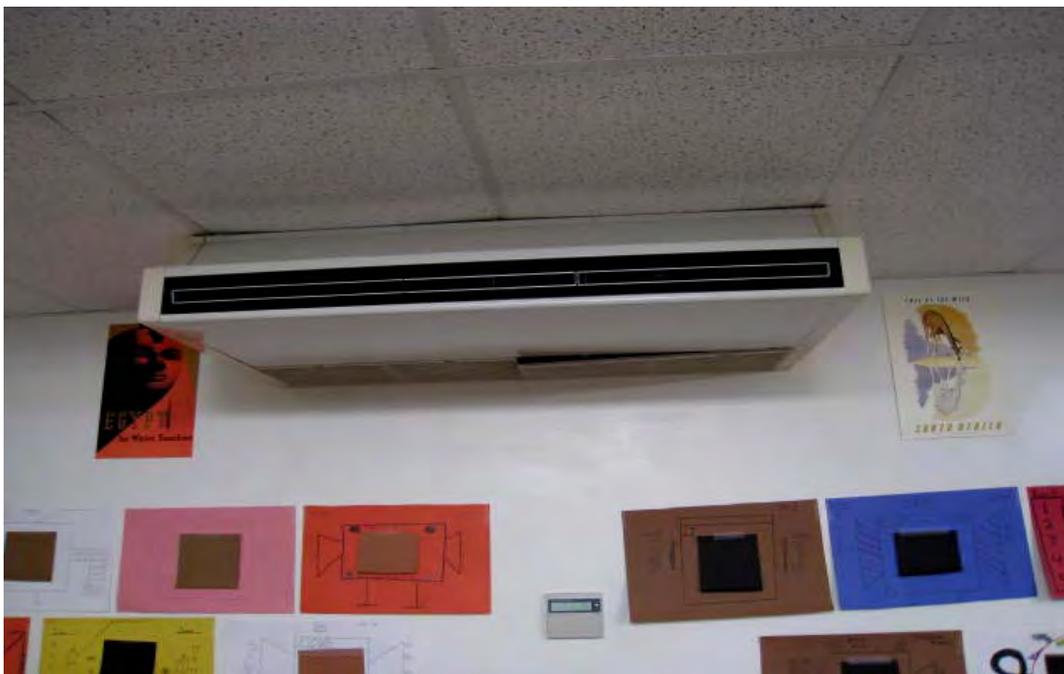
Picture 2

Ceiling/Wall-Mounted Univent

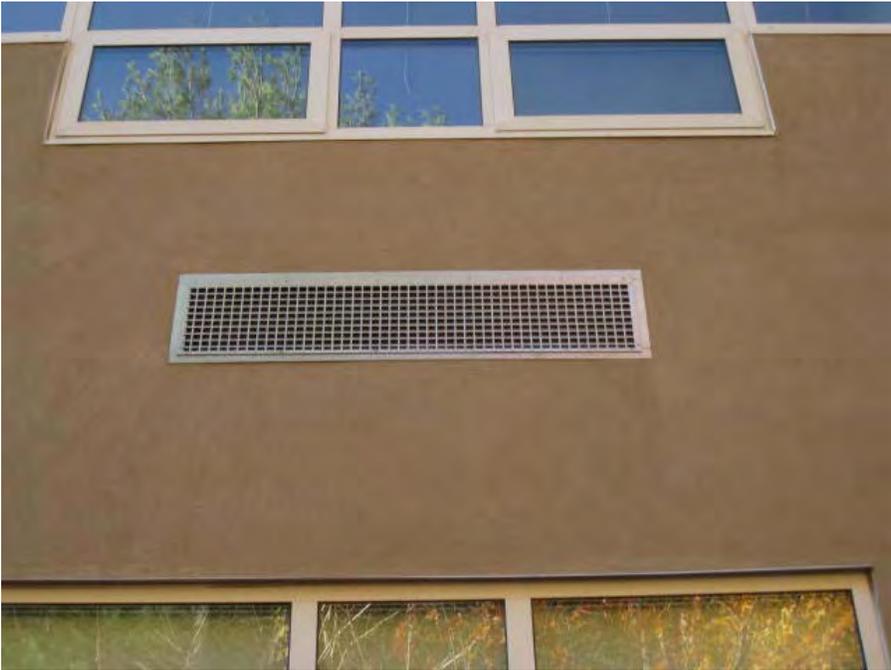
Picture 3

Univent Air Intake on Exterior Wall

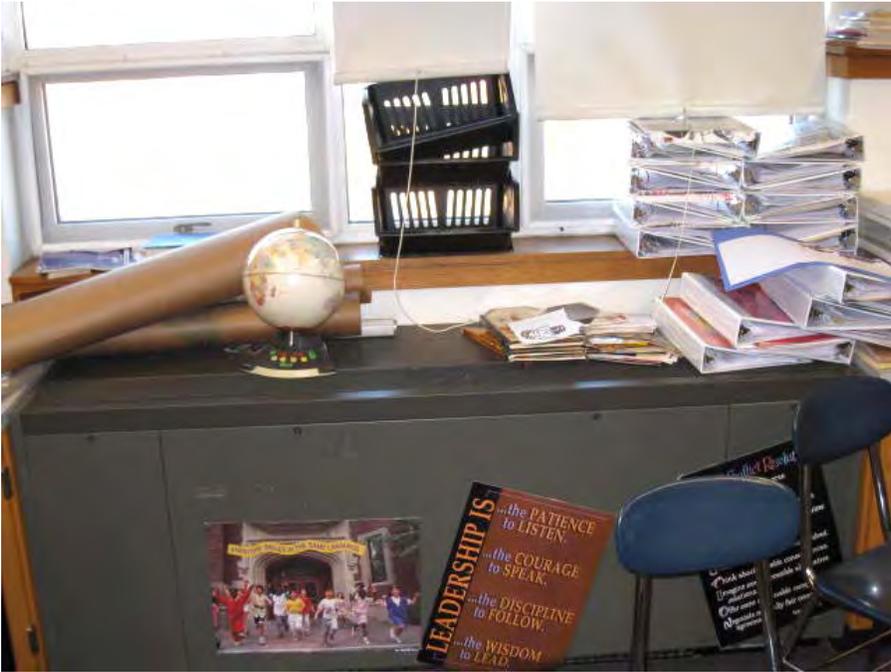
Picture 4

Univents were operating in the majority of rooms at the time of the assessment; however, BEH staff found several of them in the ‘off’ position, preventing fresh air from being introduced into these rooms ([Table 1](#)). Further, univents were blocked by books, furniture and other stored items, thereby limiting airflow in these rooms ([Picture 4](#)). In order for univents to provide fresh air as designed, they must remain free of obstructions. Importantly, these units must remain “on” and be allowed to operate while rooms are occupied.

Classroom Univent Blocked by Books and Stored Items

2. Restore exhaust ventilation. Inspect exhaust motors and belts for proper function. Repair and replace as necessary.
3. Remove all blockages from univents and exhaust vents to ensure adequate airflow.

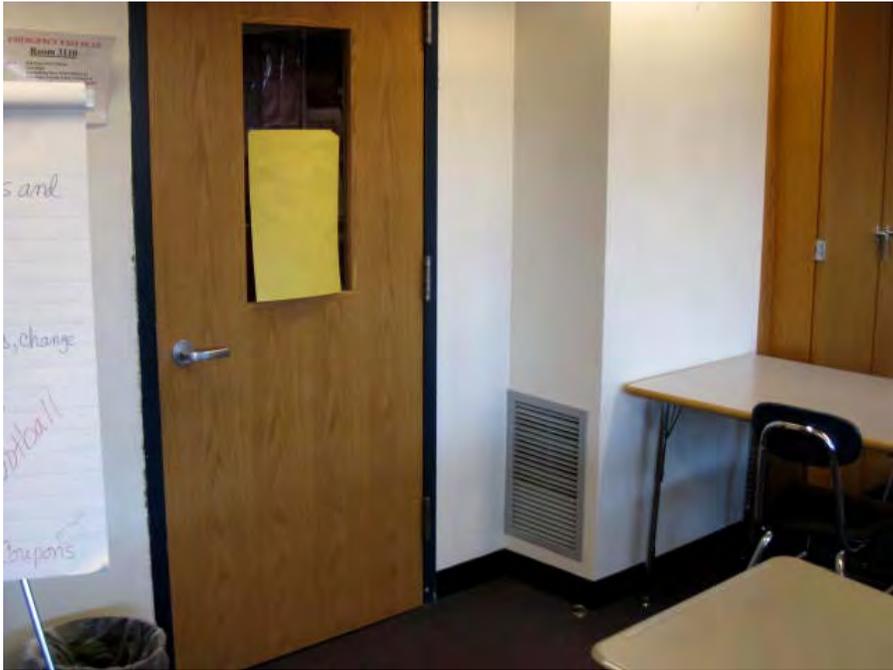
Picture 5

Exhaust ventilation in classrooms is provided by ceiling and wall-mounted vents ([Picture 5](#)). However, little or no draw of air was noted in most classrooms, indicating that the exhaust ventilation was off, or rooftop motors were not functioning. In addition, a number of exhaust vents were obstructed by furniture and other stored materials ([Picture 6](#)). It is also important to note that some classroom exhaust vents are located at the base of the wall near the classroom door. The exhaust capabilities of these vents can be diminished when classrooms doors are left open. In one instance, the vent was drawing air from the hallway due to its proximity to the open door. In another, an open door blocked the vent and prevented air from flowing toward the vent ([Picture 7](#)). In order to function properly, exhaust vents must be activated and allowed to operate while rooms are occupied. Without adequate exhaust ventilation, excess heat and stale air can build up leading to indoor air/comfort complaints.

Classroom Exhaust Vent on Wall near Door

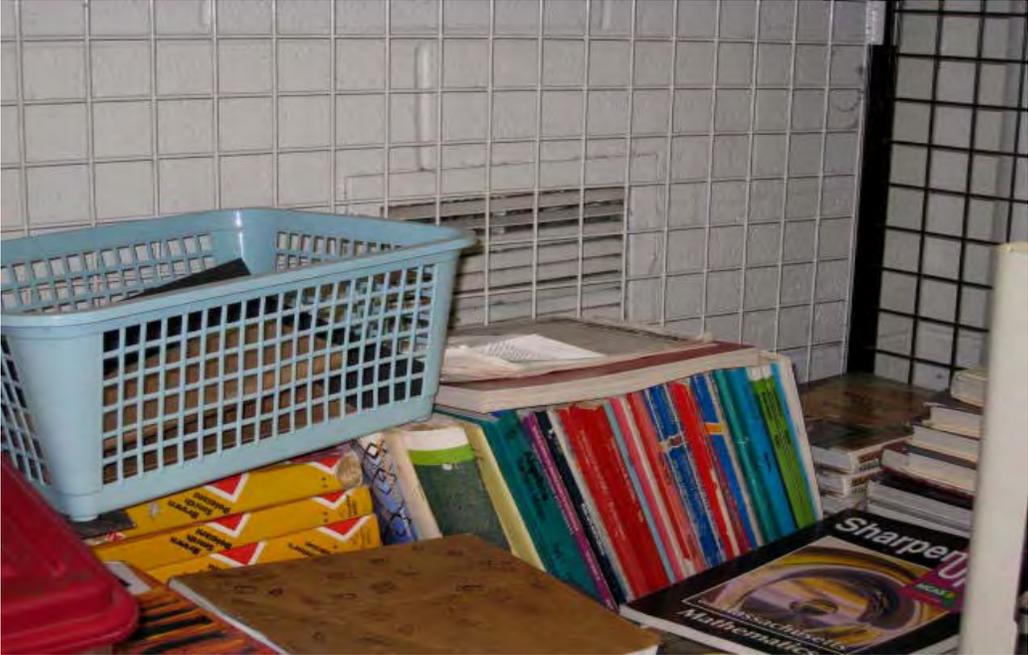
Picture 6

Exhaust Blocked by Stored Items

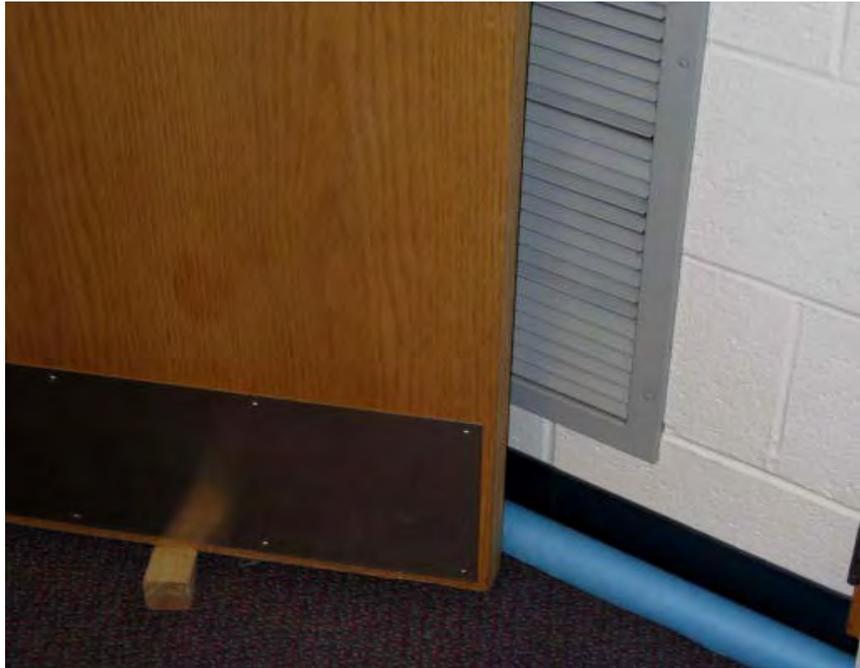
Picture 7

Exhaust Vent Partially Obstructed by Open Door

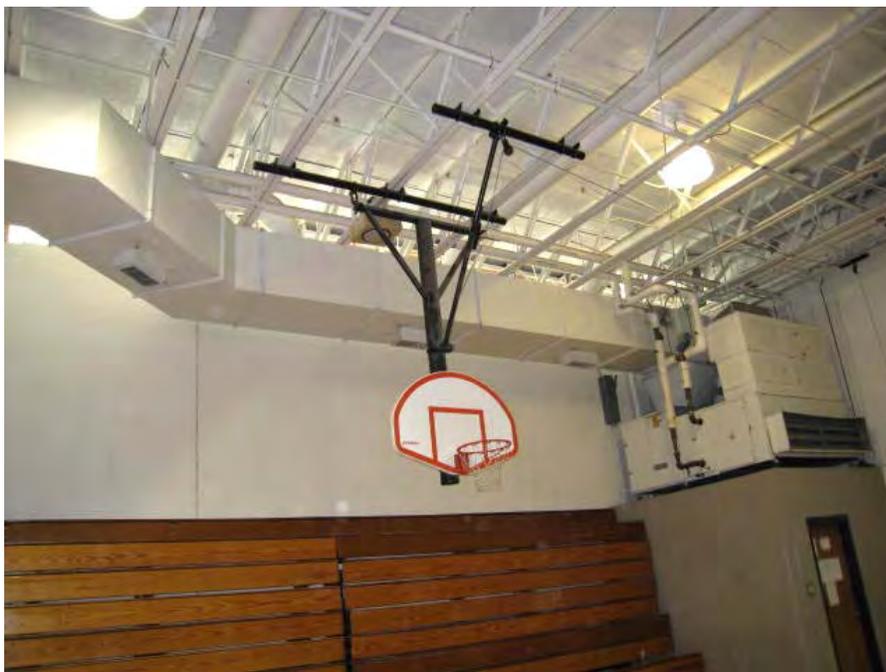
Picture 8

Mechanical ventilation for common areas such as the auditorium, cafeteria and gymnasiums is provided by rooftop or ceiling-mounted air handling units (AHUs). AHUs distribute fresh air via ceiling-mounted air diffusers and returns stale air back to AHUs via exhaust ([Picture 8](#)). The elevated carbon dioxide level in the main gymnasium indicates that the AHU was deactivated at the time of the assessment resulting in poor air exchange.

Air Handling Unit in Gymnasium

1. Operate all ventilation systems throughout the building (e.g., gymnasiums, cafeteria, classrooms) continuously during periods of school occupancy and independent of thermostat control. To increase airflow in classrooms, set univent controls to "high". School staff should be encouraged not to deactivate classroom univents; rather to report any complaints concerning temperature control to the facilities department.

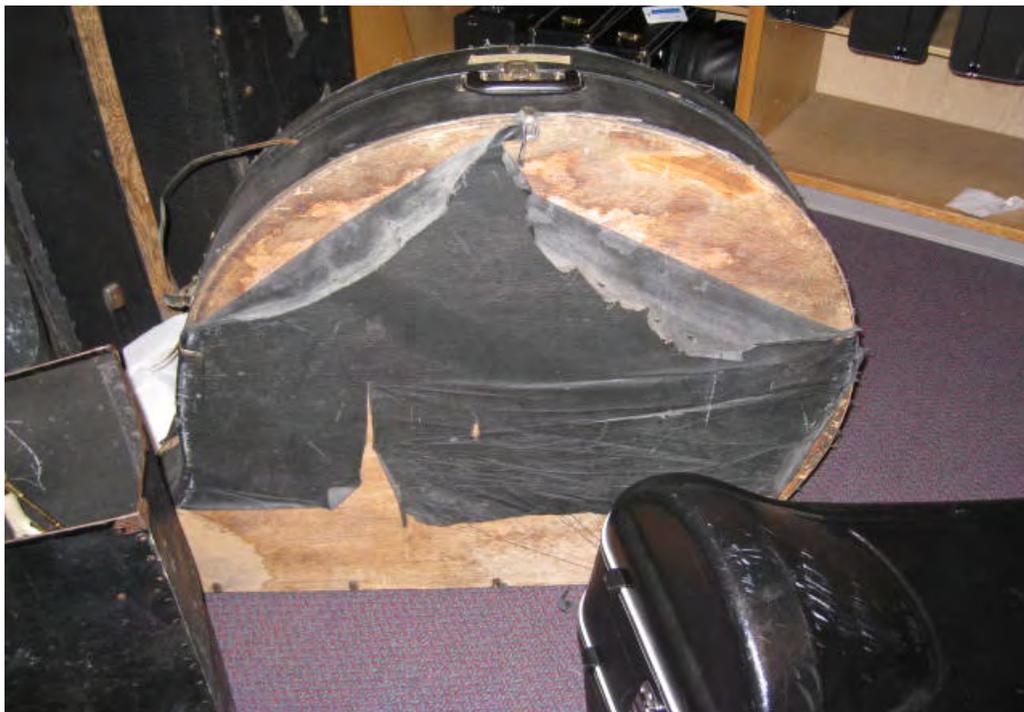
Picture 9

BEH staff performed a visual inspection of building materials for water damage and/or microbial growth. As previously mentioned, concerns about water damage and possible mold issues in the band room prompted the assessment. It was reported that band uniforms worn by students during a period of rain had been stored wet in the room. In the band room, metal storage cabinets stand on a carpeted floor. BEH staff found rust at the base of the cabinets which can indicate that the carpet was wet in this area. However, the carpet was not wet at the time of the assessment. A storage room off the band room houses an AHU, band equipment and instrument cases. Upon entering the storage room, BEH staff noted a musty odor that was emanating from old instrument cases, which were water damaged ([Pictures 9](#) and [10](#)). There was no visible mold growth on the carpet or instrument cases.

Water Damaged Instrument Case

9. Ensure band uniforms are properly cleaned and dried prior to storage.
10. Remove and discard water damaged instrument cases in band room. Monitor for moisture, consider using dehumidifier to protect instruments/cases against excessive moisture (e.g., RH > 70%) for extended periods of time.

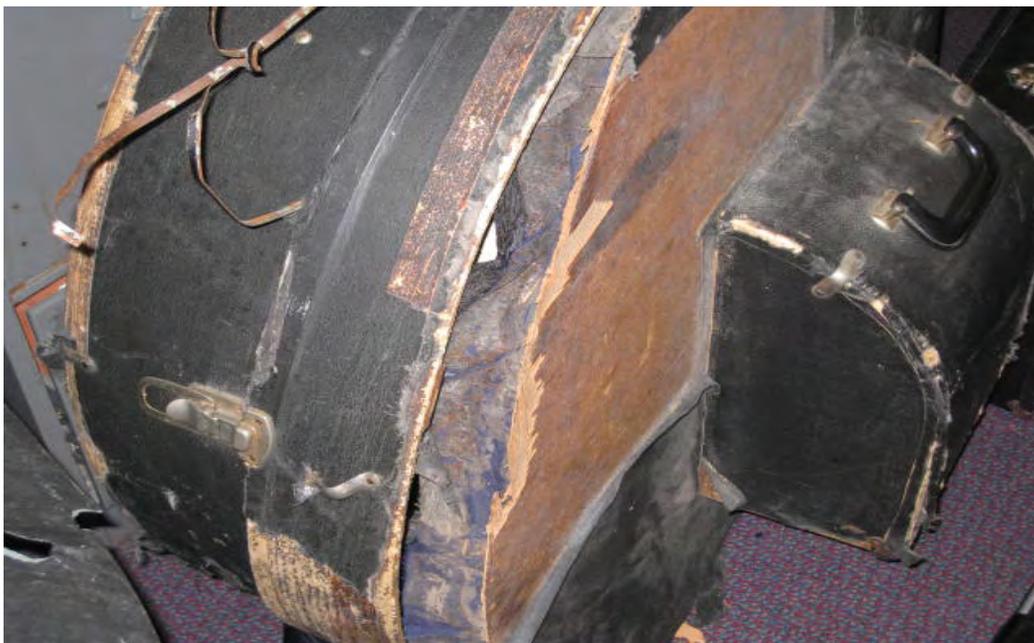
Picture 10

Water Damaged Instrument Case

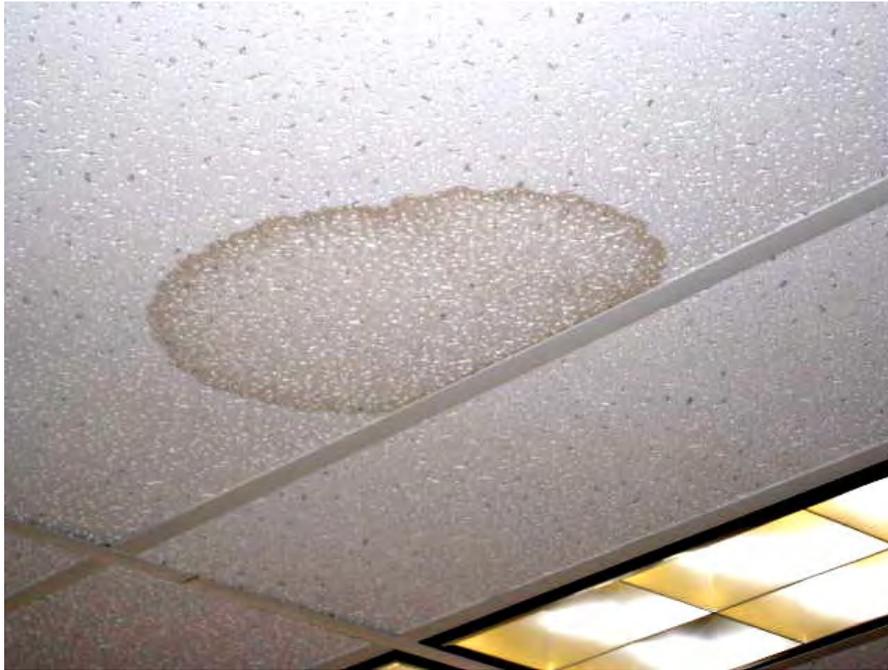
Picture 11

Water damaged/missing ceiling tiles were noted in a number of areas throughout the building ([Picture 11](#)). Water-damaged ceiling tiles can indicate sources of water penetration and provide a source of mold. Ceiling tiles should be replaced after a water leak is discovered and repaired. Chronic water leaks were reported at the base of a hallway that connects exterior door to the main corridor on a slope ([Figure 2](#)). Water runs down and pools at the base of the hallway in the main corridor ([Picture 12](#)). In the area of the leak, ceiling tiles were missing or significantly water-damaged ([Picture 13](#)). Water penetration was also evident in a storage room

Water Damaged Ceiling Tile

11. Repair any existing water leaks and replace any remaining water-damaged ceiling tiles. Examine the area above these tiles for mold growth. Disinfect areas of water leaks with an appropriate antimicrobial, as needed.

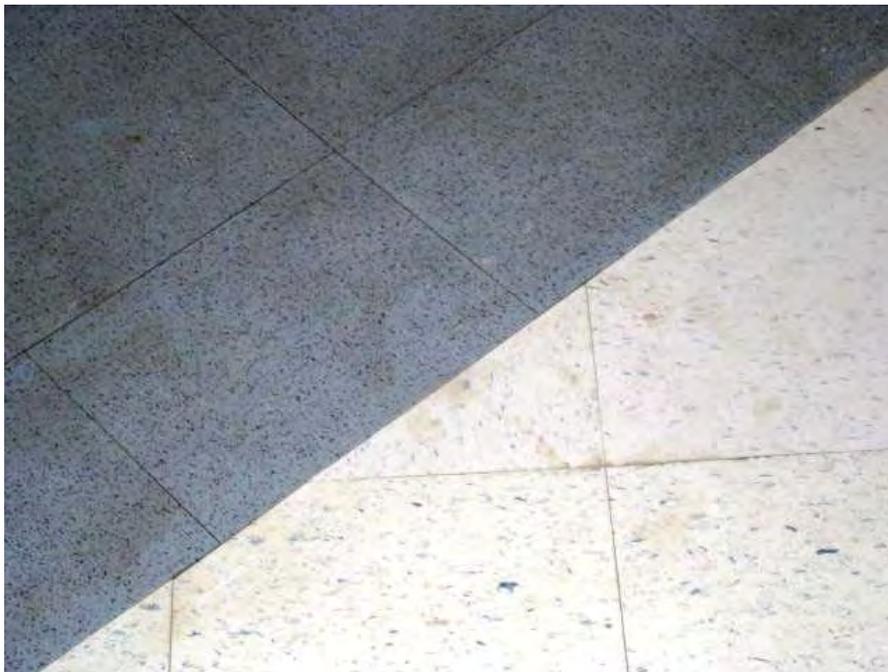
Picture 12

Water Stains on Hallway Tile from Pooling Water

12. Clean water stains from walls/floors and repaint/refinish. Monitor areas for further leaks for prompt remediation.
13. Remove leaves and debris from exterior drains, examine for proper drainage periodically. Make repairs as needed.

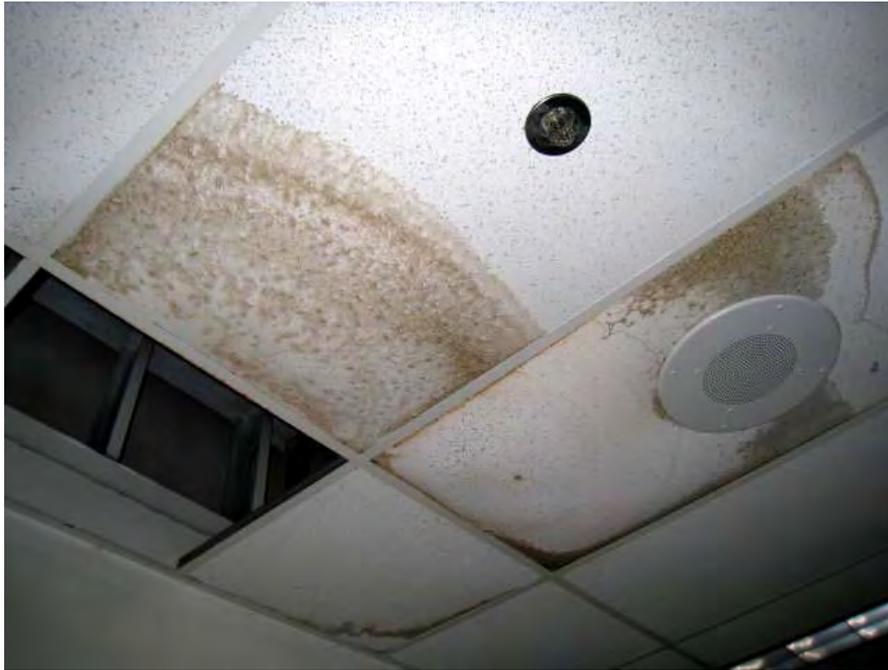
Picture 13

Water Damaged Ceiling Tiles around Hallway Leak

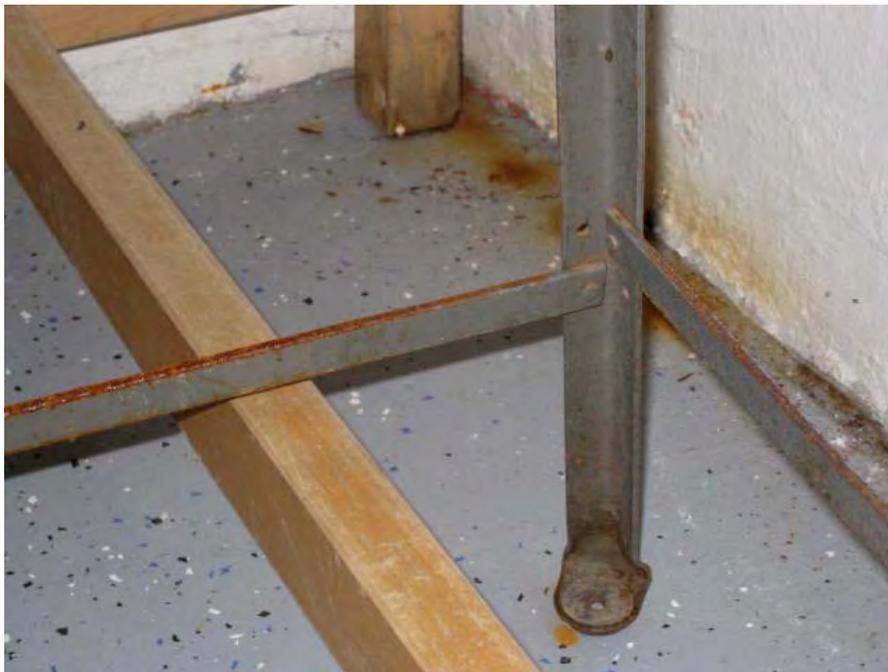
Picture 14

in the same section of the school as the hallway. Water stains were seen on the floor and walls of the storage room. Rust was observed on and around carpeting beneath stored metal furniture ([Picture 14](#)).

Water Damage and Rust in Storage Room

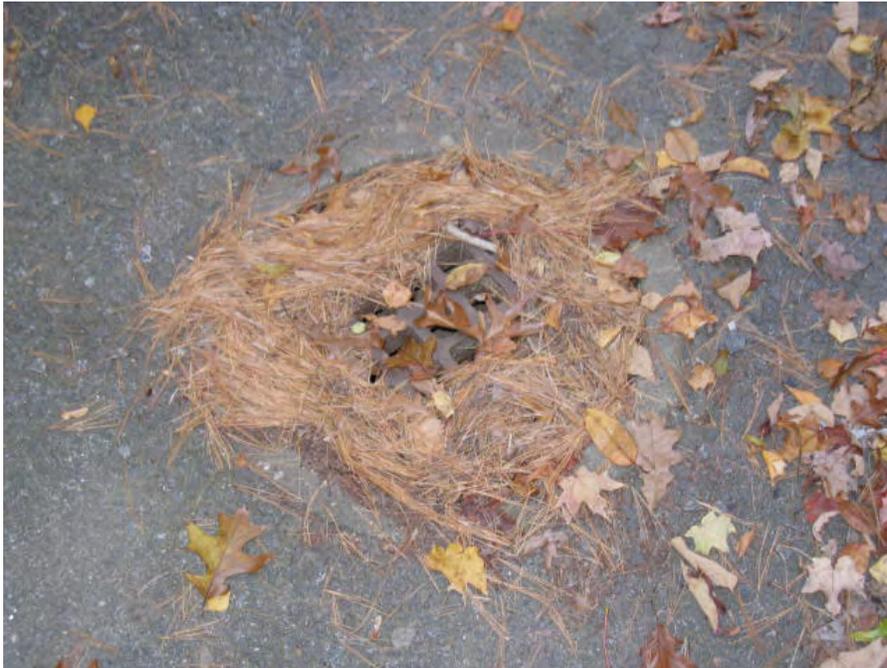
Picture 15

BEH staff examined the exterior of the school to identify breaches in the building envelope and other conditions that could provide a source of water penetration. Gutters and downspouts were missing and/or damaged, allowing water to empty against the side of the building and stain the exterior wall. Gutters and downspouts are designed to collect and divert rainwater away from the building. Storm drains around the building were blocked by accumulated debris and leaves ([Picture 15](#)). The combination of missing/damaged downspouts and blocked drains allows water to pool at the base of the building. Trees and plants were observed growing at the base of the exterior wall of the building ([Picture 16](#)). The growth of roots against exterior walls can bring moisture in contact with the foundation. Plant roots can eventually penetrate, leading to cracks and/or fissures in the sublevel foundation. The conditions listed above can undermine the integrity of the building envelope and create/provide a means of water entry by capillary action into the building through exterior walls, foundation concrete and masonry (Lstiburek & Brennan, 2001).

Storm Drain Blocked by Debris and Leaves

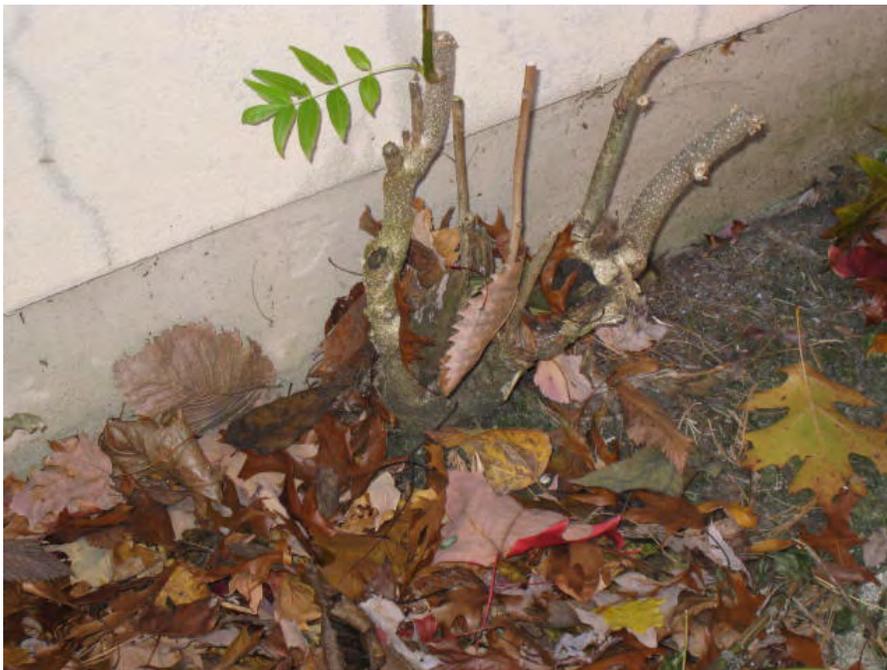
Picture 16

Plants/Tree Stump Growing at Base of Building

14. Trim overhanging branches and remove plants/trees from close proximity to exterior walls.
15. Replace missing/damaged gutters and downspouts, inspect periodically for proper drainage.

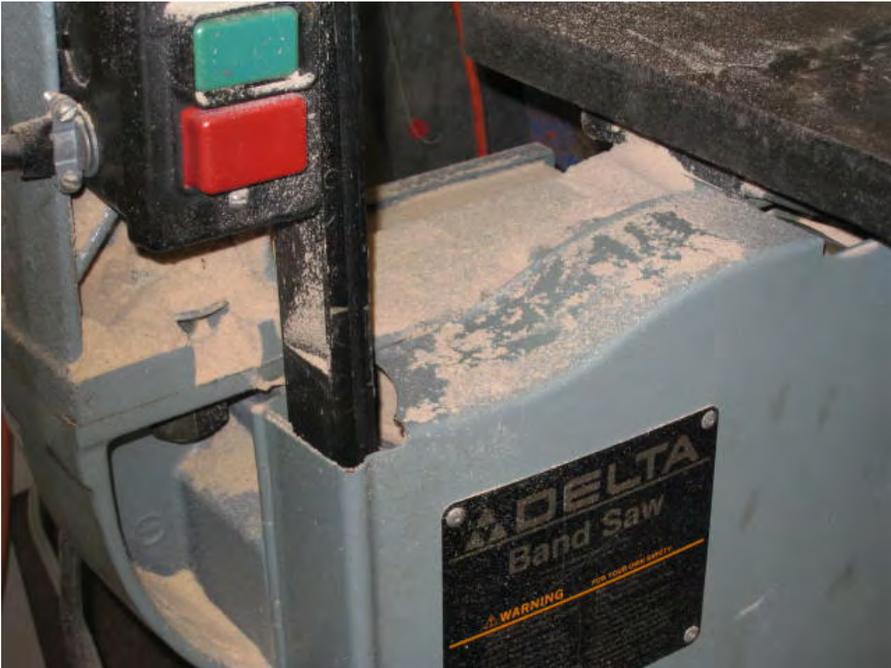
Picture 17

Outdoor PM2.5 concentrations the day of the assessment were measured at 5 $\mu\text{g}/\text{m}^3$. PM2.5 levels measured inside the school were below the NAAQS PM2.5 level of 35 $\mu\text{g}/\text{m}^3$ in all but one area, the woodshop, which measured 257 $\mu\text{g}/\text{m}^3$. Indoor measurements in all other areas ranged from 1 to 16 $\mu\text{g}/\text{m}^3$ (Table 1). Elevated PM2.5 levels in the woodshop were the result of aerosolized saw dust and debris, which had accumulated on the floor, wood cutting machines and flat surfaces throughout the shop (Pictures 17 and 18). It is important to note that the woodshop

did not contain local exhaust or a dedicated wood dust collection system. Although the shop had *general* exhaust ventilation, it was either deactivated or not functioning at the time of the assessment. It is also important to note that BEH staff entered the shop at the end of class when clean-up activities were in progress. This activity further disturbed the settled saw dust and debris. Wood dust is a fine particulate, which can be easily aerosolized and become irritating to the eyes, nose, throat and respiratory system. In addition, under certain conditions, wood dust can be a fire hazard.

Accumulated Saw Dust and Debris in Woodshop

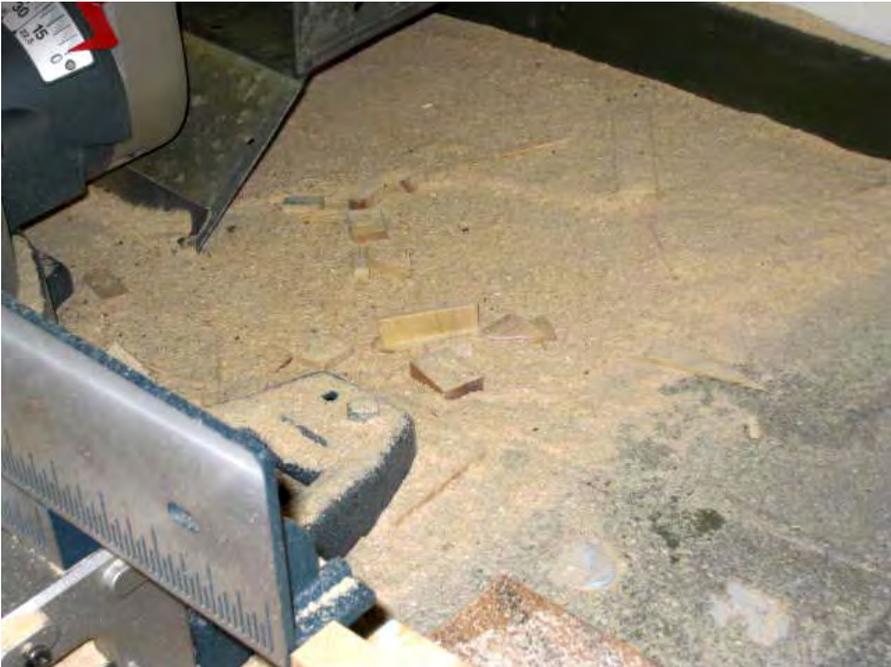
Picture 18

Accumulated Saw Dust and Debris in Woodshop

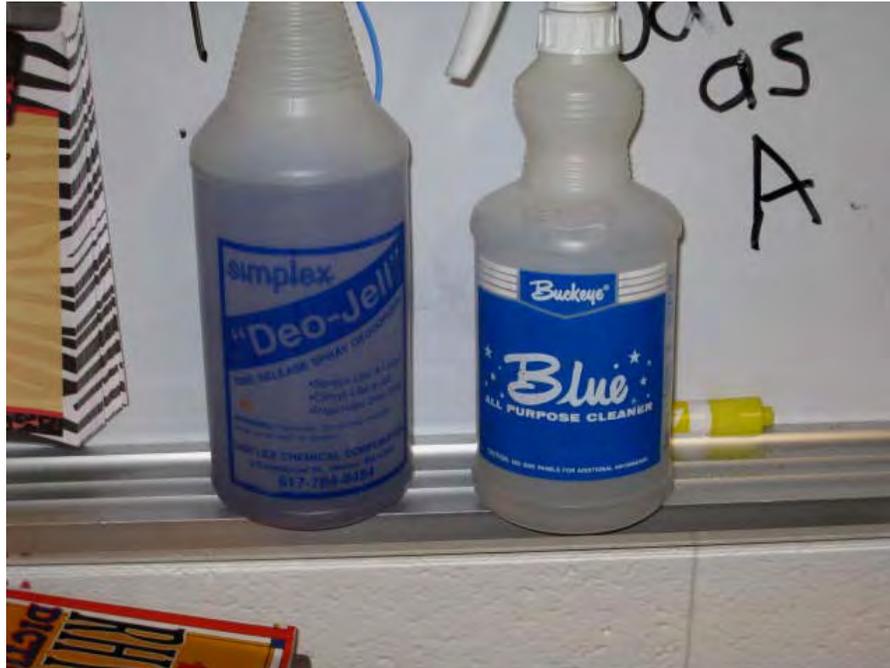
Picture 19

Cleaning Products

21. Store cleaning products properly and out of reach of students. Ensure spray bottles are properly labeled. All cleaning products used at the facility should be approved by the school department with MSDS' available at a central location.

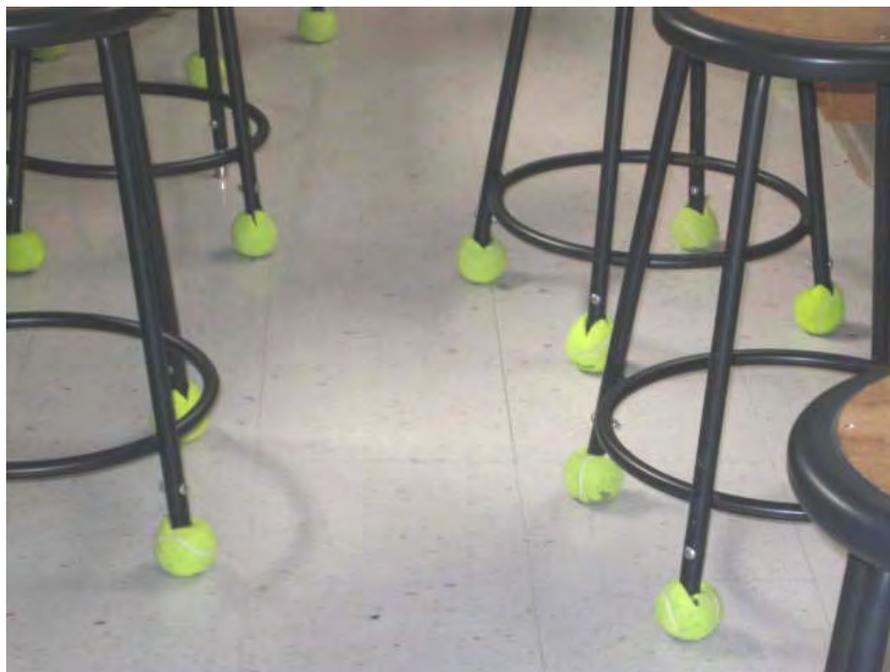
Picture 20

BEH staff observed tennis balls that had been sliced open and placed on chair and/or table legs (Picture 20). Tennis balls are made of a number of materials that are a source of respiratory irritants. Constant wearing of tennis balls can produce fibers and cause VOCs to off-gas. Tennis balls are made with a natural rubber latex bladder, which becomes abraded when used as a chair leg pad. Use of tennis balls in this manner may introduce latex dust into the school environment. Some individuals are highly allergic to latex (e.g., spina bifida patients) (SBAA, 2001). It is recommended that the use of materials containing latex be limited in buildings to reduce the likelihood of symptoms in sensitive individuals (NIOSH, 1997).

Tennis Balls on Chair Legs

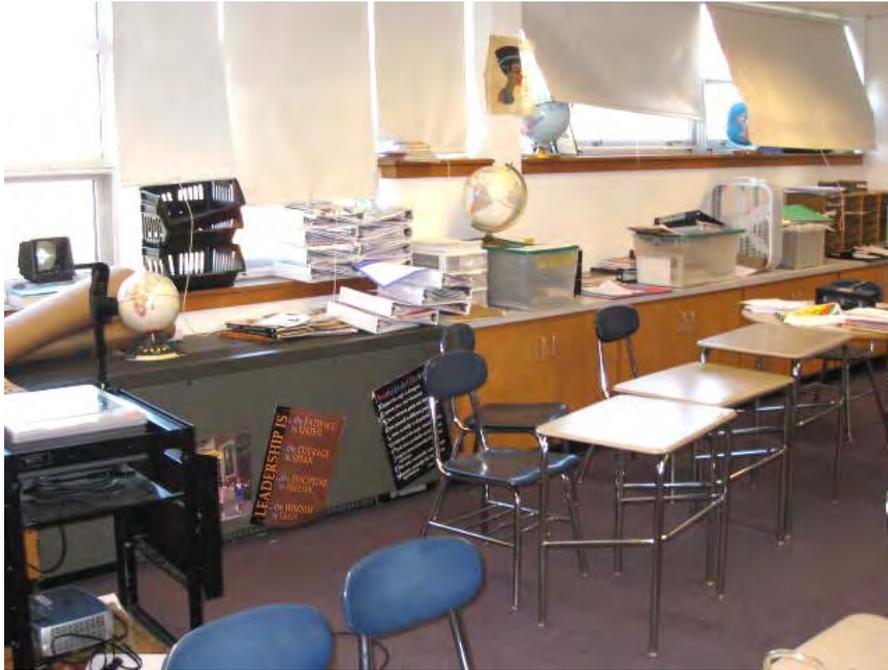
Picture 21

In several classrooms, items were observed on the floor, windowsills, tabletops, counters, bookcases and desks ([Picture 21](#)). The large number of items stored in classrooms provides a source for dusts to accumulate. These items (e.g., papers, folders, boxes) make it difficult for custodial staff to clean. Items should be relocated and/or be cleaned periodically to avoid excessive dust build up. In addition, these materials can accumulate on flat surfaces (e.g., desktops, shelving and carpets) in occupied areas and subsequently be re-aerosolized causing further irritation.

Stored Items in Classroom

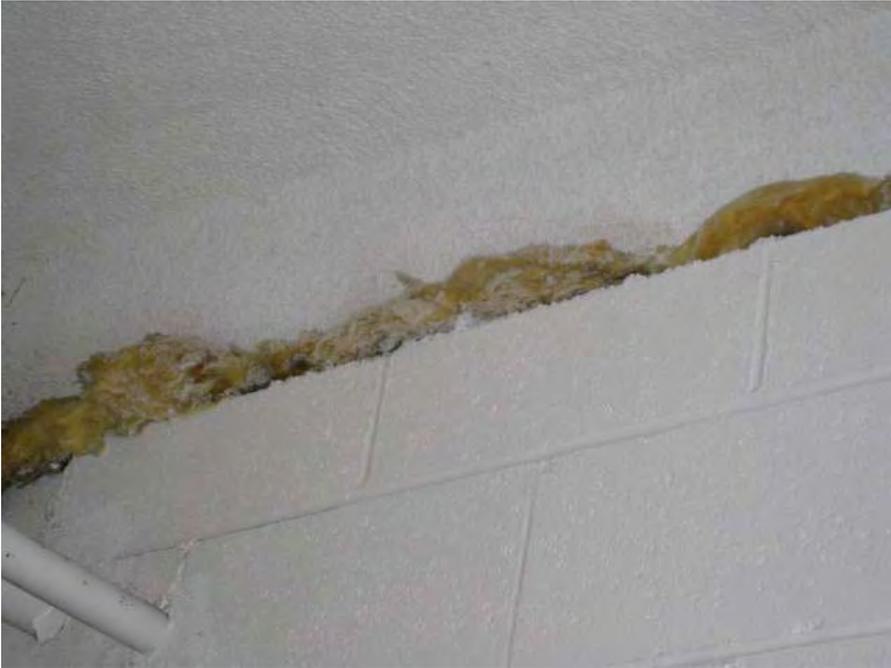
Picture 25

Finally, exposed fiberglass insulation was observed in several classrooms ([Picture 25](#)). Fiberglass insulation can provide a source of skin, eye and respiratory irritation.

Exposed Fiberglass Insulation

30. Encapsulate exposed fiberglass insulation.
