INDOOR AIR QUALITY REASSESSMENT

**North Shore Community College
Admission Office/Financial Aid
Thomas W. McGee Building
300 Broad Street
Lynn, Massachusetts 01901**

Prepared by:
Massachusetts Department of Public Health
Bureau of Environmental Health
Indoor Air Quality Program
May 2009

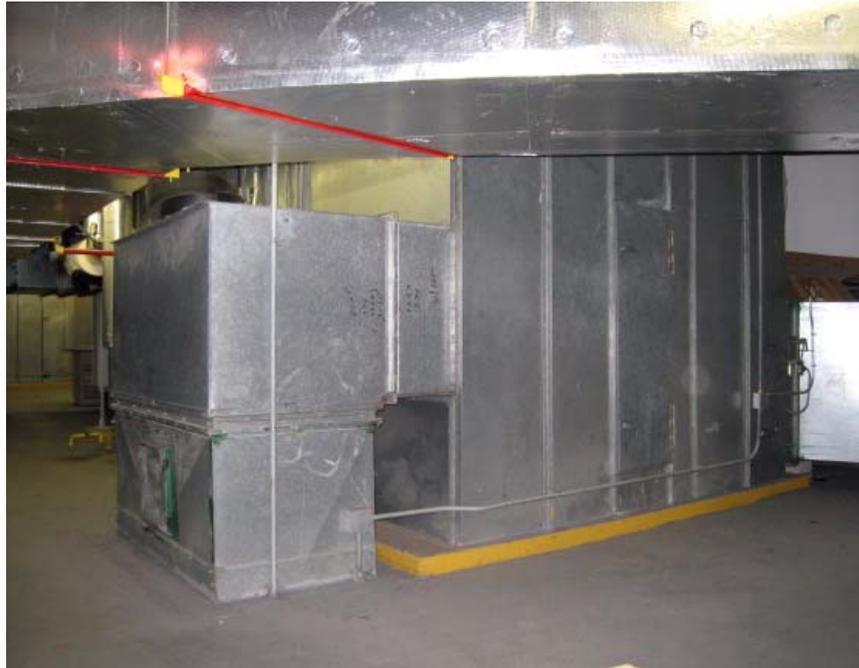
Picture 1

It can be seen from Table 1 that carbon dioxide levels were all below 800 parts per million (ppm), indicating adequate air exchange in the areas evaluated. The heating, ventilating and air conditioning (HVAC) system consists of air handling units (AHUs) located in a mechanical room on the top floor (Picture 1). Air is drawn in through fresh air intakes on the exterior of the building and passes through a bank of pleated air filters (Pictures 2 through 4). Conditioned air is distributed through ducted ceiling vents (Pictures 5) and drawn into the ceiling plenum via grated vents and ducted back to the AHUs (Picture 6). This system was operating during the assessment.

AHU for HVAC System in Mechanical Room

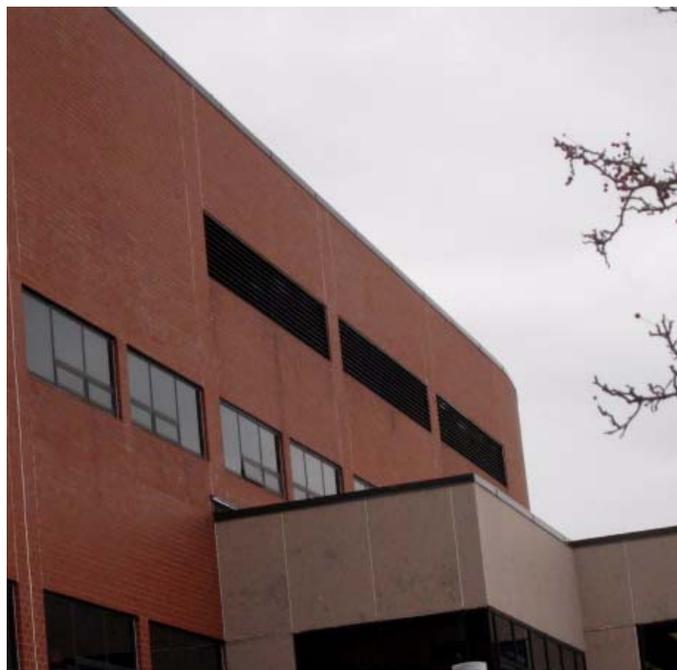
Picture 2

Fresh Air Intake Vents

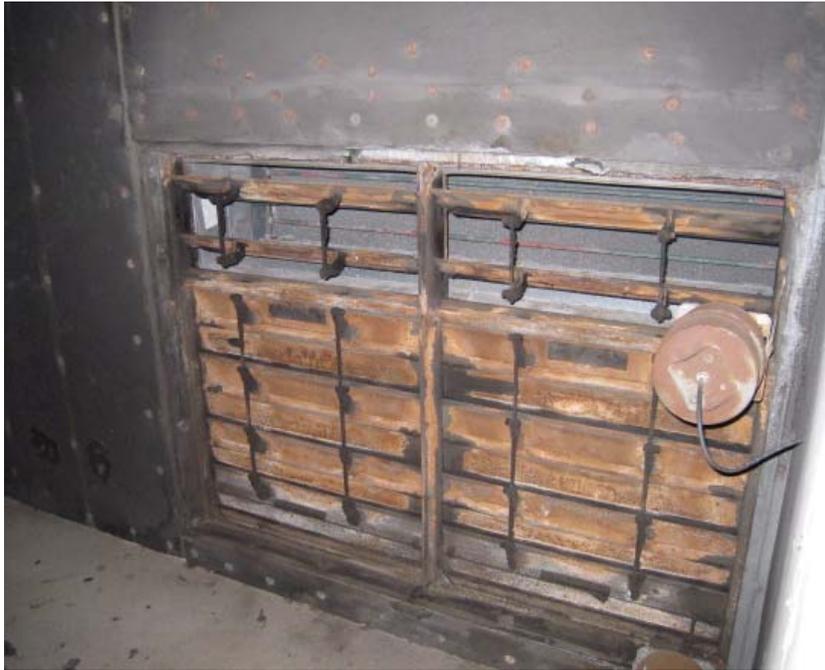
Picture 3

Fresh Air Intakes Louvers for AHU

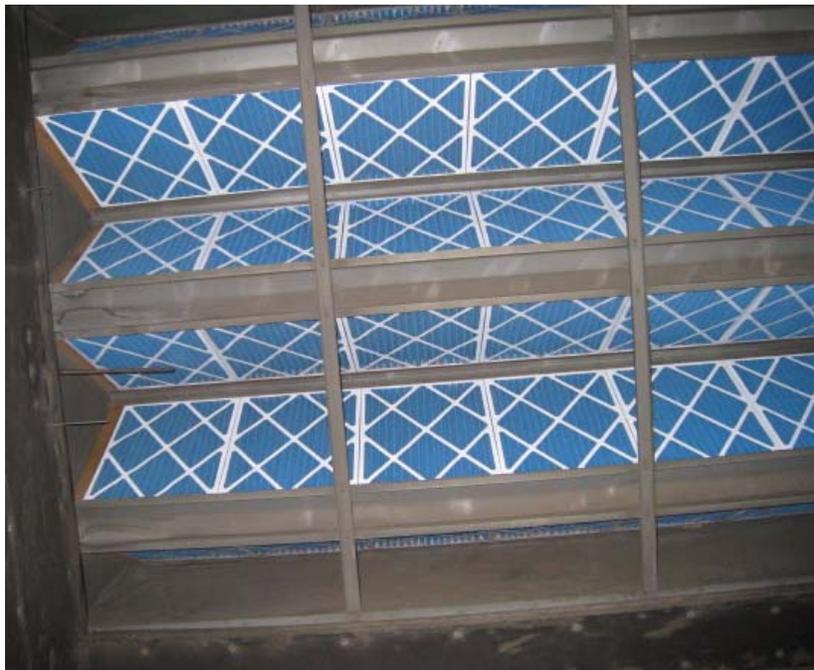
Picture 4

In response to occupant reports of exacerbation of allergies, BEH staff conducted an inspection of AHUs and filters for potential respiratory irritants as well as measurement of airborne particulate matter. The general condition of the AHUs and filters were found to be relatively clean/recently changed with no obvious sources of respiratory irritants (Picture 4).

Bank of High Efficiency Pleated Air Filters

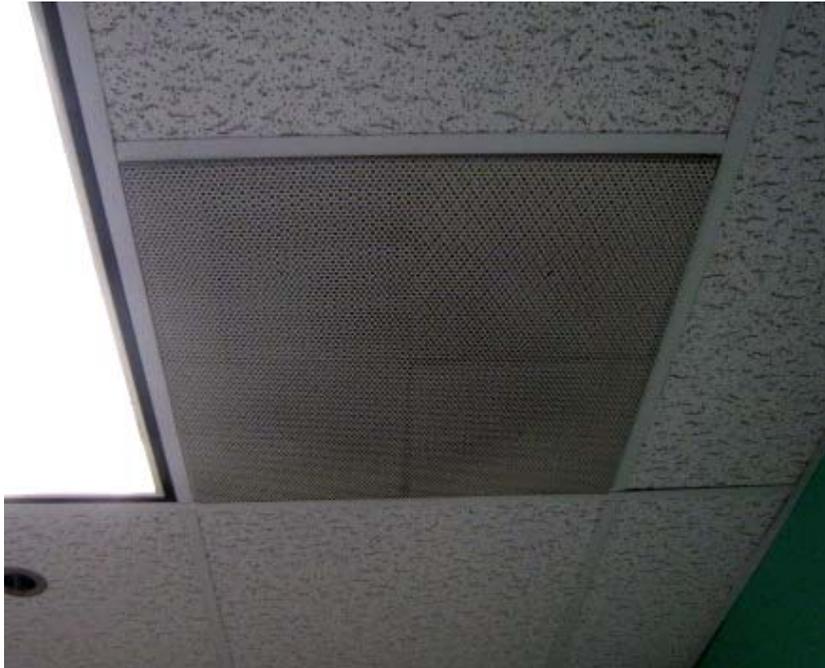
Picture 5

Ceiling-Mounted Air Diffuser

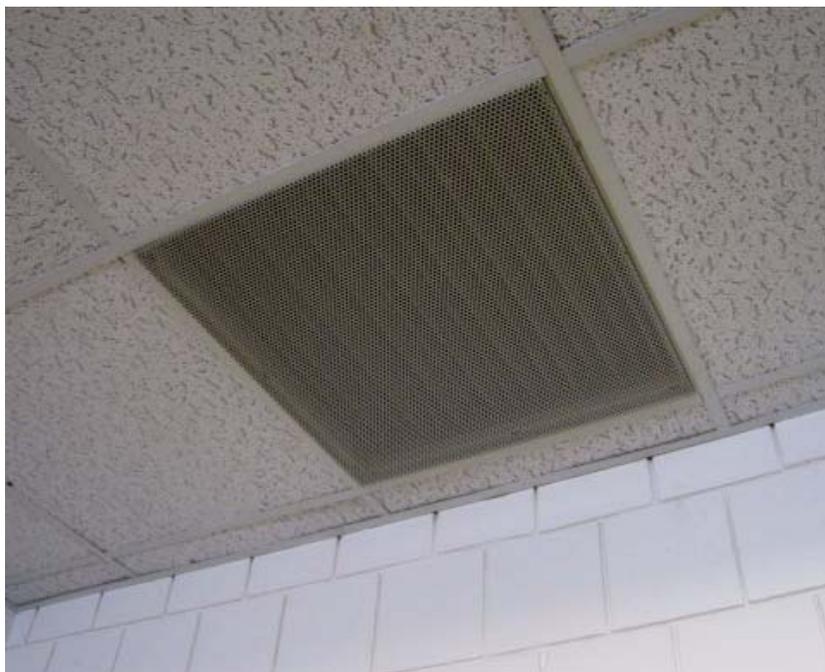
Picture 6

Ceiling-Mounted Return Vent

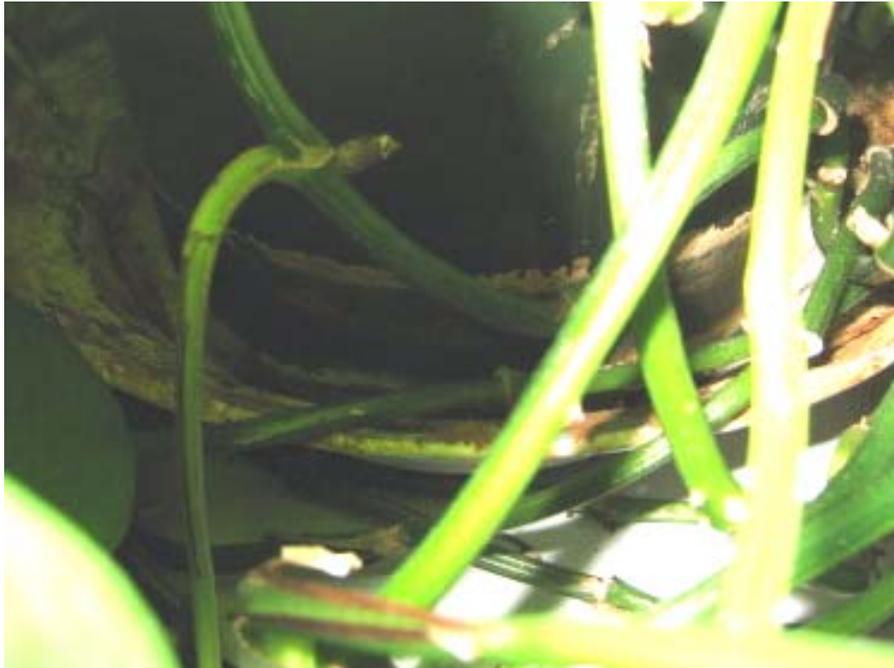
Picture 7

Plants were observed in several areas. Plants, soil and drip pans can serve as sources of mold growth, and thus should be properly maintained. Over-watering of plants should be avoided and drip pans should be inspected periodically for mold growth (Picture 7).

Moldy Drip Pan under Plant

Action: Plants all had drip pans but several of them appeared to be over-watered and/or growing mold.

1. Replace moldy/damaged potted plant drip pans, avoid over watering. Examine drip pans periodically, clean as needed.
2. Replace damaged ceiling tile in room 158.

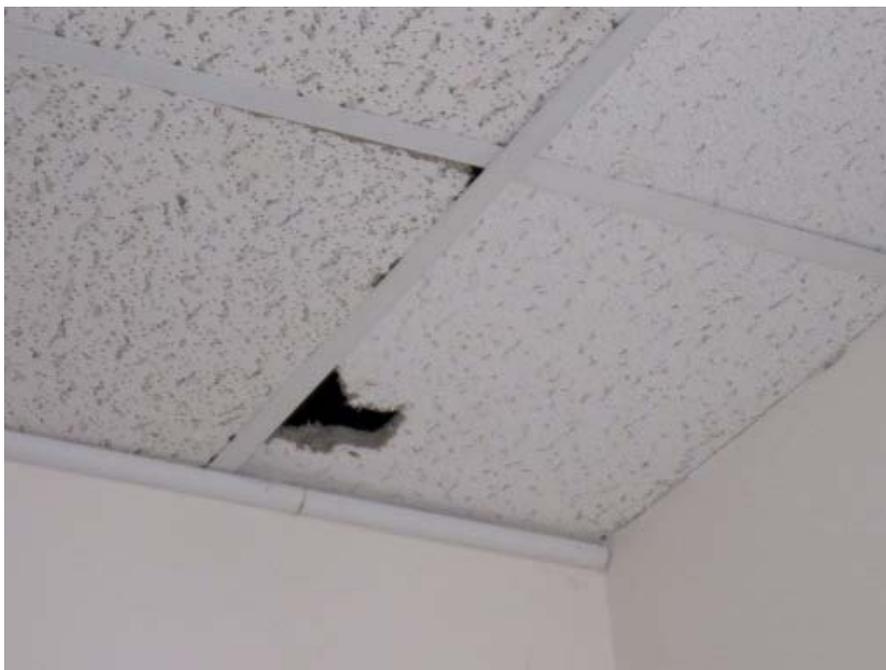
Picture 8

Finally, a damaged ceiling tile was observed in office 158 (Picture 8), which can provide a pathway for the movement of drafts, dusts, odors and particulate matter into occupied areas. In addition, missing/damaged ceiling tiles result in the degradation of the function of the exhaust vent plenum system, since this system is designed to operate with the suspended ceiling intact.

Broken Ceiling Tile in Office 158

Action: Damaged ceiling tiles identified in the previous report were replaced; another was discovered in office 158.
