INDOOR AIR QUALITY ASSESSMENT

**Clyde F. Brown Elementary School
5 Park Road
Millis, Massachusetts 02054**

Prepared by:
Massachusetts Department of Public Health
Bureau of Environmental Health
Indoor Air Quality Program
January 2009

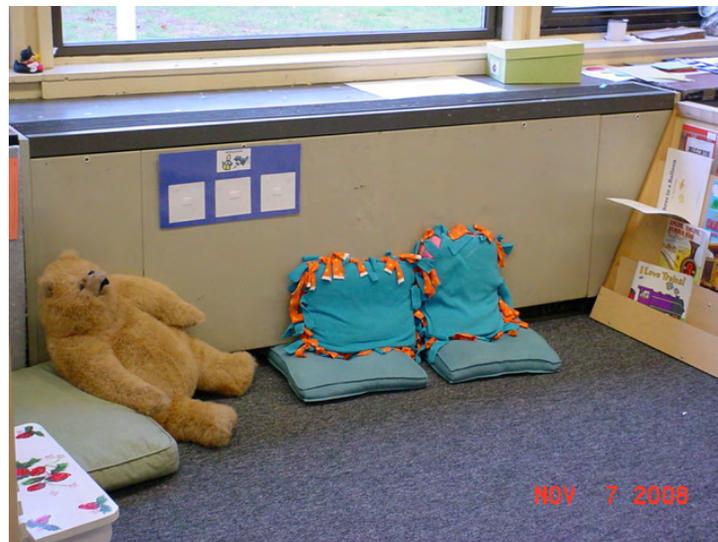
Picture 2

Fresh air in classrooms is supplied by a unit ventilator (univent) system. Univents draw air from outdoors through a fresh air intake located on the exterior wall of the building and return air through an air intake located at the base of each unit ([Figure 1](#)). Fresh air and return air are mixed, filtered, heated and provided to classrooms through a fresh air diffuser located in the top of the unit. Univents were operating in classrooms throughout the school; however, BEH staff found airflow from these units blocked by papers and books stored on top of diffusers as well as furniture in front of univent returns (Picture 2). In order for univents to provide fresh air as designed, air diffusers and return vents must remain free of obstructions and allowed to operate while rooms are occupied.

Obstructed Univent

4. Remove all blockages from univents and exhaust vents to maximize air exchange. The BEH recommends that both supply and exhaust ventilation operate continuously during periods of school occupancy independent of classroom thermostat control.

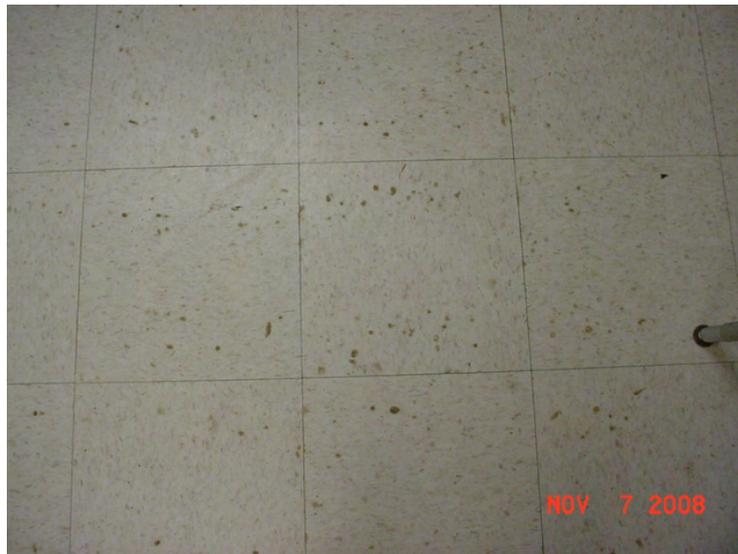
Picture 4

Concerns were raised about the dotting of floor tile in various classrooms in the 1991 SW and SE wings (Map 2, Table 1). Floor tiles in classrooms 8-12 have an indentation that appears to be filled with dirt/debris (Pictures 4 and 5). In order for mold to grow, a water source, mold spores and a growth medium is needed. In this instance, no apparent water source exists to moisten this material, limiting its ability to support mold growth. Therefore, the materials in the floor indentation appear to be accumulated dirt and are unlikely to pose a health risk for school occupants (Figure 2).

The source of this material filling the indentation is either material brought into classrooms on occupant's shoes or airborne debris aerosolized by the classroom univent. Areas around the school are grass, sand and dirt, which will become muddy during wet weather. If tracked-in, this dirt can become a source of airborne particulates once dried. Univents are

Discolored Indentation of Floor Tile

1. Apply a heavy coat of floor wax over blemished floor tile to create a barrier. Continue with plans to examine options for removing blemishes, which may include replacing floor tiles.
2. To reduce tracked-in dirt, consider replacing the hallway carpet with a rubber link mat that can be easily removed for daily wet mopping.
3. Consider increasing the dust-spot efficiency of HVAC filters. Prior to any increase of filtration, each piece of air handling equipment should be evaluated by a ventilation engineer as to whether it can maintain function with more efficient filters.

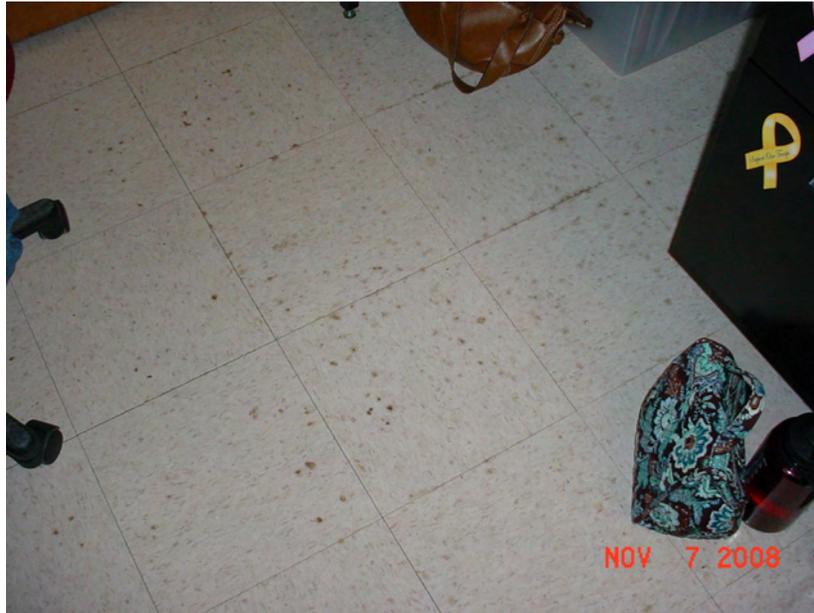
Picture 5

Discolored Indentation of Floor Tile

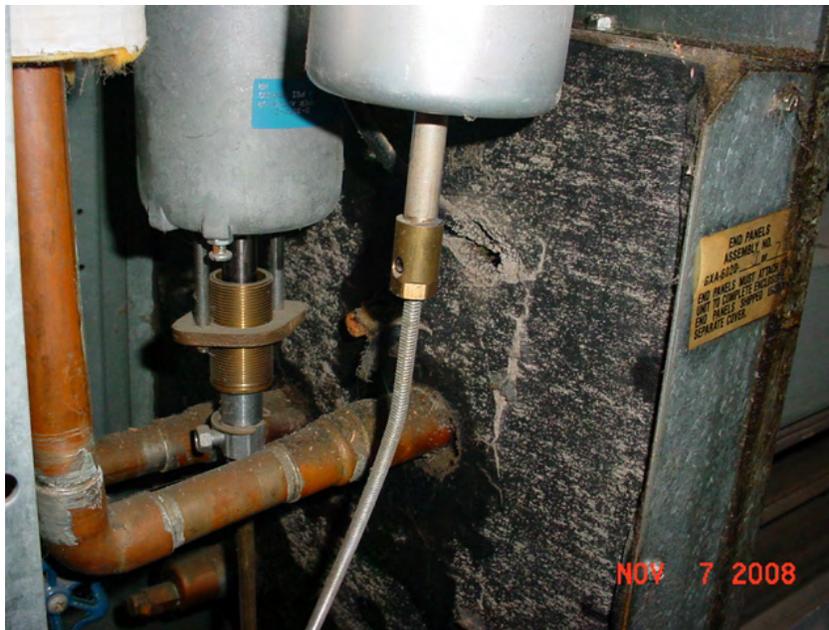
Picture 6

equipped with filters that provide minimal filtration of respirable particulates that can be distributed by univents. In addition, spaces exist in the univent cabinet that would allow for air to bypass the filter (Picture 6). Univents should be equipped with filters that strain particulates from airflow. In order to decrease aerosolized particulates, disposable filters with an increased dust spot efficiency can be installed in univents. The dust spot efficiency is the ability of a filter to remove particulates of a certain diameter from air passing through the filter. Filters that have been determined by the American Society of Heating, Refrigeration and Air-Conditioning Engineers (ASHRAE) to meet its standard for a dust spot efficiency of a minimum of 40 percent would be sufficient to reduce airborne particulates (Thornburg, 2000; MEHRC, 1997; ASHRAE, 1992). Note that increased filtration can reduce airflow as a result of increased resistance, a condition known as pressure drop. Prior to any increase of filtration, univents should be evaluated by a ventilation engineer to ascertain whether they can maintain function with more efficient filters.

Spaces Exist In the Univent Cabinet That Would Allow For Air to Bypass the Filter

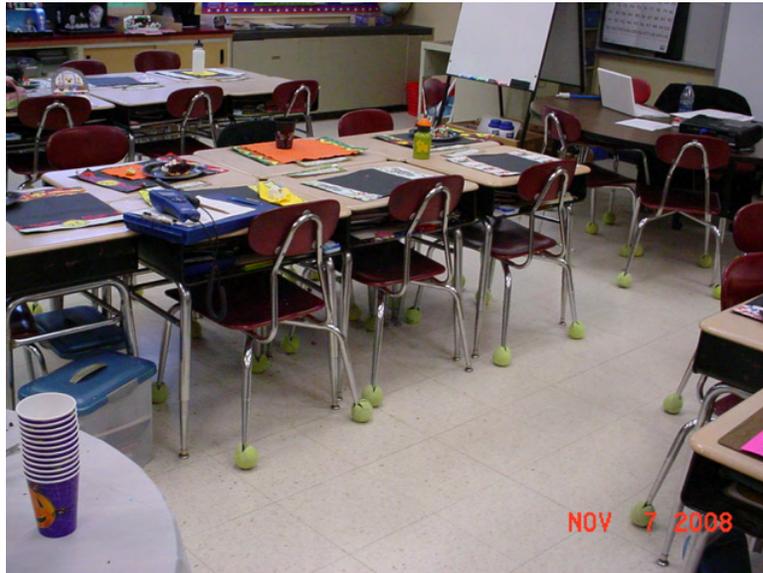
Picture 7

In an effort to reduce noise from sliding chairs, tennis balls had been spliced open and placed on chair legs (Picture 7). Tennis balls are made of a number of materials that are a source of respiratory irritants. Constant wearing of tennis balls can produce fibers and cause TVOCs to off-gas. Tennis balls are made with a natural rubber latex bladder, which becomes abraded when used as a chair leg pad. Use of tennis balls in this manner may introduce latex dust into the school environment. Some individuals are highly allergic to latex (e.g., spina bifida patients) (SBAA, 2001). It is recommended that the use of materials containing latex be limited in buildings to reduce the likelihood of symptoms in sensitive individuals (NIOSH, 1997).

Tennis Balls on Classroom Chairs

7. Discontinue the use of tennis balls on chairs to prevent latex dust generation.
