INDOOR AIR QUALITY PRE-OCCUPANCY ASSESSMENT

**Holyoke Community College at
Holyoke Transportation Center
206 Maple Street
Holyoke, Massachusetts**

Prepared by:
Massachusetts Department of Public Health
Bureau of Environmental Health
Indoor Air Quality Program
October 2010

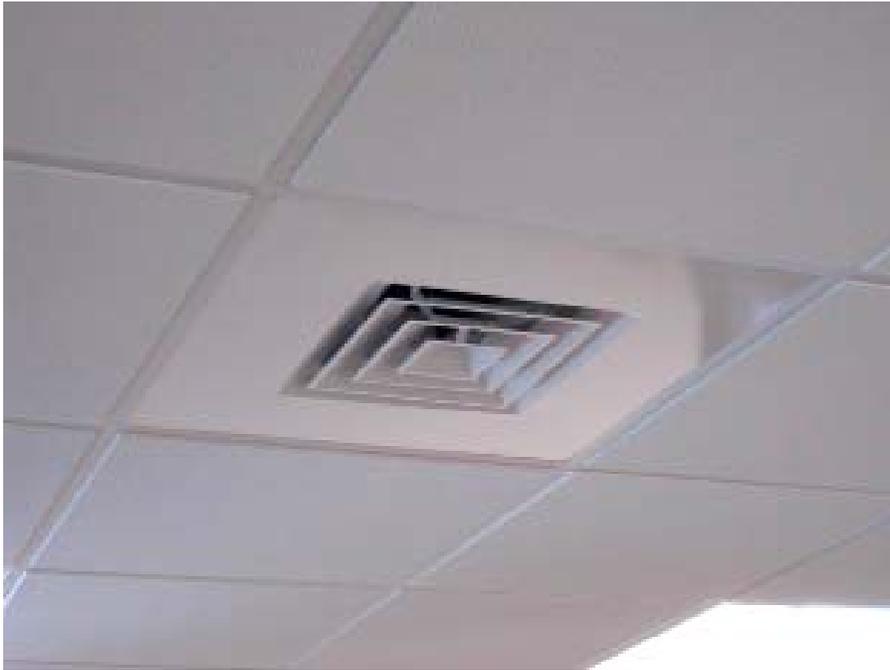
Picture 1

Each of the two floors planned for occupancy by HCC has a separate air-handling unit (AHU) located on the roof. Fresh air is drawn into the AHU through vents located within the unit. It is then heated or cooled and delivered to occupied areas through ceiling-mounted supply diffusers via ductwork (Picture 1). Return air is drawn through ceiling mounted exhaust vents into ducts that are connected to the rooftop AHUs (Picture 2). BEH/IAQ staff noted that the exhaust vents for the AHUs were located directly below the fresh air intakes (Picture 3). This close configuration of intake and exhaust vents can lead to the capture of exhaust air by the fresh air intake (called entrainment) under certain weather conditions. BEH staff was informed that a shield to direct the exhaust away from the fresh air intakes had already been requested, and would be fabricated and installed. The completion of this adjustment had been added to the final punch list by HCC staff.

Ceiling-Mounted Fresh Air Diffuser

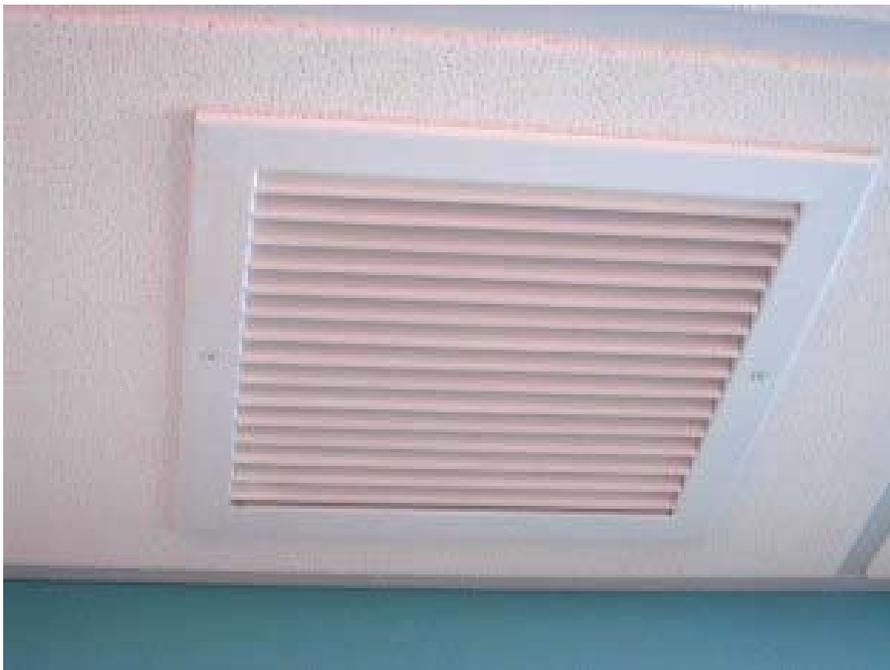
Picture 2

Ceiling-Mounted Exhaust Vent

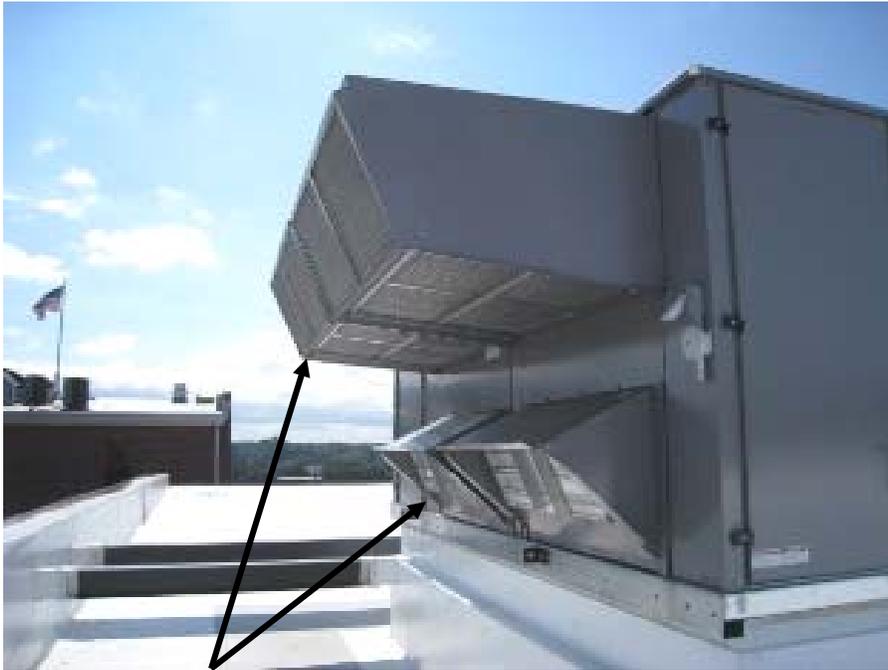
Picture 3

Rooftop AHU, Note Close Proximity of Exhaust Vent to Fresh Air Intake

1. Ensure exhaust vents on AHUs are reconfigured so they are not located directly below fresh air intakes.
2. Routinely inspect roof drains and clear perimeter of any obstructions.

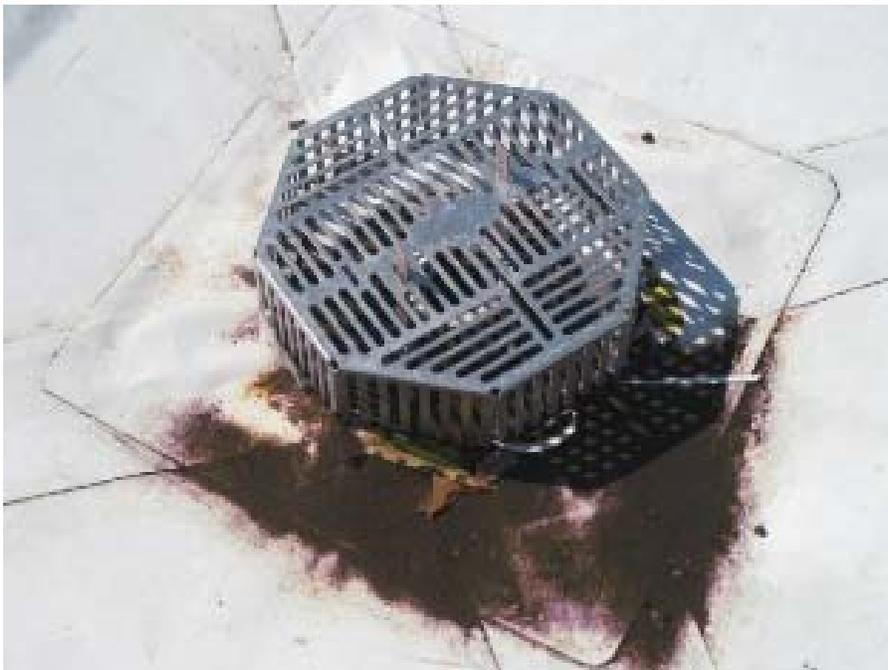
Picture 4

On the roof, organic material and debris from the installation of the membrane roof was observed to be obstructing a portion of a roof drain (Picture 4). It was evident by the accumulation of silt around the perimeter of the drain that this condition had caused water to accumulate for a period of time at this location. Over time, given conditions of freezing and thawing, the accumulation of standing water can contribute to the deterioration of the roof membrane. With time, and under these conditions, water penetration will occur.

Accumulation of Debris and Silt Around Roof Drain

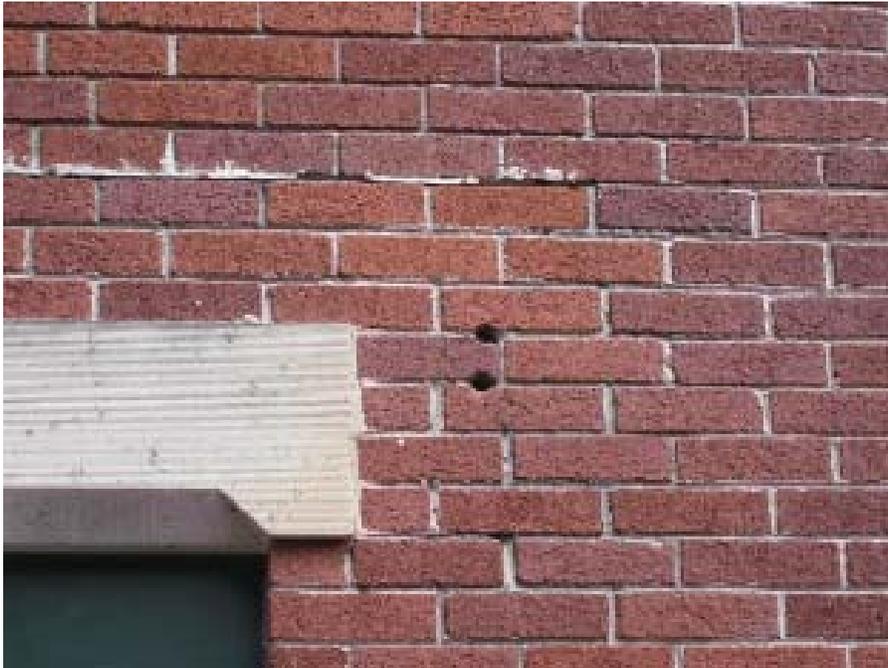
Picture 5

Open utility holes were observed in exterior masonry (Picture 5). While the majority of utility holes were properly sealed on the interior of the building, a few remained to be completed. If not properly sealed, these conditions can provide a means of water penetration through the building envelope.

Holes in Masonry

3. Seal holes in exterior masonry.
4. Seal remaining open utility holes on the interior of the building.
5. In order to eliminate fumes, particulate and carbon monoxide from entering the building, consider providing signs in bus bays to remind vehicle operators of Massachusetts anti-idling laws.

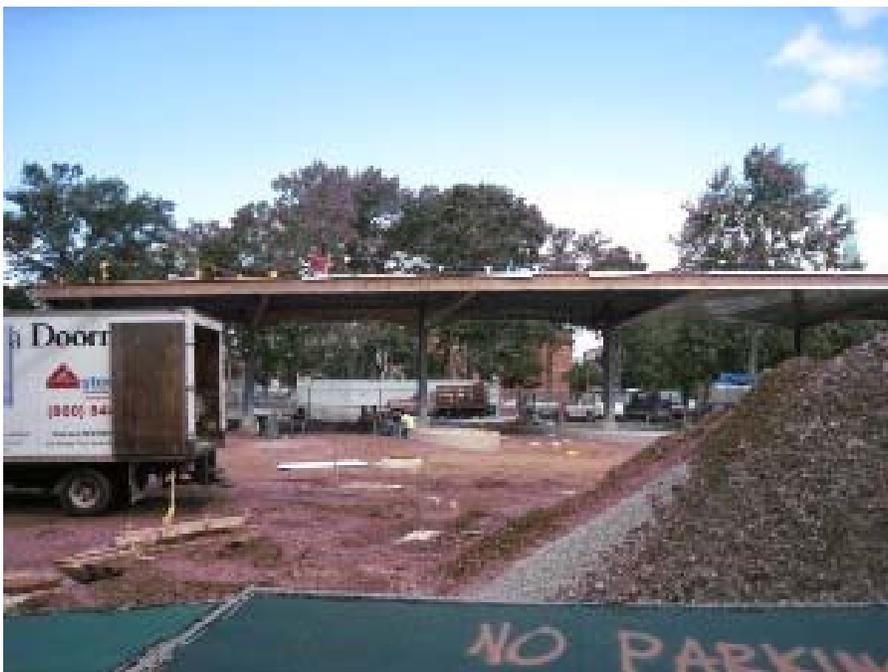
Picture 6

A parking area for the bus station was observed under construction (Pictures 6 and 7). Despite the distance between the bus bays and the AHUs at their rooftop location, the possibility exists for fumes emanating from idling buses to become captured by fresh air intakes on the AHUs,. Therefore, it is important to consider limiting the time that buses idle at the station. The Massachusetts Anti-Idling Law (MGL, 1986) prohibits the unnecessary operation of a motor engine in excess of five minutes. Consideration should be given to installing signage at the bus bays to reinforce this message to the operators of these vehicles.

Bus Bays Under Construction

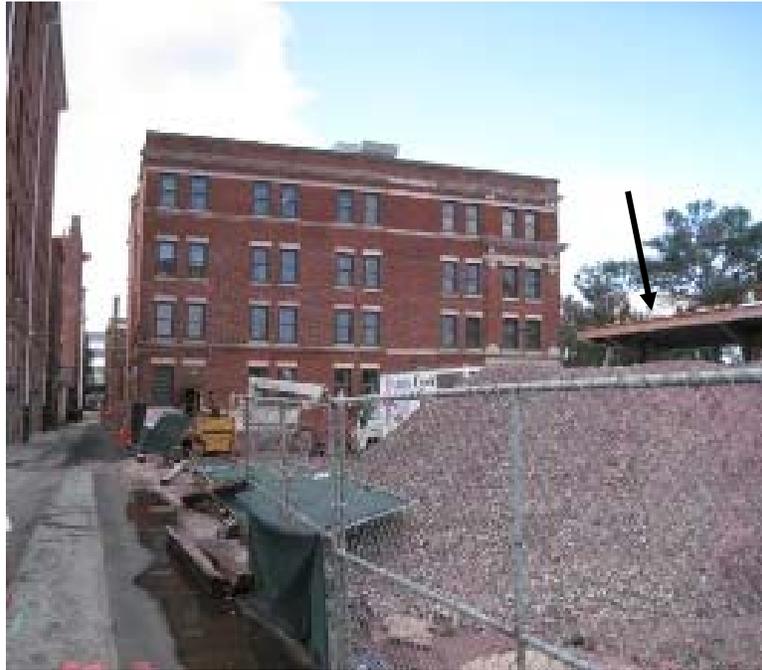
Picture 7

Note Proximity of Bus Bays (Arrow) to Building

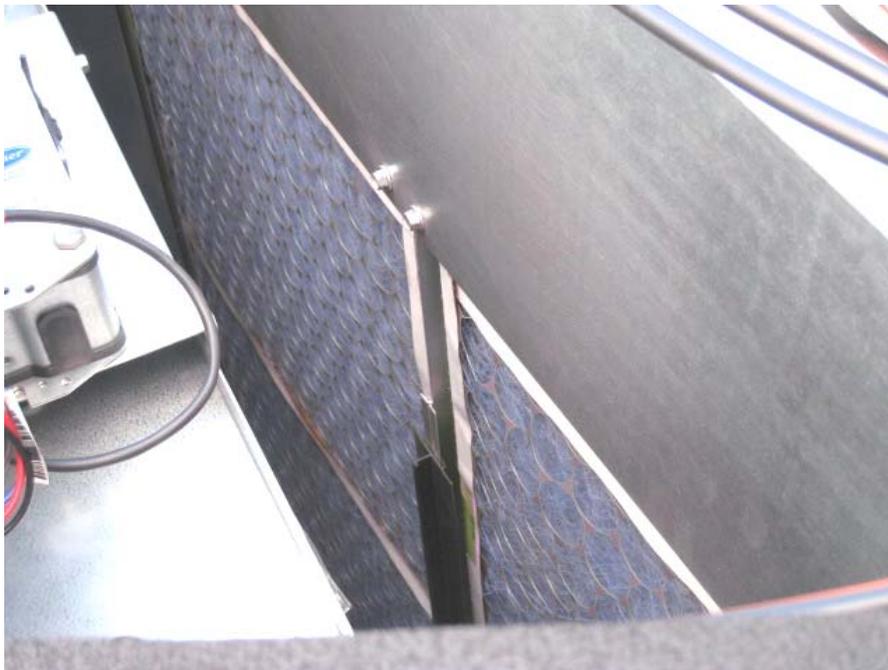
Picture 8

Finally, the type of filters installed in rooftop AHUs provide minimal filtration of respirable dusts (Picture 8). In order to decrease aerosolized particulates, disposable filters with an increased dust spot efficiency can be installed. The dust spot efficiency is the ability of a filter to remove particulates of a certain diameter from air passing through the filter. Filters that have been determined by ASHRAE to meet its standard for a dust spot efficiency of a minimum of 40 percent (Minimum Efficiency Reporting Value equal to 9) would be sufficient to reduce many airborne particulates (Thornburg, 2000; MEHRC, 1997; ASHRAE, 1992). Note that increasing filtration can reduce airflow (called pressure drop), which can subsequently reduce the efficiency of the unit due to increased resistance. Prior to any increase of filtration, each AHU should be evaluated by a ventilation engineer to ascertain whether it can maintain function with more efficient filters.

Fibrous Mesh Filters Installed in Rooftop AHUs

8. Consider increasing the dust-spot efficiency of HVAC filters. Prior to any increase of filtration, each piece of air handling equipment should be evaluated by a ventilation engineer as to whether it can maintain function with more efficient filters.
