INDOOR AIR QUALITY ASSESSMENT

**Beebe School
401 Pleasant Street
Malden, Massachusetts**

Prepared by:
Massachusetts Department of Public Health
Bureau of Environmental Health
Indoor Air Quality Program
June 2010

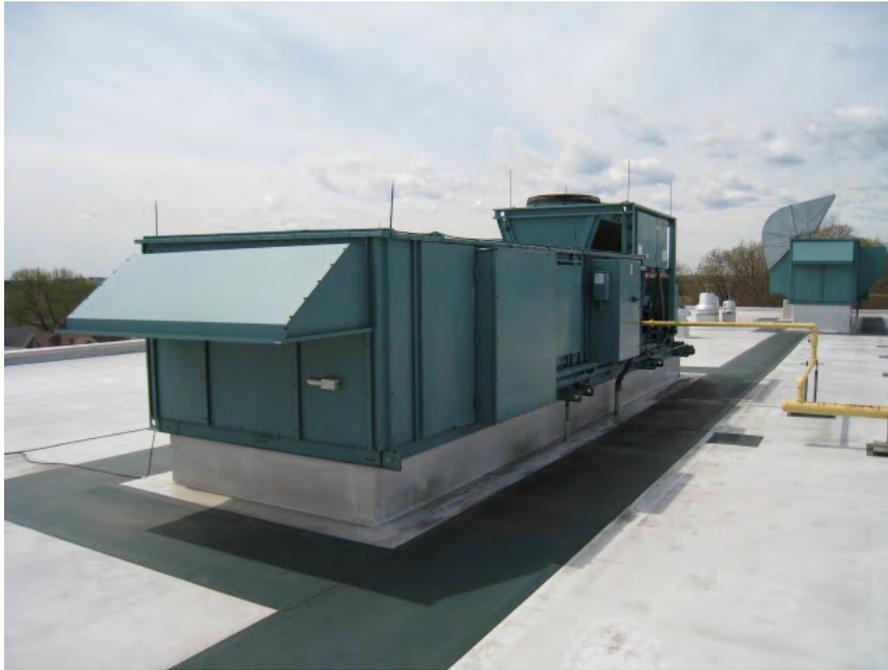
Picture 1

Rooftop air-handling units (AHUs) provide mechanical ventilation to interior areas (Picture 1). AHUs draw in fresh, outside air through a set of intake louvers and then through a bank of pleated filters (Picture 2). Air is then distributed to interior areas via ceiling-mounted air diffusers (Picture 3). The air intake for AHU-6 was shut during the assessment, which would limit the introduction of fresh, outside air for areas supplied by this unit (Picture 4). Loud squeaking noises were heard from AHU-5, which suggest either a loose belt or issues with the fly wheel. BEH staff examined the interior of the unit and found substantial debris from belt-

Rooftop Air Handling Units (AHUs)

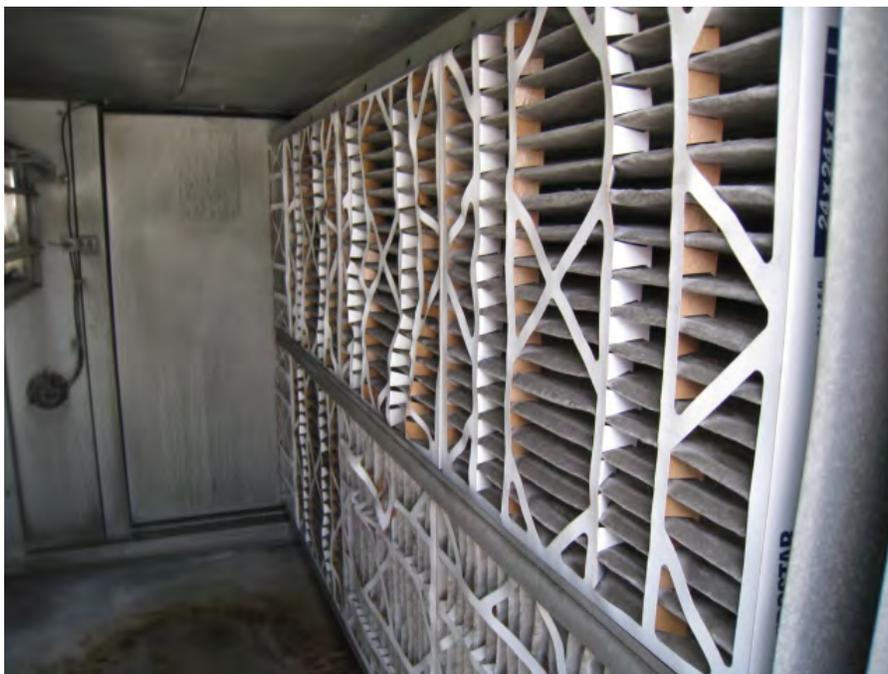
Picture 2

Bank of Pleated Air Filters in Rooftop AHU

6. Operate FCUs as designed to facilitate airflow and temperature control. Inspect FCUs in classroom 172, make repairs as needed.
7. Change filters for air-handling equipment (e.g., AHUs, and FCU) as per the manufacturers' instructions or more frequently if needed. Vacuum interior of units prior to activation to prevent the aerosolization of dirt, dust and particulate matter. Ensure filters *fit flush in their racks* with no spaces in between allowing bypass of unfiltered air into the unit.

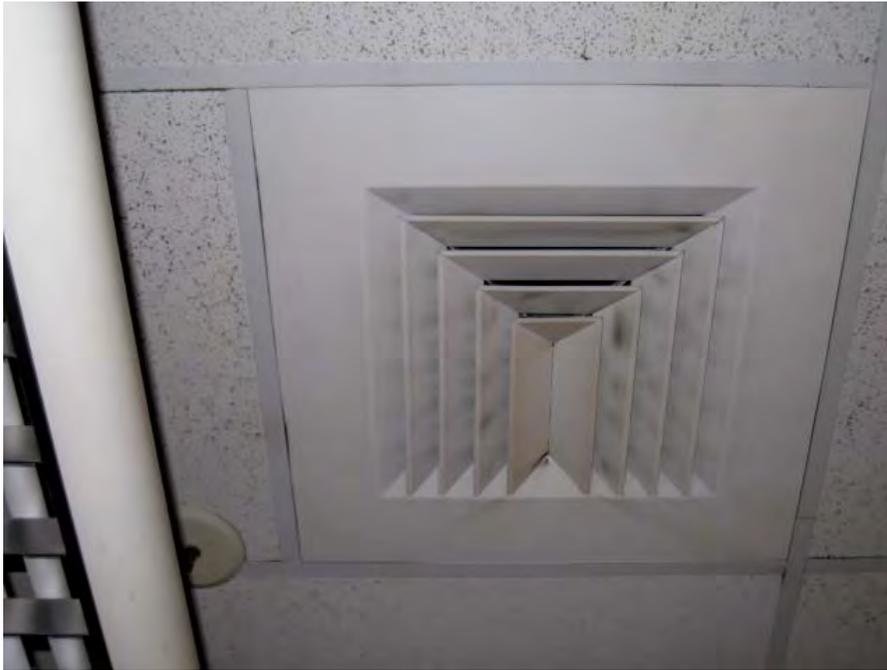
Picture 3

A number of personal fans, exhaust vents, air diffusers and flat surfaces in classrooms and hallways (e.g., windowsills, lockers, TVs) were observed to have accumulated dust/debris (Pictures 3 and 6). Accumulated dust/debris was also noted inside AHUs and FCUs (Pictures 5, 14 through 16). Re-activated FCUs, AHUs, vents or fans can aerosolize accumulated dust. If exhaust vents are not functioning, backdrafting can occur, which can re-aerosolize dust particles.

Ceiling-Mounted Air Diffuser, Note Dust/Debris Accumulation on Louvers

25. Clean upholstered furniture/pillows/cushions annually or more frequently if needed. If not feasible, consider removal.
26. Clean air diffusers, exhaust vents, FCUs and personal fans periodically of accumulated dust. If stained ceiling tiles cannot be cleaned, replace.

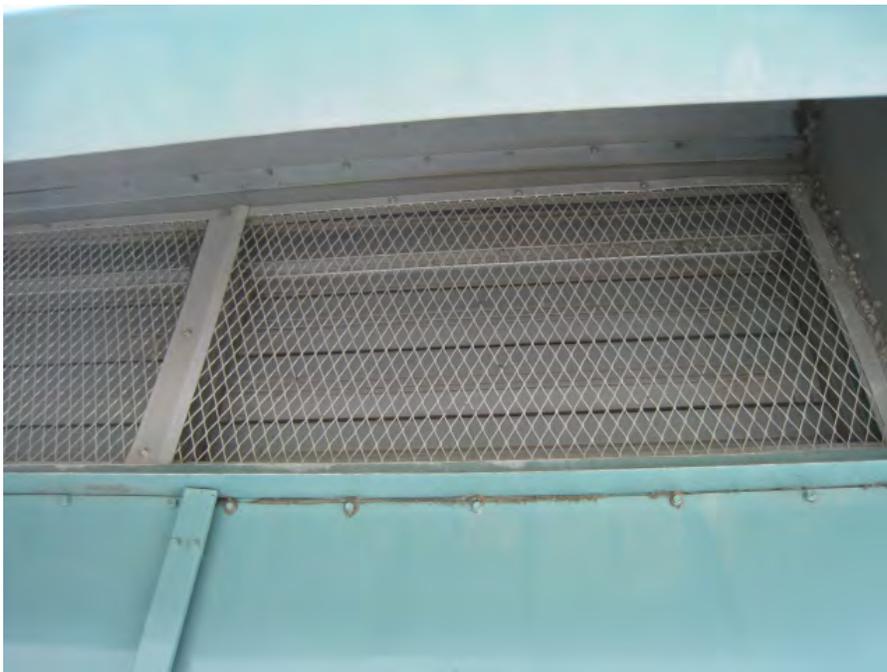
Picture 4

Air Intake Shut on Rooftop AHU 6

1. Contact an HVAC engineering firm to evaluate fresh air intake louvers/pneumatics for AHU 6, belt/flywheel function for AHU-5, and that repairs to the breach in the ductwork in classroom 425 were adequate to restore airflow.

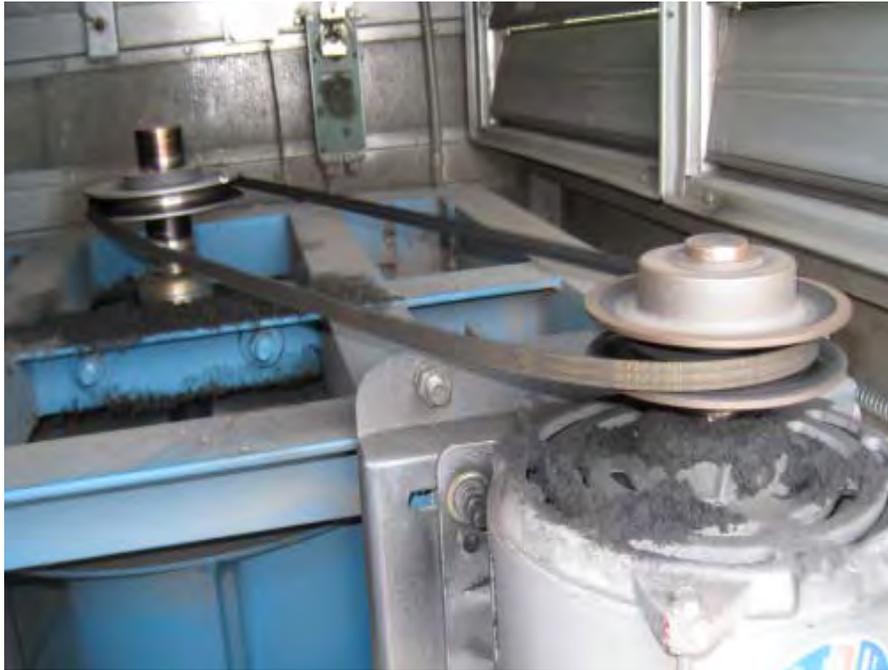
Picture 5

wear (Picture 5). Inside the building a loud “hissing” noise was detected in classroom 425. BEH staff removed ceiling tiles toward the rear of the room and discovered a breach in the supply duct, which was pressurizing the ceiling plenum and resulting in little airflow into the classroom. In subsequent correspondence with Mr. Webb, he reported that the duct was repaired and airflow re-established to classrooms supplied by this duct-line.

Interior of AHU-5, Note Piles of Debris From Belt-Wear

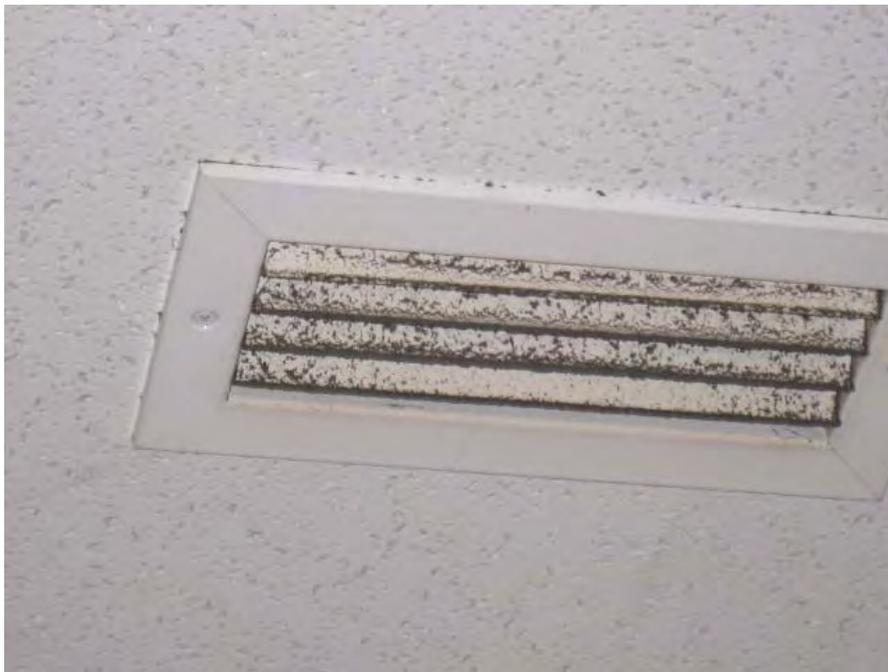
Picture 6

Exhaust ventilation is provided by ceiling-mounted vents ducted to rooftop motors (Picture 6). The exhaust ventilation system is designed to continuously remove moisture, odors, and pollutants from the indoor environment. Exhaust vents were not functioning in the majority of areas surveyed at the time of the assessment. BEH staff examined the rooftop exhaust vents and found a number of them not functioning/in disrepair (Picture 7). In subsequent correspondence with Mr. Webb he reported that exhaust vents were either repaired or are on a list awaiting repair. In a number of classrooms, the exhaust vents were located above the hallway door which can limit exhaust efficiency (Picture 8). When a classroom door is open, exhaust vents tend to draw air from both the hallway and the classroom. The open hallway door reduces the effectiveness of the exhaust vent to remove common environmental pollutants from classrooms.

Ceiling-Mounted Exhaust Vent, Note Dust/Debris Accumulation on Louvers

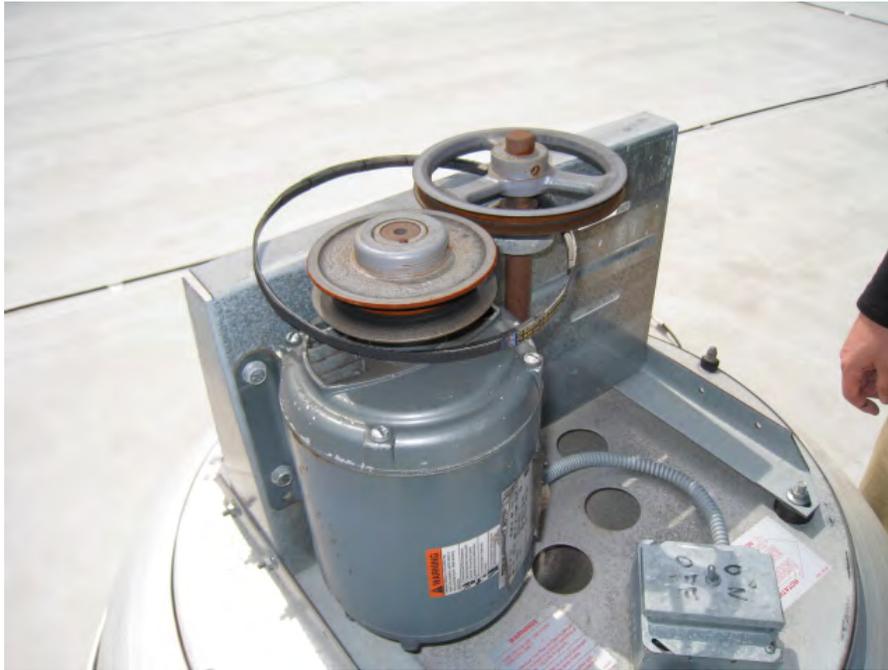
Picture 7

Rooftop Exhaust Vent, Note Damaged Fan Belt

2. Continue with plans to restore general exhaust ventilation throughout the building. Periodically inspect motors and belts for proper function; perform repairs and adjustments as necessary.

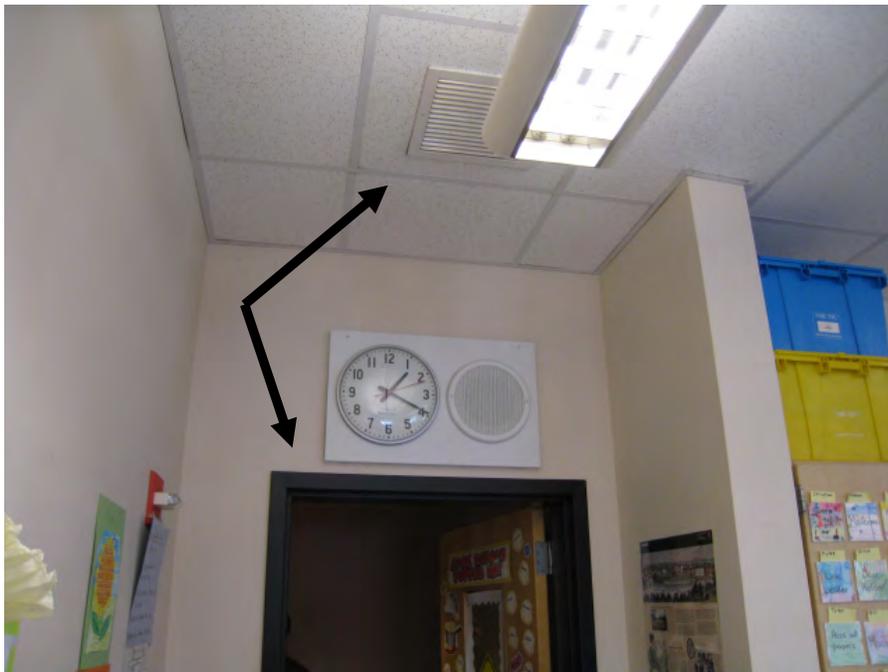
Picture 8

Proximity of Exhaust Vent to Open Classroom Door

3. Restore exhaust ventilation in bathroom areas; make repairs as necessary.
4. Close classroom doors to facilitate exhaust ventilation.
5. Remove all blockages from FCUs to ensure adequate airflow.

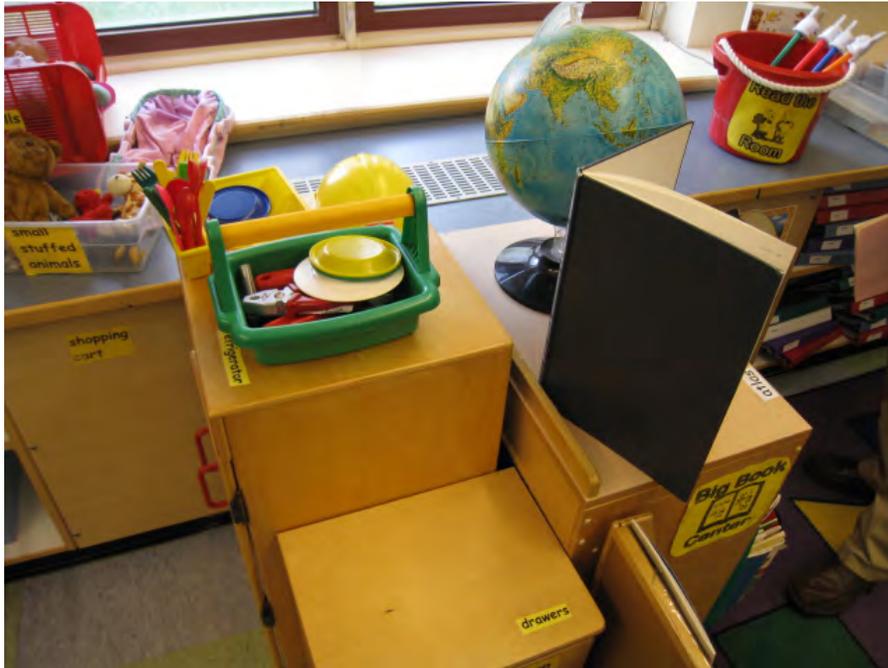
Picture 9

Fan coil units (FCUs) in each classroom facilitate airflow and temperature control. FCUs do not provide fresh air to rooms; rather, FCUs re-circulate air and provide auxiliary heating and cooling. Conditioned air is filtered and provided to the classroom by a diffuser atop the unit. Air is then drawn into a return vent at the base of the unit ([Figure 1](#)). Each classroom has two FCUs and is controlled by a switch with settings for “low”, “high” and “off”. In a number of areas, FCUs were found deactivated and/or obstructed by furniture, books and other stored materials (Picture 9). In order for FCUs to facilitate airflow as designed, air diffusers and return vents

Fan Coil Unit (FCU) Return Vent (Bottom Front) Obstructed by Classroom Furniture

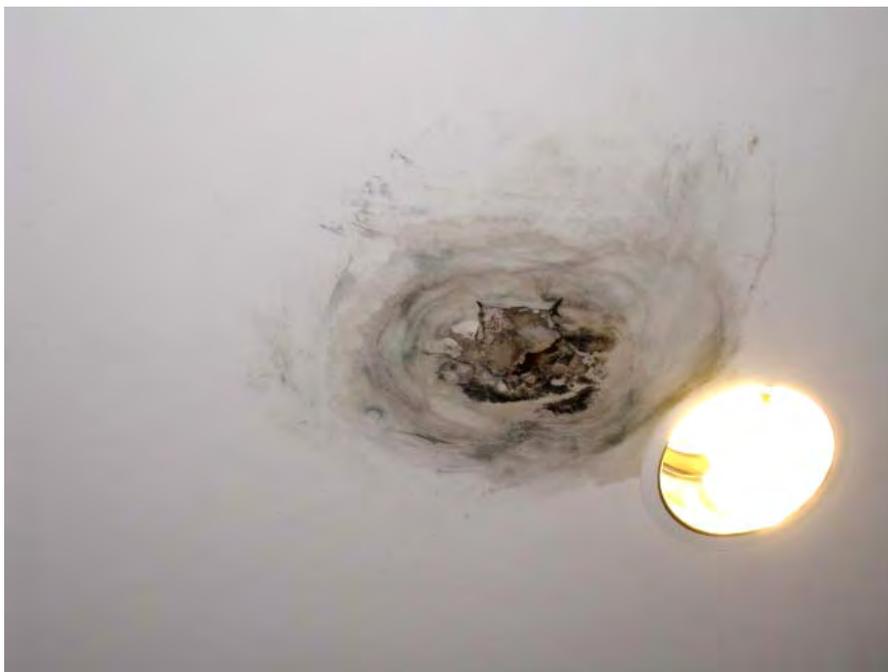
Picture 10

Water-damaged ceiling tiles were observed in a few areas, which indicate current/historic plumbing and/or roof leaks (Table 1). Water-damaged ceiling tiles can provide a source of mold and should be replaced after a water leak is discovered and repaired. Chronic leaks were reported by the occupant in room 140 along windows. Water-damaged gypsum wallboard (GW) that was possibly colonized by mold was observed on the ceiling in the hallway outside of classroom 151 (Picture 10). At the time of the assessment, BEH recommended that the damaged/mold colonized section of GW be removed.

**Water Damaged/Mold Colonized section of Gypsum Wallboard Ceiling
In Hallway Near Classroom 151**

13. Remove water damaged/mold colonized section of GW ceiling in hallway outside of classroom 151. Determine the source of water leaks and make repairs as needed.

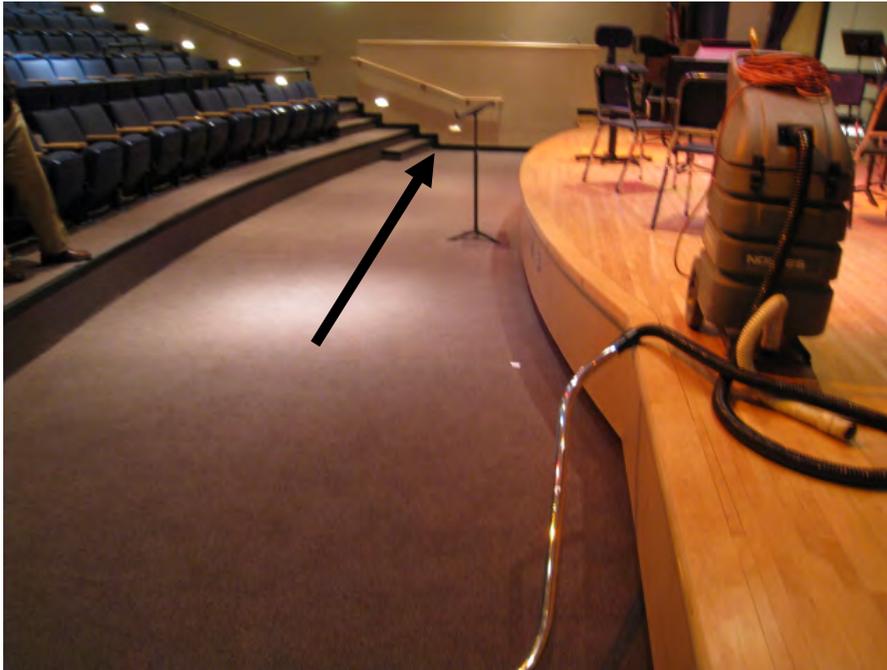
Picture 11

The auditorium is carpeted and is the lowest point of the school. It was reported that the carpet along the front of the stage is chronically wet during heavy rains that result in high water table conditions (Picture 11). BEH staff conducted moisture measurements of the carpet and found that the carpet and GW along the stairs at stage left (Picture 12) had elevated moisture measurements. At the time of the assessment, BEH staff recommended that the wet carpeting and GW be removed in this area, with a long-term recommendation to replace carpeting along the lower floor of the auditorium with a non-porous material such as tile.

Auditorium Floor Chronically Moistened, Arrow Indicates Wet Carpet and GW at Base of Stairs

15. Remove carpeting from lower level of auditorium in front of stage. Consider replacing with non-porous flooring material (e.g., tile).
16. Remove water-damaged GW at base of stairs near wet carpeting in auditorium stage left. Consider replacing with a non-porous/water resistant material.

17. Consider contacting a building engineering firm, public works and/or building envelope specialist to determine methods of preventing chronic water infiltration in the auditorium.

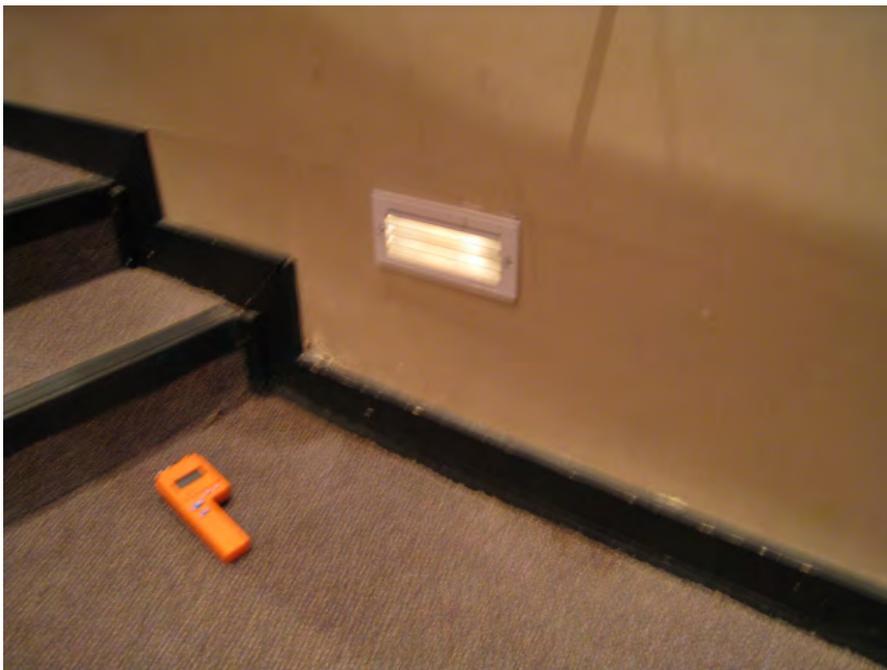
Picture 12

Wet Carpet and GW at Base of Stairs Auditorium Stage Left

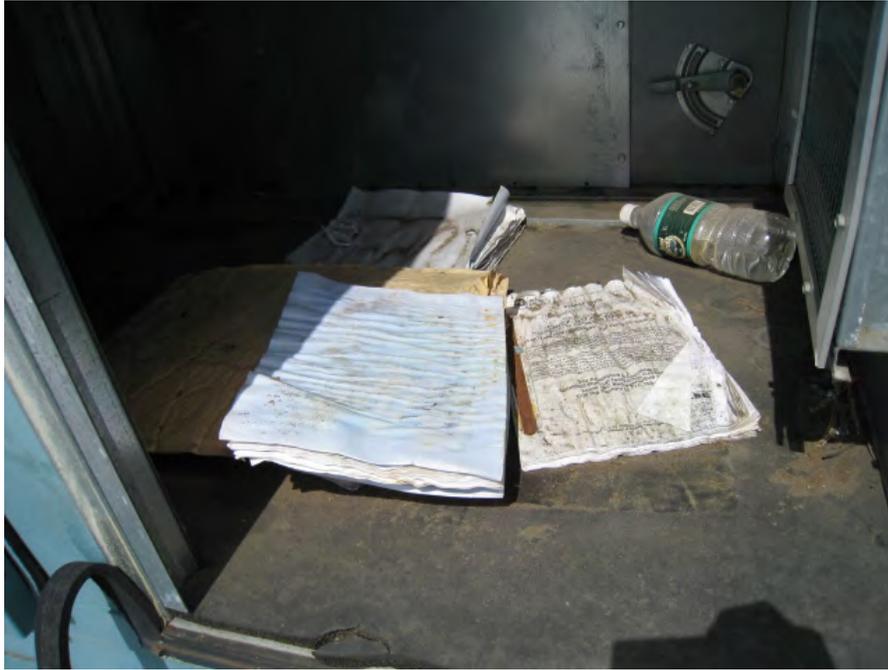
Picture 13

Water-damaged/mold colonized equipment manuals were found inside of rooftop AHUs (Picture 13). These documents should be removed to prevent a source of mold spores/odors inside the units that can be distributed to occupied areas via the HVAC system.

Water-Damaged/Mold Colonized Manuals Inside AHU Chambers

18. Remove water-damaged/mold colonized manuals from inside AHUs, clean flat surfaces with an antimicrobial as necessary.
19. Seal breaches, seams and spaces between sink countertops and backsplashes to prevent water damage.

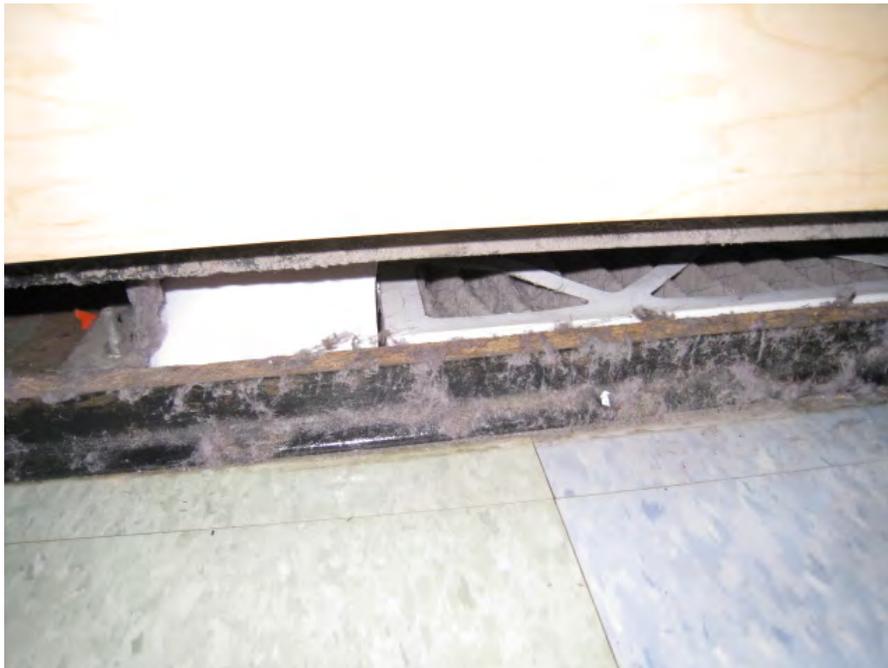
Picture 14

Accumulated Dust/Debris Along Front of FCU, Note Filter on Floor

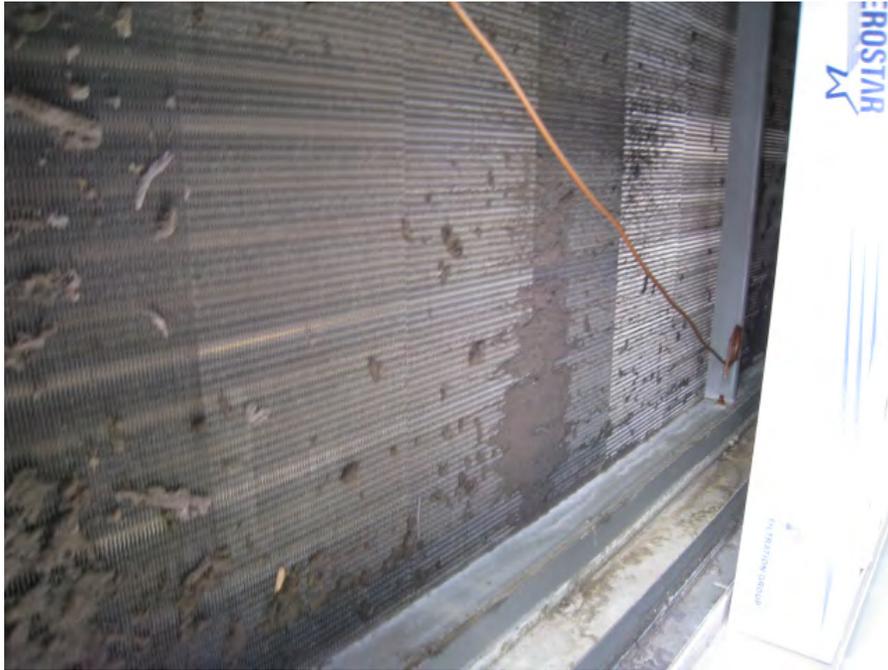
Picture 15

Accumulated Dust/Debris in Rooftop AHU

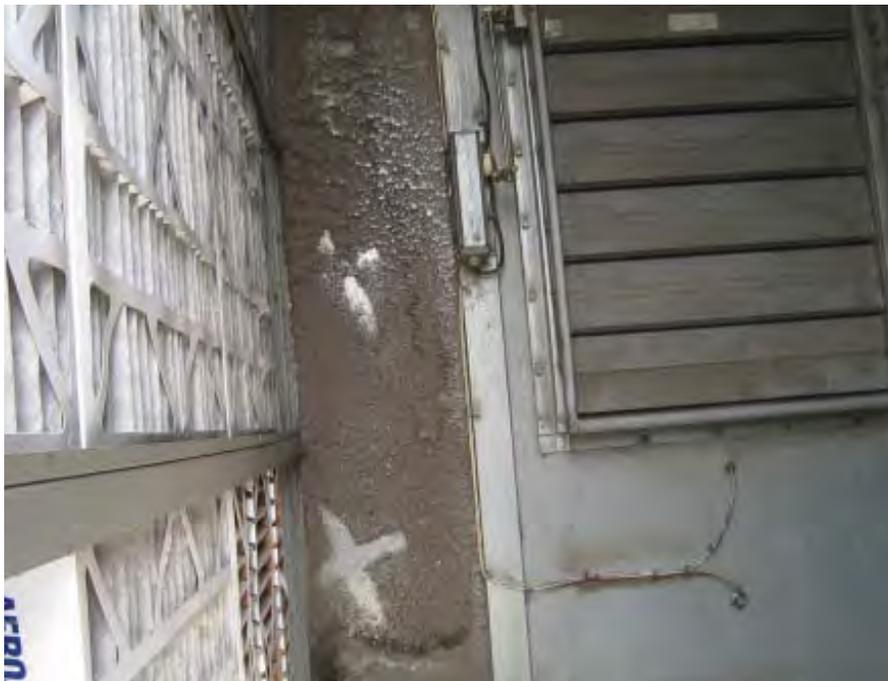
Picture 16

Accumulated Dust/Debris in Rooftop AHU

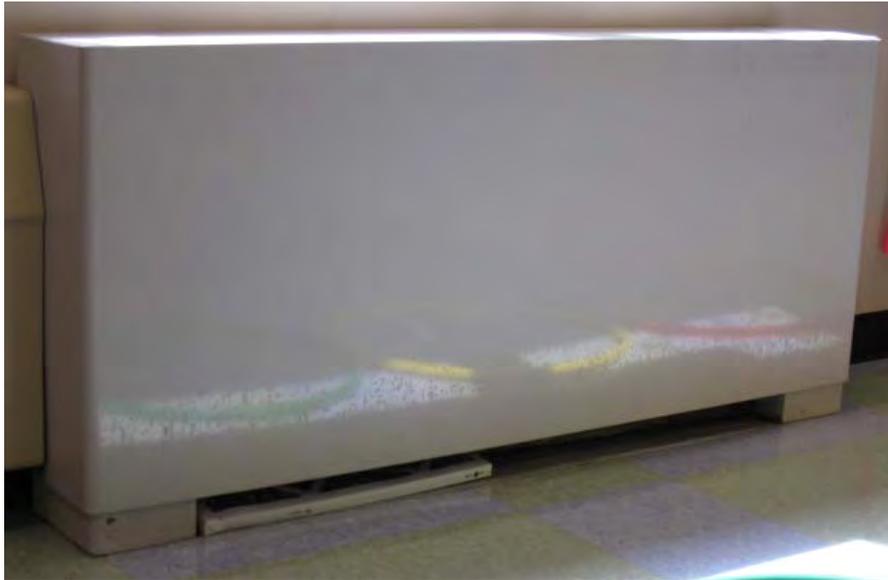
Picture 17

Finally, filters for the FCUs were observed to be ill-fitting, with many of them resting on the floor (Picture 17). In many cases the filters were occluded with dust/debris (Picture 18). Once a filter is saturated it can actually serve as a source of particulates to be re-aerosolized into the airstream by the FCUs. In addition, it can accelerate the degradation of HVAC equipment by making the equipment work harder to draw air through clogged filters.

Air Filter for FCU on Floor

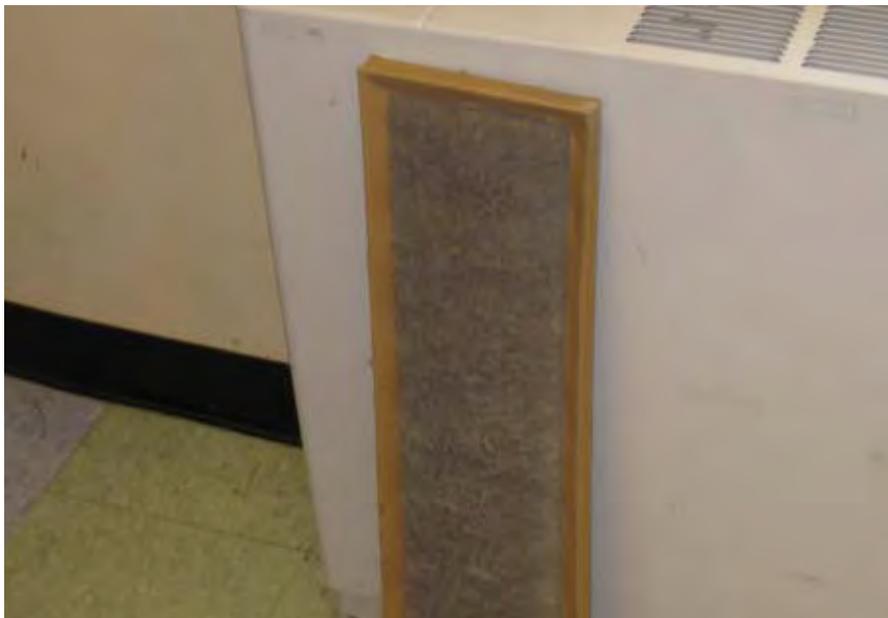
Picture 18

Air Filter for FCU Occluded With Dust/Debris
