# **INDOOR AIR QUALITY ASSESSMENT**

**Plymouth Community Intermediate School**

**Plymouth, Massachusetts**

Prepared by:  
Massachusetts Department of Public Health  
Bureau of Environmental Health  
Indoor Air Quality Program  
February 2010

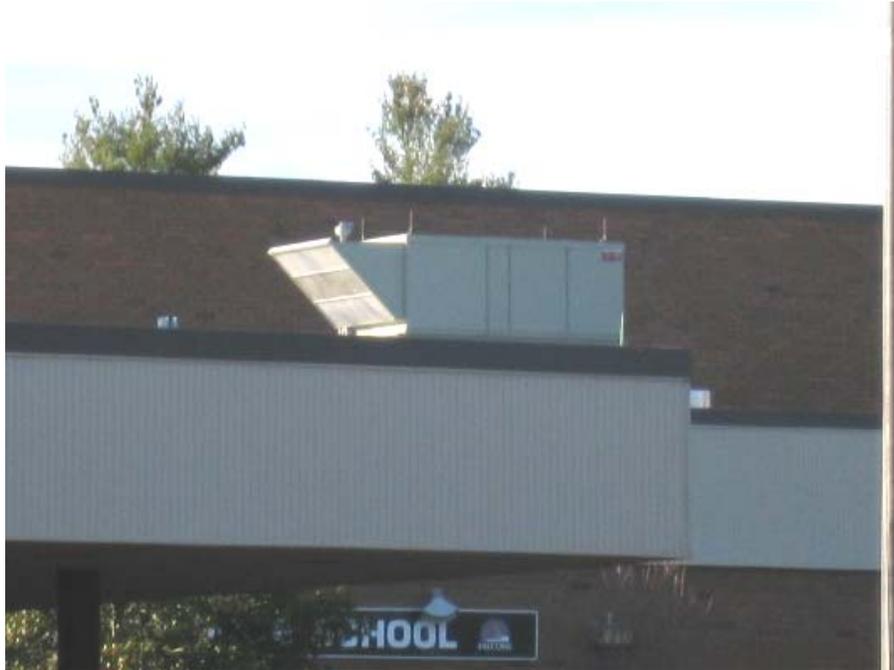
**Picture 1**

It can be seen from Table 1 that carbon dioxide levels were below 800 parts per million (ppm) in 98 of 99 areas surveyed, indicating adequate air exchange throughout the building at the time of the assessment. As previously mentioned, the HVAC system and its controls were replaced over the last year. The HVAC system consists of a number of computer-controlled rooftop air handling units (AHUs) (Pictures 1 and 2). Fresh air is distributed via ceiling-mounted air diffusers and ducted back to AHUs via ceiling-mounted return vents (Pictures 3 and 4). These units were operating at the time of the assessment.

**Rooftop Air Handling Unit**

1. Continue to operate all ventilation systems (e.g., AHUs) throughout the building continuously during occupied periods.
2. Close classroom doors to maximize air exchange.

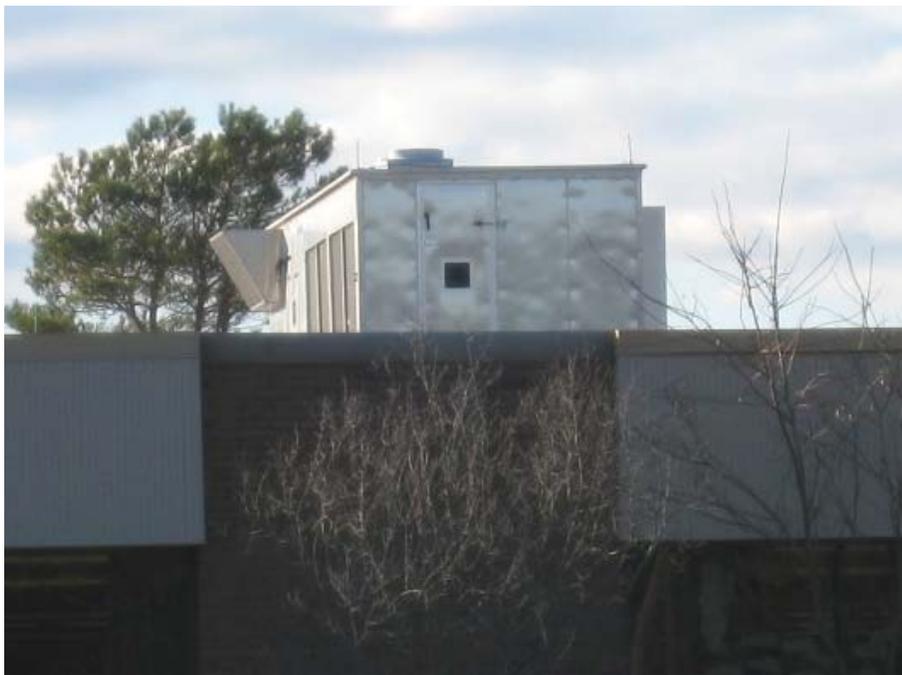
**Picture 2**

**Rooftop Air Handling Unit**

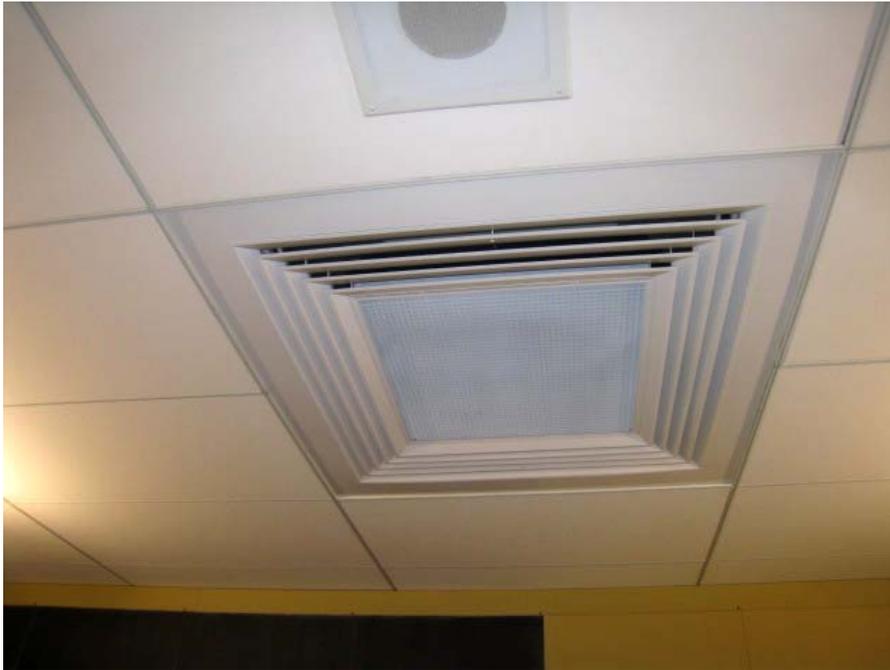
**Picture 3**

**Ceiling-Mounted Air Diffuser**

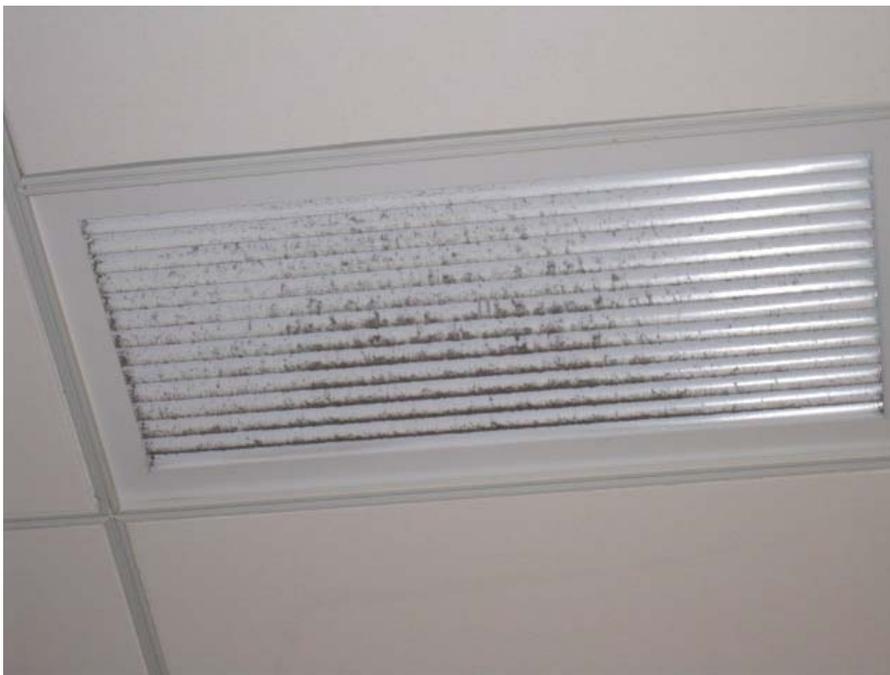
**Picture 4**

A number of return vents and personal fans in classrooms were observed to have accumulated dust/debris. If return vents are not functioning, backdrafting can occur, which can re-aerosolize dust particles. Re-activated personal fans can aerosolize dust accumulated on fan blades/housing. The majority of classrooms contain cloth curtains, which are likely not cleaned on a regular basis. Textiles can be a source of dust and allergens, which can be irritating to the eyes, nose and throat.

**Ceiling-Mounted Return Vent, Note Dust/Debris Accumulation**

9. Clean personal fans, air diffusers and return vents periodically of accumulated dust.

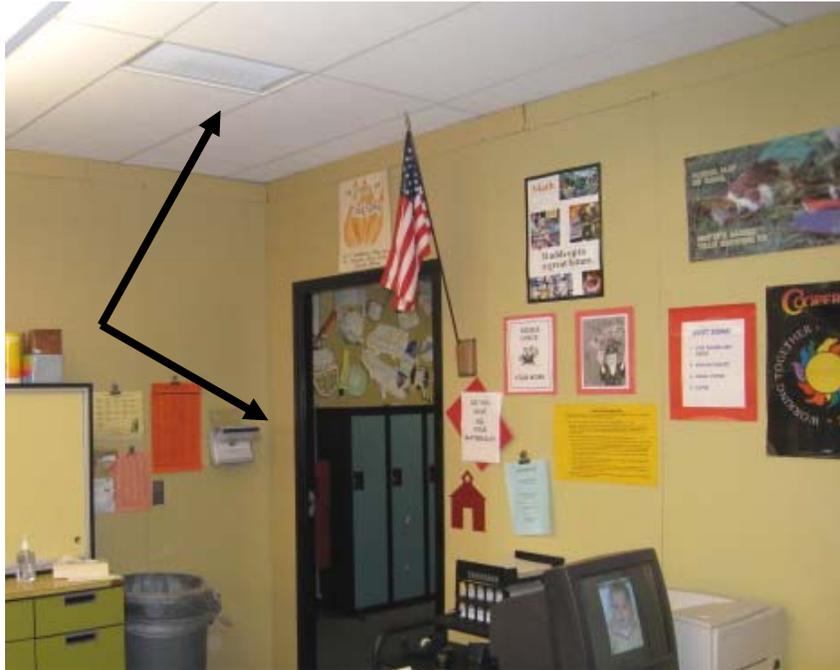
**Picture 5**

In several classrooms, return vents are located near hallway doors (Picture 5). When these classroom doors are open, the return vents will tend to draw air from both the hallway and the classroom, reducing the effectiveness of the system to remove common environmental pollutants.

**Proximity of Ceiling-Mounted Return Vent to Open Classroom Door**

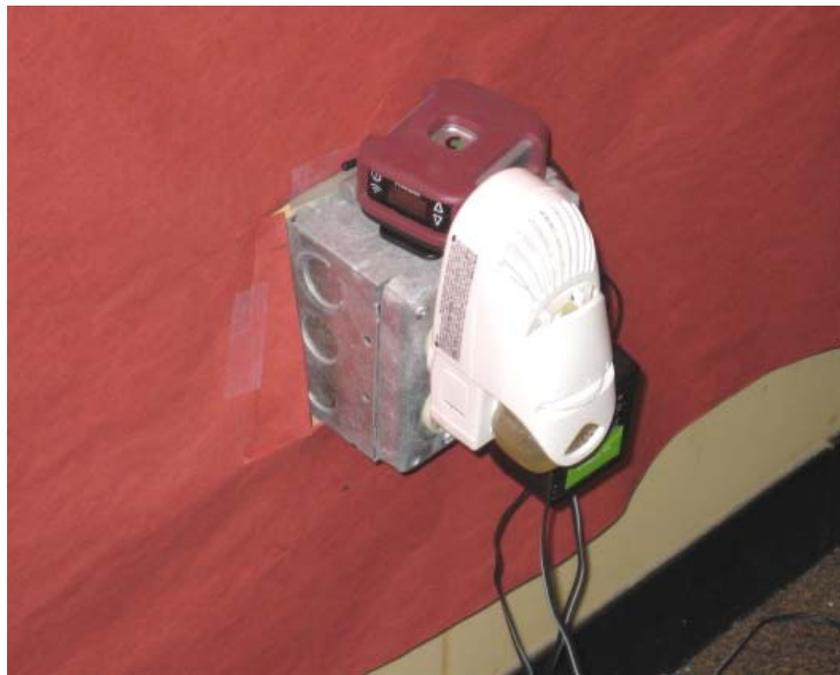
**Picture 6**

Plug-in air deodorizers (Picture 6), air fresheners and scented oils were found in several areas (Table 1). Air deodorizers contain chemicals that can be irritating to the eyes, nose and throat of sensitive individuals. Many air deodorizers contain 1,4-dichlorobenzene, a VOC which may cause reductions in lung function (NIH, 2006). Further, air deodorizers do not remove materials causing odors, but rather, mask odors which may be present in the area.

**Plug-in Air Deodorizer**

10. Refrain from using air fresheners and deodorizers to prevent exposure to VOCs.
11. Clean upholstered furniture, cloth curtains, stuffed animals, pillows and curtains on a regular schedule. If not possible/practical, consider removing from classrooms.

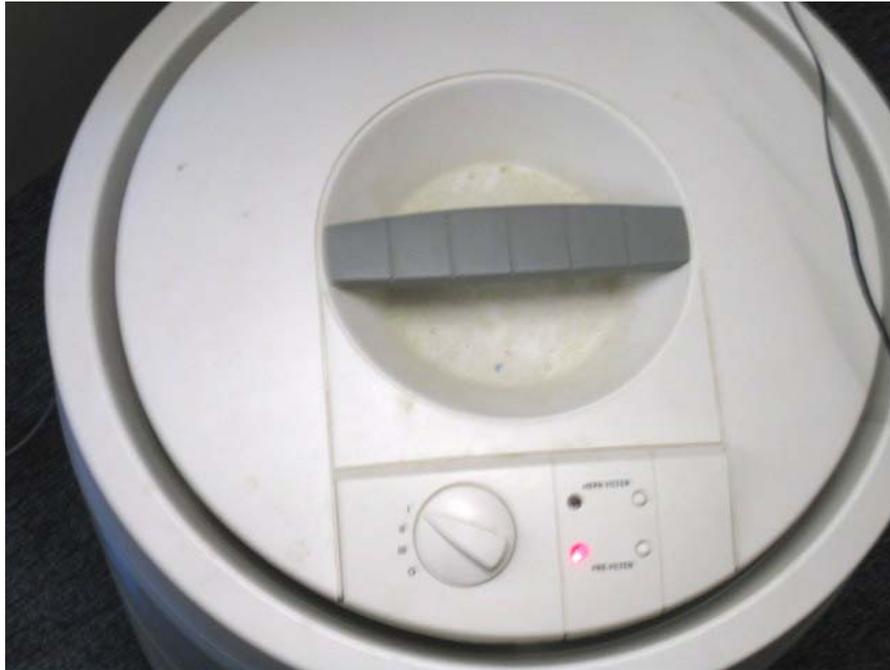
**Picture 7**

Portable air purifiers were in use in several areas. An air purifier has a filter that should be cleaned or changed as per the manufacturer's instructions to avoid the reaerosolization of dusts and particulates. The "change filter" indicator light for the air purifier in classroom R-7 was on (Picture 7) indicating it was saturated with dust and debris.

**“Change Filter” Indicator Light on for Air Purifier**

4. Change filters for air-handling equipment (e.g., AHUs and air purifiers) as per the manufacturer's instructions or more frequently if needed.
5. For buildings in New England, periods of low relative humidity during the winter are often unavoidable. Therefore, scrupulous cleaning practices should be adopted to minimize common indoor air contaminants whose irritant effects can be enhanced when the relative humidity is low. To control for dusts, a high efficiency particulate arrestance (HEPA) filter equipped vacuum cleaner in conjunction with wet wiping of all surfaces is recommended. Avoid the use of feather dusters. Drinking water during the day can help ease some symptoms associated with a dry environment (throat and sinus irritations).

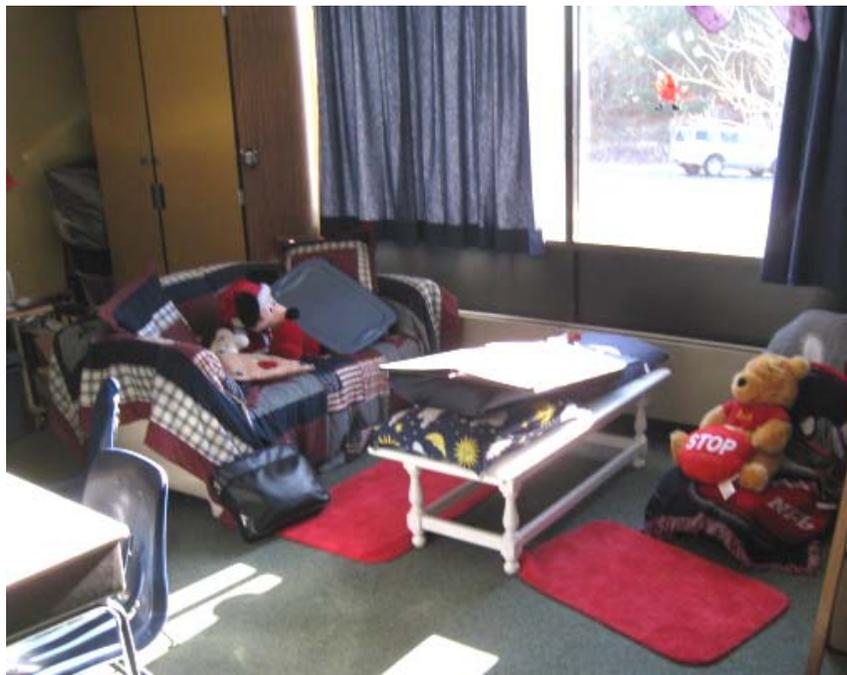
**Picture 8**

Upholstered furniture, pillows/cushions and large stuffed animals were seen in several classrooms (Pictures 8 and 9). Upholstered furniture, pillows and cushions are covered with fabric that comes in contact with human skin. This type of contact can leave oils, perspiration, hair and skin cells. Dust mites feed upon human skin cells and excrete waste products that contain allergens. In addition, if relative humidity levels increase above 60 percent, dust mites tend to proliferate (US EPA, 1992). In order to remove dust mites and other pollutants, frequent vacuuming of upholstered furniture is recommended (Berry, M.A., 1994). It is also recommended that upholstered furniture (if present in schools), be professionally cleaned on an

**Upholstered Furniture, Pillows, Stuffed Animals and Curtains in Classroom**

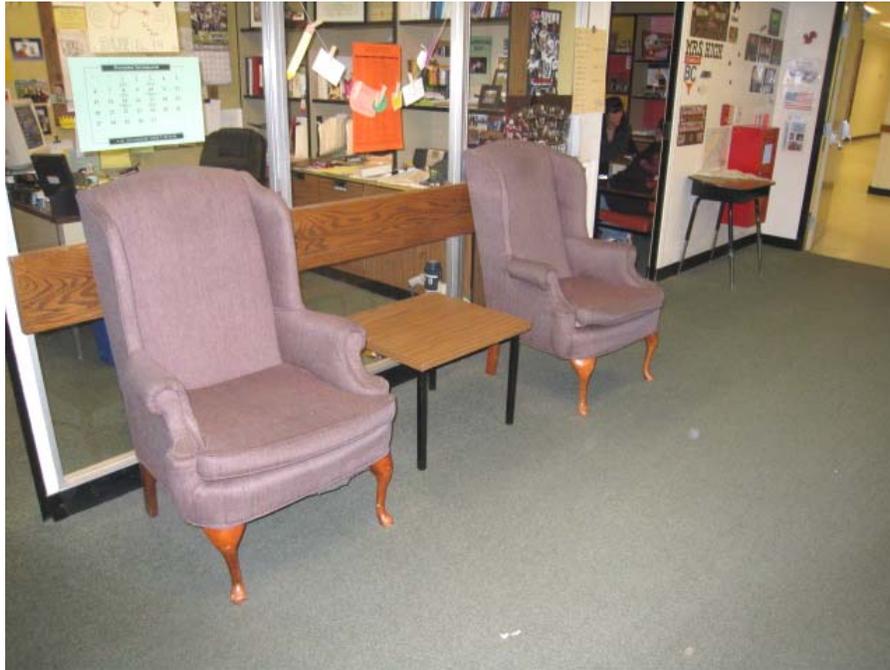
**Picture 9**

**Upholstered Furniture in Hallway**

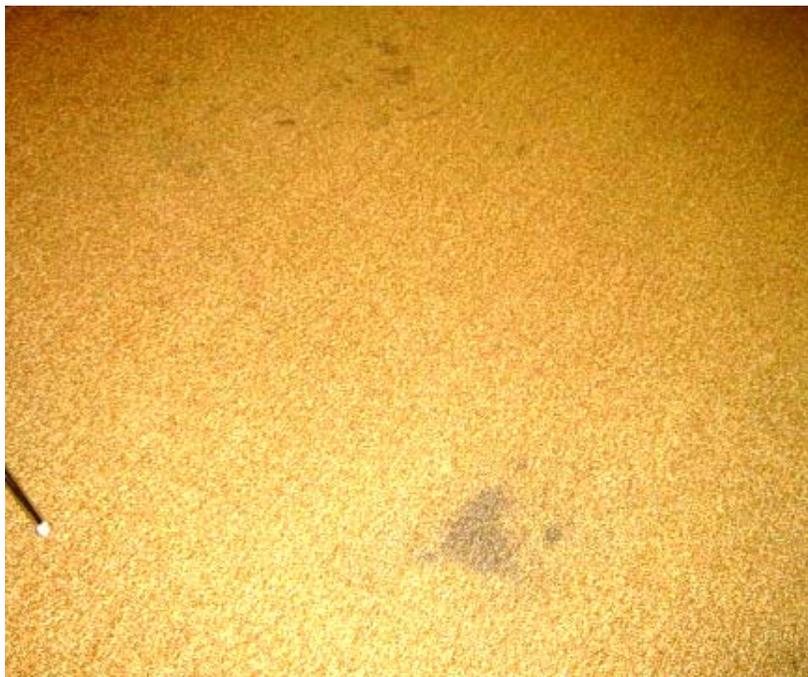
**Picture 10**

Finally, as stated, the majority of floor surfaces in the school are covered by wall to wall carpeting. In several areas, the carpeting is reportedly to be original to the building (over 30 years old). Carpeting was observed stained and/or damaged in a number of areas; in some cases the carpet had been repaired with duct tape (Pictures 10 and 11). The Institute of Inspection, Cleaning and Restoration Certification (IICRC), recommends that carpeting be cleaned annually (or semi-annually in soiled high traffic areas) (IICRC, 2005). PCIS officials reported that carpets are cleaned on an annual basis and that hallways are cleaned several times a year, usually during vacations. Since the average lifespan of a carpet in a school environment is approximately eleven years, consideration should be given to planning for the installation of new flooring (Bishop, 2002).

**Stained Carpeting**

12. Continue to clean carpeting annually or semi-annually in soiled high traffic areas as per the recommendations of the Institute of Inspection, Cleaning and Restoration Certification (IICRC). Copies of the IICRC fact sheet can be downloaded at: [http://www.cleancareseminars.com/carpet\\_cleaning\\_faq4.htm](http://www.cleancareseminars.com/carpet_cleaning_faq4.htm) (IICRC, 2005)

13. Consider a long-term plan to replace all carpeting in the building as funds become available. Consider replacing carpeting with a non-porous surface such as vinyl tile.

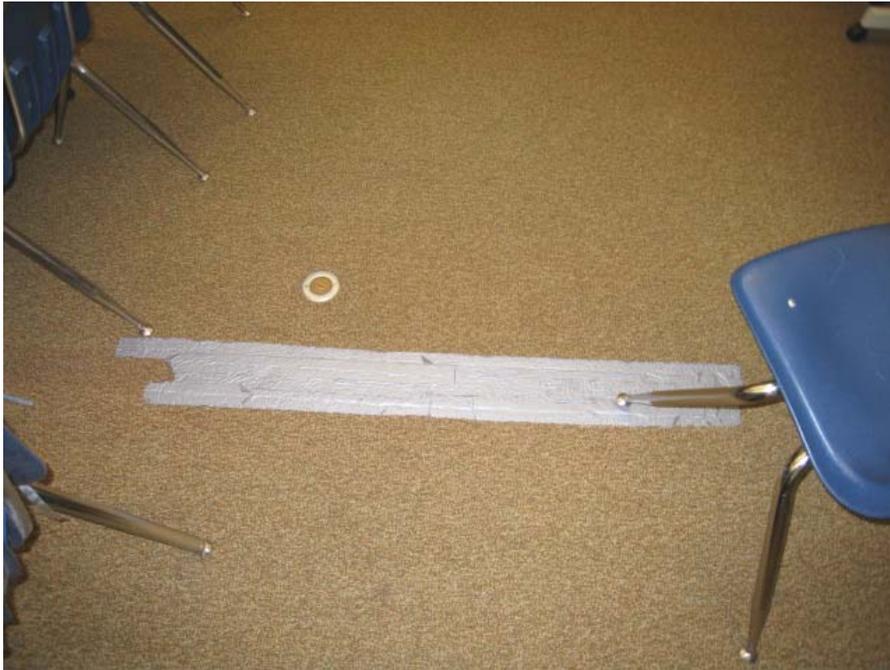
**Picture 11**

**Classroom Carpet Repaired With Duct Tape**
