# **INDOOR AIR QUALITY ASSESSMENT**

**Massachusetts Department of Mental Health  
Shetland Park Office Complex  
35 Congress Street  
Salem, Massachusetts**

Prepared by:  
Massachusetts Department of Public Health  
Bureau of Environmental Health  
Indoor Air Quality Program  
June 2010

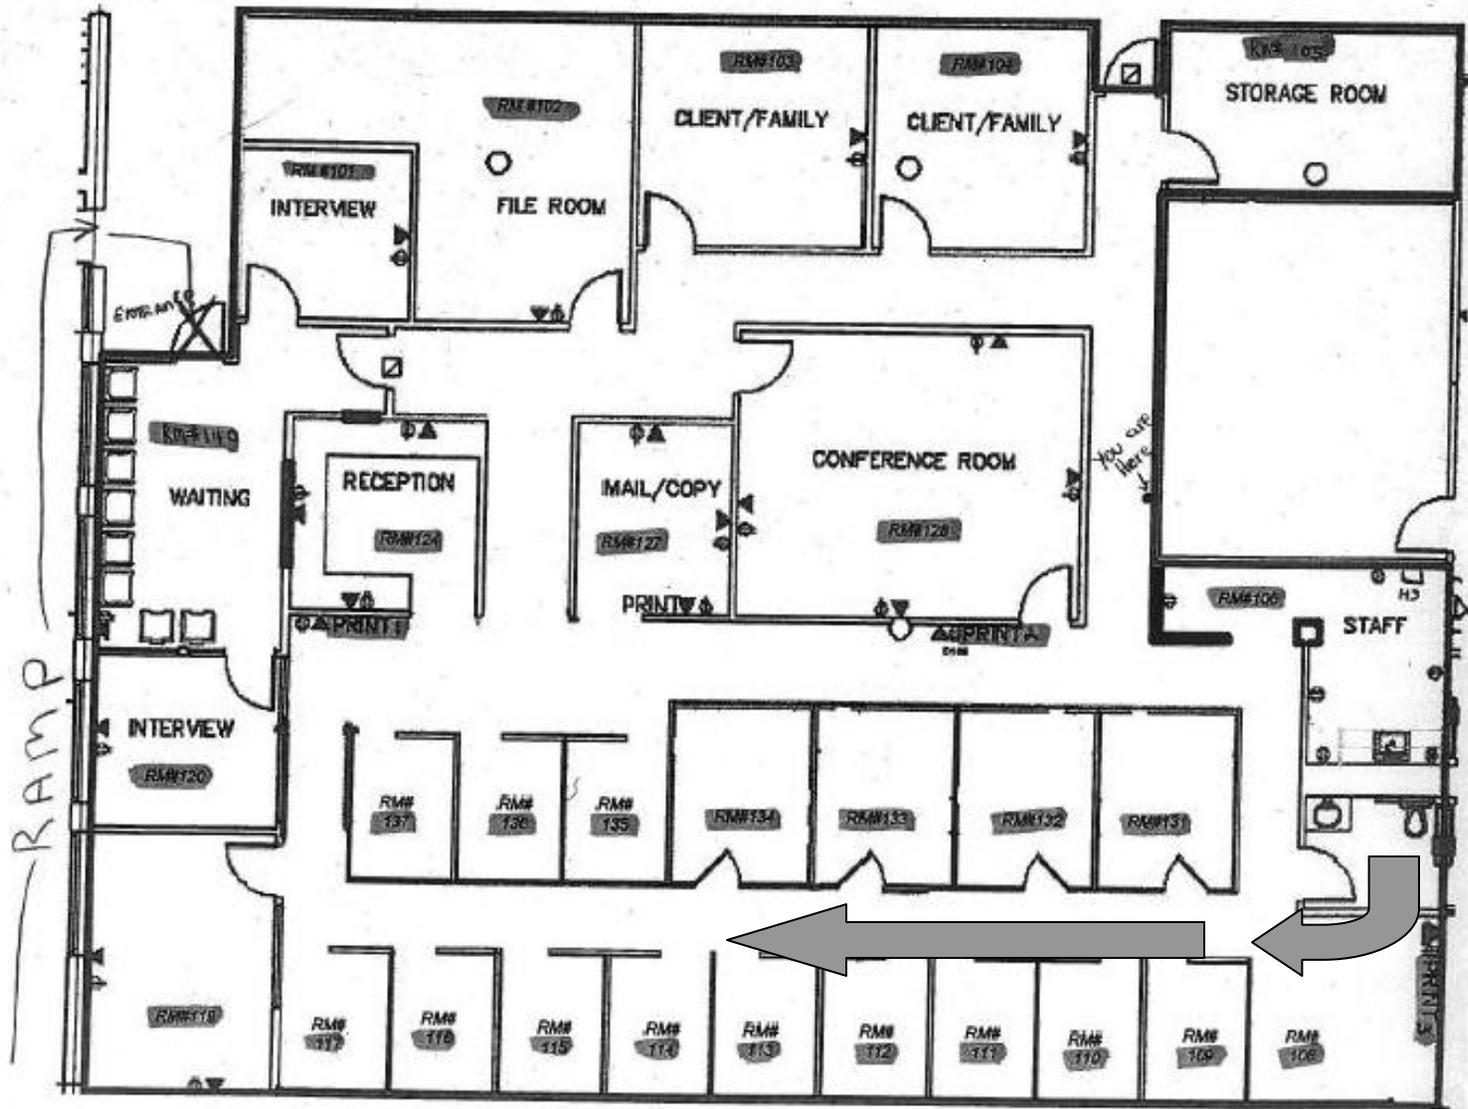
**Figure 1**  
Likely Pathway for Bathroom Fragrance to Migrate into Occupied Space (Arrows)

Further evaluation by BEH staff revealed that the restroom fan is activated/deactivated by a light switch. The fan was deactivated when BEH staff entered the restroom. After the fan was activated, the fragrance odor could be detected in adjacent space (Rooms 108 and 109) (Figure 1). BEH staff examined the ceiling plenum of the bathroom and observed that the restroom fan is connected into another duct (Picture 2). This second duct is likely one for the

BEH staff examined the housing of the restroom fan and found holes in the top of the fan casing; these breaches allowed a steady stream of restroom air into the ceiling plenum (Picture 3). In this condition, odors captured by the restroom exhaust fan would exit through breaches in the fan casing and diffuse into the ceiling plenum where it is subsequently drawn into occupied space by the operation of the HVAC system return vents (Figure 1).

1. Repair the fan housing for the restroom exhaust vent.
2. Operate the restroom exhaust vent during business hours continuously.
3. Undercut restroom doors to provide sufficient transfer air for restroom exhaust vents.
4. Discontinue the use of air fresheners/deodorizers in restrooms.

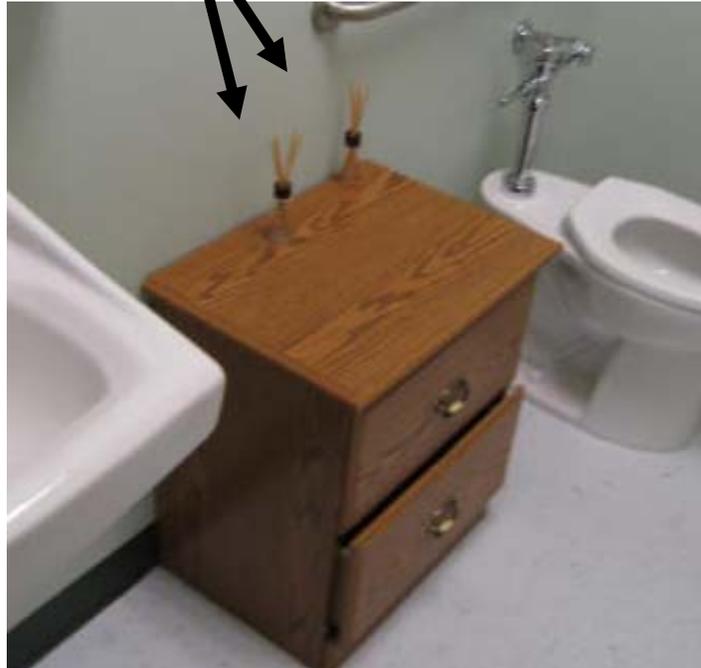
**Picture 1**

Upon entering the restroom, a strong odor was detected. The source of the odor was two open bottles containing fragrant oil with reed diffusers (Picture 1). Air measurements confirmed that these bottles were the likely source of measureable VOCs. Air deodorizers contain chemicals that can be irritating to the eyes, nose and throat of sensitive individuals. Many air fresheners contain 1,4-dichlorobenzene, a VOC which may cause reductions in lung function (NIH, 2006). Typically, an adequate HVAC exhaust system serves to dilute odors and reduce/eliminate this type of VOC situation.

**Fragrance Reed Diffuser**

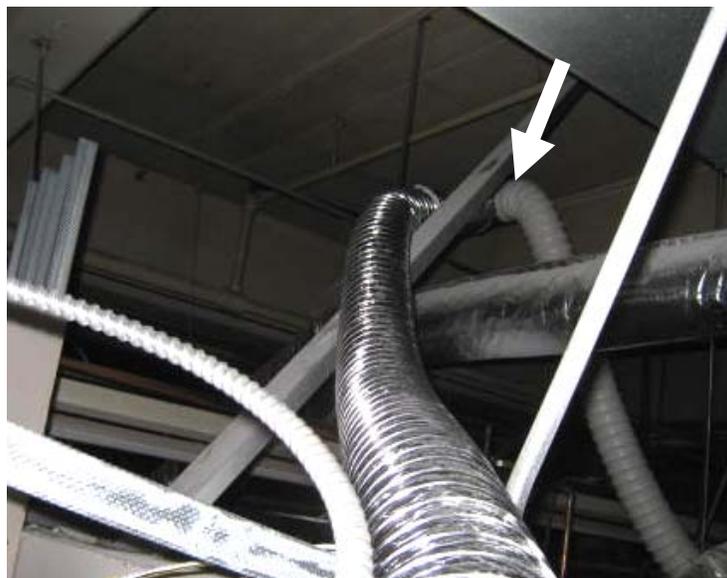
**Picture 2**

exhaust vent in the Department of Transitional Assistance's public restroom, which is adjacent to the DMH's restroom.

In addition, it does not appear that the restroom vent receives sufficient transfer or make-up air<sup>1</sup> in order to operate efficiently. The space beneath the restroom door appears to be minimal, which would limit airflow into the restroom thereby decreasing the efficiency of the fan. In addition, the restroom exhaust vent should be operating continuously during business hours to allow for rapid removal of excess moisture and odors from the restroom and prevent backflow of air from other exhaust systems that may be connected to the main exhaust vent (Picture 2).

**Flexible Duct Connecting Restroom Vent Fan to Another Duct, Likely the Restroom Exhaust Vent for the Department of Transitional Assistance Public Restrooms Which are Located on the Opposite Side of the Restroom Wall  
(Note: Other Vent Connected to Restroom Vent as indicated by arrow)**

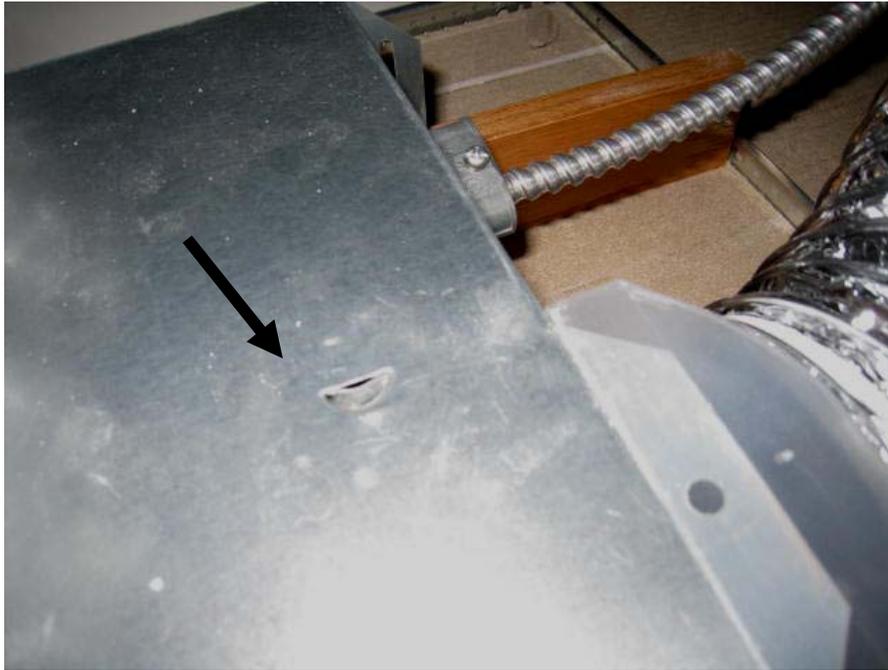
**Picture 3**

**Holes in Top of Restroom Fan Casing That Emitted a Steady Stream of Air When the Fan Was Activated**
