# INDOOR AIR QUALITY ASSESSMENT

**John A. Crisafulli Elementary School  
13 Robinson Road  
Westford, Massachusetts**

Prepared by:  
Massachusetts Department of Public Health  
Bureau of Environmental Health  
Indoor Air Quality Program  
October 2010

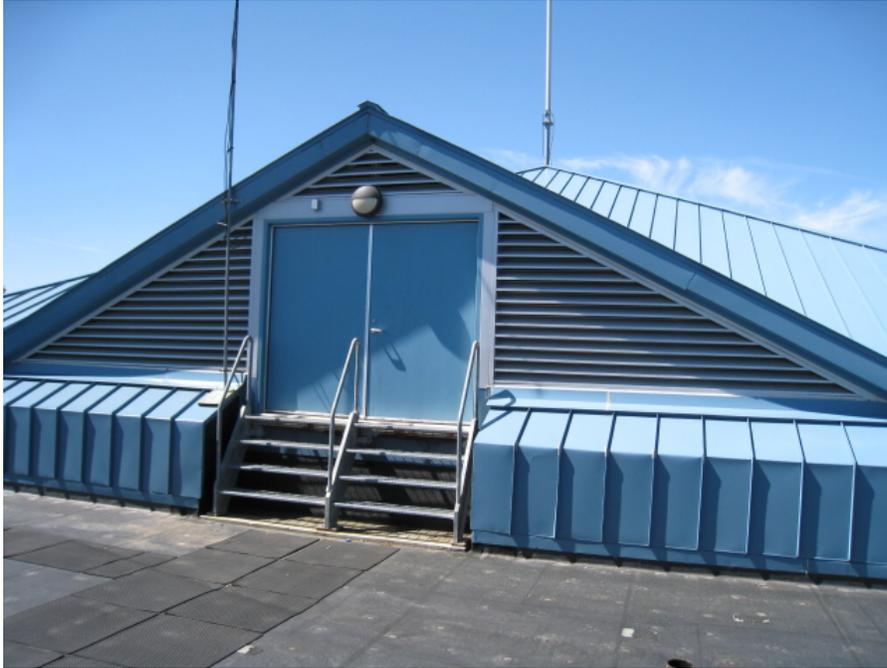
**Picture 1**

Mechanical ventilation for occupied areas is provided by air-handling units (AHUs) located in penthouse mechanical rooms (Pictures 1 and 2), or ceiling-mounted units in the case of the gymnasium. AHUs draw air in through fresh air intakes located on the exterior of the building (Picture 1). Air is filtered and heated by the AHU before it is distributed to occupied areas via ceiling-mounted air diffusers (Picture 3). Exhaust air is drawn into ceiling-mounted return vents and ducted back to the AHUs (Picture 4). Noise from the exhaust vent was heard in classroom 203, which may indicate a mechanical issue.

**Penthouse for Mechanical Ventilation Components, Note Louvered Intake Vents**

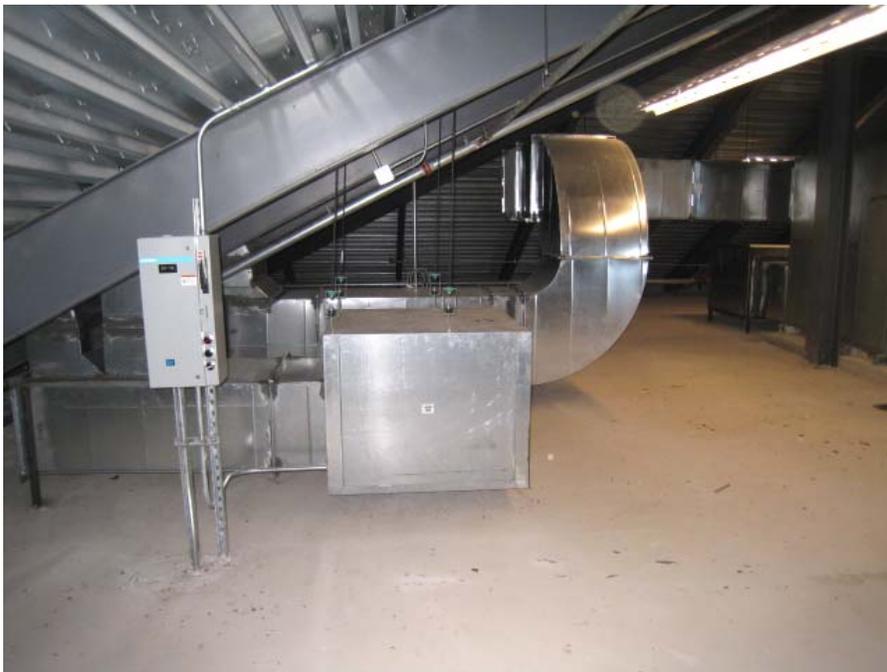
**Picture 2**

**Air Handling Unit (AHU) in Penthouse**

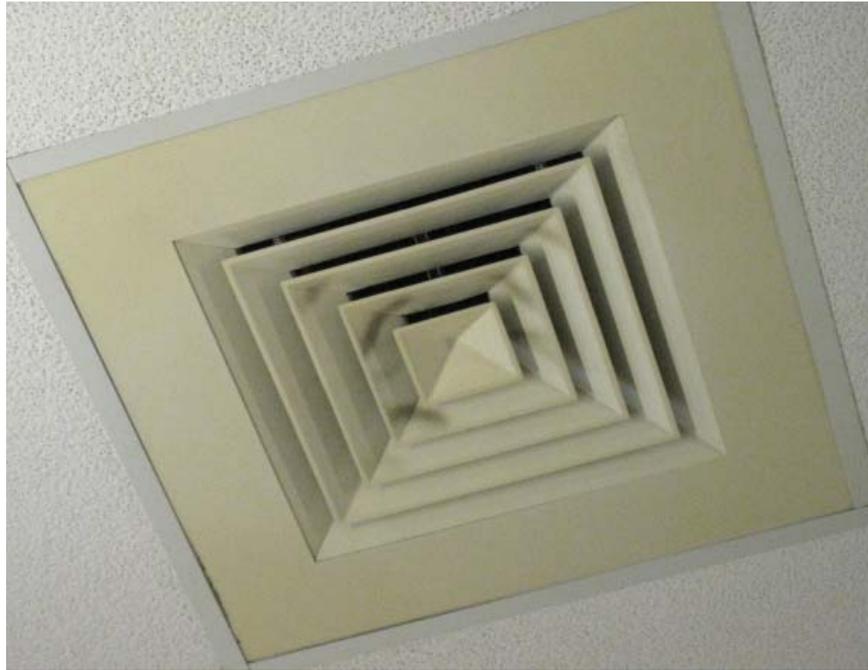
**Picture 3**

**Ceiling-Mounted Supply Diffuser**

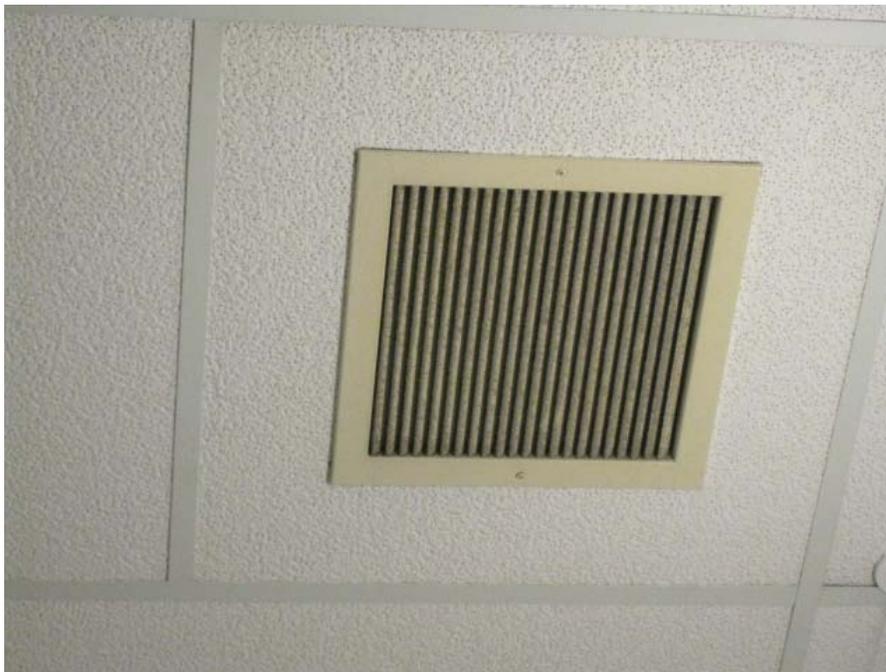
**Picture 4**

**Ceiling-Mounted Return Vent**

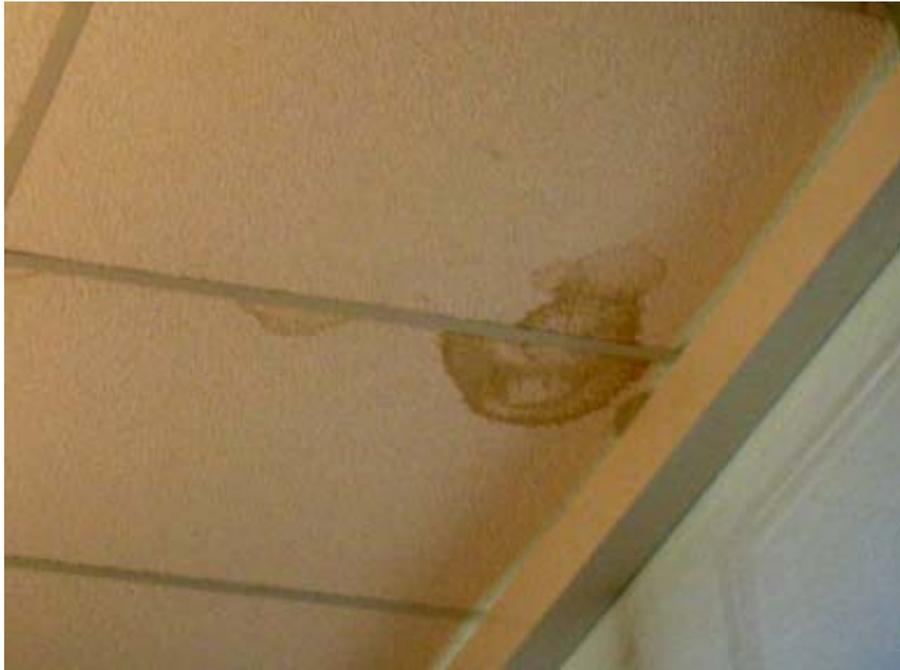
**Picture 5**

Several classrooms had water-damaged ceiling tiles which can indicate sources of water penetration from either the building envelope or plumbing system (Picture 5/Table 1). Water-damaged ceiling tiles can provide a source of moisture/microbial growth and should be replaced after a water leak is discovered and repaired. The building reportedly has issues with ice dams that result in ice accumulation on the roof to melt back into the building (Picture 6). In addition, open seams between metal roofing materials is also reported to be a source of water penetration damaging ceiling tiles (Pictures 7 and 8).

**Water Damaged Ceiling Tiles in Third Floor Classroom**

11. Repair any existing water leaks and replace any remaining water-damaged ceiling tiles. Examine the area above these tiles for mold growth. Disinfect areas of water leaks with an appropriate antimicrobial, as needed.

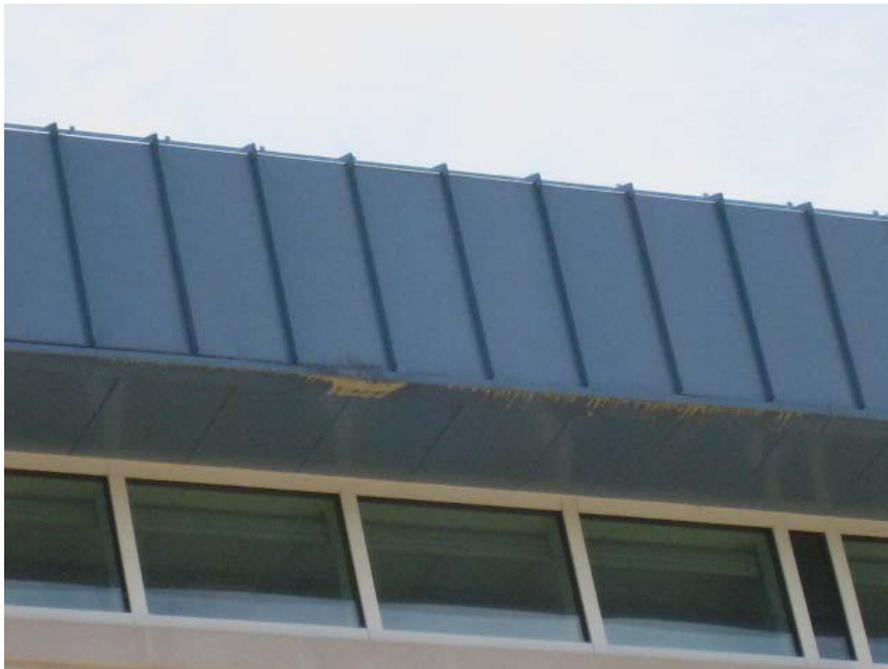
**Picture 6**

**Overhang Roof Where Ice Dams Reportedly Occur**

12. Work with building engineer and/or roofing contractor to examine best ways to prevent ice dams from occurring.
  13. Ensure plants are equipped with drip pans. Examine drip pans periodically for mold growth and disinfect with an appropriate antimicrobial, as needed. Move plants away from fresh air supply sources.

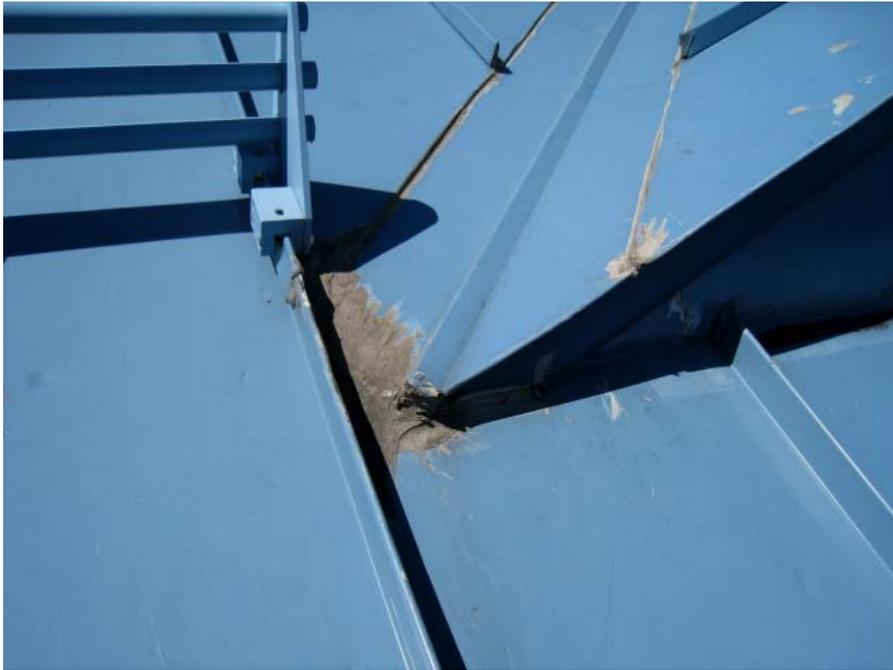
**Picture 7**

**Sealant Applied between Seams of Metal Roofing Material**

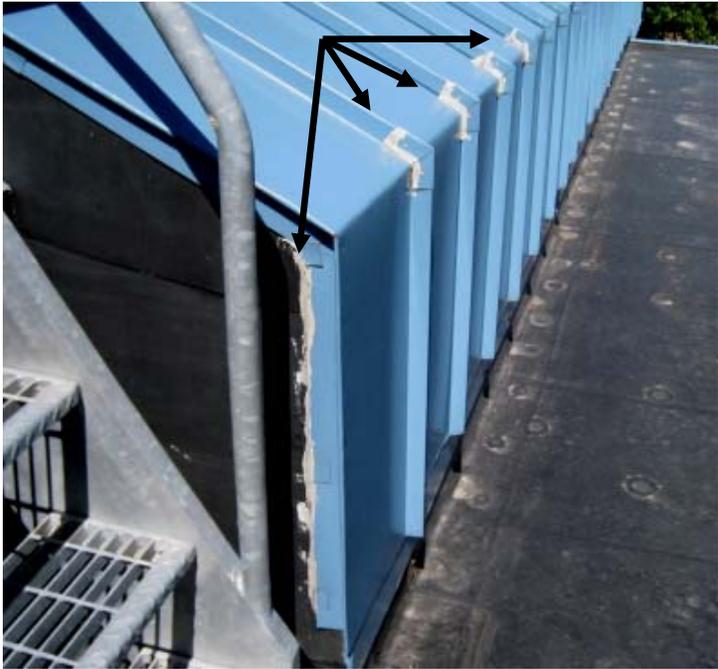
**Picture 8**

**Sealant Applied between Seams of Metal Roofing Material**

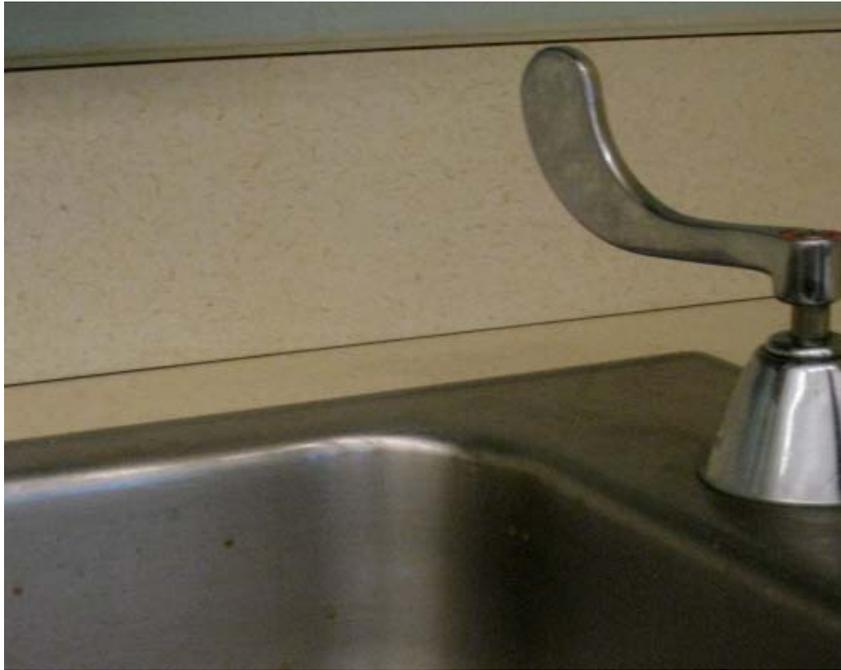
**Picture 9**

Open seams between sink countertops and backsplashes were observed in some rooms (Picture 9/Table 1). If not watertight, moisture can penetrate through seams, causing damage. Improper drainage or sink overflow can lead to water penetration into countertops, cabinet interiors and areas behind cabinets. Water penetration and chronic exposure of porous and wood-based materials can cause these materials to swell and show signs of water damage. Repeated moistening of porous materials can result in mold growth.

**Open Seam between Sink Countertop and Backsplash**

14. Seal areas around sinks to prevent water damage to the interior of cabinets and adjacent wallboard.
  15. Store cleaning products properly and out of reach of students. All cleaning products used at the facility should be approved by the school department with MSDS' available at a central location.

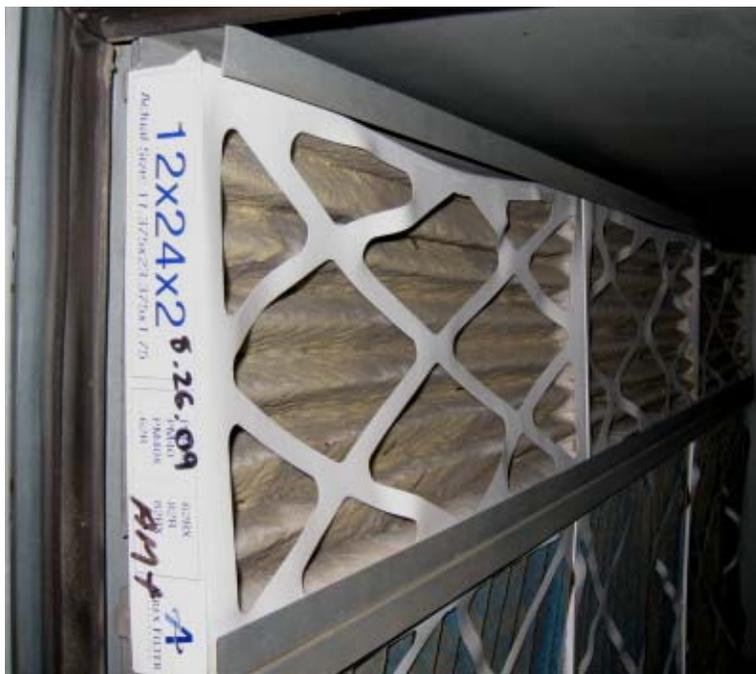
**Picture 10**

BEH staff inspected the rooftop AHUs and penthouses. The AHUs draw in fresh outside air through a bank of pleated filters. Although filters are reportedly changed twice per year, filters in one of the penthouse units were found dated “8-26-09” and saturated with accumulated dust/debris (Picture 10). Also noted was a build-up of dirt, dust/debris inside the unit and on the floor of the penthouse (Pictures 11 and 12). Filters for air-handling equipment (e.g., AHUs) should be changed as per the manufacturers’ instructions or more frequently if needed. In

**Bank of Pleated Air Filters in Penthouse AHU Accumulated with Dust/Debris, Note Date Written on Side of Filter "8-26-09"**

1. Operate all ventilation systems throughout the building (e.g., gym, cafeteria, classrooms) continuously during periods of occupancy to maximize air exchange.
2. Examine exhaust vent for classroom 203, make repairs as needed.
3. Ensure filters for air-handling equipment (e.g., AHUs) are changed as per the manufacturers' instructions or more frequently if needed. The interior of units should be

- cleaned/vacuumed on a regular basis (e.g., during filter changes) prior to activation to prevent the aerosolization of dirt, dust and particulate matter.

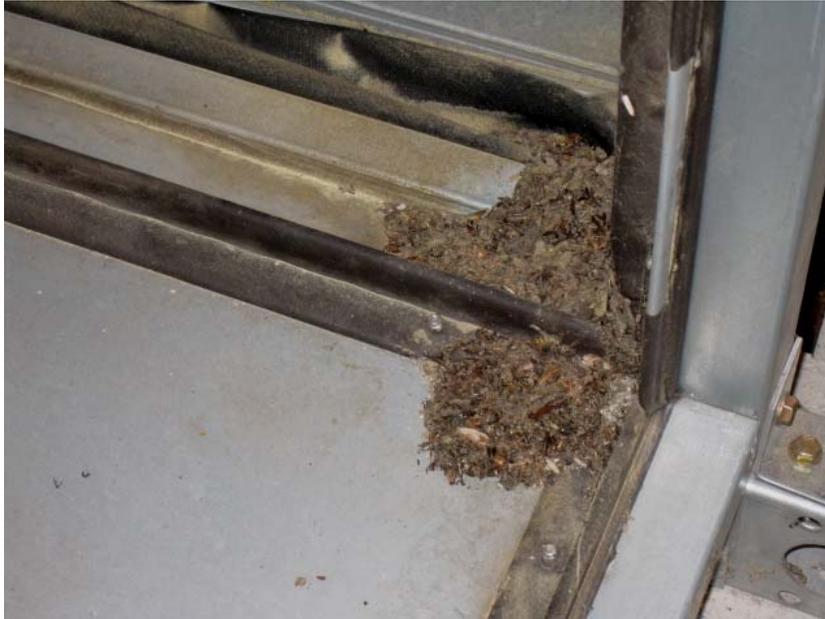
**Picture 11**

addition, the interior of units should be cleaned/vacuumed on a regular basis (e.g., during filter changes) to prevent the accumulation/aerosolization of dirt, dust and particulate matter.

**Dirt/Dust/Debris Buildup inside Penthouse AHU**

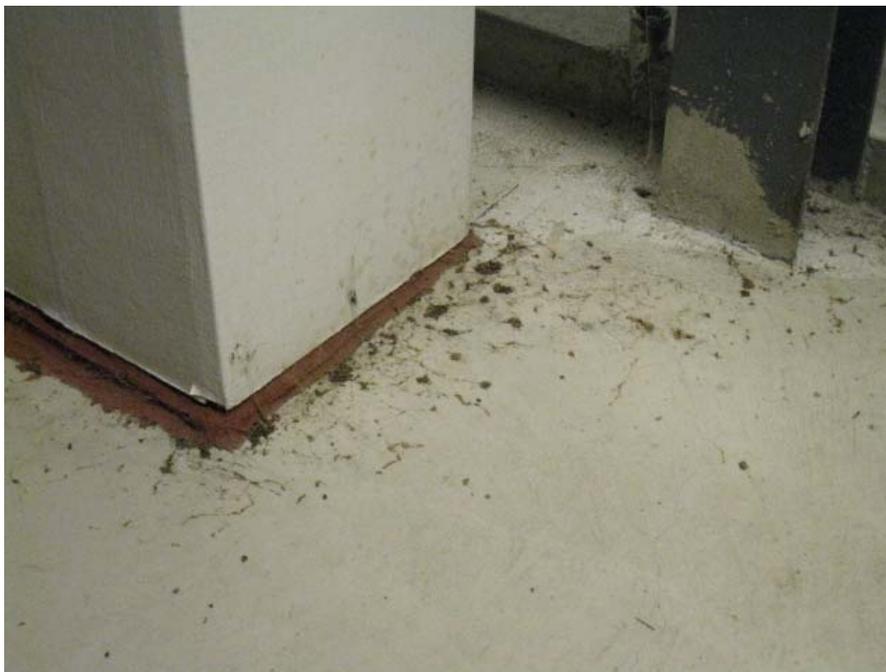
**Picture 12**

**Dirt/Dust/Debris Buildup inside Penthouse**

4. Clean/inspect the penthouse area on a regular basis to prevent the accumulation of dust, dirt/debris.
  5. Close classroom doors to facilitate air exchange.
