INDOOR AIR QUALITY ASSESSMENT

**Massachusetts Department of Transportation
10 Park Plaza, 6th Floor
Boston, Massachusetts**

Prepared by:
Massachusetts Department of Public Health
Bureau of Environmental Health
Indoor Air Quality Program
February 2011

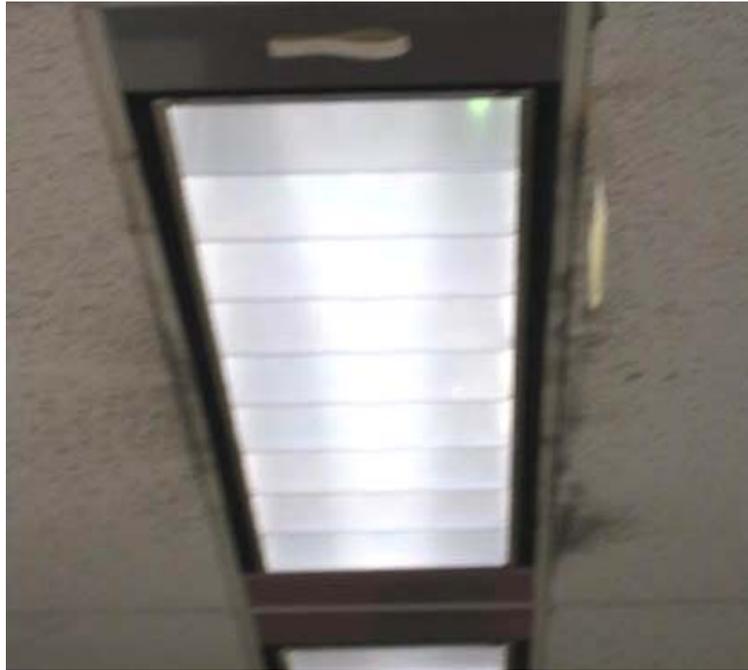
Picture 1

It can be seen from Table 1 that carbon dioxide levels were below 800 parts per million (ppm) in all areas surveyed, indicating optimal air exchange at the time of the assessment. Mechanical ventilation is provided by air-handling units (AHUs) located in mechanical rooms. Fresh air is drawn into the AHUs, filtered and heated/cooled before it is distributed by variable air volume (VAV) boxes to occupied areas via ducted vents around light fixtures (Pictures 1 and 2). Return air is drawn back into ducted vents around light fixtures, which is returned to the AHUs.

Vents around Light Fixtures, Note Dust/Debris Accumulation Adjacent to Vents

9. Clean personal fans, air diffusers, and return/exhaust vents periodically of accumulated dust/debris.
10. Examine the feasibility of adapting/operating one of the fans in Picture 7 in a manner to help relieve hallway pressurization.

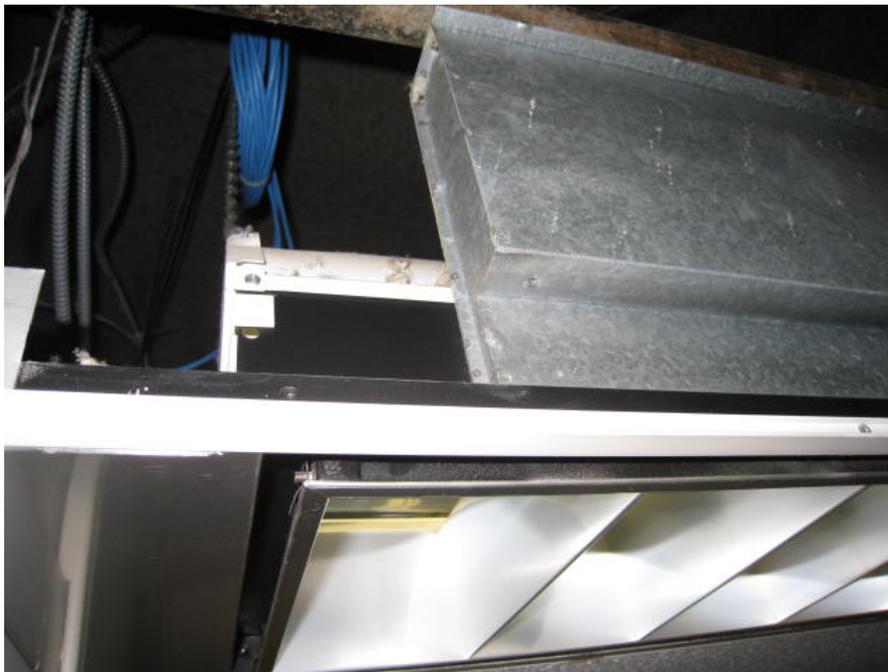
Picture 2

Ducted Supply Vent above Light Fixture

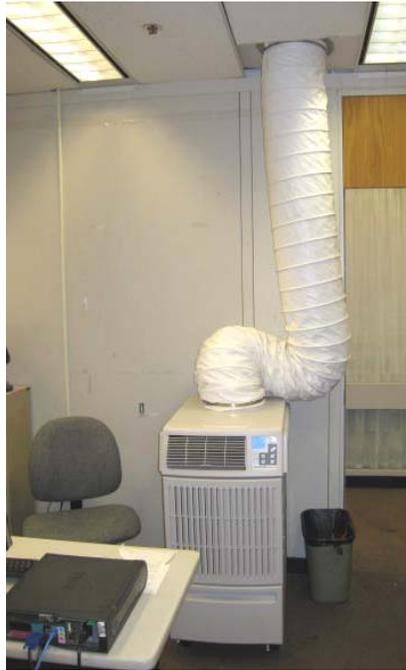
Picture 3

Due to temperature control complaints and HVAC issues, training room 6424 was retrofitted with a portable floor model air conditioning unit (Picture 3). This air conditioner is *designed* for use in a building that has a ceiling plenum¹ return air system. Based on the unit design, waste heat generated by the portable air conditioner would be drawn into the ventilation system. However, the HVAC system at the DOT is *ducted* for both supply and return. The DOT *does not* use the ceiling plenum for return ventilation. In its current configuration, waste heat is vented into the ceiling plenum, which becomes pressurized and forces heated air back into the room. In addition, pressurization of the ceiling plenum can force any dirt, dust and loose debris that accumulates above the ceiling tiles into occupied areas, providing sources of eye and respiratory irritation. This system should be ducted directly to the outdoors through an exterior wall or window.

In order to address concerns regarding mold in the BSS, BEH staff examined the office for water-damaged materials and moisture sources. In order to support mold growth, a material susceptible to fungal colonization must be exposed to moisture. As noted previously, the installation of the portable air conditioner would pressurize the ceiling plenum as well as vent direct heated and moisture into this space ceiling plenum. The portable air conditioner would be the most likely source of musty odors previously reported in the BSS.

**Floor Model Air Conditioning Unit in Training Room 6424,
Note Unit is Ducted into Ceiling Plenum**

1. Continue to operate all ventilation systems (e.g., AHUs) throughout the building continuously during occupied periods.
2. Vent the portable air conditioner in training room 6424 to the outdoors.

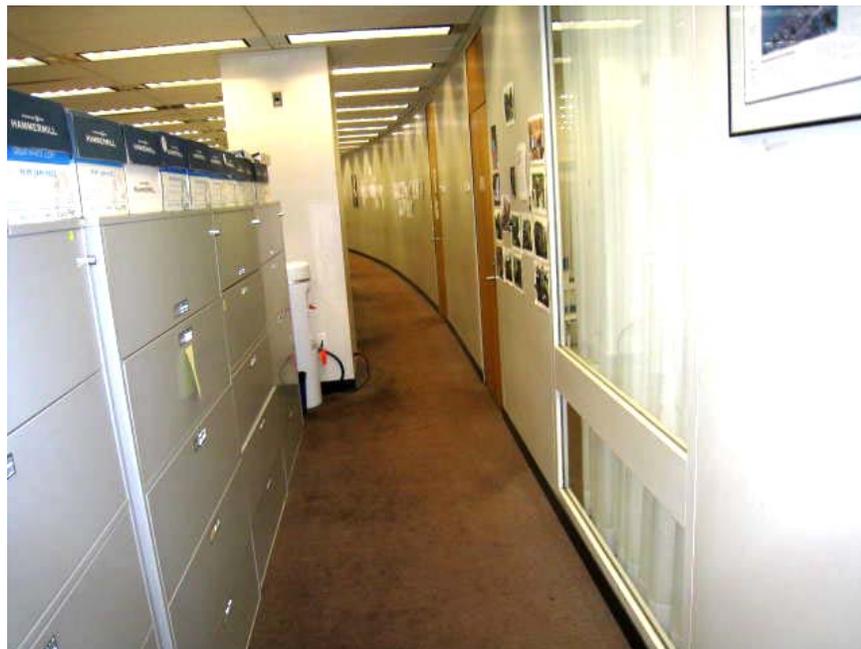
Picture 4

A few areas had water-damaged ceiling tiles. Water-damaged ceiling tiles can provide a source of mold and should be replaced after a water leak is discovered and repaired. Many areas had water-damaged, soiled or worn carpeting (Pictures 4 and 5). It was not clear whether the DOT had a carpet cleaning program in place. The Institute of Inspection, Cleaning and Restoration Certification (IICRC), recommends that carpeting be cleaned annually (or semi-annually in soiled high traffic areas) (IICRC, 2005). Since the average lifespan of a carpet is approximately eleven years, consideration should be given to replace flooring (Bishop, 2002).

Water-Damaged Carpet (Note Discoloration)

6. Clean carpeting annually or semi-annually in soiled high traffic areas as per the recommendations of the Institute of Inspection, Cleaning and Restoration Certification

7. Consider a long-term plan to replace carpeting as funds become available. Consider replacing carpeting with carpet squares or a non-porous surface such as vinyl tile.

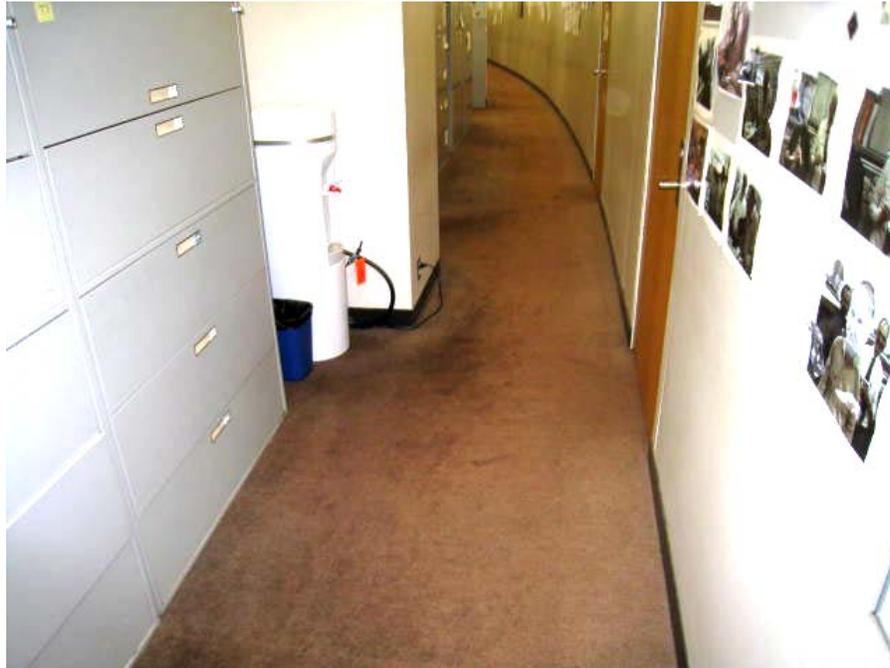
Picture 5

Water-Damaged, Soiled, Worn Carpeting

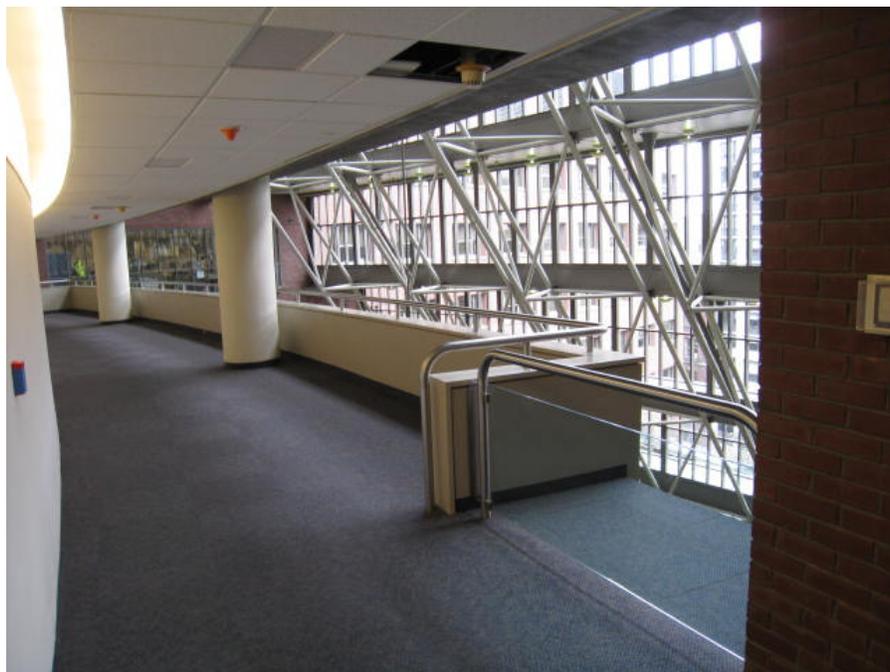
Picture 6

Of note is the pressure differential between the hallway and the BSS/HD offices. A strong current was noted blowing into the offices when the hallway door was opened. This is likely due to the fact that the hallway is open near the upper portion of the atrium (Picture 6). Air rises from the floor of the atrium and pressurizes the upper area of it, which then causes air to be forced into hallways that lead off from atrium balconies. In this configuration, odors, heated air and other airborne materials can be forced into office space. Customarily, office space is pressurized in relation to hallways to prevent the migration of odors from adjoining spaces. The

Hallway Leading to Open Balcony

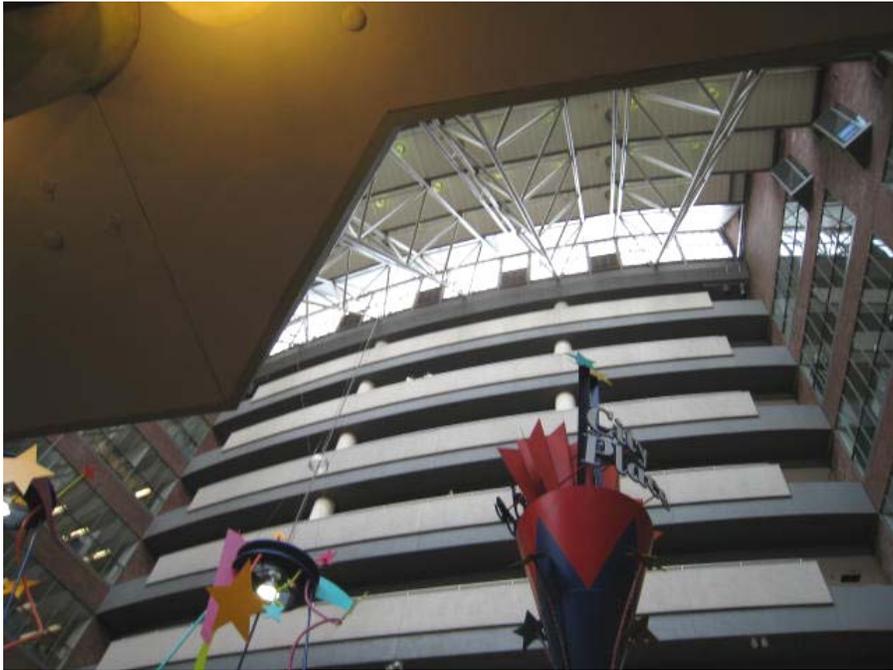
Picture 7

top of the atrium appears to have a number of smoke ejector fans in the case of fire (Picture 7). If one of these fans can be adapted to operate continuously, the hallway pressurization in the upper areas of the atrium would likely be alleviated.

Fans near Apex of Atrium
