# **INDOOR AIR QUALITY ASSESSMENT**

**Green Meadow Elementary School  
5 Tiger Drive  
Maynard, Massachusetts**

Prepared by:  
Massachusetts Department of Public Health  
Bureau of Environmental Health  
Indoor Air Quality Program  
August 2011

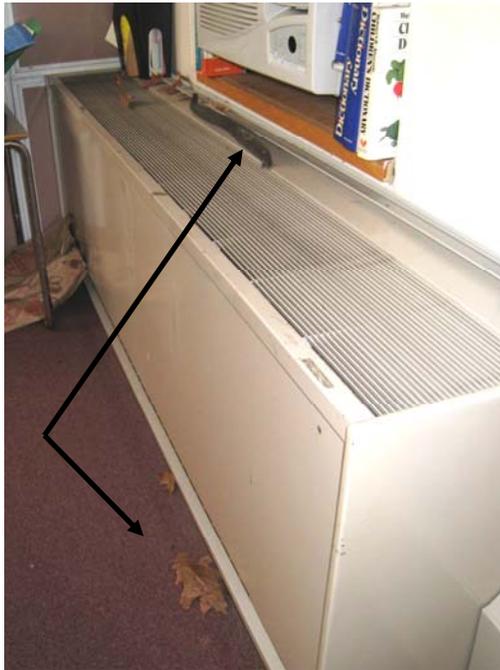
**Picture 1**

Fresh air in classrooms is supplied by unit ventilators (univents) ([Figure 1](#); Picture 1). A univent is designed to draw air from outdoors through a fresh air intake located on the exterior wall of the building. Return air is drawn through an air intake located at the base of each unit. Fresh and return air are mixed, filtered, heated and provided to classrooms through a fresh air diffuser located in the top of the unit. As mentioned, new univents were installed in the 1956 portion of the building. However, univents in the 1974 and 1988 additions are original equipment.

Leaves and debris were observed on a classroom univent, below a window-mounted air conditioner (Picture 1). With the insulation removed, the area below the air-conditioning unit is no longer sealed (Picture 11). As a result, materials/debris and moisture from the outdoors was allowed to penetrate into the classroom through this opening. This space can also serve as a pathway for pests.

Window-mounted air conditioners (ACs) were observed in some areas (Picture 1; Table 1). These units are normally equipped with filters, which should be cleaned or changed as per manufacturer's instructions. AC filters were found to have accumulations of dirt, dust and debris.

**Classroom univent, note leaves and displaced insulation for air conditioner (arrows)**

29. Clean personal fans, univent air diffusers, return vents and exhaust vents periodically of accumulated dust.
30. Clean/change filters for window-mounted ACs as recommended by the manufacture.

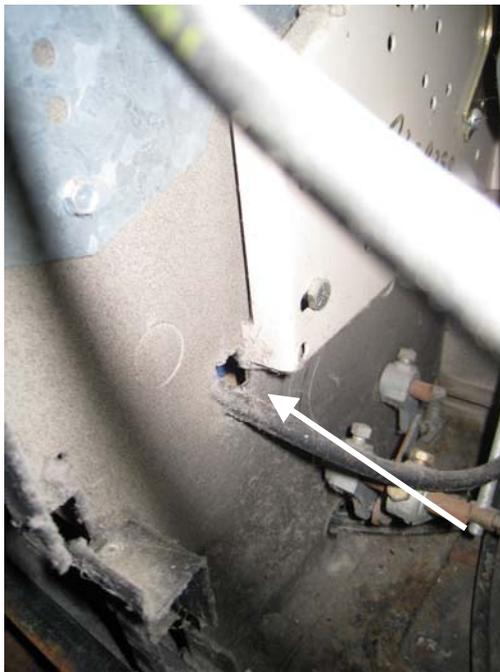
**Picture 2**

While examining univents, BEH staff observed utility holes in the divider that separates the side cabinets of the univent from the fan cabinet (Picture 2). These holes can allow air, dust, debris, and odors to be drawn into the univent's main compartment post-filtration, resulting in the distribution of unfiltered air and debris that may accumulate in the side cabinet. The unit ventilator cabinet walls should be rendered airtight and breaches around pipes should be sealed to prevent distribution of unfiltered air.

**Hole in univent cabinet (arrow), note visible filter**

8. Seal spaces around pipes and univent cabinets with a fire-rated sealant where needed.
9. For buildings in New England, periods of low relative humidity during the winter are often unavoidable. Therefore, scrupulous cleaning practices should be adopted to minimize common indoor air contaminants whose irritant effects can be enhanced when the relative humidity is low. To control for dusts, a high efficiency particulate arrestance (HEPA) filter equipped vacuum cleaner in conjunction with wet wiping of all surfaces is recommended. Avoid the use of feather dusters. Drinking water during the day can help ease some symptoms associated with a dry environment (throat and sinus irritations).

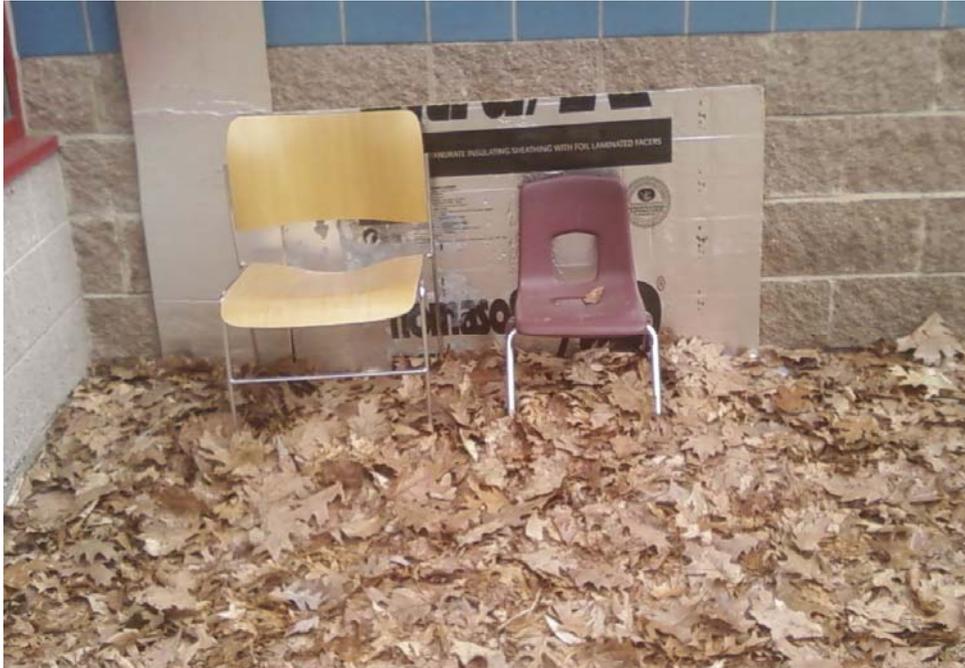
**Picture 3**

Please note, fresh air intakes for univents in classrooms along the northern wall of the original building were sealed with insulation board (Picture 3). It is unclear how long these fresh air intakes have been sealed. Additionally, univents were found deactivated in a number of areas at the time of the assessment. Furthermore, univents were obstructed by items such as chairs, tables, desks, and books in many classrooms. In order to function as designed, univents must be activated and allowed to operate free of obstructions and blockages. Without adequate fresh air, normally occurring pollutants can accumulate, leading to indoor air quality complaints.

Leaves and associated debris was also located in close proximity to fresh air intakes (Picture 3). As leaves begin to decompose, materials and odors can become entrained in the univent systems and subsequently be distributed to classrooms. Furthermore, leaf material holds water against the base of the building, which can result in damage to the foundation.

**Univent fresh air intake covered by insulation board, note leaf litter**

19. Periodically inspect/remove plant growth, leaves and debris from exterior univent air intakes and against foundation.
20. Move plants away from univents in classrooms. Ensure all plants are equipped with drip pans. Examine drip pans for mold growth and disinfect areas of water leaks with an appropriate antimicrobial where necessary.

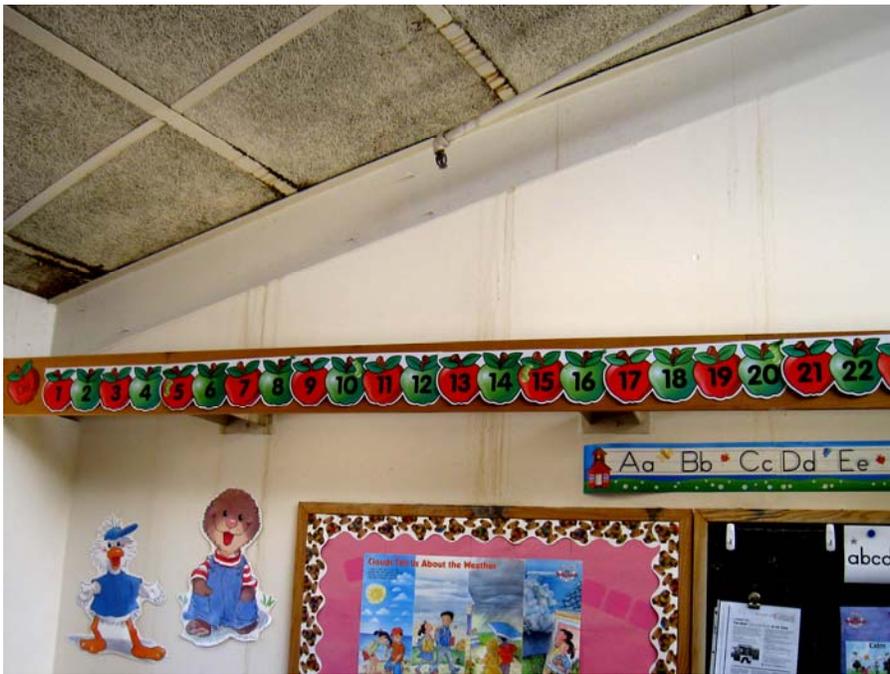
**Picture 4**

At the time of assessment, school staff reported an active roof leak in classroom 4D. Water-damaged acoustic ceiling tiles and walls were observed there and in other classrooms in the 1988 wing (Picture 4). These leaks are likely related to spaces that may exist in roofing/flashing where two different roofs join (Picture 5). Evidence of moss growth in these areas suggests heavy water is accumulating in the “valleys”.

**Water stains on acoustic ceiling tiles and wall**

10. Ensure any roof/plumbing leaks are repaired (e.g., classroom 4D). Replace water-damaged ceiling tiles and fiberglass insulation (Picture 6). Examine the area above and around these areas for mold growth. Disinfect areas of water leaks with an appropriate antimicrobial.

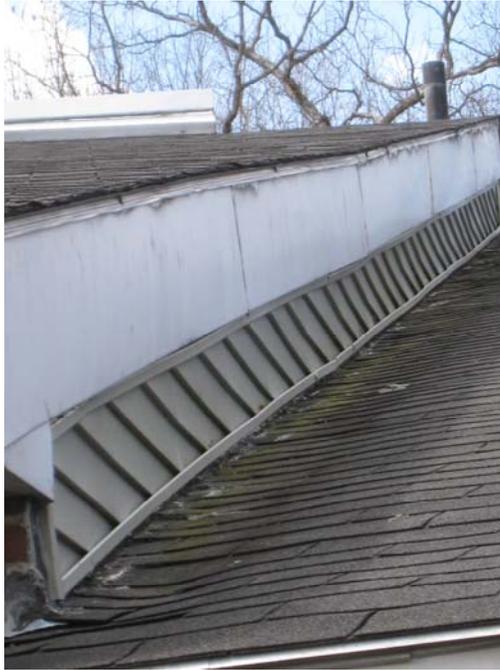
**Picture 5**

**Lifted asphalt shingles, note moss growth**

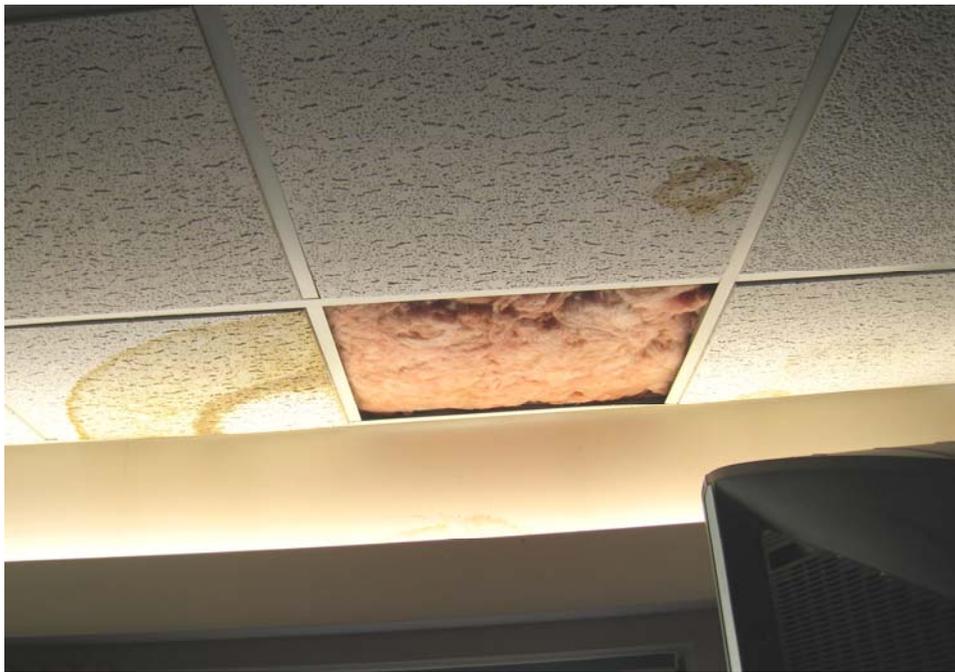
**Picture 6**

Of note was the presence of water-damaged fiberglass insulation and ceiling tiles in the library office (Picture 6). It appears that fiberglass insulation was installed in the ceiling plenum area above the suspended tile system. The purpose of the fiberglass insulation is likely for sound attenuation. If not dried completely, fiberglass insulation can be a source of mold growth.

**Water-damaged ceiling tiles and fiberglass insulation**

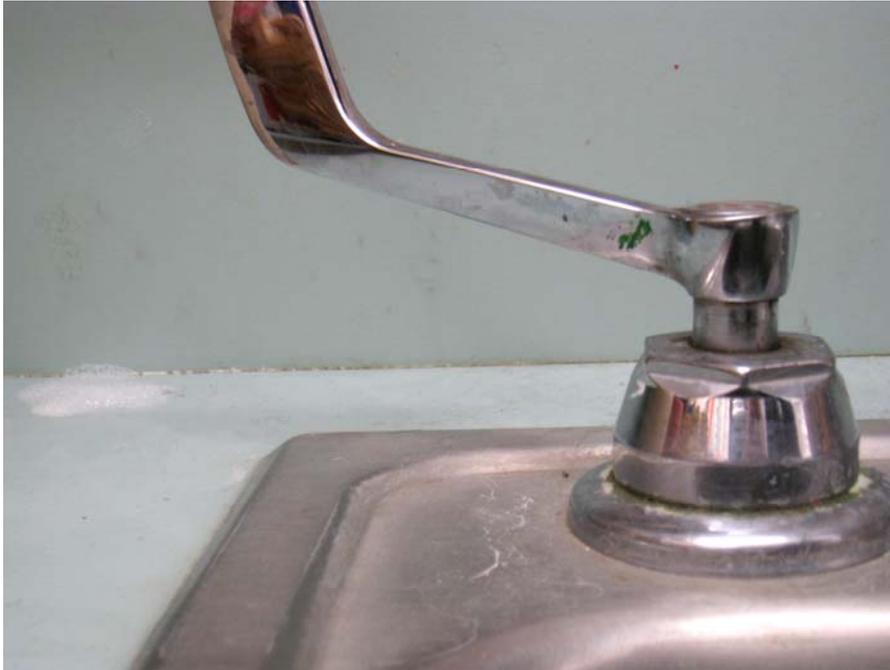
**Picture 7**

Breaches were observed between countertops and sink backsplashes in a number of classrooms (Picture 7; Table 1). If not watertight, water can penetrate through backsplash seams or can leak from plumbing. Water penetration and chronic exposure of porous and wood-based

material can cause swelling and show signs of water damage. As discussed, moistened materials that are not dried within 24 to 48 hours can become potential sources for mold growth.

**Breach between sink backsplash and countertop**

18. Seal areas around sinks to prevent water damage to the interior of cabinets and adjacent wallboard. Repair/replace countertop as necessary. Consider replacing these with a one piece/seamless molded countertop.

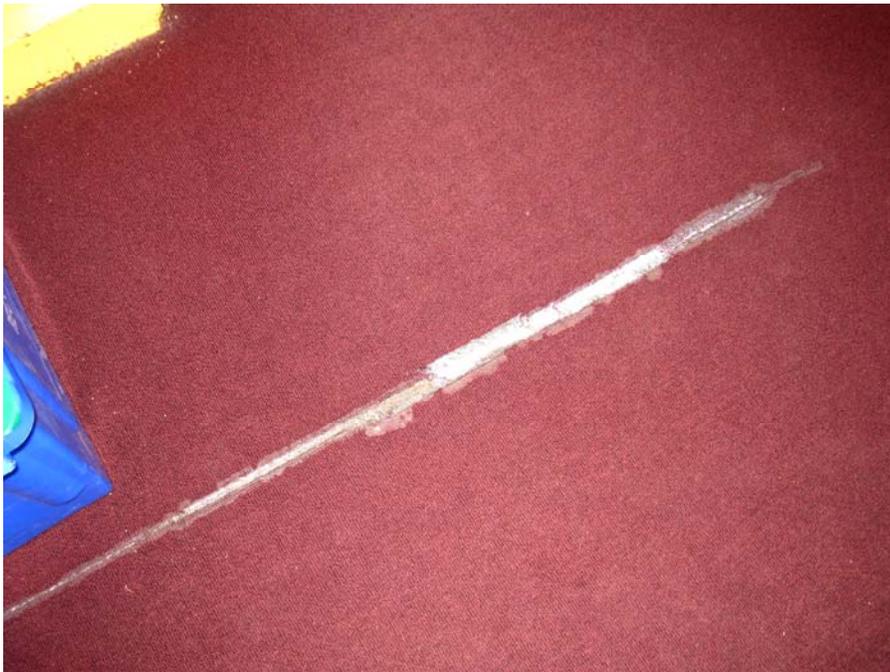
**Picture 8**

Some hallway areas in the building are carpeted. These carpets are original to the building in some areas (the 1974 addition) and used for encapsulating asbestos-containing floor tiles in other areas (the original 1954 section). Efforts should be made to remove these carpets and replace them with non-porous materials (i.e., floor tiles). Water-damaged carpeting can be a potential source for mold growth. In addition, worn/disintegrating textiles observed in a few areas (Picture 8) can be a source of particulates, which can be irritating to the eyes, nose and throat.

**Damaged/fraying carpeting**

11. Repair or replace broken or missing downspouts to drain water away from the foundation.
12. Continue with plans for carpet removal/replacement as funds/materials become available.

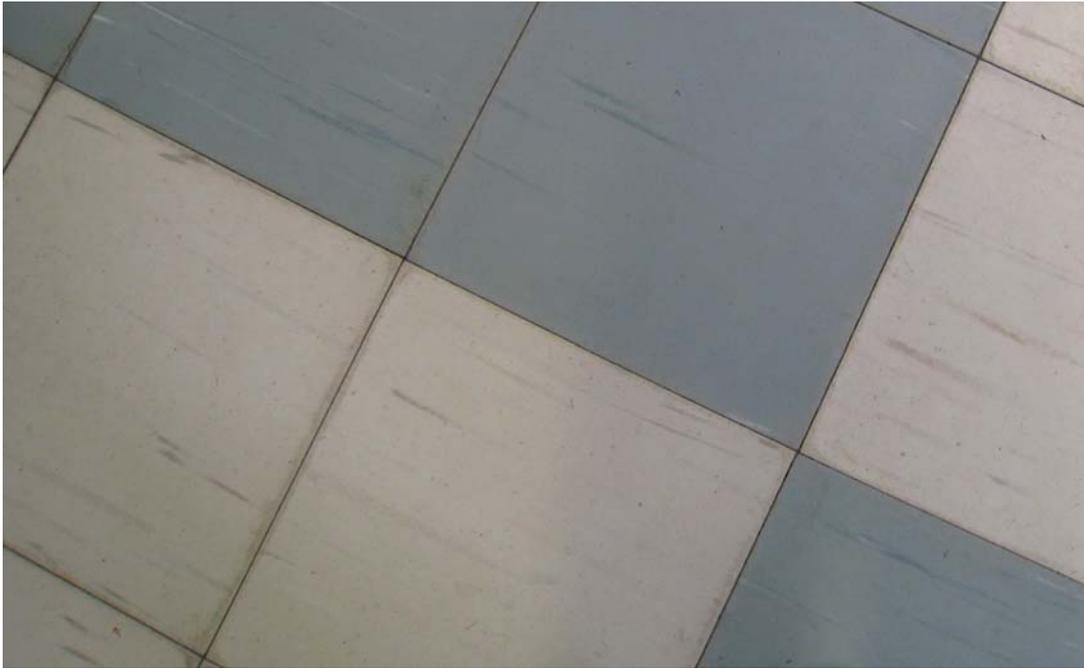
**Picture 9**

Water stains were also observed around floor tiles in the cafeteria (Picture 9), likely indicating condensation accumulation in this portion of the building. Over time, repeated exposure to moisture can result in damage to these tiles. Given the age of this portion of the building (1974), it is likely that these are asbestos-containing tiles. As indicated above, appropriate precautions should be taken with asbestos-containing materials.

**Stains around floor tile edges**

15. To help prevent condensation in the cafeteria and/or reduce musty odors from carpeting in other areas, use portable dehumidifiers and/or air conditioners during periods of excessive relative humidity (e.g., over 70% for extended periods of time).

16. Increase frequency of waxing cafeteria floor to create seal and improve cleaning.
17. Ensure dehumidifiers are cleaned/maintained as per the manufacturer's instructions to prevent mold/bacterial growth.

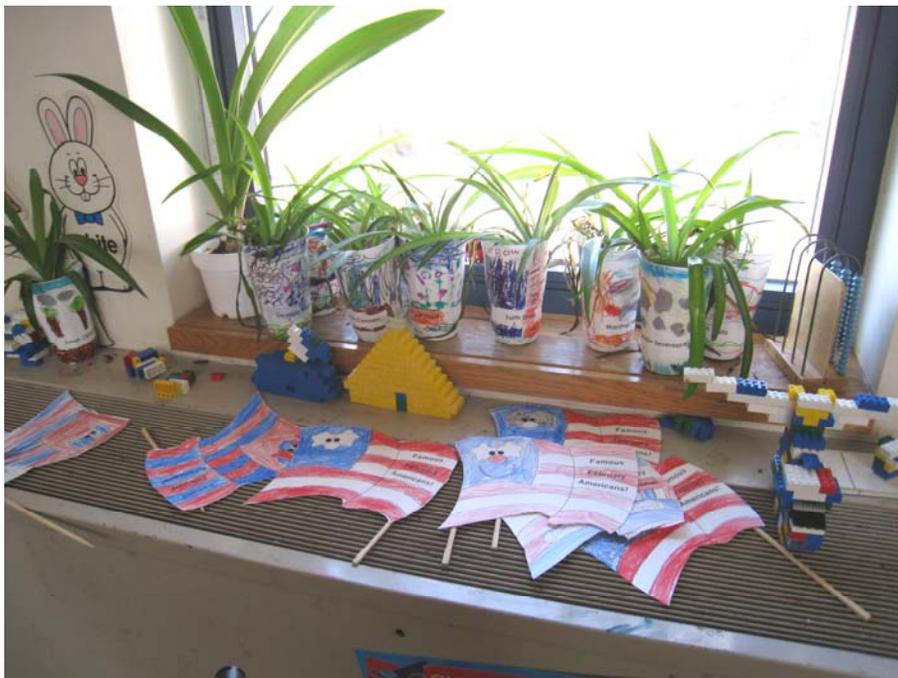
**Picture 10**

Plants were observed in several areas, some of which were located on or directly adjacent to univents (Table 1; Picture 10). Plants should be properly maintained and equipped with washable drip pans. Plants should be located away from ventilation sources to prevent aerosolization and distribution of dirt, pollen or mold. Plants should also not be placed on porous materials (e.g., paper or cardboard), since water damage to porous materials may lead to microbial growth.

**Plants and items on univent**

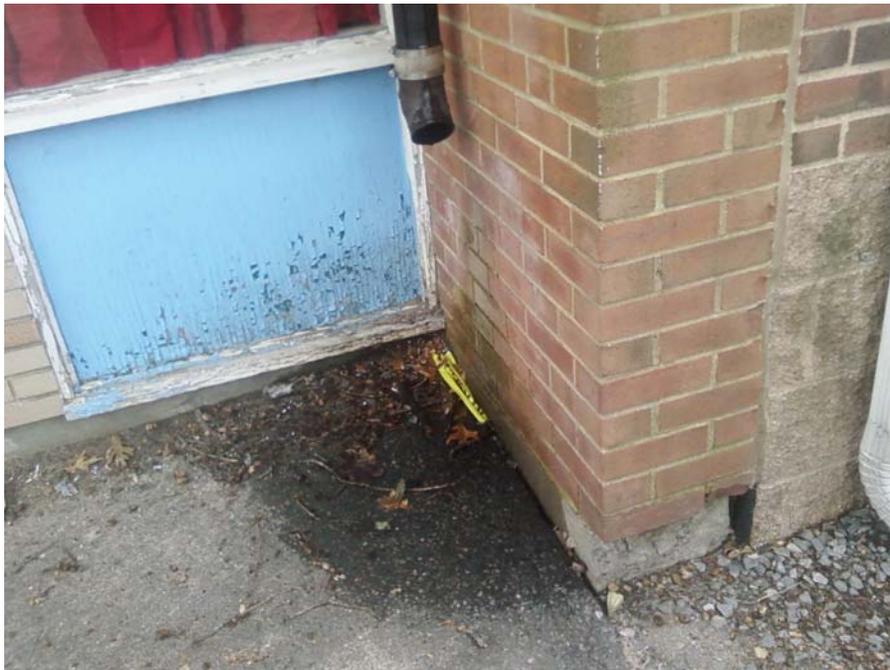
**Picture 12**

BEH staff examined the outside perimeter of the building to identify breaches in the building envelope and/or other conditions that could provide a source of moisture. Gutters/downspouts were missing, which may allow water to pool against the building rather than drain away (Picture 12). Over time, these conditions can undermine the integrity of the building envelope and provide a means of water entry into the building via capillary action through foundation concrete and masonry (Lstiburek & Brennan, 2001). The freezing and thawing of water during winter months can lead to further damage and subsequent water penetration into the interior of the building. In addition, these breaches may provide a means for pests/rodents into the building.

**Downspout emptying against building exterior**

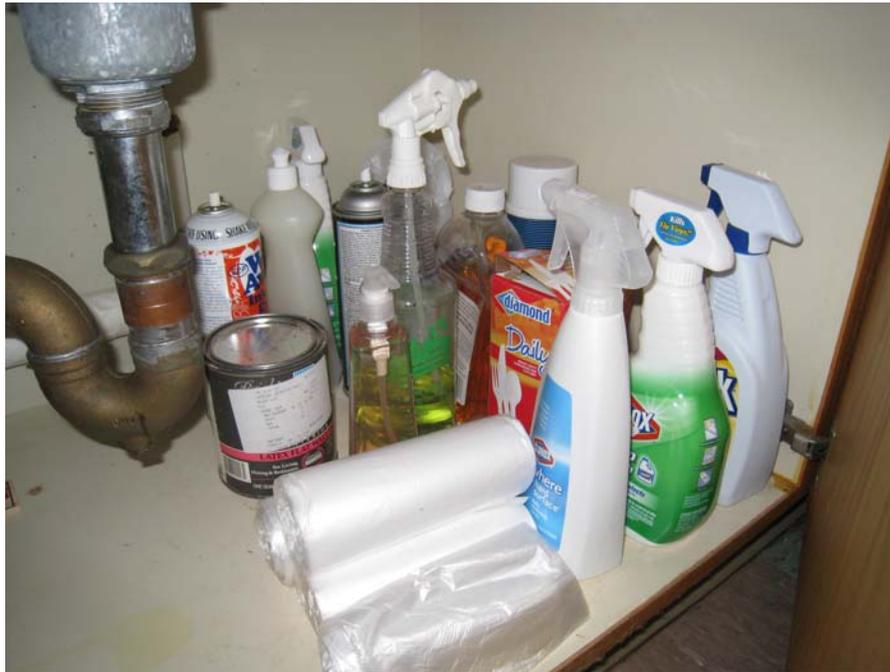
**Picture 13**

Cleaning and sanitization products were observed in a number of rooms (Picture 13; Table 1). These products contain chemicals that can be irritating to the eyes, nose and throat of sensitive individuals. Cleaning products should be properly labeled and stored in an area inaccessible to children. In addition, a Material Safety Data Sheets (MSDS) should be available at a central location for each product in the event of an emergency. Consideration should be given to providing teaching staff with school issued cleaning products and supplies to prevent

any potential for adverse chemical interactions between residues left from cleaners used by the facilities staff and those left by cleaners brought in by others.

**Cleaning products stored under unlocked sink**

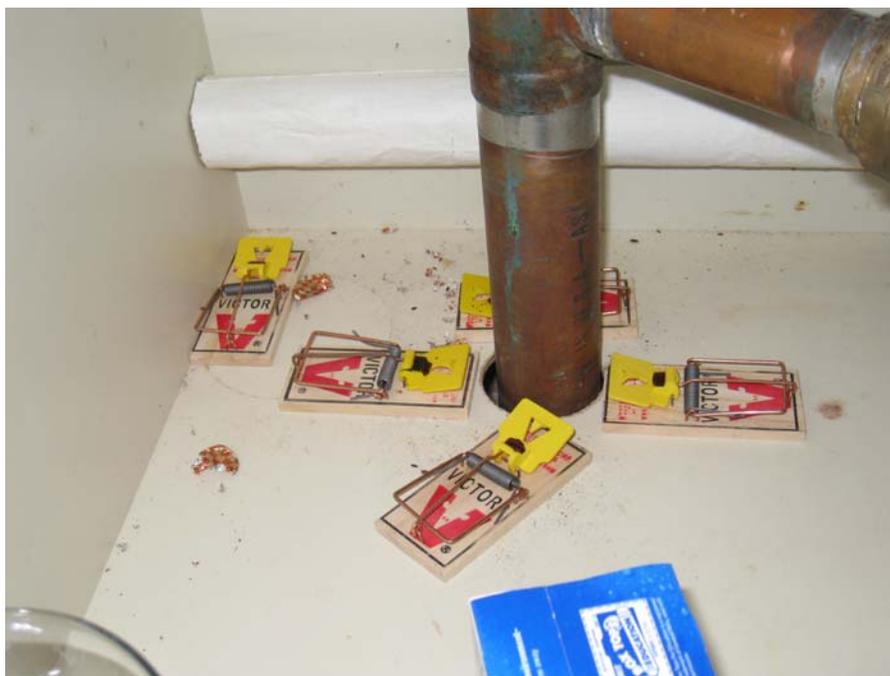
**Picture 14**

Other conditions that can affect indoor air quality were observed during the assessment. Mouse droppings and traps were observed in the sink of a classroom (Picture 14). The presence of rodents is likely related to food storage/preparation equipment observed in the area (Picture 15). Rodent infestation can result in indoor air quality related symptoms due to materials in their wastes. Mouse urine contains a protein that is a known sensitizer (US EPA, 1992). A sensitizer is a material that can produce symptoms (e.g., running nose or skin rashes) in sensitive individuals.

**Mouse droppings and traps, note space around pipe**

A three-step approach is necessary to eliminate rodent infestation:

- removal of the rodents;
- cleaning of waste products from the interior of the building; and
- reduction/elimination of pathways/food sources that are attracting rodents.

To eliminate exposure to allergens, rodents must be removed from the building. Please note that removal, even after cleaning, may not provide immediate relief, since allergens can exist in the interior for several months after rodents are eliminated (Burge, 1995). Once the infestation is

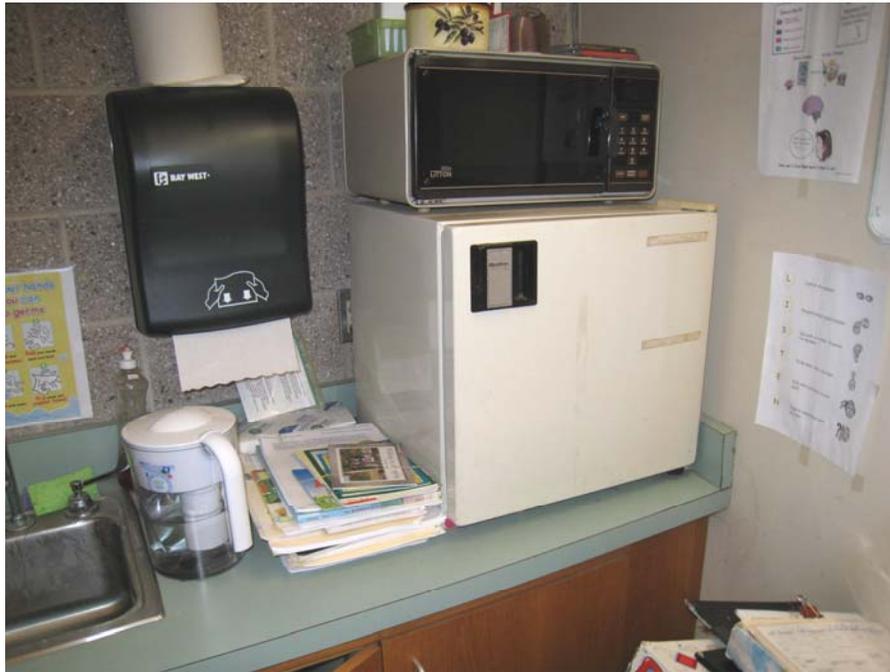
**Picture 15**

**Food preparation equipment in classroom**

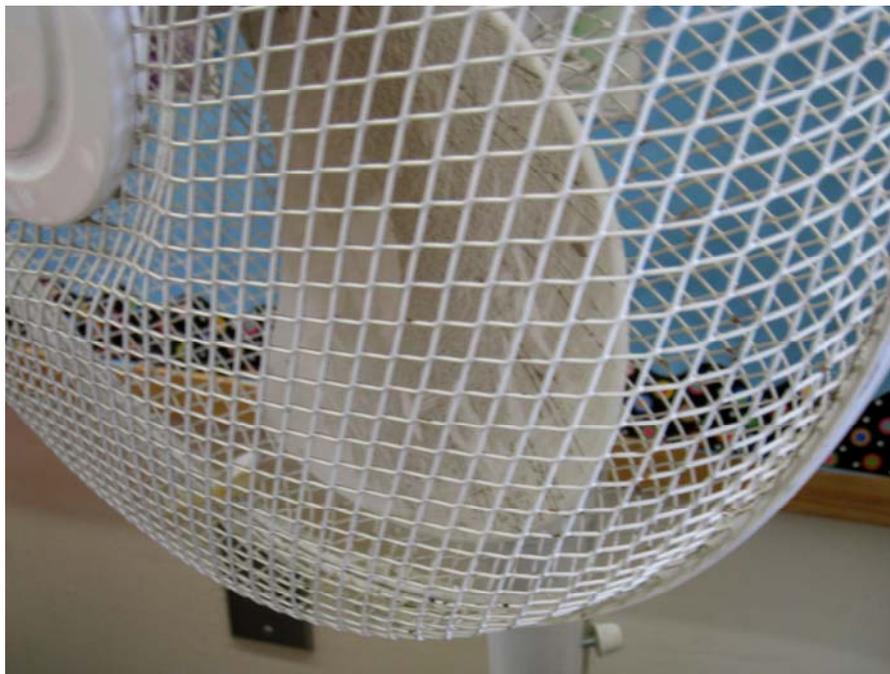
**Picture 16**

**Accumulated dust on fan blades**
