INDOOR AIR QUALITY ASSESSMENT

**Ralph C. Mahar Regional School
507 South Main Street
Orange, Massachusetts**

Prepared by:
Massachusetts Department of Public Health
Bureau of Environmental Health
Indoor Air Quality Program
July 2011

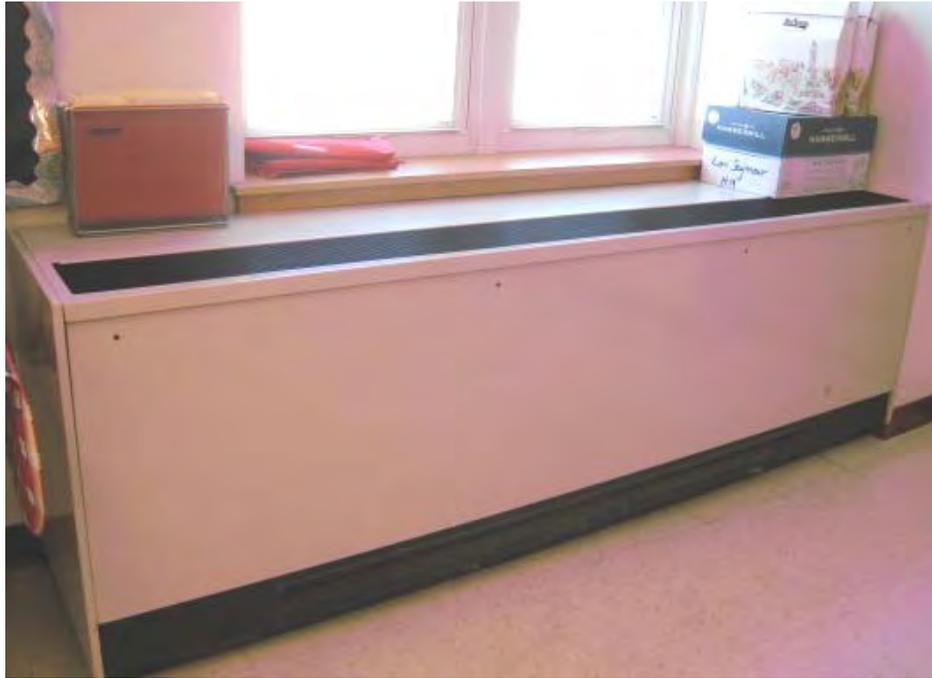
Picture 1

Fresh air in classrooms is supplied by unit ventilator (univent) systems ([Figure 1](#)). A univent draws air from the outdoors through a fresh air intake located on the exterior wall of the building and returns air through an air intake located at the base of the unit. Fresh and return air are mixed, filtered, heated and provided to classrooms through an air diffuser located in the top of the unit (Picture 1). Obstructions to airflow on top of univents and in front of univent returns was seen in a number of classrooms (Picture 2).

Unit Ventilator (Univent)

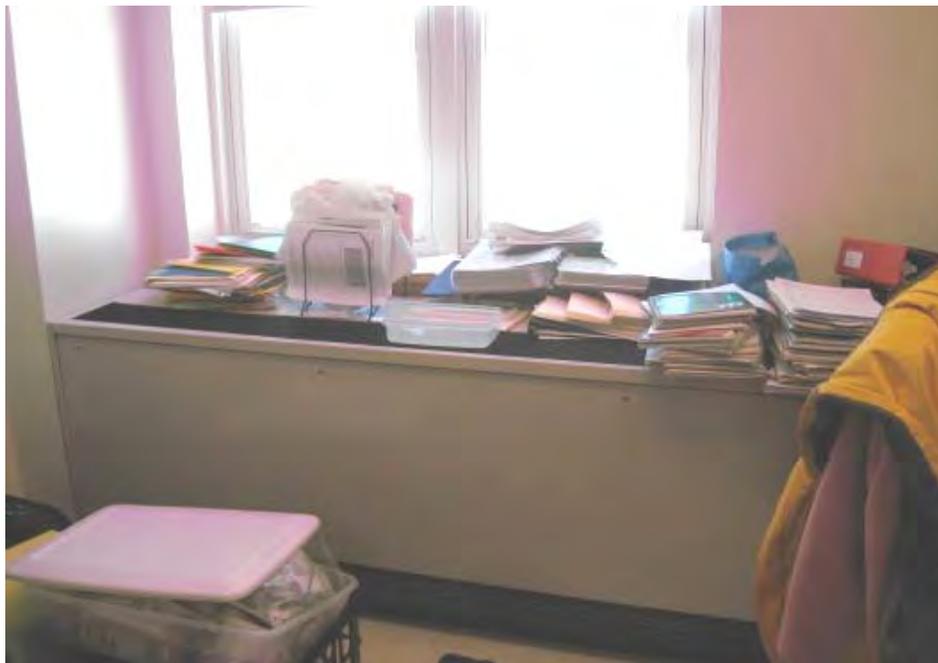
Picture 2

Univent Partially Obstructed with Classroom Materials

Ventilation equipment must remain free and clear of obstructions in order to perform optimally.

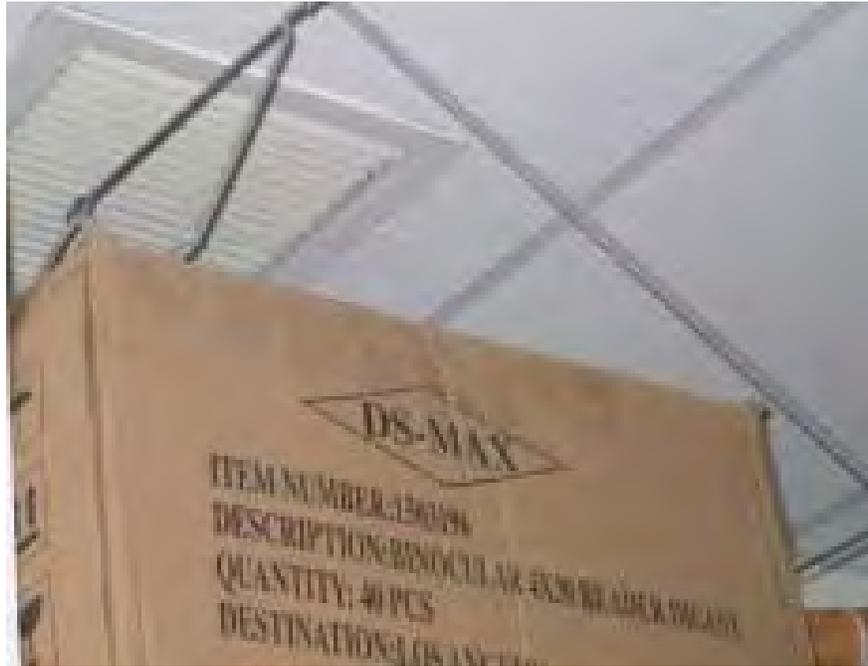
Picture 3

Ceiling Exhaust Vent Partially Obstructed

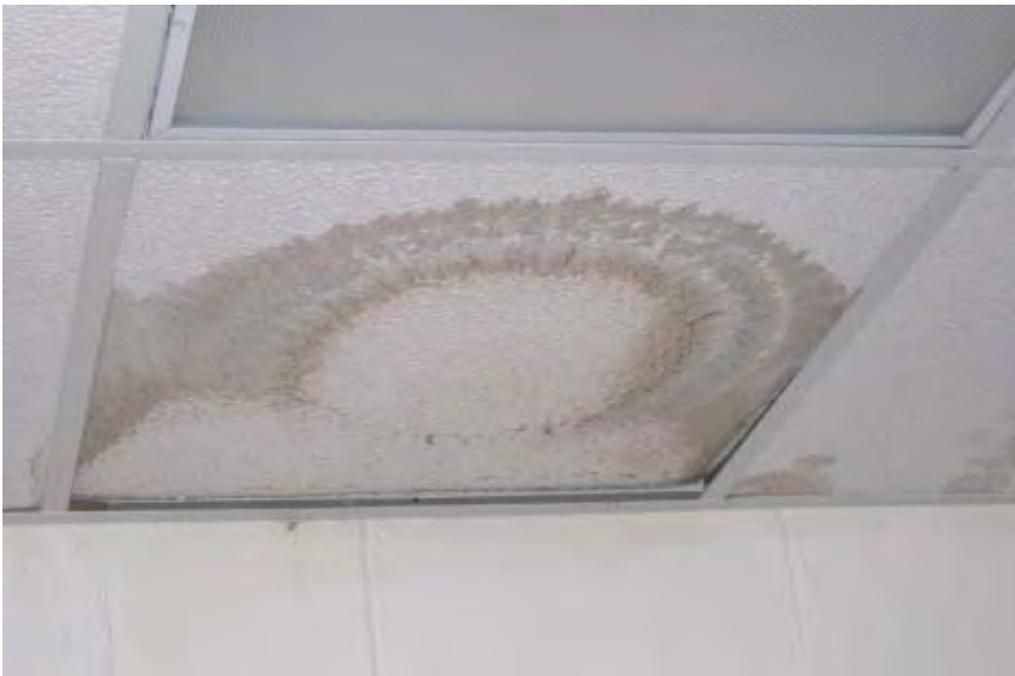
Picture 4

Several classrooms and hallways had water-damaged ceiling tiles, some of which had been painted over. Water-damaged ceiling tiles can indicate sources of water penetration/leaks from either the building envelope or plumbing system (Picture 4). Water-damaged ceiling tiles can provide a source of mold and should be replaced after a water leak is discovered and repaired.

Water-Damaged Ceiling Tiles

9. Repair any existing water leaks and replace any remaining water-damaged ceiling tiles.

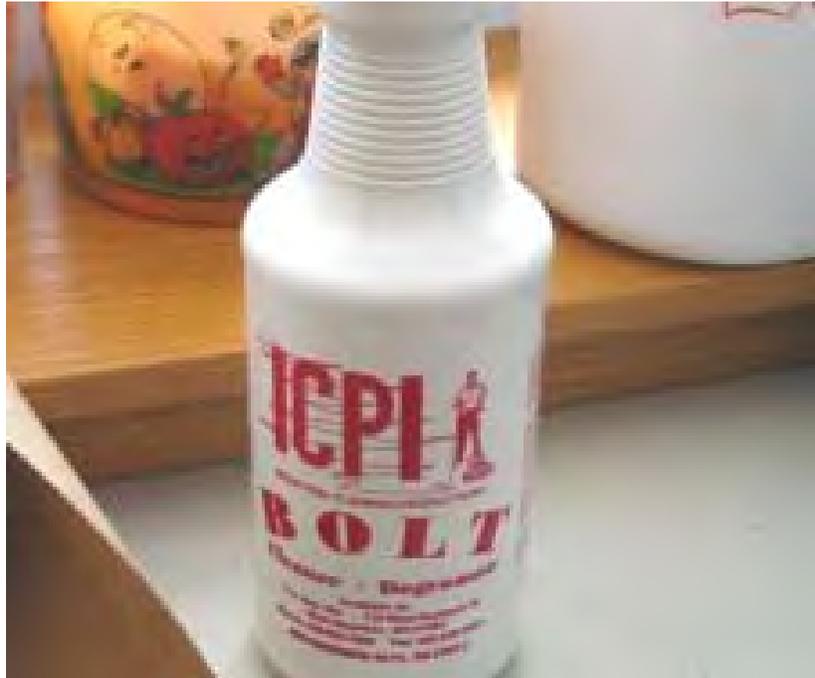
Picture 5

Cleaning products were observed in some classrooms (Picture 5). These items contain chemicals that can be irritating to the eyes, nose and throat and should be kept out of reach of

Cleaner/Degreaser Stored on Classroom Shelf

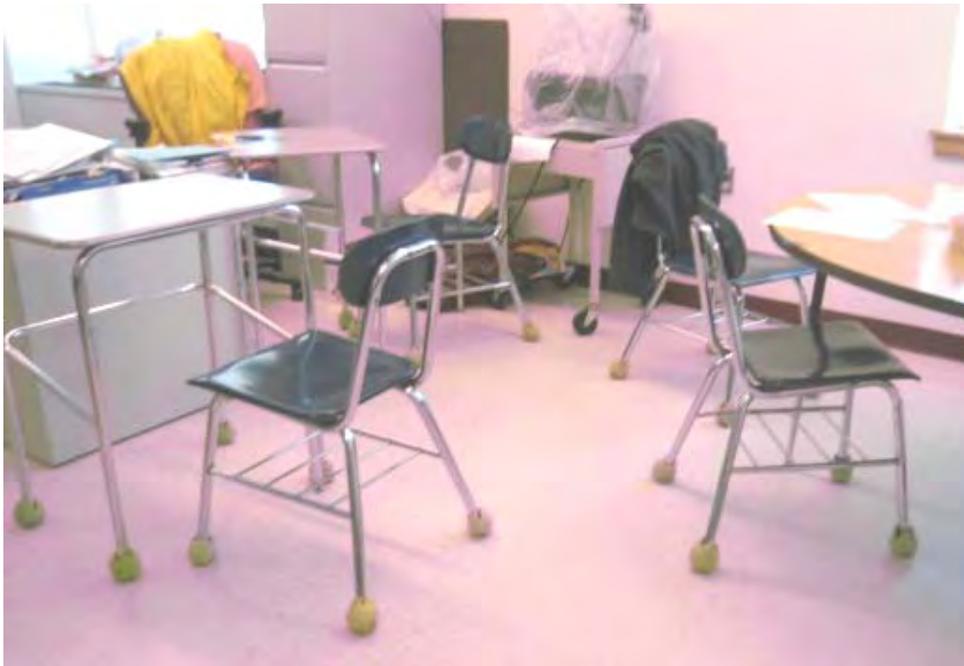
Picture 6

BEH staff observed tennis balls which had been sliced open and placed on chair and/or table legs (Picture 6). Tennis balls are made of a number of materials that are a source of respiratory irritants. Constant wearing of tennis balls can produce fibers and cause VOCs to off-gas. Tennis balls are made with a natural rubber latex bladder, which becomes abraded when used as a chair leg pad. Use of tennis balls in this manner may introduce latex dust into the school environment. Some individuals are highly allergic to latex (e.g., spina bifida patients) (SBAA, 2001). It is recommended that the use of materials containing latex be limited in buildings to reduce the likelihood of symptoms in sensitive individuals (NIOSH, 1997).

Tennis Balls used as Glides on Legs of Chairs and Desks

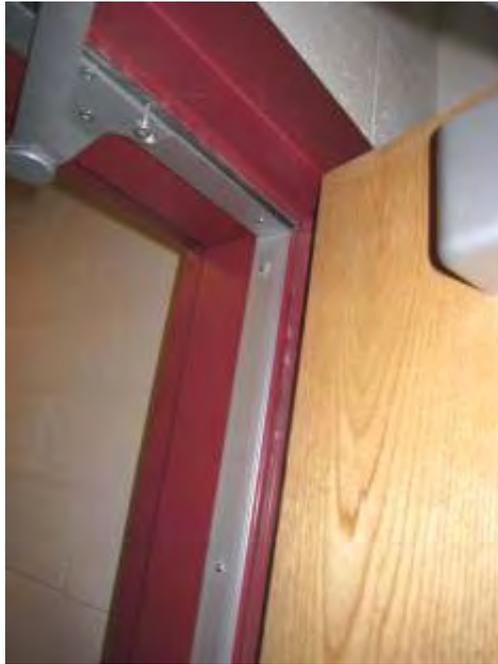
Picture 7

Several conditions were noted in the woodshop that may impact indoor air quality. A noticeable wood dust odor was detected in the hallway outside of the woodshop. A gasket was missing/in disrepair on the woodshop door, which can allow dusts/odors to migrate into adjacent areas of the school (Picture 7). In the woodshop, the wood cutting/sanding machines are connected to a ducted wood dust collection system, which is located indoors in a room adjacent to the woodshop. A gap was observed at the base of the door to this room, which may allow fine wood dust to re-enter the woodshop. A heavy accumulation of wood dust was observed on the woodshop floor and numerous horizontal surfaces (Picture 8). Wood dust is a fine particulate,

Missing Gasket on Woodshop Door

15. Repair gasket on woodshop hallway door.
16. Repair gaps in exterior door to woodshop. Repair gaps at bottom of paint room and wood dust collection room.

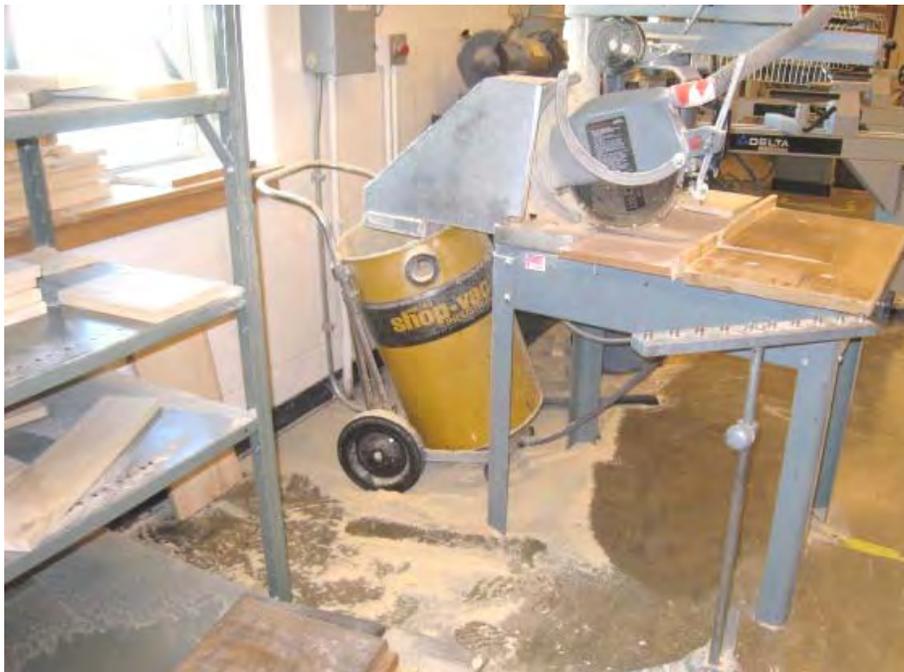
Picture 8

which can be easily aerosolized and become irritating to the eyes, nose, throat and respiratory system. Therefore, the practice of cleaning wood dust from equipment using compressed air should be discontinued, as should sweeping due to the fact that both practices can cause fine wood dust to become air borne and to potentially be breathed in by students and staff. Under certain conditions, wood dust is also a fire hazard.

**Wood Dust Deposition on Floors
Note Wood Dust on Adjacent Shelves**

17. Ensure roof of paint room is repaired and is weathertight.
18. Clean wood dust from woodshop surfaces and equipment using a vacuum cleaner equipped with a high efficiency particle arrestance (HEPA) filter.

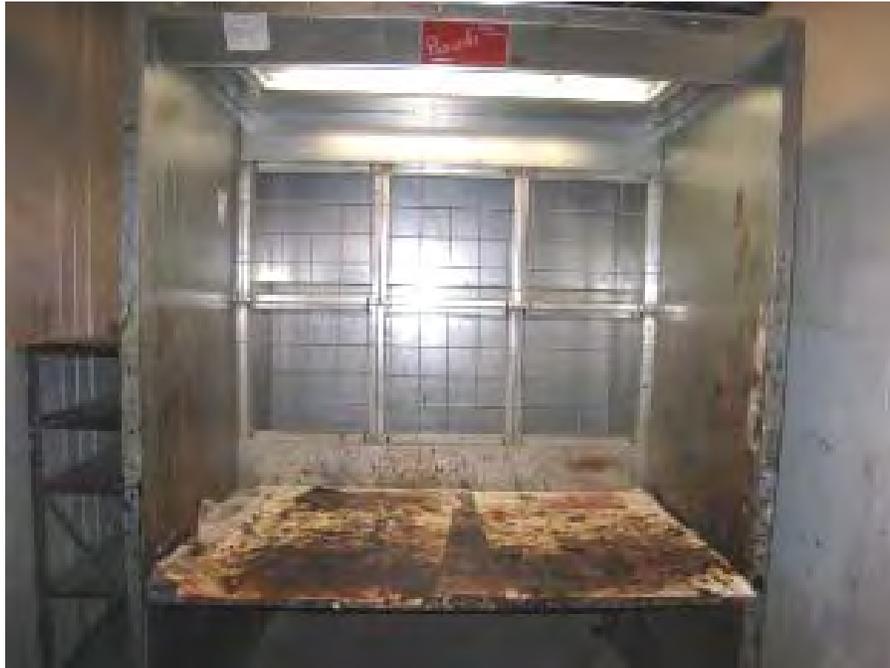
Picture 9

The woodshop has a room that is used for painting/staining projects. The room contains a spray booth that is vented to the outdoors (Pictures 9 and 10). The roof adjacent to the exhaust duct for the spray booth was not properly sealed, therefore one could see through to the outdoors. This condition could allow paint fume exhaust and unconditioned air to enter the room. A gap was also observed in the exterior door at the rear of the woodshop. Unconditioned outside air has the potential to create condensation on surfaces under certain conditions. Condensation on porous surfaces can promote mold colonization. These breaches can allow drafts, moisture, insects and rodents to enter the building.

Spray Booth in Paint Room in Woodshop

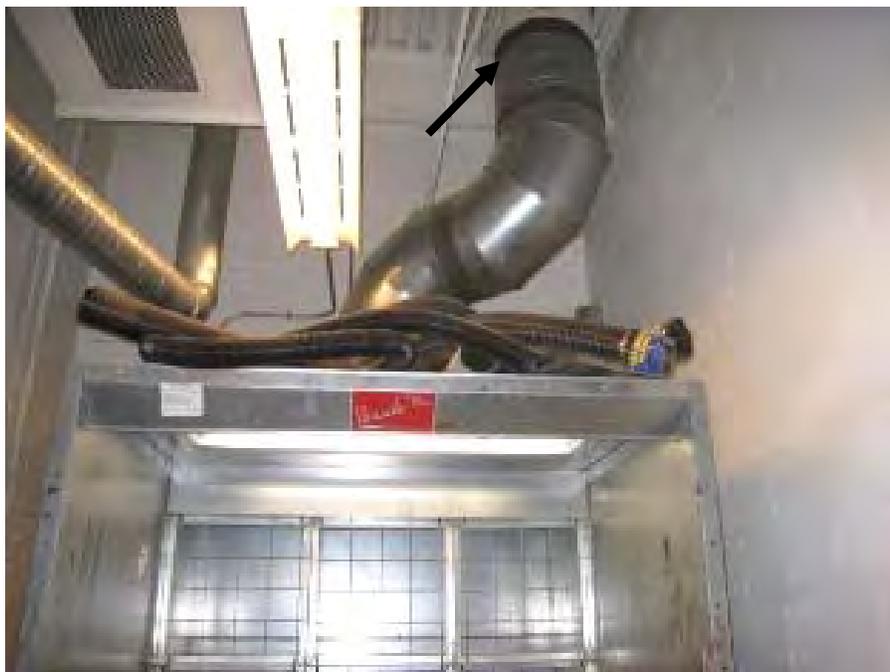
Picture 10

Open Penetration around Exhaust Duct through Roof (Arrow)

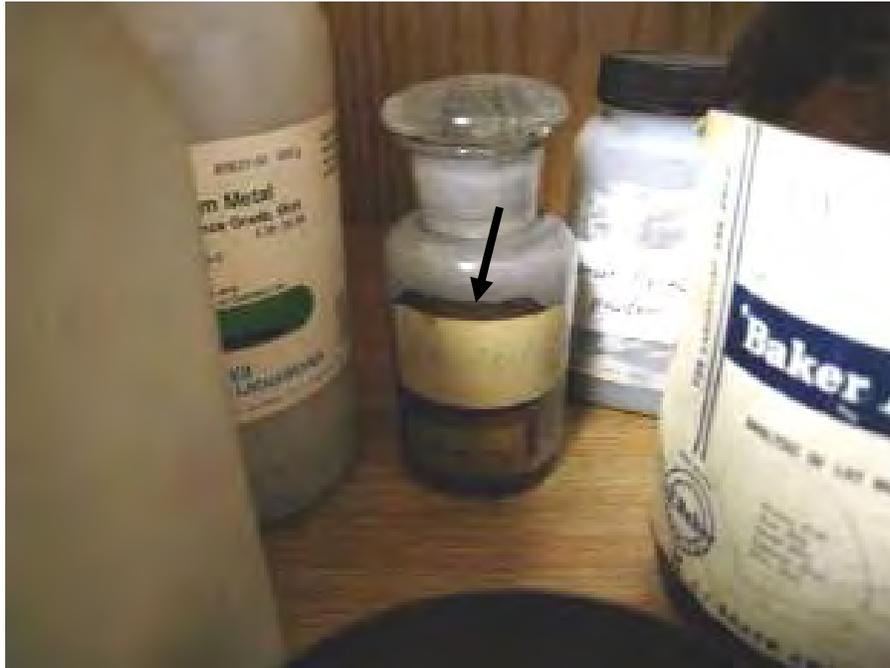
Picture 11

Arsenic in Chemical Storage Area (Arrow)

chemical storage cabinet as observed by BEH staff. Substances in Tables 3 and 4 marked with an asterisk (*) are chemicals that in the opinion of the safe practices subcommittee of the American Chemical Society “should not be found in a secondary school chemical inventory...” (ACS, unknown). It is important to note that these substances appear to have been purchased several decades prior to this assessment. Due to the particular hazards posed by each of the chemicals highlighted (Pictures 11 and 12); it is recommended that these materials be removed by a licensed hazardous waste disposal contractor.

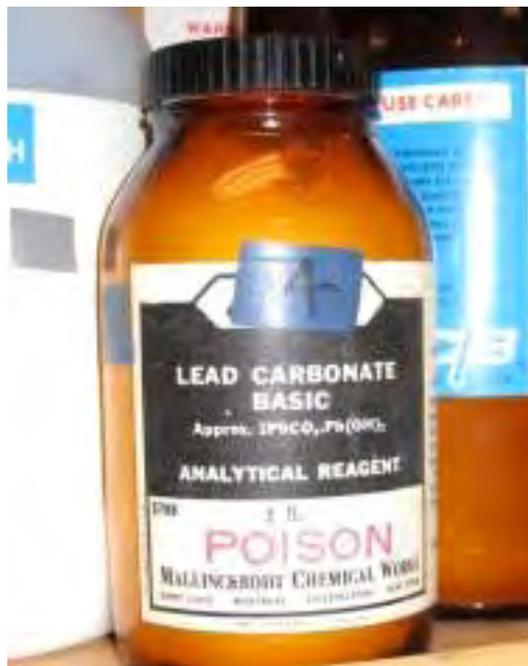
Picture 12

Bottle of Lead Carbonate

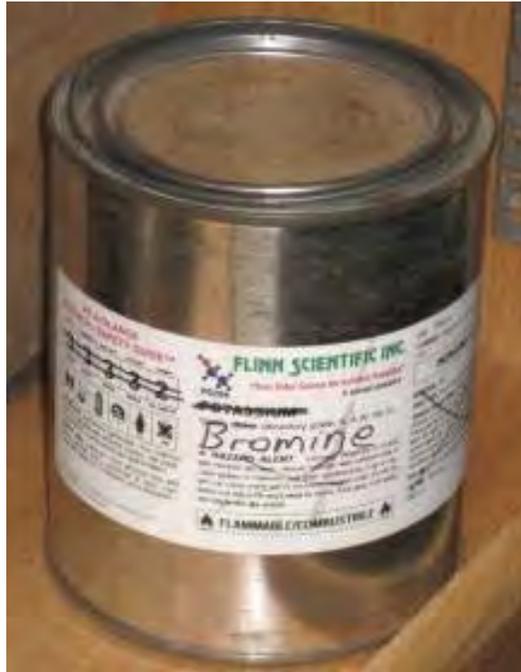
Picture 13

Chemical containers appear to be re-used in some cases (Picture 13). The practice of re-use of chemical storage containers should be discontinued. Chemicals should remain in their original containers or be placed in a properly labeled container. Some hand-written labels on chemicals have also begun to deteriorate with age.

Apparent Re-Use of Chemical Storage Container

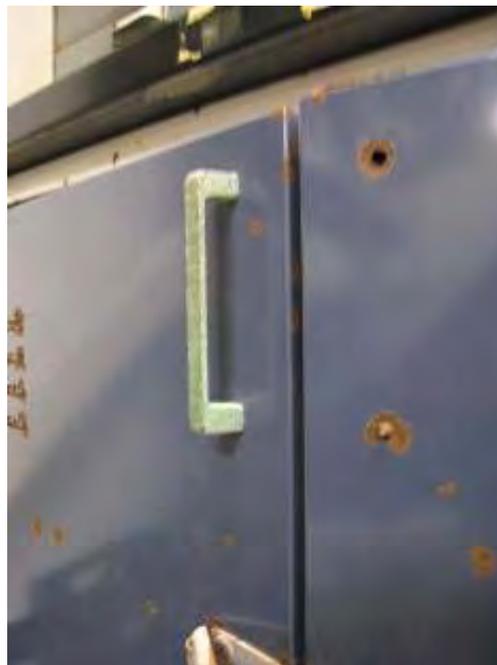
Picture 14

Metal shelving did not have a lip, which can cause chemicals to easily fall off storage shelves. Oxidation was observed on many metal surfaces, including but not limited to shelving, cabinet components and chemical containers (Pictures 14 through 16). Chemical residues were observed on shelving as well as on glass bottles (Pictures 17 through 19). These conditions occur as a result of chemicals off-gassing into the environment. Related exposure to such vapors may cause irritation to the eyes, nose and respiratory system. Several corrosive and moisture

Oxidation of Metal Cabinet

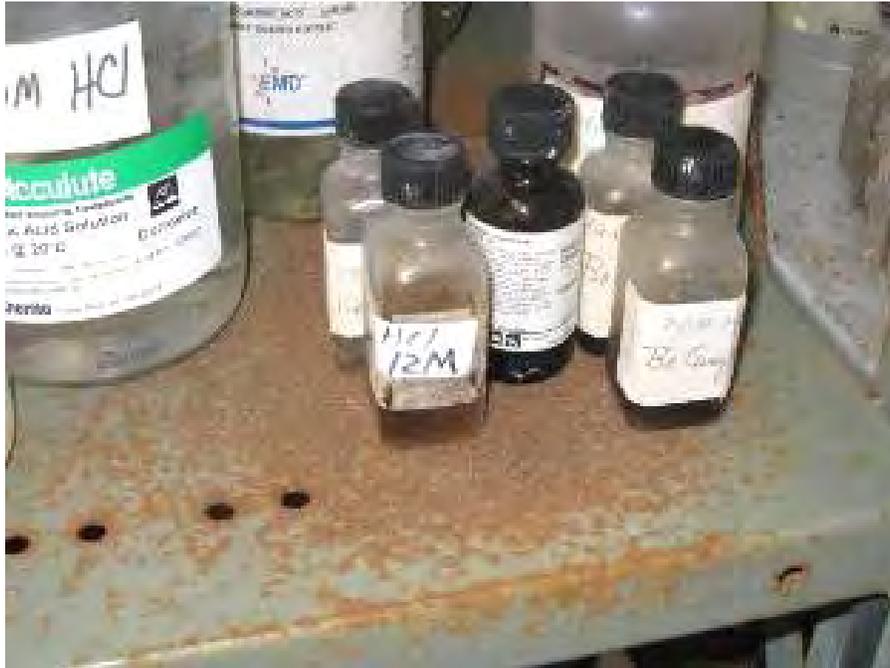
Picture 15

Rusted Metal Storage Shelves

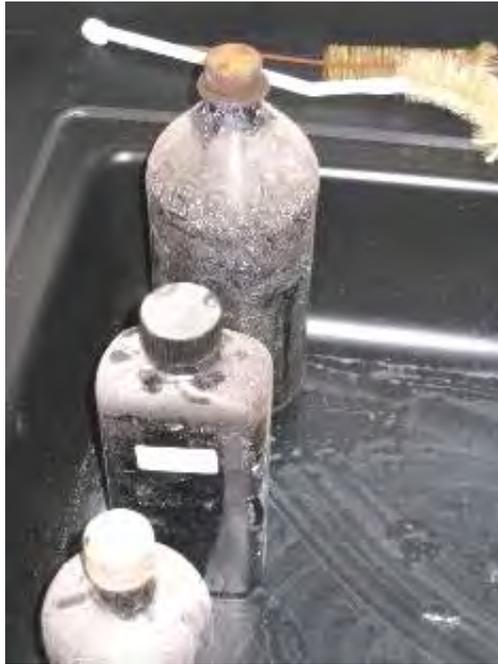
Picture 17

Chemical Residue on Glass Bottles

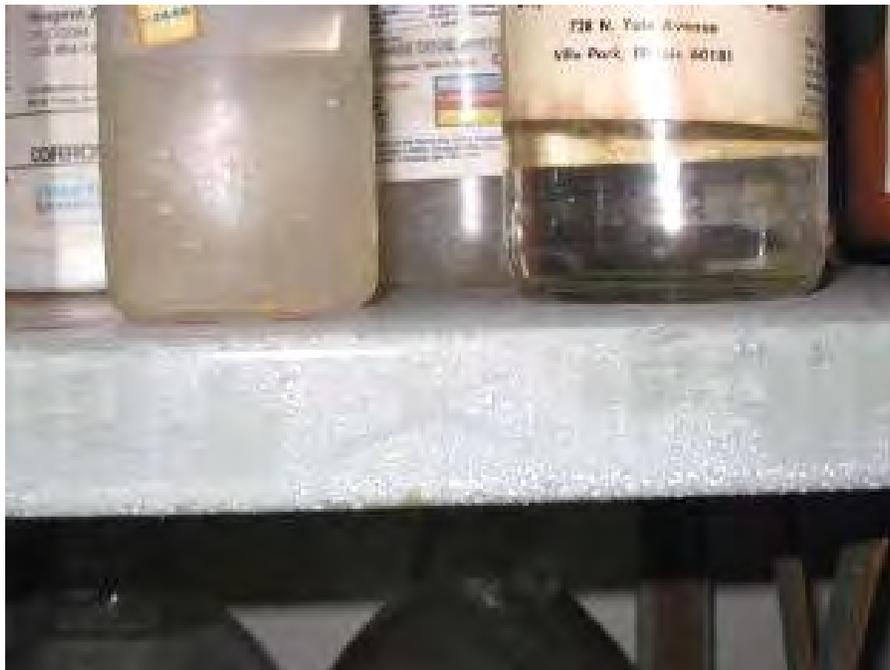
Picture 18

Residue on Storage Shelves

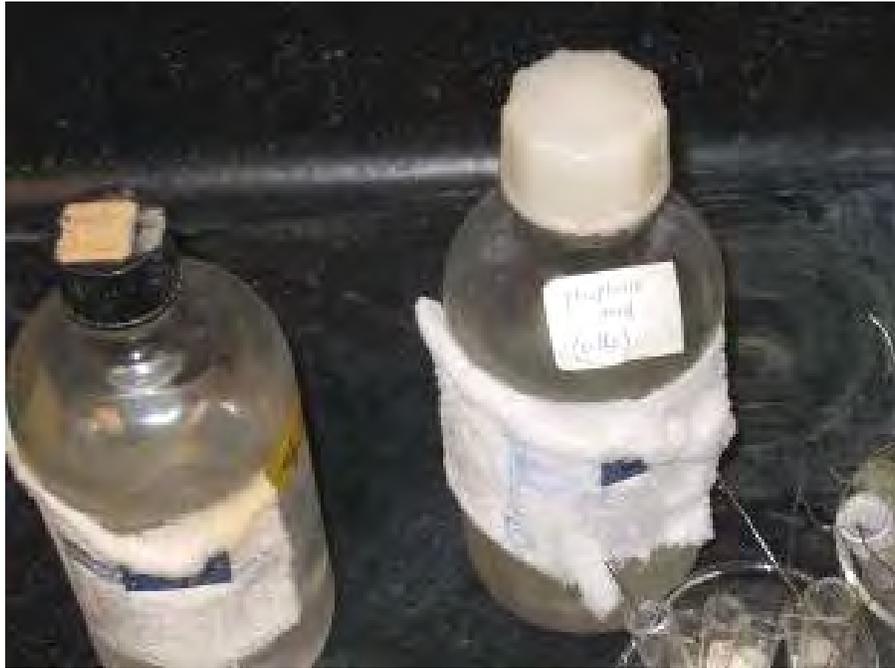
Picture 19

Crystallized Chemicals on Exterior of Bottles

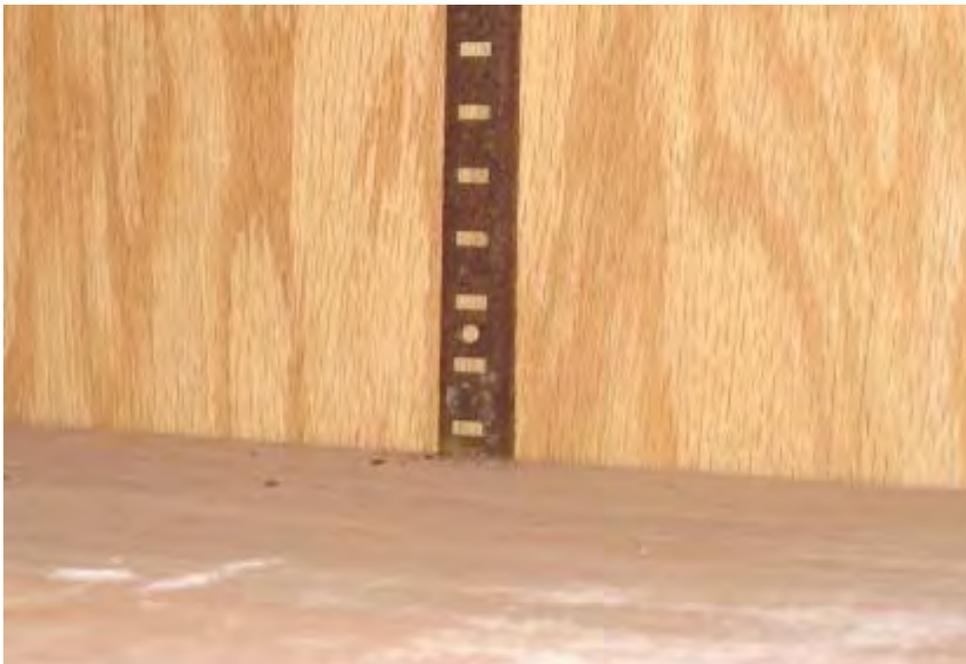
Picture 20

Other conditions that can affect indoor air quality were observed during the assessment. A hole was observed in the exhaust duct leading from the kiln. This condition can allow heat and fumes to exhaust into the kiln room, and may be responsible for the rusted shelving observed in the kiln room (Picture 20).

Oxidized Metal Shelving Brackets in Kiln Room

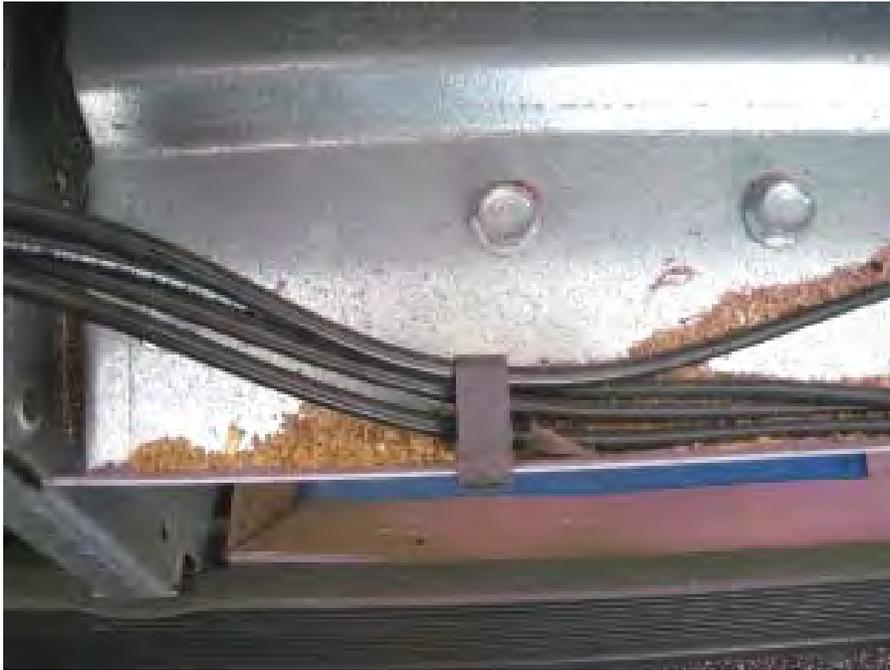
Picture 21

Pencil shavings and food particles were observed in the interior of one univent (Picture 21). Another univent, lacking a properly sized filter, was observed to have a large filter folded over to fit into the unit. This excess filter media is not conducive to proper operation of the univent (Picture 22).

Debris in Univent

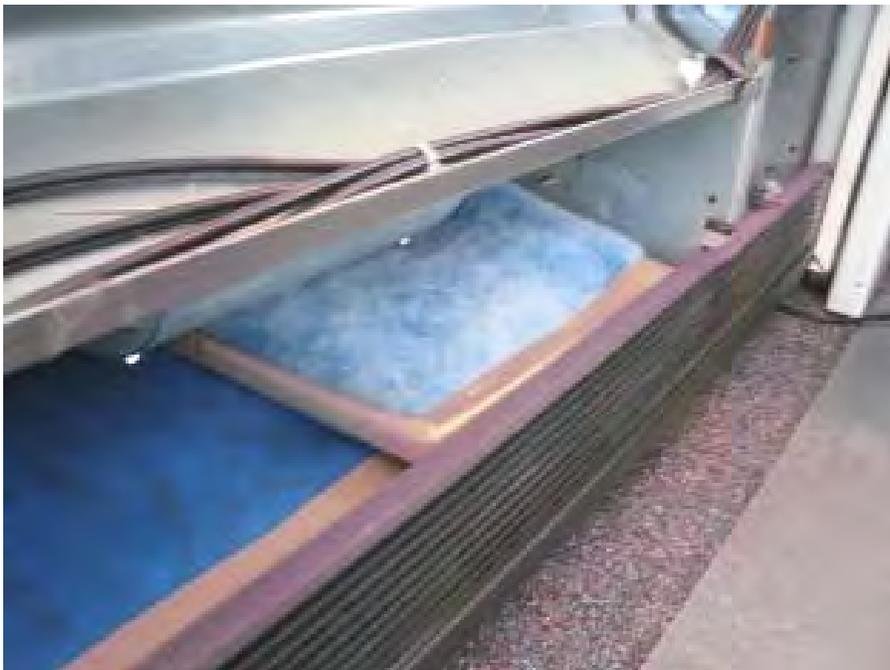
Picture 22

Oversized Univent Filter Folded Over inside Univent

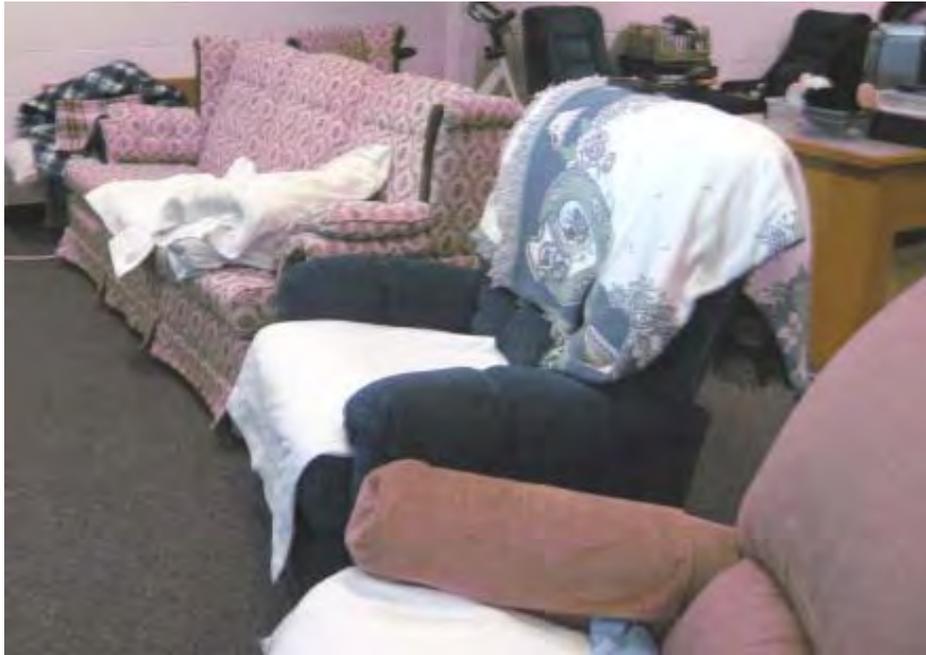
Picture 23

Stuffed pillows/toys, blankets and upholstered furniture were noted in some classrooms (Picture 23). Stuffed toys used by an individual child should be washed on a weekly basis to prevent disease (Hale and Polder, 1996). Furthermore, stuffed pillows/toys can be a point for dust collection. Close contact with such items can leave oils, perspiration, hair and skin cells. Dust mites feed upon human skin cells and excrete waste products that contain allergens. As discussed, dust can be irritating to the eyes, nose and respiratory system.

Upholstered Furniture, Blankets and Pillows

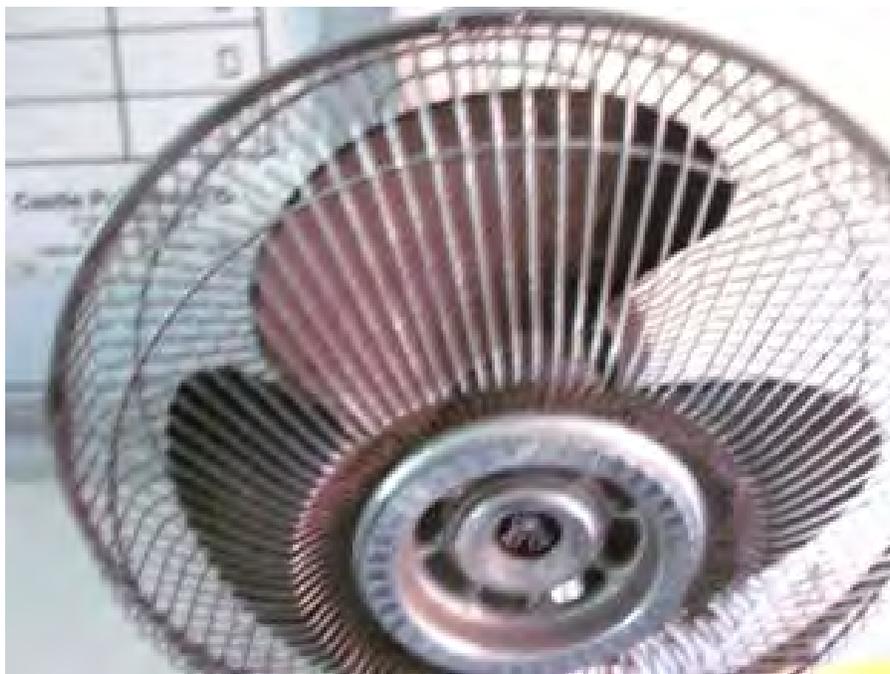
Picture 24

A number of univents, exhaust vents and personal fans were observed to have accumulated dust/debris (Picture 24). These diffusers, vents and fans should be cleaned in order to prevent dust/debris from being aerosolized and redistributed throughout the room.

Heavy Dust Accumulation on Fan Blades

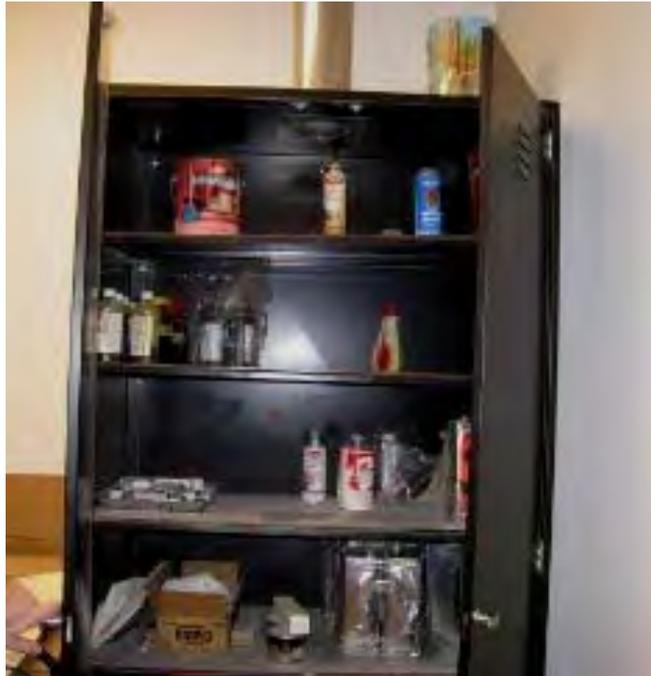
Picture 1

Chemical Storage Cabinet in Art Department

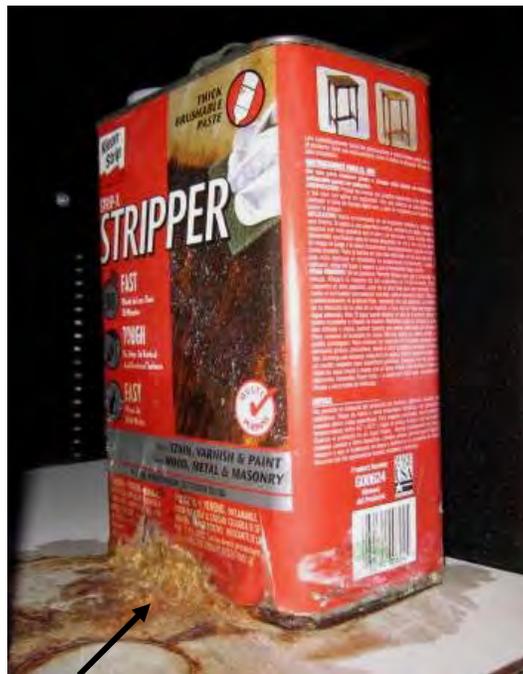
Picture 2

Leaking Can of Stripper; Note Area of Solidified Chemical from Container to Board on top of Metal Shelf

disturb the “plug” and cause the product to leak. At the time of the assessment, it was recommended that the Orange Fire Department be contacted for further instruction.

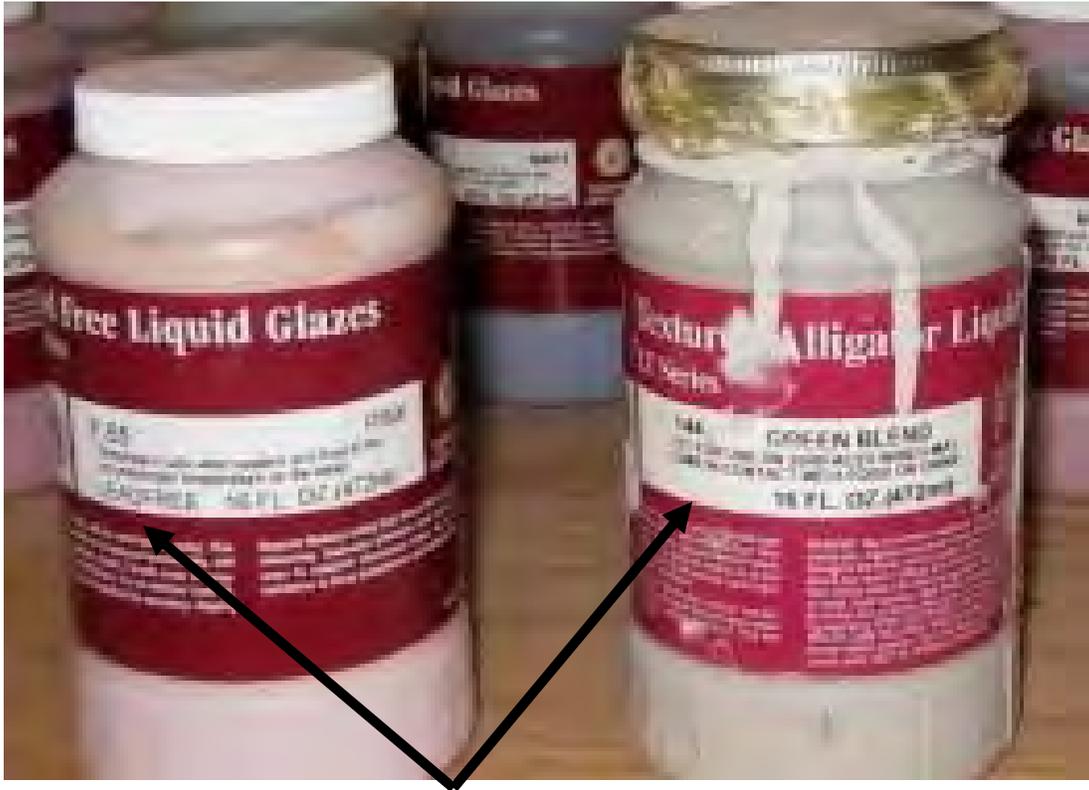
Picture 3

Containers of Glazes; Note Container on Right Lacks “Lead Free” Label
