INDOOR AIR QUALITY ASSESSMENT

**Templeton Center School
17 South Road
Templeton, MA**

Prepared by:
The Massachusetts Department of Public Health
Bureau of Environmental Health
Indoor Air Quality Program
May 2011

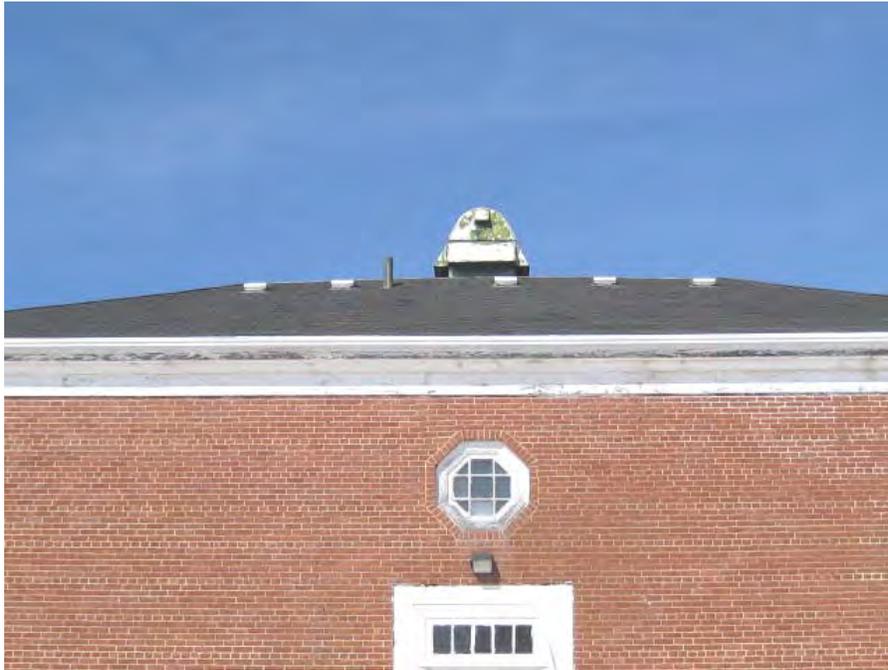
Picture 1

The TCS is a one story brick building with wooden roof and occupied basement constructed in 1941, according to the Templeton School Department. An addition was constructed sometime before 1970. The roof is flat with peaked sides (Picture 1). Windows are openable throughout the building. It was reported to BEH staff by Superintendent Roseli S. Weiss that the school district is attempting to seek funds for either renovations or replacement of the TCS within the next several years.

Exhaust ventilation in classrooms is provided by hearth-like structures at the base of walls (Picture 5) that are connected to exhaust vents in the attic that direct air through vents located on the flat section of the roof (Pictures 1 and 6). At the time of the assessment, the exhaust system was found deactivated. In addition, several classrooms had exhaust vents that were either shut or obstructed by papers, posters, bookcases and furniture. As with the univents, exhaust vents need to be free from obstruction to function as designed. Without adequate exhaust ventilation, excess heat and environmental pollutants can build up and lead to indoor air/comfort complaints.

A Hip Roof Without a Peak

1. Contact an HVAC engineering firm for a building-wide ventilation systems assessment. Based on historical issues with air exchange/indoor air quality complaints, age, physical deterioration and availability of parts for ventilation components, such an evaluation is necessary to determine the operability and feasibility of replacing the equipment.
2. Strong consideration should be given to replacing univents in classrooms. Consideration should also be given to replacing exhaust units.
3. Consideration should be given for full roof replacement.

4. To alleviate ice dams, removal of the passive vents mentioned in our previous report (Appendix A) should be considered. Installation of a ridge-like vent should be considered.
5. If roof alterations are planned, the addition of a peak the flat roof would decrease snow accumulation of the flat surface and therefore decrease the snow load on the roof.
6. If a peak is added to the roof, consideration should be given to redesigning the exhaust vent system so it directs air from existing vents at the front and rear of the building.
7. Consideration should also be given to window replacement to reduce/eliminate water penetration.

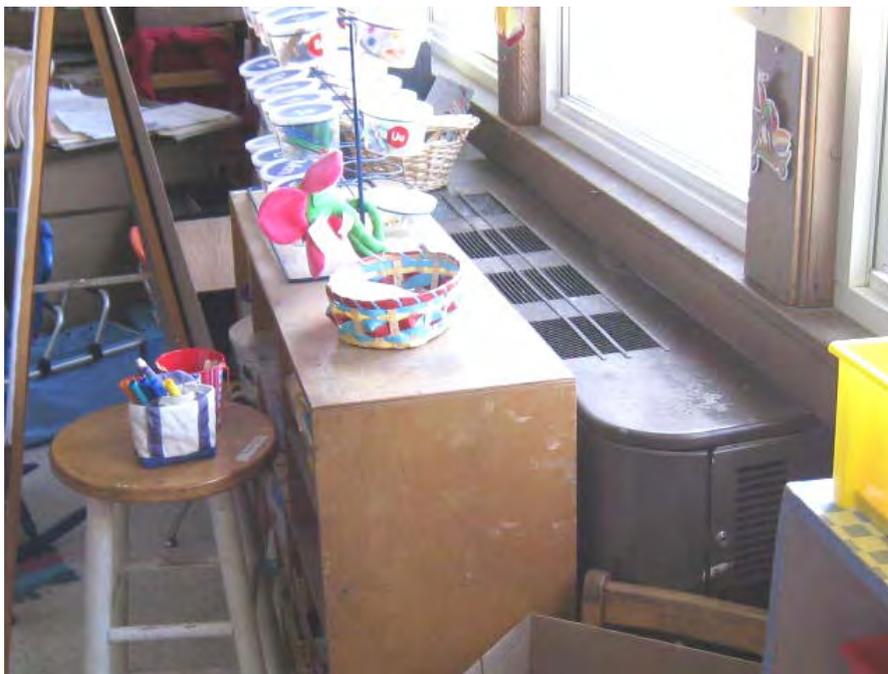
Picture 2

therefore no means of mechanical introduction of fresh air was being provided. Univents were also obstructed by items such as chairs, tables, desks, and books (Pictures 2 and 3). In order to function as designed, univents must be activated and allowed to operate free of obstructions. Mechanical ventilation for large/common areas such as the cafeteria and other basement level rooms is provided by ceiling-mounted univents (Picture 4).

Univent Blocked by Shelf Unit

4. Remove all blockages from univents and exhaust vents to ensure adequate airflow.
5. Use openable windows in conjunction with classroom univents and exhaust vents to facilitate air exchange until repairs that are more permanent can be made. Care should be taken to ensure windows are properly closed at night and weekends to avoid the freezing of pipes and potential flooding.

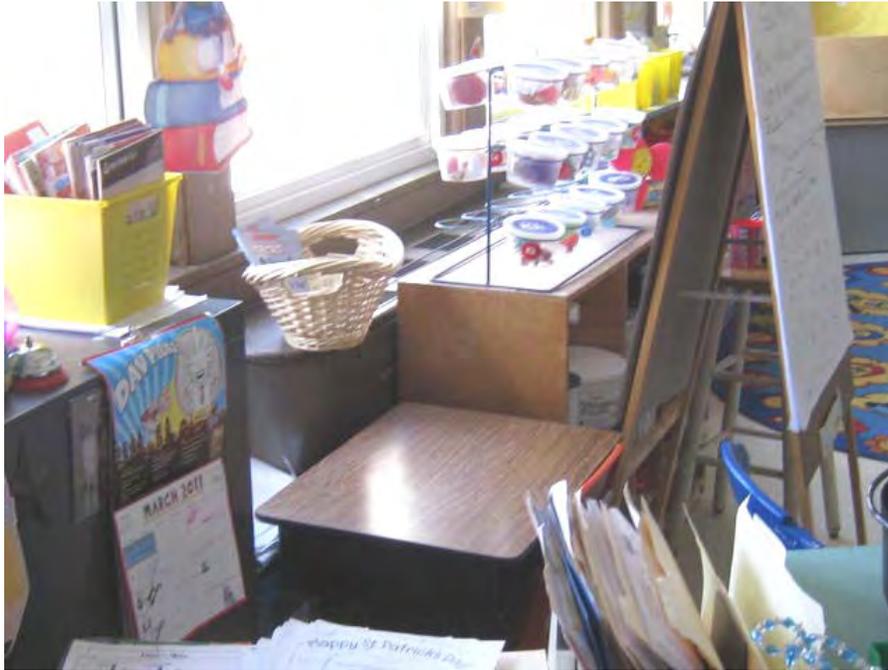
Picture 3

Univent Obstructed by Various Classroom Materials

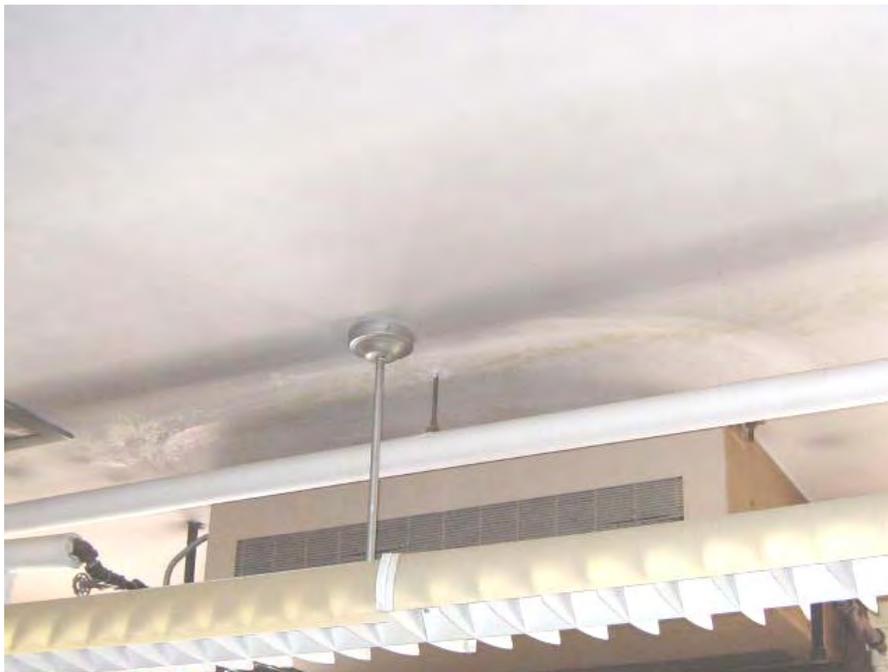
Picture 4

Example of a Ceiling-Mounted Univent in Basement

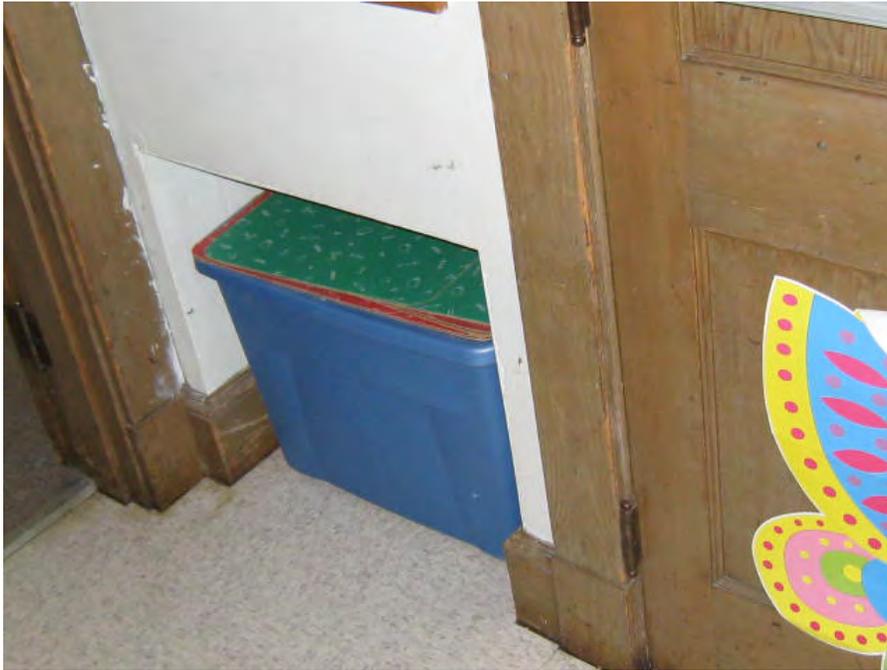
Picture 5

Exhaust Ventilation/Hearth-Like Structure in Classrooms

3. Operate all functional ventilation systems throughout the building (e.g., cafeteria, classrooms) continuously during periods of occupancy. An increase in the percentage of fresh air supply and/or increased exhaust capabilities is recommended.

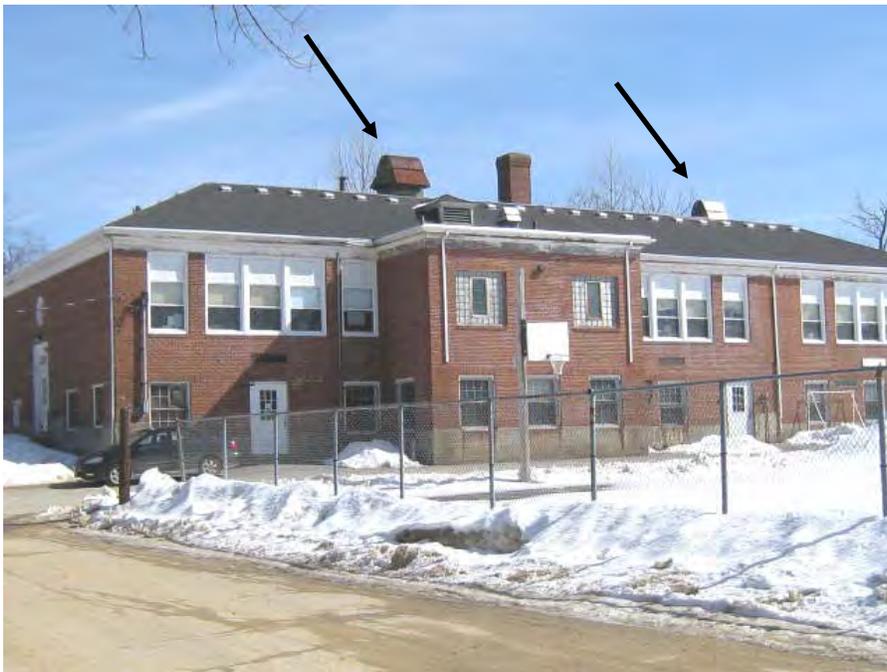
Picture 6

Exhaust Vents on Roof

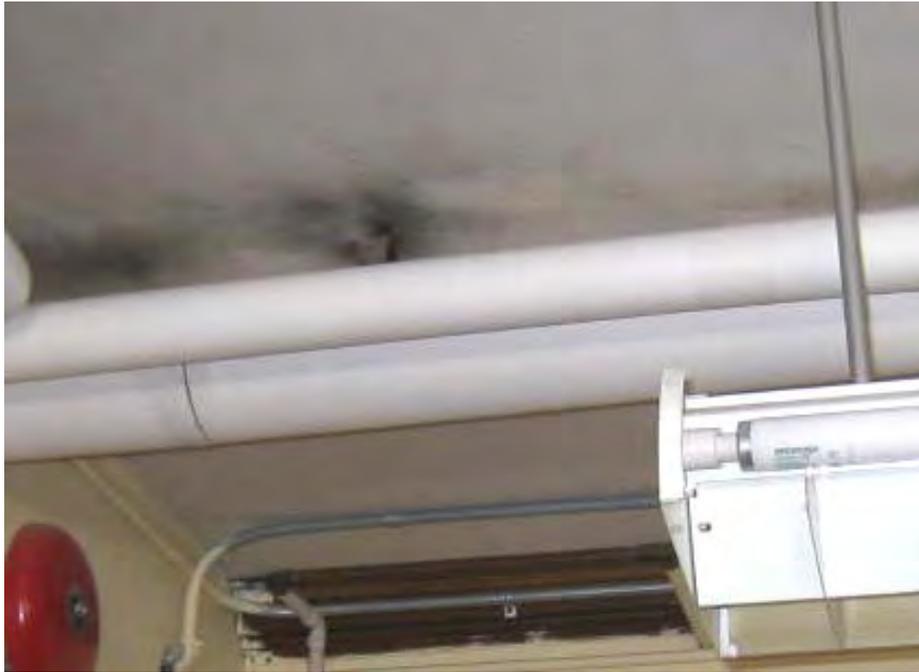
Picture 7

While no elevated levels of airborne particulate were measured, soot deposition was observed in the library around light fixtures (Picture 7). This soot may be attributed to furnace generated pollutants in the mechanical room next door to the library. A number of holes in the wall of the mechanical room were noted (Pictures 8 and 9). These holes should be sealed to prevent the migration of combustion products into occupied areas.

Soot Deposition around Light Fixtures in Library

7. Seal holes in mechanical room/library wall with a fire-rated sealant; clean soot deposition from ceiling.
8. Relocate or consider reducing the amount of materials stored in classrooms to allow for more thorough cleaning of classrooms. Clean items regularly with a wet cloth or sponge to prevent excessive dust build-up.
9. Consider replacing tennis balls with latex-free tennis balls or glides.
10. Consider adopting the US EPA (2000) document, “Tools for Schools”, as an instrument for maintaining a good indoor air quality environment in the building. This document is available at: <http://www.epa.gov/iaq/schools/index.html>.
11. Refer to resource manual and other related indoor air quality documents located on the MDPH’s website for further building-wide evaluations and advice on maintaining public buildings. These documents are available at: <http://mass.gov/dph/iaq>.

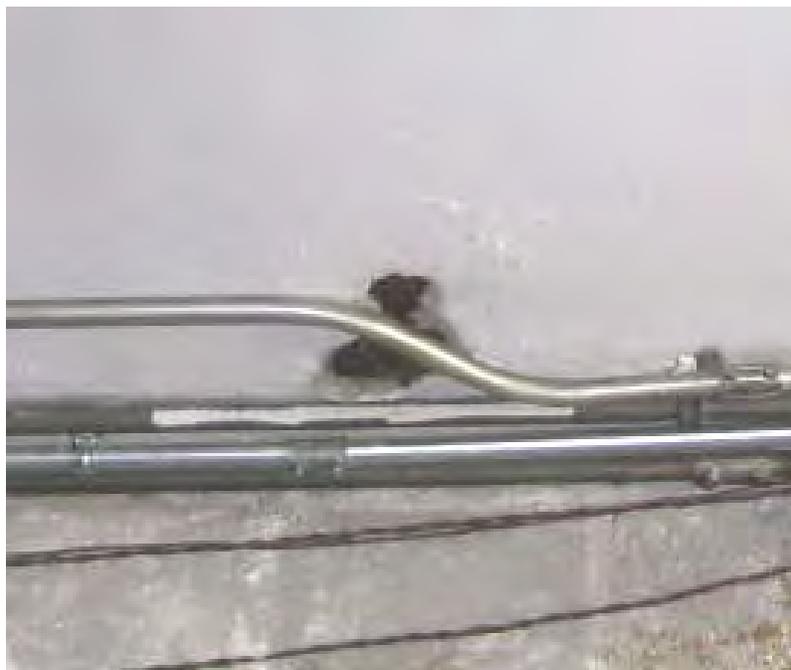
Picture 8

Hole in Furnace Room Wall

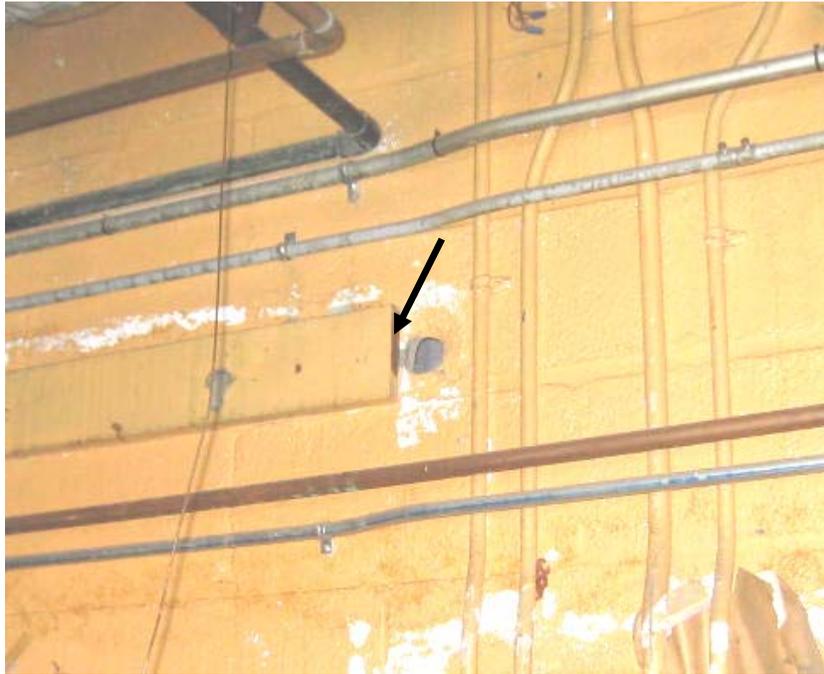
Picture 9

Hole in Furnace Room Wall

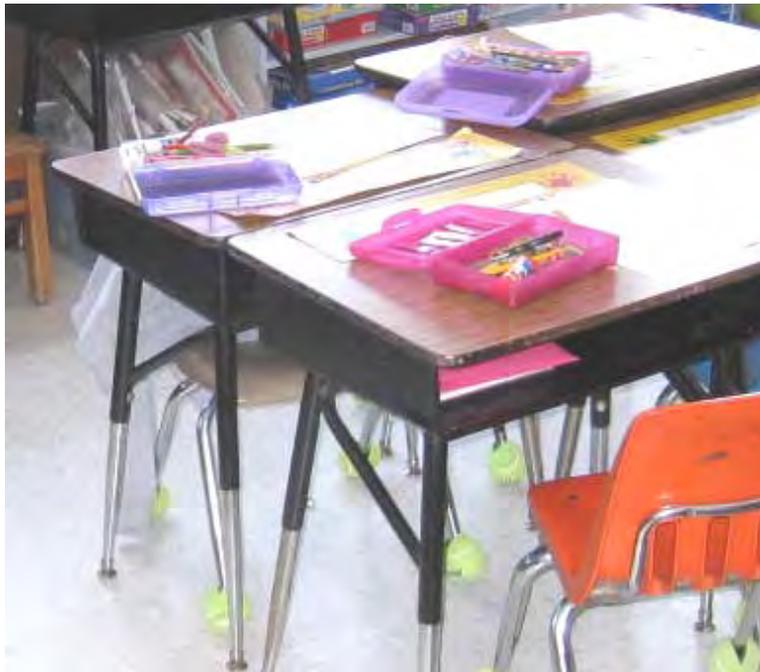
Picture 10

Other conditions that can affect indoor air quality were observed during the assessment. BEH staff observed tennis balls which had been sliced open and placed on chair and/or table legs presumably to reduce noise (Picture 10). Tennis balls are made of a number of materials that are a source of respiratory irritants. Constant wearing of tennis balls can produce fibers and cause volatile organic compounds (VOCs) to off-gas. Tennis balls are made with a natural rubber latex bladder, which becomes abraded when used as a chair leg pad. Use of tennis balls in this manner may introduce latex dust into the school environment. Some individuals are highly allergic to latex (e.g., spina bifida patients) (SBAA, 2001). It is recommended that the use of materials containing latex be limited in buildings to reduce the likelihood of symptoms in sensitive individuals (NIOSH, 1997).

Tennis Balls on Chairs Legs
