# **INDOOR AIR QUALITY ASSESSMENT**

**Department of Developmental Services  
1221 Main Street  
Weymouth, Massachusetts**

Prepared by:  
Massachusetts Department of Public Health  
Bureau of Environmental Health  
Indoor Air Quality Program  
May 2011

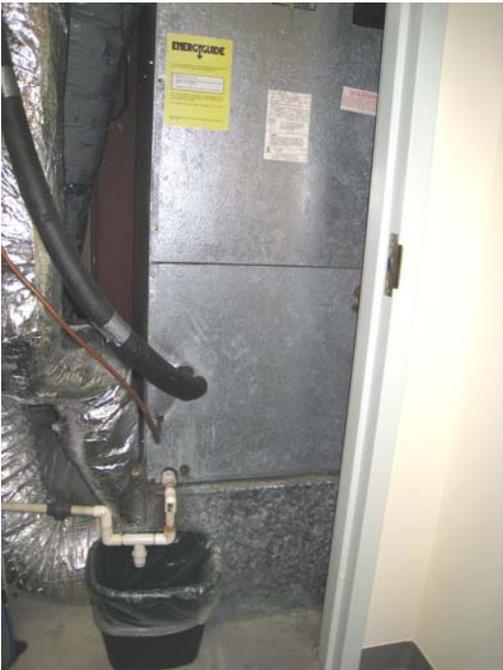
**Picture 1**

It can be seen from Table 1 that carbon dioxide levels were above 800 parts per million (ppm) in all areas surveyed, indicating a lack of air exchange at the time of the assessment. Ventilation is provided by two air-handling units (AHUs) located in mechanical closets on the third floor (Picture 1). Ductwork located above the ceiling connects the AHUs to ceiling-mounted air diffusers (Picture 2), which provide conditioned air to occupied areas. At the time of assessment, MDPH/BEH staff could not identify a source of fresh air for the AHUs. Subsequent correspondence with the building's property manager revealed that 2 roof-mounted fans introduce fresh air to the AHUs servicing the DDS. These fans are currently set to provide 20% fresh air mixed with 80% recycled air.

**AHU in closet**

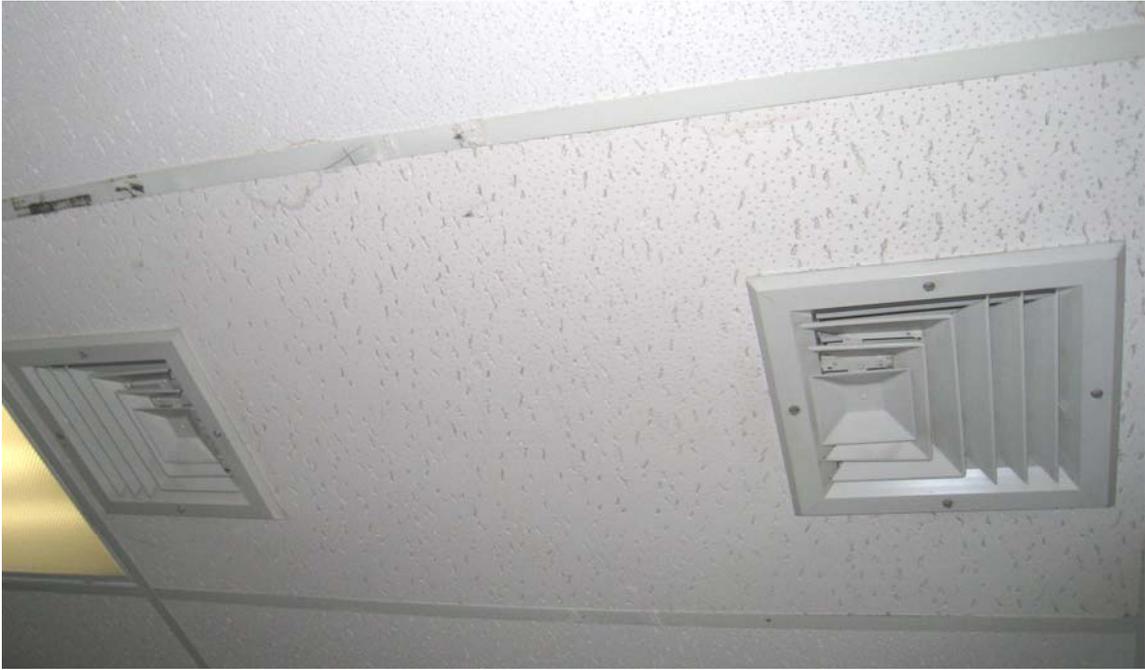
**Picture 2**

**Ceiling-mounted air diffusers**

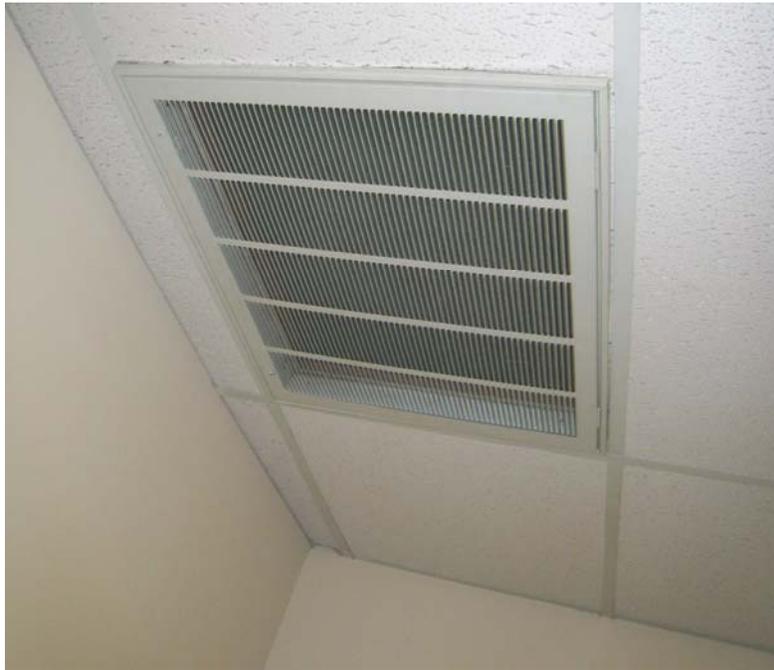
**Picture 3**

Two return vents were observed in the office suite, one in conference room A (Picture 3) and another in office ZZ (Picture 4; Figure 1). These vents are designed to return air back to the AHUs. The system is designed to use hallways to draw return air from office areas. To facilitate airflow, office doors are undercut approximately one-inch to provide a space through which air can be drawn into the hallways.

**Ceiling-mounted return vent**

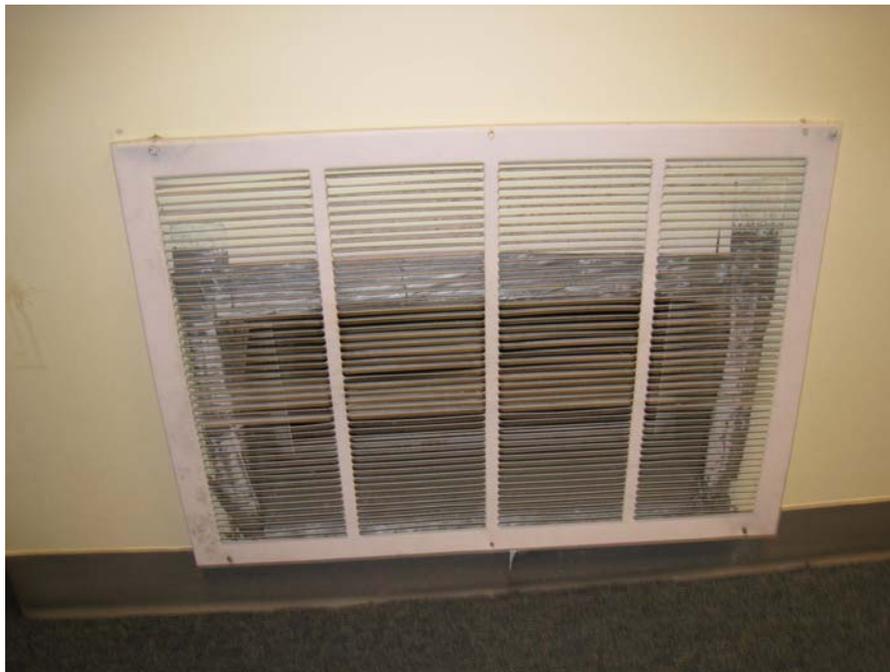
**Picture 4**

**Wall-mounted return vent**

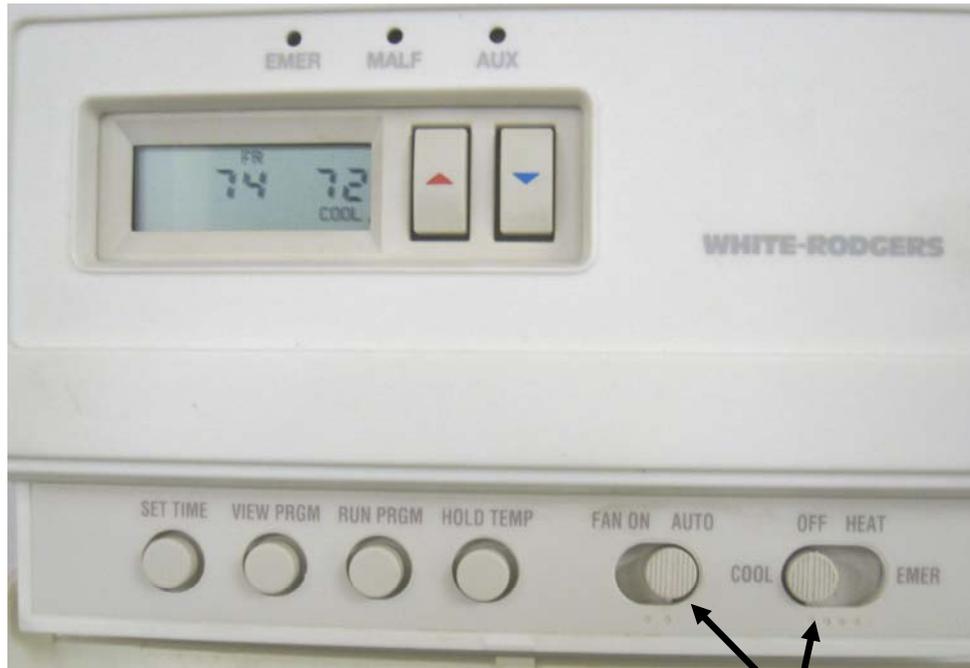
Picture 5

Digital wall-mounted thermostats control each of the AHUs. Thermostats have fan settings of *on* and *automatic*. Both thermostats were set to the *automatic* setting during the assessment (Picture 5). The automatic setting on the thermostat activates the HVAC system at a preset temperature. Once a preset temperature is measured by the thermostat, the HVAC system is deactivated. Therefore, no mechanical ventilation is provided until the thermostat re-activates the system. MDPH recommends that the fan setting of thermostats be set to the *on* position during occupied periods, as this setting provides a continuous source of air circulation.

As mentioned previously, staff typically override the thermostat system due to excessive heat in the building throughout the year. Repeated actions to override the thermostat's current preset parameters to increase provision of cool air may have played a role in the coil freezing.

Digital wall-mounted thermostat set to cool (AC) with fan in *auto* setting (arrows)

1. Remove and replace water-damaged/mold colonized GW in a manner consistent with US EPA guidance (US EPA, 2001).
2. Program thermostats to operate AHUs with the fan in the *on* setting during occupied hours to increase air movement and comfort and prevent future occurrences of cooling coils from freezing.
3. Increase the provision of fresh air to the DDS space to dilute/reduce airborne pollutants and increase comfort.
4. Consider enlarging the closets that the AHUs are currently located. Reconfiguring to create more space to increase ventilation to the AHUs, which would prevent the equipment from overheating.
5. Service/clean AHUs regularly to ensure function and integrity of equipment.
6. Clean/change filters for AHUs and air purifiers as per the manufacturer's instructions or more frequently if needed. Ensure filters are in place and that they fit properly.

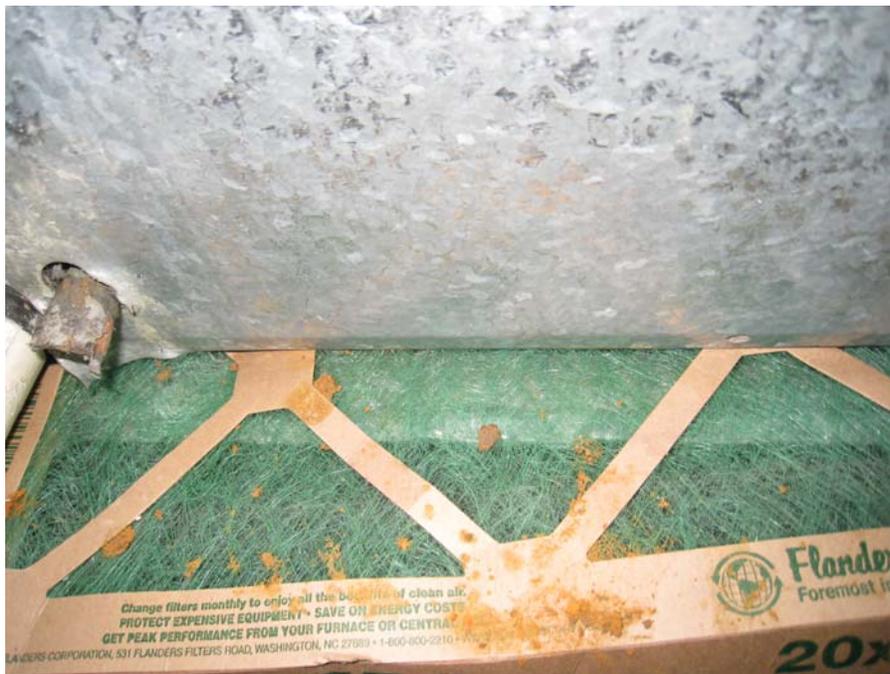
Picture 6

Please note, while examining the AHU in the closet of office G, BEH staff observed rust color debris on the post-filtration side of the filter (Picture 6). The deposition of this material is an indication that the AHUs are aging/becoming damaged through routine use and nearing the end of their useful service life. These AHUs are likely original equipment, approximately 24 years old. According to the American Society of Heating, Refrigeration and Air-Conditioning Engineers (ASHRAE), the service life for a unit heater (hot water or steam) is 20 years, assuming routine maintenance of the equipment (ASHRAE, 1991).

AHU with filter installed, note debris on top of filter

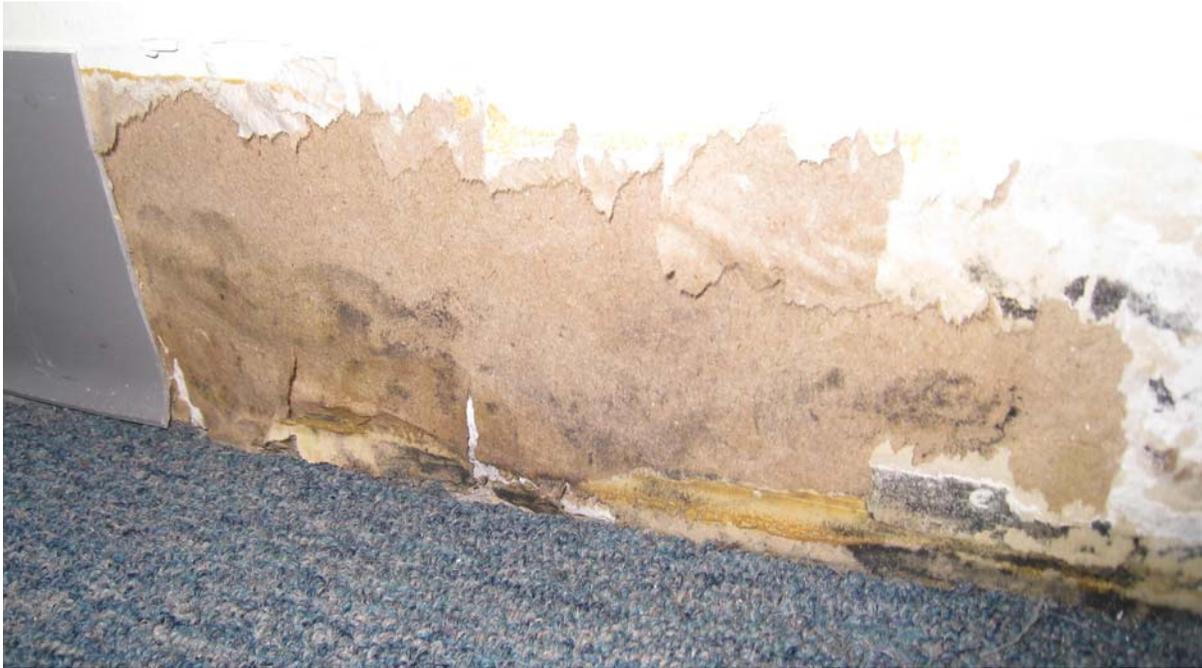
**Picture 7**

DDS staff reported that flooding occurred over the summer of 2010. The flooding resulted when a frozen coiling coil for the AHU thawed, reportedly causing water damage to GW walls and carpeting in the Telcom room and office G. DDS staff reported that, at the time of flooding, water was vacuumed/mopped, but no measures were taken to dry moistened materials (i.e., use of industrial fans).

At the time of assessment, no excessive moisture was measured in any affected materials. DPH staff removed portions of the vinyl wall coving on GW in the Telcom room for moisture testing and visual observation. While no moisture was detected, visible mold growth was observed on GW behind the vinyl coving (Picture 7). No microbial growth was observed beneath carpeting in this area. Damaged GW should be removed and replaced. Remediation of water-damaged/mold contaminated materials should be done in a manner consistent with recommendations in "Mold Remediation in Schools and Commercial Buildings" published by the US Environmental Protection Agency (US EPA, 2001).

**Mold growth on GW behind vinyl coving in Telcom room**

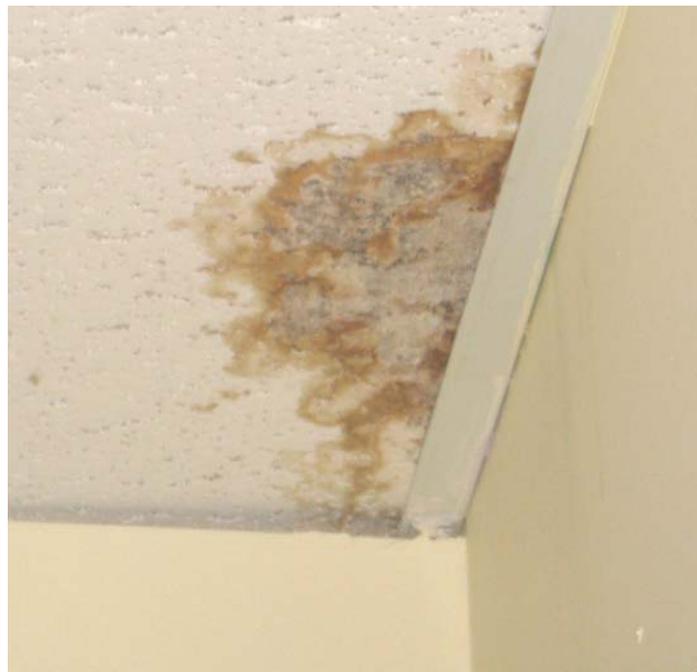
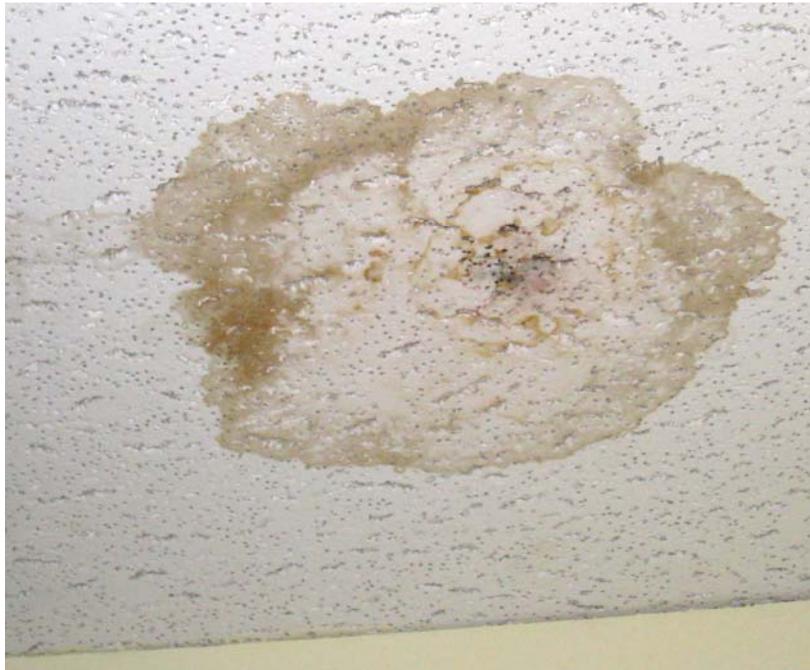
Water-damaged ceiling tiles were observed in several areas, a few of which appeared to have microbial growth (Pictures 8 and 9; Table 1). Water-damaged ceiling tiles indicate leaks from either the roof or plumbing system and can be a medium on which mold can grow. Water stains were also observed on the wall of an office, but no other signs of water damage (i.e. damaged ceiling tiles) were observed (Table 1). DDS staff reported that water periodically leaks from flooding from washrooms from the medical facility on the floor above. No materials were wet at the time of the assessment. Measures should be taken to disinfect affected surfaces (i.e., walls) and tiles should be replaced after a water leak is discovered and repaired.

**Mold growth on ceiling tile**

10. Ensure leaks are repaired and replace water-damaged/mold-colonized ceiling tiles.
11. Disinfect walls in areas where leaks have occurred with a mild detergent or bleach and water (one-to-ten) solution. Refrain from storing porous materials in areas where leaks are known to occur.

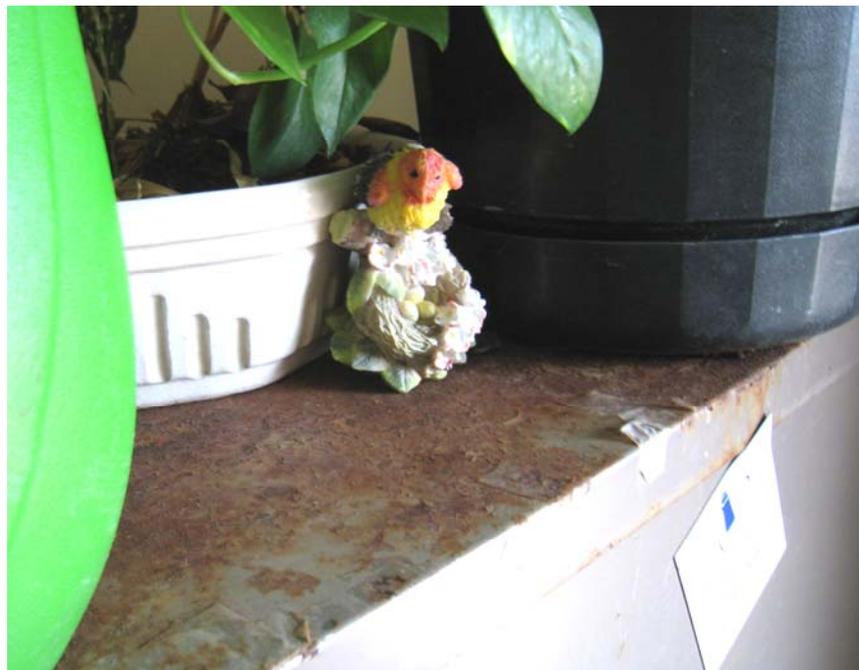
**Picture 10**

Plants were observed in several areas, including directly on carpeting. In one case, over-watering was observed as evidenced by damage to furnishing (Picture 10). Plants, soil and drip pans can serve as sources of mold/bacterial growth. Plants should be properly maintained, over-watering of plants should be avoided and drip pans should be inspected periodically for mold growth. Plants should also be placed away from ventilation sources to prevent the aerosolization of related materials.

**Rusting cabinet likely from overwatering of plants**

12. Avoid over watering of plants. Examine drip pans periodically for mold growth and disinfect with an appropriate antimicrobial where necessary. Refrain from placing plants on porous materials (e.g., paper/cardboard, carpeting). Remove plants from the air stream of ventilation equipment. Consider reducing number of plants in some areas.

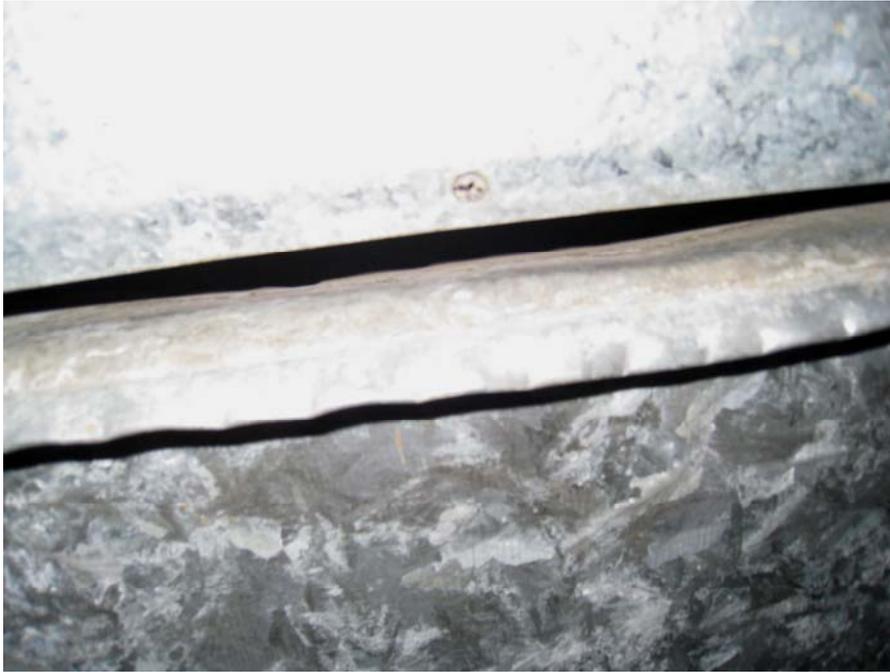
**Picture 11**

Other conditions that can affect indoor air quality were observed during the assessment. AHUs are typically fitted with filters to remove particles from the air stream before air is distributed to occupant areas. As discussed, two AHUs provide fresh air to the DDS space. Building management reported that filters are changed every 3 months. At the time of the assessment, BEH staff observed that a filter was installed in one AHU but not the other (Pictures 10 and 11). Without filtration, normally occurring pollutants/particulates will continue to cycle through the space. As discussed, no exhaust system was observed, which can result in an accumulation of particulates in this building.

**AHU lacking filter**

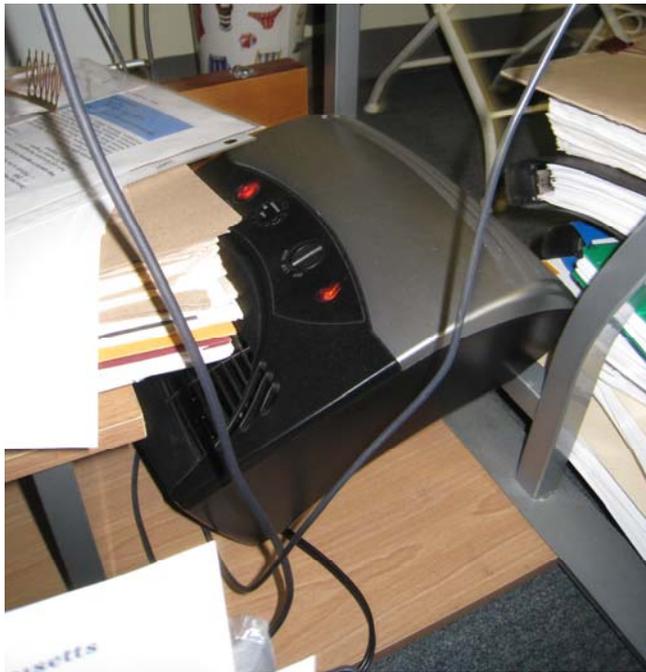
**Picture 12**

An air purifier was observed on the floor of one office (Picture 12; Table 1). Air purifiers should be placed within the breathing zone rather than at floor level to ensure filtered air is being provided to the occupant and to prevent aerosolization of materials that may be trapped in carpeting. In addition, this equipment is normally equipped with filters that should be cleaned or changed as per manufacturer's instructions to prevent build up and re-aerosolization of dirt, dust and particulate matter.

**Air purifier**
