INDOOR AIR QUALITY ASSESSMENT

**Massachusetts State Lottery
151 West Boylston Street
Worcester, Massachusetts**

Prepared by:
Massachusetts Department of Public Health
Bureau of Environmental Health
Indoor Air Quality Program
January 2011

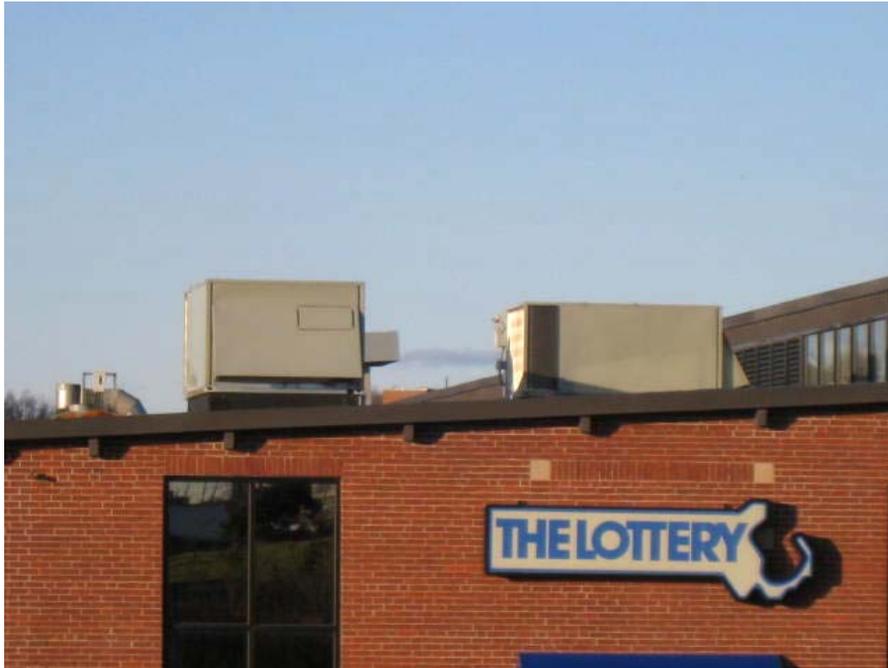
Picture 1

Mechanical ventilation is provided by rooftop air-handling units (AHUs) (Picture 1). Fresh air is drawn into the AHUs and delivered to occupied areas via ductwork. Return air is

drawn into vents connected to the rooftop AHUs by ductwork in the ceiling plenum. As noted previously, the system did not appear to be activated at the time of the IAQ assessment. In order to ascertain that supply diffusers were distributing heated air during the assessment, surface temperatures of the vents were measured using a laser thermometer. In the heating mode, the temperature of the supply vents should be roughly 20° higher than the measured air temperature. The supply vents had a temperature equal to or less than room temperature, indicating that the HVAC system was not providing heated air during the assessment.

Rooftop Air Handling Units

To maximize air exchange, the MDPH recommends that both supply and exhaust ventilation operate continuously during periods of occupancy. In order to have proper ventilation with a mechanical supply and exhaust system, the systems must be balanced to provide an adequate amount of fresh air to the interior of a room while removing stale air from the room. It is recommended that HVAC systems be re-balanced every five years to ensure adequate air systems function (SMACNA, 1994). The date of the last balancing of these systems was not available at the time of the assessment.

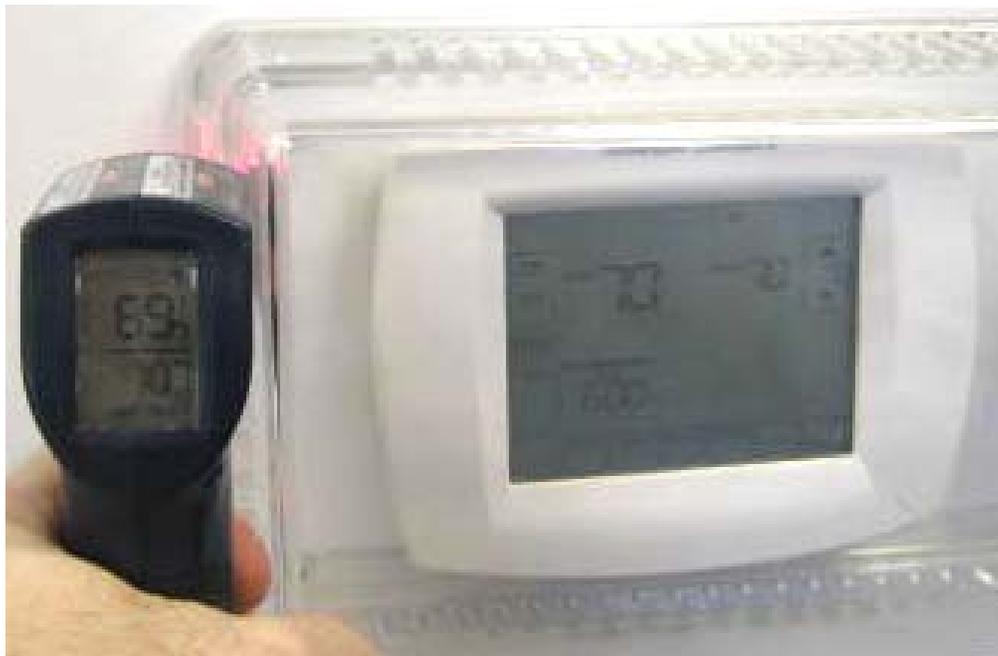
Picture 2

Digital wall-mounted thermostats control the HVAC system. Of note was the temperature readings of wall-mounted thermostats. The thermostat in the main meeting room measured temperature at 70°F, with a room temperature of 65°F. Since the HVAC system was not operating, the thermostat was the same temperature as the wall to which it was affixed (Picture 2), indicating that either the thermostat was deactivated due to the wall temperature or that the HVAC system was deactivated for some unknown reason.

Thermostat Temperature Roughly Matches Temperature Readout of Air Testing Equipment

1. Set thermostats to the fan “on” position to operate the ventilation system continuously during business hours.
2. Ensure that thermostats are operable and are placed in a location to readily measure room temperature. The areas around and beneath thermostats should be clear of obstructions and should not have any heat-producing office equipment located in close proximity.

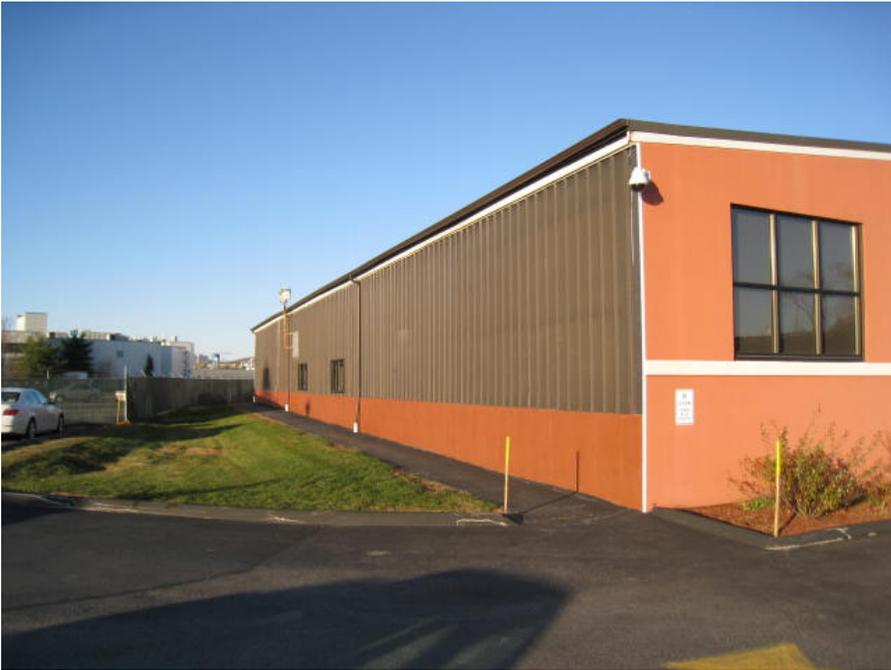
Picture 3

No water damage was noted during the assessment. When the building was constructed, metal cladding was installed along the south wall, which serves to prevent water impingement on the exterior brick and therefore decreases the likelihood of water penetration (Picture 3).

Metal Covering Exterior Brick
