# **INDOOR AIR QUALITY ASSESSMENT**

**Dorchester Division, Boston Municipal Court Department  
510 Washington Street  
Boston, Massachusetts**

Prepared by:  
Massachusetts Department of Public Health  
Bureau of Environmental Health  
Indoor Air Quality Program  
June 2012

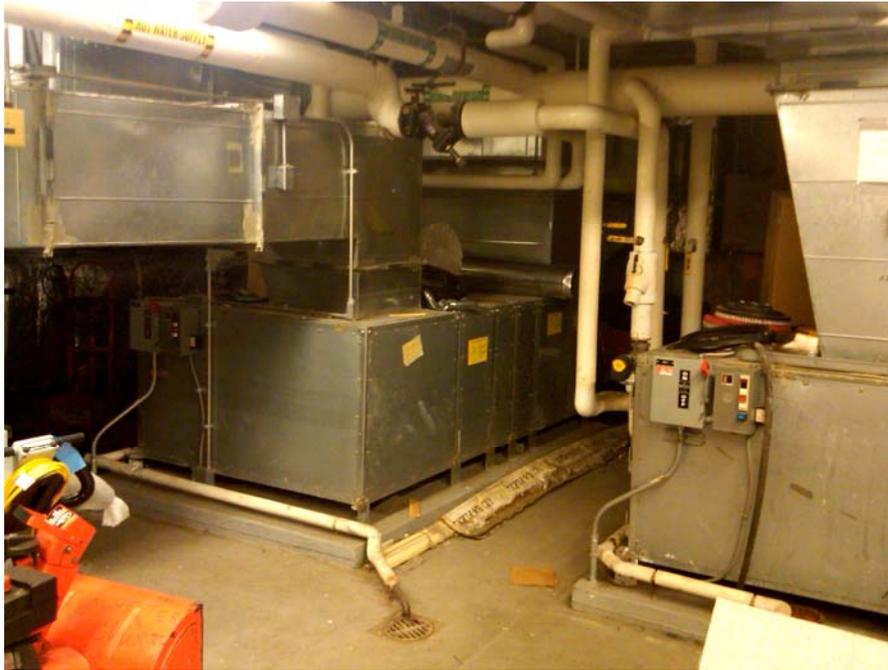
**Picture 1**

Mechanical ventilation for the original building is provided by air-handling units (AHUs) located in a ground floor mechanical room (Picture 1). Fresh air is drawn into the AHUs through an air intake located in a pit on the exterior of the building and delivered to occupied areas via ceiling-mounted air diffusers (Picture 2). Exhaust air is drawn into ductwork via grilled vents and returned to the mechanical room.

**Air-handling unit**

4. Clean/change filters for air handling equipment as per the manufactures' instructions or more frequently if needed. Prior to activation, vacuum interior of units to prevent the aerosolization of dirt, dust and particulates.

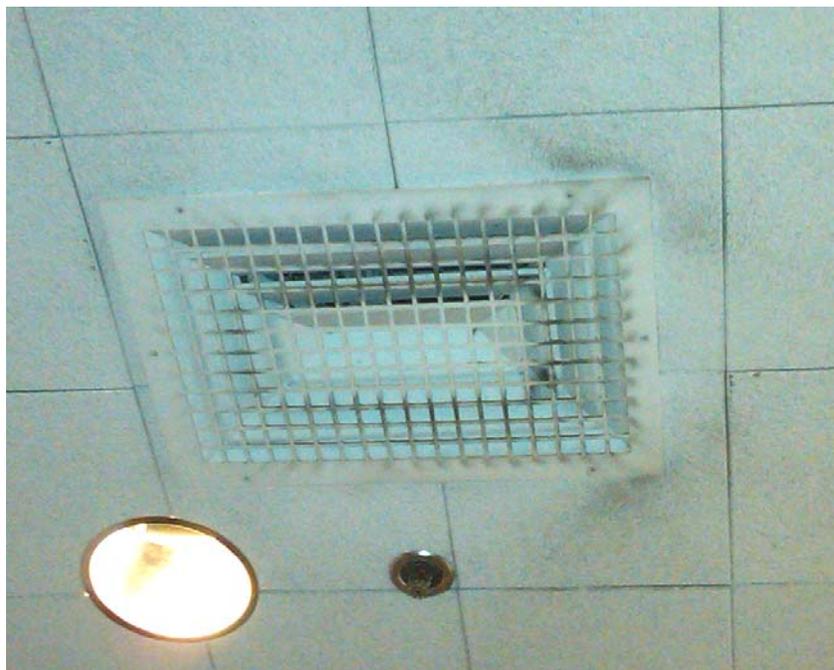
**Picture 2**

Dust/debris were observed around supply vents (Picture 2) and on personal fans. Dust/debris should be cleaned periodically to prevent re-aerosolization when fans and/or the mechanical ventilation system become reactivated.

**Fresh air diffuser, note dust/debris around diffuser**

13. Routinely clean accumulated dust and debris periodically from the surface of supply/exhaust vents and blades of personal fans.

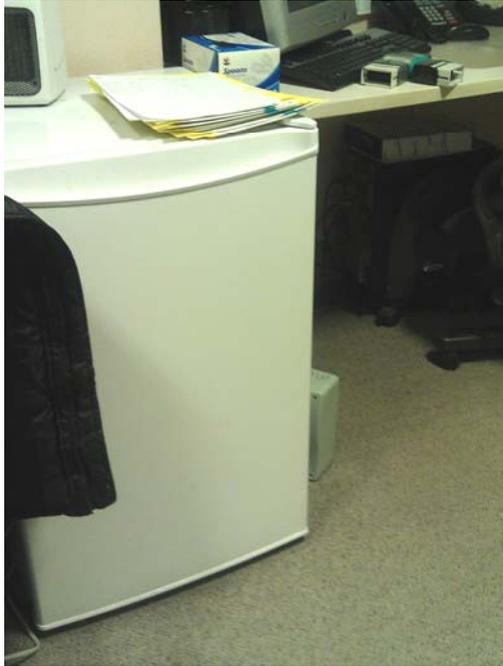
**Picture 3**

Carpeting, if well maintained, is expected to have a service life of 7 to 11 years<sup>1</sup> (Bishop, 2002). A number of refrigerators and water coolers were observed in carpeted areas (Picture 3). Refrigerators are sources of condensation that can result in chronic moistening. Overflow of the water basin or spills that often occur can moisten carpeting, which can lead to mold growth. It is also important that catch basins of water coolers be cleaned regularly as stagnant water can be a source of odors. Further, materials (i.e., dust) collected in the water can provide a medium for mold growth. Carpets were also observed in a number of below grade spaces. In previous instances, BEH staff recommended removal of carpet from below grade space due to chronic

**Refrigerator on carpet**

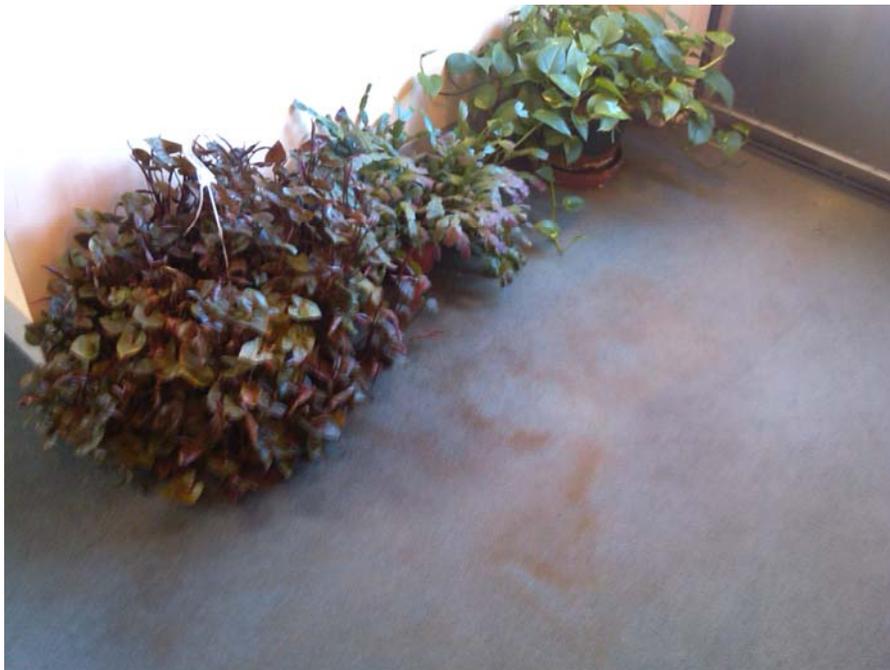
**Picture 4**

Plants were noted in several areas including on carpeting, which has caused water-staining (Picture 4). Plants should be properly maintained and be equipped with drip pans made of a non-porous material. Drip pans should be cleaned and inspected periodically to prevent mold growth. Plants should be located away from ventilation sources to prevent aerosolization of dirt, pollen or mold.

**Plants on carpeting, note water-stained carpet**

7. Ensure all plants are equipped with drip pans that are made of a *non-porous* material. Examine drip pans for mold growth and disinfect areas of water leaks with an appropriate antimicrobial where necessary. Move plants away from ventilation sources.

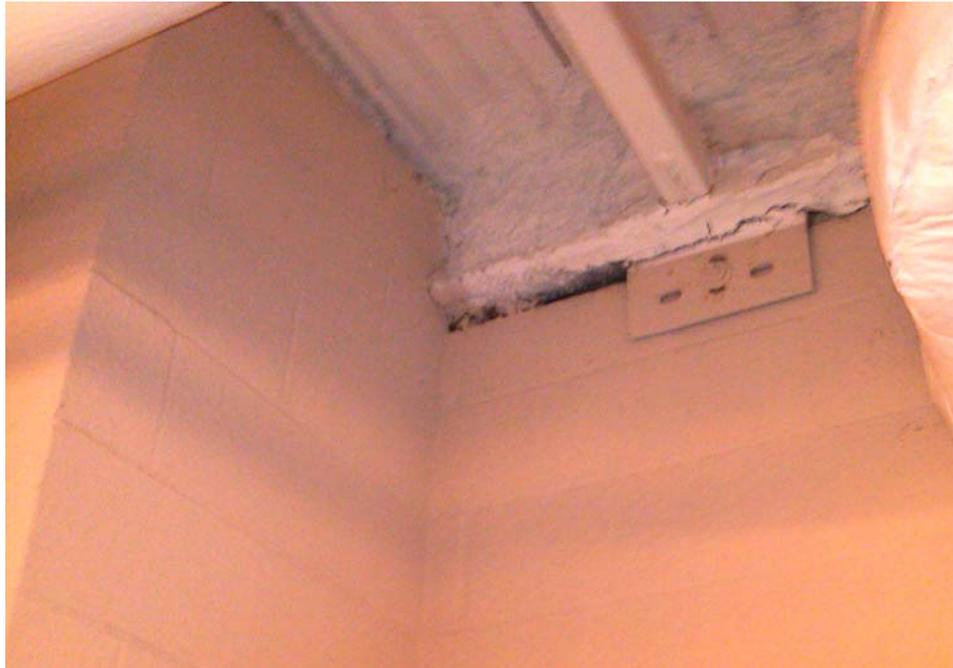
**Picture 5**

prisoners are loaded/offloaded. The sally port is equipped with a dedicated exhaust system, but this unit was found deactivated at the time of the assessment. The exhaust system for the sally port should be activated continuously during use of the cell block. Spaces were observed between the roof decking and interior wall of the sally port (Picture 5). Such breaches can allow vehicle exhaust to penetrate the interior of the building.

**Space in wall of sally port**

1. Operate the exhaust fan in the lock-up sally port when transport vehicles are present.
2. Seal all holes/breaches in the walls of the sally port.
3. Consider installing an automatic switch to activate the sally port exhaust system during use hours.

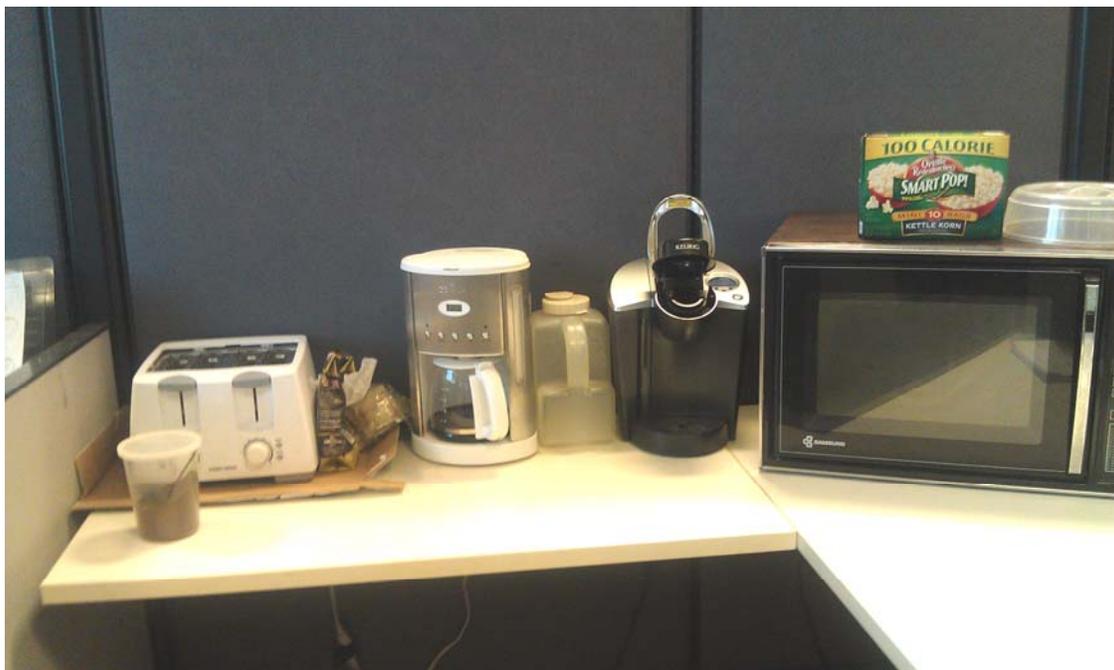
**Picture 6**

Food, food containers and food preparation equipment were observed in a number of areas (Picture 6). Of note was a display of soda cans observed in one office (Table 1). Stored food attracts insects and rodents, as do crumbs or food waste in trash cans. The building shows signs of rodent infestation. Mouse wastes were noted behind computers on desks in the clerk's office. Rodent traps were employed in some areas (Picture 7). Rodent infestation can result in indoor air quality related symptoms due to materials in their wastes. Mouse urine contains a protein that is a known sensitizer (US EPA, 1992). A sensitizer is a material that can produce allergic symptoms (e.g., running nose or skin rashes) in sensitive individuals following repeated exposures. A three step approach is necessary to eliminate rodent infestation:

**Food preparation equipment in cubicle**

- c. Store foods in tight fitting containers.
  - d. Avoid eating at work stations. In areas where food is consumed, periodic vacuuming to remove crumbs is recommended.

- e. Regularly clean crumbs and other food residues from toasters, toaster ovens, microwave ovens, coffee pots and other food preparation equipment.
  - f. Examine each room and the exterior walls of the building for means of rodent entry and seal them. Holes as small as ¼" are enough space for rodents to enter an area. If doors do not seal at the bottom, install a weather strip as a barrier to rodents.

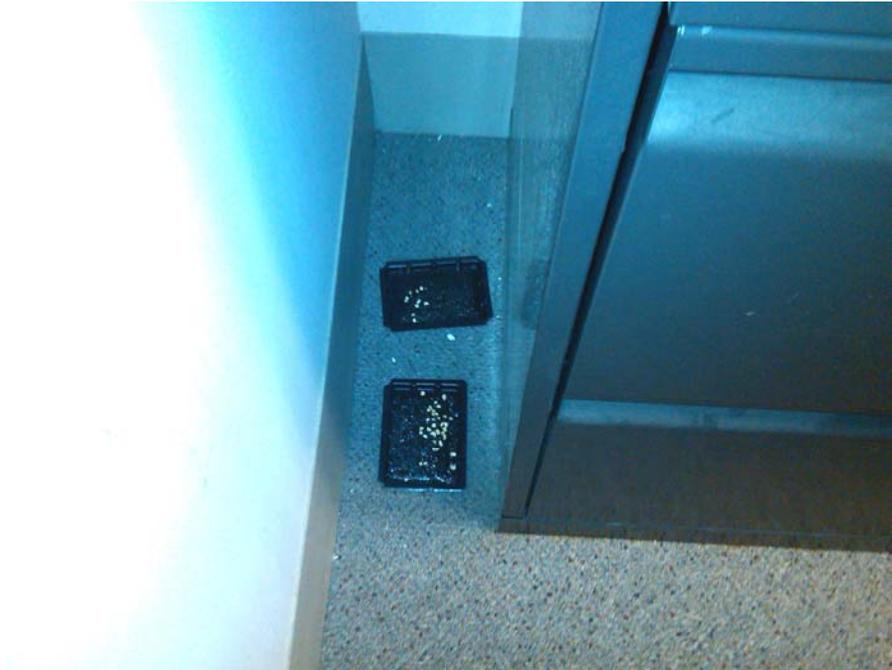
**Picture 7**

**Baited traps**

9. Implement the principles of integrated pest management (IPM) to rid the building of pests. Activities that can be used to eliminate pest infestation may include the following activities.

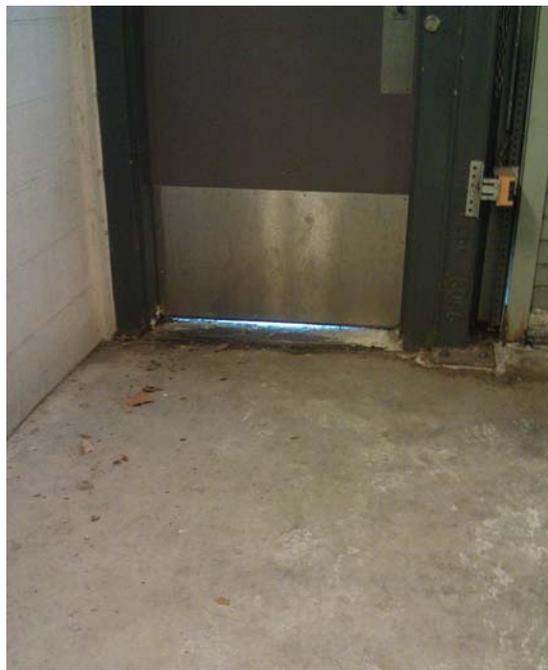
**Picture 8**

**Space under door of sally port**

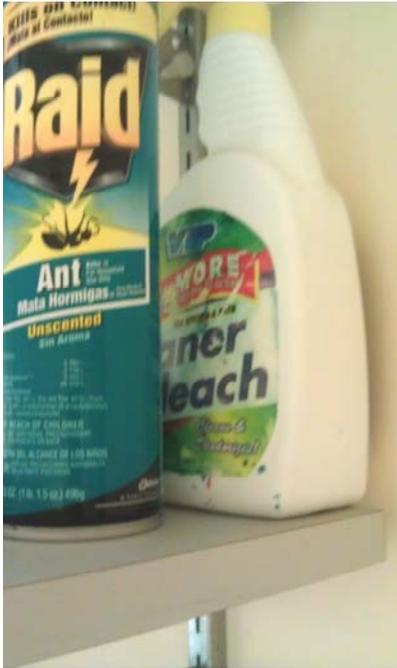
**Picture 9**

A container of permethrin and pyrethrin-based pesticide was observed (Picture 9). Pyrethrins have been associated with cross sensitivity with individuals who have ragweed allergy (US EPA, 1989). Applicators of this product should be in full compliance with federal and state rules and regulations that govern pesticide use including posting and notification requirements (333 CMR 13.10). Under no circumstances should untrained personnel apply this material. This product should not be applied prior to or during normal work hours. Under current Massachusetts law (effective November 1, 2001), the principles of integrated pest management (IPM) must be used to remove pests in state buildings (Mass Act, 2000). Pesticide use indoors can introduce chemicals into the indoor environment that can be sources of eye, nose and throat irritation.

**Pesticide on shelf**

8. Remove pesticides from the building.

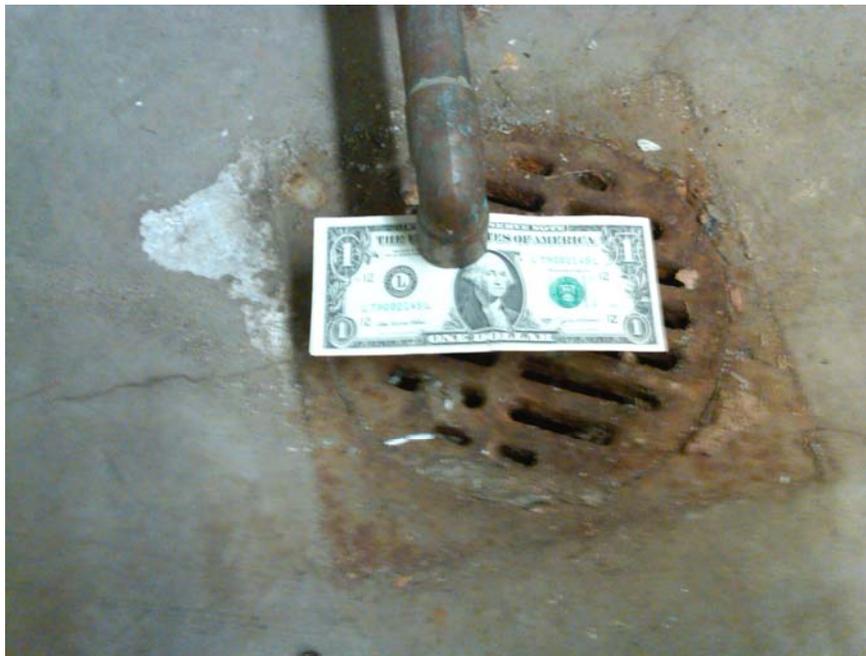
**Picture 10**

BEH staff noted that the condensation drain pipe for the AHU in the mechanical room was drawing air into it (Picture 10). With no water entering the drain during the heating season from the AHU, the drain trap can dry, resulting in odors from the drainage system to be drawn into the AHU and distributed into the building. Pouring water into the floor drains during the winter on a weekly basis would prevent odor capture by the AHU as described.

**AHU condensation drain drawing air**

11. Consider providing staff with building-issued cleaning products.
12. Pour water into the floor drains of the mechanical room once a week during the heating season.

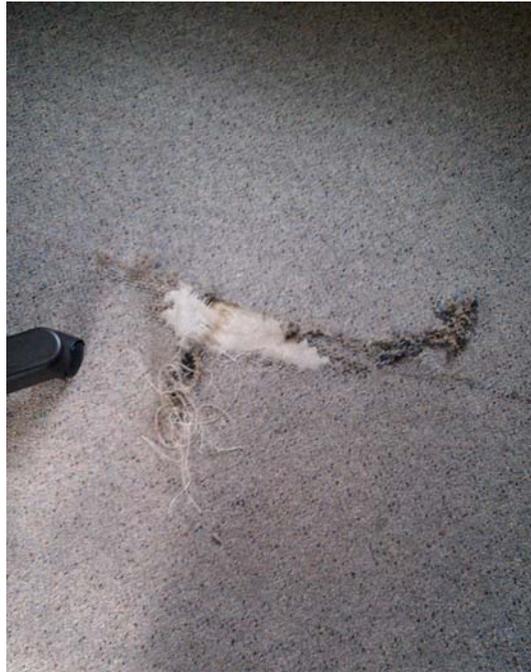
**Picture 11**

Finally, occupants expressed concerns the condition of carpeting and carpet cleaning in several areas throughout the building above the ground floor. At the time of the assessment, BEH staff observed damaged carpeting, including duct tape placed over worn spots, in a number of areas (Pictures 11 and 12). Such carpets should be removed and replaced to prevent aerosolization of fibers. The Institute of Inspection, Cleaning and Restoration Certification (IICRC), recommends that carpeting be cleaned annually or semi-annually in high traffic areas (IICRC, 2005).

**Torn carpeting**

14. Consider cleaning carpeting annually or semi-annually in soiled/high traffic areas as per the recommendations of the Institute of Inspection, Cleaning and Restoration Certification (IICRC). Copies of the IICRC fact sheet can be downloaded at: [http://www.cleancareseminars.com/carpet\\_cleaning\\_faq4.htm](http://www.cleancareseminars.com/carpet_cleaning_faq4.htm) (IICRC, 2005)
15. Consider a long-term plan to replace carpeting that is past its useful life as funds become available.
16. Refer to resource manual and other related indoor air quality documents for further building-wide evaluations and advice on maintaining public buildings; these materials are located on the MDPH's website: [www.mass.gov/dph/iaq](http://www.mass.gov/dph/iaq).

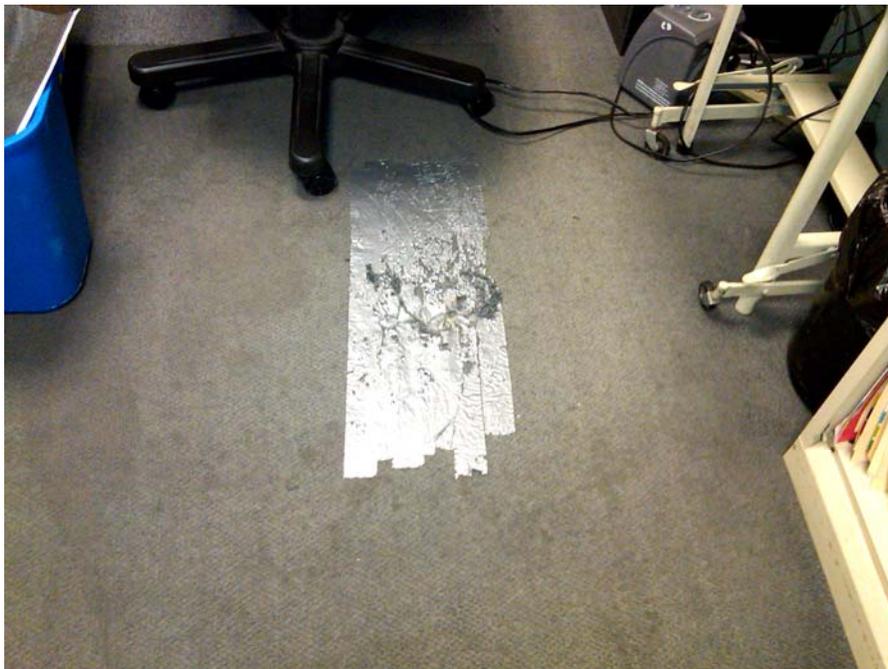
**Picture 12**

**Duct tape covering damaged carpeting**
