INDOOR AIR QUALITY REASSESSMENT

**East Gloucester Elementary School
8 Davis Street Extension
Gloucester, Massachusetts**

Prepared by:
Massachusetts Department of Public Health
Bureau of Environmental Health
Indoor Air Quality Program
May 2012

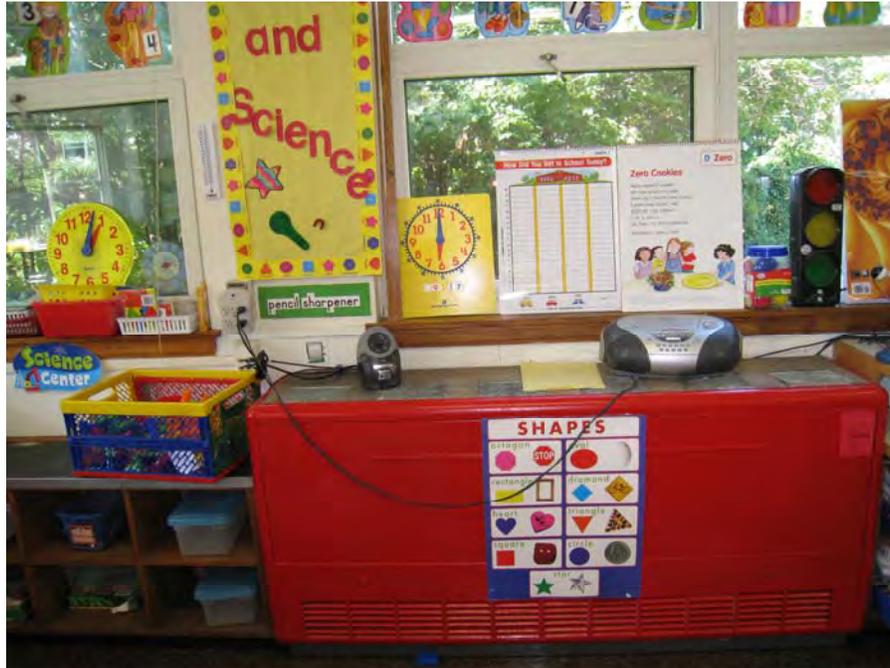
Picture 1

Fresh air to classrooms in the original building as well as the 1974 and 2008 additions is supplied by unit ventilator (univent) systems (Picture 1). A univent draws air from the outdoors through a fresh air intake located on the exterior wall of the building (Picture 2). Return air from the classroom is drawn through an air intake located at the base of the unit ([Figure 1](#)). Fresh and return air are mixed, filtered, heated and provided to classrooms through an air diffuser located

Classroom univent

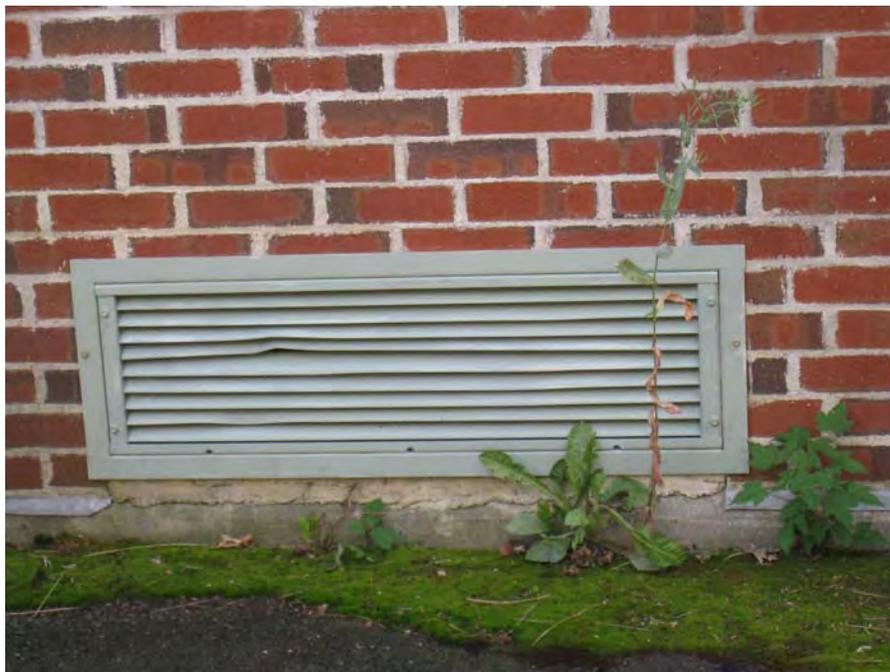
Picture 2

Univent fresh air intake

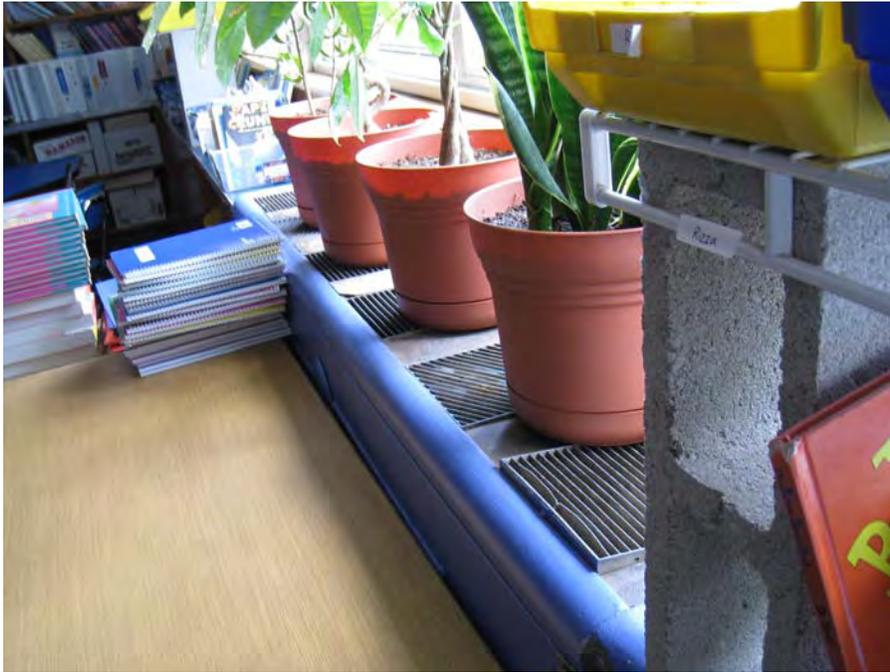
Picture 3

in the top of the unit. As mentioned, univents were found deactivated in the majority of rooms/areas in the school at the time of assessment (Table 1). In addition, several univents were found obstructed by furniture and other items on top of air diffusers and/or in front of return vents along the bottom of the units (Pictures 1 and 3). In order for univents to provide fresh air as designed, they must remain “on” and operating while rooms are occupied. Furthermore, units must remain free of obstructions.

Items on top and in front of univent

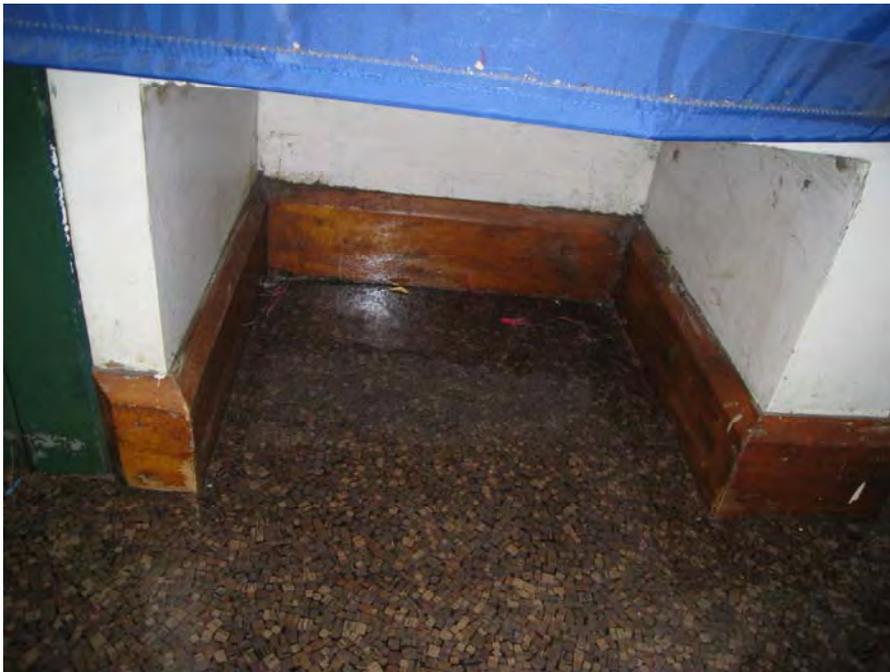
Picture 4

Exhaust ventilation for classrooms in the original building as well as the 1974 and 2008 additions is provided by switch activated cubby exhausts ducted to rooftop motors (Picture 4). During the assessment, exhaust ventilation was not operating. At the conclusion of the assessment, BEH staff notified Principal Gregory Bach that exhaust ventilation in these areas was not operating. Principal Bach manually reactivated all exhausts in these areas.

Switch-activated classroom exhaust cubby

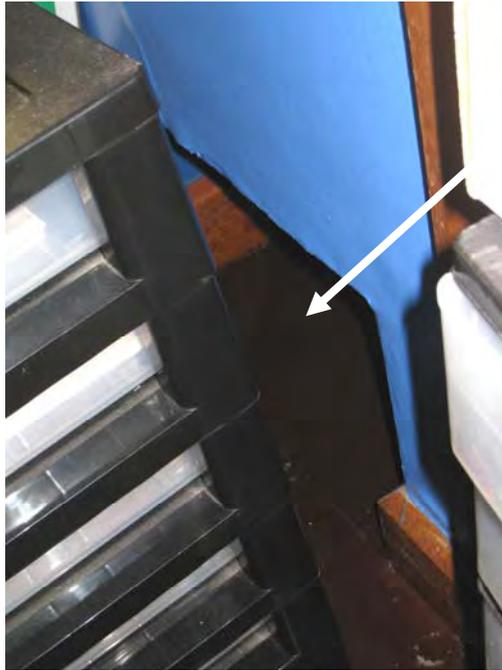
Picture 5

In several classrooms, exhaust vents are located near hallway doors. When these classroom doors are open, exhaust vents will tend to draw air from both the hallway and the classroom, reducing the effectiveness of the exhaust vents to remove common environmental pollutants from classrooms. Furthermore, many exhaust vents were obstructed by furniture (Picture 5). As with univents, in order to function properly, exhaust vents must be activated and allowed to operate while rooms are occupied. Without adequate supply and exhaust ventilation, excess heat and environmental pollutants can accumulate, leading to indoor air/comfort complaints.

Obstructed exhaust cubby (arrow)

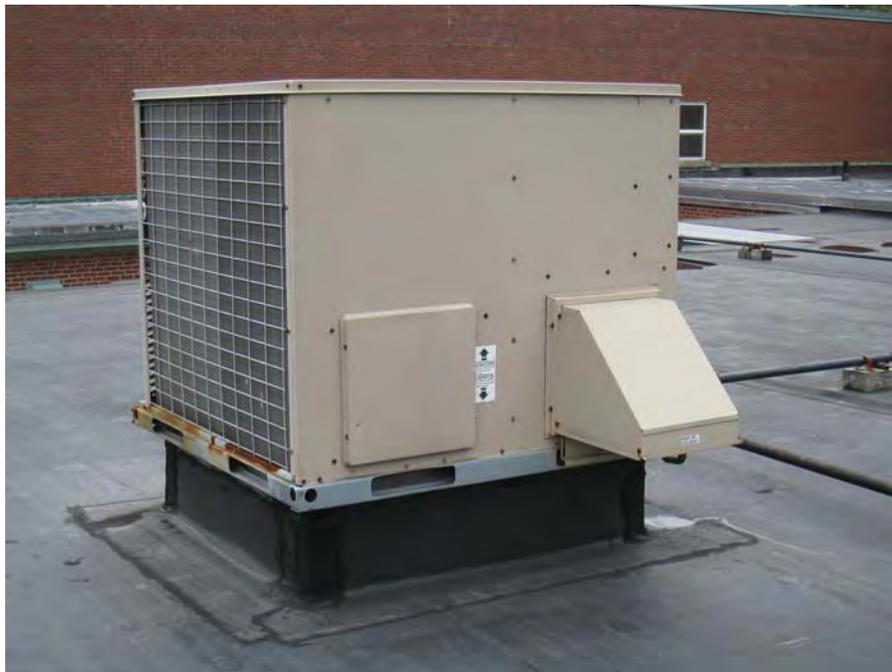
Picture 6

Mechanical ventilation for modular classrooms and common areas (e.g., gymnasium, auditorium) is provided by rooftop, ceiling or side-mounted air-handling units (AHUs) (Pictures 6 and 7). Fresh air is distributed via ceiling-mounted air diffusers (Picture 8) and ducted back to AHUs via ceiling or wall-mounted return vents (Picture 9). AHUs for modular classrooms are

Rooftop AHU

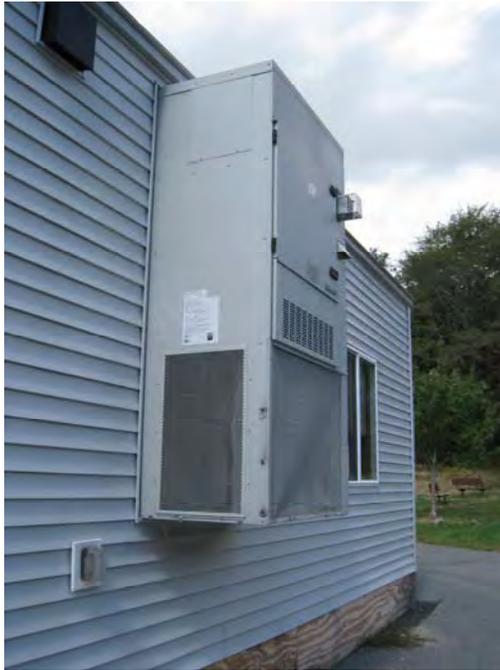
Picture 7

Side-mounted AHU

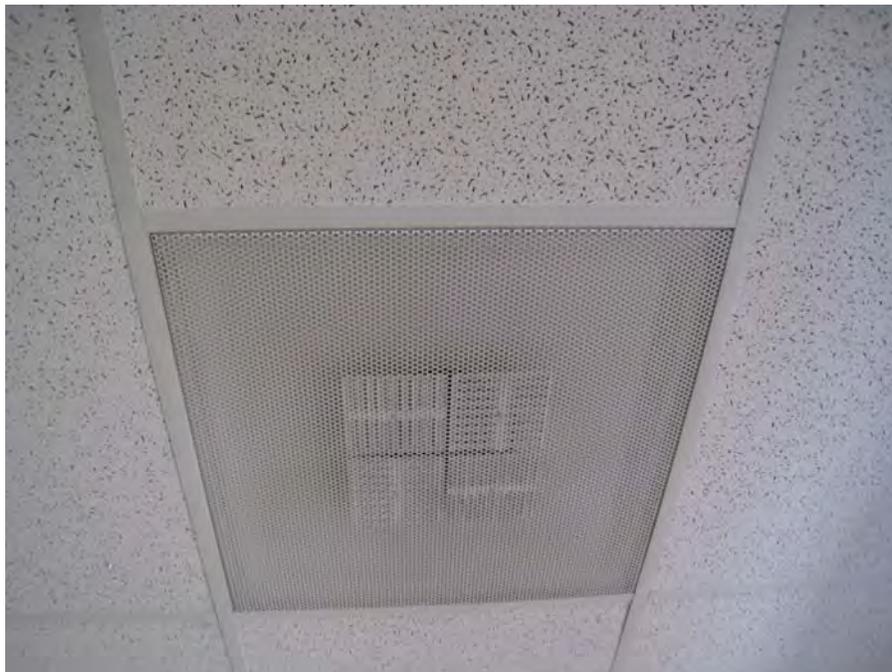
Picture 8

Ceiling-mounted diffuser

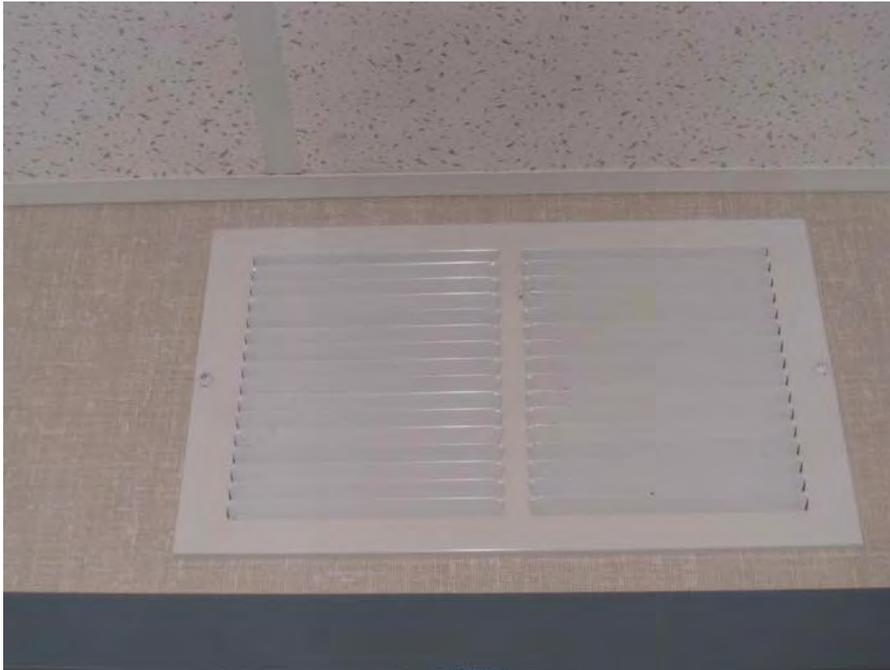
Picture 9

Wall-mounted exhaust vent

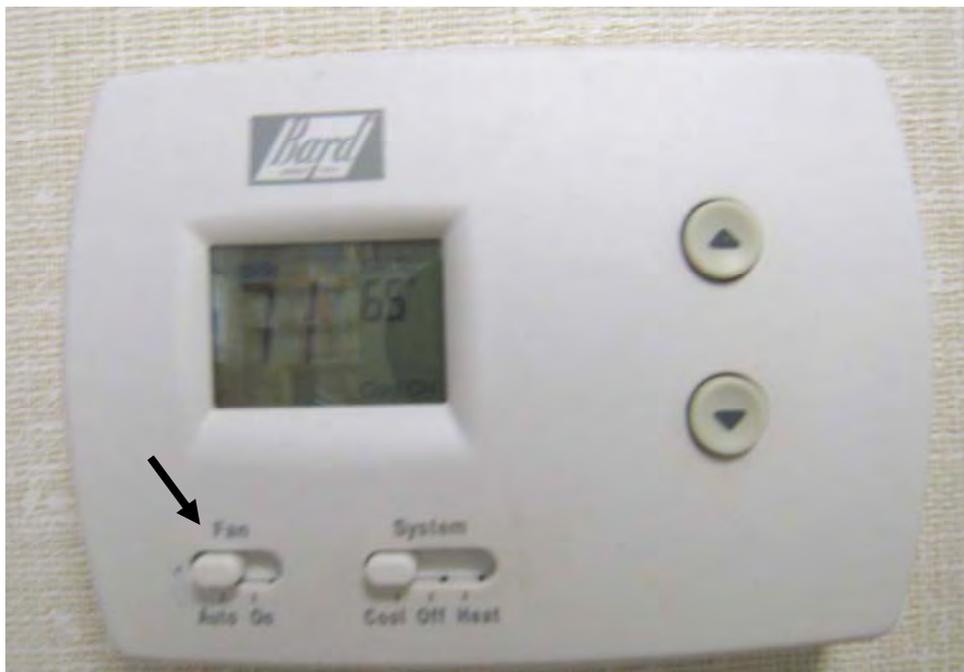
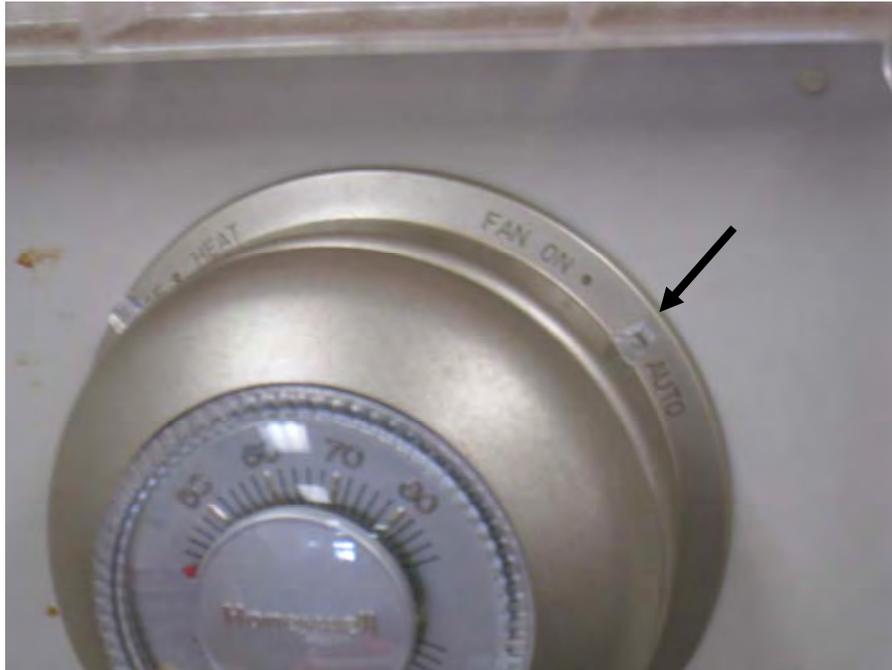
Picture 10

controlled by thermostats, which have fan settings of “on” and “auto” (Pictures 10 and 11). The automatic setting on the thermostat activates the heating, ventilation and air-conditioning (HVAC) system at a preset temperature. Once a preset temperature is measured by the thermostat, the HVAC system is deactivated. Therefore, no mechanical ventilation is provided until the thermostat re-activates the system. Thermostats were set to the “auto” setting in all modular rooms surveyed during the assessment. The AHUs for the gymnasium and auditorium were also found deactivated at the time of the assessment; therefore there was no means of mechanical air exchange. As with univents, AHUs should be activated and allowed to operate continuously during occupied periods. Consideration should be given to setting thermostat controls for modular classrooms to the fan “on” setting.

Thermostat set to auto

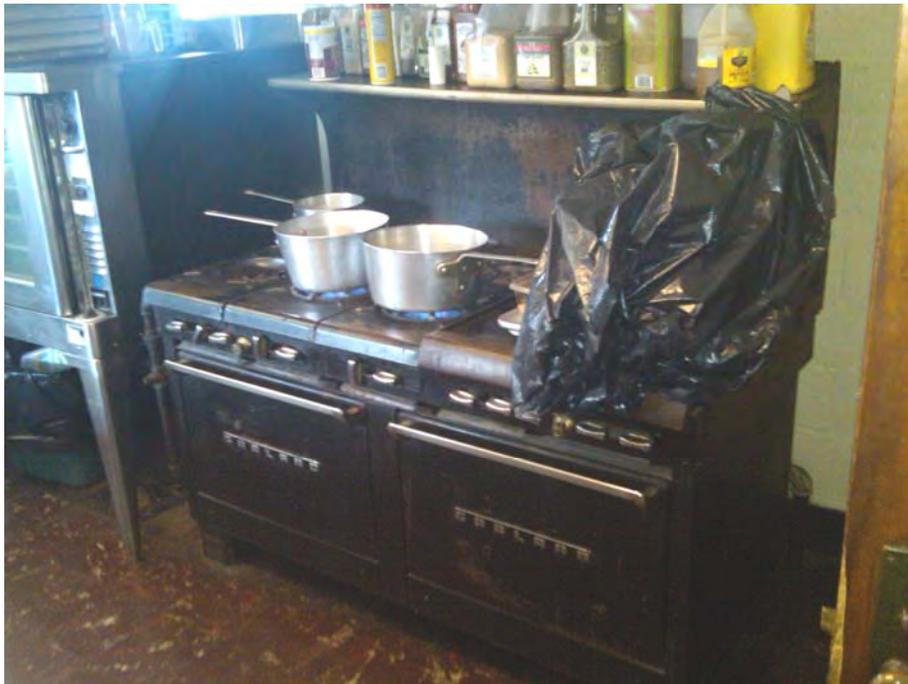
Picture 12

Carbon monoxide should not be present in a typical, indoor environment. If it is present, indoor carbon monoxide levels should be less than or equal to outdoor levels. Outdoor carbon monoxide concentrations were non-detect (ND) at the time of the assessment (Table 1). No measureable levels of carbon monoxide were detected in classrooms. However, slight amounts of carbon monoxide were measured in the cafeteria (1 ppm). The source of the carbon monoxide was traced to the gas-fired stove in the kitchen (Picture 12), near which a carbon monoxide level of 15 ppm was measured. BEH staff determined that the kitchen hood over the stove was not drawing air, despite the presence of an operating motor in the hood. BEH staff attempted to examine the exterior vent for the kitchen hood (Picture 13), which may have its shutter vent frozen in the closed position, preventing exhaust from exiting the kitchen. Kitchen hood shutter vents should be functional and freely open when the fan is activated. In addition, if any seams exist in the kitchen hood ducts, exhaust air and cooking pollutants may be directed into adjacent wall cavities.

Gas stove in kitchen

1. Repair the kitchen hood exhaust vent to allow for ejection of cooking pollutants from the building. Inspect exhaust ductwork for integrity and seal any breaches/seams as necessary.
2. Consideration should be given to replacing the gas stove with pilot lights with one using automatic ignition.
3. Use alternative materials to food for student art projects.
4. Implement the recommendations made in previous BEH IAQ assessments of the EGES.

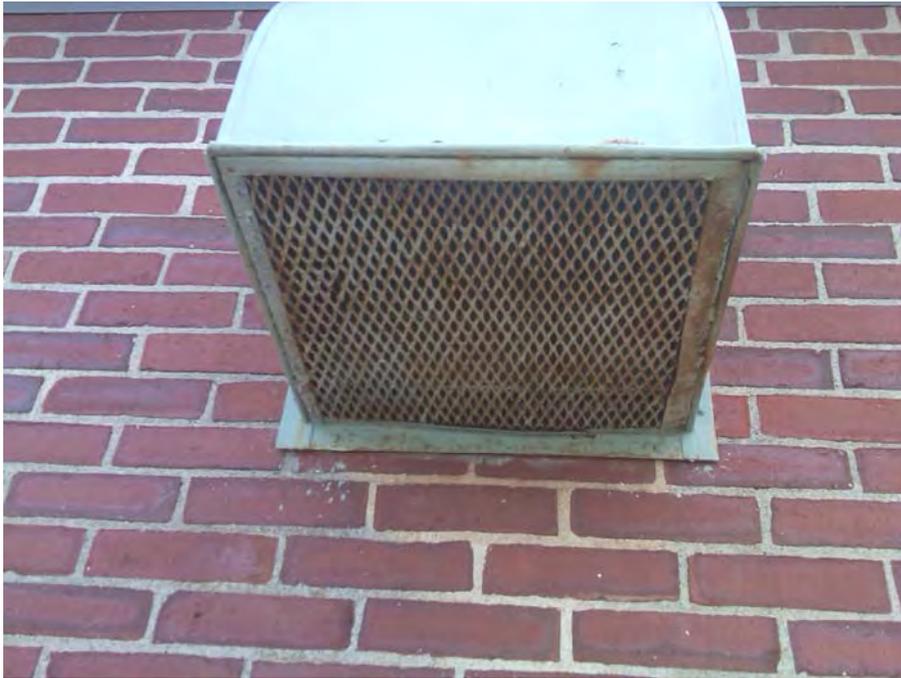
Picture 13

Exterior vent for kitchen hood

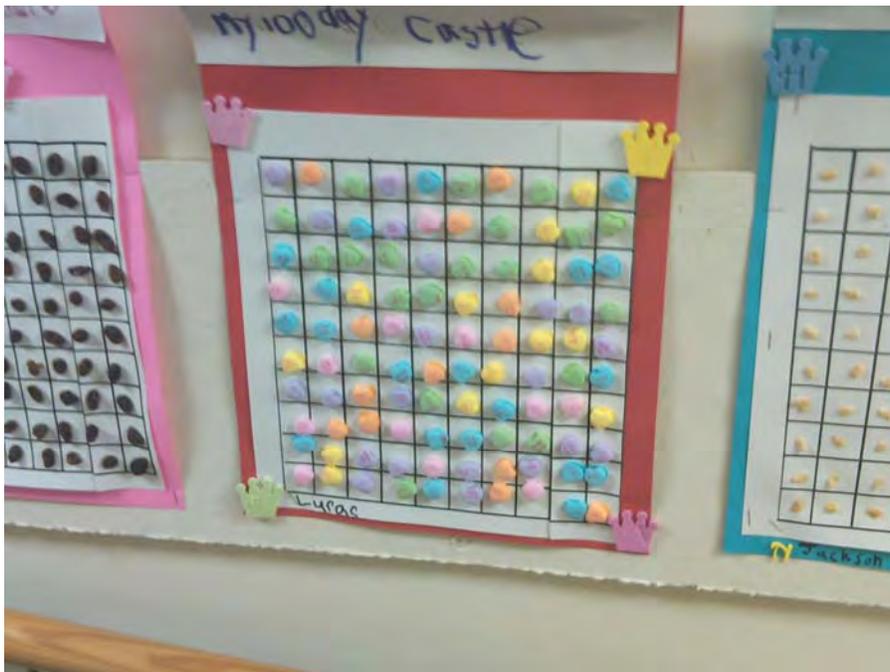
Picture 14

Other conditions that can affect indoor air quality were observed during the assessment. Of note was the use of food for student art projects (Picture 14). Exposed food products and reused food containers can attract a variety of pests. The presence of pests inside a building can produce conditions that can degrade indoor air quality. For example, rodent infestation can result in indoor air quality related symptoms due to materials in their wastes. Mouse urine is known to contain a protein that is a known sensitizer (US EPA, 1992). A sensitizer is a material that can produce symptoms in exposed individuals on repeated exposure, including nose irritations and skin rashes. Pest attractants should be reduced/eliminated. Proper food storage is an integral component in maintaining indoor air quality. Food should be properly stored and

clearly labeled. Reuse of food containers (e.g., for art projects) is not recommended since food residue adhering to the container surface may serve to attract pests.

Food being used for art projects
