INDOOR AIR QUALITY ASSESSMENT

**New Bedford Health Department
1213 Purchase Street
New Bedford, Massachusetts**

Prepared by:
Massachusetts Department of Public Health
Bureau of Environmental Health
Indoor Air Quality Program
January 2012

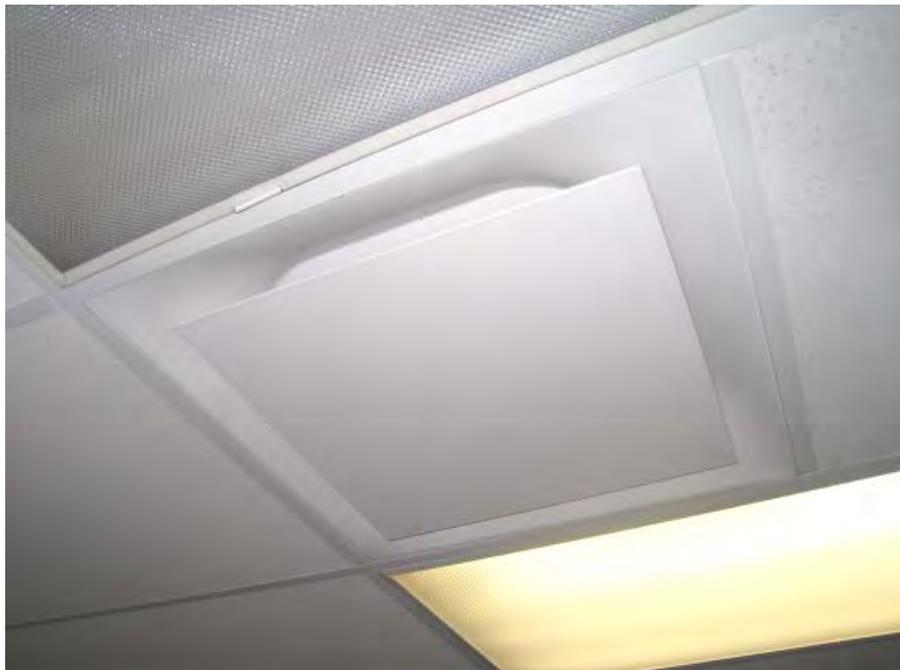
Picture 2

It can be seen from Table 1 that carbon dioxide levels were below 800 ppm (parts per million) in all areas surveyed, indicating adequate air exchange throughout the space at the time of the assessment. The heating, ventilation and air conditioning (HVAC) system consists of rooftop air handling units (AHU) that draw in outside air through air intakes and distribute it to occupied areas via ductwork. Conditioned air is distributed via ceiling-mounted air diffusers (Picture 1) and ducted back to the AHU via return vents (Picture 2).

Ceiling-Mounted Return Vent

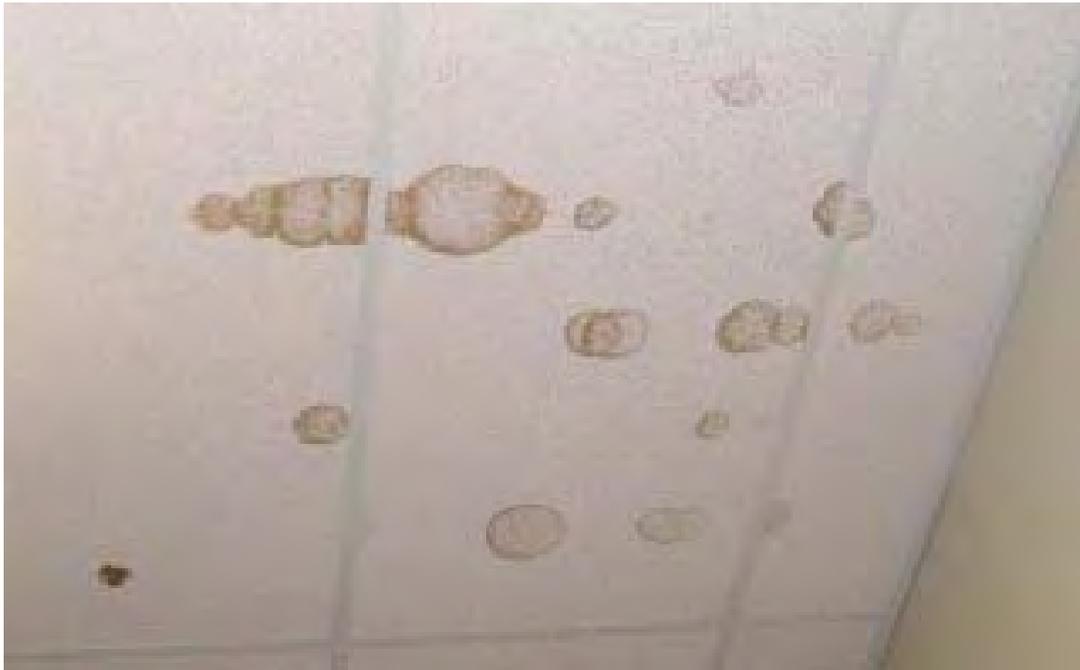
Picture 3

Water-damaged ceiling tiles were seen in several areas throughout the NBHD and Veterans Office (Pictures 3 through 5). Water-damaged ceiling tiles indicate leaks from either the roof or plumbing system and can provide a source for mold growth. Active leaks were reported in the 1st floor hallway outside of the NBHD. These tiles should be replaced after a water leak is discovered and repaired.

Water-Damaged Ceiling Tiles

1. Ensure leaks are repaired and remove/replace water-damaged ceiling tiles. Examine the area above and around these areas for mold growth. Disinfect areas of water leaks with an appropriate antimicrobial.

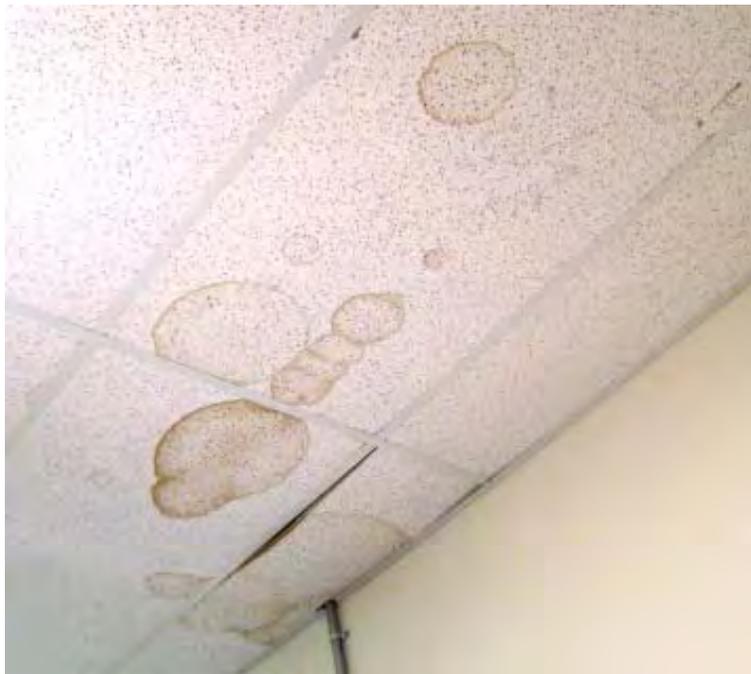
Picture 4

Water-Damaged Ceiling Tiles

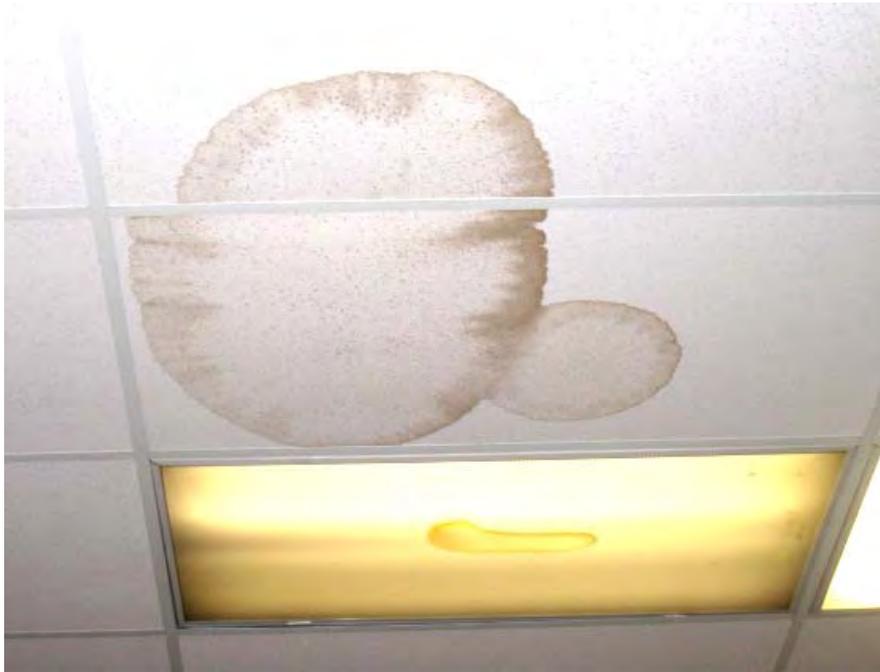
Picture 5

Water-Damaged Ceiling Tiles and Fluorescent Light Panel

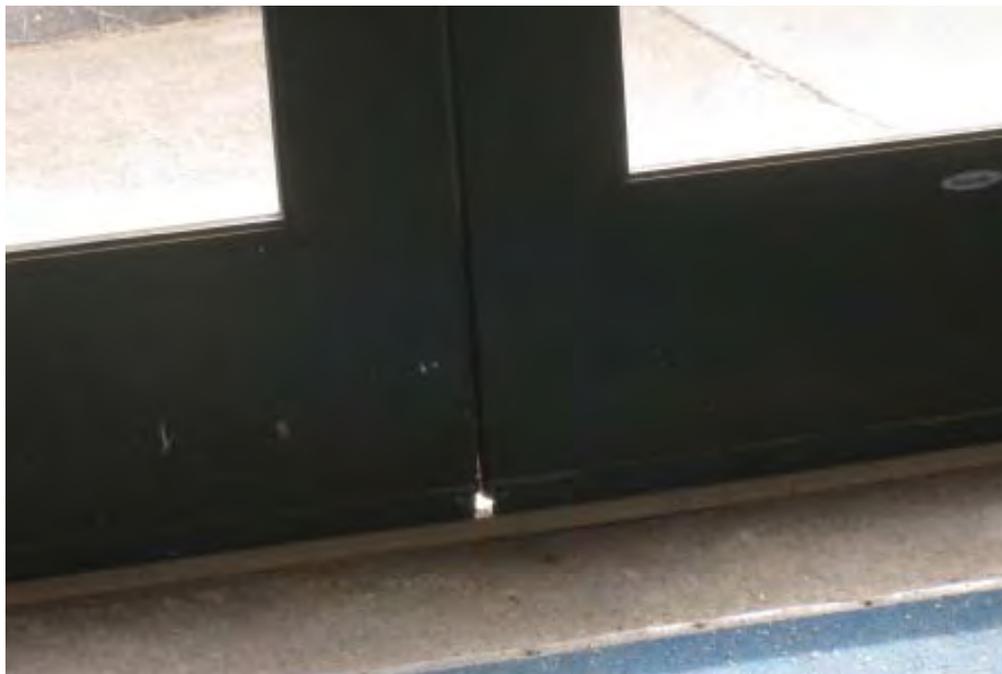
Picture 6

Other conditions that can affect indoor air quality were observed during the assessment. Light could be seen penetrating beneath exterior doors (Pictures 6 and 7). These spaces can provide access for rodents and insects to enter the building. To penetrate the exterior of a building, rodents require a minimal breach of ¼ inch (MDFA, 1996). Rodent infestation can result in indoor air quality related symptoms due to materials in their wastes. Mouse urine contains a protein that is a known sensitizer (US EPA, 1992).

Light Penetrating between Exterior Doors

2. Eliminate spaces around exterior doors. Ensure door fits flush with threshold. Seal doors on all sides with foam tape and/or weather-stripping. Ensure tightness of doors by monitoring for light penetration and drafts around doorframes.

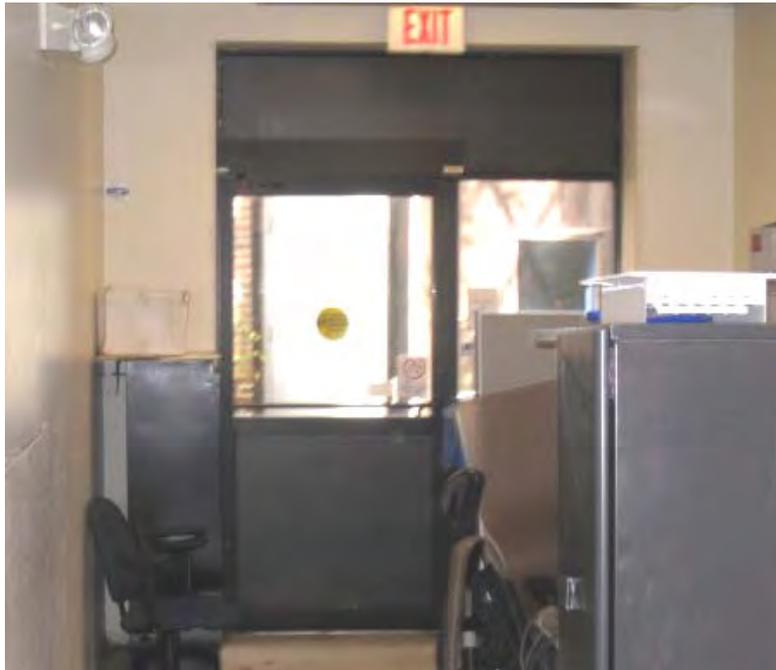
Picture 7

Light Penetrating beneath Exterior Door

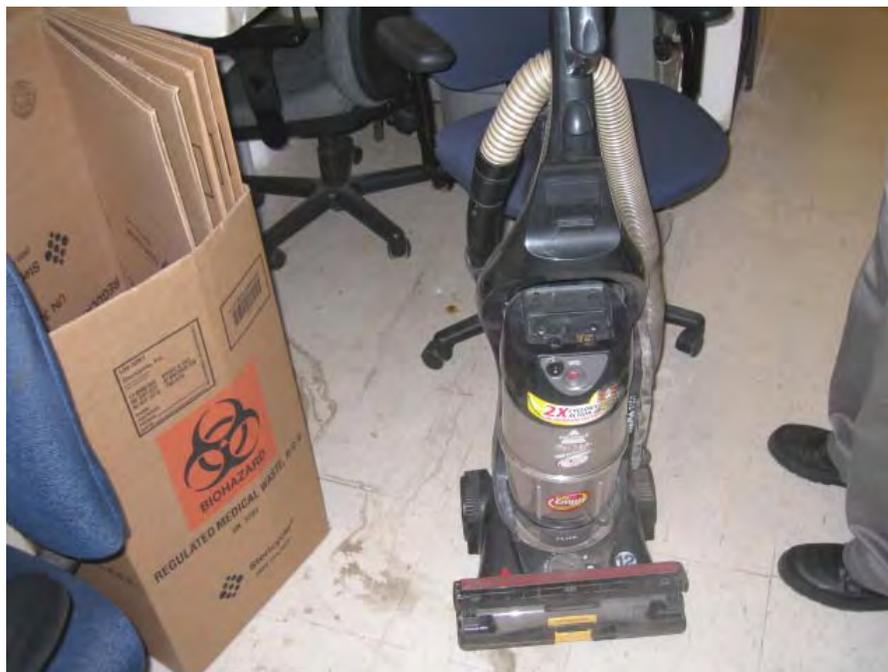
Picture 8

Although the office contains a vacuum cleaner equipped with a high efficiency particulate arrestance (HEPA) filter equipped vacuum cleaner, the filter was completely occluded with dust and debris (Pictures 8 and 9). If not periodically cleaned or changed as per the manufacture's instructions, a saturated filter can actually serve as a reservoir for dirt, dust and debris to be reaerosolized into occupied areas. A number of supply diffusers and return vents were observed to have accumulated dust/debris (Picture 10). Dust can be irritating to the eyes, nose and respiratory tract.

HEPA Filtered Vacuum Cleaner

3. Clean/change filters for vacuum cleaner as per the manufacturer's instructions or more frequently if needed. If filters cannot be adequately cleaned/maintained consider replacing vacuum.

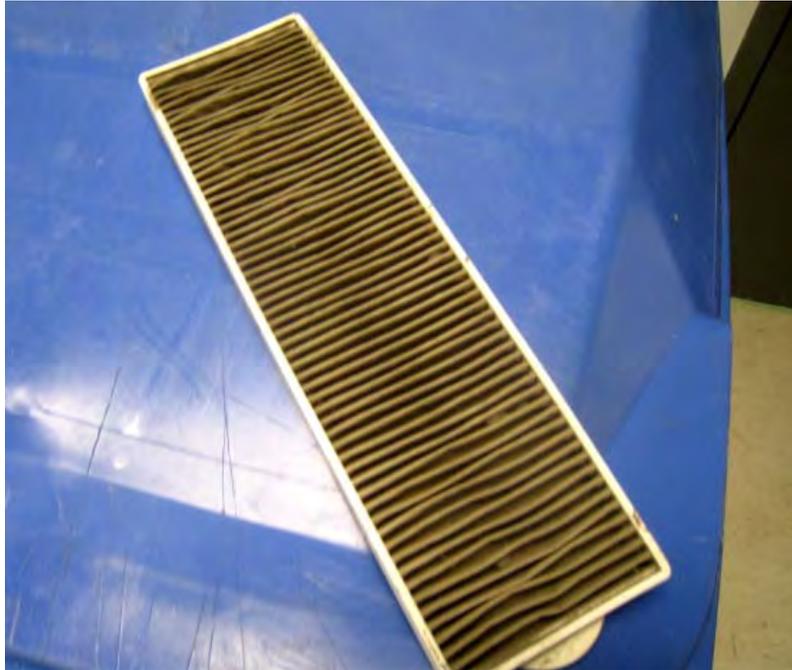
Picture 9

Dirty Filter for HEPA Vacuum Occluded with Dust/Debris

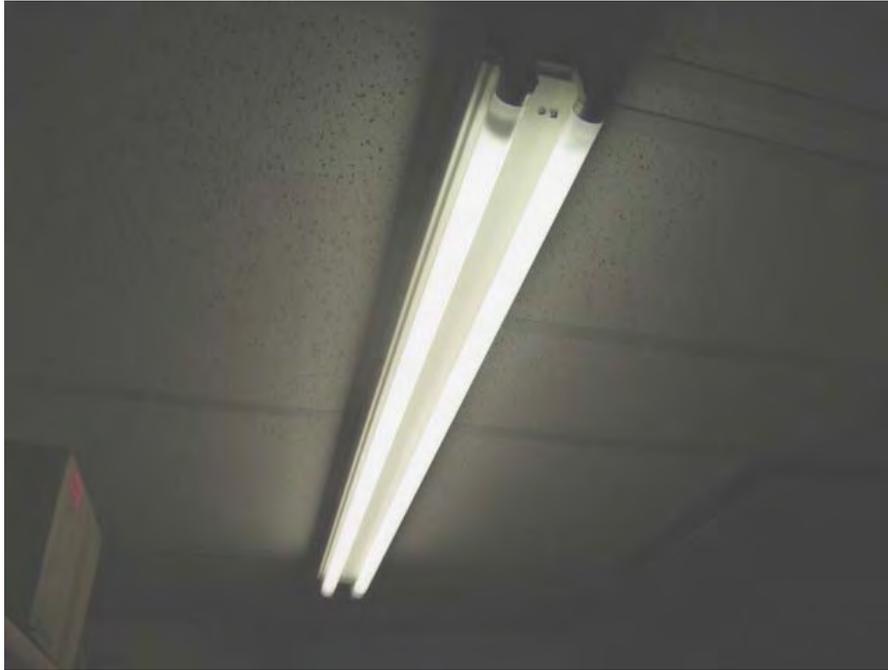
Picture 11

Fluorescent light fixtures were missing covers in several areas including the medical supply office (Picture 11). Fixtures should be equipped with access covers installed with bulbs

fully secured in their sockets. Breakage of glass can cause injuries and may release mercury and/or other hazardous compounds.

Missing Fluorescent Light Cover in Medical Supply Office

8. Contact a licensed asbestos remediation firm to determine if damaged floor tiles in the electrical room contain ACM. Remediate damaged ACMs in conformance with Massachusetts asbestos remediation and hazardous waste disposal laws and regulations.
9. Replace all covers for fluorescent light fixtures.
10. Refer to resource manuals and other related indoor air quality documents for further building-wide evaluations and advice on maintaining public buildings. Copies of these materials are located on the MDPH's website: <http://www.mass.gov/dph/iaq>.

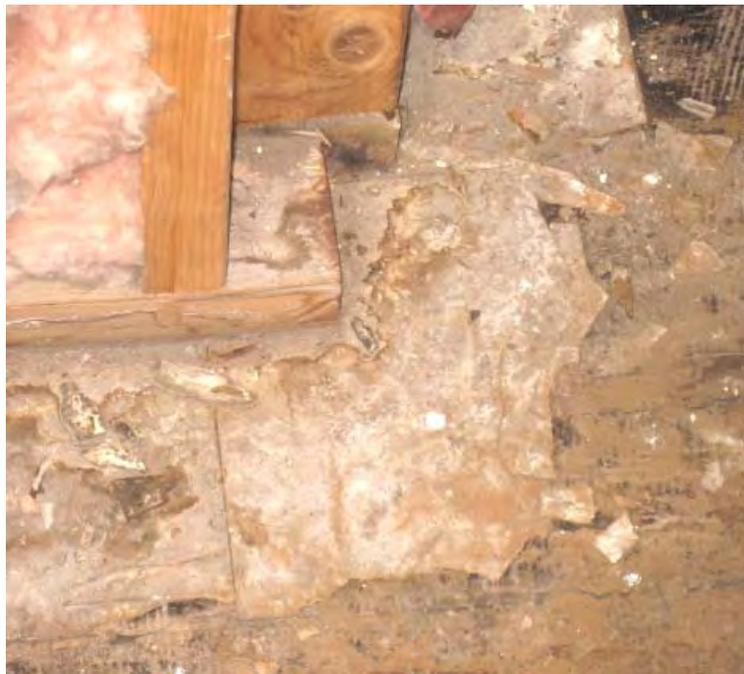
Picture 12

Damaged and/or missing floor tiles were observed in the electrical room where the water heater is located (Pictures 12 and 13). These floor tiles may contain asbestos. Intact asbestos-containing materials (ACM) do not pose a health hazard. If damaged, ACM can be rendered friable and become aerosolized. Friable asbestos is a chronic (long-term) health hazard, but will not produce acute (short-term) health effects (e.g., headaches) typically associated with buildings believed to have indoor air quality problems. Where asbestos-containing materials are found damaged, these materials should be removed or remediated in a manner consistent with Massachusetts asbestos remediation laws (MDLI, 1993).

Damaged Floor Tiles in Electrical Room

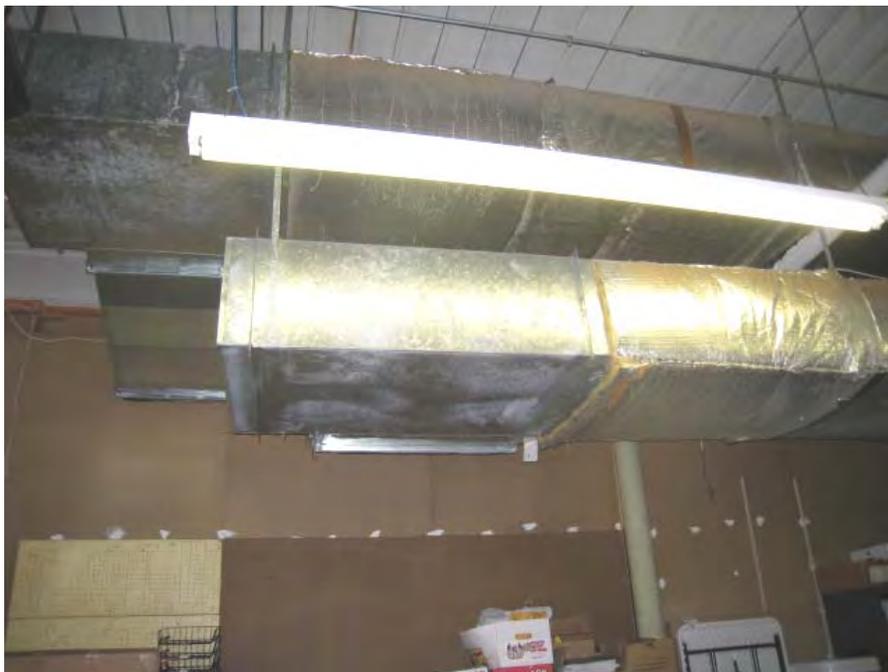
Picture 14

The file/storeroom is located in an unfinished room outside of the NBHD office. The storeroom has interior wooden walls, an unfinished wooden floor and an open ceiling system (Pictures 14 through 15). Although ductwork traverses the room, there is no ventilation provided to this room. At the time of the assessment the floor was covered with dust/debris and appeared not to have been cleaned for some time. The room contains file cabinets and wall shelving with pamphlets, cardboard boxes, books and other materials. The amount of stored materials and lack of finish on the floor make it prone to dust/debris accumulation, which can be a source of eye and respiratory irritation. In addition, the hallway/adjacent areas outside of the file/storeroom had piles of accumulated dust and debris.

Open Ceiling Exposing Ductwork and Fixtures

1. Clean file/storeroom regularly.
2. Install supply vent in file/storeroom. This will provide fresh/outside air to the space as well as positively pressurize the room, preventing the infiltration of dirt, dust and pollutants from adjacent areas.

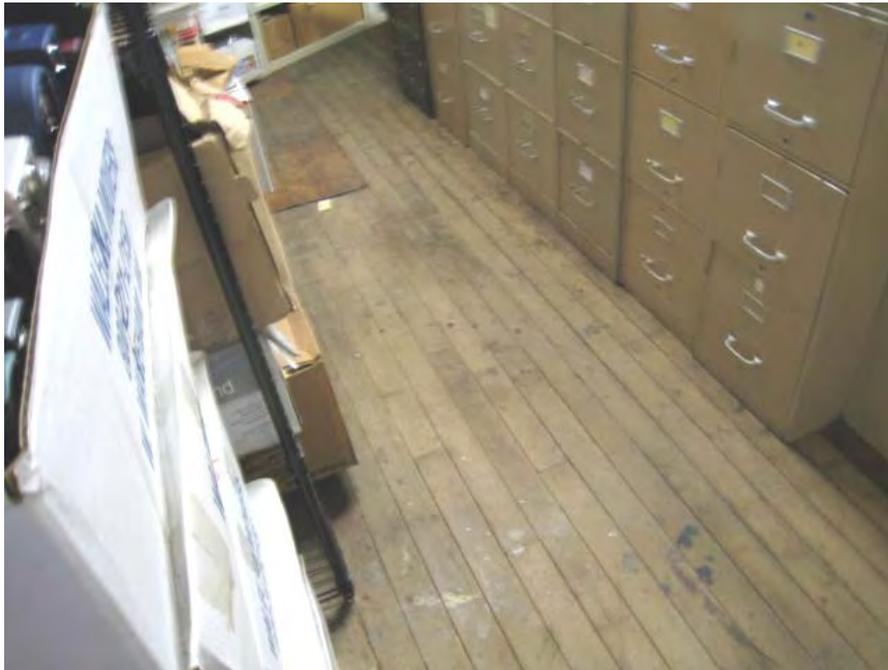
Picture 15

Unfinished Flooring in File/Storeroom

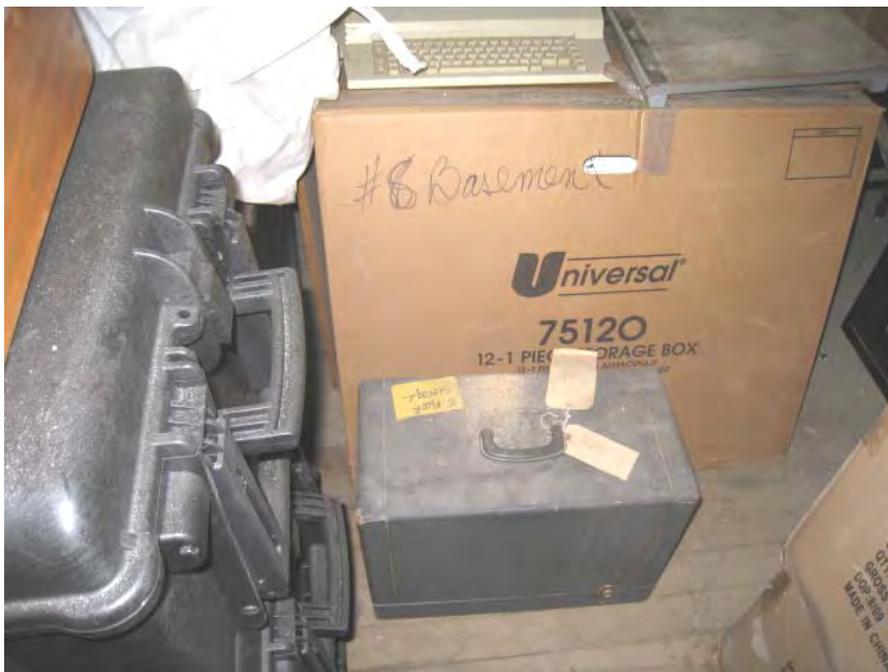
Picture 16

On the other side of the file/storeroom is a larger area that is also used for storage. This area was dirty/dusty and had exposed fiberglass insulation (Pictures 16 and 17), which can be a source of eye and respiratory irritation. Breaches in the wall separating these two areas were observed (Pictures 18 and 19). These breaches can serve as pathways for dirt, dust and other airborne pollutants into the file/storeroom.

Various Dust/Debris-Covered Stored Items in Larger Storeroom

3. Remove/discard out of date materials to reduce clutter. Obtain plastic storage totes to seal materials in.
4. Seal all wall penetrations and breaches between file/storeroom and adjacent areas with an appropriate fire-rated sealant. Ensure tightness of doors by monitoring for light penetration and drafts

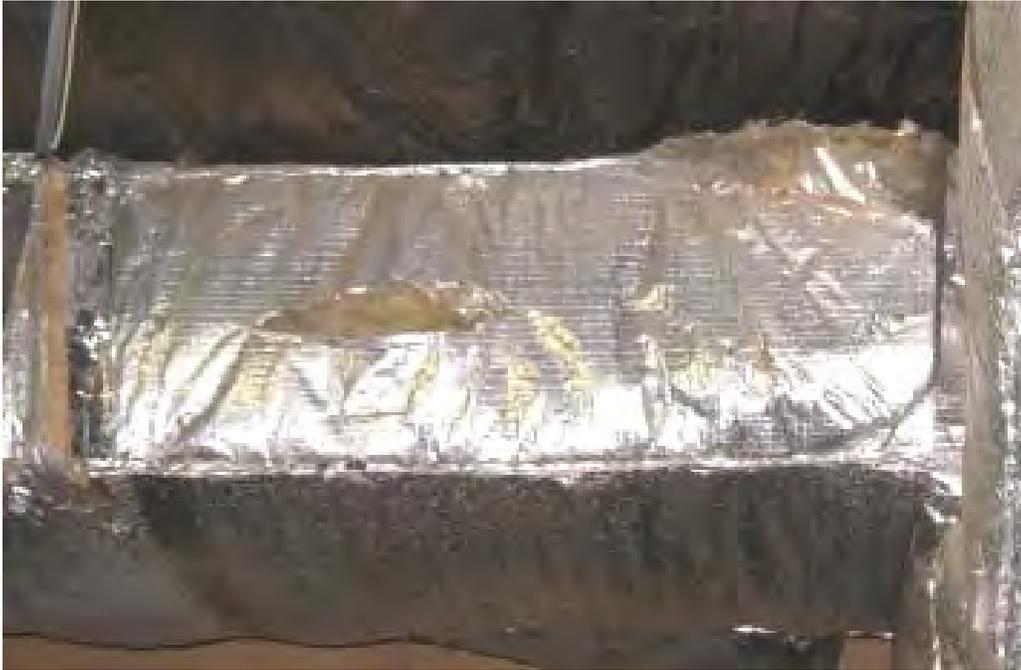
Picture 17

Damaged/Dust-Covered Duct Insulation Exposing Fiberglass

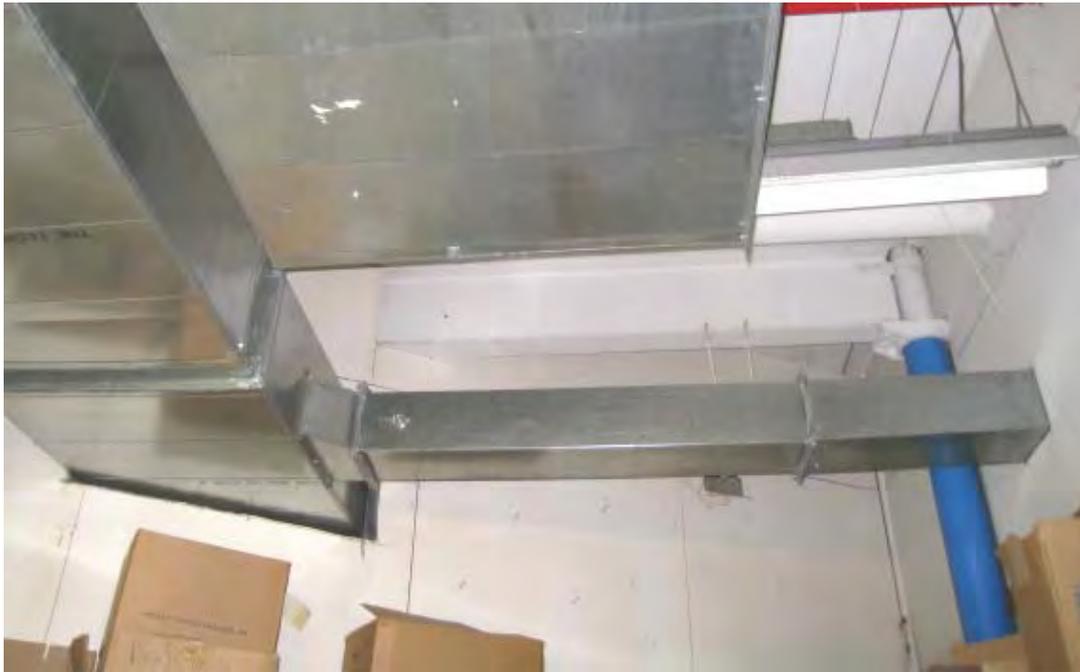
Picture 19

Breaches in Walls around Ductwork

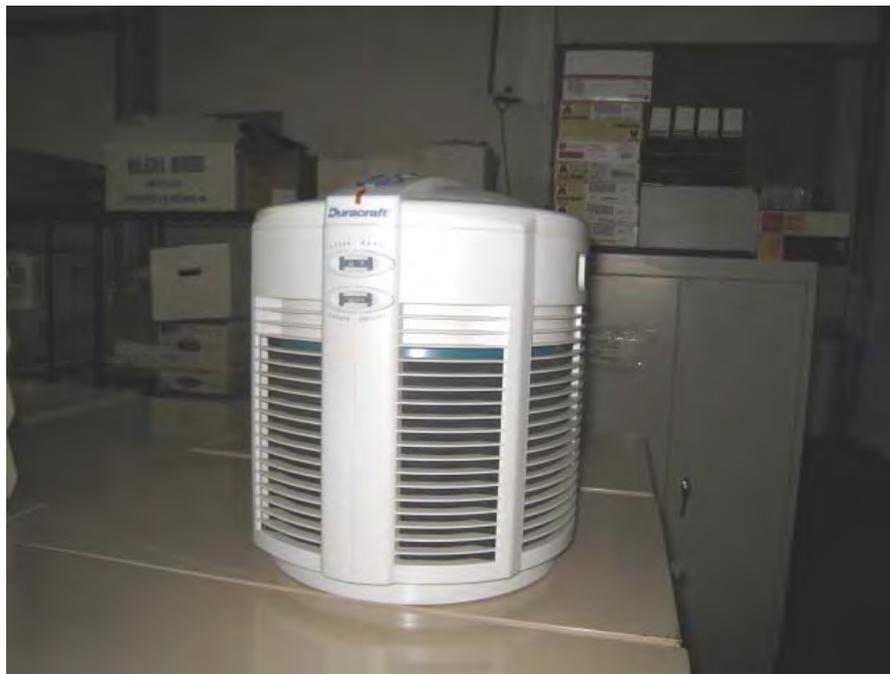
Picture 20

To improve IAQ, NBHD staff have stationed an air purifier equipped with a high efficiency particulate arrestance (HEPA) filter in the storage room (Picture 20). However, because there is no outlet in this room the door is kept open to accommodate an extension cord. In this condition, the air purifier is actually drawing in airborne particulates into the storeroom through the open door (Picture 21). The previously mentioned breaches in walls and spaces around the door exacerbate this problem.

HEPA-Filtered Air Purifier in File/Storeroom

6. Install outlet to accommodate HEPA filter. Keep door shut during HEPA filter operation.
7. If preceding recommendations are not feasible or prove ineffective, consider relocating frequently accessed file cabinets within the NBHD office space.

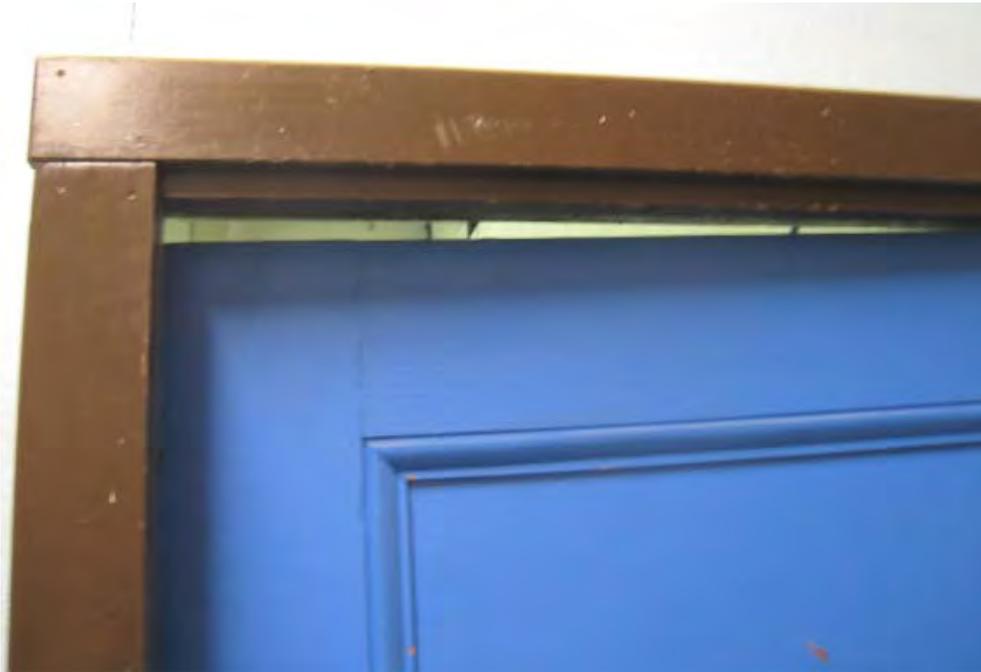
Picture 21

Ill-Fitting Storeroom Door, Note Light Penetration at top of Door

5. Ensure door fits flush with threshold. Seal doors on all sides with foam tape and/or weather-stripping. Installing weather-stripping/door sweeps on bottom of door. Ensure tightness of doors by monitoring for light penetration and drafts around doorframes.
