INDOOR AIR QUALITY ASSESSMENT

**Early Childhood Center
100 Walnut Street
Newtonville, Massachusetts**

Prepared by:
Massachusetts Department of Public Health
Bureau of Environmental Health
Indoor Air Quality Program
July 2012

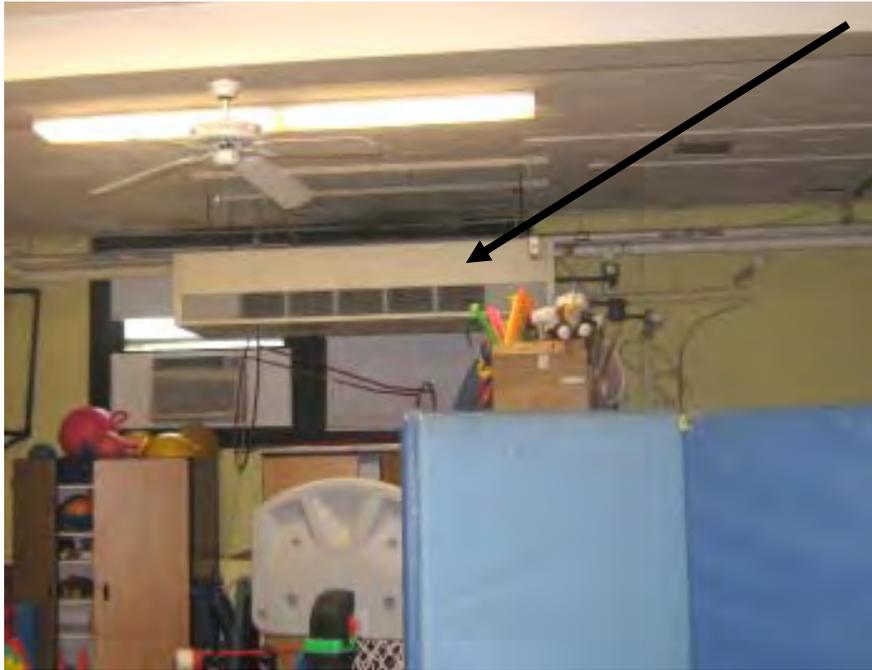
Picture 1

Fresh air is supplied to ECC areas by unit ventilator (univent) systems and/or air handling units (AHUs) (Pictures 1 through 6). A univent is designed to draw air from outdoors through a fresh air intake located on the exterior wall of the building (Picture 4) and return air through an air intake located at the base of each unit ([Figure 1](#)). Fresh and return air are mixed, filtered, heated and provided to classrooms through a fresh air diffuser located in the top of the unit. As previously mentioned, univents and AHUs were found deactivated in a number of areas; therefore mechanical means of air exchange was limited at the time of assessment. The back office near the kitchen was reported to have up to 6 occupants at times, and has no means of mechanical ventilation.

Ceiling-Mounted Univent (arrow)

1. Operate all ventilation systems (e.g., AHUs, univents and exhaust vents) throughout the building *continuously* during periods of occupancy. To increase airflow in classrooms, set univent controls to “high”. School staff should be encouraged to not deactivate classroom univents but to report any complaints regarding univent function to the facilities department.
2. Ensure classroom exhaust vents are operating at the start of each school day and are allowed to operate during occupancy. Make repairs as needed.
3. Install a means to mechanically ventilate the back office near kitchen.
4. Consider contacting a ventilation engineer to inspect HVAC equipment and control systems for proper function. Repair or replace components as necessary to ensure

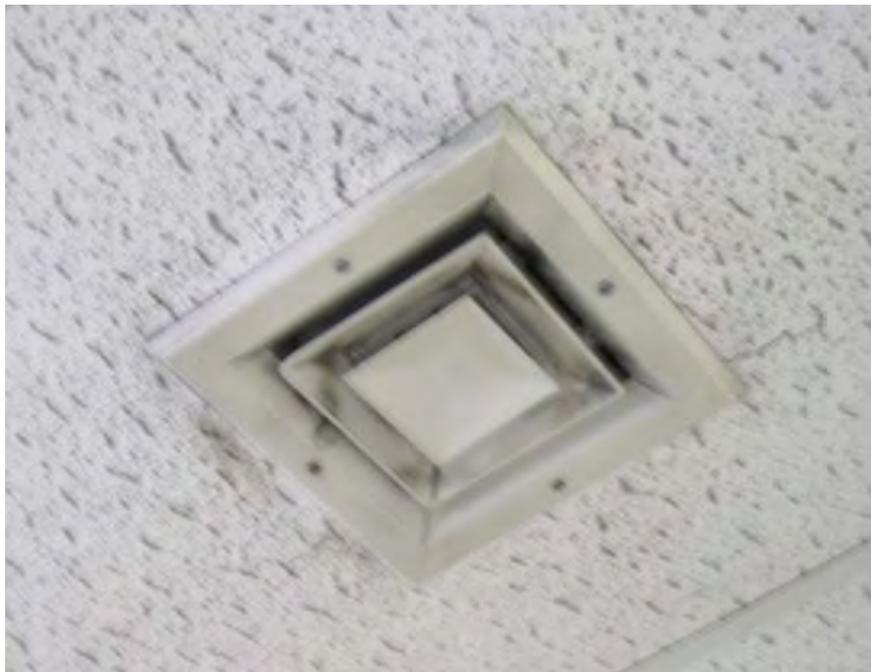
Picture 2

Personal fans, supply diffusers and exhaust vents were observed to have accumulated dust/debris (Pictures 2 and 18). Re-activated diffusers, vents or fans can aerosolize accumulated dust. If exhaust vents are not functioning, backdrafting can occur, which can re-aerosolize dust particles. Accumulated dust and debris was also noted on metal ductwork in the gym (Room 112). This should be cleaned to avoid the debris serving as a source of mold growth should condensation form on the cool metal ductwork.

Ceiling-Mounted Supply Diffuser, Note Dust/Debris Accumulation

19. Clean dust/debris from ductwork in gym (room 112).
20. Clean personal fans, supply air diffusers and exhaust/return vents periodically of accumulated dust.

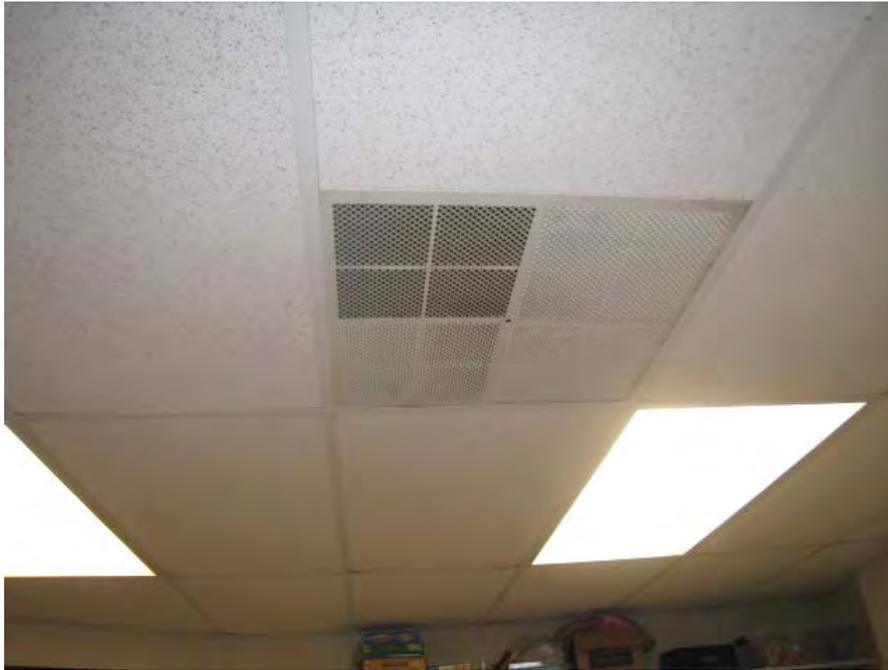
Picture 3

Ceiling-Mounted Vent

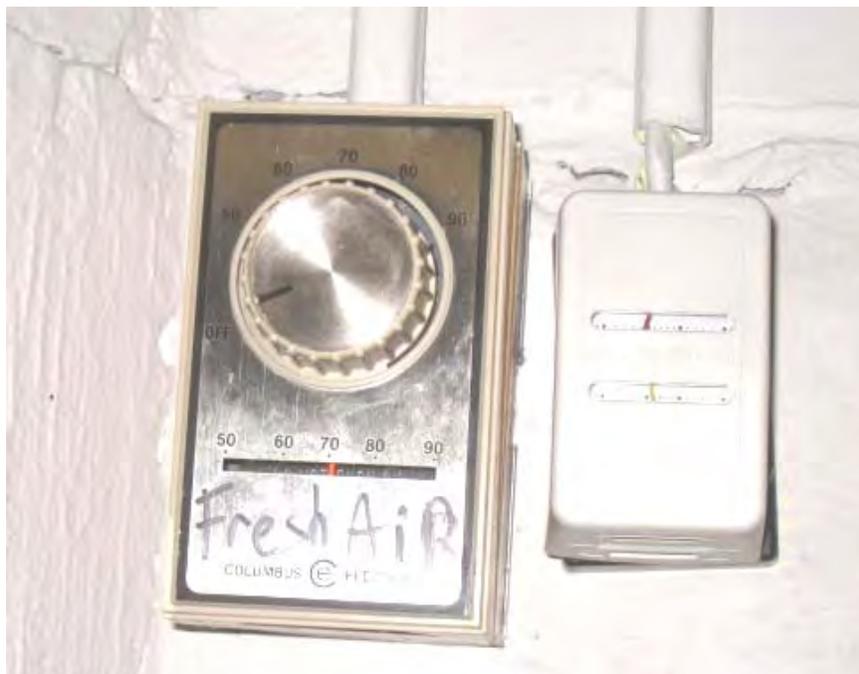
Picture 4

Control for HVAC System in Room 107, Note System in “Off” Position

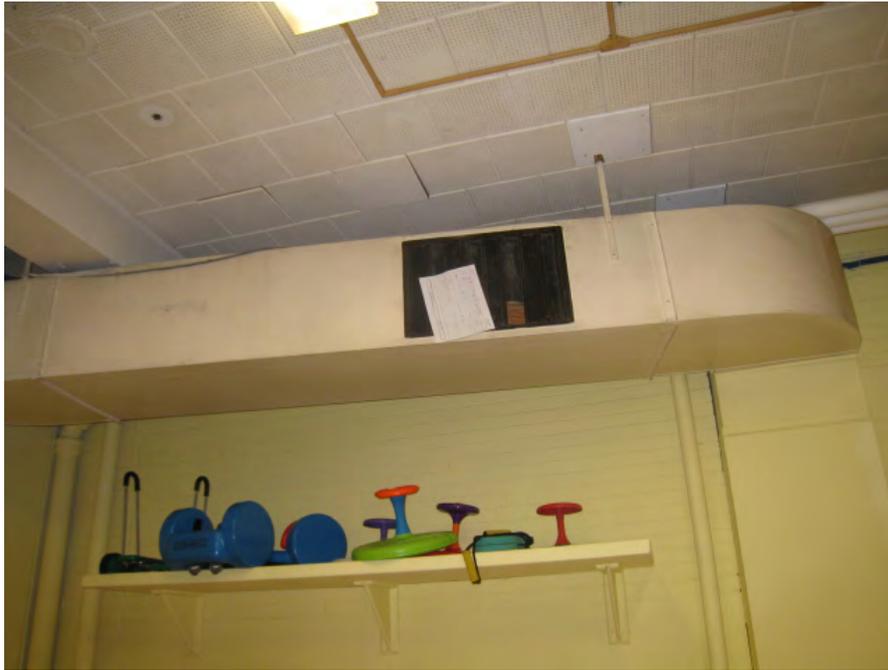
Picture 5

Exhaust Vent/Duct in Gym

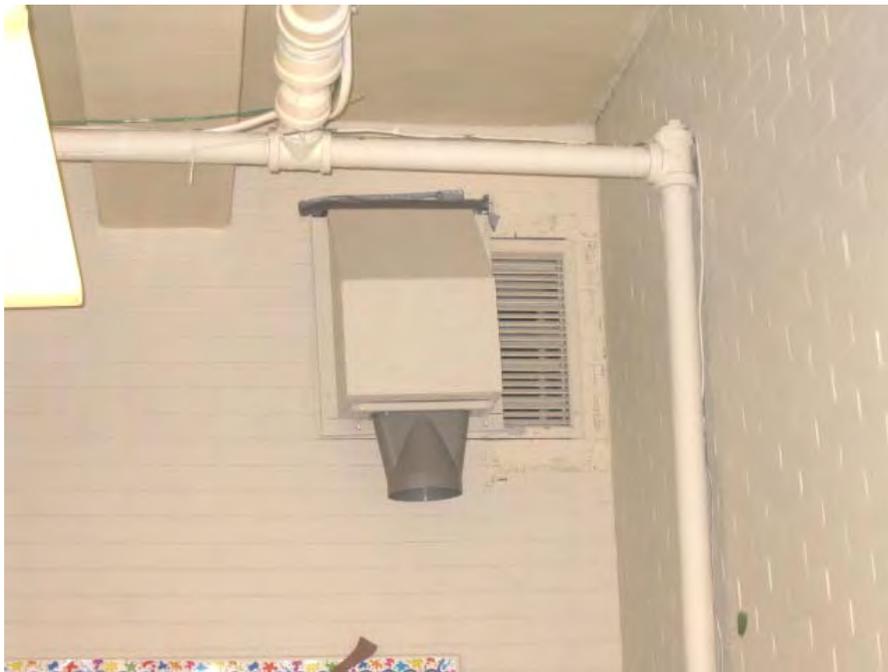
Picture 6

Wall-Mounted Exhaust Vent

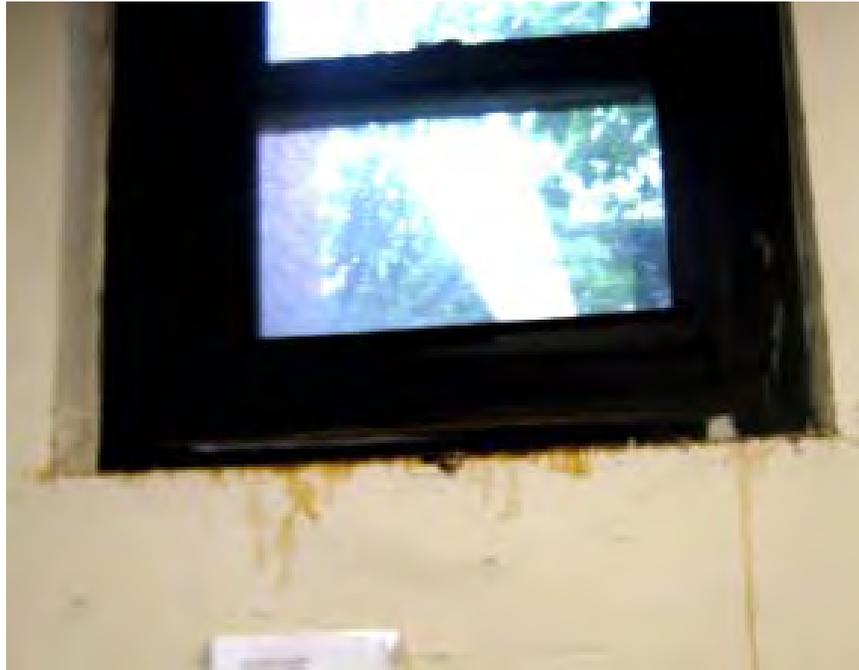
Picture 7

Building occupants reported chronic moisture issues in below-grade areas and specifically reported mold growth on classroom items. Below-grade areas are often subjected to chronic dampness, therefore it is important to take measures to reduce relative humidity (e.g., dehumidification or AC) to prevent condensation. It is also important to limit the presence of materials that can grow mold (e.g., porous building materials and/or stored materials). At the time of assessment, no mold growth was observed on classroom items. However, old worn carpeting was observed in the Occupational Therapy (OT) clinic. Carpeting is generally not recommended in below-grade areas. Also noted in the OT clinic was rust and water damage around the window (Picture 7), which appears to be the result of chronic water penetration.

Rust and Water Damage around Window in OT Clinic, Note Dripping/Staining on Wall

12. Ensure classroom doors are closed for proper operation of HVAC system/dehumidification equipment and to maintain comfort.
13. Ensure window leaks are repaired and reseal as needed. Scrape and clean loose paint/rust/debris from around OT clinic window. Monitor for further leakage and repair as needed.

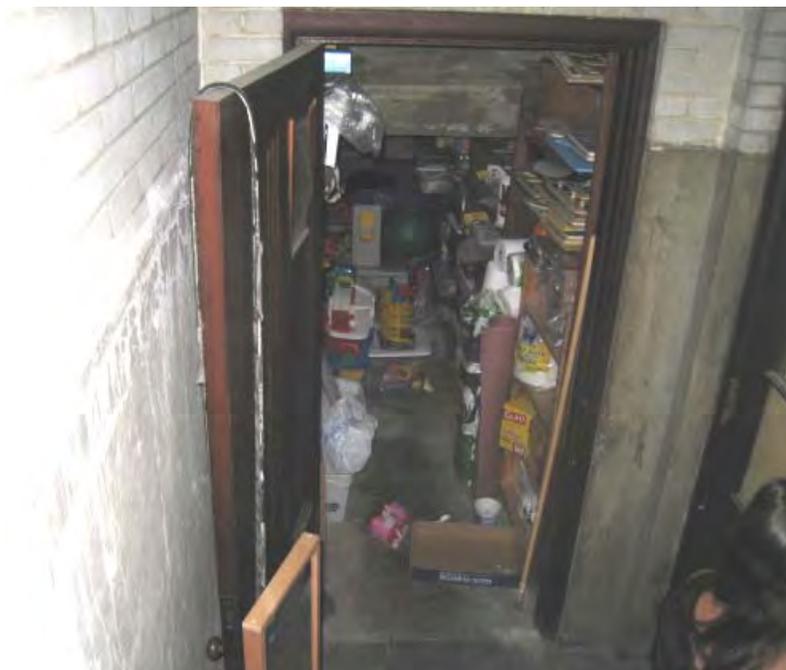
Picture 8

Other potential sources of mold growth were identified including an area where a number of porous items were stored in an unconditioned space at the bottom of an exterior stairwell (Picture 8), and exercise mats and large cushions/pillows on the basement floor (Picture 9). Pillows/cushions are covered with fabric that comes in contact with human skin. This type of contact can leave oils, perspiration, hair and skin cells. Dust mites feed upon human skin cells and excrete waste products that contain allergens. In addition, if relative humidity levels increase above 60 percent, dust mites tend to proliferate (US EPA, 1992). In order to remove dust mites and other pollutants, frequent vacuuming/cleaning is recommended (Berry, M.A., 1994). It is also recommended these items (if present in schools), be professionally cleaned on an annual basis. If an excessive dusty environment exists due outdoor conditions or indoor activities (e.g., renovations), cleaning frequency should be increased (every six months) (IICRC, 2000). These large surface items, if located on the floor, can also trap moisture and lead to condensation and mold growth.

Porous Materials Stored in an Unconditioned Space/Exterior Stairwell

11. Refrain from using the unconditioned space in the stairwell outside of room 114 for storage, particularly of porous items (Picture 8).

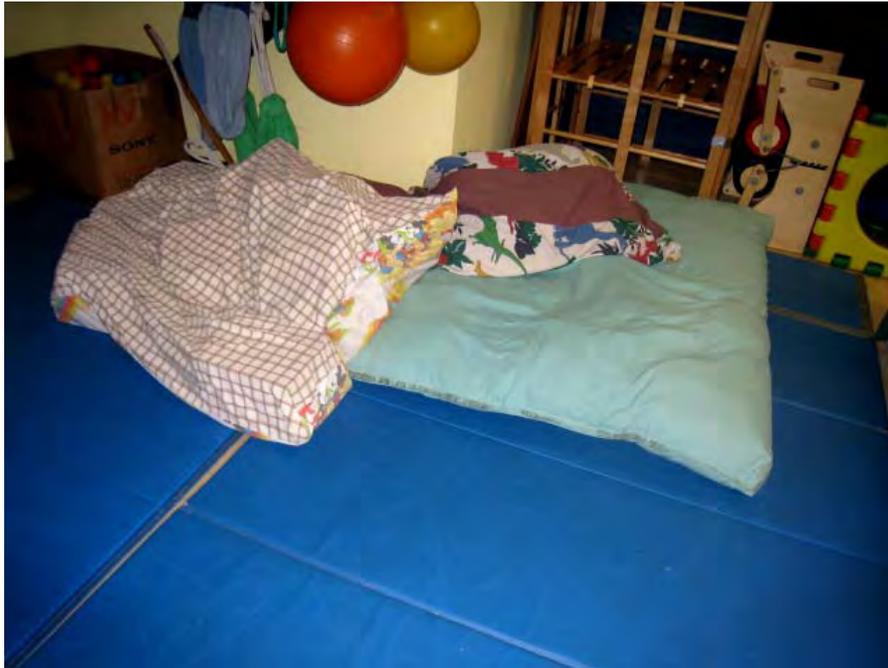
Picture 9

Exercise Mats and Large Cushions/Pillows on Floor

21. Professionally clean large pillows/cushions annually or more frequently as needed.
22. Inspect exterior stairwell drains on a regular basis; consider replacing drain caps to provide better drainage.

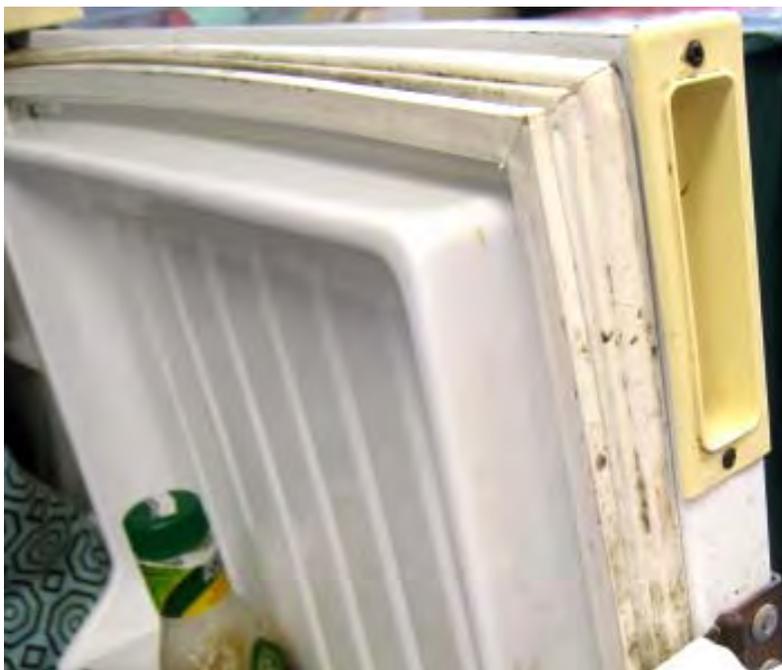
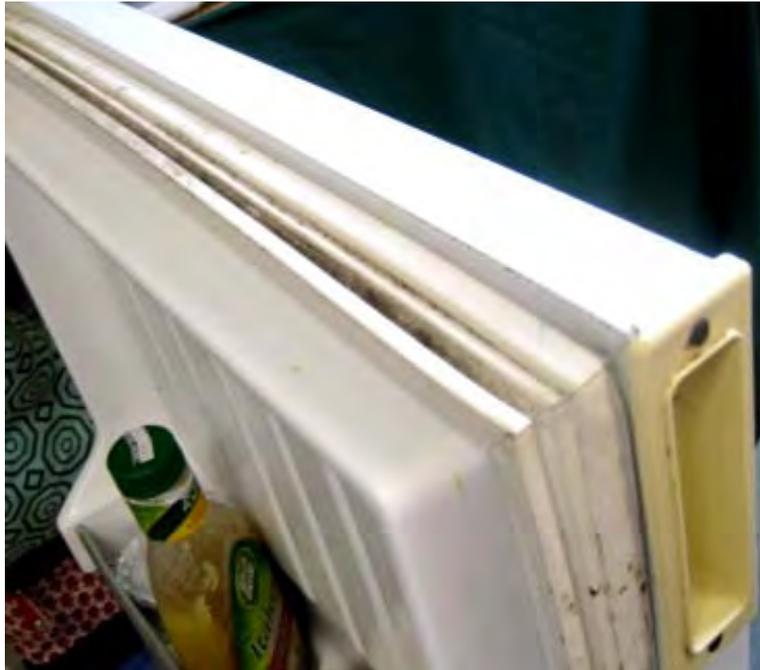
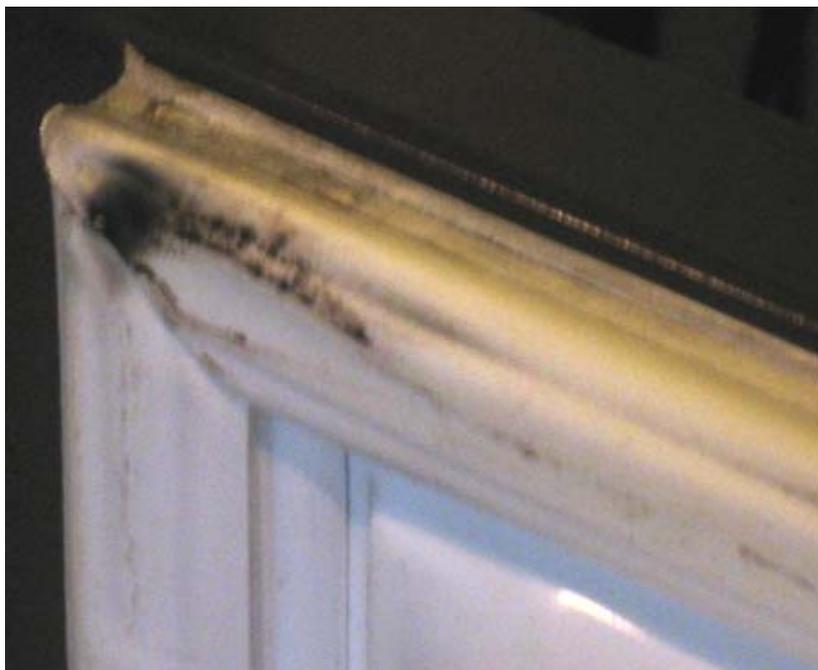
The US EPA and the American Conference of Governmental Industrial Hygienists (ACGIH) recommend that porous materials be dried with fans and heating within 24 to 48 hours of becoming wet (US EPA, 2001; ACGIH, 1989). If not dried within this time frame, mold growth may occur. Once mold has colonized porous materials, they are difficult to clean and should be removed/discarded. Visible mold growth was observed in portable refrigerators. Upon opening refrigerators, BEH staff found refrigerator door gaskets to be colonized with mold (Pictures 10 through 12). The refrigerators appeared not to have been cleaned for some time.

Refrigerator Gasket Colonized with Mold (Dark Staining)

17. Clean and disinfect interior of refrigerators and freezers with mild detergent or antimicrobial agent. Consider replacing mold-contaminated gaskets. Clean spilled food promptly, and clean out the refrigerator of expired items on a regular schedule.

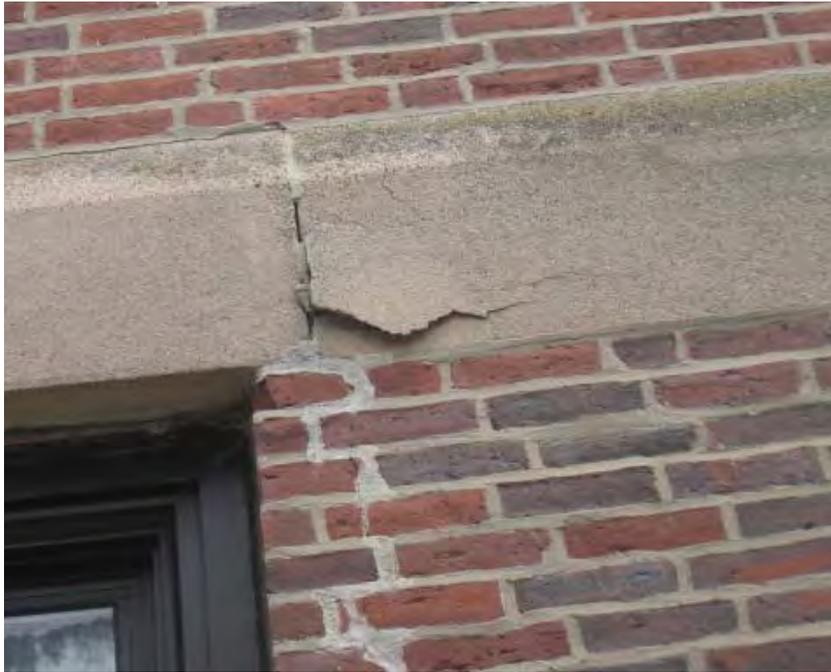
Picture 13

- Damaged/flaking masonry (Picture 13);

The aforementioned conditions represent potential water penetration sources. Over time, these conditions can undermine the integrity of the building envelope and provide a means of water entry into the building via capillary action through exterior walls, foundation concrete and masonry (Lstiburek & Brennan, 2001). The freezing and thawing action of water during the winter months can create cracks and fissures in the foundation. In addition, they can serve as pathways for insects, rodents and other pests into the building.

Damaged/Flaking Masonry

14. Contact a masonry firm or general contractor to repair holes/breaches in exterior walls/joints to prevent water penetration, drafts and pest entry. Remove moss accumulation on masonry and mortar.

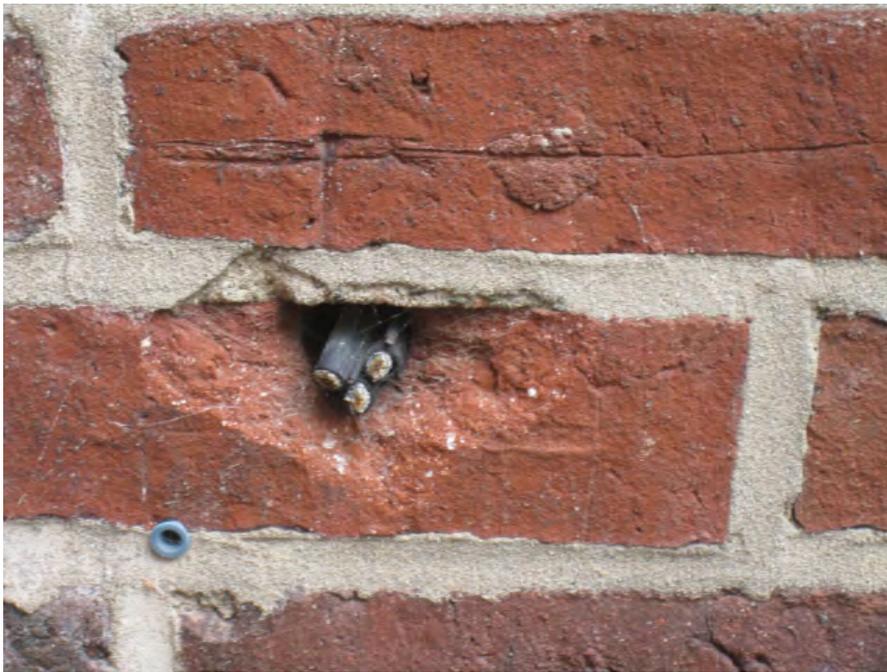
Picture 14

- Open utility holes (Picture 14);
- Moss growth was noted in several areas along exterior brickwork (Picture 15). A substantial source of water is needed for moss to grow. Moss growth is a sign of heavy/continuous water exposure which can threaten the structural integrity of the building;
- Missing/damaged mortar around brickwork (Pictures 15 and 16); and
- Drains at the bottom of exterior stairwells (Picture 17). Although the drains were not clogged at the time of assessment, this design provides limited drainage and makes them tend towards blockage.

Open Utility Hole

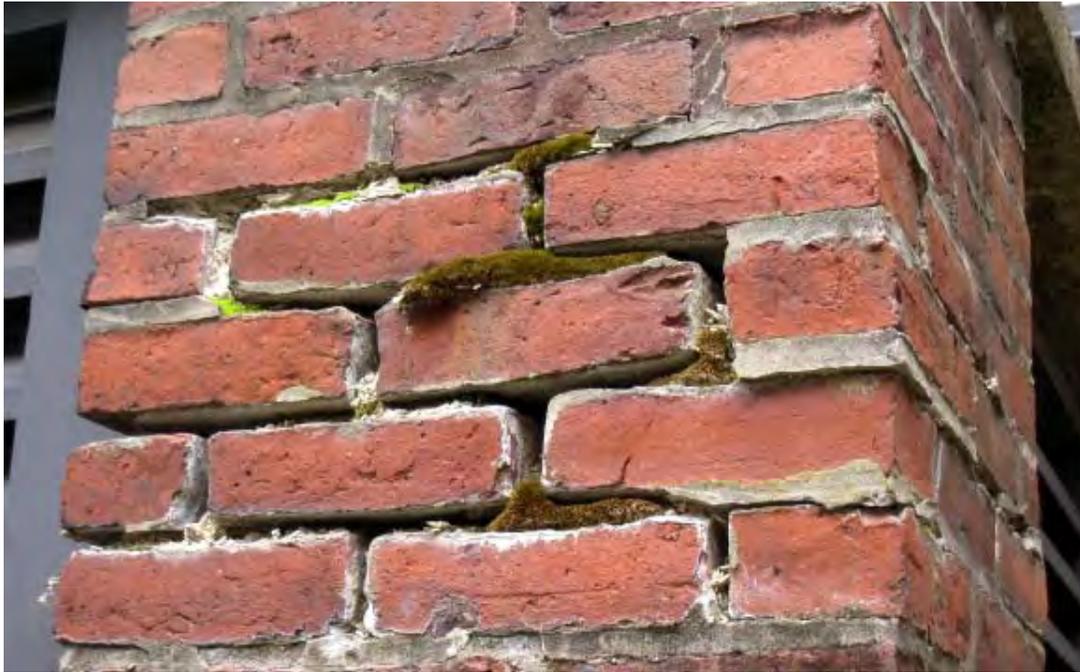
Picture 15

Moss Growth, Missing/Damaged Mortar around Brickwork

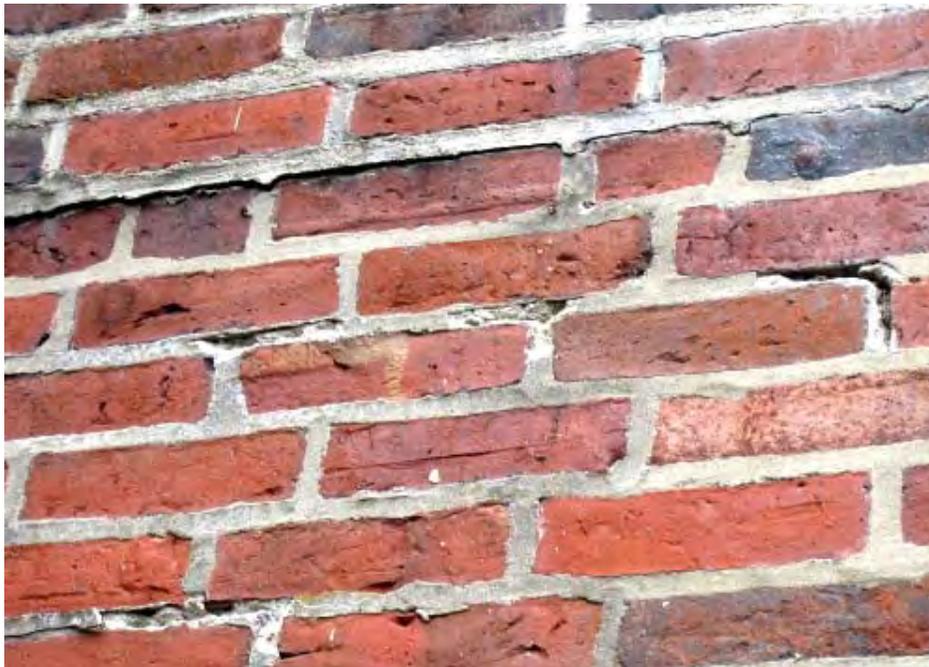
Picture 16

Missing/Damaged Mortar around Brickwork

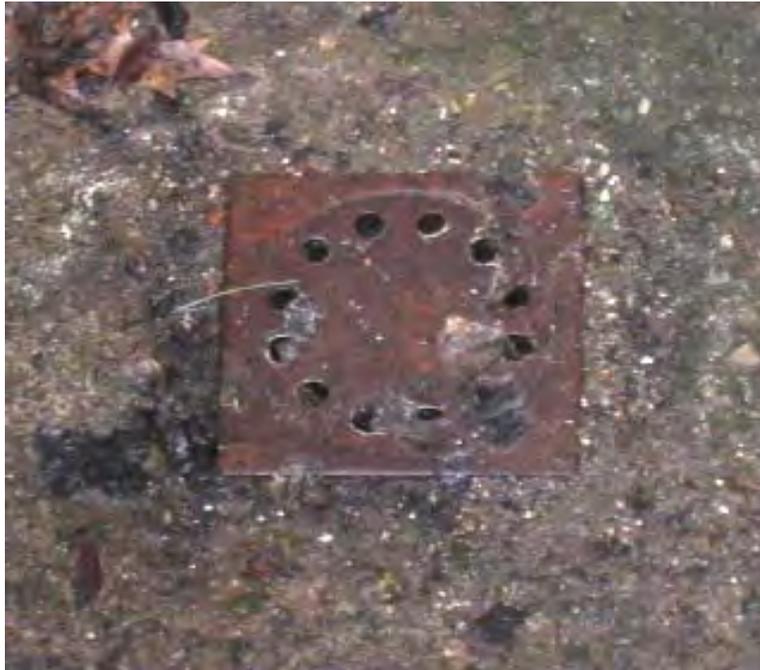
Picture 17

Drain at bottom of Exterior Stairwell

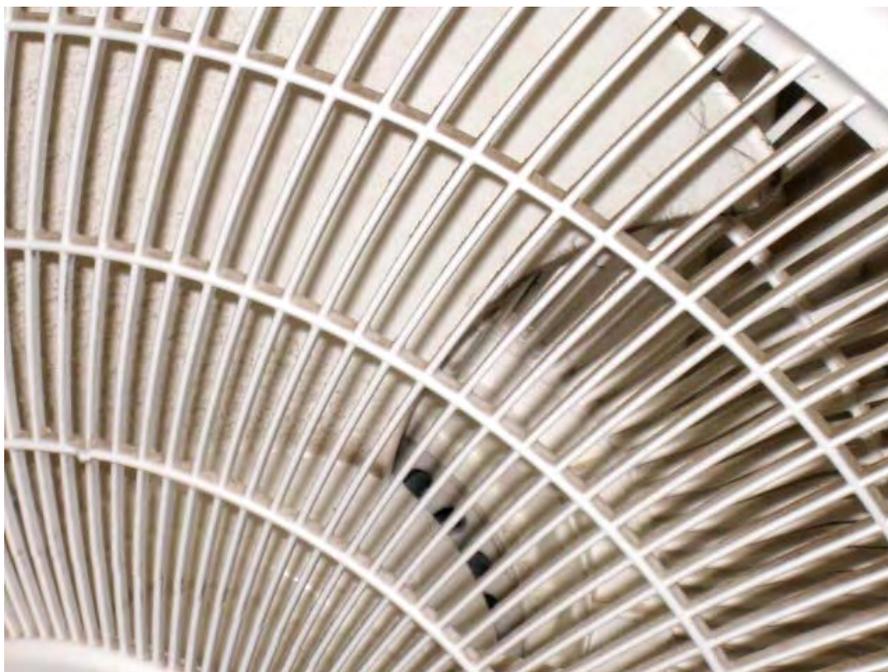
Picture 18

Dust/Debris Accumulation on Personal Fan

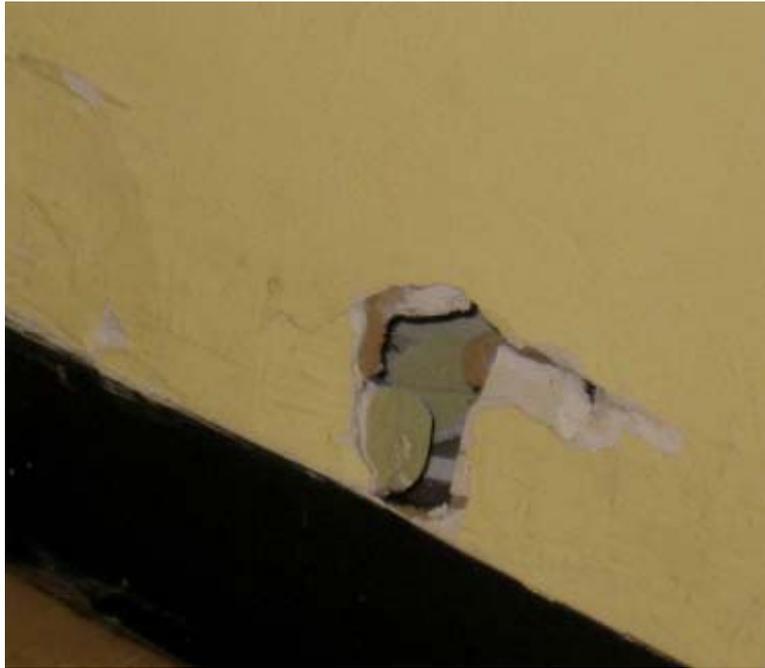
Picture 19

Finally, a hole was observed in the wall of the gym and open utility holes in walls were seen in a number of areas (Pictures 19 and 20). Breaches in walls and open spaces around

pipes/utilities can serve as pathways for dust, dirt, odors and other pollutants to move from the floor/wall cavities into occupied areas.

Hole in Gym Wall

25. Patch hole in gym wall and seal open utility holes in walls with a fire-rated sealant.
26. Refer to resource manuals and other related indoor air quality documents for further building-wide evaluations and advice on maintaining public buildings. These materials are located on the MDPH's website: <http://mass.gov/dph/iaq>.

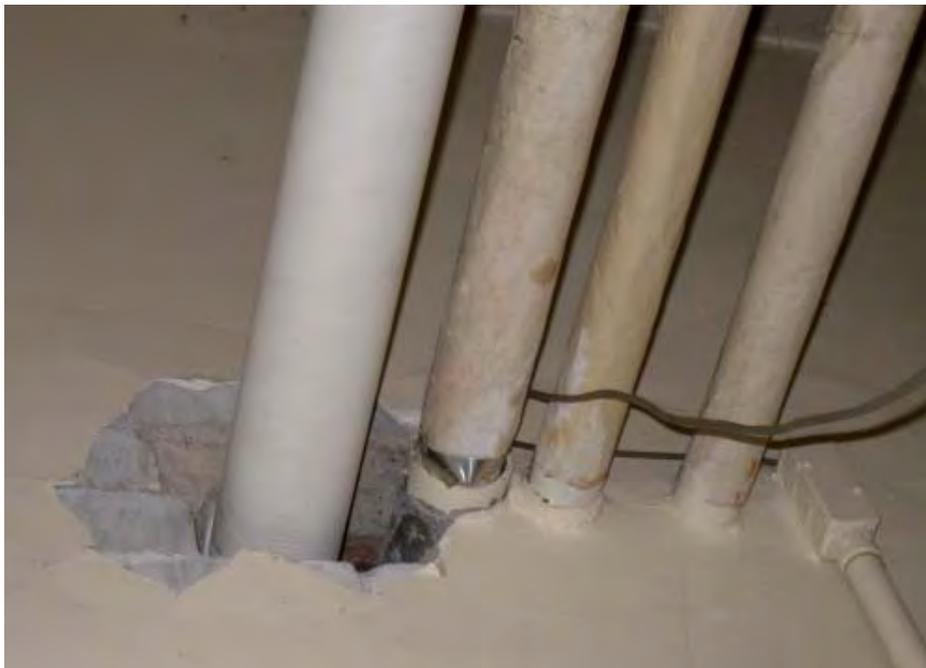
Picture 20

Open Hole in Wall around Utility Pipes
