INDOOR AIR QUALITY POST-OCCUPANCY ASSESSMENT

**Massachusetts Department of Disability Services
140 High Street
Springfield, MA**

Prepared by:
Massachusetts Department of Public Health
Bureau of Environmental Health
Indoor Air Quality Program
December 2012

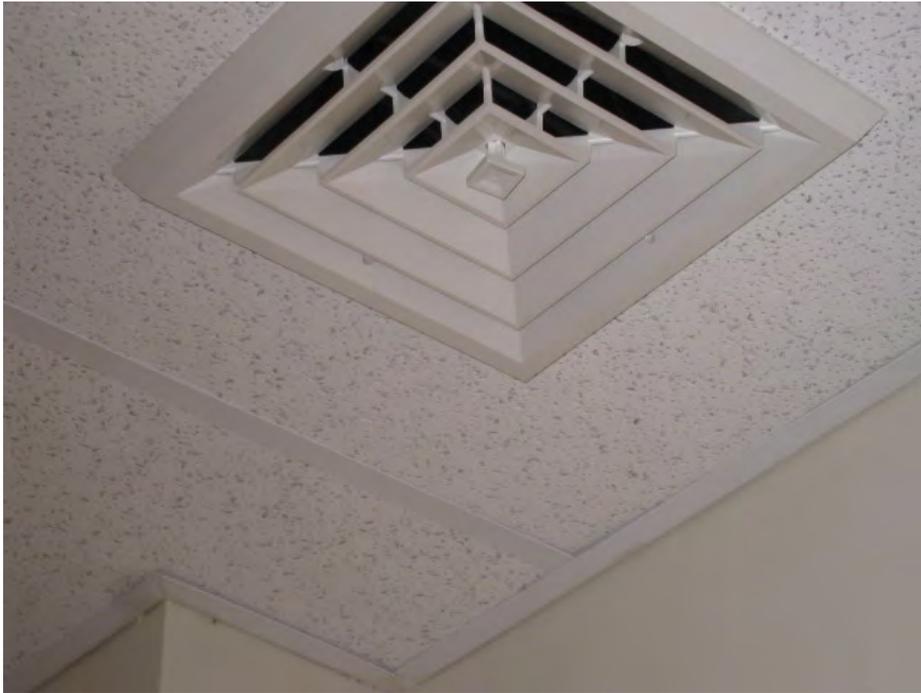
Picture 1

The heating, ventilating and air conditioning (HVAC) system consists of air-handling units (AHU) located in the basement, which draw in fresh air and distribute it to occupied areas via ceiling-mounted air diffusers and fresh air intake vents (Pictures 1 and 2). The offices do not have return ventilation; rather the system consists of ceiling-mounted exhaust grilles ducted directly to the outside powered by rooftop motors.

HVAC Fresh Air Supply Diffuser

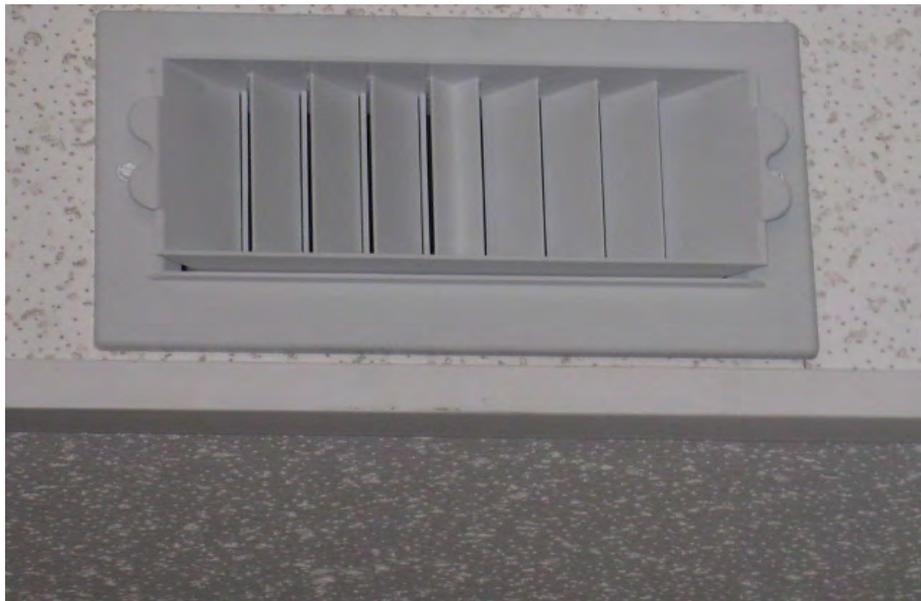
Picture 2

Fresh Air Intake Vent

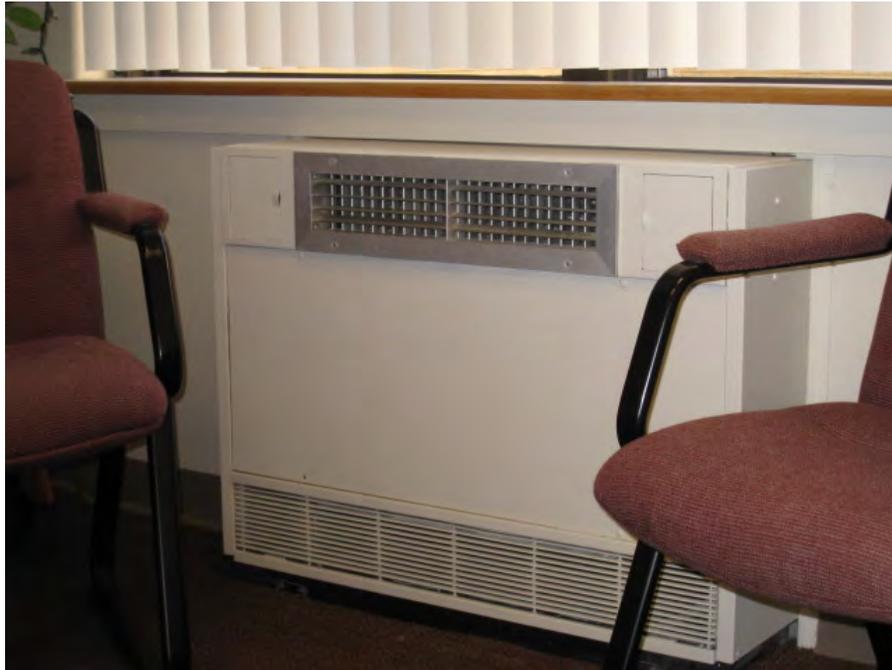
Picture 3

Fan coil units (FCUs) are located along the base of walls under windows and/or mounted to ceilings (Pictures 3 and 4) and provide supplemental heating or cooling to perimeter areas. FCUs do not introduce outside air; these units are limited to recirculating air only. The FCUs were operating in all of the areas surveyed during the assessment. In some areas, FCUs were blocked/obstructed by several items including cardboard boxes, books and other stored materials (Picture 5). In order for FCUs to facilitate airflow as designed, they must remain free of obstructions. FCUs located at the

base of walls appear to be original to the building, which would make them approximately 50 years old. Mechanical ventilation equipment of this age is difficult to maintain because replacement parts are often unavailable.

Fan Coil Unit

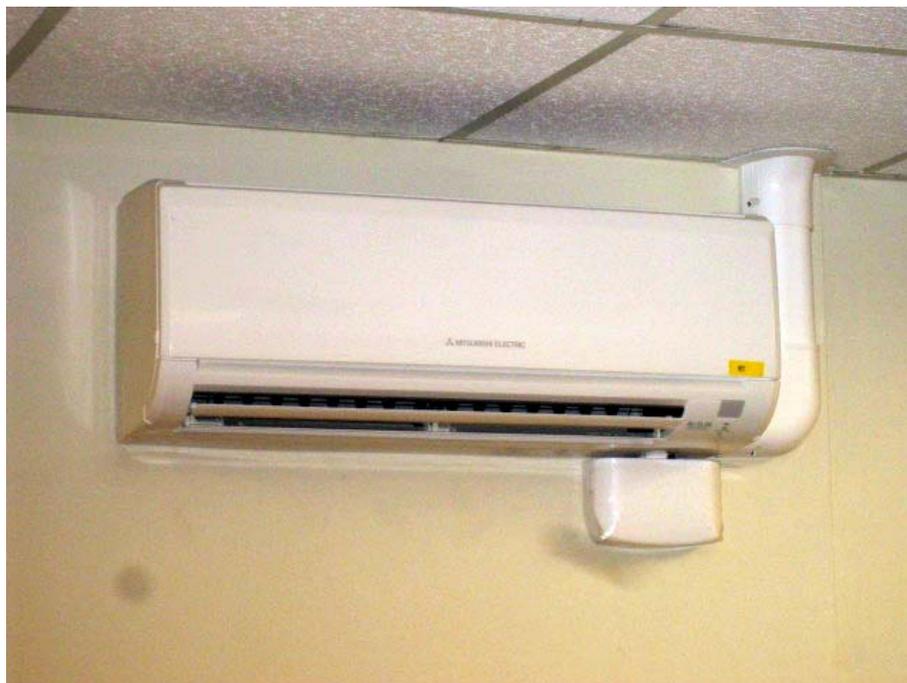
Picture 4

Ceiling-mounted Fan Coil Unit

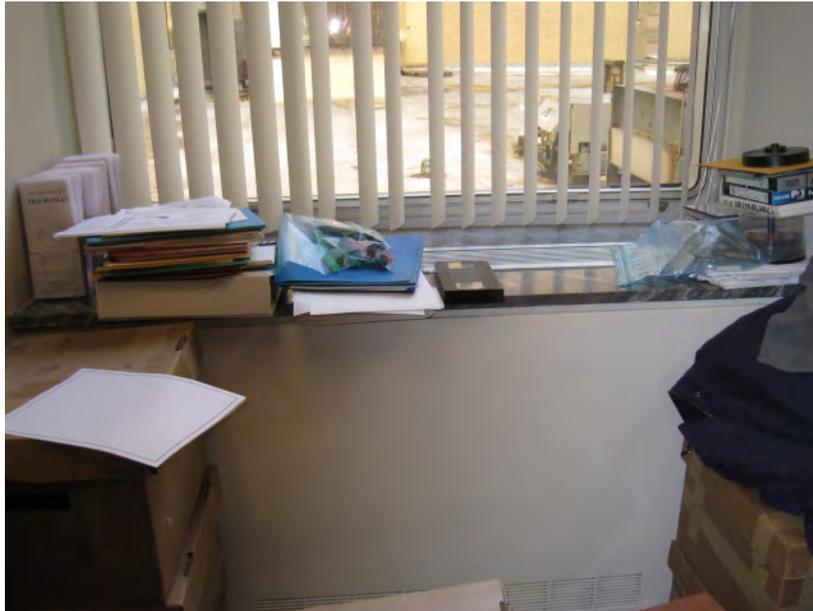
Picture 5

Obstructed Fan Coil Unit

1. Remove materials and obstructions from FCU intakes and diffusers.
2. Consider adopting a balancing schedule of every 5 years for all mechanical ventilation systems, as recommended by ventilation industrial standards (SMACNA, 1994).

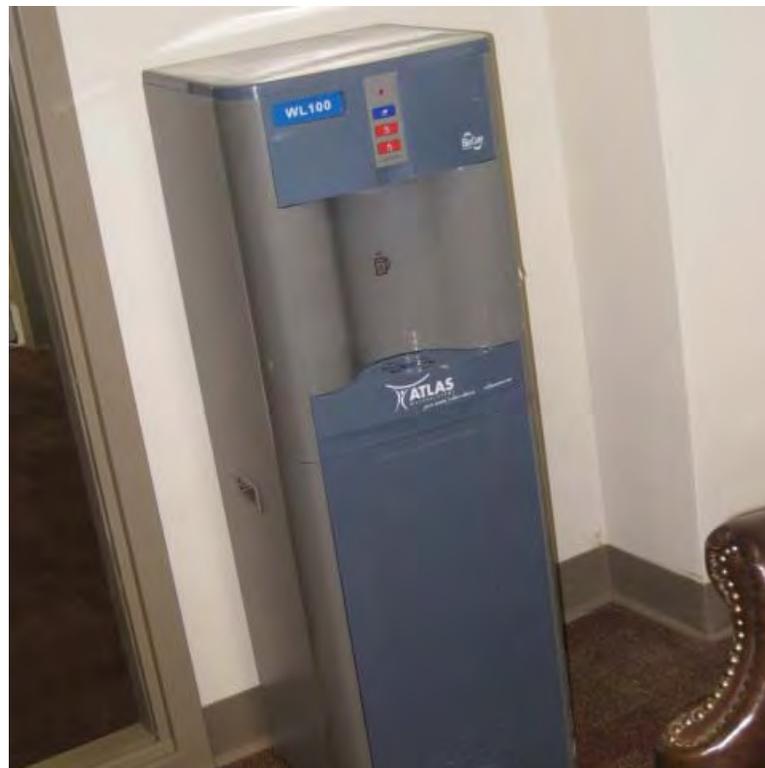
Picture 6

In order for building materials to support mold growth, a source of water exposure is necessary. No evidence of building leaks and/or other moisture concerns were observed or reported. It was noted however, that water dispensers were located on carpeted areas (Picture 6). Spills/condensation from these appliances can be a source of moisture in carpeting that can lead to water damage and mold growth. When possible, these units should be located in tiled areas or placed on a waterproof mat.

Water Dispenser Located on Carpet

4. Consider moving water dispensing equipment to areas with tiled floors instead of carpeting, or installing waterproof mats to prevent leaks from damaging carpet.

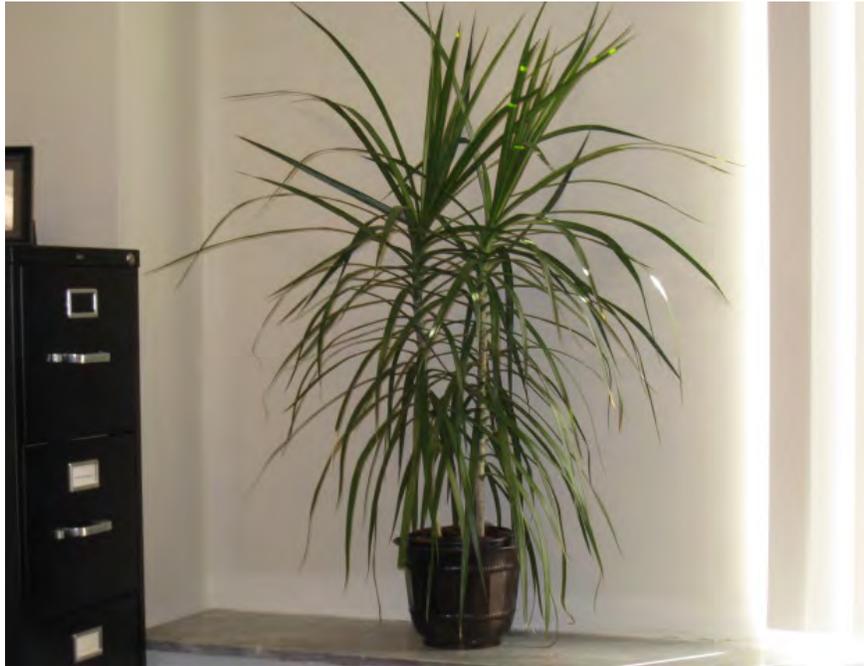
Picture 7

Plants were observed in office areas (Picture 7). Plants should be properly maintained and equipped with drip pans. Plants should be located away from ventilation sources (e.g., FCUs) to prevent aerosolization of dirt, pollen or mold. Plants should not be placed on porous materials, since water damage to porous materials may lead to microbial growth.

Plant in Office Space

5. Avoid overwatering of plants. Ensure flat surfaces around plants are free of potting soil and other plant debris. Examine drip pans periodically for mold growth and disinfect with an appropriate antimicrobial where necessary. Do not place plants on porous materials (e.g., paper/cardboard).

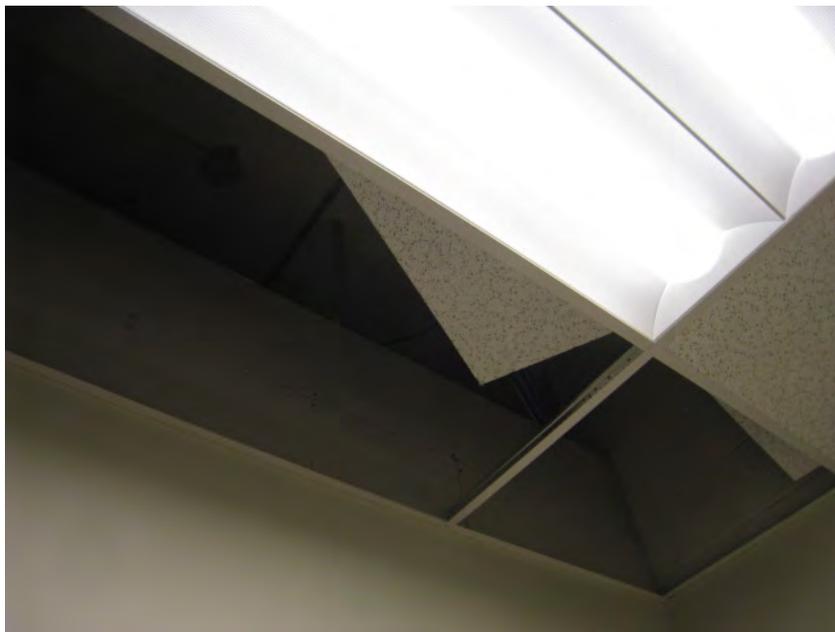
Picture 8

Missing and ajar ceiling tiles were observed in some areas (Picture 8). Breaches in the ceiling tile system can provide pathways for dust, dirt, odors and other pollutants to move into occupied areas.

Ajar Ceiling Tile

6. Replace missing ceiling tiles. Ensure all ceiling tiles are flush to prevent movement of materials from the plenum.
7. Refer to resource manual and other related indoor air quality documents located on the MDPH's website for further building-wide evaluations and advice on maintaining public buildings. These documents are available at: <http://mass.gov/dph/iaq>.
