RENOVATION ASSESSMENT

**Quinsigamond Community College
100 Front Street
Worcester, MA**

Prepared by:
Massachusetts Department of Public Health
Bureau for Environmental Health
Indoor Air Quality Program
February 2012

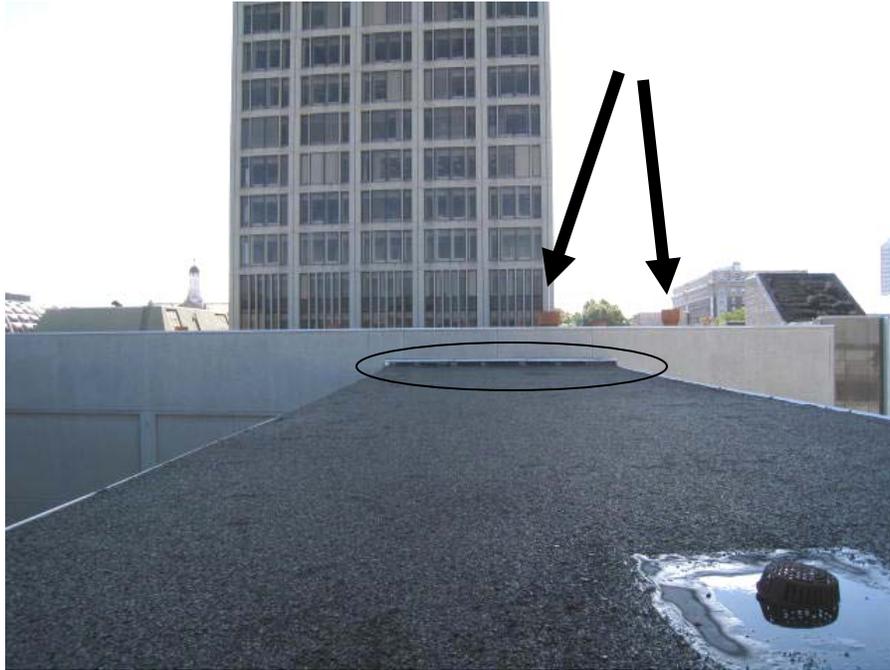
Picture 1

QCC staff were concerned about the presence of both squirrels and mice in the space. According to Ms. Cleary, squirrels entering the suspended ceiling above QCC had been a chronic problem. Trapping of squirrels was ongoing and reportedly several squirrels had been removed several weeks prior to the DPH visit. BEH staff examined the roof of the building for potential entry points for rodents/pests and identified several vents that, if not equipped with appropriate

bird screens, could allow squirrels into ductwork and from there, to become trapped in the ceiling plenum (Picture 1).

Pressure equalization vents (oval) and other potential penetrations (arrows)

1. Examine the vents/openings identified on and adjacent to the building roof to see if appropriate bird screens are present and if not, install appropriate screening.

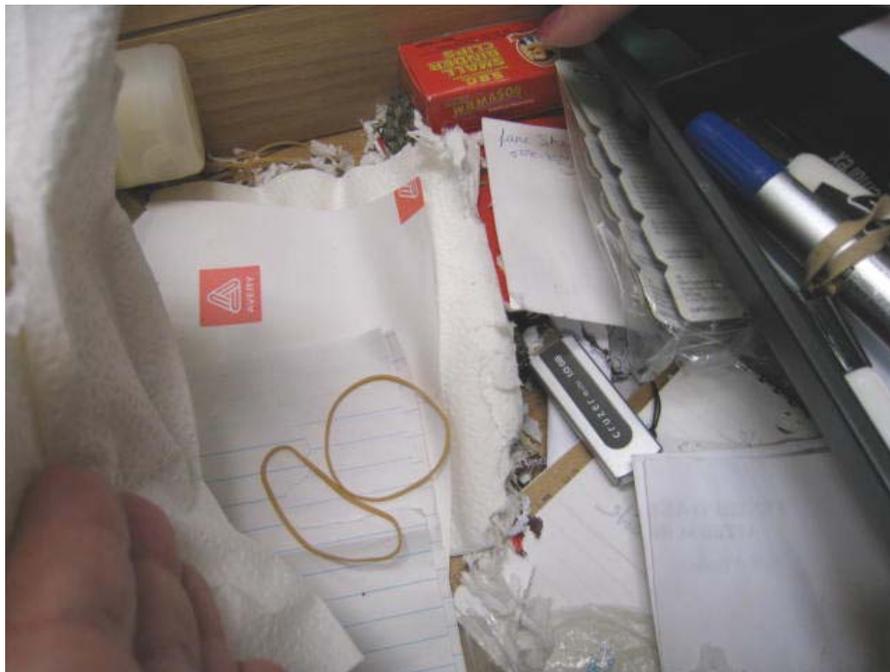
Picture 2

BEH staff also examined each room for evidence of rodents as well as potential entry points for rodents/pests. QCC staff reported frequent mouse sightings, including mice disrupting classroom activities, especially over the several days prior to the BEH visit. Droppings and chewed paper were found in several desk drawers (Picture 2).

Chewed paper in desk drawer

4. Once the openings have been sealed, have the facility professionally cleaned, including steam cleaning/drying of carpets and cleaning of all surfaces. Reduction of clutter and stored paper beforehand will allow for more thorough cleaning and reduce the harborage opportunities for rodents afterwards. Maintain regular cleaning of carpeting and surfaces.

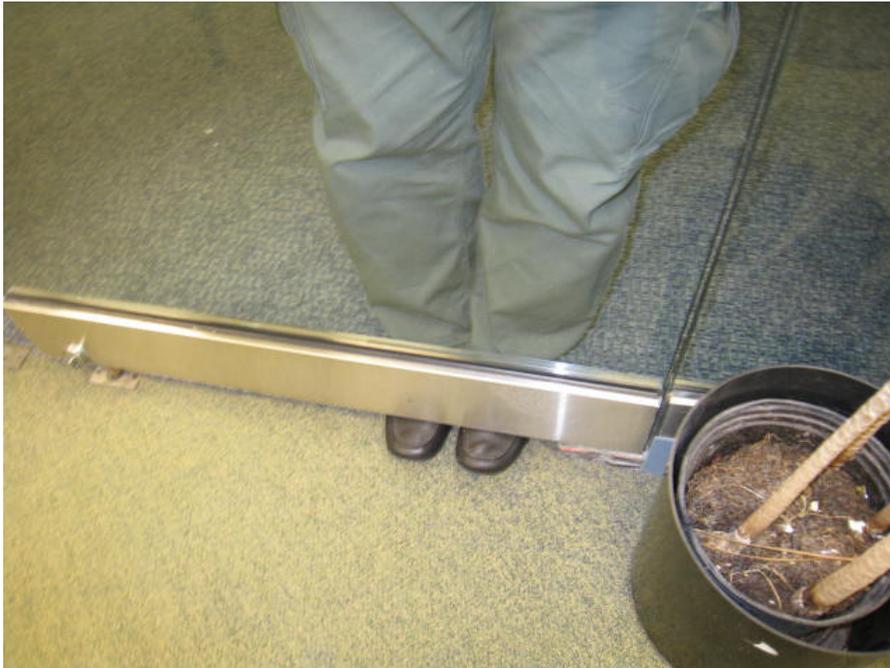
Picture 3

To penetrate a building, rodents require a minimal breach of ¼ inch in the exterior wall/building envelop (MDFA, 1996). A large rodent access point exists in the main entrance to QCC space between the floor and bottom portion of the main entrance glass doors (Picture 3). Metal plates appear to be retrofitted to the bottom of each door (Picture 4). The purpose of the plates appeared to be preventing individuals from reaching under the door to open its lock, not to prevent rodent access. Other doors in the floor of empty retail space are configured in a similar pattern.

Gap under glass front doorway

3. Seal the gap noted at the bottom of the glass front doors (Picture 3) with metal stripping edged with a flexible door sweep or similar containment. Ensure tightness by monitoring for light penetration and drafts.

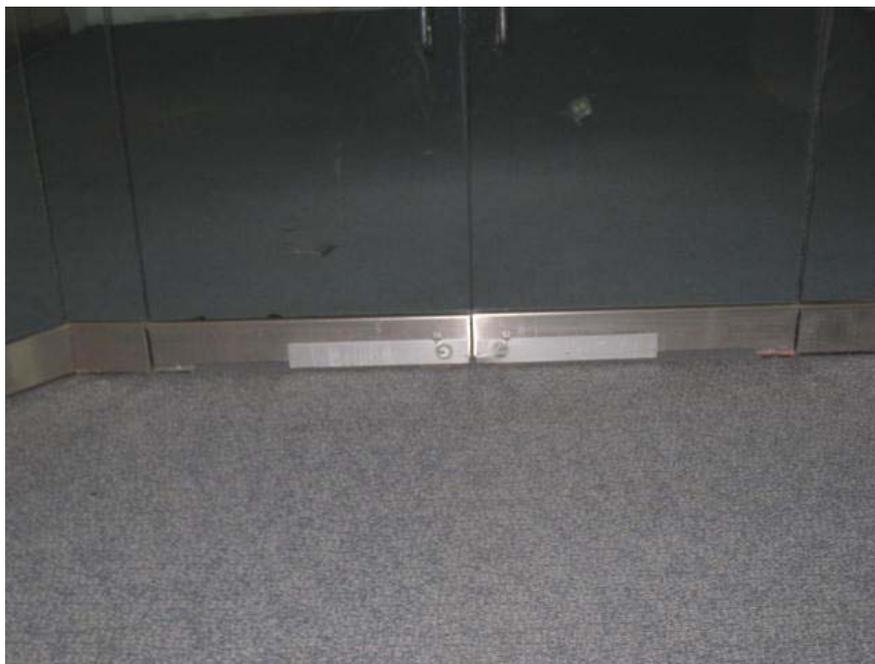
Picture 4

Spaces/metal plates at bottom of doors

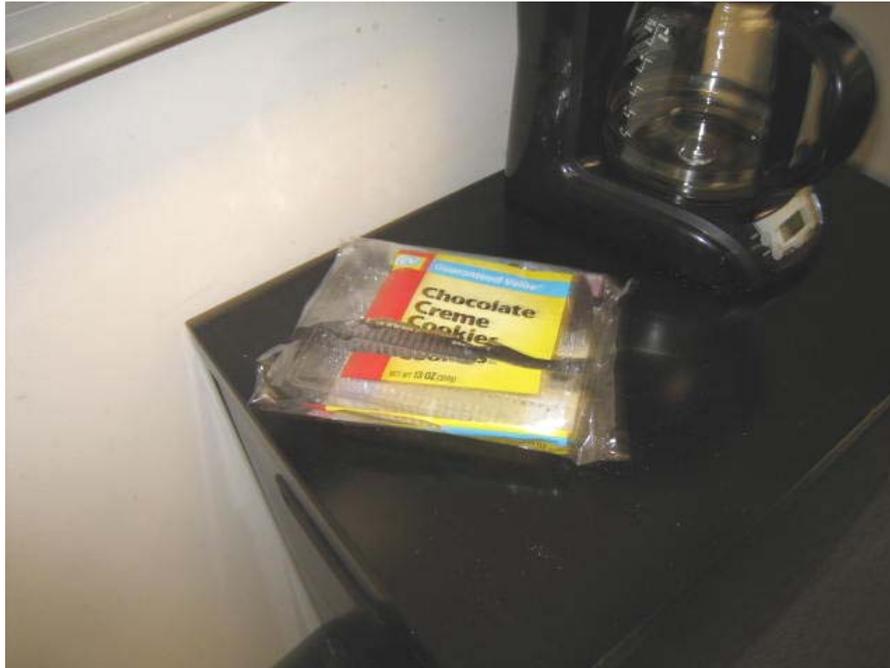
Picture 5

A significant number of rodent attractors and harborages exist in the QCC space. Paper items and clutter, open containers of food (Picture 5), and empty food containers are attractive to rodents. Chemical bait traps were found in several of the occupied areas (Picture 6). Although bait traps are designed to kill rodents, the bait is attractive and can increase rodent traffic when they are placed in occupied areas.

Open container of food in classroom

5. Move bait traps out of the QCC space to the utility corridors and other unoccupied areas.
6. Institute policies to prevent storage and consumption of food in offices and classroom areas. If possible, set aside a single uncarpeted area for use as a break room and ensure that this area is cleaned daily.

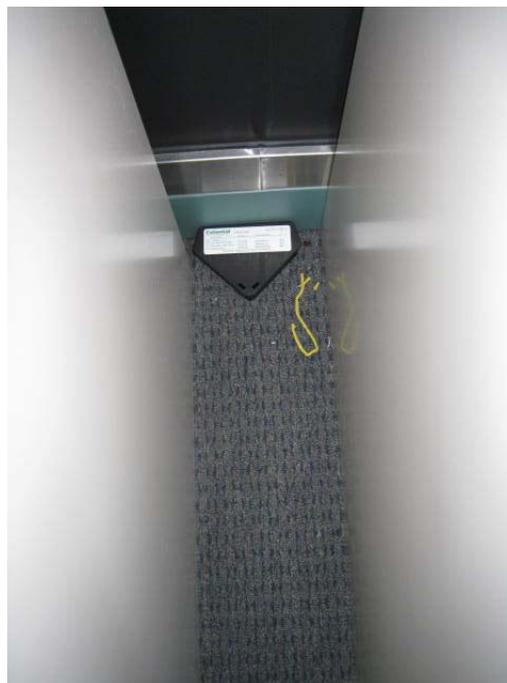
Picture 6

Bait trap between filing cabinets
