INDOOR AIR QUALITY ASSESSMENT

**West Elementary School
2463 Main Street
West Barnstable, Massachusetts**

Prepared by:
Massachusetts Department of Public Health
Bureau of Environmental Health
Indoor Air Quality Program
August 2013

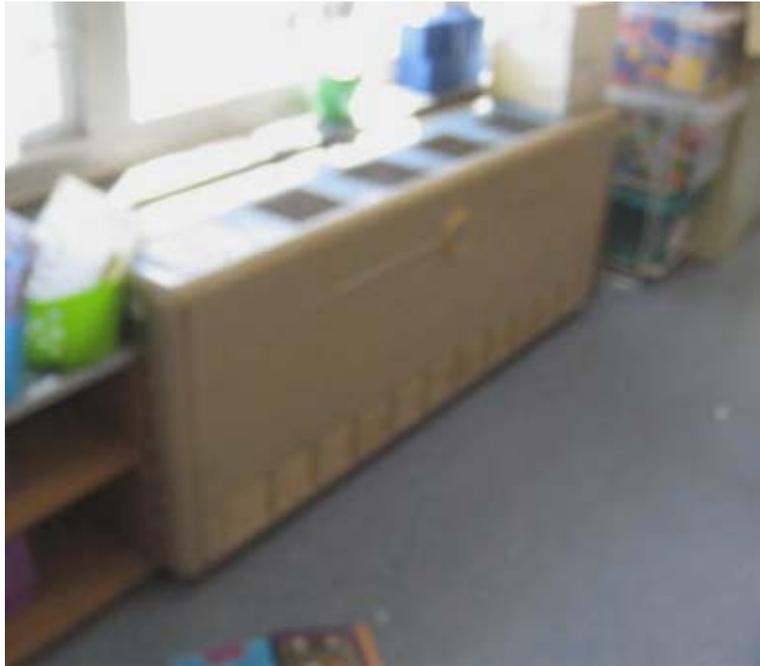
Picture 1

It can be seen from Table 1 that carbon dioxide levels were above 800 parts per million (ppm) in 13 out of 24 areas, indicating less than optimal air exchange in about half of the areas surveyed. Fresh air in classrooms is supplied by unit ventilators (univents) (Picture 1). A univent is designed to draw air from outdoors through a fresh air intake located on the exterior wall of the building (Picture 2). Return air is drawn through an air intake located at the base of each unit where fresh and return air are mixed, filtered, heated or cooled and provided to classrooms through an air diffuser located in the top of the unit ([Figure 1](#)).

Note that the univents and AHUs are original equipment, over 50 years old (30 years for modular classroom AHUs). Function of equipment of this age is difficult to maintain, since compatible replacement parts are often unavailable. According to the American Society of Heating, Refrigeration and Air-Conditioning Engineers (ASHRAE), the service life¹ for a unit heater, hot water or steam is 20 years, assuming routine maintenance of the equipment (ASHRAE, 1991). Despite attempts to maintain the univents, the operational lifespan of the equipment has been exceeded. Maintaining the balance of fresh air to exhaust air will become more difficult as the equipment ages and as replacement parts become increasingly difficult to obtain.

1950s vintage univent

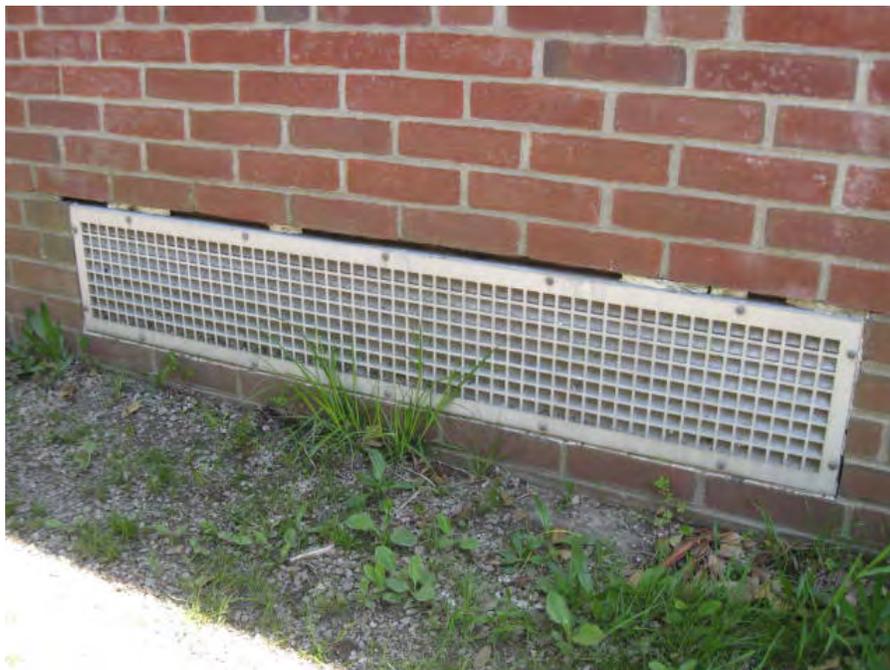
Picture 2

Univent fresh air intake

12. Ensure leaks around windows are fixed and make replace/repair water-damaged building materials around windows.
13. Ensure plants, trees and shrubs are located at least five feet away from exterior walls/foundation of the building, particularly those in close proximity to univent fresh air intakes.

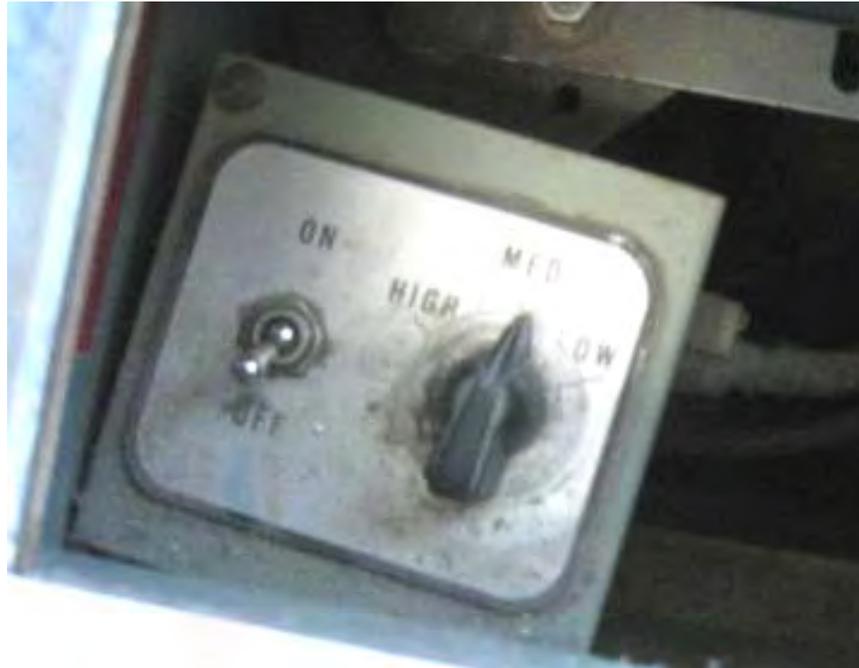
Picture 3

Univents have fan settings of “low”, “med” and “high”. Univents were found deactivated or obstructed with classroom items in several areas (Pictures 3 and 4; Table 1). In order for univents to provide fresh air as designed, intakes/returns must remain free of obstructions. Importantly, these units must remain on and be allowed to operate while rooms are occupied. A “buzzing” noise was detected from the univent in classroom 11 during the assessment, which may indicate a mechanical problem.

Univent controls, note unit is deactivated/switched “off”

1. Operate all ventilation systems throughout the building (e.g., gym, cafeteria, classrooms) continuously during periods of occupancy to maximize air exchange. If increased airflow is desired, operate univents in fan “high” mode.
2. Consider setting thermostat fan controls in modular classrooms to the “on” position to provide constant supply and exhaust ventilation during periods of occupancy.
3. Contact HVAC engineering firm to restore proper operation of cafeteria AHU, make repairs as needed.
4. Investigate “buzzing” noise for univent in classroom 11, make repairs as needed.

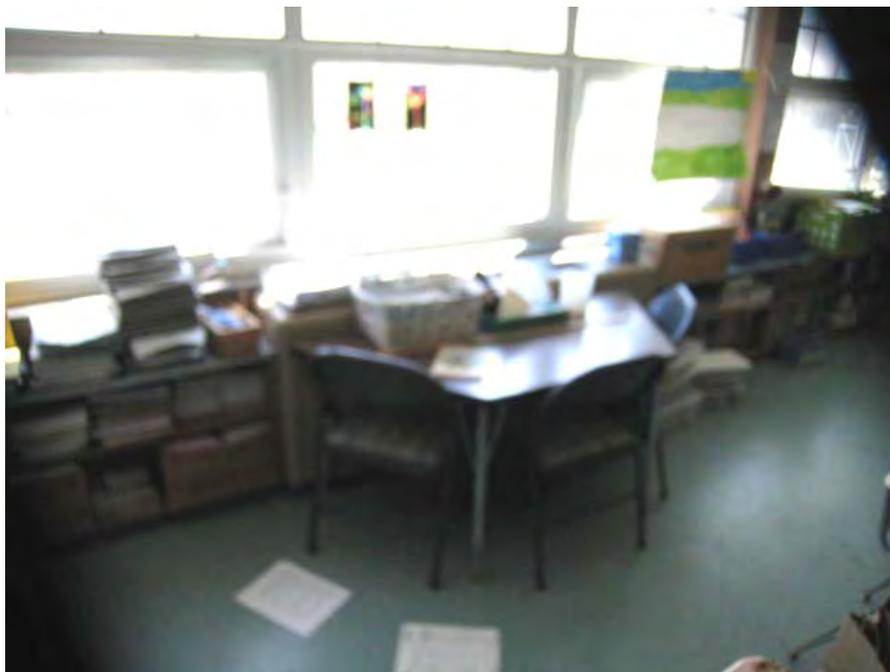
Picture 4

Items on and in front of classroom univent

5. Remove all blockages/items from the surface of univent air diffusers and return vents (along front/bottom) and coat closet exhausts to ensure adequate airflow.

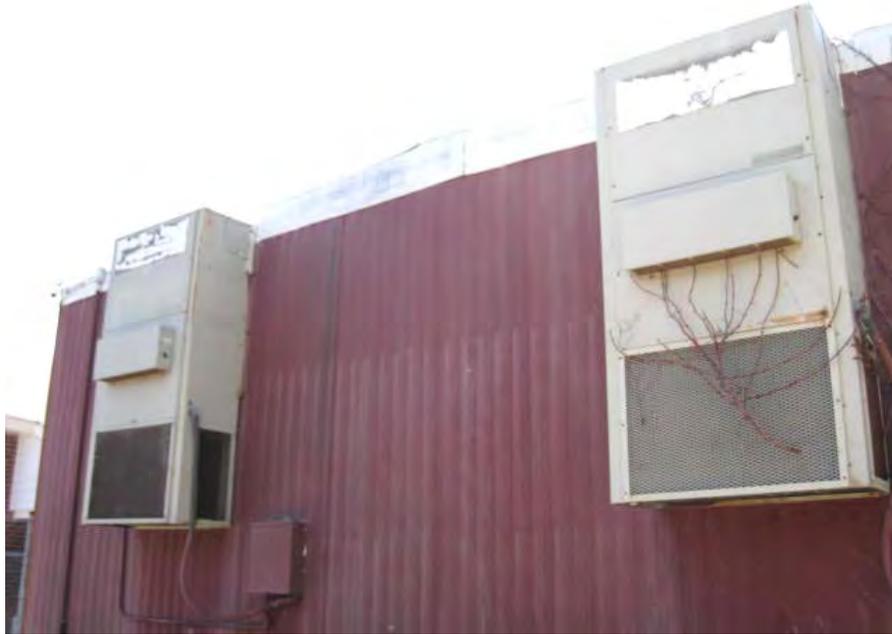
Picture 5

Ventilation for modular classrooms is provided by wall-mounted AHUs (Picture 5). Fresh air is drawn in through air intakes on the exterior of the building and distributed to classrooms via ceiling or wall-mounted air diffusers and drawn back to the AHUs through return grills. Thermostats for both portable classrooms were set to the fan “auto” setting, which deactivates the HVAC system when it reaches a preset temperature. Therefore, no mechanical ventilation is provided until the thermostat reactivates the system.

AHUs for modular classroom, note plant growth on right unit

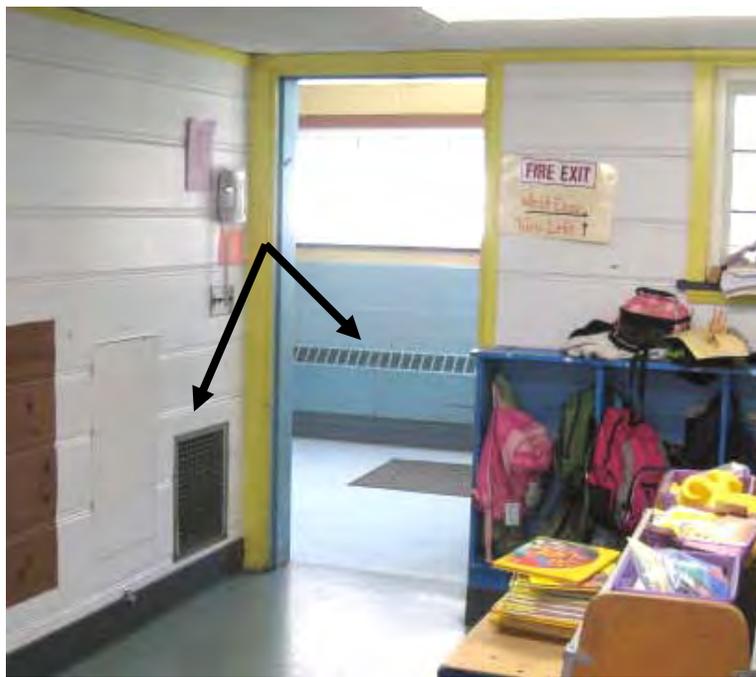
Picture 6

Exhaust ventilation in classrooms is provided by wall-mounted vents ducted to rooftop motors. It is important to note that exhaust vents are located near hallway doors, which are generally left open (Picture 6). With the hallway doors open, the exhaust vent will tend to draw air from the hallway *into* the classroom, instead of drawing stale air *from* the classroom.

Proximity of wall-mounted exhaust vent to open classroom door (arrows)

Therefore it is recommended that classroom doors remain shut while exhaust vents are operating

6. Ensure classroom doors are closed for proper operation of mechanical ventilation system/air exchange.
7. Continue to change filters for air handling equipment (univents and AHUs) 2-4 times a year. Ensure filters for modular classrooms are included. Vacuum interior of units prior to activation to prevent the aerosolization of dirt, dust and particulates. Ensure filters fit flush in their racks with no spaces in between allowing bypass of unfiltered air into the unit.

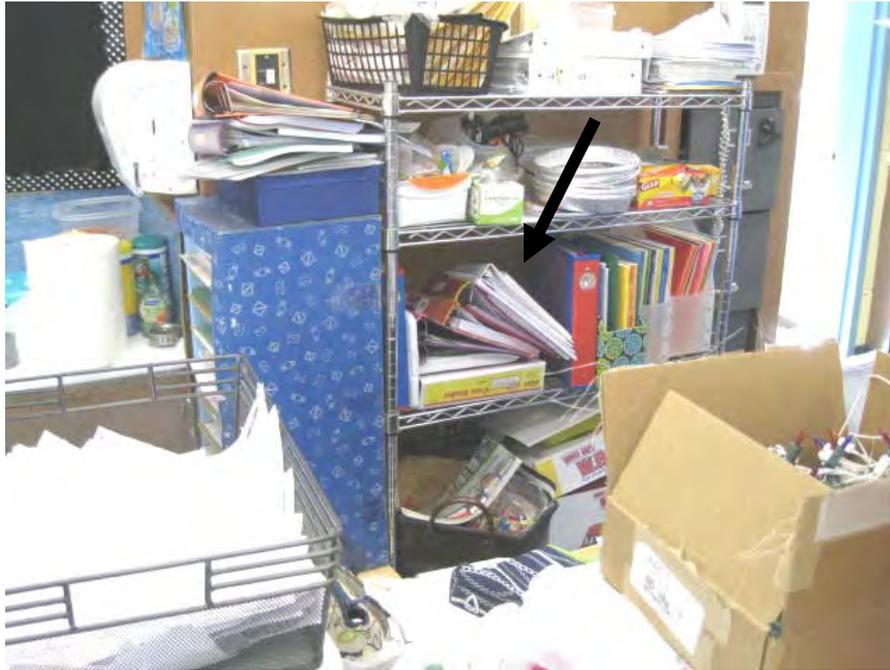
Picture 7

to function as designed. Exhaust vents were also found off and/or obstructed in some areas (Picture 7; Table 1).

Classroom items obstructing wall-mounted exhaust vent (arrow)

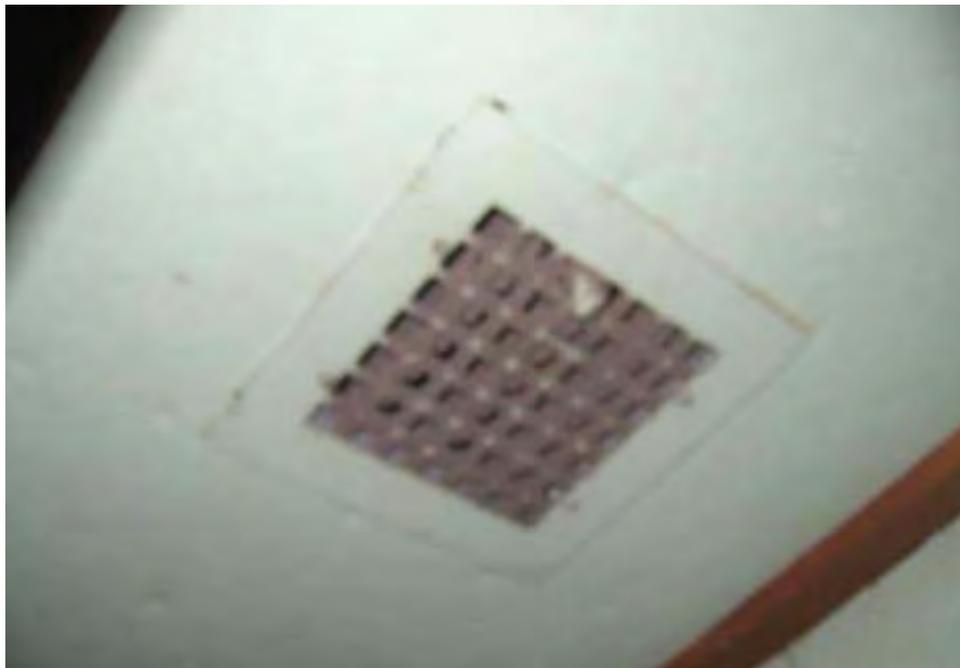
Picture 8

The WBES was designed for wall-mounted exhaust vents in classrooms to be supplemented by exhaust vents located in the ceilings of coat closets (Picture 8). Air is drawn into the coat closet from the classroom via undercut closet doors. However, the design of the closet vents allows them to be easily blocked by stored materials. The majority of the exhaust vents were not drawing air at the time of assessment. As with univents, in order to function properly, exhaust vents must be activated and remain free of obstructions.

A number of air diffusers, exhaust/return vents and personal fans were found to have accumulated dust/debris (Picture 8; Table 1). If exhaust vents are not functioning, backdrafting can occur, which can re-aerosolize accumulated dust particles. Re-activated supply, exhaust/return vents and fans can also aerosolize dust accumulated on vents/fan blades.

Coat closet exhaust vent, note accumulated dust and debris on grill

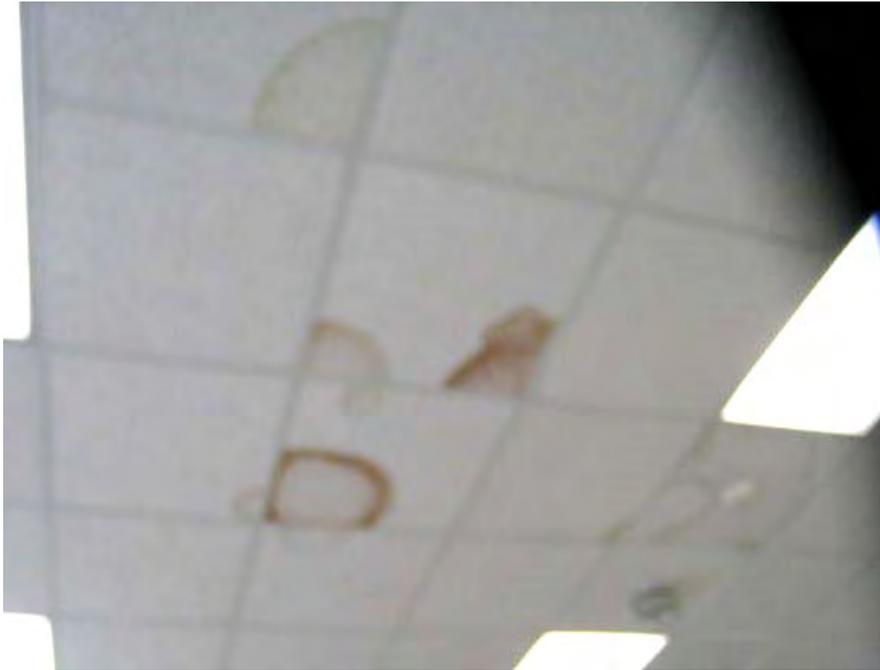
Picture 9

Water-damaged ceiling tiles were observed in a few areas (Table 1), which appear to be from current/historic roof and/or building envelope leaks (Pictures 9 through 11). Water-damaged ceiling tiles can provide a source of mold and should be replaced after a water leak is discovered and repaired. During the assessment, active leaks through windows were reported in portable classroom B (Picture 12); and water-damaged ceilings and walls were observed in the front right corner of classroom 13 (Picture 13). BEH/IAQ staff inspected conditions on the

Water-damaged ceiling tiles in main building

10. Ensure roof/plumbing leaks are repaired and replace any remaining water-damaged ceiling tiles. Examine the area above these tiles for mold growth. Disinfect areas of water leaks with an appropriate antimicrobial, as needed.

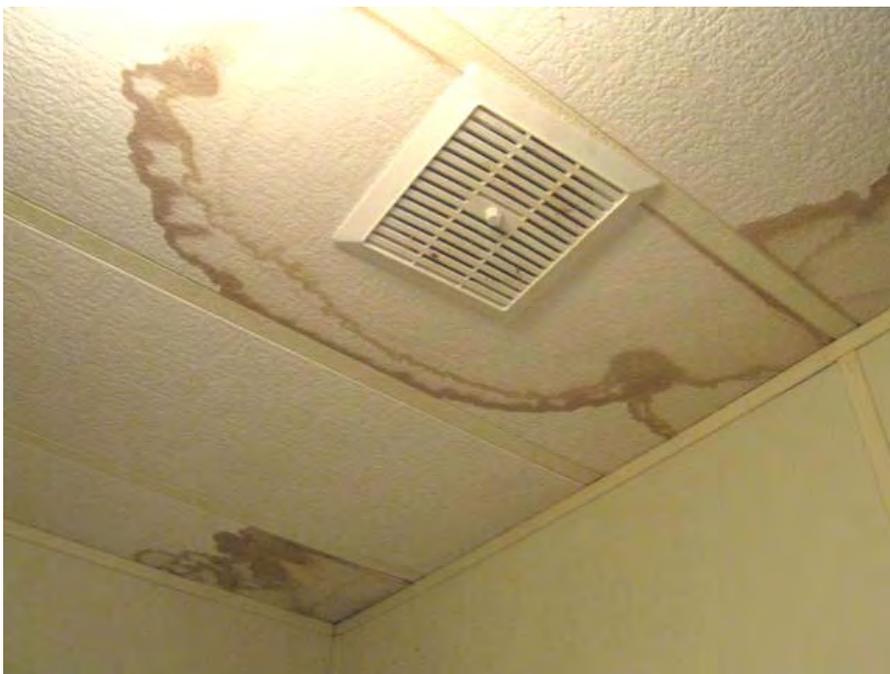
Picture 10

Water-damaged ceiling tiles in portable classroom B

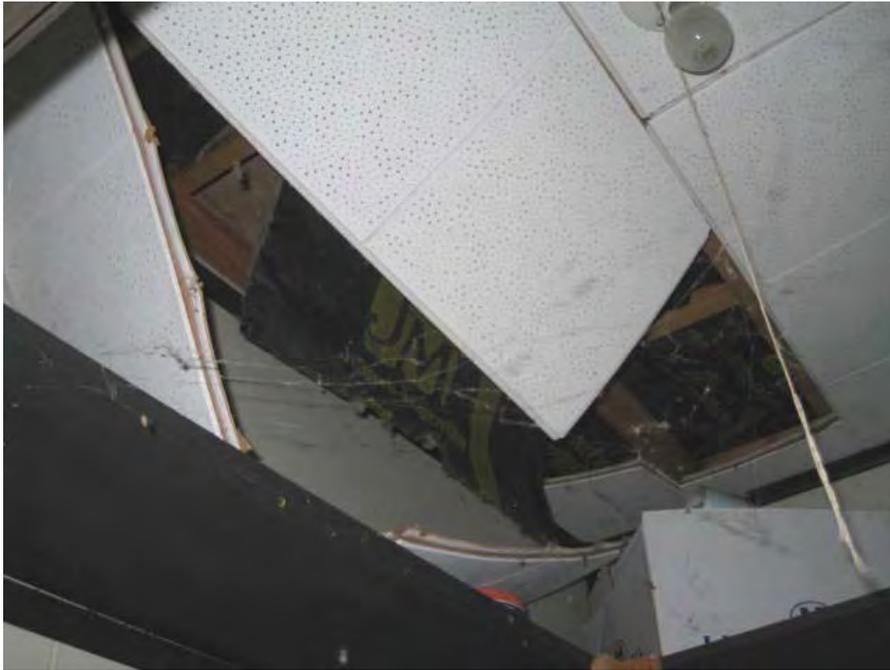
Picture 11

Failing/water-damaged closet ceiling in portable classroom A

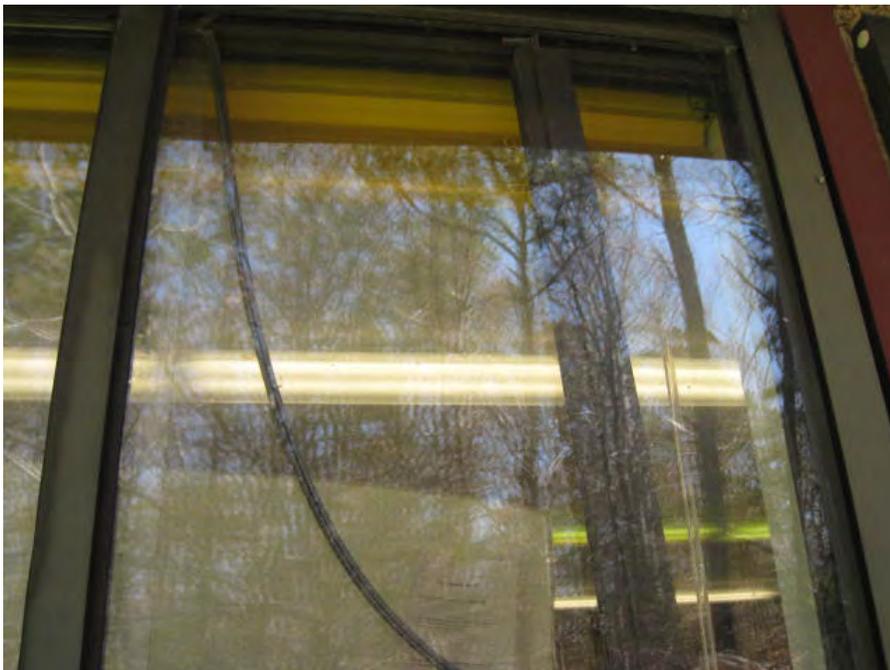
Picture 12

Failing window strip caulking in portable classroom B

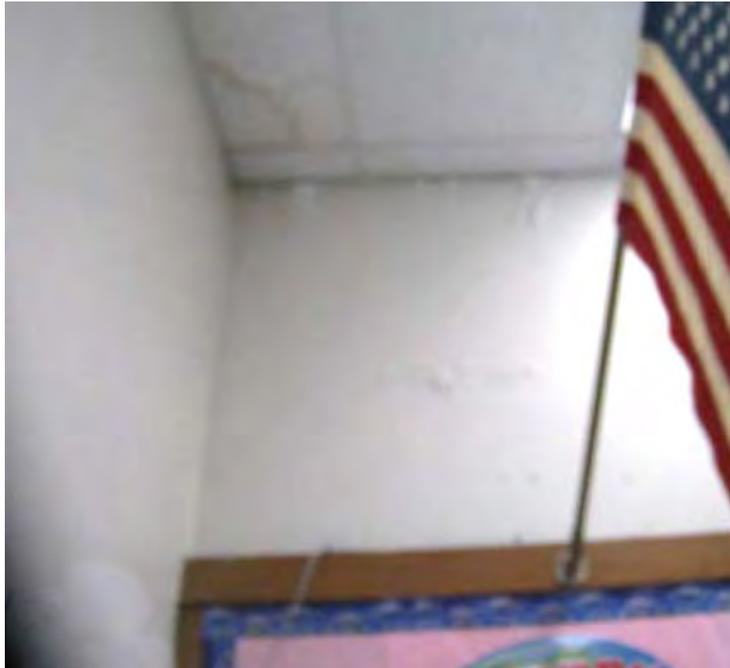
Picture 13

Water-damaged building material in classroom 13

11. Repair breach/damaged section of wooden fascia along roof edge outside of classroom 13 to prevent water/pest infiltration/damage. Once completed, repair/refinish water-damaged ceiling and walls inside classroom.

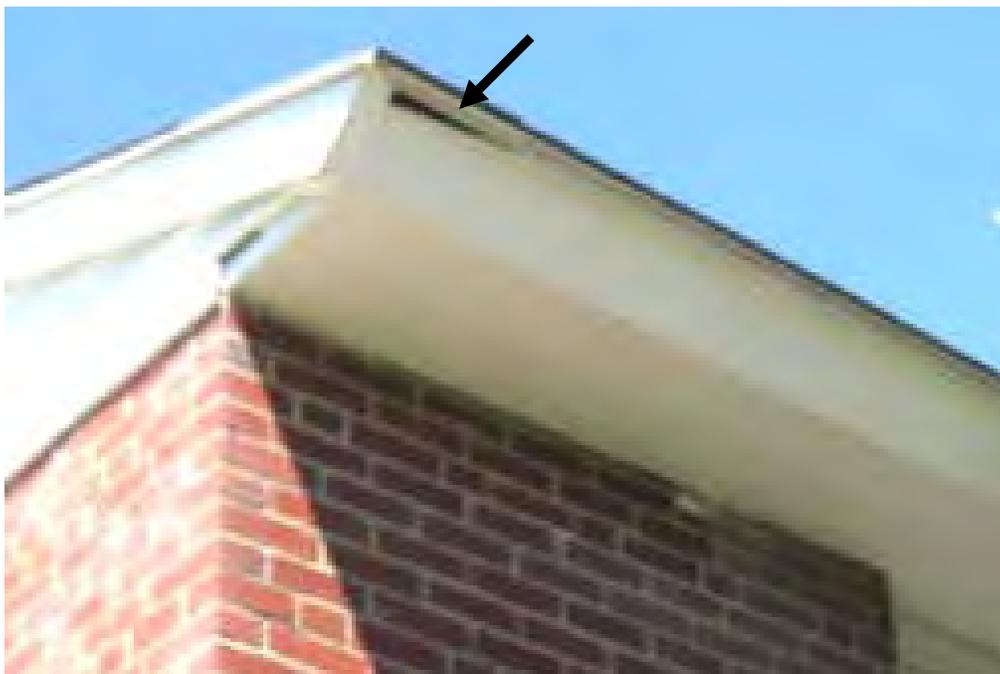
Picture 14

exterior of this area and found a breach/damage to the fascia near the roof, which likely serves as the source of water penetration causing the damage (Picture 14).

Breach in exterior fascia (arrow) outside of classroom 13

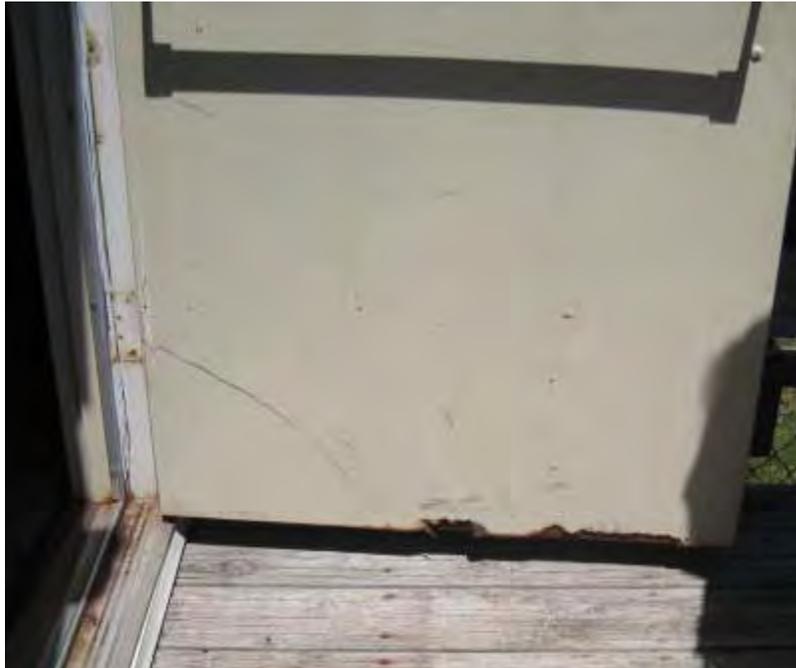
Picture 15

BEH/IAQ staff examined the exterior of the portable classrooms to identify breaches in the building envelope and/or other issues that could provide a source of water penetration. Portable classrooms showed numerous signs of damage and deterioration. As previously mentioned, portable classrooms were added in the late 1970s and mid 1980s and as reported by BPS officials, and at least one of them was reportedly previously used condition at the time it was installed. These reports, as well as the observed present condition, would indicate that they are being used far beyond their intended service life. Along the exterior, numerous breaches were noted to the underside, exterior doors, walls and along the roof edge of portable classrooms (Pictures 15 through 19), which could allow pest entry or increased water damage that could lead to mold growth. Portable classrooms had leaking windows (Picture 12) and clogged/missing/damaged gutters and downspouts which can enhance water penetration issues and create water pooling around the buildings (Picture 20).

Corroded/damaged metal exterior door

15. Replace missing/damaged weather-stripping on exterior doors (e.g., portables) to prevent drafts, moisture infiltration and pest entry. Ensure tightness of doors by monitoring for light penetration and drafts around doorframes.

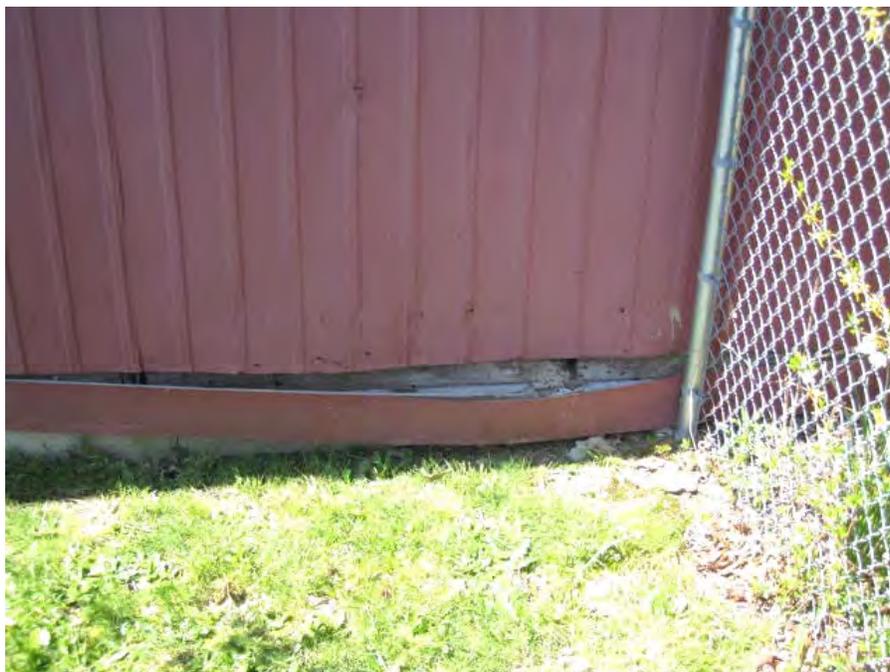
Picture 16

Damaged siding exposing insulation of portable classroom

17. Seal spaces/breaches and/or open utility holes around exterior of the building.
18. Ensure indoor plants are equipped with drip pans. Examine drip pans periodically for mold growth and disinfect with an appropriate antimicrobial, as needed. Move plants away from the air stream of mechanical ventilation equipment.

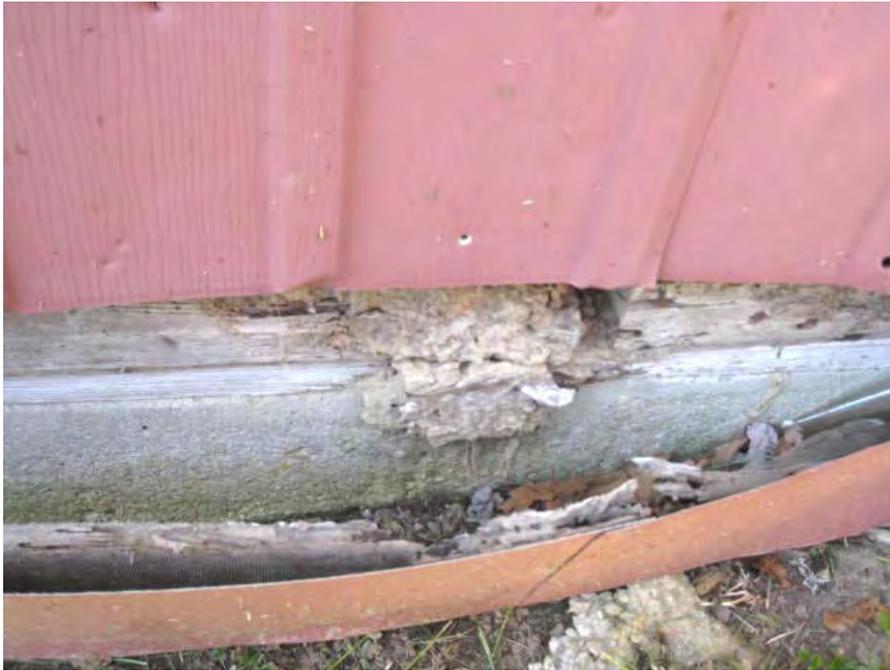
Picture 17

Damaged siding exposing insulation of portable classroom

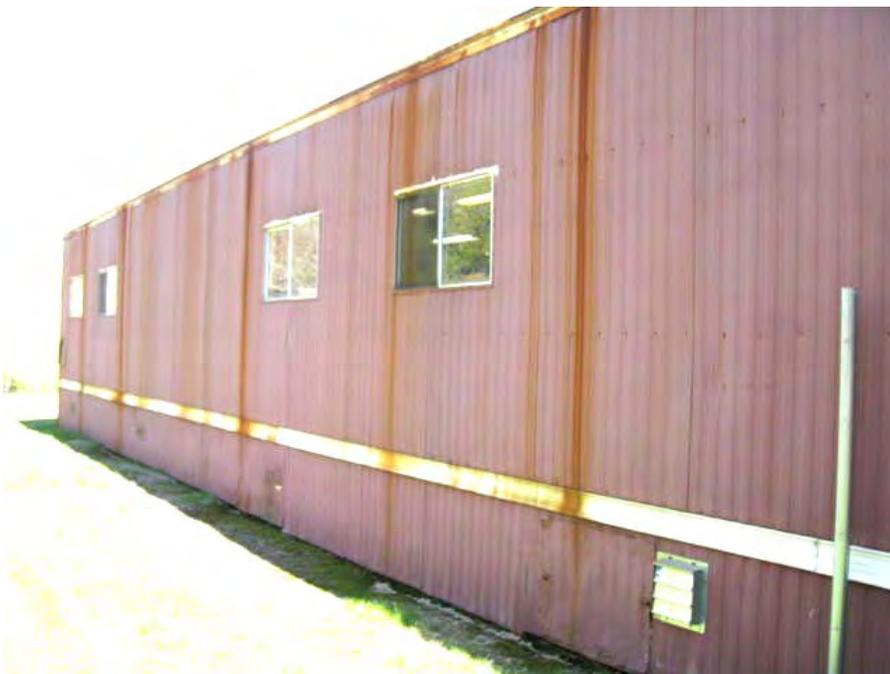
Picture 18

Rusted/corroded siding (as indicated by dark vertical staining)

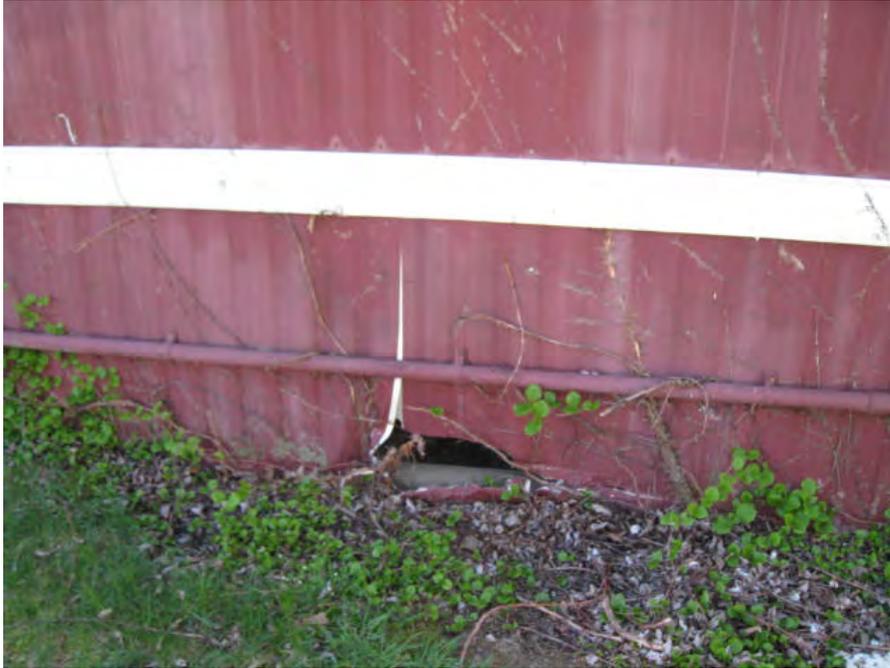
Picture 19

Missing/damaged siding to portable classroom

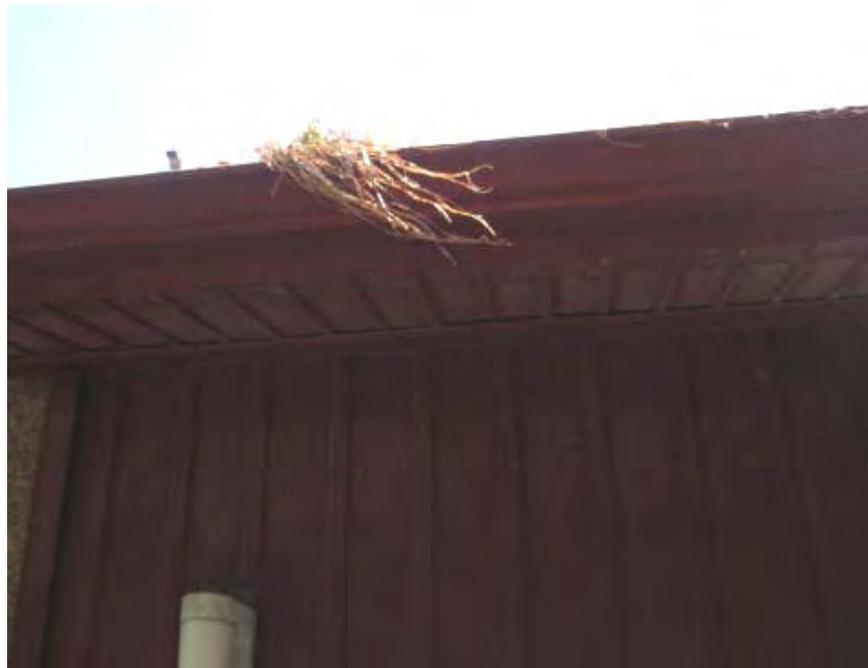
Picture 20

Gutter to portable classroom clogged with debris

14. Make repairs to existing gutter and downspout systems; replace missing elbow extensions to drain water away from the building. Clean out gutters on regular basis to prevent blockage.

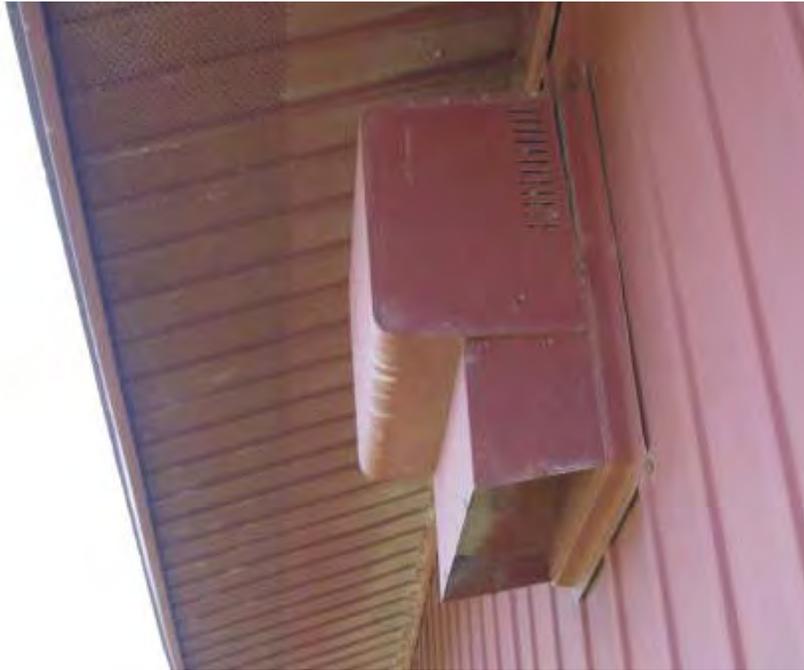
Picture 21

Bird nesting materials were observed inside an abandoned exhaust vent along the exterior of portable classroom B (Pictures 21 and 22). Birds can be a source of disease, and bird wastes and feathers can contain mold and mildew, which can be irritating to the respiratory system. No obvious signs of bird roosting inside the building was noted by BEH/IAQ staff or reported by occupants; however, the vent should be properly sealed.

Abandoned exhaust vent on exterior of portable classroom B

16. Remove bird nesting materials from abandoned exhaust vent on exterior of portable classroom B. If not functional, seal to prevent reoccupation; if vent is restored it must be cleaned and disinfected with an antimicrobial agent prior to reactivation.

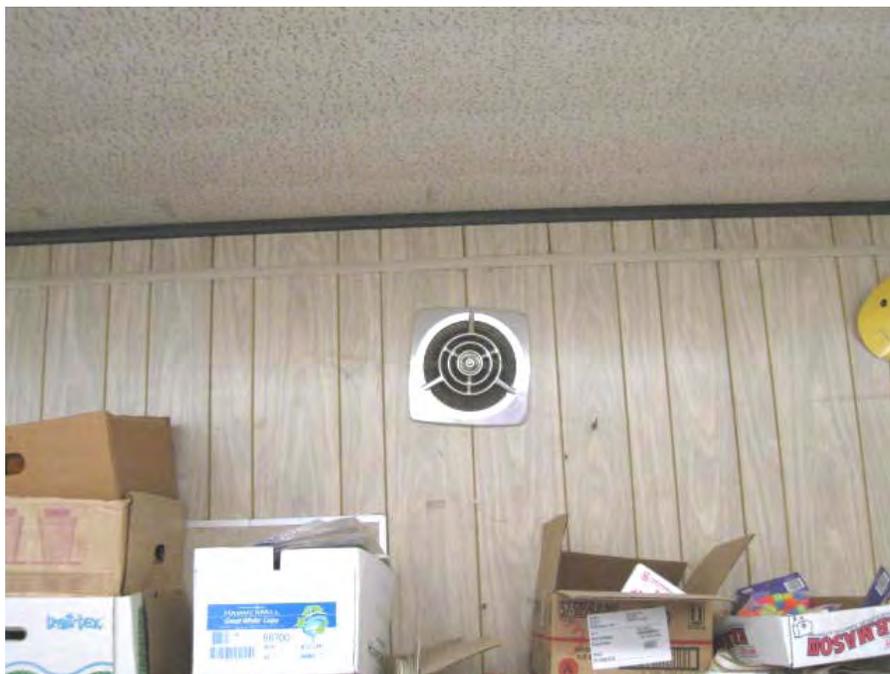
Picture 22

Interior view of abandoned exhaust vent in preceding picture
