INDOOR AIR QUALITY ASSESSMENT

**Lester J. Gates Intermediate School
327 1st Parish Road
Scituate, Massachusetts**

Prepared by:
Massachusetts Department of Public Health
Bureau of Environmental Health
Indoor Air Quality Program
June 2013

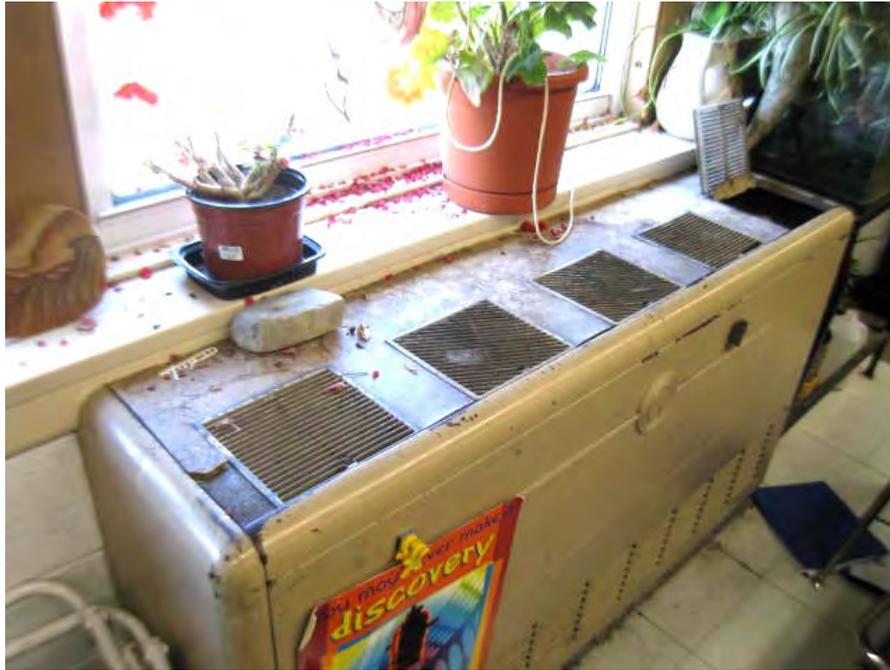
Picture 1

Fresh air to the majority of classrooms is supplied by unit ventilator (univent) systems (Pictures 1 and 2). A univent draws air from the outdoors through a fresh air intake located on the exterior wall of the building (Pictures 3 and 4). Return air from the classroom is drawn

Note that the univents are original equipment and thus more than 50 years old. Function of equipment of this age is difficult to maintain, since compatible replacement parts are often unavailable. According to the American Society of Heating, Refrigeration and Air-Conditioning Engineers (ASHRAE), the service life¹ for a unit heater, hot water or steam is 20 years, assuming routine maintenance of the equipment (ASHRAE, 1991). Despite attempts to maintain the univents, the operational lifespan of the equipment has been exceeded. Maintaining the balance of fresh air to exhaust air will become more difficult as the equipment ages and as replacement parts become increasingly difficult to obtain.

Early 1950s vintage univent, note plants/plant debris near unit and on flat surfaces

1. Operate all ventilation systems throughout the building including univents and interior classroom HVAC systems continuously during periods of occupancy to maximize air exchange. Continue to work with an HVAC engineering firm to adjust/repair univents and exhaust vents to improve air exchange in classrooms.
2. Remove all blockages/items from the surface of univent air diffusers and return vents (along front/bottom) to ensure adequate airflow. Remove all blockages from exhaust vents.

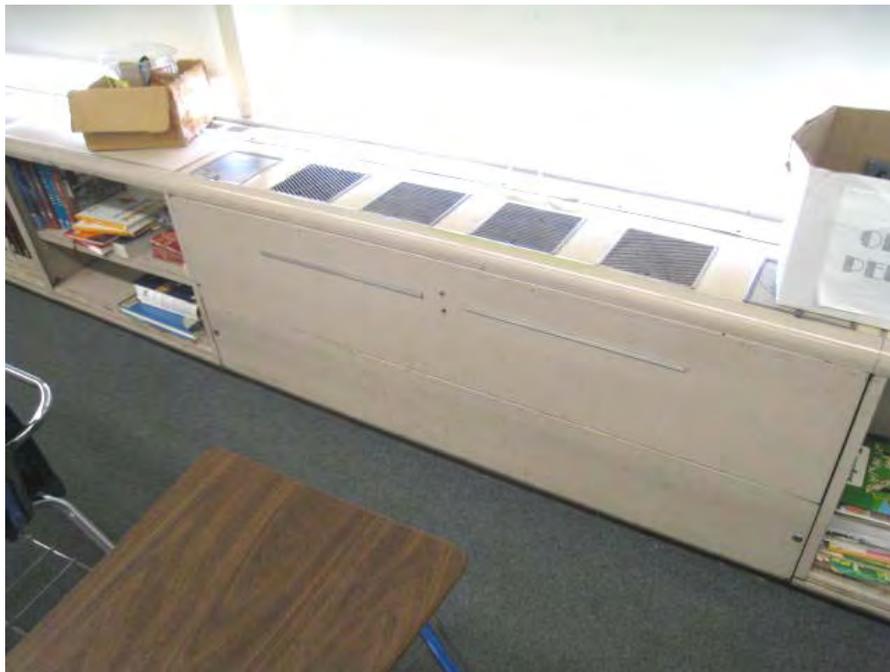
Picture 2

Mid 1950s vintage univent

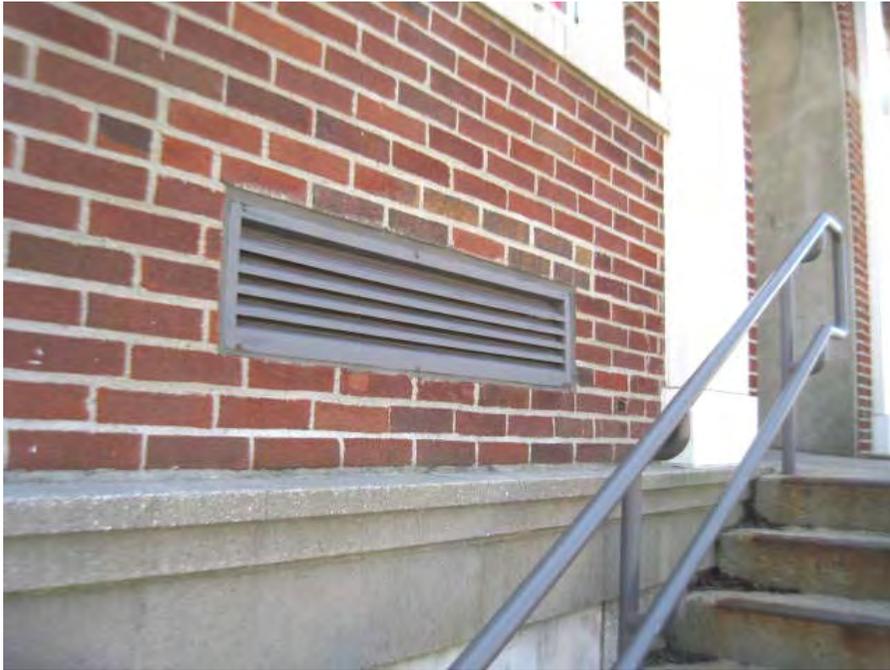
Picture 3

Univent fresh air intake

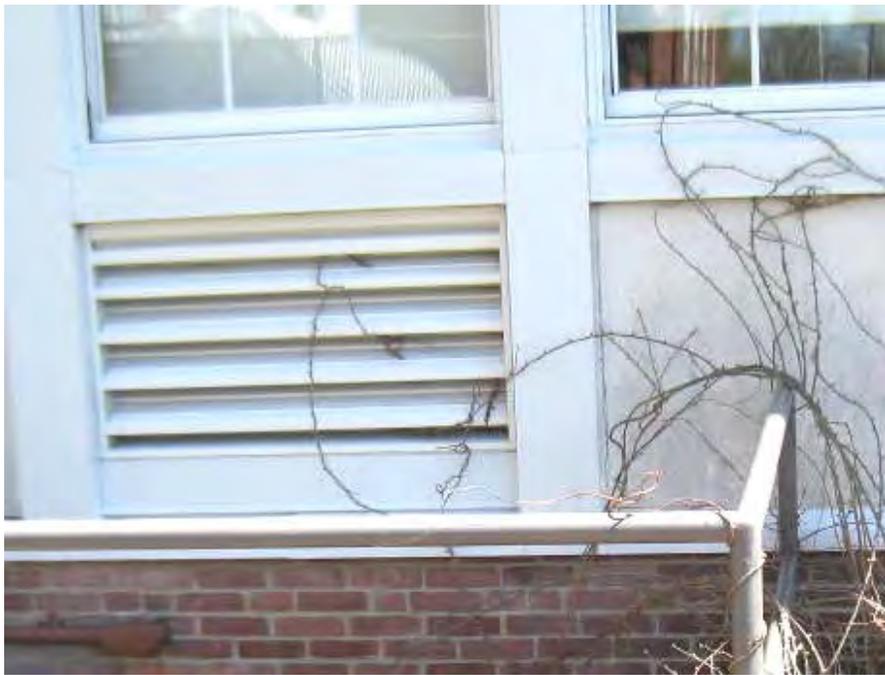
Picture 4

During an examination of the exterior of the building, BEH/IAQ staff observed plants and shrubs in close proximity to the building in some areas, including directly adjacent to univent air intakes (Picture 4). Shrubs/trees in close proximity to the building hold moisture against the building exterior and prevent drying. The growth of roots against exterior walls can bring moisture in contact with the foundation. Plant roots can eventually penetrate the wall, leading to cracks and/or fissures in the sublevel foundation. Over time, these conditions can undermine the integrity of the building envelope and provide a means of water entry into the

Univent fresh air intake, note plant growth near/on intake

8. Ensure plants, trees and shrubs are located at least five feet away from exterior walls/foundation of the building and inspect univent air intakes for plant intrusion.

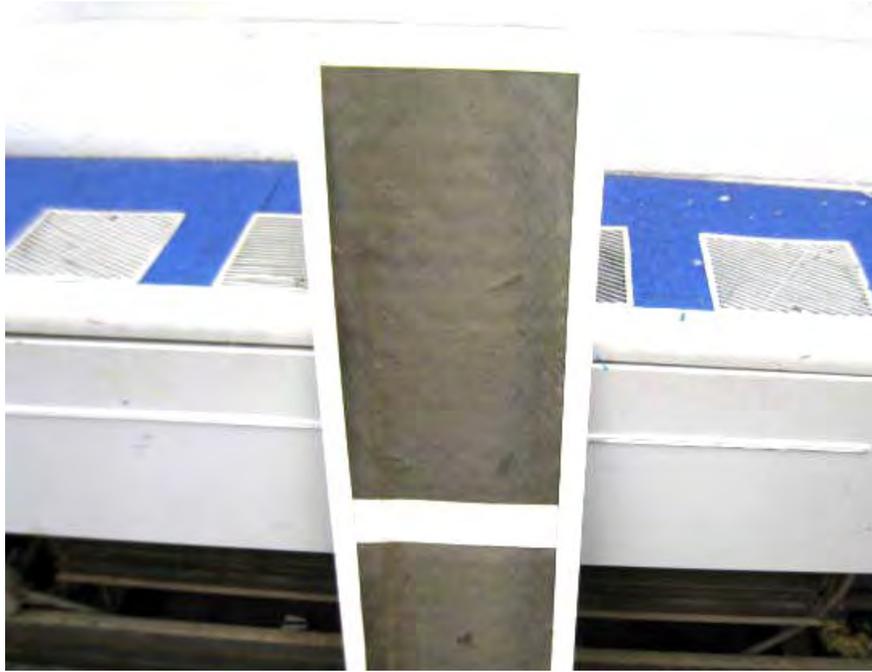
Picture 5

It was reported to BEH/IAQ staff that filters are only changed once a year. In the experience of BEH/IAQ staff, univent filters are typically replaced two to four times a year in other school districts across the state. Univents examined had filters occluded with dust and debris (Pictures 5 and 6). In addition, accumulated dust/debris was noted on the inside of cabinets, radiator fins and other components (Pictures 7 and 8). This material should be cleaned/removed during regular filter changes.

Univent filter occluded with dust/debris

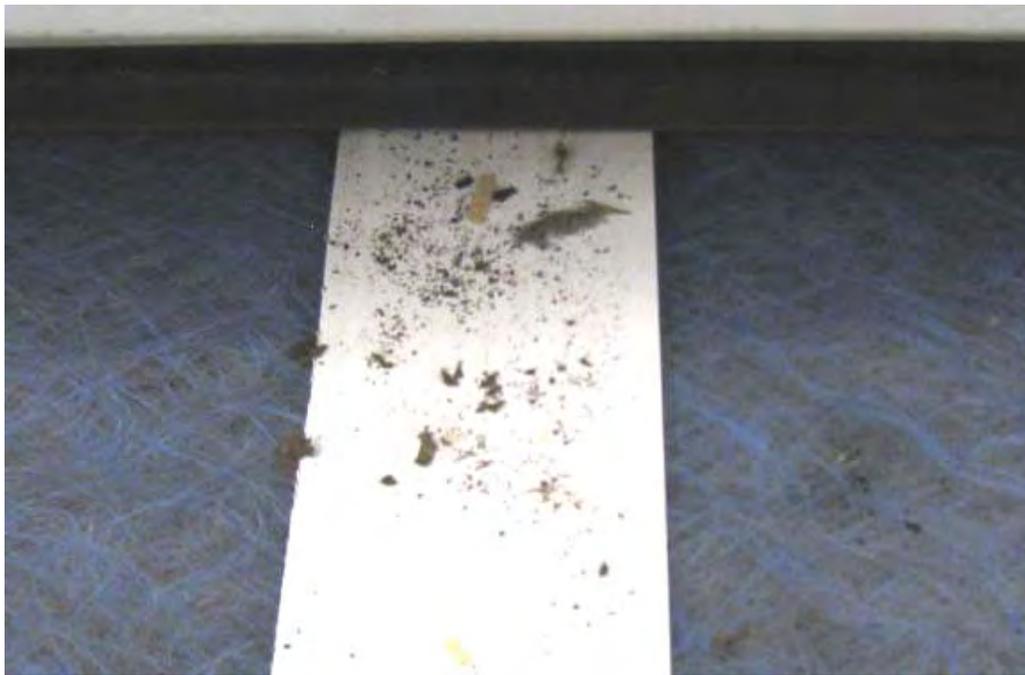
Picture 6

Loose dust/debris on filter inside univent

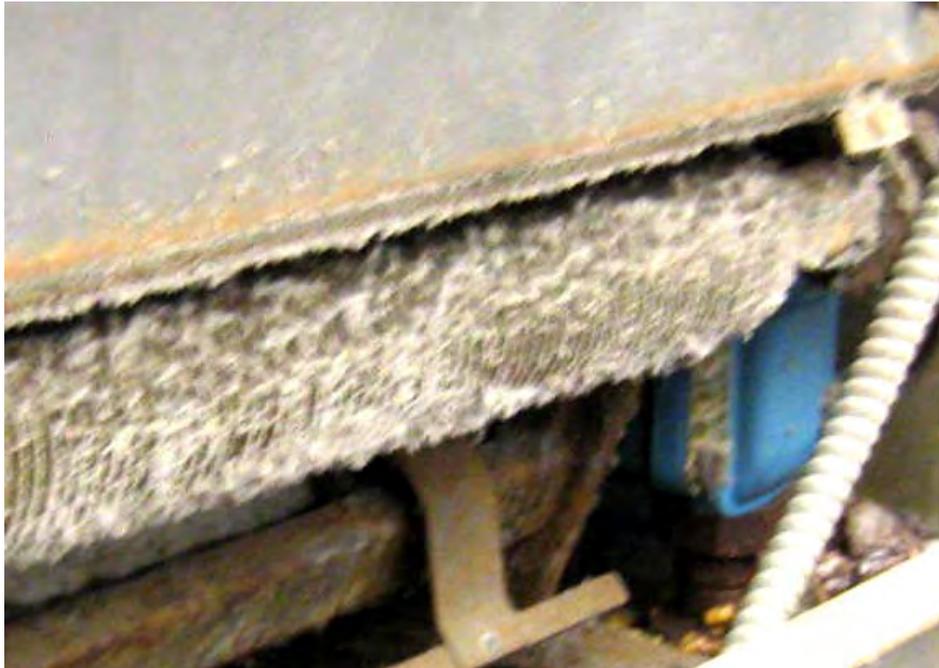
Picture 7

Dust/debris accumulation inside univent

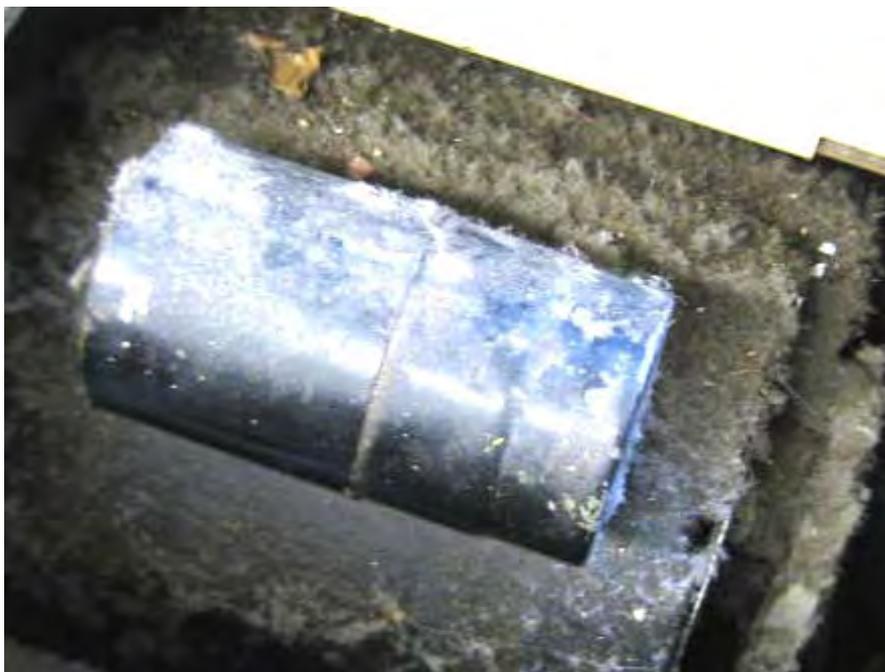
Picture 8

Dust/debris accumulation inside univent

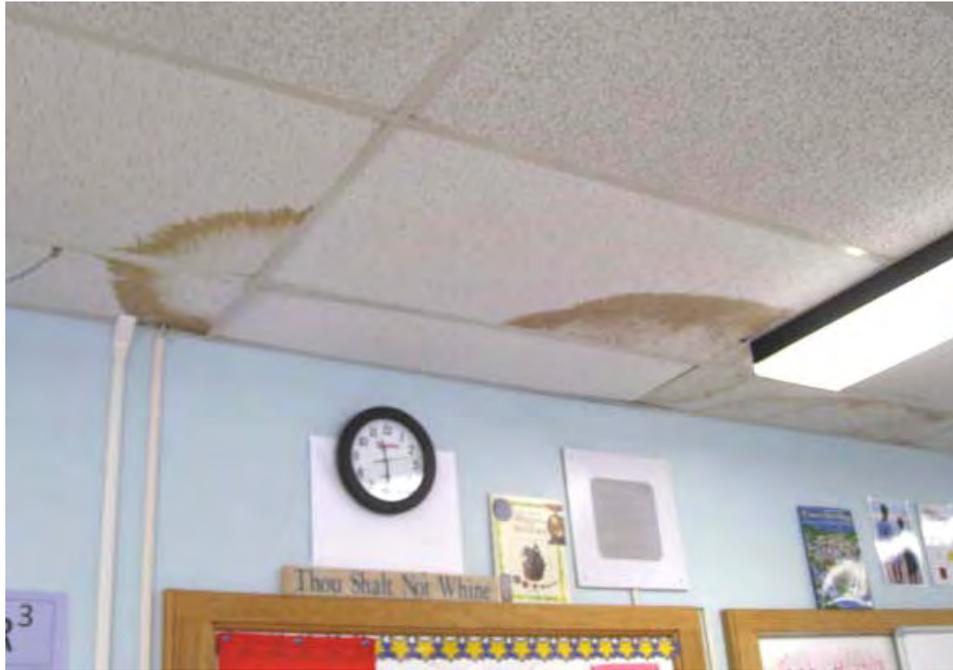
Picture 9

Water-stained ceiling tiles were observed in several classrooms (Table 1; Picture 9). These reportedly stemmed from historic roof leaks; since the most recent roof repairs have reportedly decreased leaks significantly. Water-damaged ceiling tiles should be replaced once a leak has been detected and repaired.

Water-damaged ceiling tiles

7. Replace any remaining water-damaged ceiling tiles. Examine the area above these tiles for mold growth. Disinfect areas of water leaks with an appropriate antimicrobial, as needed.

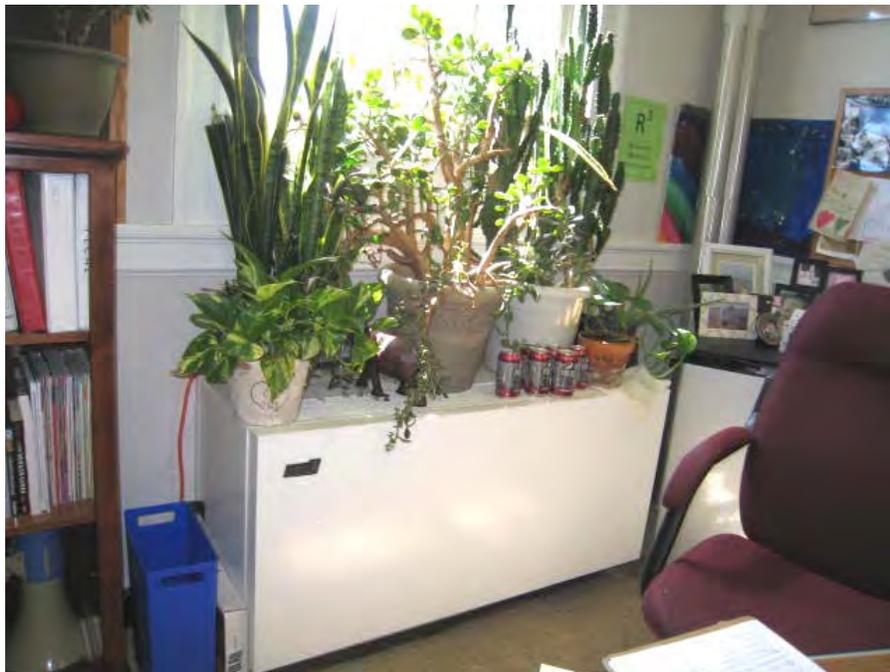
Picture 10

Plants were observed in some areas, including on top of univents (Table 1; Picture 10). Plants should be properly maintained and equipped with drip pans. Plants should also be located

away from ventilation sources to prevent aerosolization of dirt, pollen or mold. Plants should also not be placed on porous materials, since water damage to porous materials may lead to microbial growth.

Plants on univent

9. Ensure indoor plants are equipped with drip pans. Examine drip pans periodically for mold growth and disinfect with an appropriate antimicrobial, as needed. Move plants away from the air stream of mechanical ventilation equipment.

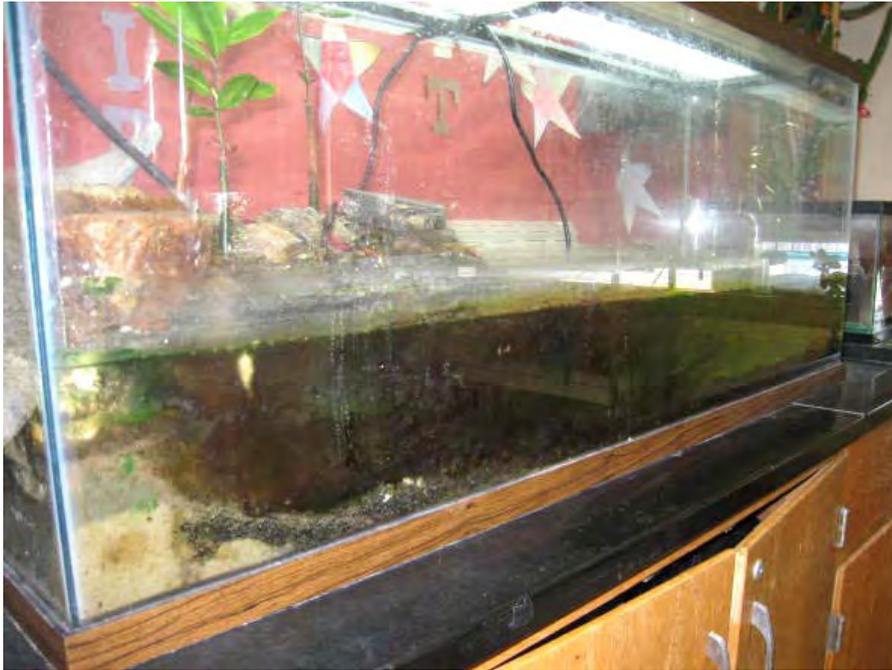
Picture 11

Several aquariums were located in one of the science classrooms, including one which appeared to have a large quantity of algal growth (Picture 11). Aquariums need to be properly maintained and cleaned so as not to emit odors; they should not be placed on or near univents.

Aquarium with algal growth

10. Clean and maintain aquariums regularly to prevent microbial growth and odors.
11. Consider relocating portable refrigerators and water dispensing equipment away from carpeted areas or using a waterproof mat to prevent spills from moistening carpet. Consider replacing carpeting with non-porous floor tiles in the vicinity of built-in sinks and drinking fountains.

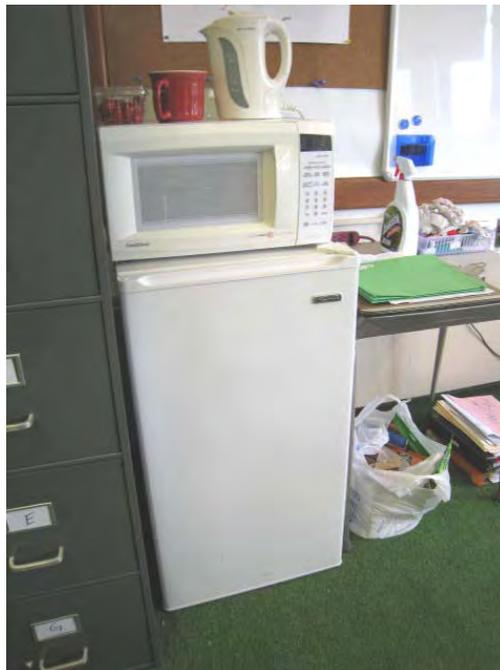
Picture 12

In some areas, refrigerators and water-dispensing equipment (e.g., sinks, drinking fountains) were observed to be located directly on carpeting (Table 1; Pictures 12 and 13). These appliances can leak or spill, which can moisten carpet. It is recommended that these items be located on a non-porous surface. Areas under sinks were examined and some were found to contain porous materials, which can become moistened due to leaks or condensation.

Refrigerator on carpet

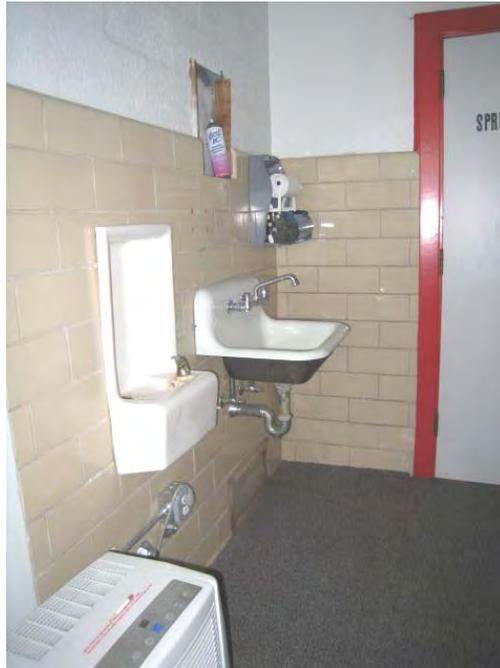
Picture 13

Sink and drinking fountain over carpeted area in weight room

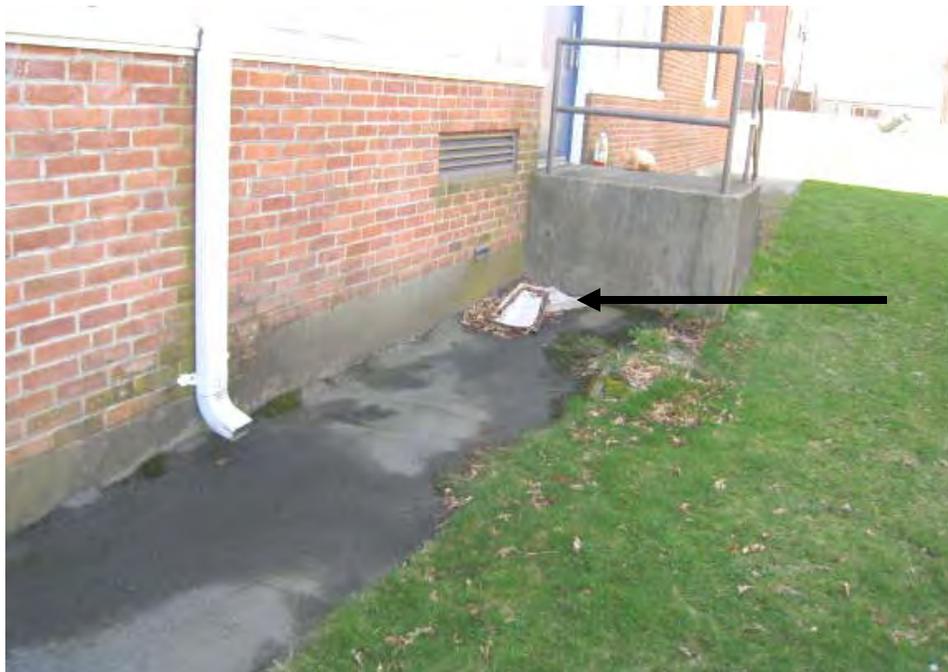
Picture 14

Some of the splash pads for gutter downspouts were found to be missing or had been moved away from the end of the downspout, allowing stormwater to impinge on and accumulate next to the building foundation (Picture 14). These pads should be replaced/put back to direct rainwater away from the building.

Downspout splash footer moved from end of downspout (arrow)

14. Replace the splash footings beneath gutter downspouts to direct rainwater away from the foundation.
15. Store cleaning products properly and out of reach of students. All cleaning products used at the facility should be approved by the school department with MSDS' available at a central location.

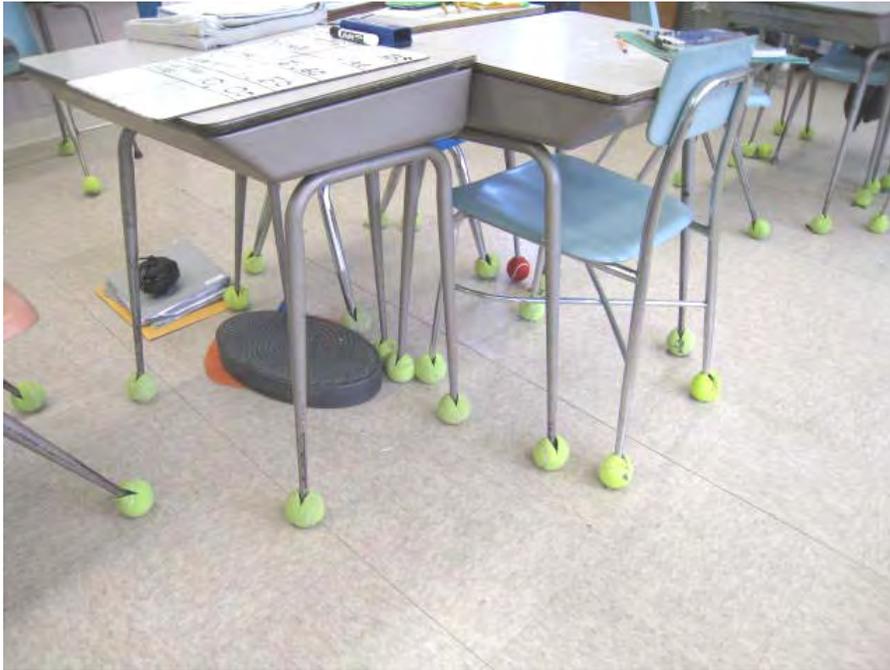
Picture 15

In an effort to reduce noise, tennis balls had been sliced open and placed on the base of desk/chair legs in some classrooms (Picture 15). Tennis balls are made of a number of materials that are a source of respiratory irritants. Constant wearing of tennis balls can produce fibers and cause VOCs to off-gas. Tennis balls are made with a natural rubber latex bladder, which becomes abraded when used as a chair leg pad. Use of tennis balls in this manner may introduce latex dust into the school environment. Some individuals are highly allergic to latex (e.g., spina

bifida patients) (SBAA, 2001). It is recommended that the use of materials containing latex be limited in buildings to reduce the likelihood of symptoms in sensitive individuals (NIOSH, 1997).

Tennis balls being used as glides

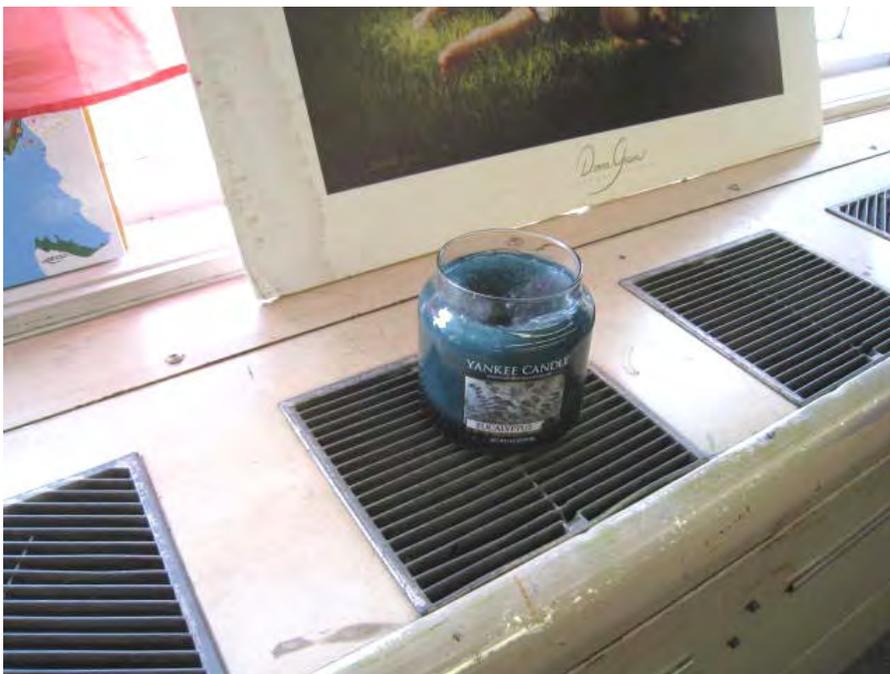
Picture 16

Air fresheners, deodorizing materials and other scented products were observed in some areas (Table 1; Picture 16). Air deodorizers contain chemicals that can be irritating to the eyes, nose and throat of sensitive individuals. Many air fresheners contain 1,4-dichlorobenzene, a VOC which may cause reductions in lung function (NIH, 2006). Furthermore, deodorizing agents do not remove materials causing odors, but rather mask odors that may be present in the area.

Scented candle on univent

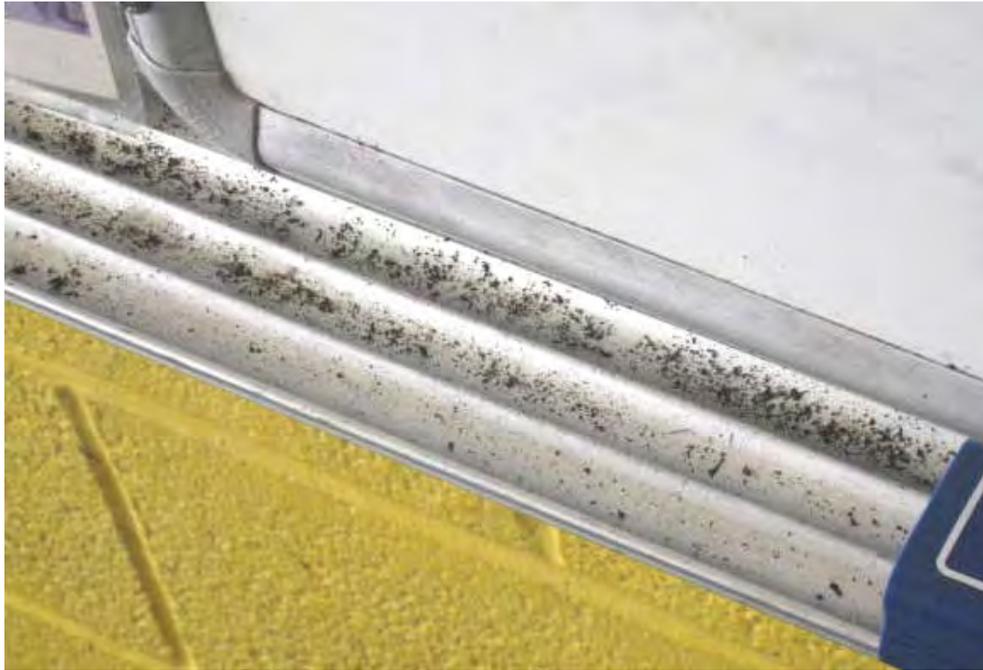
Picture 17

Accumulation of dry erase debris

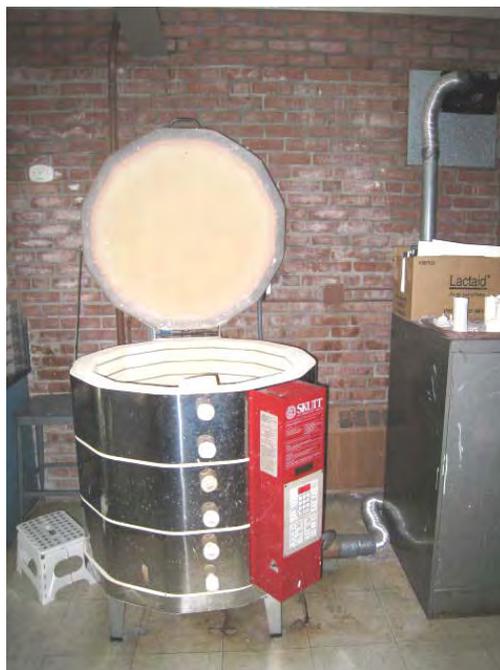
Picture 18

Other conditions that can affect indoor air quality were observed during the assessment. A pottery kiln was observed in room C102 (Picture 18). Pottery kilns can be a significant source of water vapor, particulate and other related pollutants when operating. In addition, a pottery kiln is a source of waste heat that can present a safety/fire hazard. The kiln appeared to be

electrically operated with an exhaust vent from the back of the unit. Kilns should be vented directly outdoors and kept away from students. If possible, limit operation of the kiln to periods when the room will be unoccupied for the entire cycle. It was reported that the kiln is professionally inspected every year to ensure proper/safe functioning. Bottles of pottery glazing materials were examined and they were labeled as “lead free”, which is appropriate and recommended to protect the safety and health of staff and students.

Pottery kiln

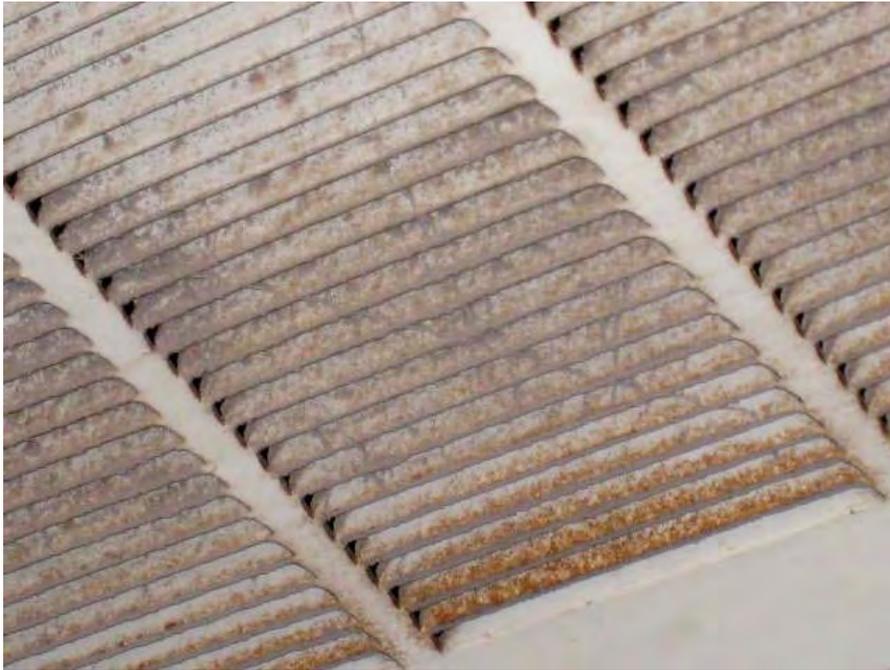
Picture 19

Dust was also observed accumulated on the blades of personal fans, univent diffusers and exhaust vents (Picture 19). Univents, exhaust vents and fans should be cleaned periodically in order to prevent them from serving as a source of aerosolized particulates.

Dusty exhaust vent

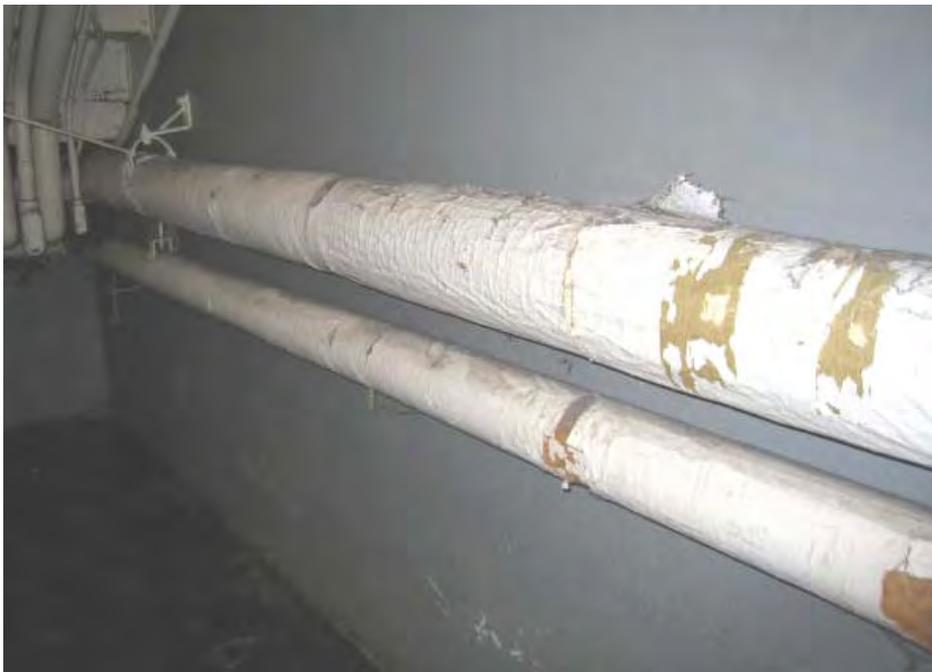
Picture 20

Exposed fiberglass insulation was observed in the B-wing hallway (Picture 20). Fiberglass can be a source of irritation to the skin, eyes and respiratory system. Pipe wrapping should be examined, and exposed insulation should be re-wrapped to prevent aerosolization of fiberglass materials.

Exposed fiberglass insulation around pipes in the lower level of B wing

23. Encapsulate exposed fiberglass insulation (e.g., damaged pipes).
24. Clean carpeting annually or semi-annually in soiled high traffic areas as per the recommendations of the Institute of Inspection, Cleaning and Restoration Certification (IICRC). Copies of the IICRC fact sheet can be downloaded at: http://1.cleancareseminars.net/?page_id=185 (IICRC, 2005).
