# **INDOOR AIR QUALITY ASSESSMENT**

**Massachusetts Commission for the Blind  
436 Dwight Street  
Springfield, Massachusetts**

Prepared by:  
Massachusetts Department of Public Health  
Bureau of Environmental Health  
Indoor Air Quality Program  
May 2013

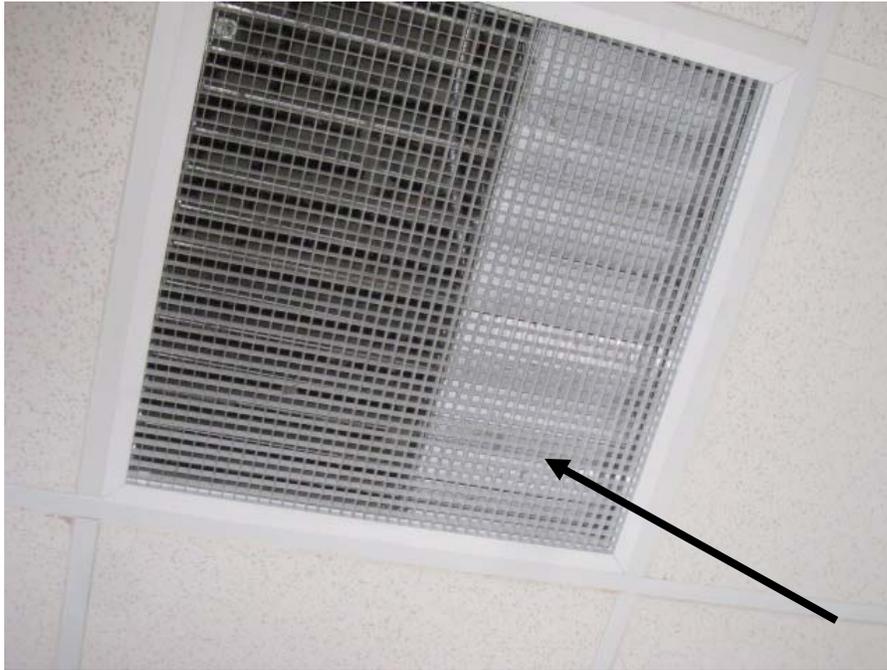
**Picture 1**

Heating, ventilation and air-conditioning (HVAC) is provided by rooftop air-handling units (AHUs). Fresh air is drawn into the AHUs and delivered to occupied areas via ceiling-mounted air diffusers. Return air is drawn into the ceiling plenum via ceiling-mounted exhaust grates and directed back into the AHU. BEH/IAQ staff observed that corrugated decking partially obstructed a return vent (Picture 1). This type of blockage can impede the ability of the HVAC system to remove normally-occurring environmental pollutants.

**Return vent: note corrugated decking obstruction (arrow)**

1. Continue operating all mechanical HVAC systems to provide fresh air during occupied periods. Remove any blockages from supply or exhaust ventilation, such as from the exhaust vent shown in Picture 1.
2. Consider adopting a balancing schedule of every 5 years for all mechanical ventilation systems, as recommended by ventilation industry standards (SMACNA, 1994).
3. For buildings in New England, periods of low relative humidity during the winter are often unavoidable. Therefore, scrupulous cleaning practices should be adopted to

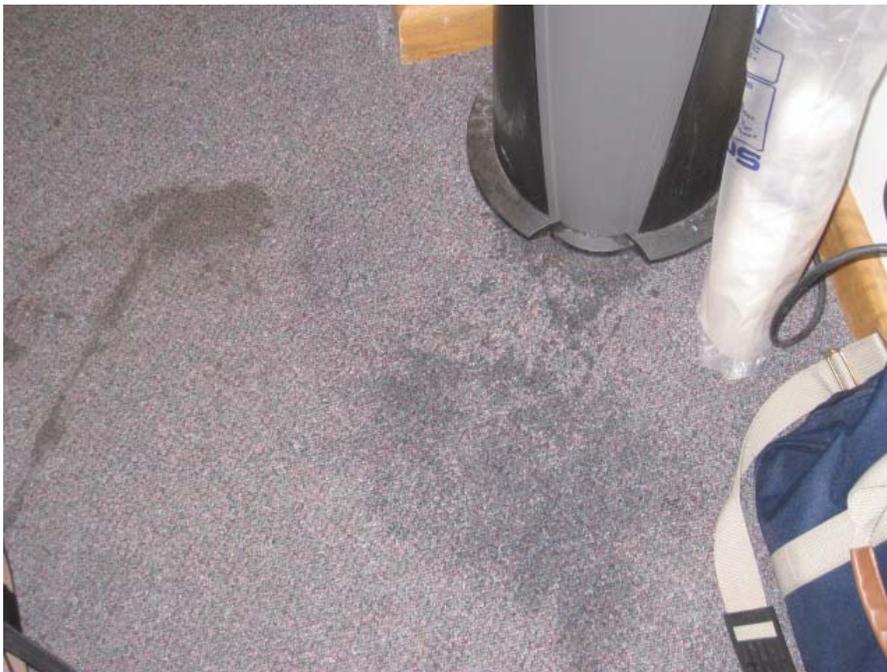
**Picture 2**

In order for building materials to support mold growth, a source of water exposure is necessary. No evidence of building leaks, plumbing leaks or water damage were observed in the MCB office space. However, BEH/IAQ staff observed wet carpeting around a water dispenser located in the conference room/lounge (Picture 2). Spills/condensation from these appliances can lead to water damage and mold growth. When possible, water dispensers should be located in tiled areas or placed on a waterproof mat.

**Wet carpeting surrounding water dispenser**

4. Consider moving water dispensing equipment to areas with tiled floors instead of carpeting, or installing waterproof mats to prevent leaks from damaging carpet.

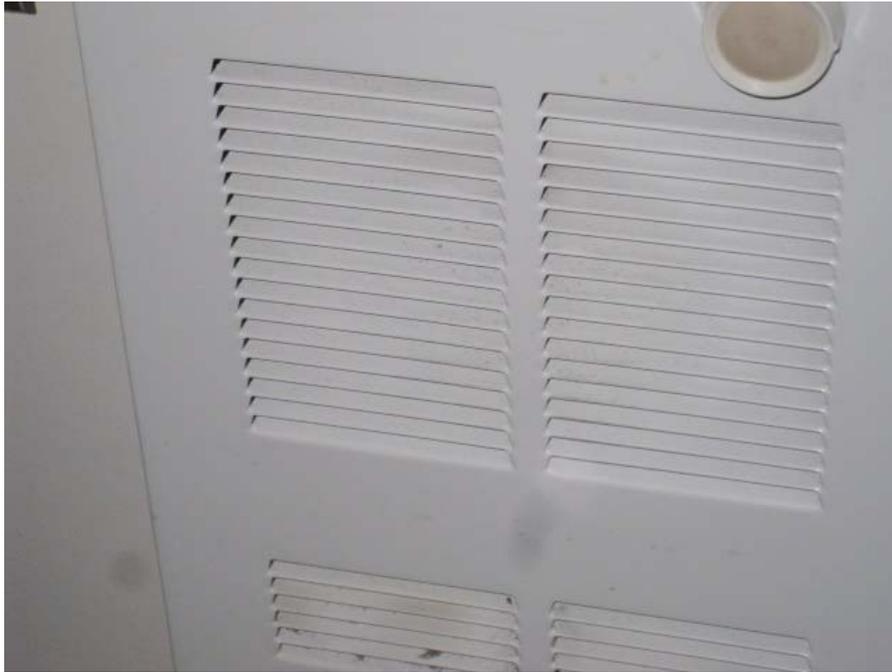
**Picture 3**

Other conditions that can affect indoor air quality were observed during the assessment. Offices located on the exterior walls of the MCB were equipped with wall-mounted electric heaters (Picture 3). Vents and fan blades from these units can accumulate dust/debris. Re-activated fans can aerosolize accumulated dust. Fans should be cleaned regularly to prevent aerosolization of dust.

**Wall-mounted electric heater vent: note dust on grates**

5. Clean air diffusers, return vents and electric heater vents/ fans periodically of accumulated dust/debris.
6. Relocate or consider reducing the amount of materials stored in offices and common areas to allow for more thorough cleaning. Relocate or consider reducing the amount of materials stored in offices and common areas to allow for more thorough cleaning.

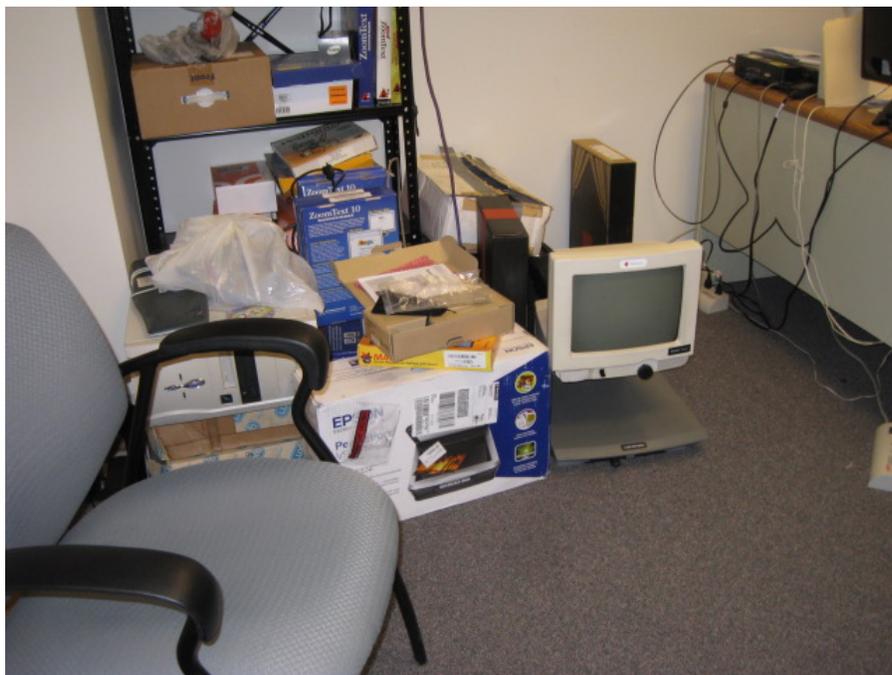
**Picture 4**

In a number of areas, items were observed on the floors, windowsills, bookcases and desks (Pictures 4 and 5). The large number of items stored provides a source for dusts to accumulate. These items (e.g., papers, folders, boxes) make it difficult for custodial staff to clean. Items should be relocated and/or be cleaned periodically to avoid excessive dust build up.

**Items stored on floor in office space**

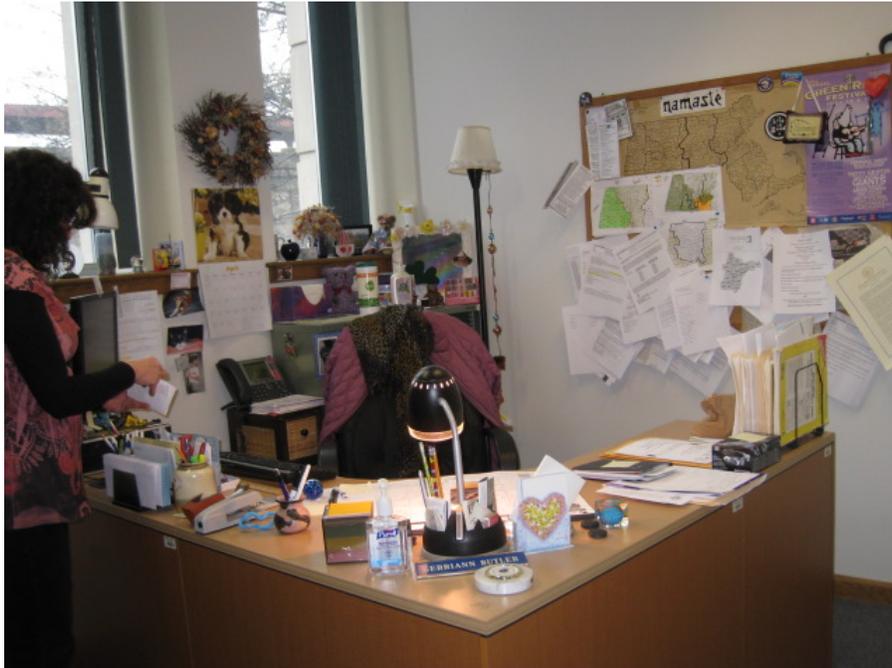
**Picture 5**

**Office space cluttered with items**

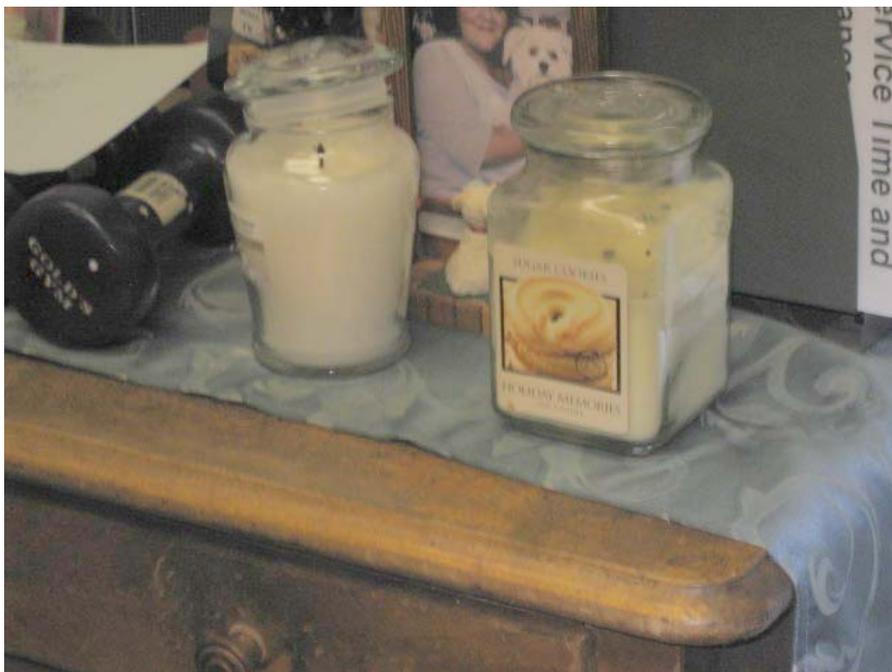
**Picture 6**

Scented candles (Picture 6) were noted in one administrative office. Scented candles contain chemicals that can be irritating to the eyes, nose and throat of sensitive individuals. Furthermore, deodorizing agents do not remove materials causing odors, but rather mask odors that may be present in the area.

**Scented candles in office space**

8. Refrain from having scented candles or using air fresheners/deodorizers to prevent exposure to VOCs.
9. Vacuum upholstered furniture/pillows/cushions frequently and clean annually. If not feasible, consider removal.

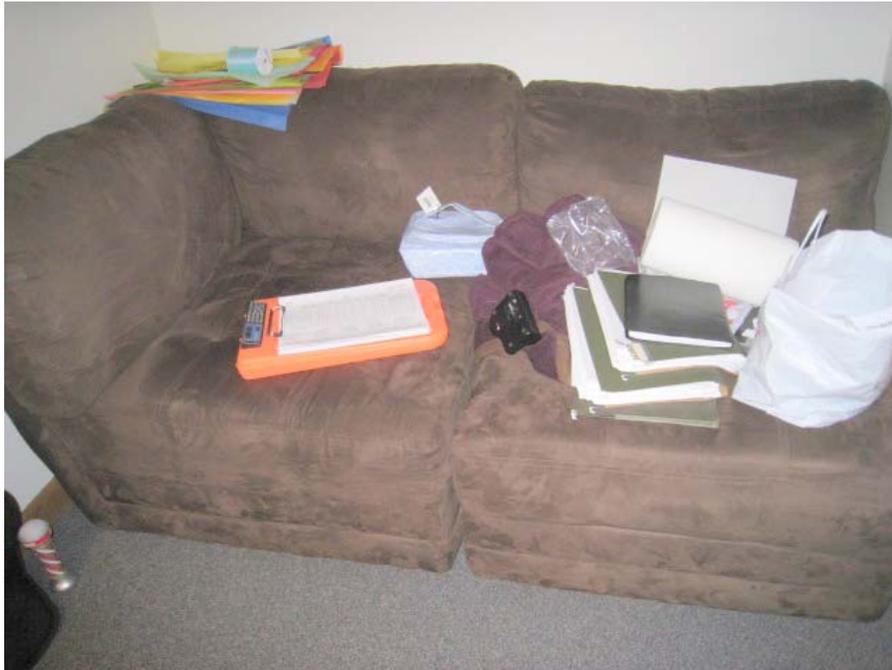
**Picture 7**

MCB staff reported that the office space was infested with fleas during the summer of 2012, which coincided with the addition of a second-hand upholstered couch in one office (Table 1; Picture 7). Used furniture may carry insects as well as allergens and irritants such as pet hair and tobacco smoke. For this reason, the use of second-hand upholstered furniture is not recommended in an office environment. Upholstered furniture can be a vector for the transmission of bedbugs. They can hide in furniture, along walls, in draperies and under loose

In addition, upholstered furniture, pillows and cushions are covered with fabric that comes in contact with human skin. This type of contact can leave oils, perspiration, hair and skin cells. In addition to being a source for fleas, upholstered furniture may accumulate dust mites, which feed upon human skin cells and excrete waste products that contain allergens. In addition, if relative humidity levels increase above 60 percent, dust mites tend to proliferate (US EPA, 1992). In order to remove dust mites and other pollutants, frequent vacuuming of upholstered furniture is recommended (Berry, M.A., 1999). It is also recommended that upholstered furniture be professionally cleaned on an annual basis. If an excessively dusty environment exists due to outdoor conditions or indoor activities (e.g., renovations), cleaning frequency should be increased (every six months) (IICRC, 2000).

**Upholstered couch in office space**
