INDOOR AIR QUALITY ASSESSMENT

**Richer Elementary School
80 Foley Road
Marlborough, Massachusetts**

Prepared by:
Massachusetts Department of Public Health
Bureau of Environmental Health
Indoor Air Quality Program
August 2014

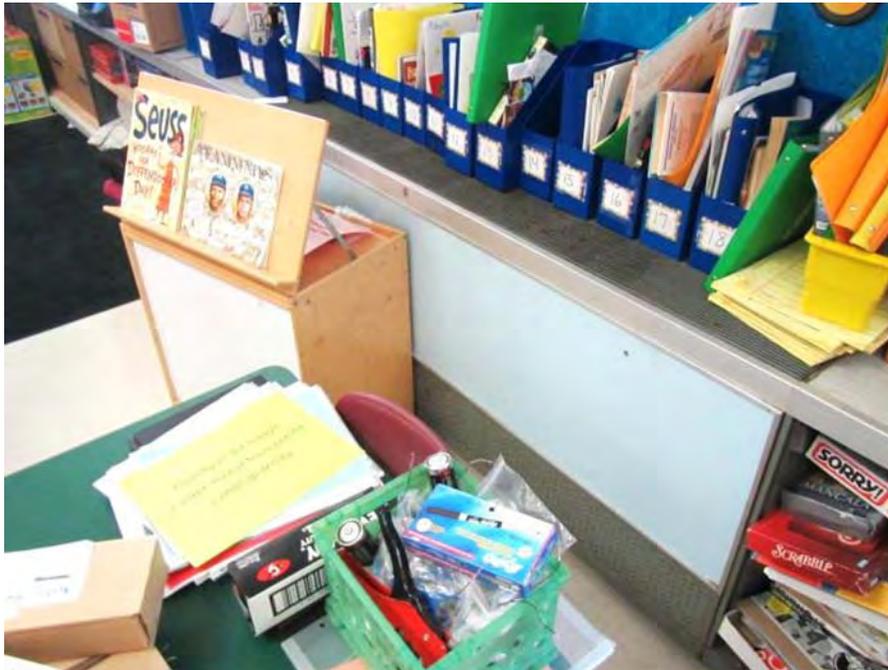
Picture 1

Univents were also found deactivated or obstructed with classroom items/furniture on top/front of units in a number of areas (Pictures 1 and 2; Table 1). The occupant in room 107 reported that the univent in that area was not operational. In order for univents to provide fresh air as designed, intakes/returns must remain free of obstructions. Importantly, these units must remain on and be allowed to operate while rooms are occupied.

Classroom univent, note front/return vent obstructed

4. Remove blockages/items from the surface of univent air diffusers and return vents (along front/bottom).
5. Remove all blockages from exhaust vents (items on top shelf of coat closets and curtains) to ensure adequate airflow.

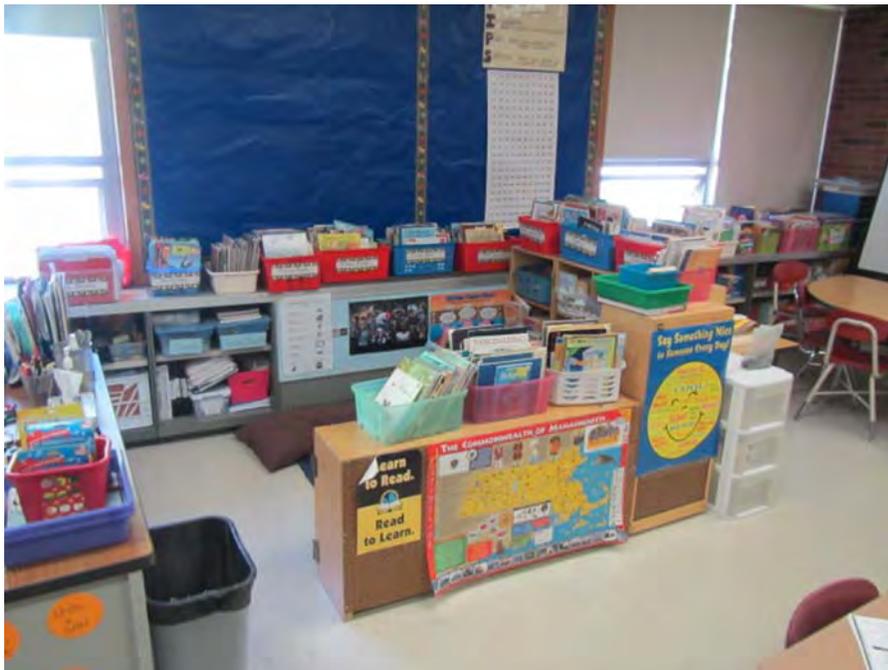
Picture 2

Airflow around univent obstructed by items

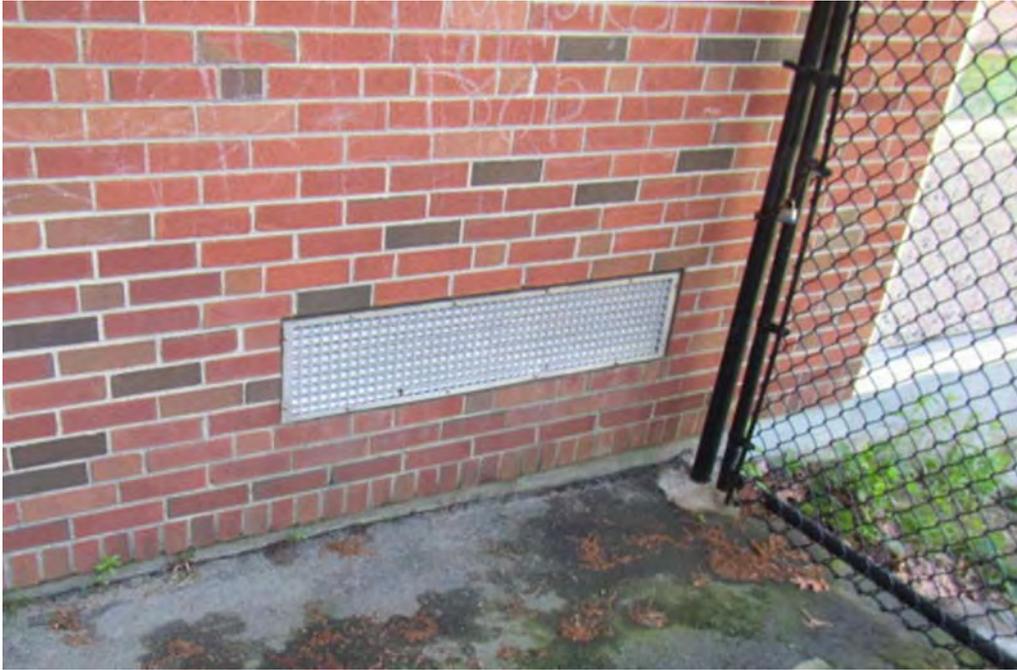
Picture 3

Univent fresh air intake

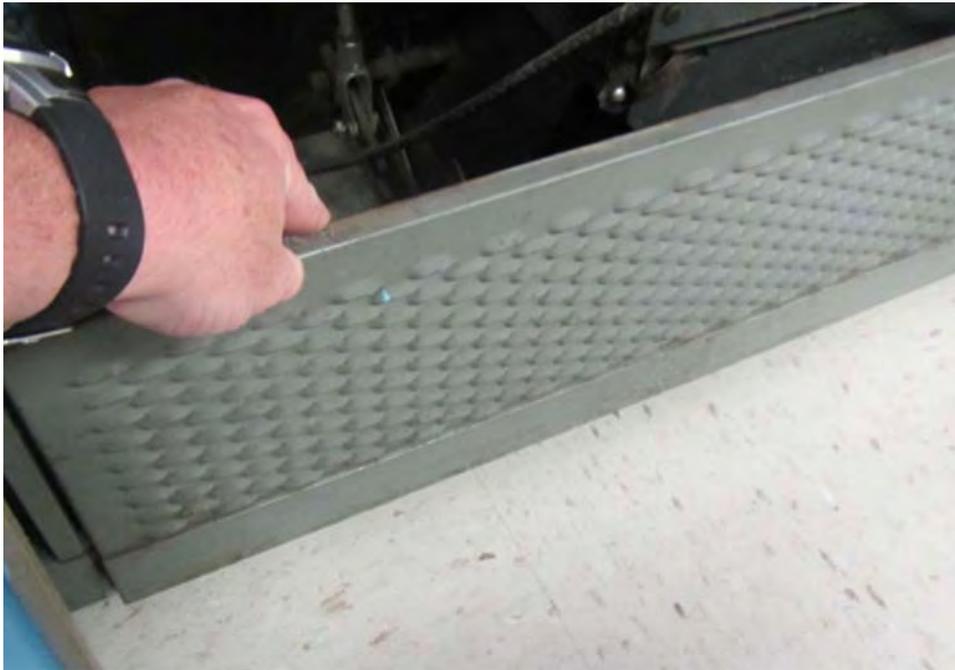
Picture 4

Univent return vent (along bottom front)

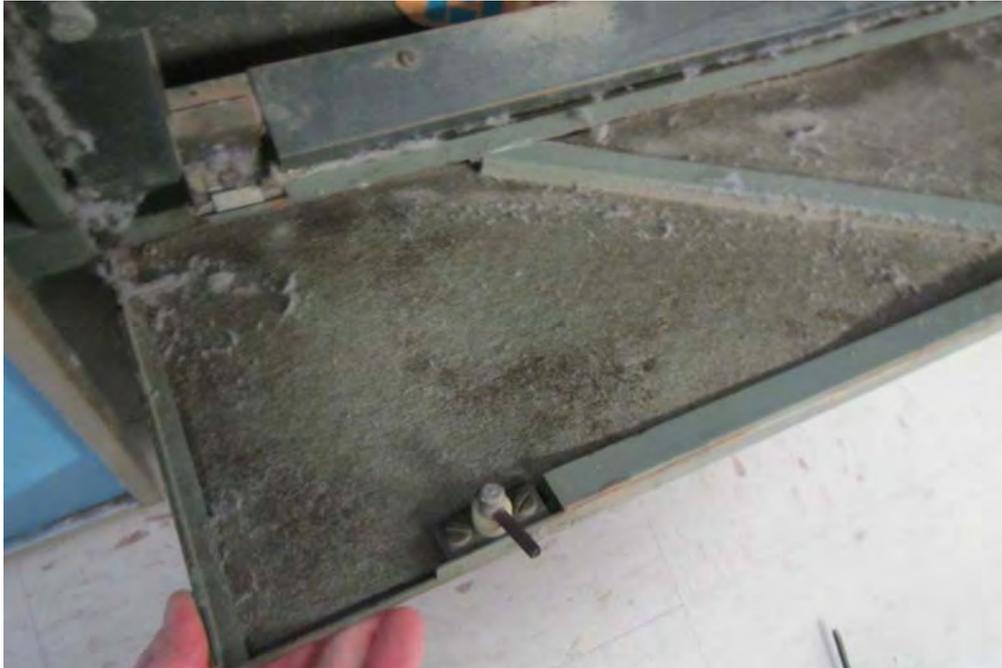
Picture 5

Inside shot of univent return vent sealed with fibrous material obstructing airflow

1. Inspect all univents and remove fibrous material (Pictures 5 and 6) sealing return vents to restore original function as designed.
2. Operate all ventilation systems throughout the building (e.g., classrooms, gym, cafeteria) continuously during periods of occupancy to maximize air exchange. If increased airflow is desired, operate univents in fan “high” mode.

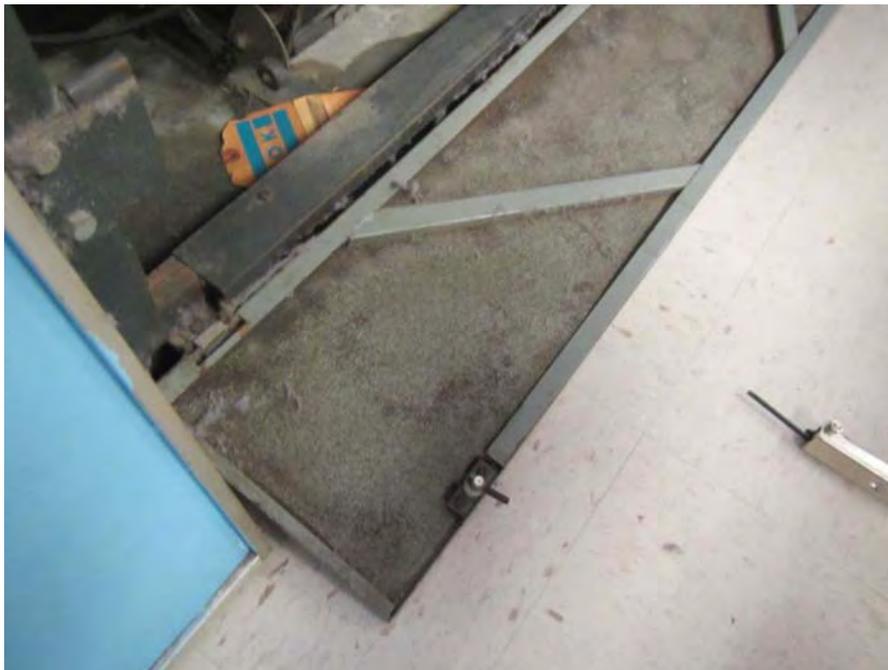
Picture 6

Inside shot of univent return vent sealed with fibrous material obstructing airflow

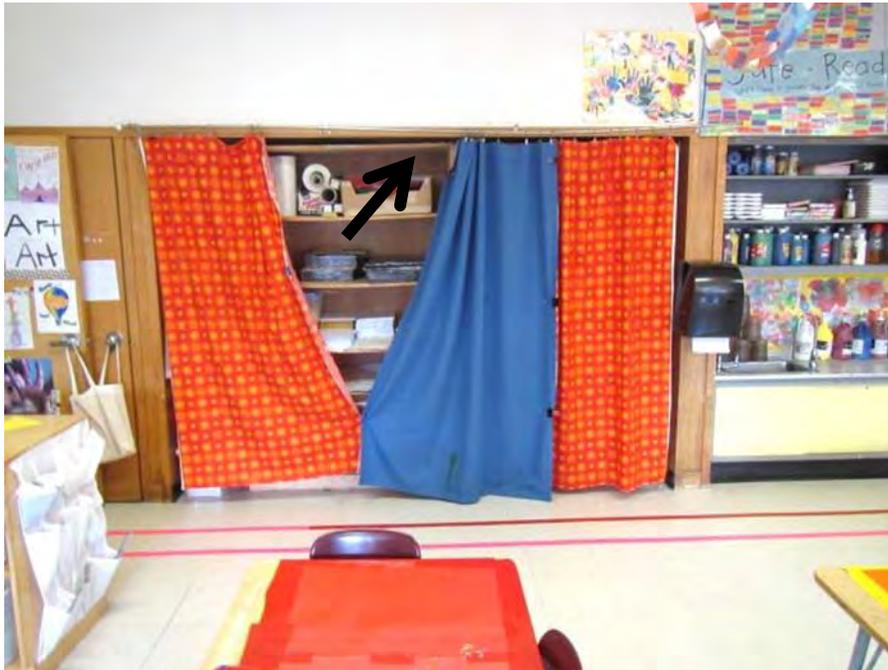
Picture 7

Exhaust ventilation in classrooms in the original building is provided by vents located in the ceilings of coat closets (Pictures 7 and 8) and powered by rooftop motors. MDPH staff did not detect any draw from a number of exhaust vents at the time of the assessment, which can indicate that they were deactivated or inoperable. The location of the closet vents also allows them to be easily blocked by stored materials (Picture 8). In addition, many occupants had installed curtains over the closet doors, which can inhibit airflow (Picture 7).

Coat closet exhaust vent, approximate position shown by arrow

3. Restore exhaust ventilation throughout the building. Inspect motors and belts for proper function, and perform repairs and adjustments as necessary.

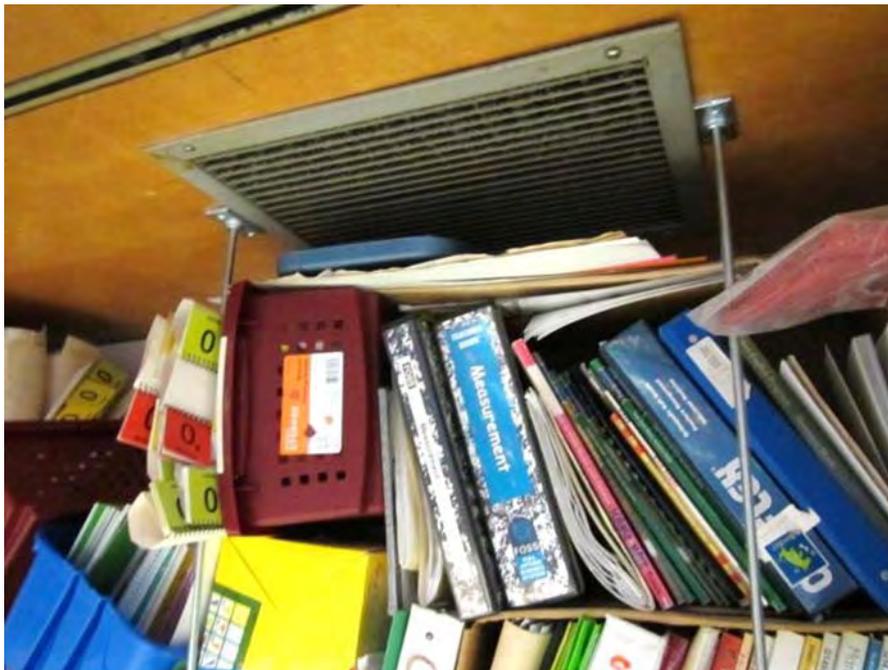
Picture 8

Coat closet exhaust vent, note stored materials

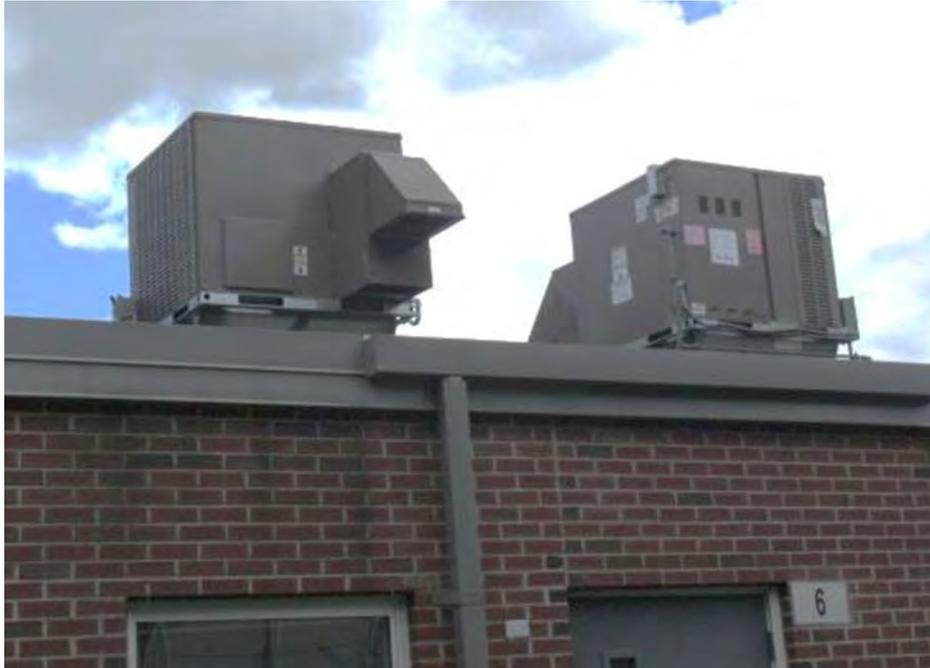
Picture 9

Ventilation for common areas such as the gym and cafeteria is provided by air-handling units (AHUs) either mounted from the ceiling or rooftop. These units did not appear to be operating at the time of the assessment and are also likely to be original equipment from the mid 1960s. Fresh air for classrooms in the 1994 addition is provided by rooftop AHUs (Picture 9). Fresh air is distributed to classrooms via ductwork connected to ceiling-mounted air diffusers. Return vents draw air back to the AHU through ceiling-mounted grilles. A digital wall-mounted thermostat controls the heating, ventilating and air conditioning (HVAC) system (Picture 10). Thermostats have fan settings of “on” and “automatic”. The thermostats were set to the “automatic” setting at the time of the assessment. The automatic setting on the thermostat activates the HVAC system at a preset temperature. Once a preset temperature is measured by the thermostat, the HVAC system is deactivated. Therefore, no mechanical ventilation is

Rooftop air handling units

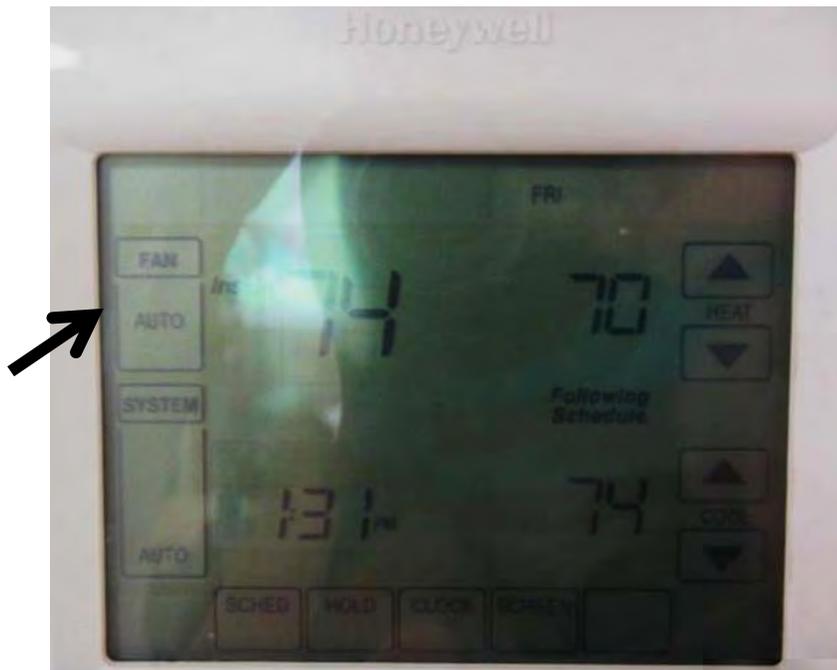
Picture 10

Wall-mounted thermostat, note fan in “auto” setting (arrow)

7. For continuous airflow/filtration set the thermostats for 1994 addition to the fan “on” position rather than “automatic” during the school day.
8. Ensure classroom doors are closed for proper operation of mechanical ventilation system/air exchange.

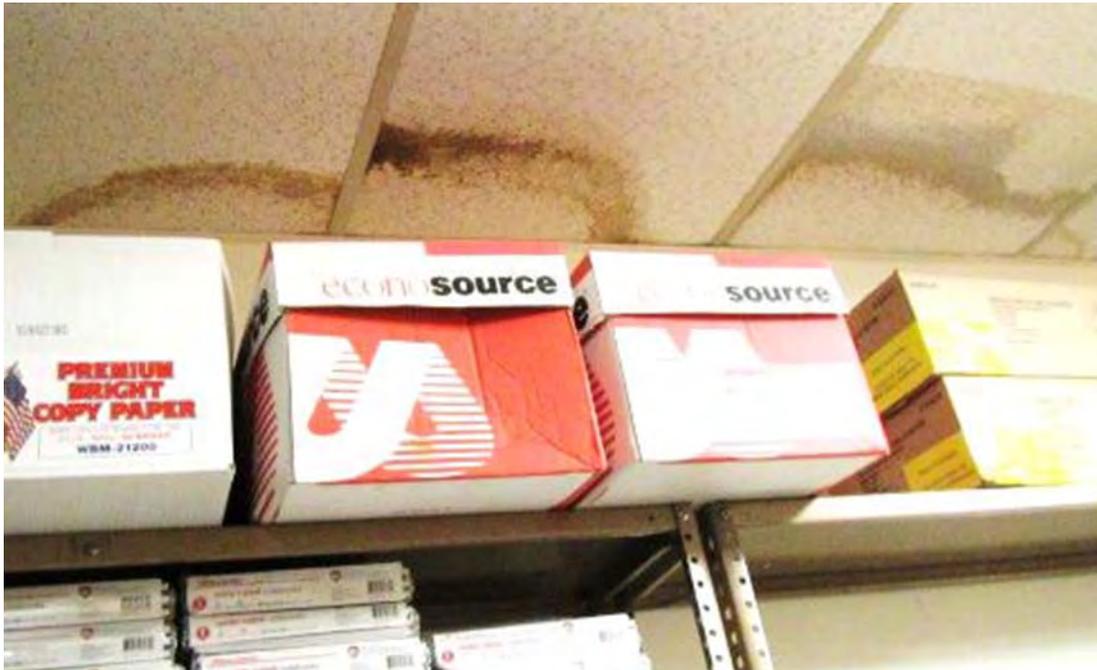
Picture 11

Water-damaged ceiling tiles were observed in a number of areas throughout the building (Table 1); these can indicate active/historic leaks from either the roof/building envelope or plumbing system. Periodic leaks through the exterior wall/concrete apron along the exterior of the building were reported in room 115-A and its storeroom (Pictures 11 and 12). It was reported that attempts have been made to repair this area. Water-damaged ceiling tiles can provide a source of mold and should be replaced after a water leak is discovered and repaired. A

Water-damaged ceiling tiles in room 115-A/storeroom

14. Ensure building envelope/exterior (e.g., area outside room 115-A/Picture 12) and plumbing leaks are repaired and replace any remaining water-damaged ceiling tiles. Examine the area above these tiles for mold growth. Disinfect areas of water leaks with an appropriate antimicrobial, as needed.

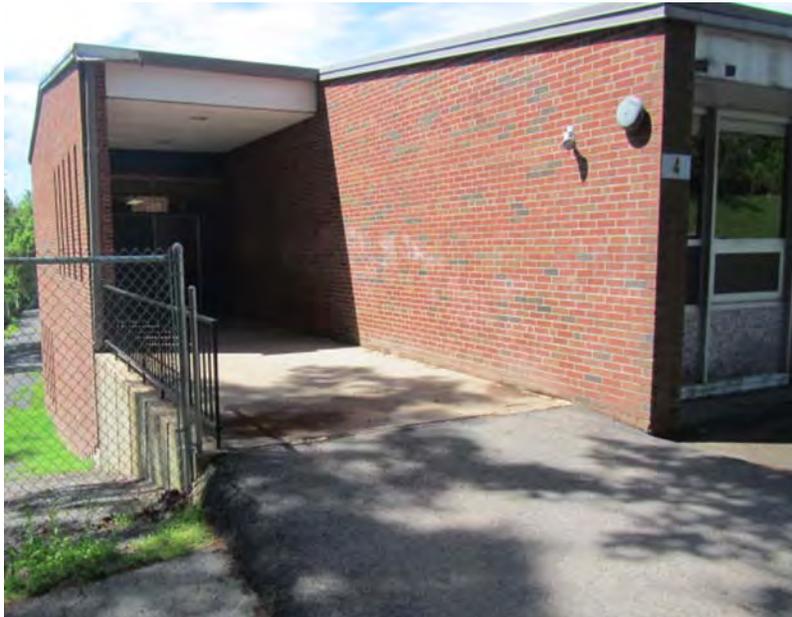
Picture 12

Exterior area of building believed to be source of water penetration into room 115-A/storeroom

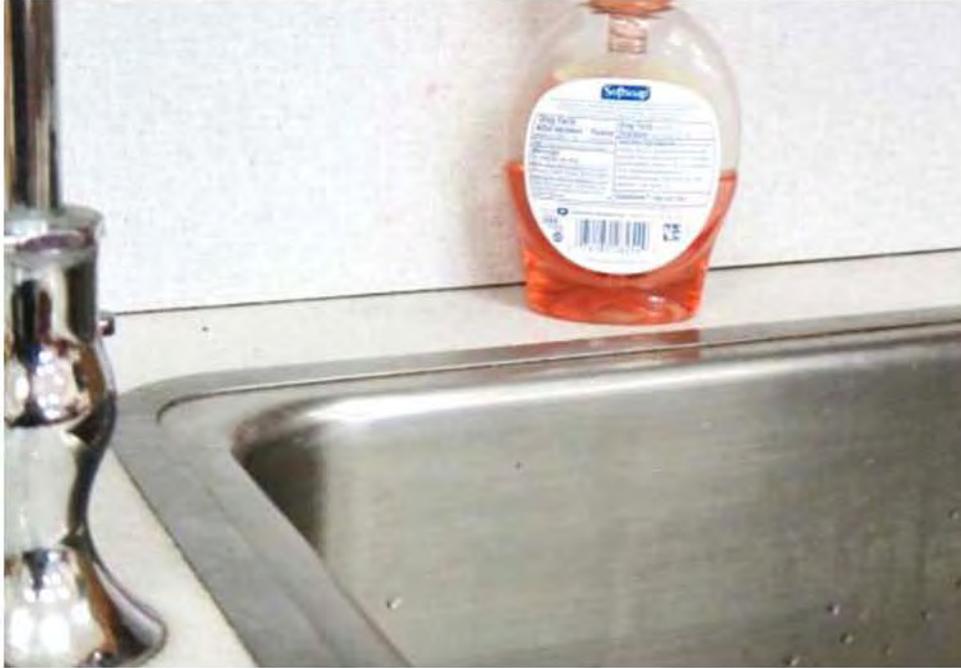
Picture 13

Open seams between the sink countertop and backsplash were observed in a number of rooms (Table 1; Picture 13). If seams are not watertight, water can penetrate the seam, causing water damage. Water penetration and chronic exposure of porous and wood-based materials can cause these materials to swell, show signs of water damage and lead to potential mold growth.

Spaces between sink countertop and backsplash

18. Periodically clean/power-wash moss/plant growth along exterior (north side) of building.
19. Seal breaches, seams, and spaces between sink countertops and backsplashes to prevent water damage. Consider long-term plans to replace with a one-piece molded countertop.

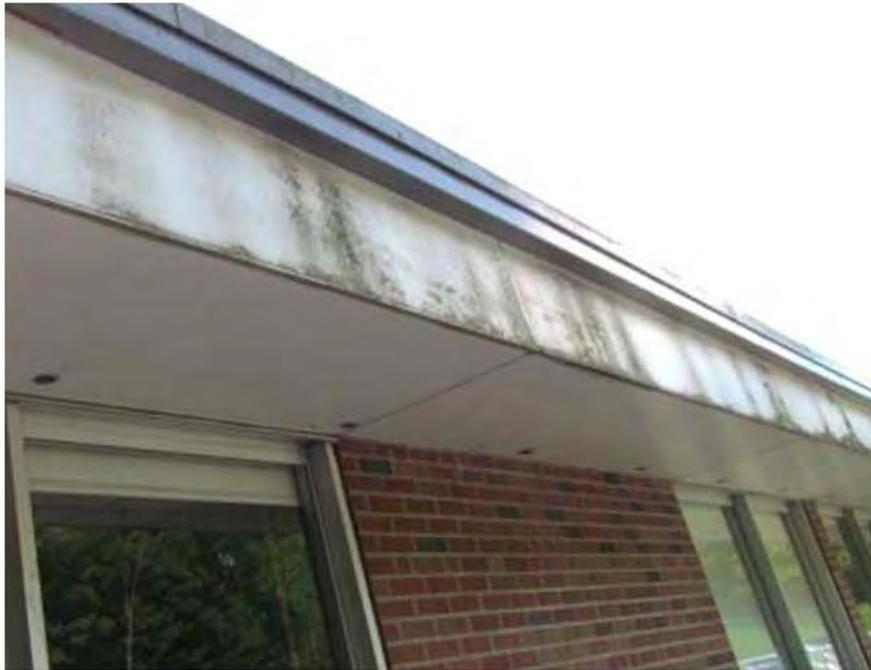
Picture 14

Moss/plant growth was observed growing on exterior walls/windows along the north/northwest side of the building (Pictures 14 and 15), due to chronic moisture/lack of sunlight. This material can hold moisture against the building, which can lead to deterioration and water penetration issues.

Moss growth (dark staining) on building façade along the north side of the building

21. Remove/clean moss from the windows and north/northwest side of building regularly.
22. Refrain from storing flammable products in classrooms. Store cleaning products properly and out of reach of students. Ensure spray bottles are properly labeled. All cleaning

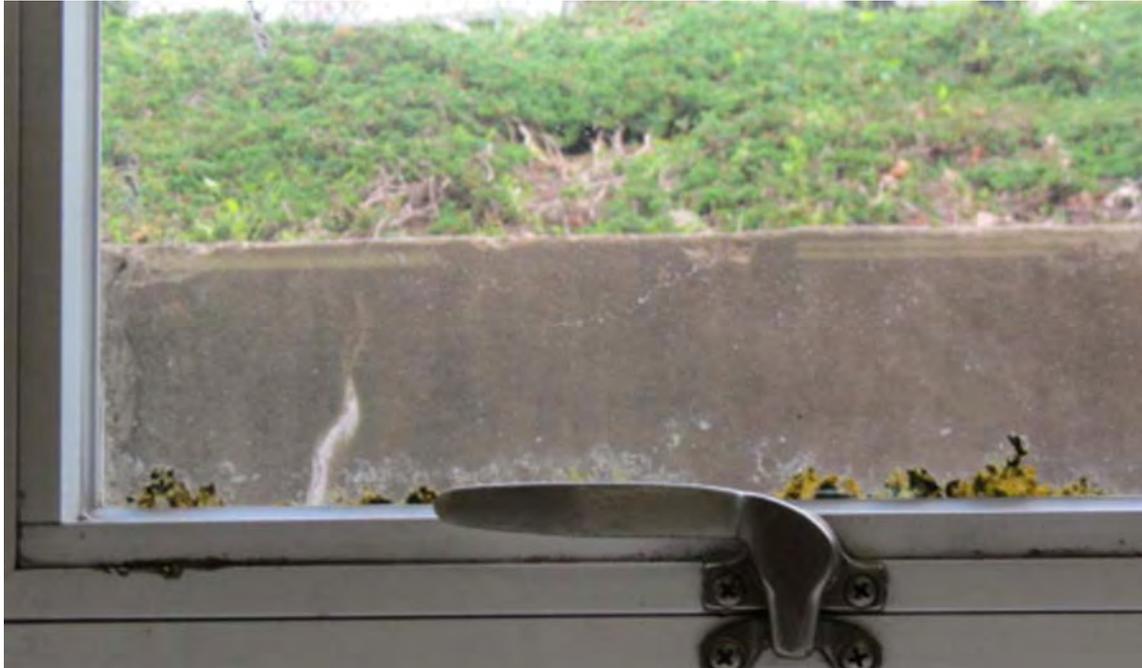
Picture 15

Moss growth on base of window along the north side of the building

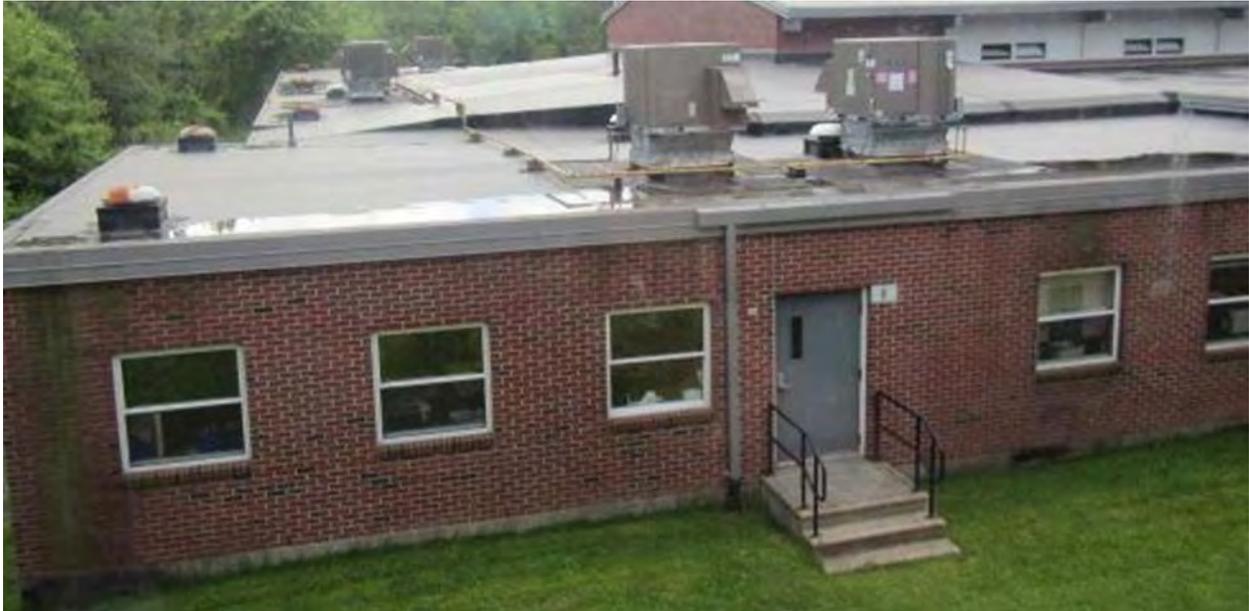
Picture 17

Pooling water was observed in a number of areas on the roof, particularly on the 1994 addition (Picture 17). The freezing and thawing of water during winter months can lead to roof leaks and subsequent water penetration into the interior of the building. Pooling water can also become stagnant, which can lead to mold and bacterial growth, which can be introduced into the building by rooftop ventilation equipment. In addition, stagnant pools of water can serve as a breeding ground for mosquitoes.

Pooling water on roof (near edge) of 1990s addition

16. Improve drainage on roof; consider consulting a building engineer/roofing contractor about possible options to eliminate water pooling.
17. Periodically clean/dry underneath padded mats in the PT room. Remove mats over the summer during hot/humid conditions to prevent moisture trapping/mold growth.

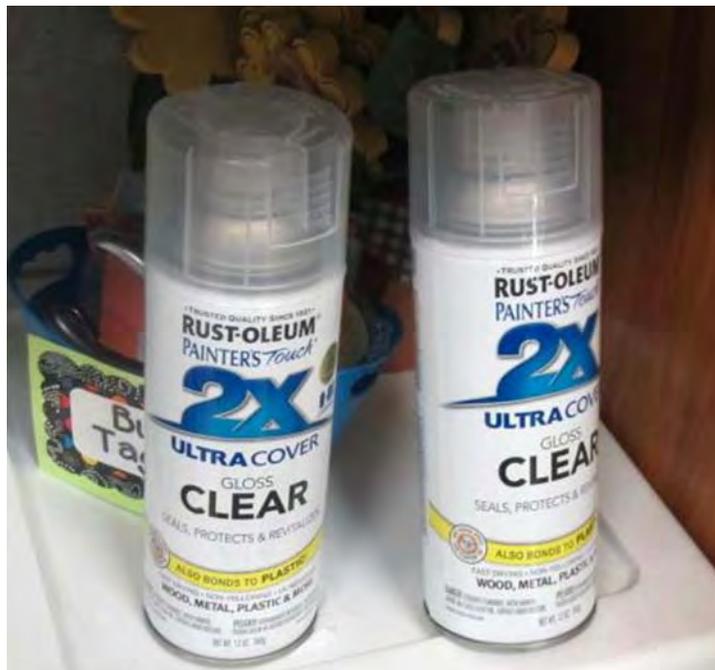
Picture 18

Cleaning and sanitizing products were observed on/under sinks in some rooms (Table 1); spray paint products were seen in one area (Picture 18). These products contain chemicals that can be irritating to the eyes, nose and throat of sensitive individuals. The spray paint product had a label stating “DANGER! Extremely Flammable, Vapor Harmful” (Picture 19). These items should be stored in a flammable cabinet in the maintenance area. Cleaning products should be properly labeled and stored in an area inaccessible to children. In addition, a Material Safety Data Sheet (MSDS) should be available at a central location for each product in the event of an emergency. Consideration should be given to providing teaching staff with school issued cleaning products and supplies to prevent any potential for adverse chemical interactions between residues left from cleaners used by the facilities staff and those left by cleaners brought in by others.

Spray paint products near sink in classroom

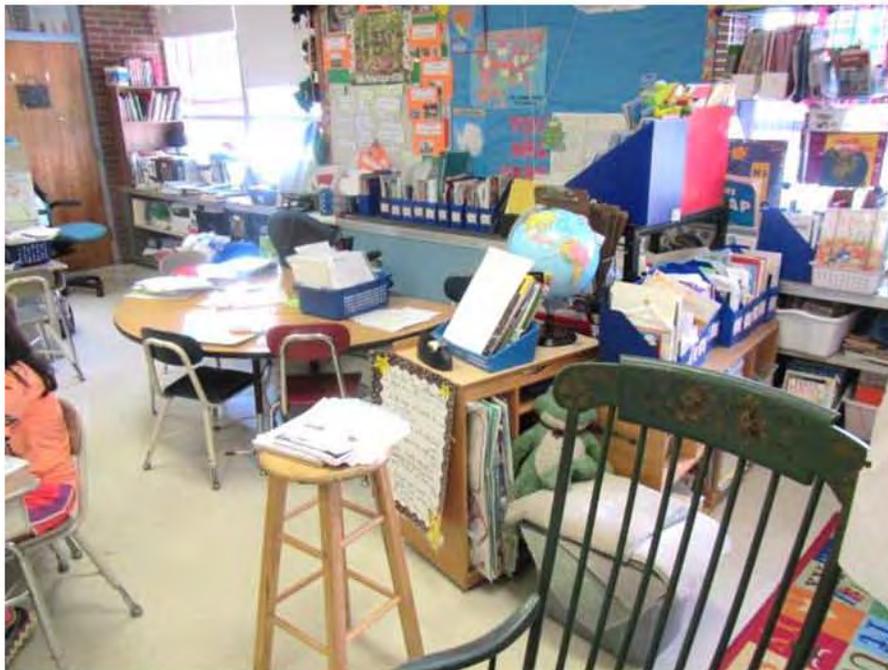
Picture 20

Other conditions that can affect IAQ were observed during the assessment. In many classrooms, a large number of items were on floors, windowsills, tabletops, counters, bookcases

and desks (Picture 20), which provide a source for dusts to accumulate. These items (e.g., papers, folders, boxes) make it difficult for custodial staff to clean. Items should be relocated and/or be cleaned periodically to avoid excessive dust build up. In addition, dust and debris can accumulate on flat surfaces (e.g., desktops, shelving and floors) in occupied areas and subsequently be re-aerosolized causing further irritation.

Accumulated items on flat surfaces in classroom

23. Relocate or consider reducing the amount of materials stored in classrooms to allow for more thorough cleaning of classrooms. Clean items regularly with a wet cloth or sponge to prevent excessive dust build-up.

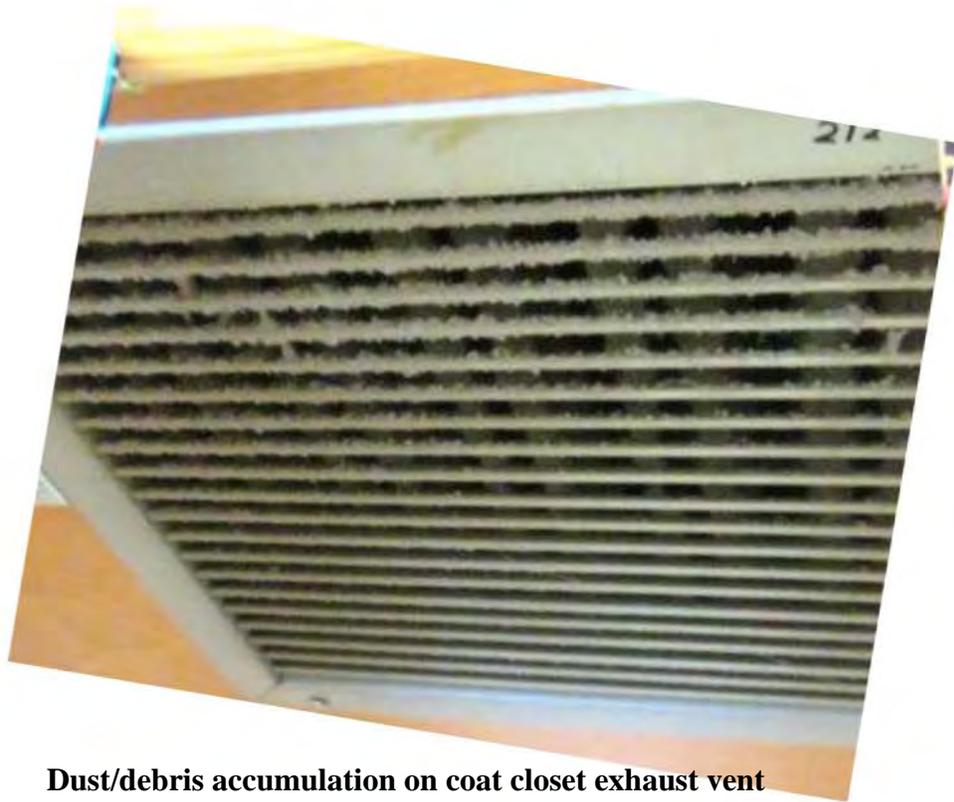
Picture 21

A number of exhaust vents and personal fans were found to have accumulated dust/debris (Table 1; Pictures 21 and 22). If exhaust vents are not functioning, backdrafting can occur, which can re-aerosolize accumulated dust particles. Re-activated supply, exhaust/return vents and fans can also aerosolize dust accumulated on vents/fan blades. Portable air conditioner filters, univent filters and cabinet interiors were also noted to have a build-up of dust/debris (Pictures 23 and 24). Univent filters should be changed as per the manufacturer's recommendations (typically 2-4 times a year). Since the BEH/IAQ assessment occurred toward the last few weeks of the school year, filters were likely due for changing (e.g., over the summer).

Dust/debris accumulation on coat closet exhaust vent

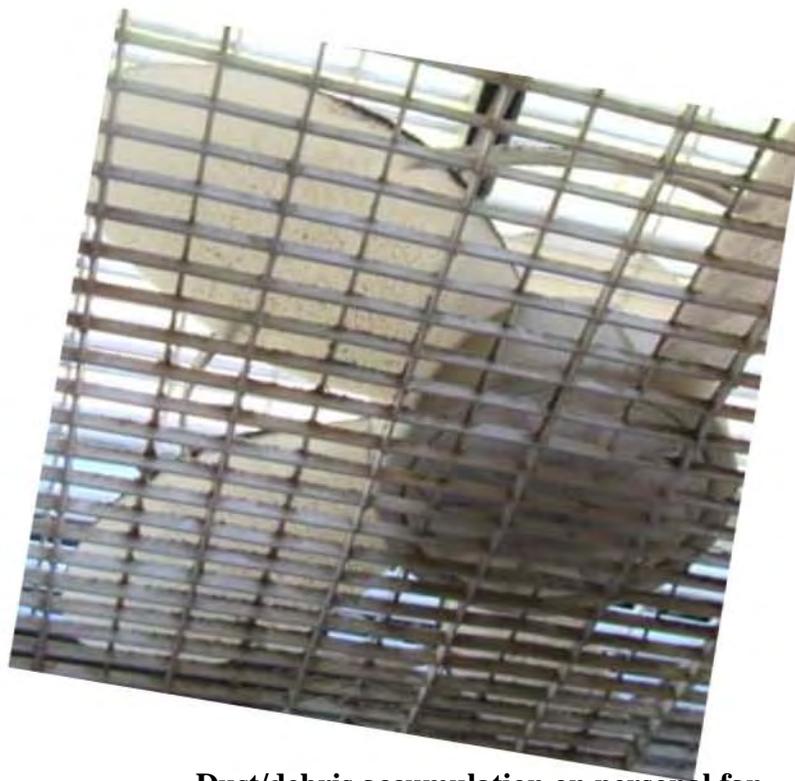
Picture 22

Dust/debris accumulation on personal fan

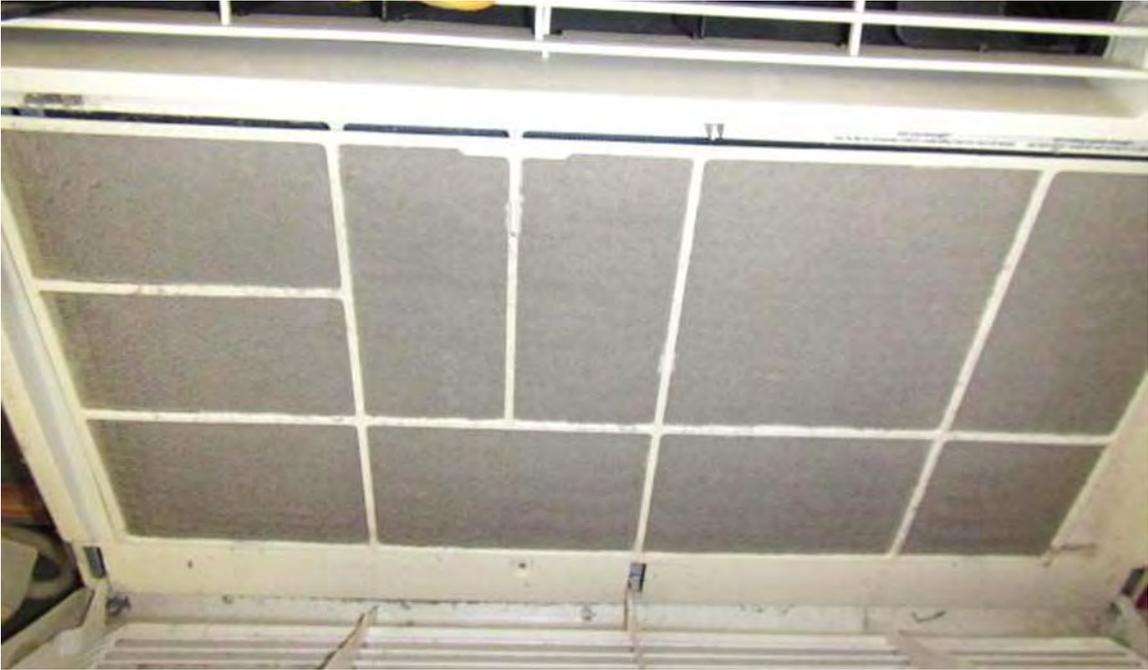
Picture 23

Portable air conditioner filter occluded with dust/debris

9. Change filters for all air handling equipment (univents and AHUs) as per the manufacturer’s instructions (typically 2-4 times a year). Thoroughly clean/vacuum out all units during each filter change.

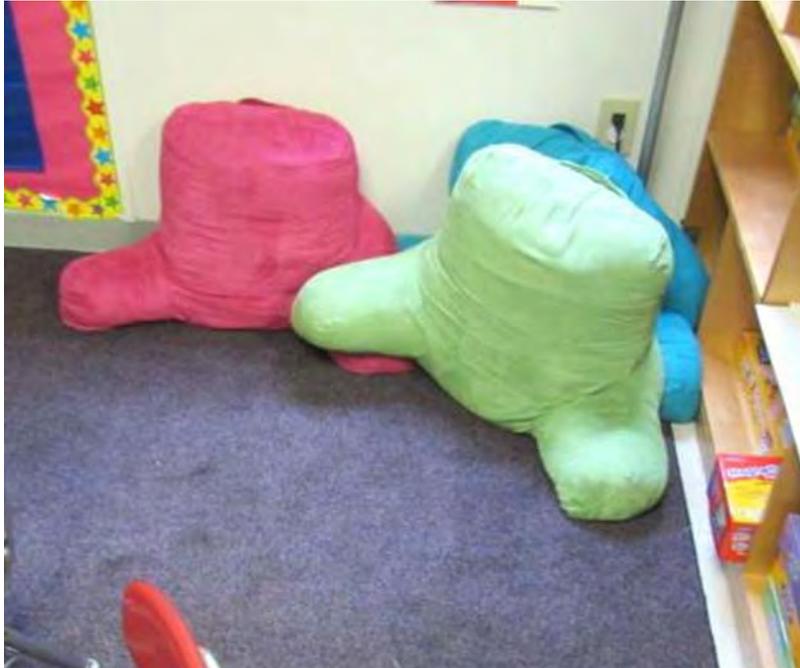
Picture 25

Upholstered furniture, pillows/cushions and large stuffed animals were seen in several classrooms (Pictures 25 through 27). Upholstered furniture, pillows and cushions are covered with fabric that comes in contact with human skin. This type of contact can leave oils, perspiration, hair and skin cells. Dust mites feed upon human skin cells and excrete waste products that contain allergens. In addition, if relative humidity levels increase above 60 percent, dust mites tend to proliferate (US EPA, 1992). In order to remove dust mites and other

Stuffed cushions on floor/carpet

pollutants, frequent vacuuming of upholstered furniture is recommended (Berry, M.A., 1994). It is also recommended that upholstered furniture (if present in schools), be professionally cleaned on an annual basis. If outdoor conditions or indoor activities (e.g., renovations) create an excessively dusty environment, cleaning frequency should be increased (every six months) (IICRC, 2000).

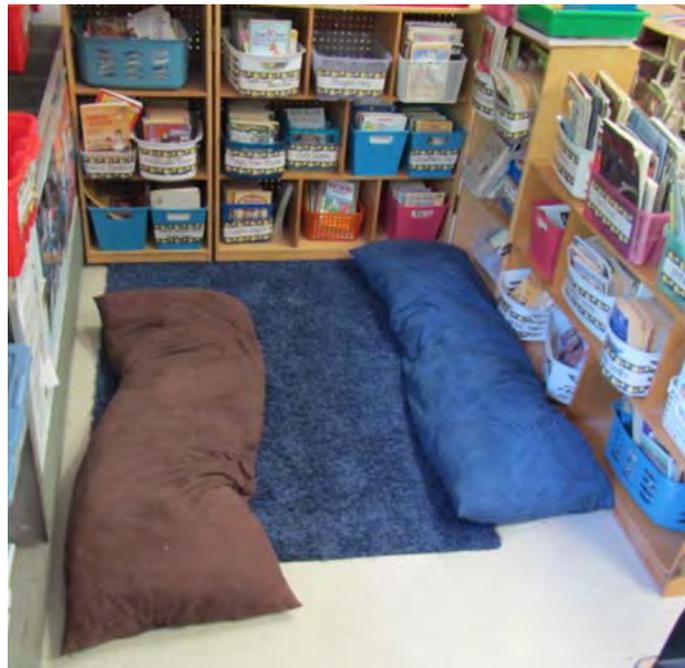
Picture 26

Stuffed pillows on floor/carpet

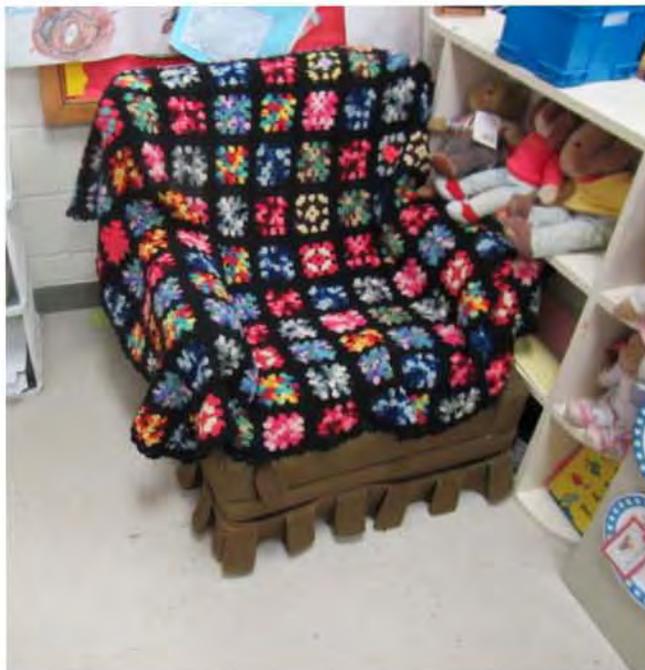
Picture 27

Upholstered chair in classroom
