# **INDOOR AIR QUALITY ASSESSMENT**

**Miscoe Hill School  
148 North Avenue  
Mendon, Massachusetts**

Prepared by:  
Massachusetts Department of Public Health  
Bureau of Environmental Health  
Indoor Air Quality Program  
January 2014

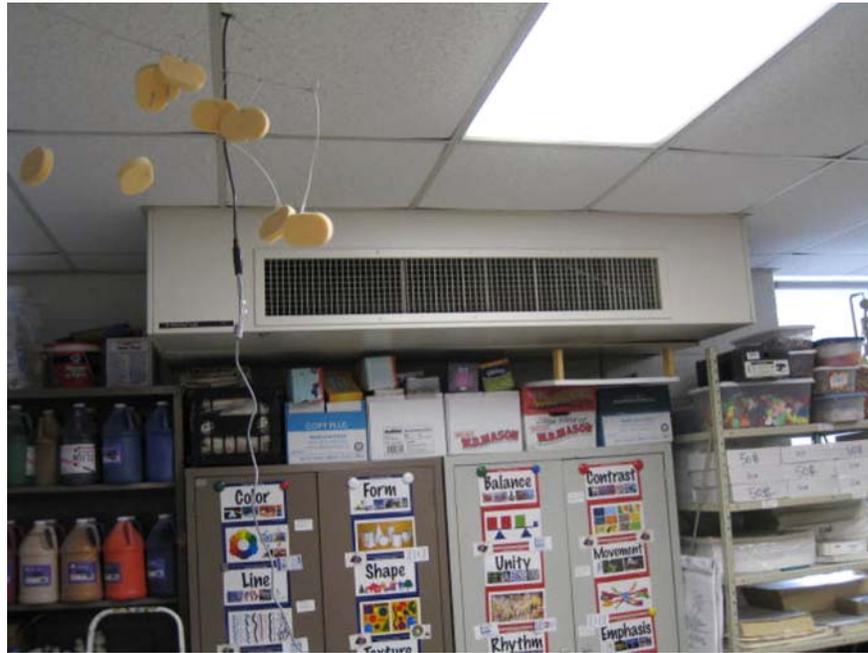
**Picture 1**

**Classroom univent suspended from ceiling**

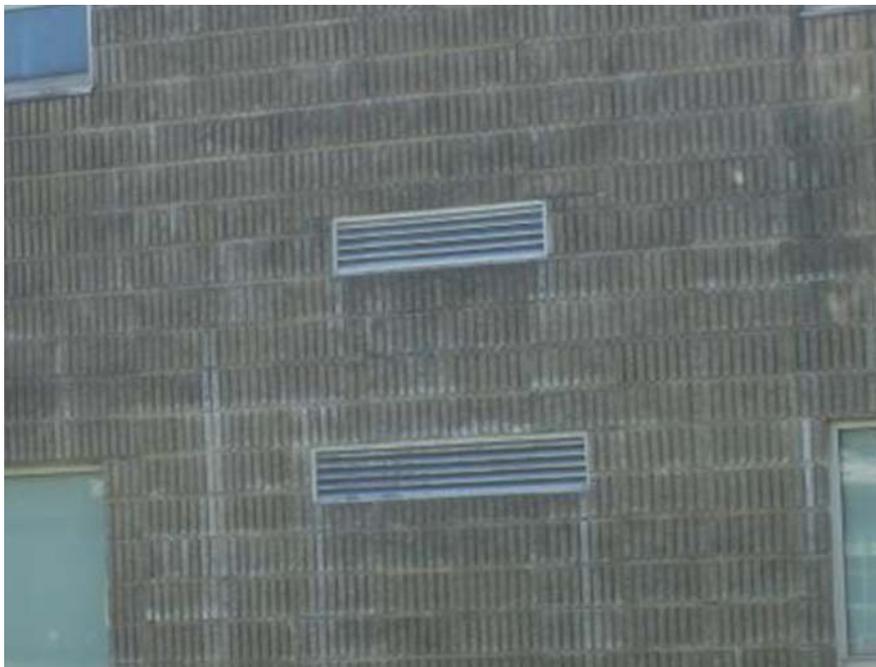
**Picture 2**

**Univent fresh air intakes**

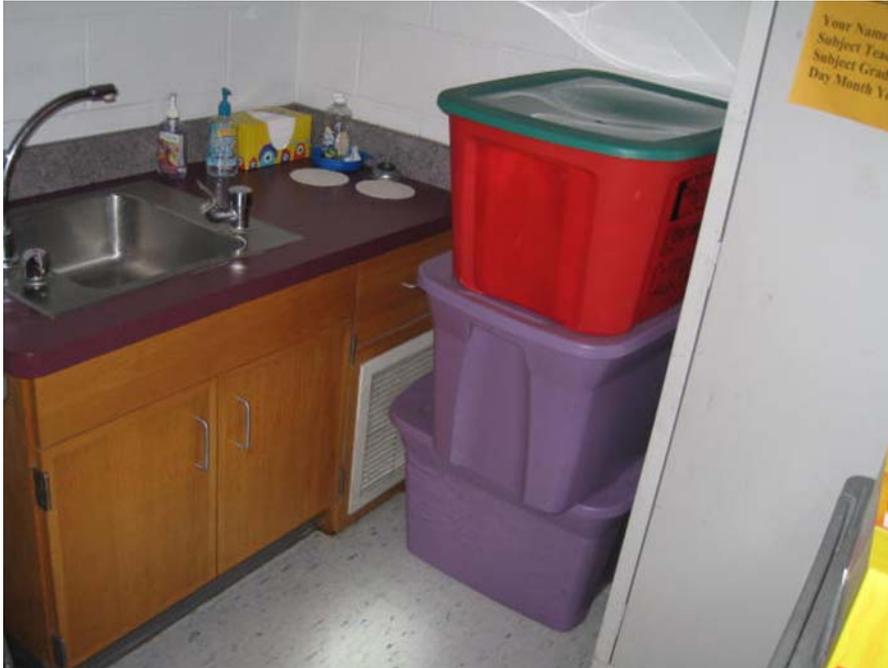
**Picture 3**

Exhaust ventilation in most classrooms is provided by wall-mounted vents. In a number of cases exhaust vents were not drawing air and/or were found obstructed (Table 1; Picture 3). As with univents, in order to function properly, exhaust vents must be activated and allowed to

**Exhaust vent obstructed by plastic bins**

1. Operate all ventilation systems (supply and exhaust) throughout the building (e.g., gym, cafeteria, classrooms) *continuously* during periods of occupancy to maximize air exchange. If more airflow is needed, operate univent fans in “high” setting.
2. Remove blockages/items from the surface of univent air diffusers and return vents (along front/bottom).
3. Remove blockages/items from exhaust vents to ensure adequate airflow.

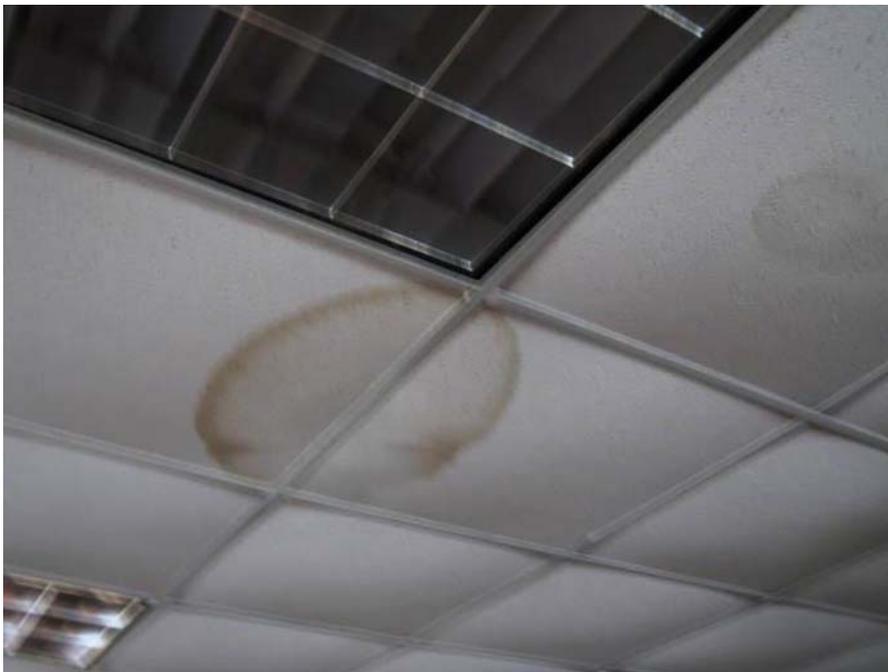
**Picture 4**

Water-damaged ceiling tiles were observed in a few areas (Table 1; Picture 4); these were reportedly from previous leaks. Water-damaged ceiling tiles can provide a source of mold and should be replaced after a water leak is discovered and repaired.

**Water-damaged ceiling tiles**

8. Ensure roof/plumbing leaks are repaired and replace any remaining water-damaged ceiling tiles. Examine the area above these tiles for mold growth. Disinfect areas of water leaks with an appropriate antimicrobial, as needed.

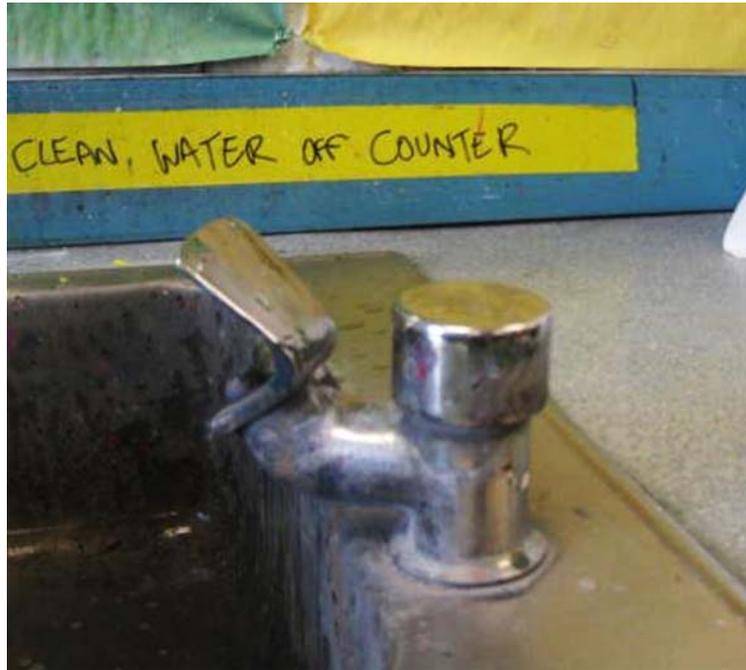
**Picture 5**

Open seams between the sink countertop and backsplash were observed in several rooms (Table 1; Picture 5). If seams are not watertight, water can penetrate the seam, causing water damage. Water penetration and chronic exposure of porous and wood-based materials can cause these materials to swell, show signs of water damage and lead to potential mold growth.

**Open seam between sink countertop and backsplash**

9. Seal breaches, seams, and spaces between sink countertops and backsplashes to prevent water damage.
10. Ensure dehumidifiers are cleaned/maintained as per the manufacturer's instructions to prevent mold/bacterial growth.

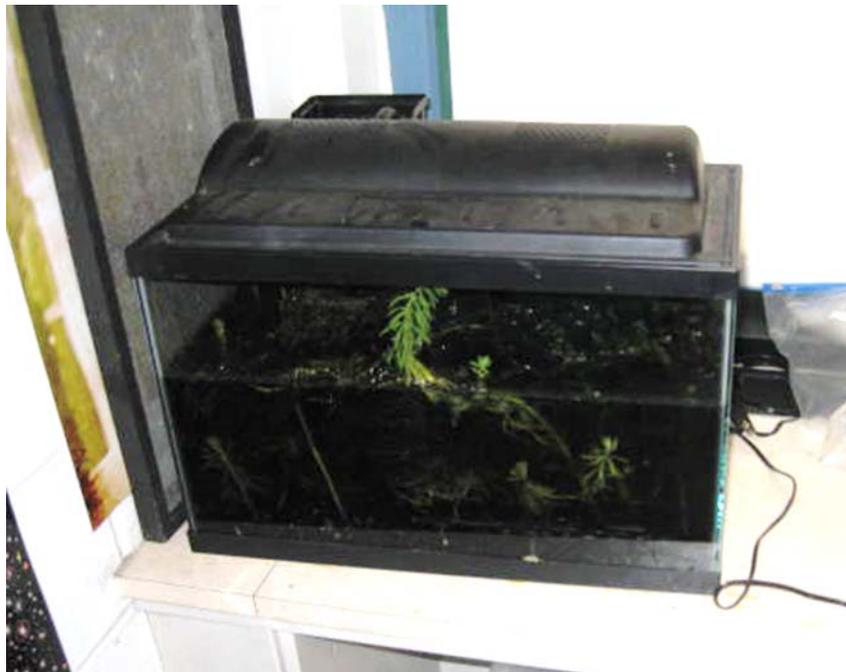
**Picture 6**

**Unplugged aquarium with standing water in classroom**

12. Clean and maintain aquariums and terrariums to prevent bacterial/microbial growth and associated odors.
13. Replace broken ceiling tiles.
14. Relocate or consider reducing the amount of materials stored in classrooms to allow for more thorough cleaning of classrooms. Clean items regularly with a wet cloth or sponge to prevent excessive dust build-up.

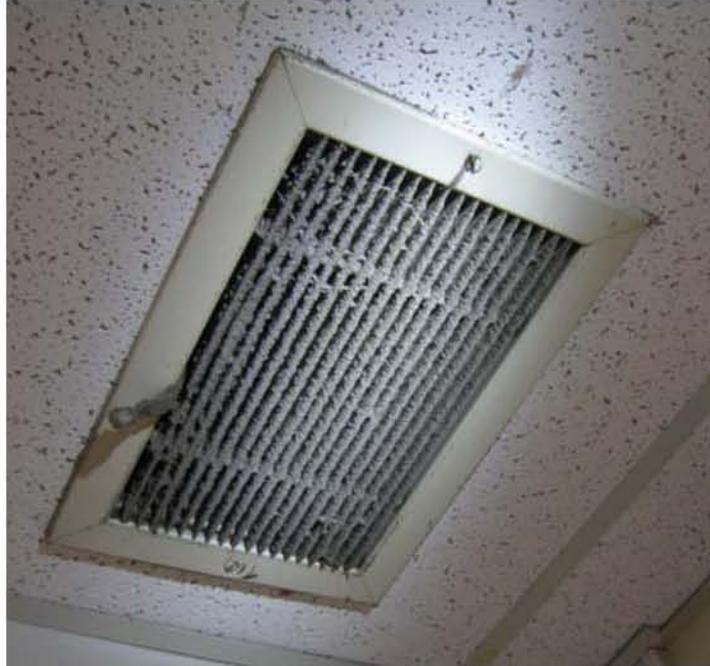
**Picture 7**

A number of univents, air diffusers, exhaust/return vents and personal fans were found to have accumulated dust/debris (Table 1; Pictures 7 and 8). If exhaust vents are not functioning, backdrafting can occur, which can re-aerosolize accumulated dust particles. Re-activated univents, supply vents and fans can also aerosolize dust accumulated on vents/fan blades.

**Dust/debris accumulation on exhaust vent**

15. Clean univents, personal fans, air diffusers and exhaust/return vents periodically of accumulated dust/debris.
16. Clean chalkboards and dry erase board trays regularly to avoid the build-up of particulates.

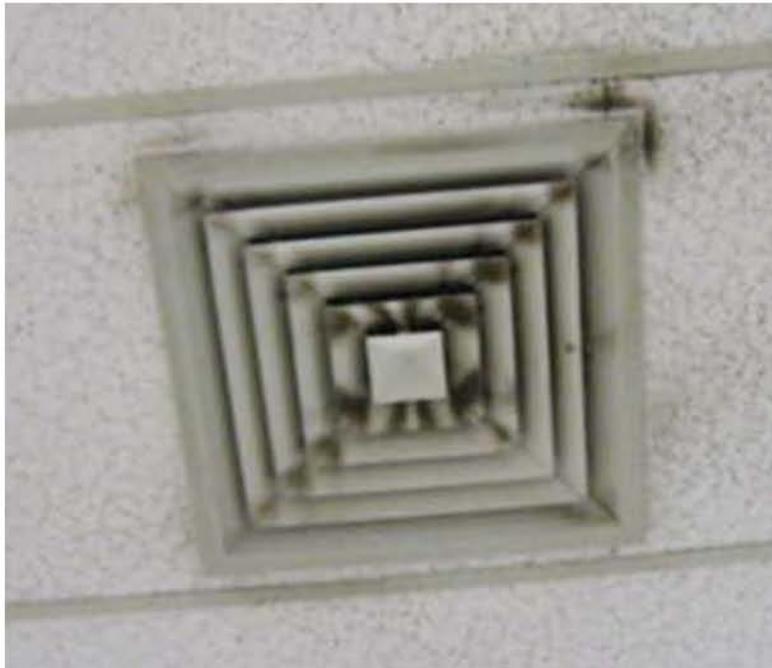
**Picture 8**

**Dust/debris accumulation on supply diffuser**
