# **ODOR INVESTIGATION**

**George R. Martin Elementary School  
455 Cole Street  
Seekonk, Massachusetts**

Prepared by:  
Massachusetts Department of Public Health  
Bureau of Environmental Health  
Indoor Air Quality Program  
January 2014

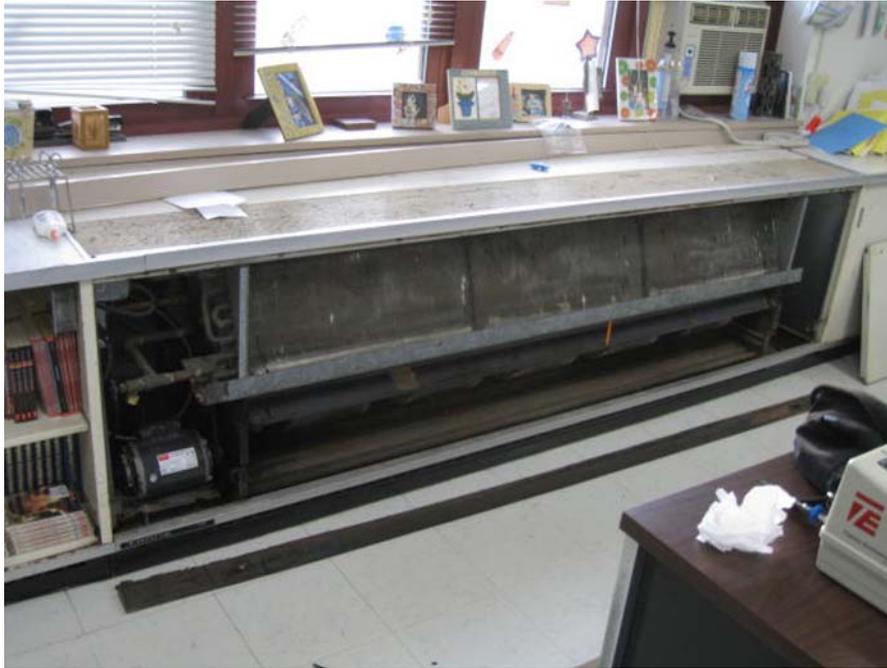
**Picture 1**

On both days of assessment, a pungent/musty odor could be detected upon entry into classroom B226. The odor was noticeably potent towards the southeast wall of the classroom where the unit ventilator (univent) is located (Picture 1). A univent draws air from the outdoors through a fresh air intake located on the exterior wall of the building (Picture 2). Return air from the classroom is drawn through an air intake located at the base of the unit ([Figure 1](#)). Fresh and return air are mixed, filtered, heated and provided to classrooms through an air diffuser located in the top of the unit. A wall panel directly above the univent was removed and BEH/IAQ staff noted a space between the wall and windowsill (Picture 3). Cold drafts and odors were noted from this space, which makes the wall cavity (or the univent itself) the most likely source of the odors. However, to fully evaluate the wall cavity behind the univent, the hot water supply pipes must be cut and the entire unit must be pulled out.

**Univent on southeast wall of classroom B226, with cover removed for inspection**

1. Continue with plans to replace univent (weather permitting) and windowsill/trim to investigate conditions behind/beneath unit for:
  - a. Breaches in exterior wall or window frames that can allow for drafts/moisture infiltration;
  - b. Water-damaged building components/debris;
  - c. Broken down/deteriorating/odor-producing building/HVAC components and/or other items in wall cavity; and
  - d. Evidence of pests/rodents.

2. Determine if current univent has ductwork/metal airtight sleeve connecting unit to exterior fresh air intake.
3. Prior to installation of new univent, consult with manufacturer/HVAC engineering firm regarding connection of ductwork/metal airtight sleeve to exterior fresh air intake to prevent draw of air, odors and particulates from the wall cavity.
4. Contact BEH's IAQ Program to coordinate scheduling for further investigation during univent removal/replacement.

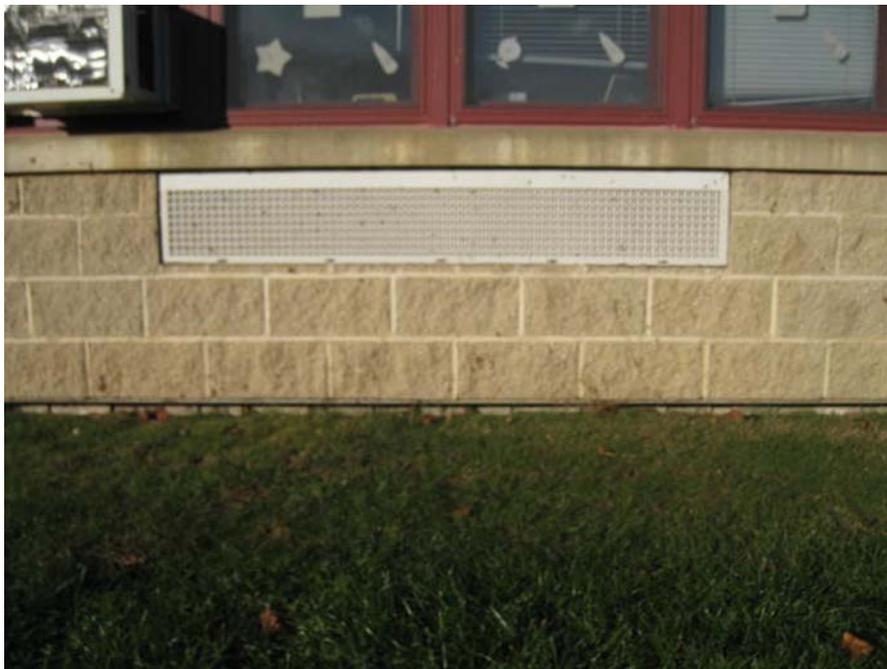
**Picture 2**

Typical installation of a univent will have a short section of ductwork that provides an airtight connection from the outdoor air intake directly to the unit. It was not clear if the univent in classroom B226 had this ductwork in place or if it was drawing air from both the fresh air intake and wall cavity. If odors are being drawn from the wall cavity they can be distributed via the univent and/or they can be drawn across the classroom by the exhaust vent located near the hallway door.

**Univent fresh air intake**

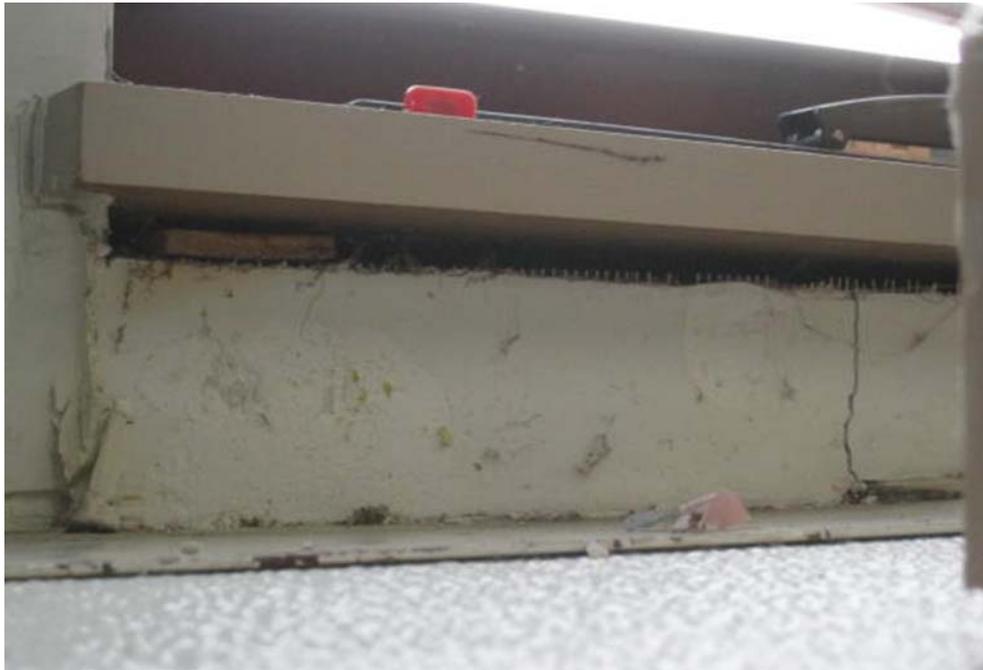
**Picture 3**

In order for building materials to support mold growth, a source of water exposure is necessary. Identification and elimination of the source of water moistening building materials is necessary to control mold growth. No visible mold growth or obvious signs of moisture were observed in classroom B226, with the exception of a water-damaged ceiling tile near the interior wall opposite the univent. BEH/IAQ staff inspected the ceiling plenum above this tile. No current moisture intrusion was evident, and no odors were detected. The stained tile appeared to be related to a previous leak that has since been repaired. However, as stated previously, the most likely source of odors is suspected to be behind/beneath the uninvent being replaced.

**Space between wall and windowsill (near univent) where drafts/odors were detected in classroom B226**
