# **INDOOR AIR QUALITY ASSESSMENT**

**Greater Lowell Technical High School  
250 Pawtucket Boulevard  
Tyngsborough, Massachusetts**

Prepared by:  
Massachusetts Department of Public Health  
Bureau of Environmental Health  
Indoor Air Quality Program  
September 2014

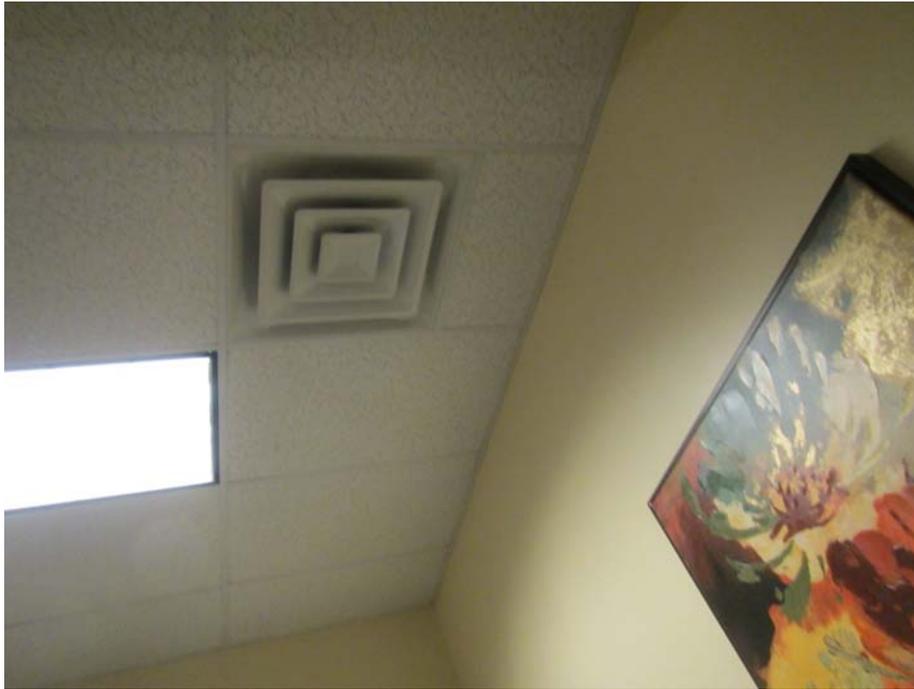
**Picture 1**

**Supply vent from rooftop AHU**

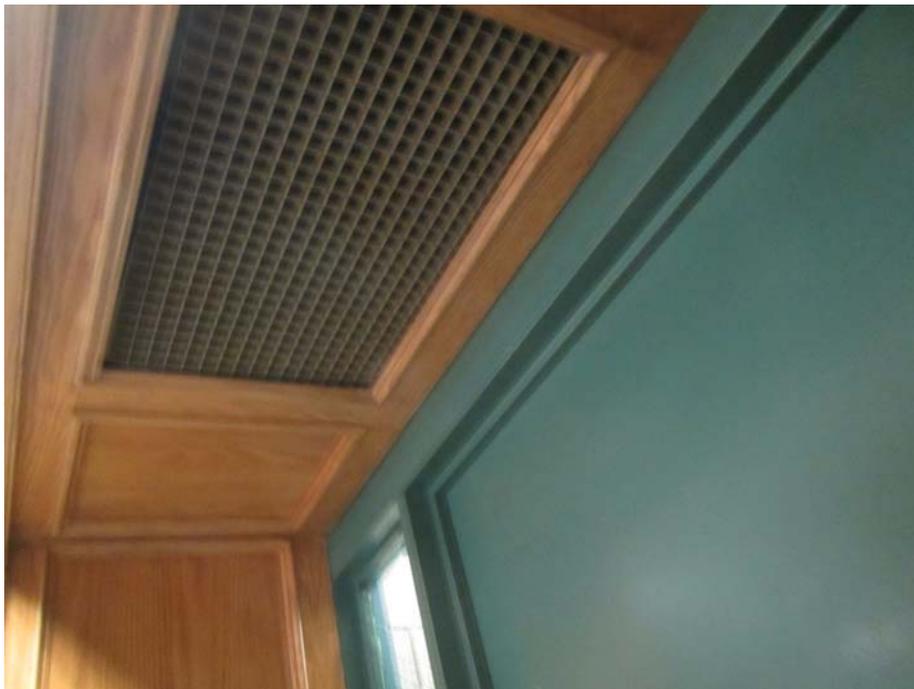
**Picture 2**

**Return vent inside superintendent's suite**

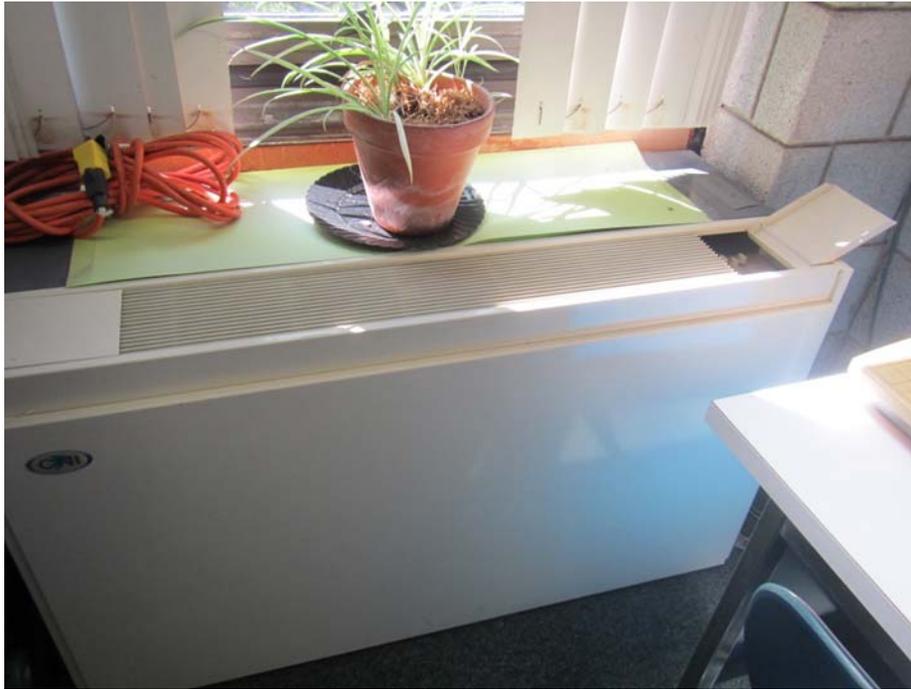
**Picture 3**

**Typical univent, note plant on top**

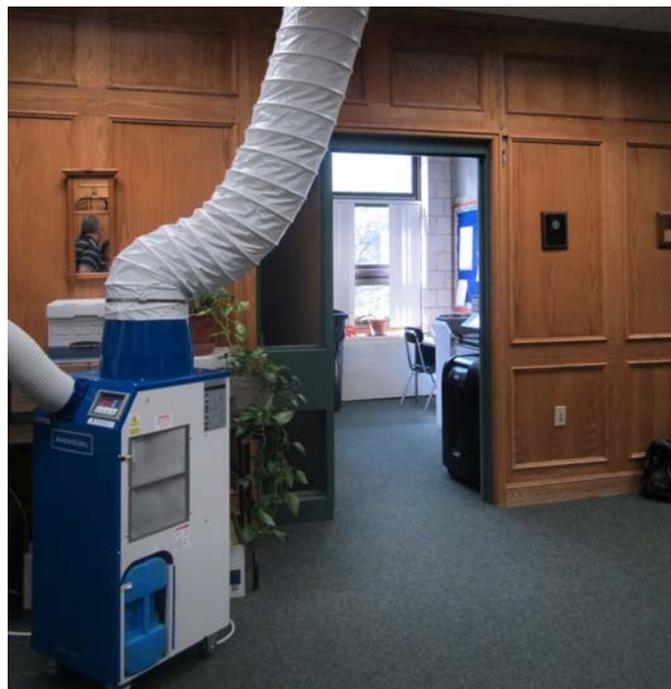
**Picture 4**

Some areas were additionally served by portable ducted or ductless air conditioning units (Picture 4) on the day of the assessment due to portions of the HVAC system being deactivated for construction; some of these units supplied fresh air while others were did not have the capacity to do so. MDPH recommends that HVAC systems be separated and/or turned off when construction is occurring in a building to prevent entrainment and distribution of construction-

**Portable air conditioner**

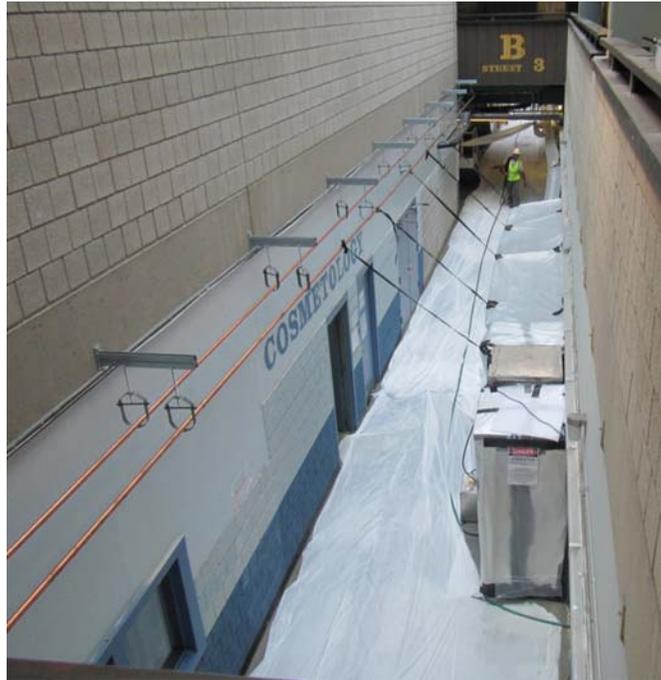
**Picture 5**

Note that because of the layout of the school, with open atrium/hallways (Picture 5), open stairwells and the distribution of staff in areas throughout the building rather than in one single area, containment between areas of construction and areas occupied by staff was incomplete. Staff were reportedly moved away from the most active and disruptive activities, including floor-removal activities in the main hallway, which are discussed further under the Total Volatile Organic Compounds section below. Areas specifically under renovation that included asbestos remediation were subject to the enclosures and other activities required by asbestos remediation regulations, as overseen by the DLS.

the hallway and atrium (“mall”) section of the first floor of the building. This floor was originally constructed of a layer of creosote with wooden blocks set into it, cross-grain-side up (Picture 7), which was then covered with several topcoat layers. Part of the renovation included removing the wood blocks and covering the base layer with several inches of poured concrete (Picture 5). During the process of removal of the wood, layers of creosote were exposed, leading to odors.

**Open hallway from second floor balcony area; note hallway concrete has been poured and covered with plastic to aid curing**

3. Ventilate the hallway/atrium areas to the greatest extent possible to remove lingering odors and TVOCs from creosote flooring. Consider washing all surfaces (e.g., walls) with a mild detergent to remove odorous material that may have deposited there over time.

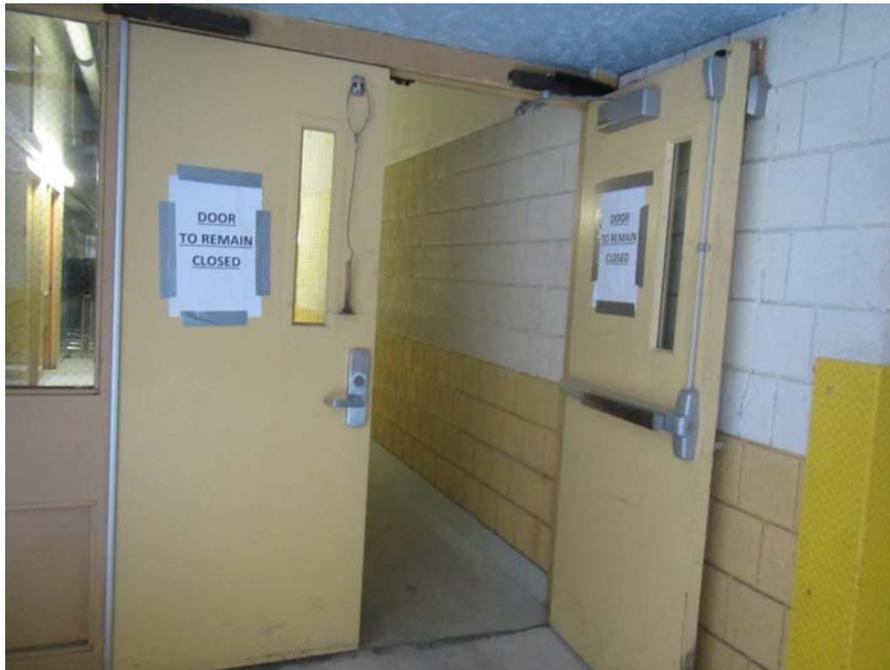
**Picture 6**

**Door with sign found open during the assessment**

2. Ensure that all doors remain closed between occupied areas and areas of construction. Whenever possible, install barriers including taped plastic sheeting and possibly more permanent installations, isolating areas where construction is taking place from areas that are occupied. These barriers should be maintained in good condition at all times, and should be regularly monitored for integrity, with a logbook kept of observations of the containment. These actions should be taken while any construction is taking place during the occupied periods at the school, and particularly when students have returned.

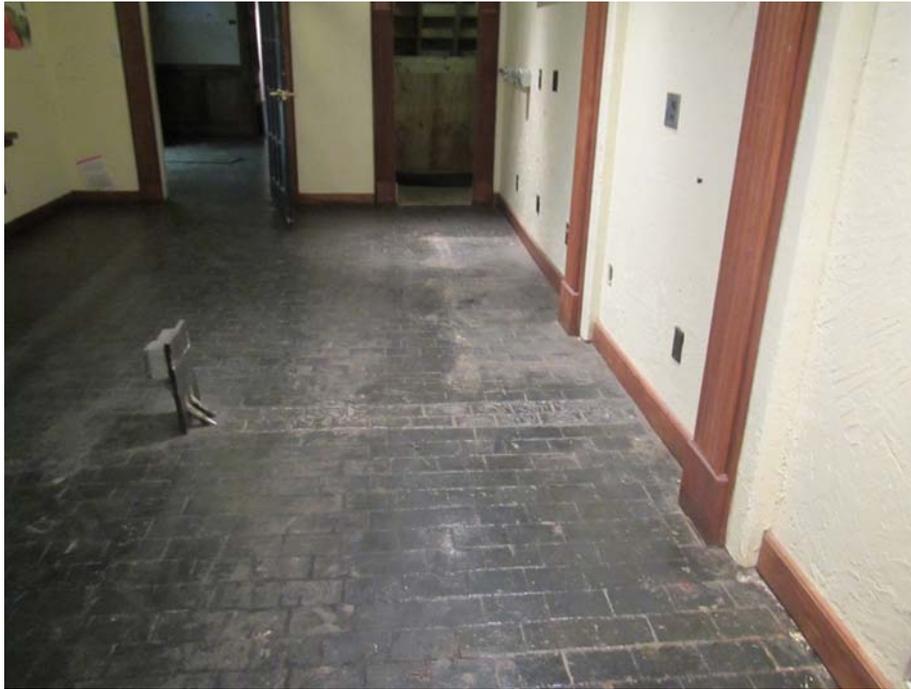
**Picture 7**

Creosote is composed of a mixture of hydrocarbons (ATSDR, 2002) and can have a strong odor even at low concentrations, mostly due to the presence of naphthalene, which has an odor threshold significantly below 1 ppm (ATSDR, 2005). Reportedly, ever since the building was constructed, occupants would detect creosote odors in this area upon entering the building. The pouring of several inches of concrete on top of the remaining creosote is expected to reduce or eliminate these odors. TVOC measurements in the hallway above the area where this floor is under remodeling were between 2 and 4 ppm (Table 1) and an odor of creosote was detected in this area. BEH/IAQ staff recommended that ventilation be increased throughout the open hallway/atrium as much as possible during unoccupied periods (e.g., nights and weekends) using open doors and fans to remove lingering odors. Since odors can also linger on surfaces, washing/cleaning of surfaces, including walls may also be helpful in removing these odors from the building. Due to construction activities on flooring, occupants had been moved to the unaffected wing of the building prior to the start of the flooring removal/refinishing to reduce exposure to nuisance odors.

**Original first-floor flooring, wood block over creosote**

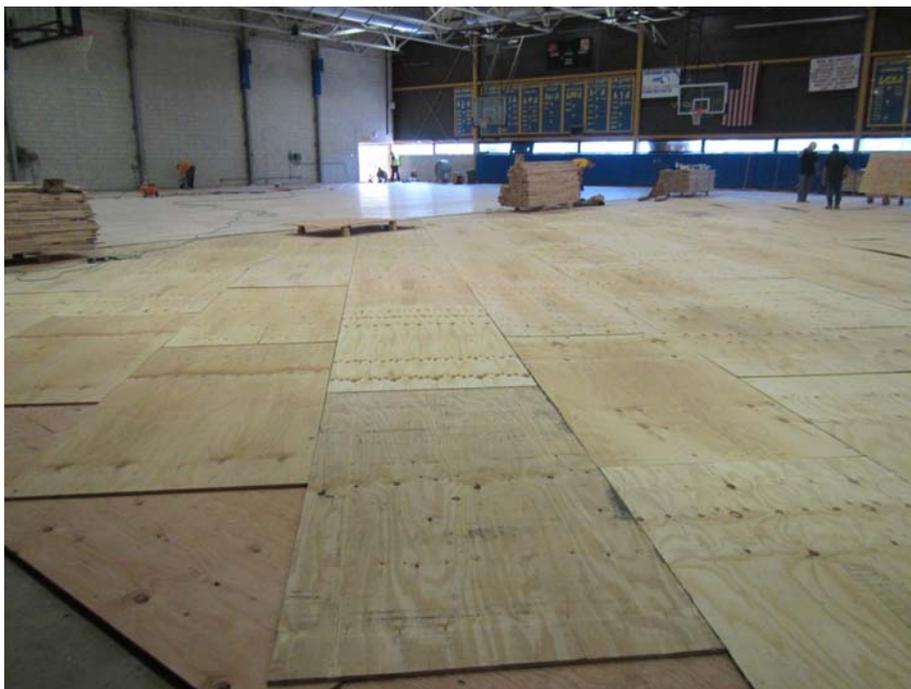
**Picture 8**

On the day of the assessment, it was also observed that the wood platform for a new gymnasium floor was in the process of being constructed (Picture 8). The finishing of the gym floor would include the use of a coating containing polyurethane. These coatings give off TVOCs and odors when they are applied and until they are cured. At the time of the visit, BEH/IAQ staff recommended that staff should not be in the area of the gymnasium when the coating was applied, and that preferably the coatings should be applied after hours on weekends or during otherwise unoccupied times. BEH/IAQ staff further advised that the area should be isolated and generously ventilated to the outdoors using fans to keep the area under negative pressure to avoid the odors getting into occupied spaces until the coatings are completely cured.

**New gym floor under construction**

4. Ensure that the gymnasium area is well ventilated and completely separated from the rest of the building when the polyurethane flooring is being applied and while it cures. Ensure that all ventilation systems to the gym that may have recirculation be turned off and covered. Use fans and open doors/windows to create a negative pressure in the gym as compared to the rest of the building to prevent migration of odors. Perform as much of this work off-hours (evenings and weekends) as possible.
