INDOOR AIR QUALITY ASSESSMENT

**Commonwealth of Massachusetts
Department of Children and Families
500 Main Street
Hyannis, Massachusetts**

Prepared by:
Massachusetts Department of Public Health
Bureau of Environmental Health
Indoor Air Quality Program
May 2015

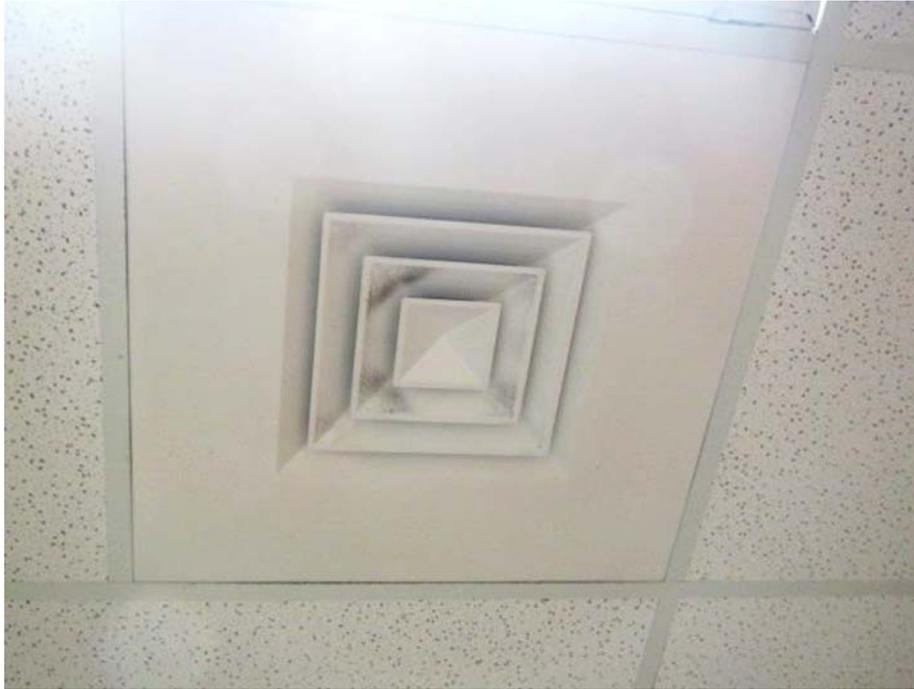
Picture 1

Fresh air is provided by rooftop air handling units (AHUs) ducted to ceiling-mounted supply diffusers (Picture 1). Return air is drawn back into ceiling vents (Picture 2) and returned to the AHUs. While most occupied areas had supply ventilation, many exhaust vents were located in hallways/common areas. Additional ventilation in restrooms is provided by exhausts vented directly to fans on the roof. At the time of the assessment most restroom exhaust vents were found to be off/nonfunctional and some appeared to be backdrafting. Lack of exhaust

Personal fans, supply and exhaust vents were found to be dusty in some areas (Picture 1, Table 1). Regular cleaning of supply diffusers, exhaust vents and personal fans will reduce aerosolizing any accumulated particulate matter on these surfaces.

Typical supply vent, note dust/debris accumulation on louvers

16. Keep the area under the sink clean and avoid storage of porous materials.
17. Regularly clean supply diffusers, exhaust vents and personal fans to avoid re-aerosolizing any accumulated debris.

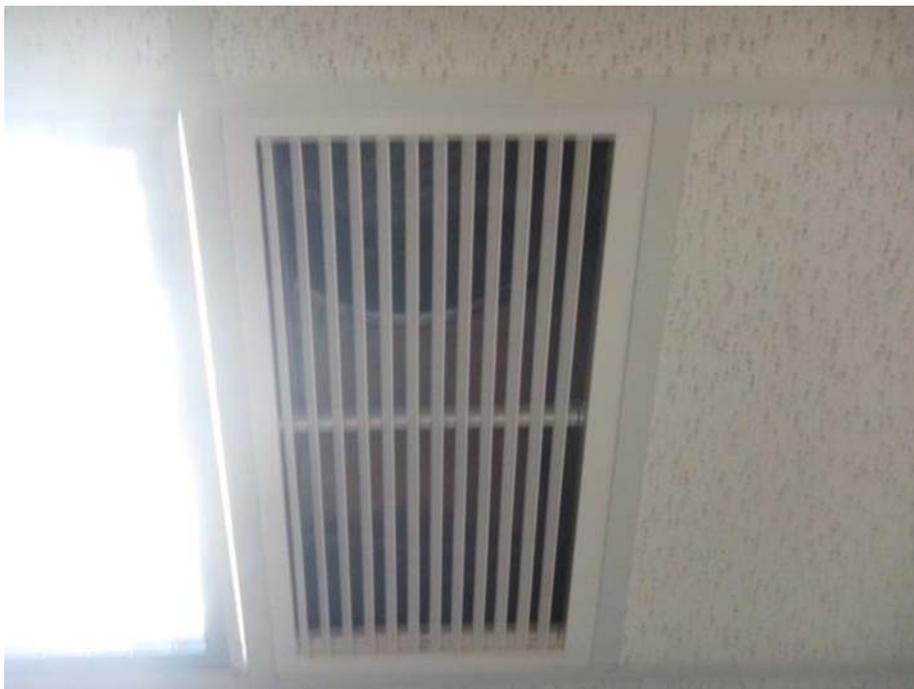
Picture 2

Typical exhaust vent

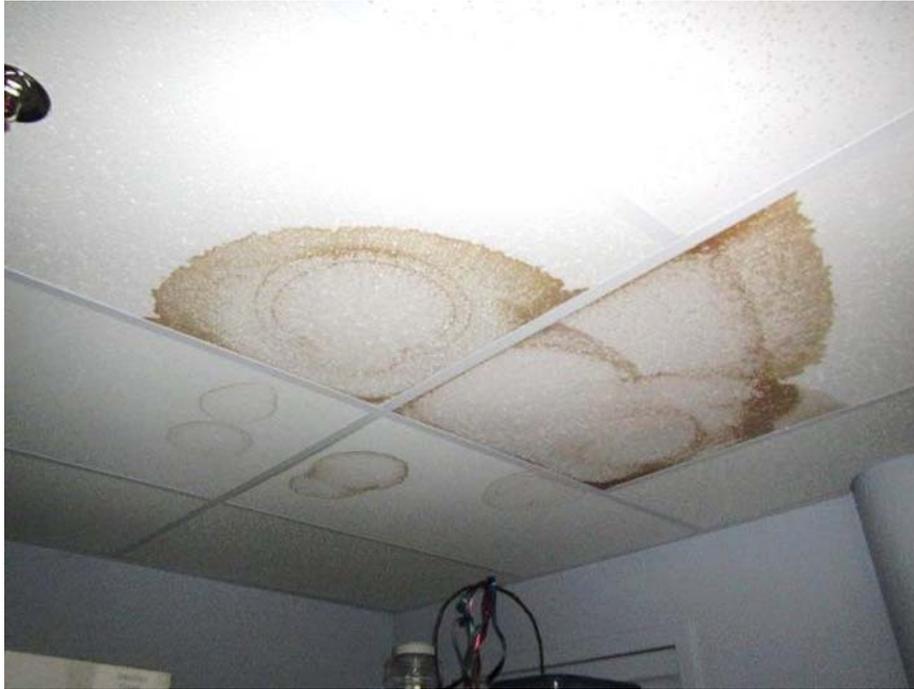
Picture 3

A few water-damaged ceiling tiles were observed in offices/work areas (Picture 3, Table 1). These appeared to be from historic roof or plumbing leaks. In Interview room 2, water-damaged ceiling tiles and damaged paint were observed (Picture 4). Moisture measurements were taken of the ceiling tiles and wall in this area and the materials were found to be dry. Water-damaged ceiling tiles should be removed and replaced once the source of water has been identified and remediated. The wall with the water-damaged paint was determined to be dry and did not require removal however; the paint should be scraped and refinished. No odors or microbial colonization was noted.

Water-damaged ceiling tiles in a storeroom

5. Examine areas of leakage and ensure any water-damaged ceiling tiles are repaired and/or replaced. Examine the area above ceiling tiles for mold growth. Disinfect areas of water leaks with an appropriate antimicrobial, as needed.

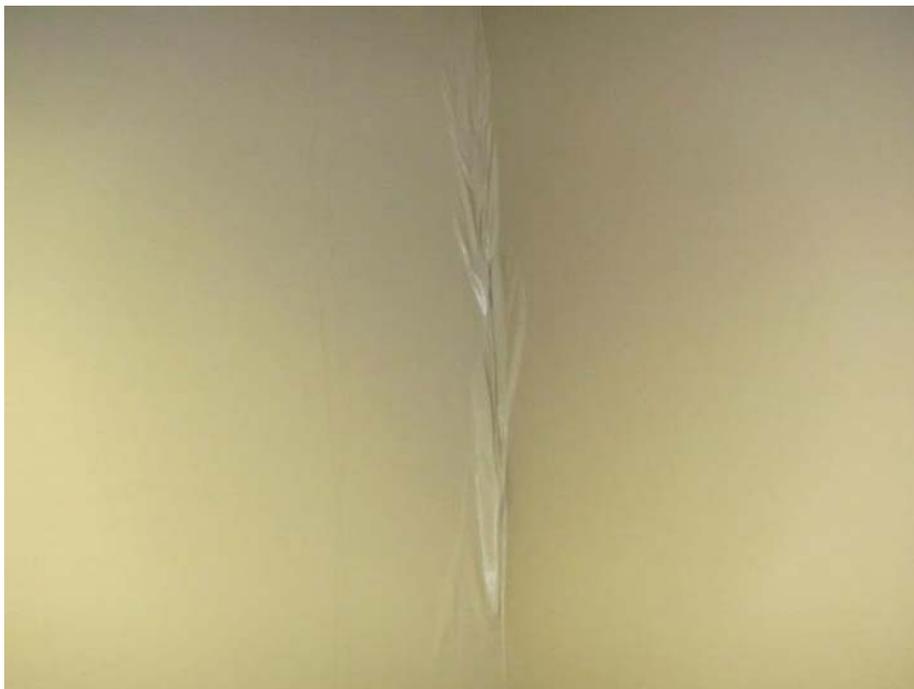
Picture 4

Close-up of peeling/water-damaged paint on wall of interview room 2

6. Scrape and refinish damaged paint in Interview room 2.
7. Indoor plants should be properly maintained and equipped with drip pans to prevent water damage to porous building materials and be located away from ventilation sources to prevent the aerosolization of dirt, pollen or mold.

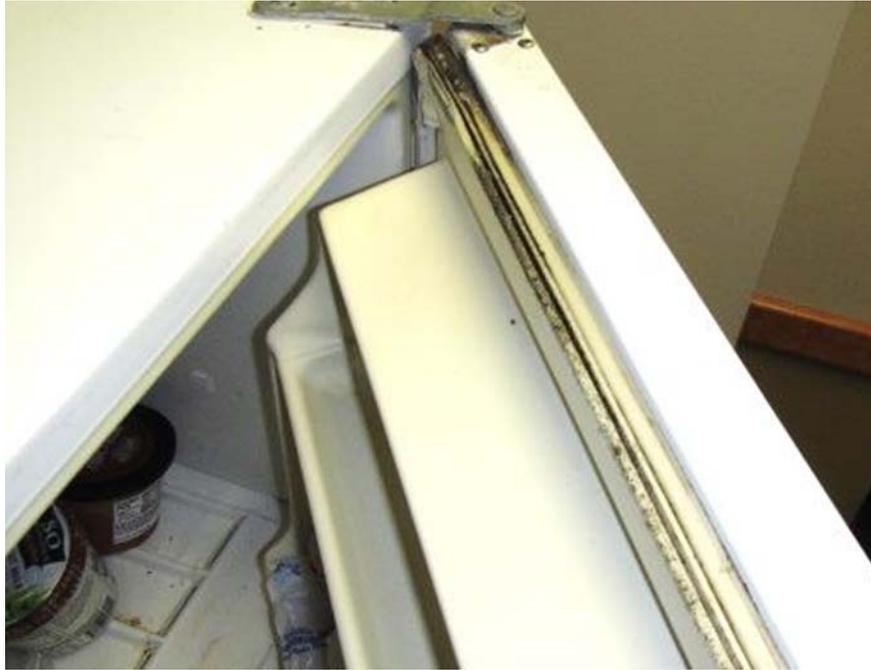
Picture 5

Refrigerators in the lunch area were examined and one had significant mold staining on the gasket (Picture 5). Refrigerators in general, appeared to be in need of cleaning. Refrigerators should be kept clean to prevent mold and spoiled food odors from occurring.

Mold staining and debris on refrigerator gasket

10. Clean out refrigerators regularly. Clean stained gaskets with an antimicrobial solution. If gaskets cannot be cleaned, consider replacing them.
11. Consider installing local exhaust vents near photocopiers or relocating them to areas with local exhaust ventilation and away from occupants.

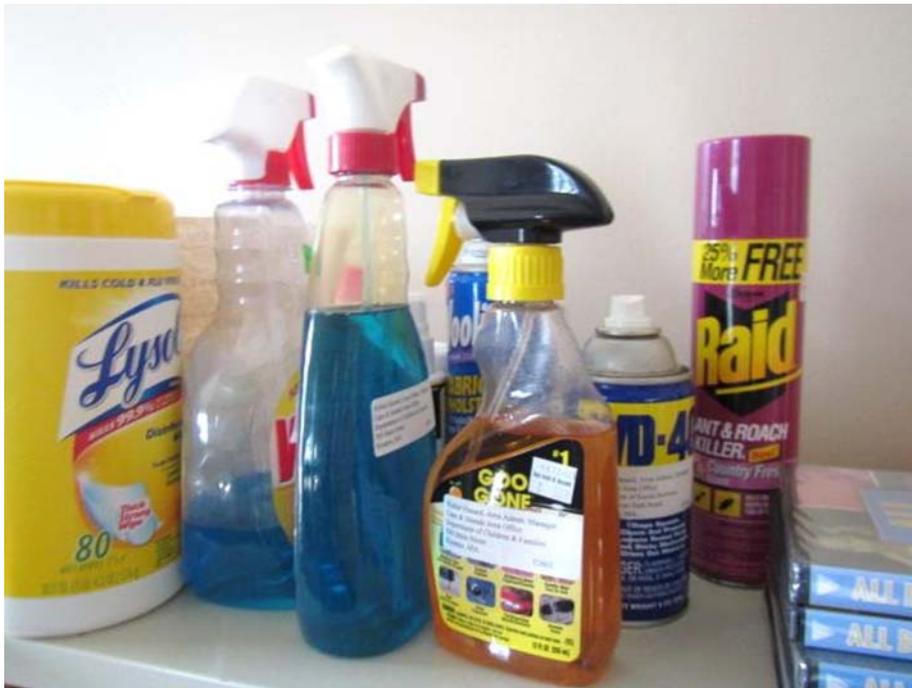
Picture 6

Cleaning products, pesticides, air freshening sprays and scented products were also observed (Pictures 6 and 7, Table 1). Plug-in air fresheners and other air deodorizers contain chemicals that can be irritating to the eyes, nose and throat of sensitive individuals. Many air fresheners contain 1,4-dichlorobenzene, a VOC which may cause reductions in lung function (NIH, 2006). Furthermore, deodorizing agents do not remove materials causing odors, but rather mask odors that may be present in the area. Many cleaning products and pesticides contain chemicals that can be irritating to the eyes, nose and throat of sensitive individuals. Cleaning

Cleaning products and pesticides in an office

products and pesticides should be properly labeled and stored in an appropriate area. In addition, a Material Safety Data Sheet (MSDS) should be available at a central location for each product in the event of an emergency.

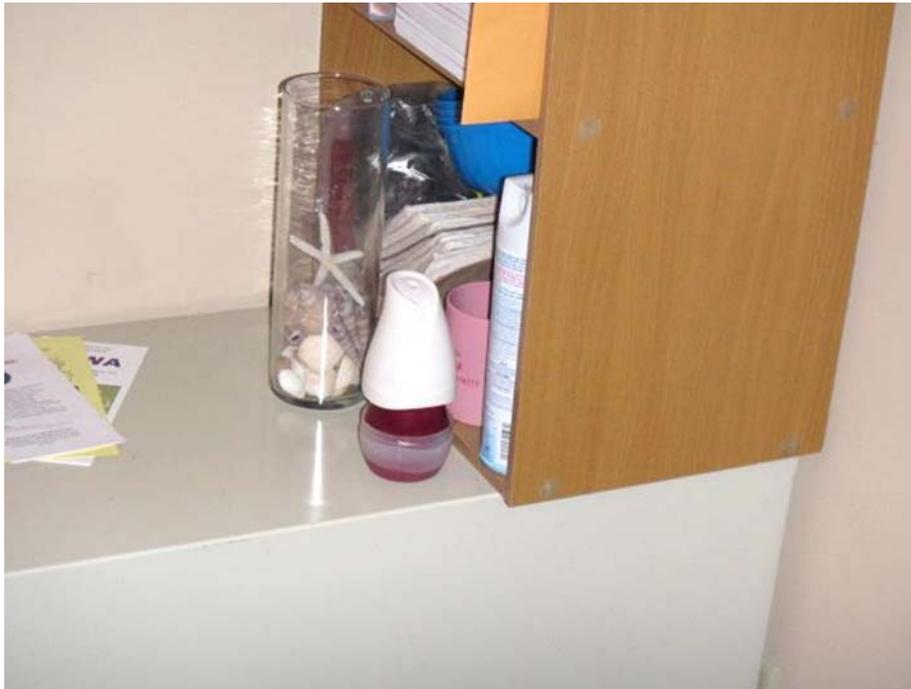
Picture 7

Air freshener product

14. Avoid the use of air freshener sprays, solids and diffuser reeds to avoid exposure to VOCs and fragrance compounds.
15. Ensure that items in storerooms are enclosed to protect from dust and are in plastic containers or on shelves off the floor to prevent condensation.

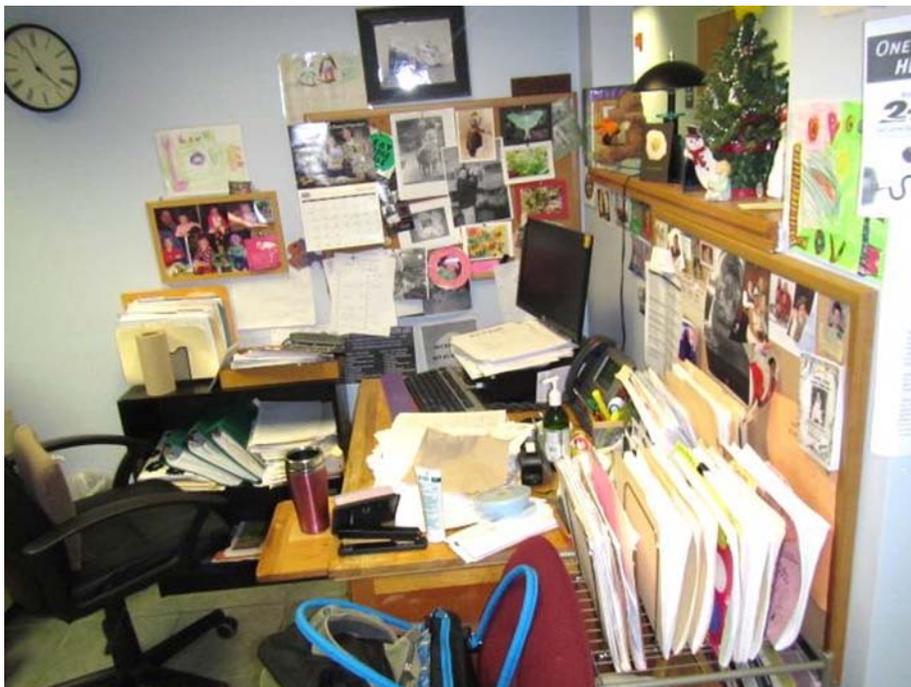
Picture 8

Other conditions that can affect IAQ were observed during the assessment. In some areas, accumulations of items were seen on floors, windowsills, tabletops, counters, bookcases and desks, which provide a source for dusts to accumulate (Picture 8). These items (e.g., papers, folders, boxes) make it difficult for custodial staff to clean. Items should be relocated and/or be cleaned periodically to avoid excessive dust build up. The DCF also has a large number of items stored, including clothing, luggage and other items (Picture 9). Some of these items were observed to be in open bins or on floors in storage rooms, where they can become dusty, dirty or subject to condensation. Cardboard, paper, cloth and other porous items should not be stored in contact with floors.

Papers and other items in an office

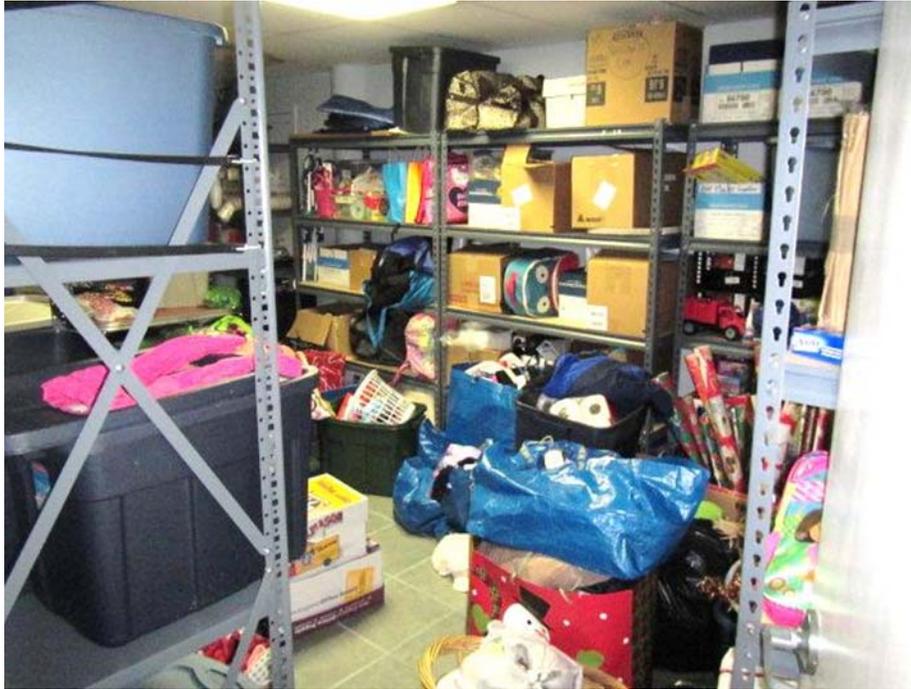
Picture 9

Items in storage

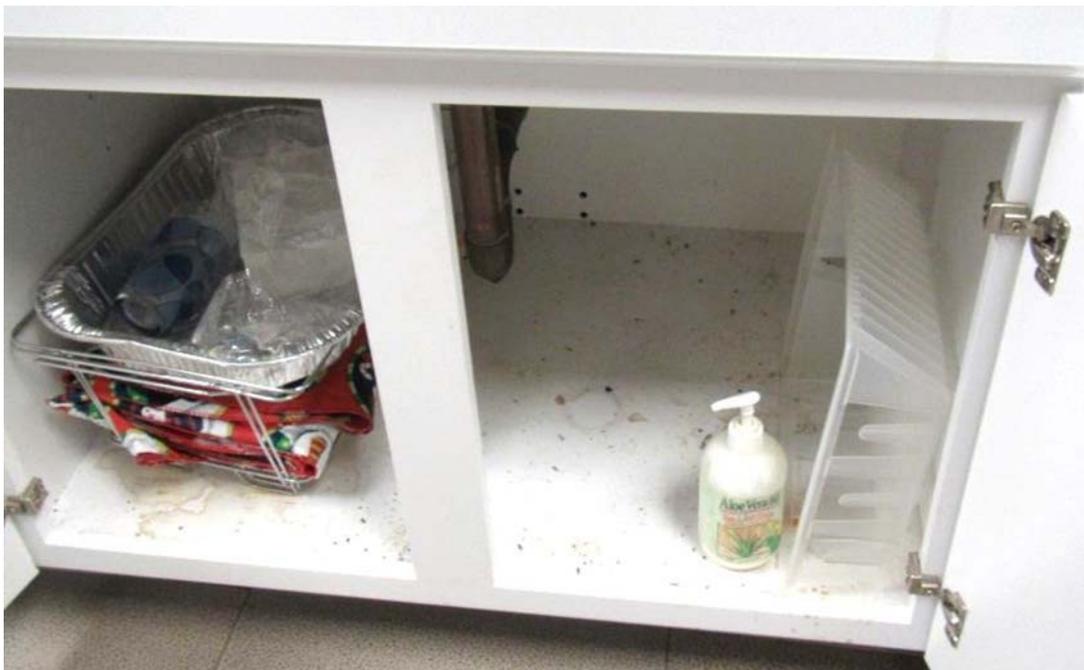
Picture 10

Debris was observed in the cabinet under the kitchen sink (Picture 10). Organic debris may be attractive to pests. In addition, the area under the sink is a moist environment and debris may become colonized by mold. This area should be cleaned regularly and not used for storage of porous materials.

Debris in sink cabinet
