INDOOR AIR QUALITY ASSESSMENT

**Cambridge City Information Technology and
Historical Commission Offices
831 Massachusetts Avenue, 2nd floor
Cambridge, MA 02139**

Prepared by:
Massachusetts Department of Public Health
Bureau of Environmental Health
Indoor Air Quality Program
August 2015

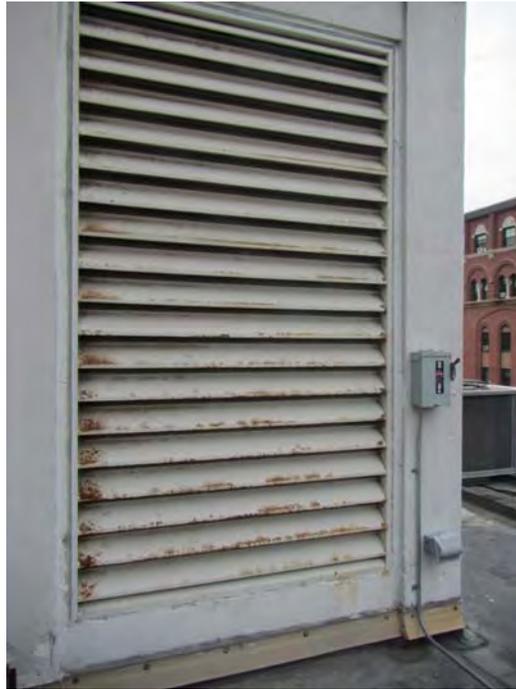
Picture 1

It can be seen from Table 1 that carbon dioxide levels were below 800 parts per million (ppm) in all 30 areas tested, indicating adequate air exchange on the day of the assessment. Fresh air for the space is provided by an air handling unit (AHU) located in a penthouse above the second floor. Outside air is drawn into the AHUs through a vent outside the penthouse (Picture 1) and ducted to ceiling-mounted supply diffusers. Return air is drawn back into ceiling vents via a plenum system and returned to the AHUs. Thermostats are computer-controlled centrally.

AHU intake vent on the penthouse

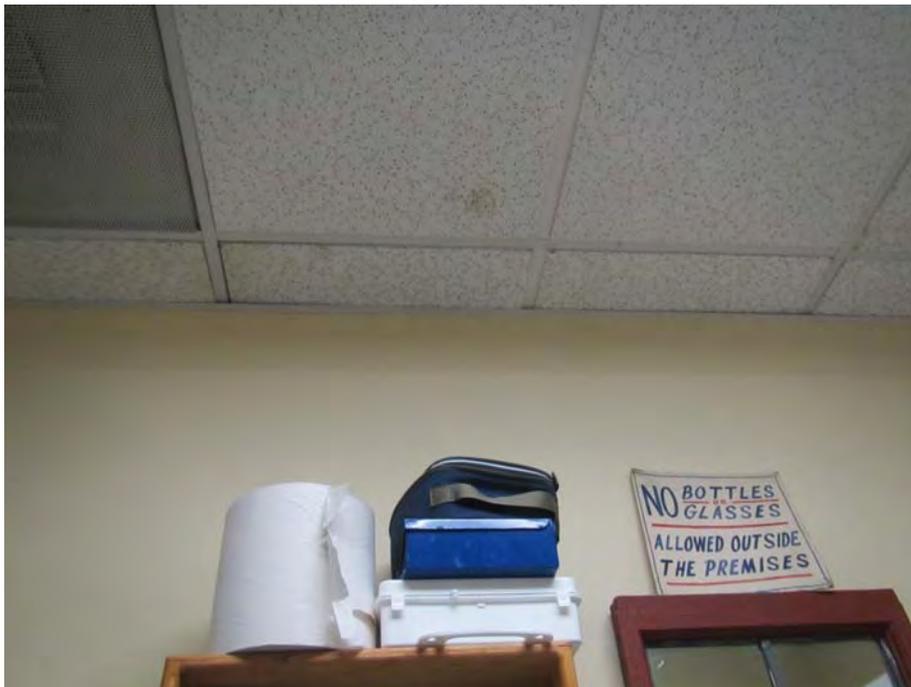
Picture 2

A few water-damaged ceiling tiles were observed in offices and the kitchen area (Picture 2). It was reported that when periodic roof leaks occur, they are repaired and tiles are replaced. It was reported by Mr. Lyle that the City of Cambridge is planning capital maintenance, including roof work, on all City buildings including the CIT/HC.

Water-damaged ceiling tile in kitchen

5. Continue to repair roof and replace water-damaged tiles as needed. Ensure that any water-damaged materials are removed/repared in accordance with USEPA and ACGIH recommendations. Address flashing and brickwork repairs when capital roof maintenance is performed.

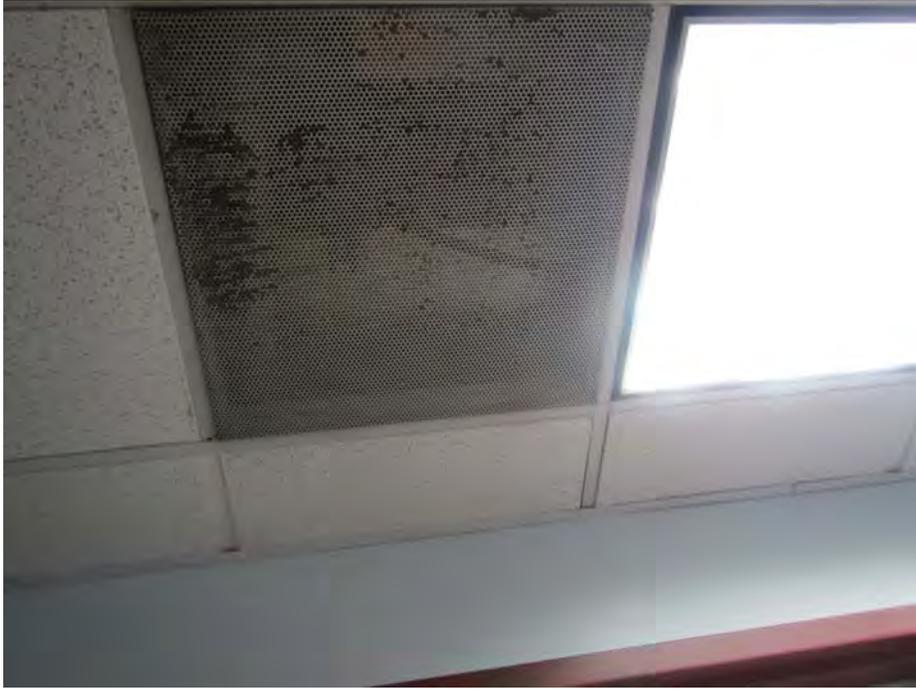
Picture 3

A corroded/damaged exhaust vent grate was observed outside one of the restrooms (Picture 3). This damage is likely due to water vapor from the restrooms condensing on the grate over a long period of time. The damaged grate should be replaced. In addition, the restroom door should remain closed so that the exhaust vents in the restrooms can remove accumulated water vapor. It may be useful to move this grate a few tiles over to prevent it from drawing air from the restroom directly into the plenum.

Water-damaged/corroded exhaust vent grate

6. Replace damaged return vent grate shown in Picture 3. Keep restrooms doors closed when not in use to prevent water vapor from penetrating into the hallway. Consider relocating this vent.

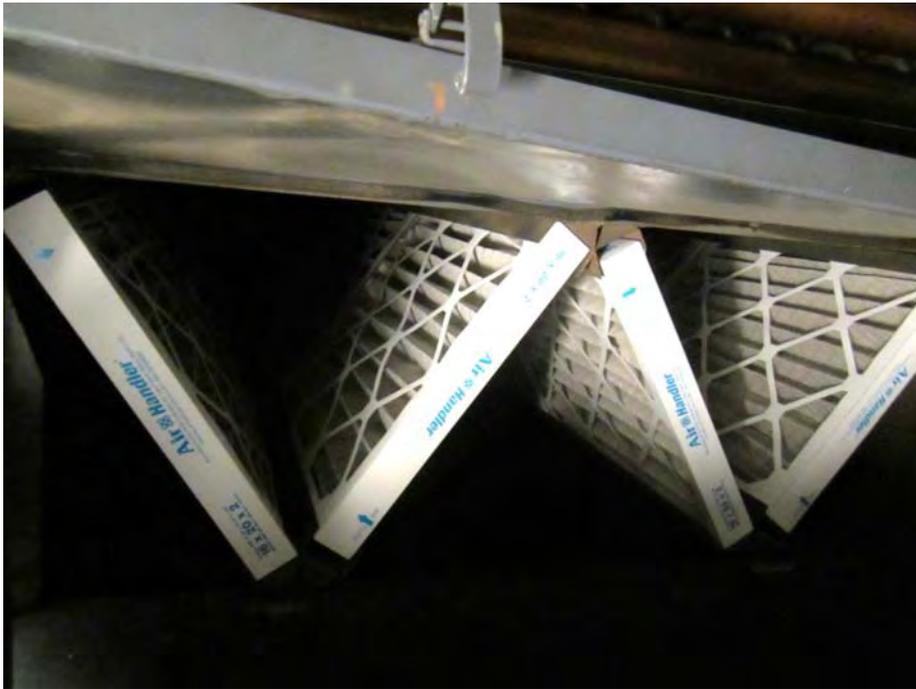
Picture 4

Filters on the AHU were examined during the assessment (Picture 4). They appear to be properly fitted pleated filters but the dust spot efficiency could not be determined. The dust spot efficiency is the ability of a filter to remove particulate matter of a certain diameter from air passing through the filter. Filters that have been determined by ASHRAE to meet its standard for a dust spot efficiency of a minimum of 40 percent (i.e. a MERV of 9) would be sufficient to

Pleated filters in the AHU

8. Use and maintain humidifiers in accordance with manufacturer's instructions.
9. Determine the MERV value of the filters used in the HVAC system and consider upgrading to higher dust-spot efficiency filters if they are lower than MERV 9. Prior to any increase of filtration, HVAC system components should be evaluated by a ventilation engineer as to whether they can maintain function with more efficient filters.

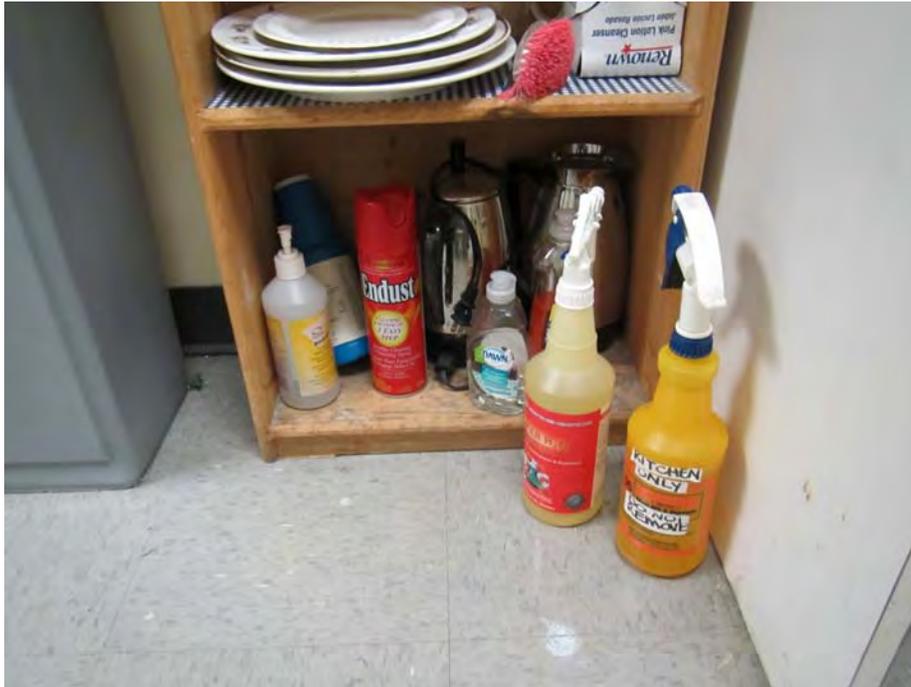
Picture 5

Cleaning and air freshening products were observed (Picture 5). Cleaning products, air fresheners and other air deodorizers contain chemicals that can be irritating to the eyes, nose and throat of sensitive individuals. Many air fresheners contain 1,4-dichlorobenzene, a VOC which can reduce lung function (NIH, 2006). Furthermore, deodorizing agents do not remove materials causing odors, but rather mask odors that may be present in the area. Cleaning products should be properly labeled and stored in an appropriate area. In addition, a Material Safety Data Sheet (MSDS) should be available at a central location for each product in the event of an emergency.

Cleaning products in the kitchen

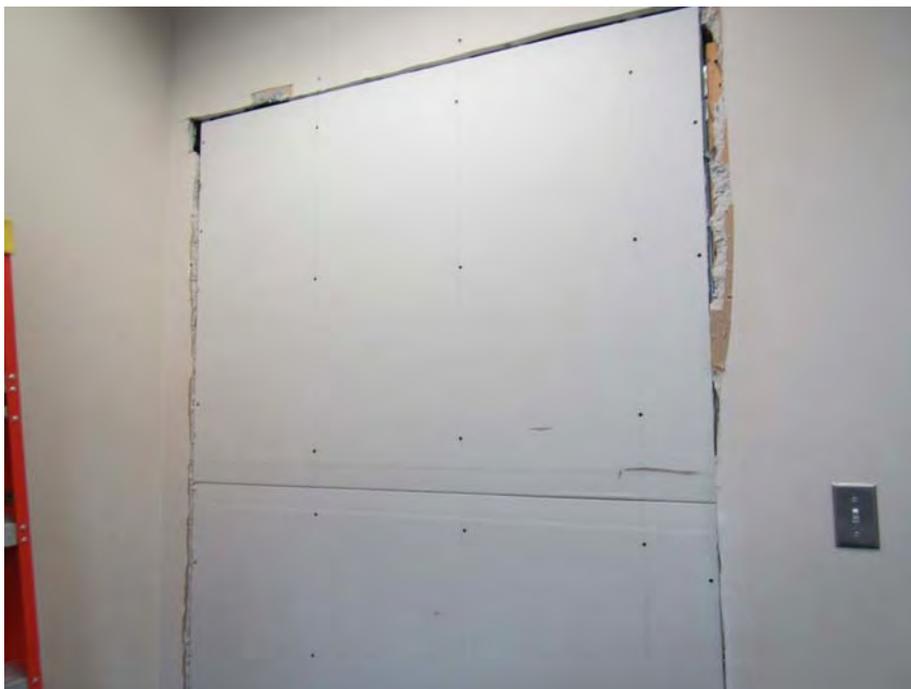
Picture 6

cleaning to remove dust and debris before it can be reaerosolized and distributed to occupied areas is also important. One room was vacant due to construction (Picture 6; note dust and debris on floors and surfaces). Plastic barriers over doorways should be used in such situations to contain dusts until work is completed and cleaning has been performed.

Inside room being renovated

1. Perform any renovation work during unoccupied hours whenever possible. When renovations during occupied hours are necessary, isolate renovation areas from occupied areas to the greatest extent possible and keep the work areas as clean as possible to avoid dusts and fumes penetrating occupied spaces. Ensure paints, mastics or other potential VOC-containing products are used in well-ventilated areas. Consider blocking plenum return vents in areas undergoing renovations. Refer to [Appendix B](#) “Methods Used to Reduce/Prevent Exposure to Construction/Renovation Generated Pollutants in Occupied Buildings” for more information.

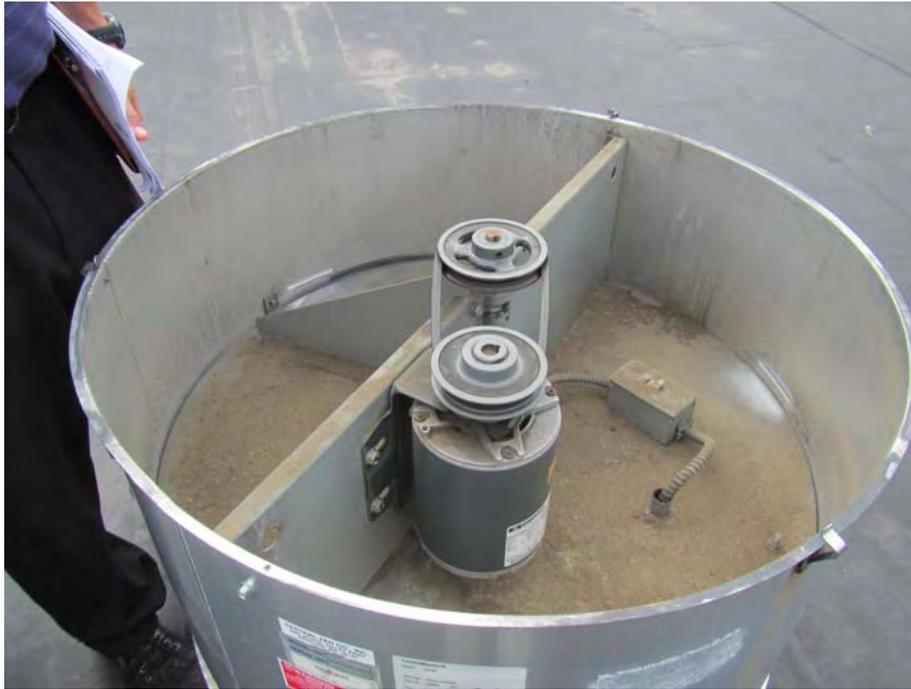
Picture 7

An exhaust vent on the roof was opened and examined (Picture 7), which was not currently running and contained some debris. Since the bathroom exhaust vents were operating at the time of the assessment, the purpose of this vent was not clear. The vent was reportedly in the process of being repaired and should be cleaned of debris.

Non-functioning exhaust vent, note debris inside

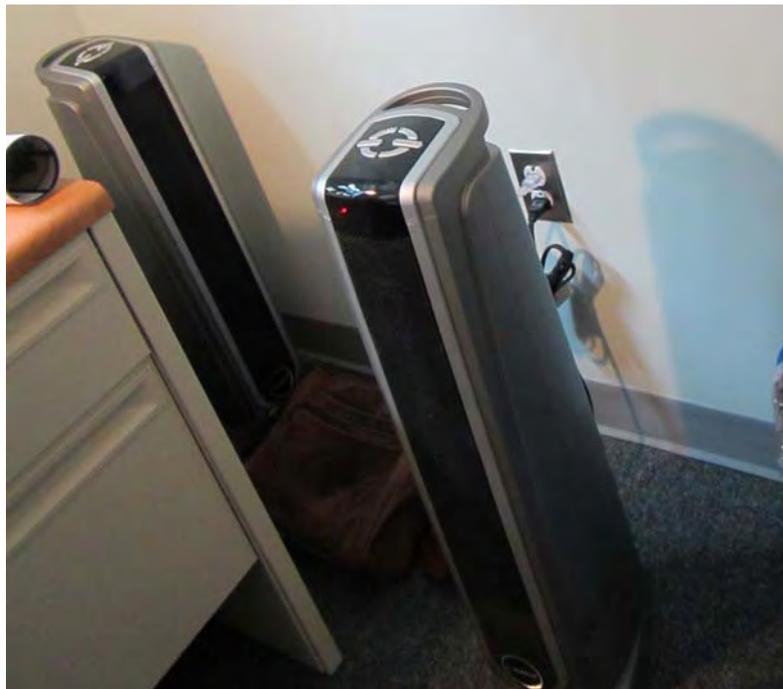
Picture 8

Personal fans, air purifiers and heaters were observed in many offices (Picture 8). Some of these appliances were dusty. Dust on these items can be reaerosolized and cause irritation or odors. In addition, air purifiers may have filters or other components that need to be cleaned and maintained so that they do not become a source of air pollution.

Air purifiers

12. Maintain heaters, air purifiers and personal fans in accordance with manufacturers' instructions and keep them clean of dust and debris.
13. Remove or relocate papers and other items to allow custodial staff to clean.

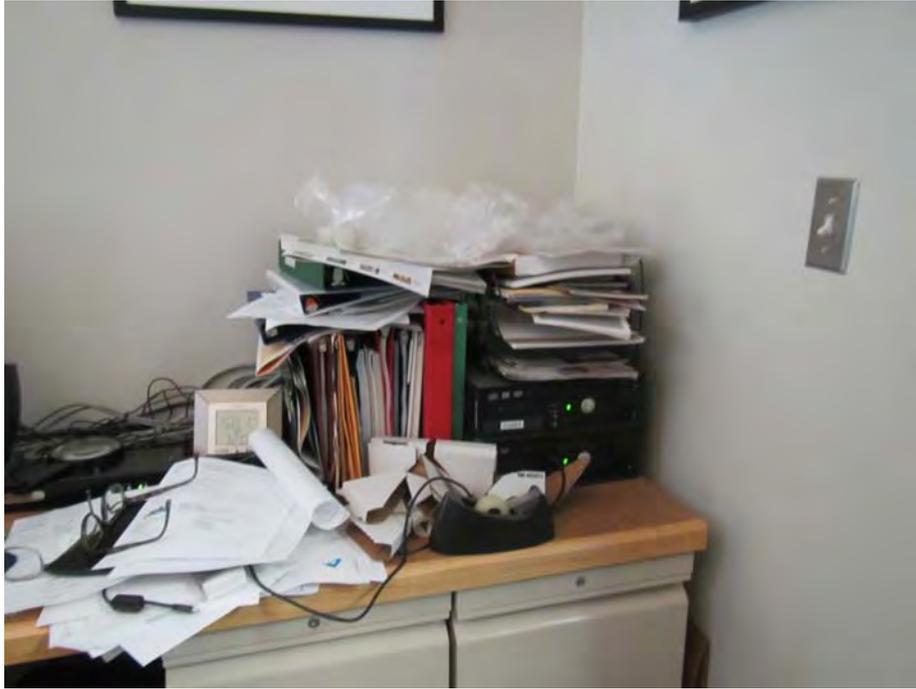
Picture 9

In some areas, accumulations of items were seen on floors, windowsills, tabletops, counters, bookcases and desks, which provide a source for dusts to accumulate (Picture 9). These items (e.g., papers, folders, boxes) make it difficult for custodial staff to clean. Items should be relocated and/or be cleaned periodically to avoid excessive dust build up.

Papers and accumulated items in an office
