# INDOOR AIR QUALITY ASSESSMENT

**Commonwealth of Massachusetts  
MassHealth Office  
45 Spruce Street  
Chelsea, Massachusetts**

Prepared by:  
Massachusetts Department of Public Health  
Bureau of Environmental Health  
Indoor Air Quality Program  
April 2015

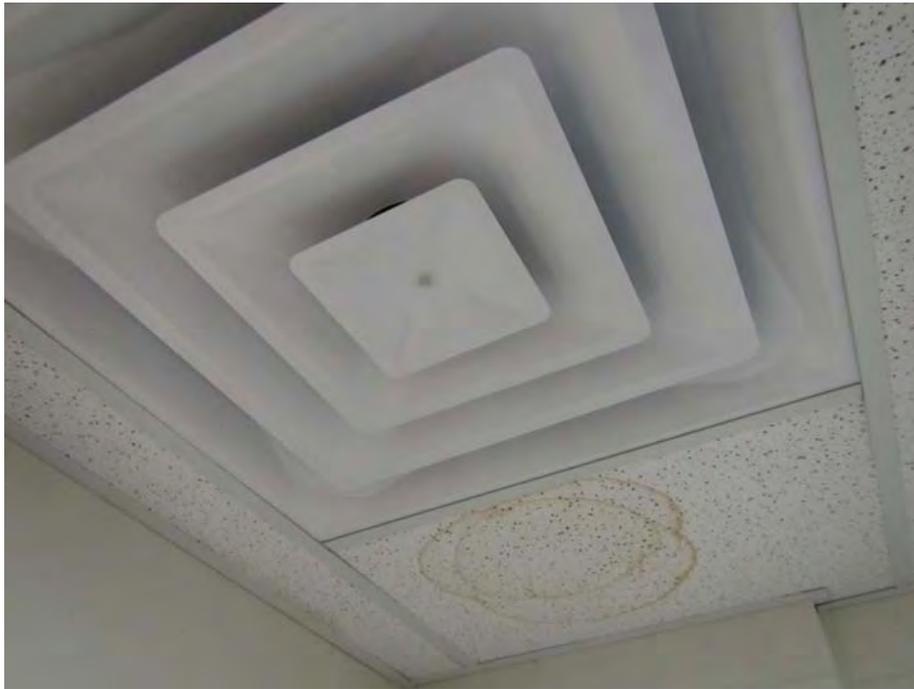
**Picture 1**

Fresh air is provided by rooftop air handling units (AHU) ducted to ceiling-mounted supply diffusers (Picture 1). Return air is drawn back into ceiling vents (Picture 2) and returned to the AHUs. In a few locations, the exhaust appeared to be vented into ducts which may exhaust directly to the roof. The BEH/IAQ program recommends that direct venting be used in areas where pollutants may be generated such as kitchens, copy areas and high-use areas.

Water-damaged ceiling tiles were observed in several areas of the building (Pictures 1 and 3, Table 1) which appeared to be the result of historic roof or plumbing leaks. Water-damaged ceiling tiles should be removed and replaced once the source of water has been identified and remediated.

**Ceiling-mounted supply vent (note water-damaged ceiling tile)**

5. Examine areas of leakage and ensure any water-damaged ceiling tiles are repaired and/or replaced. Examine the area above ceiling tiles for mold growth. Disinfect areas of water leaks with an appropriate antimicrobial, as needed.

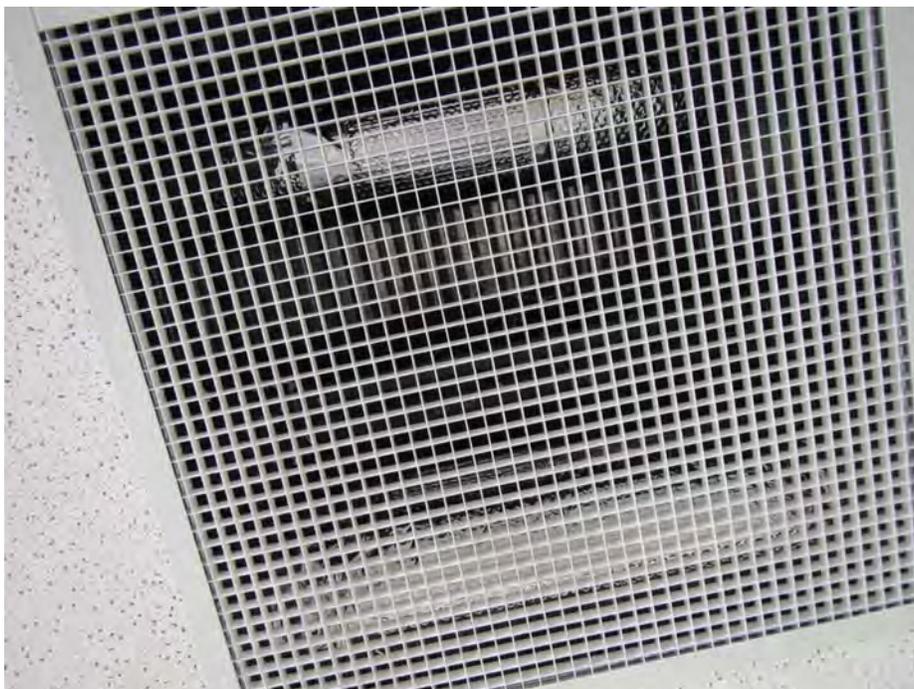
**Picture 2**

**Ceiling-mounted return vent**

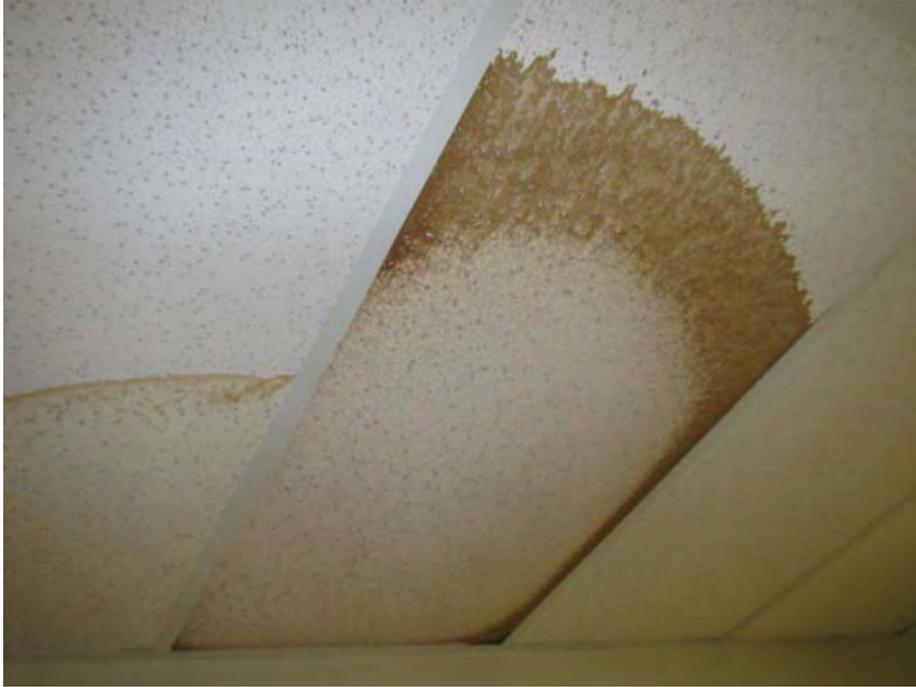
**Picture 3**

**Water-damaged ceiling tiles in a storage room**

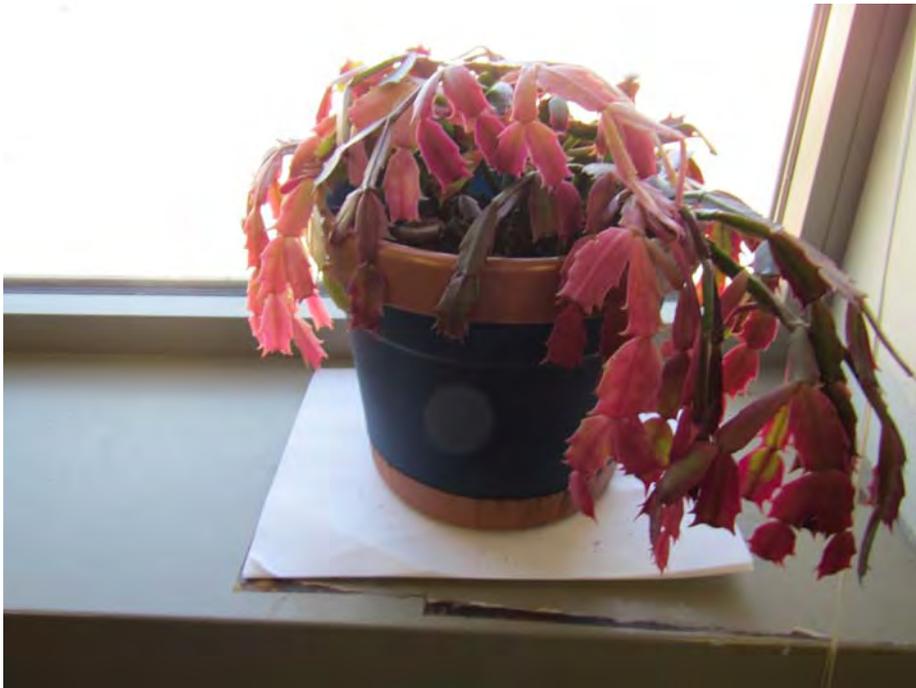
**Picture 4**

Plants were observed in several areas (Table 1). Some of these plants appeared to be poorly maintained, overwatered, and inappropriately placed on porous materials (Pictures 4 and 5). Plants, soil and drip pans can serve as sources of mold/bacterial growth. Plants should be properly maintained, over-watering of plants should be avoided and drip pans should be inspected periodically for mold growth. Water-damaged windowsills were observed in a few areas that appeared to be due to plants or other items that had been placed there in the past (Pictures 4 and 6).

**Plant on cardboard, note damage to windowsill**

6. Indoor plants should be properly maintained and equipped with drip pans to prevent water damage to porous building materials and be located away from ventilation sources to prevent the aerosolization of dirt, pollen or mold.

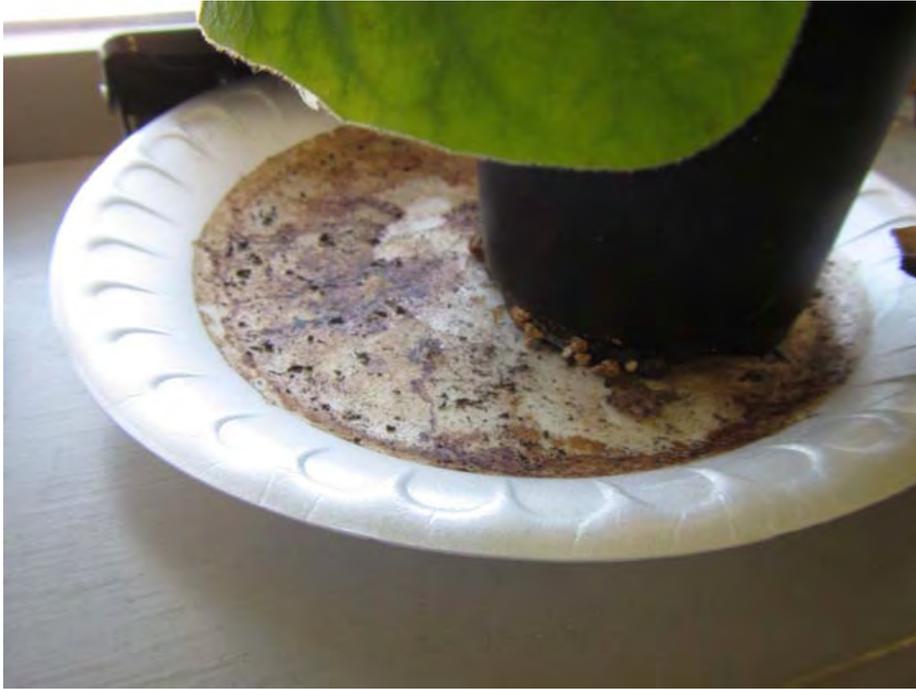
**Picture 5**

**Debris in plant drip pan**

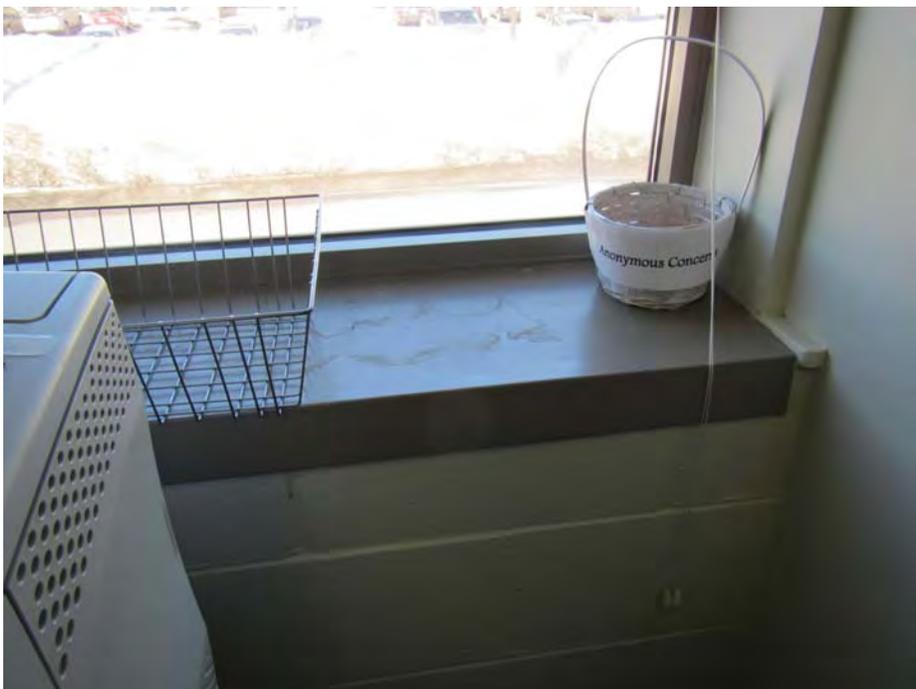
**Picture 6**

**Water stains/damage on windowsill**

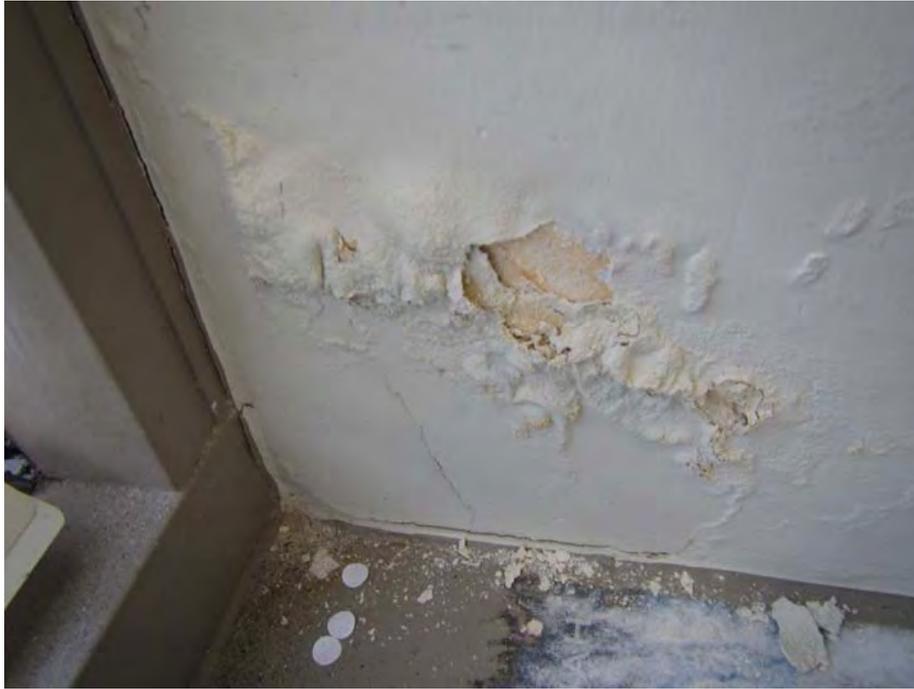
**Picture 7**

An area of water-damaged plaster/paint was observed in one room on the first floor next to a window (Picture 7). This may indicate a leak from outside, or chronic condensation in this area. The water-damaged materials should be removed and the wall cavity should be monitored for leaks. Items should not be stored on this windowsill on order to prevent the build-up of condensation in this location and to avoid moistening of materials.

**Water-damaged plaster**

7. Inspect the damaged plaster shown in Picture 7 for sources of water and repair. Do not store materials on this windowsill until the source of water has been repaired.

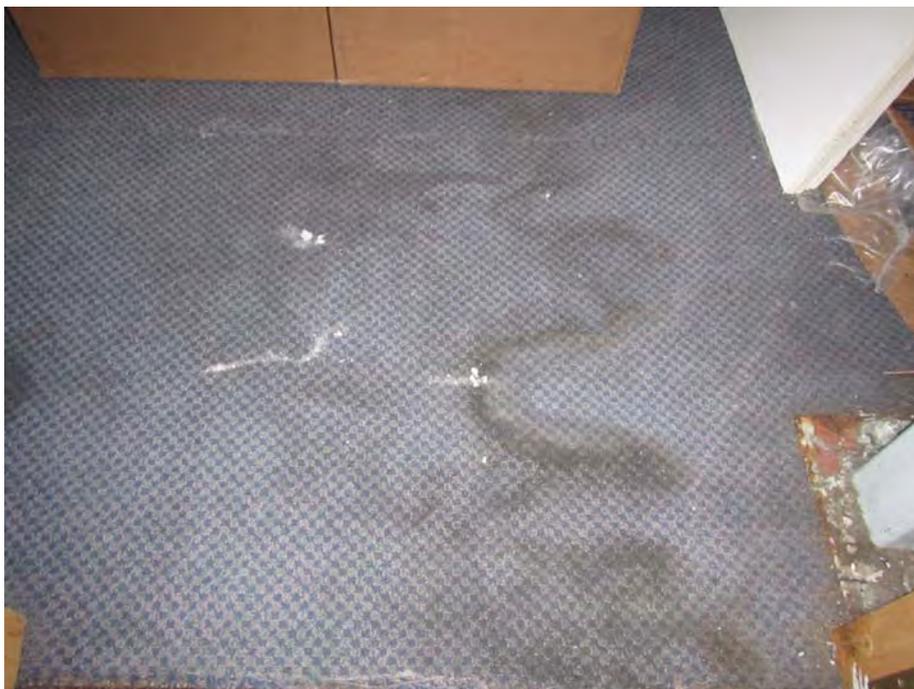
**Picture 8**

Water-damaged carpeting was observed in a storeroom under stairs (Picture 8). If this area is subject to periodic water infiltration or condensation, it should not be used for storage of porous items. In addition, in this room and in others, boxes were found stored on the floor. Items in contact with floors may be subject to moistening from condensation, which can damage porous materials such as cardboard, and may lead to microbial growth.

**Water-damaged carpeting in storage area**

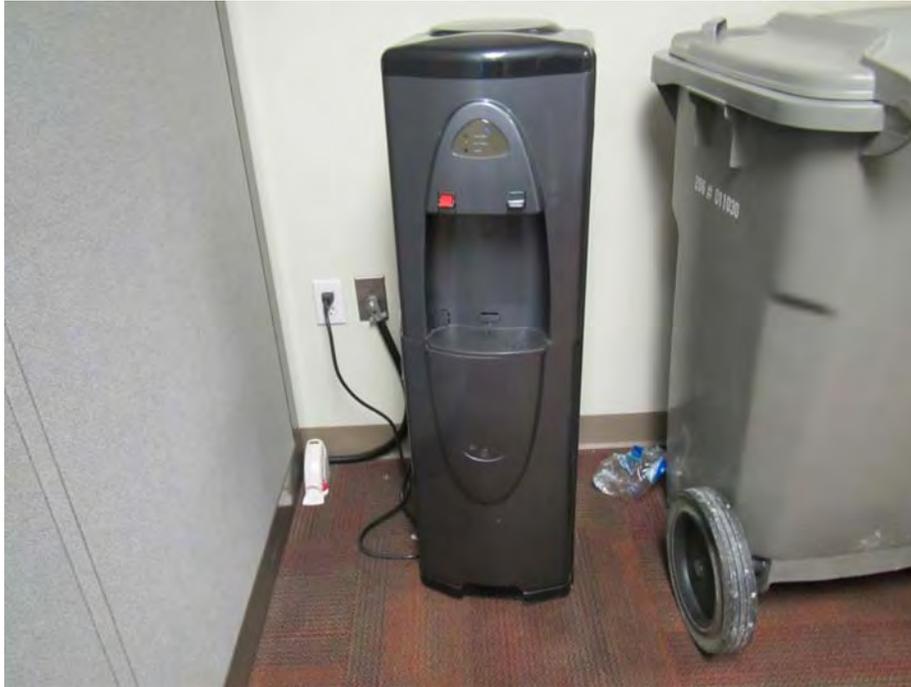
**Picture 9**

Water coolers were observed in carpeted areas (Picture 9). Spills or leaks from these appliances can moisten carpeting. They should be located in a non-carpeted area or on waterproof mats.

Evidence of rodent activity was observed in the form of mouse traps in several areas (Picture 9). Building staff reported rodents in the building in the past. Rodent infestation can result in indoor air quality related symptoms due to materials in their wastes. Mouse urine contains a protein that is a known sensitizer (US EPA, 1992). A sensitizer is a material that can

**Water cooler on carpet, also note mousetrap to the left**

8. Place water coolers/dispensers in areas without carpeting or place on a waterproof mat.
9. Regularly inspect the ductless air conditioning units for proper condensation drainage.

16. Use the principles of integrated pest management (IPM) to rid this building of pests.
- Activities that can be used to eliminate pest infestation may include the following:

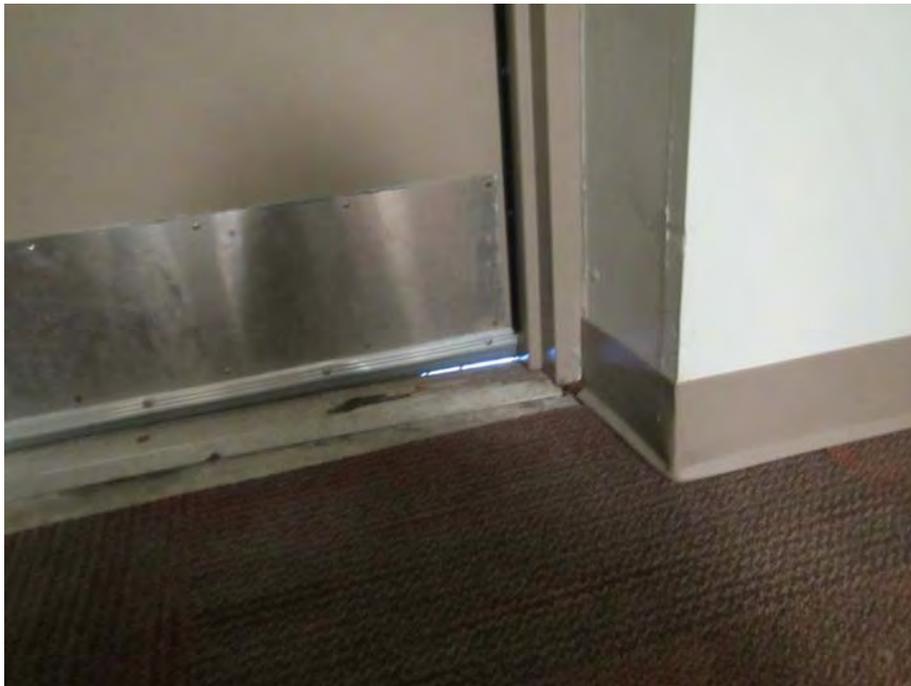
**Picture 10**

The exterior of the building was examined for conditions that might lead to indoor air quality concerns. Doors to the exterior were seen to be missing weather stripping (Picture 10), which can allow unconditioned air, moisture and pests into the building. In addition, a hole was noted in the EFIS siding on one area (Picture 11). This should be repaired to prevent infiltration of water into the building and to allow the drainage plane to function properly.

**Gap under door (light penetration)**

10. Repair/install weather-stripping on doors to the outside to prevent infiltration of unconditioned air, moisture and pests.
11. Repair the siding shown in Picture 11.

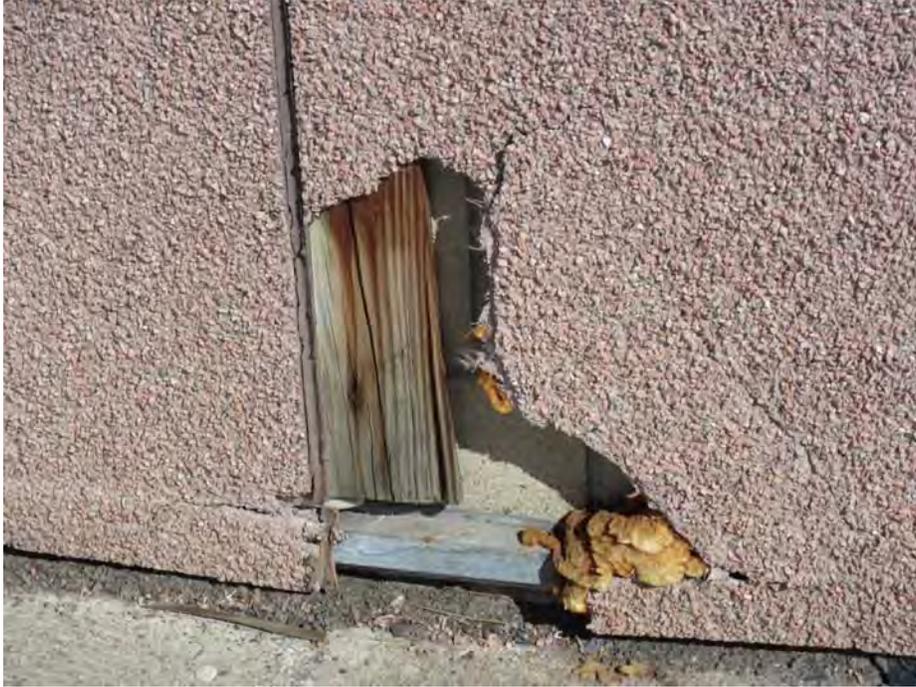
**Picture 11**

**Hole in siding**

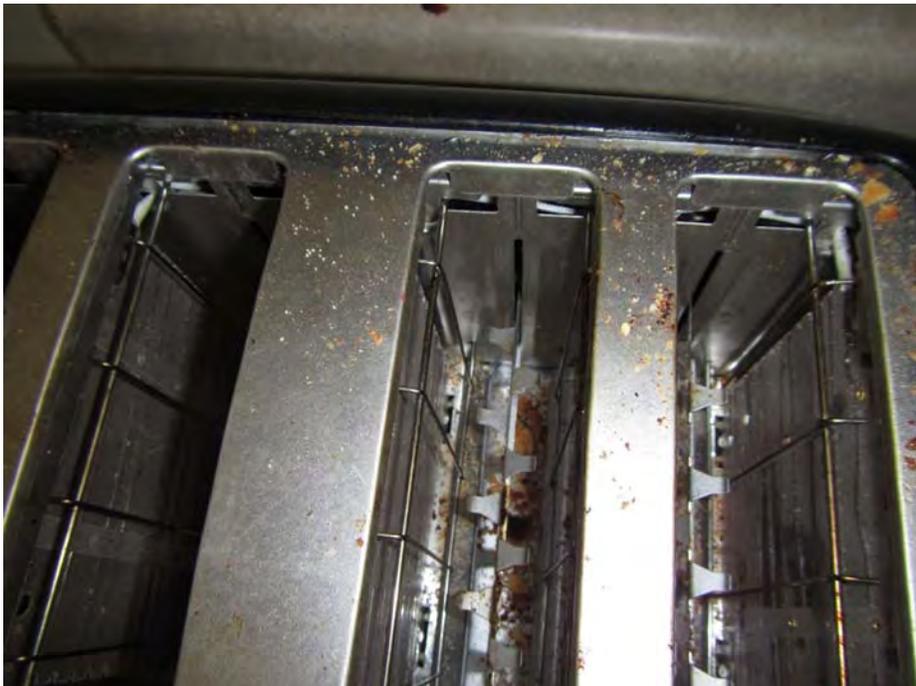
**Picture 12**

Note that in the kitchen area, debris was observed on toasters and other equipment (Picture 12). This debris can be attractive to pests. It can also lead to smoke and odors when the appliances are used/heated.

**Toaster in kitchen area with crumbs**

- f. Regularly clean crumbs and other food residues from toasters, toaster ovens, microwave ovens coffee pots and other food preparation equipment;
  - g. Examine each room and the exterior walls of the building for means of rodent egress and seal appropriately. Holes as small as ¼” is enough space for rodents to enter an area. If doors do not seal at the bottom, install a weather strip as a barrier to rodents;

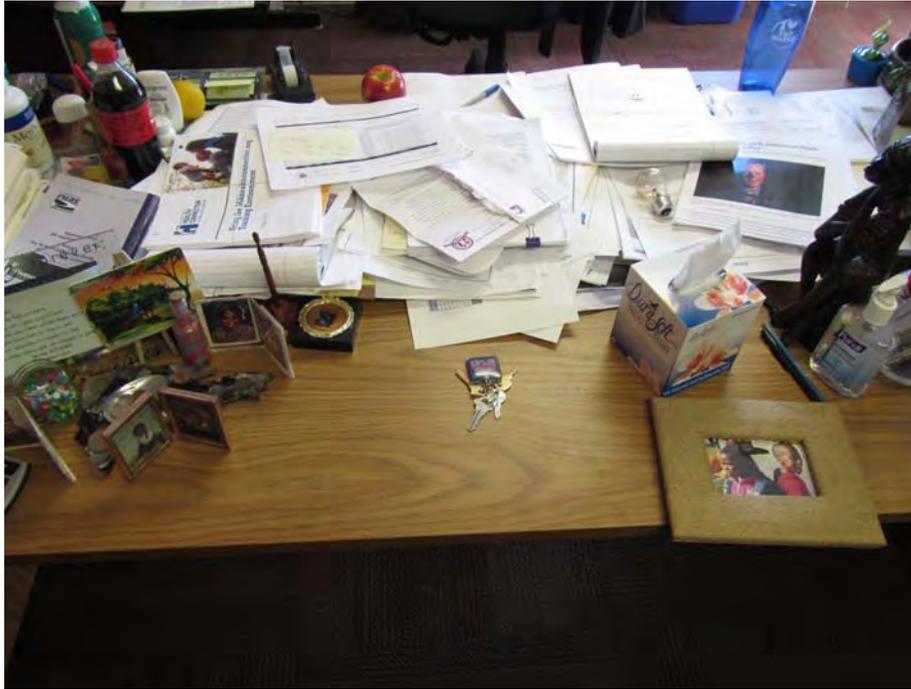
**Picture 13**

In some office areas, accumulations of items were on floors, windowsills, tabletops, counters, bookcases and desks, which provide a source for dusts to accumulate (Picture 13). These items (e.g., papers, folders, boxes) make it difficult for custodial staff to clean. Items should be relocated and/or be cleaned periodically to avoid excessive dust build up. Pencil shavings were observed in one office (Picture 14). These materials can also be aerosolized by air

**Papers and items on desk**

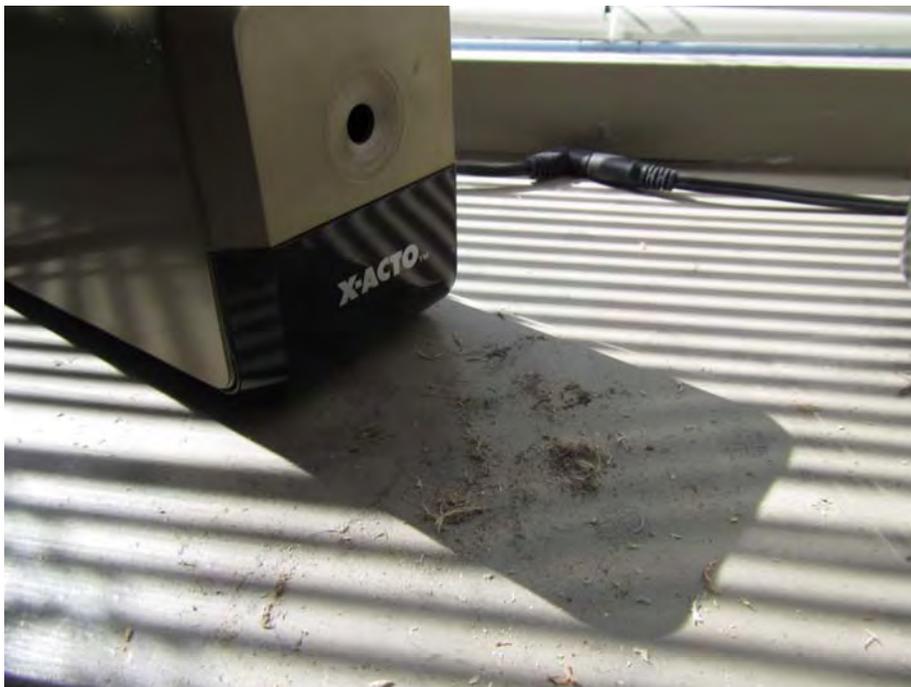
**Picture 14**

**Pencil shavings**

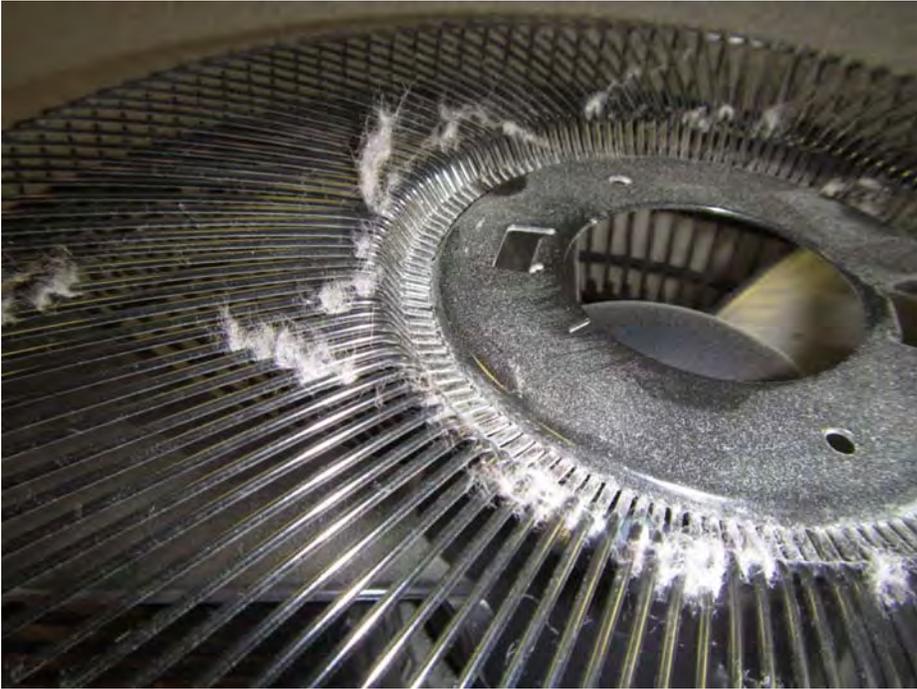
**Picture 15**

movement from the ventilation system or opening/closing of doors; aerosolized materials may present an eye or respiratory irritant. Personal fans, and supply and exhaust vents were found to be dusty in some areas (Picture 15). Regular cleaning of supply diffusers, exhaust vents and personal fans will reduce aerosolizing any accumulated particulate matter on these surfaces.

**Debris on personal fan**

18. Regularly clean supply diffusers, exhaust vents and personal fans to avoid re-aerosolizing any accumulated debris.
19. Vacuum carpet with a high efficiency particulate arrestance (HEPA) filtered vacuum in combination with an annual cleaning to help to reduce accumulation and potential aerosolization of materials from the carpeting.
20. Refer to resource manuals and other related indoor air quality documents for further building-wide evaluations and advice on maintaining public buildings. Copies of these materials are located on the MDPH's website: <http://mass.gov/dph/iaq>.
