INDOOR AIR QUALITY ASSESSMENT

**Fowler Middle School
3 Tiger Drive
Maynard, Massachusetts**

Prepared by:
Massachusetts Department of Public Health
Bureau of Environmental Health
Indoor Air Quality Program
December 2015

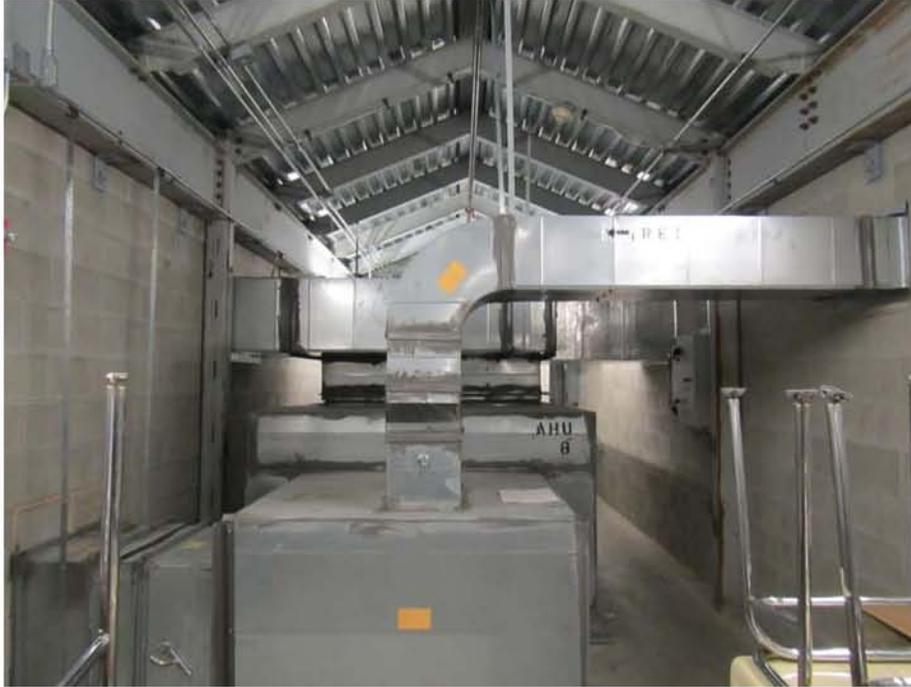
Picture 1

Air handling unit in mechanical space

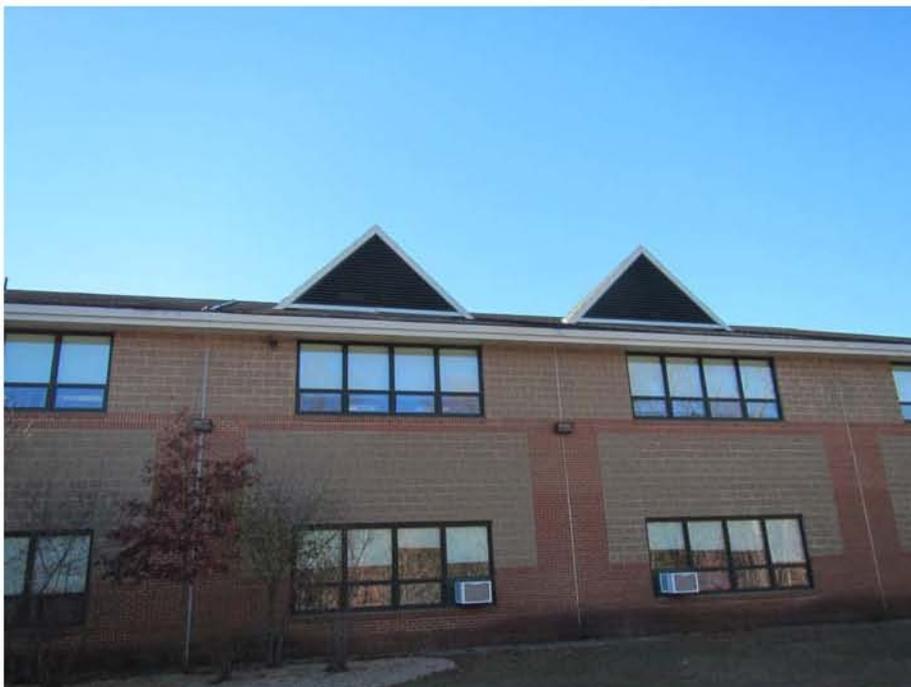
Picture 2

Air intakes at top of roof

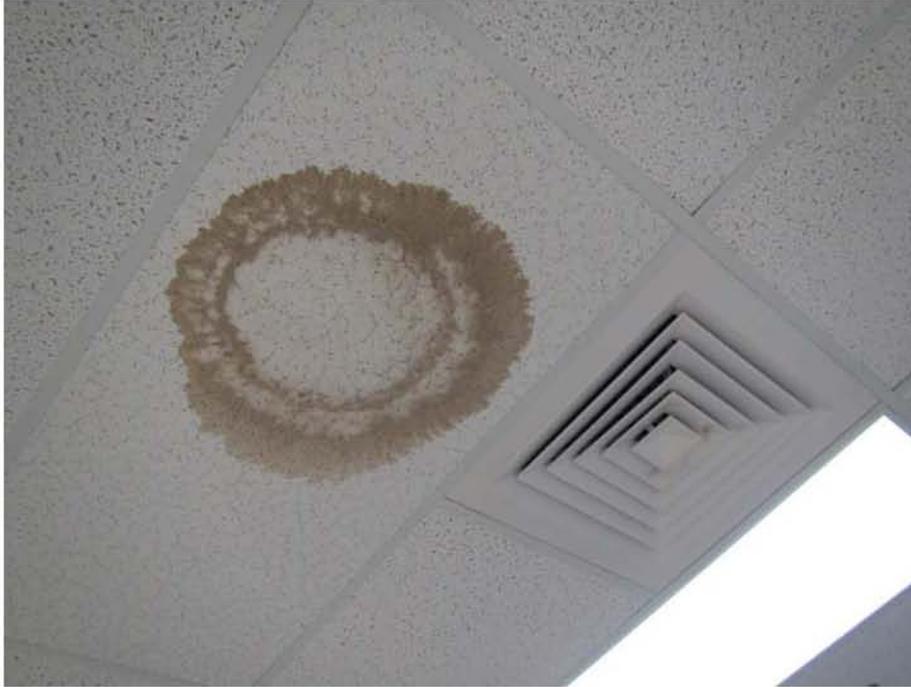
Picture 3

Water-damaged ceiling tiles were observed in many classrooms and other areas (Pictures 3 and 6; Table 1). These reportedly originate from intermittent roof leaks. Water-damaged ceiling tiles can provide a source of mold and should be removed and replaced when leaks are discovered and repaired. However, no mold staining was visible on any of the tiles examined.

Ceiling-mounted supply vent (note water-damaged ceiling tile)

1. Replace water-damaged ceiling tiles promptly. Make necessary repairs to roof and plumbing to reduce water damage from occurring in the future.
2. Operate HVAC equipment continuously during occupied hours.
3. Investigate draw of air from exhaust vents in bathrooms and other areas and repair if necessary.
4. Work with facilities staff to adjust temperatures for occupied areas.
5. For buildings in New England, periods of low relative humidity during the winter are often unavoidable. Therefore, scrupulous cleaning practices should be adopted to minimize common indoor air contaminants whose irritant effects can be enhanced when the relative humidity is low. To control for dusts, a high efficiency particulate arrestance

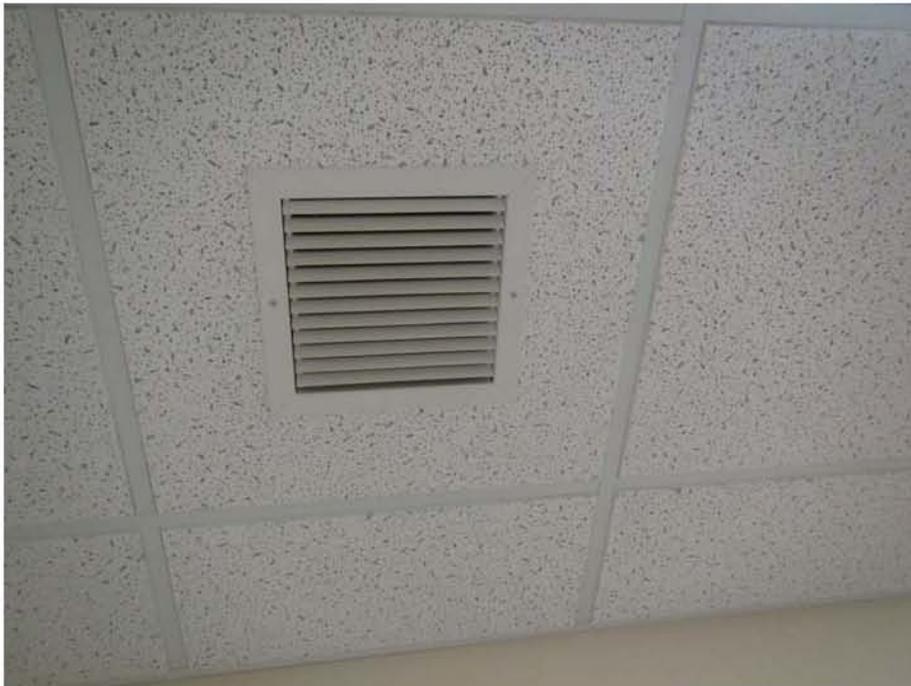
Picture 4

Return vent

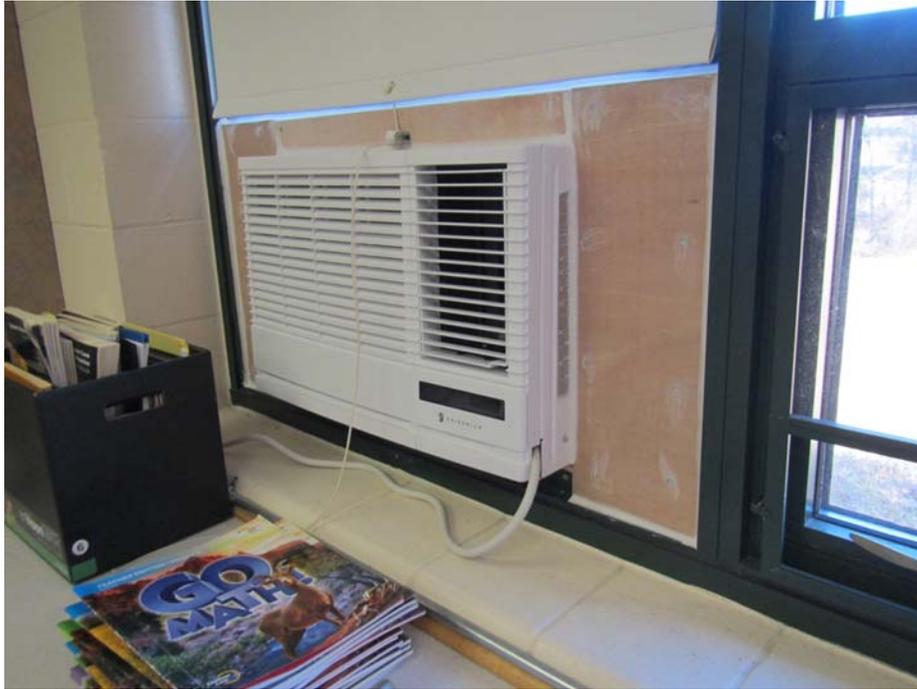
Picture 5

The AHUs for common areas provide cooling as well as heating. Additional cooling for the administrative wing and some classrooms is provided by window-mounted air conditioners (Picture 5).

Window-mounted air conditioner

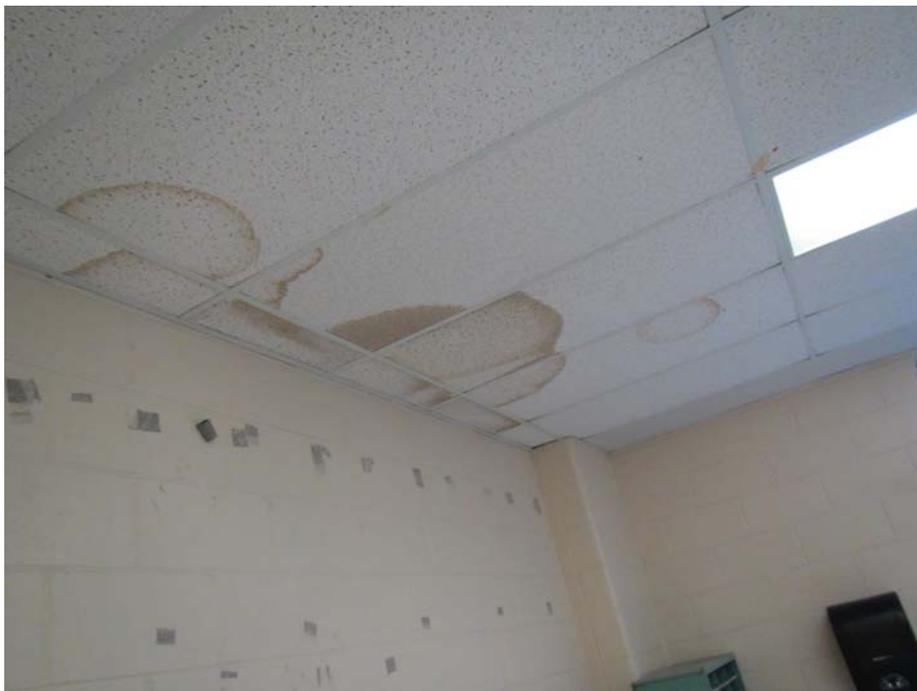
Picture 6

Water-damaged ceiling tiles

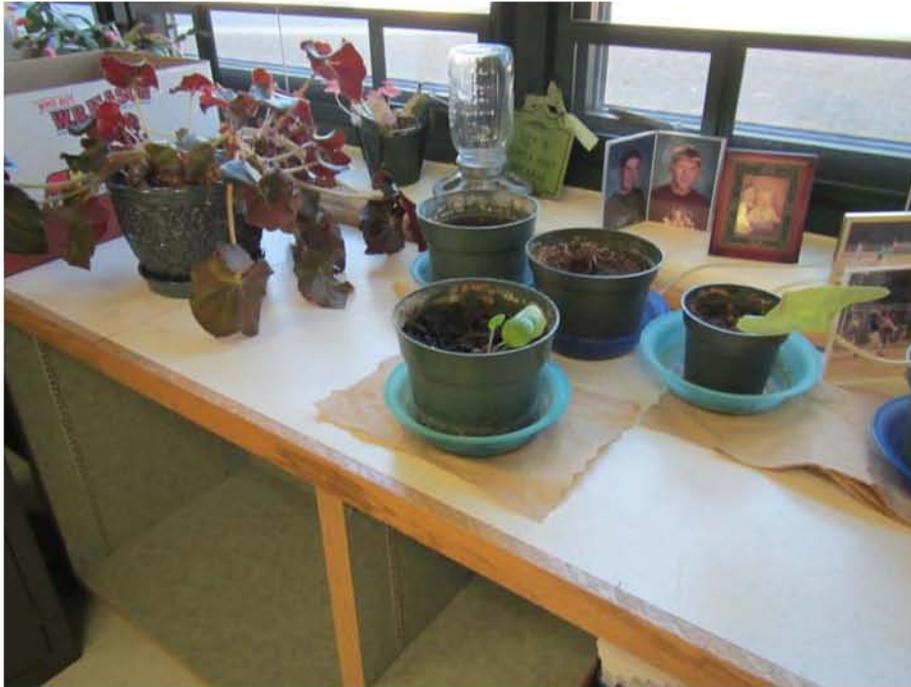
Picture 7

Indoor plants were also observed in some areas, which can introduce pollen or mold indoors (Picture 7; Table 1). Plants should be kept away from sources of airflow which may distribute particles, pollen, mold and odors. Plants should be properly maintained, over-watering of plants should be avoided and drip pans should be inspected periodically for mold growth and cleaned or replaced as necessary. An aquarium and a terrarium were observed in classrooms, these should also be well maintained to prevent odors.

Plants on porous materials

7. Maintain indoor plants, use non-porous drips pans, prevent overwatering and refrain from placing them near ventilation equipment.
 8. Maintain aquariums and terrariums to prevent odors.

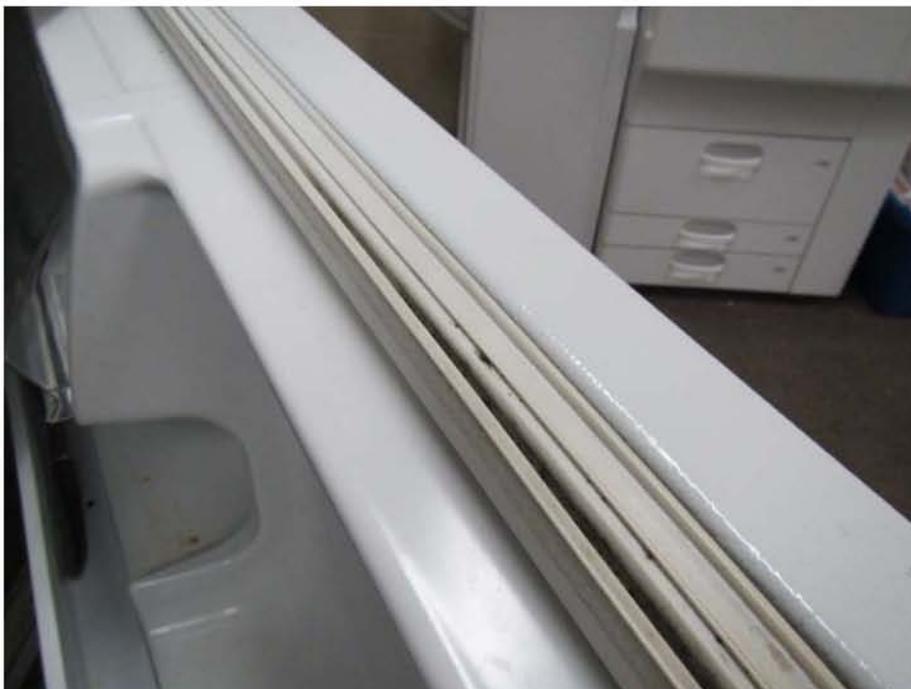
Picture 8

Water dispensing equipment and small refrigerators were observed in carpeted areas (Table 1). Spills or leaks from this equipment can moisten carpet and lead to microbial growth and carpet degradation. Some refrigerators examined had gaskets that were stained with mold (Picture 8); these should be cleaned with an antimicrobial solution or replaced. Refrigerators should be cleaned out regularly to prevent odors from spilled/spoiled food.

Stained refrigerator gasket

9. Consider placing water dispensers/small refrigerators in non-carpeted areas or place a waterproof mat underneath them.
 10. Clean out refrigerators often. Clean gaskets with an antimicrobial solution or replace when stained.

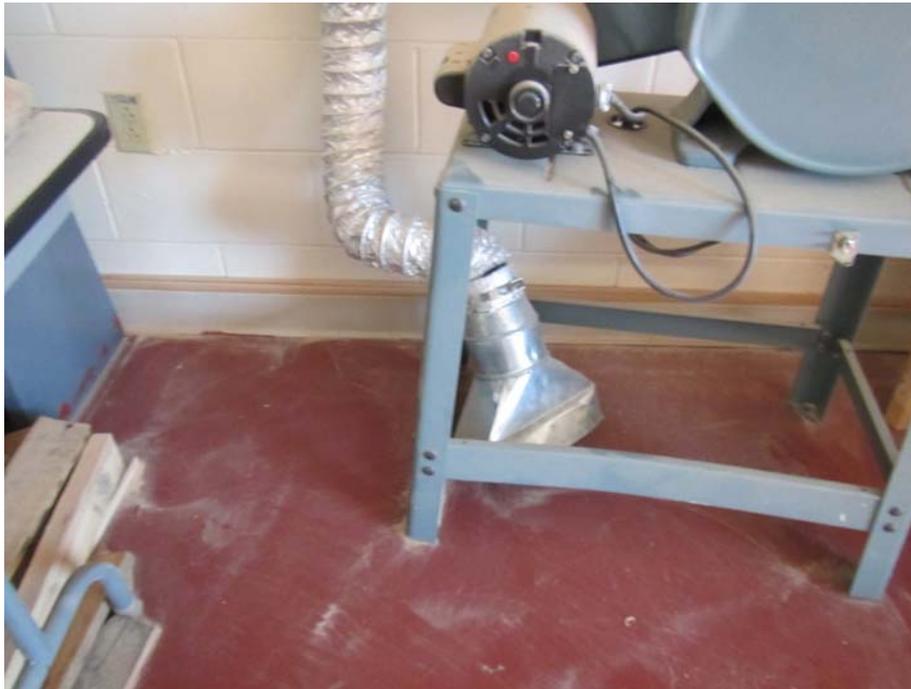
Picture 9

Other conditions that can affect IAQ were observed during the assessment. The woodshop area had task-based exhaust/vacuum systems that emptied into a collection system outside the building (Picture 9). This system should be used as needed to collect wood chips/shavings and maintained, including emptying the receptacle of sawdust/chips on a regular basis. Sawdust can be a source of mold, and can provide harborage for pests.

Woodshop sawdust exhaust

13. Use and maintain the sawdust collection system in the wood shop, including regular emptying of the collection receptacle.
 14. Use the exhaust vent for the kiln whenever the kiln is in operation. Keep the kiln area clear of materials, particularly flammable materials and those that may off-gas when heated.

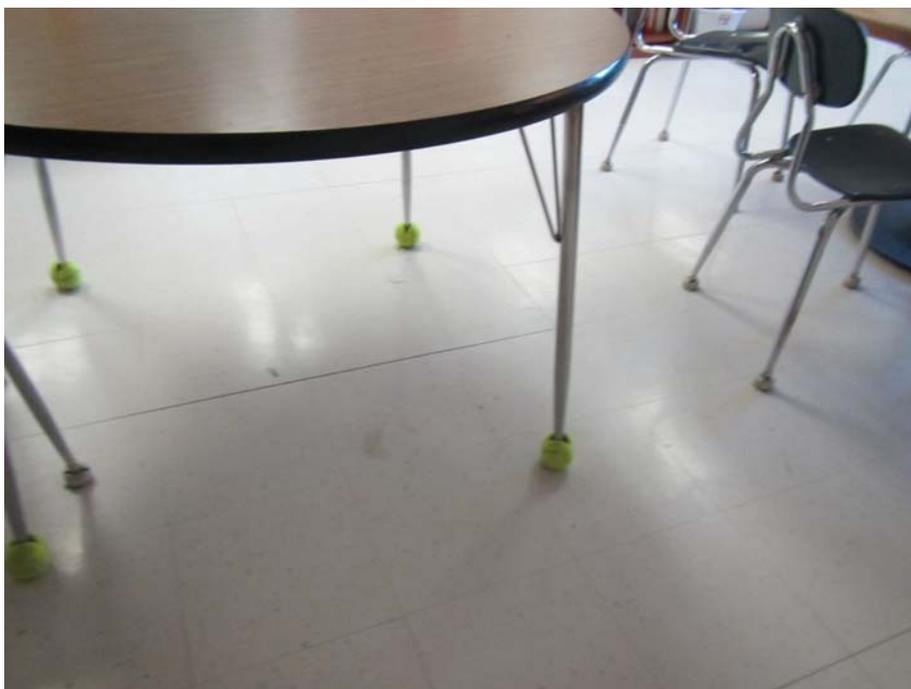
Picture 10

Tennis balls were observed sliced open and used at the bottom of table and chair legs (Picture 12). Tennis balls are made of a number of materials that are a source of respiratory

irritants. Constant wearing of tennis balls can produce fibers and off-gas VOCs. Tennis balls are made with a natural rubber latex bladder, which becomes abraded when used as a chair leg pad. Use of tennis balls in this manner may introduce latex dust into the school environment. Some individuals are highly allergic to latex (e.g. spina bifida patients) (SBAA, 2001). It is recommended that the use of materials containing latex be limited to reduce the potential for symptoms in sensitive individuals (NIOSH, 1997). Latex-free glides should be used for this purpose.

Tennis balls used as chair and table glides

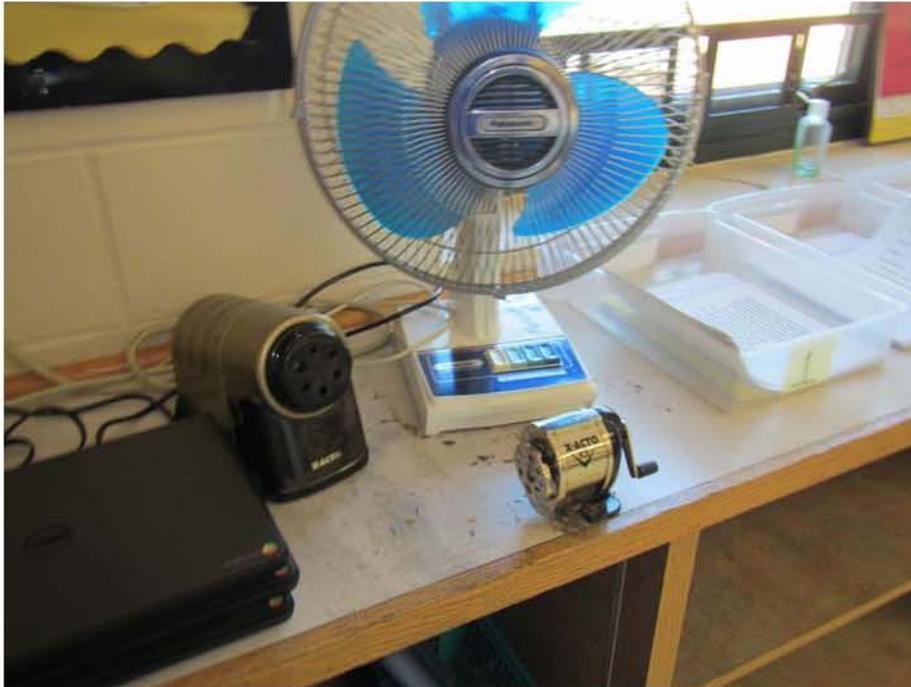
Picture 11

Some personal fans and supply/exhaust vents were observed to be dusty (Picture 10). Dust on these items can be reaerosolized and cause irritation or odors. A pencil sharpener with shavings spilling out of it was located in front of a personal fan (Picture 11). Pencil shavings can be a source of irritation, and should be kept contained and emptied frequently to avoid becoming airborne and should not be in the airstream of ventilation equipment or fans.

Dusty personal fan and pencil shavings in front of fan

15. Clean surfaces, vents, window air conditioner filters and personal fans regularly. Change AHU filters on a preventative maintenance schedule.
 16. Clean carpeting annually or semi-annually in soiled high traffic areas as per the recommendations of the Institute of Inspection, Cleaning and Restoration Certification (IICRC, 2012). Consider a schedule for replacing any worn carpeting that is beyond its service life.
