INDOOR AIR QUALITY ASSESSMENT

**Commonwealth of Massachusetts
Department of Developmental Services
151 Campanelli Drive
Middleborough, MA**

Prepared by:
Massachusetts Department of Public Health
Bureau of Environmental Health
Indoor Air Quality Program
October 2015

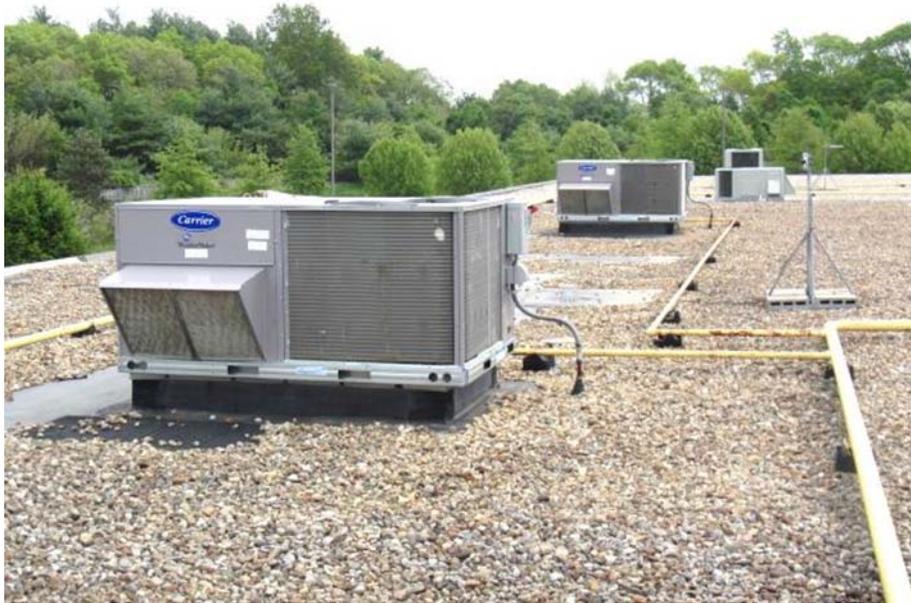
Picture 1

It can be seen from Table 1 that carbon dioxide levels were below 800 parts per million (ppm) in all areas tested, indicating optimal air exchange at the time of the assessment (Table 1). Fresh air is provided by rooftop air-handling units (AHUs, Picture 1). Once air is filtered, it is heated or cooled and delivered to occupied areas via ducted supply diffusers (Picture 2). Return air is drawn into a combination of plenum and ducted ceiling-mounted vents (Picture 3) and returned back to rooftop AHUs.

Rooftop air handling units

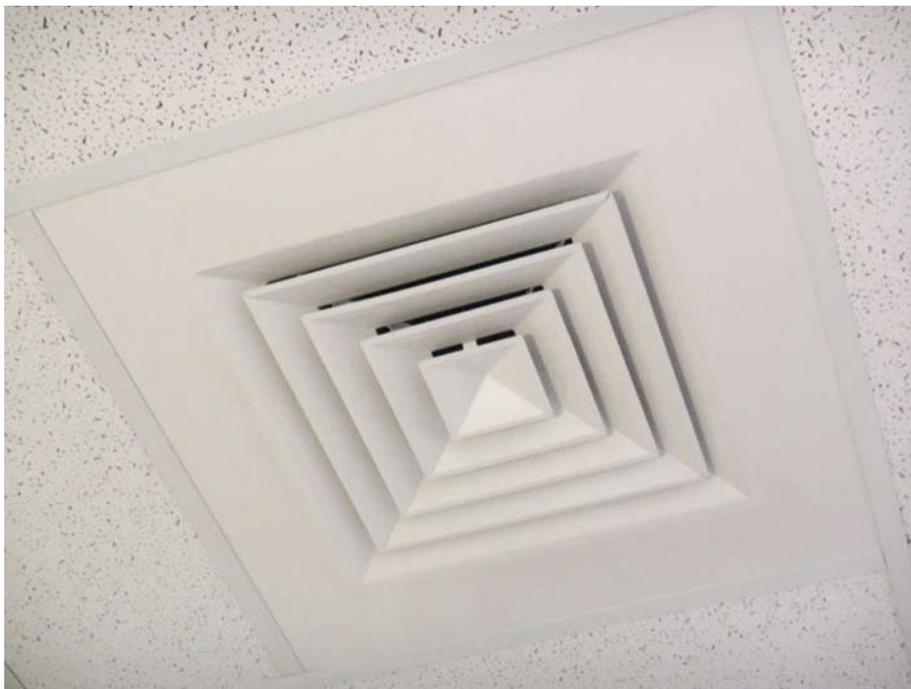
Picture 2

Supply diffuser

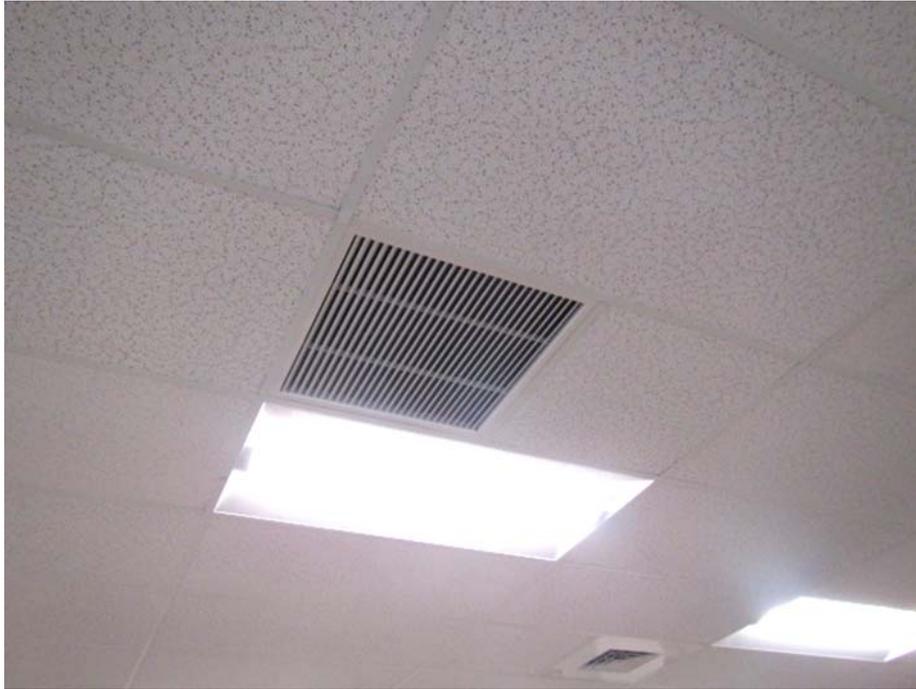
Picture 3

Return vent

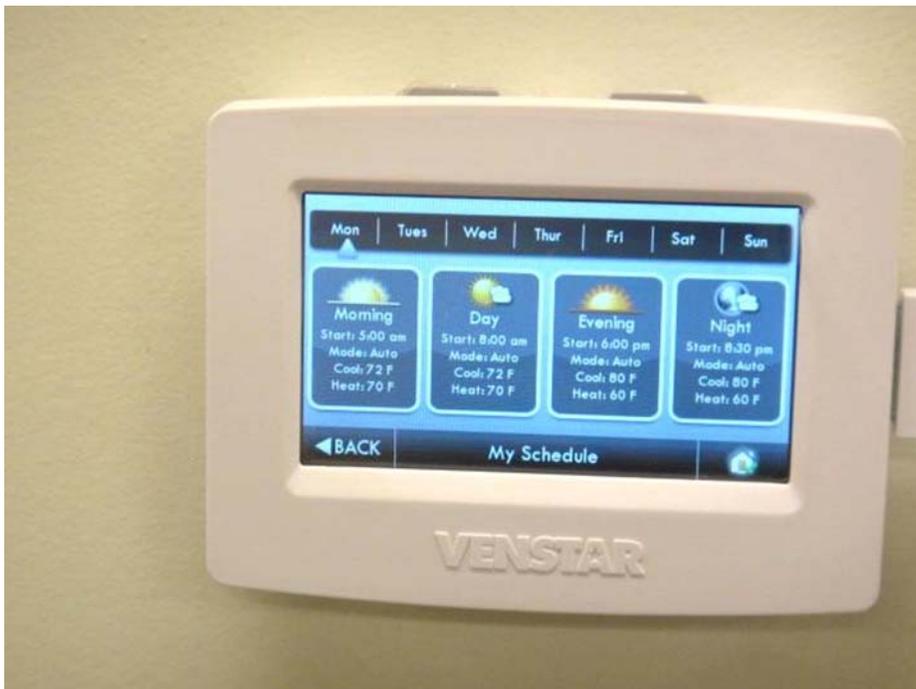
Picture 4

The HVAC system for the DDS office is controlled by digital touch screen thermostats (Picture 4). Thermostats examined had a fan switch with two settings, *on* and *auto*. When the fan is set to *on*, the system provides a continuous source of air circulation and filtration. The

automatic setting on the thermostat activates the HVAC system at a pre-set temperature. Once the pre-set temperature is reached, the HVAC system is deactivated. Therefore, no mechanical ventilation is provided until the thermostat re-activates the system. At the time of the assessment, the thermostat fan settings appeared to be in the “on” position, as recommended by MDPH for continuous airflow and filtration.

Digital touchscreen thermostat

1. Work with HVAC engineer to adjust temp/AC controls to achieve optimal temp/relative humidity conditions as well as continuous air circulation/filtration and adequate fresh air supply during business hours.
2. Consider adopting a balancing schedule of every 5 years for all mechanical ventilation systems, as recommended by ventilation industrial standards (SMACNA, 1994).
3. Consider reducing/removing small appliances generating waste heat in offices to improve comfort.
4. Consider applying tinted film to windows as needed to reduce solar gain as well as solar glare.
5. For buildings in New England, periods of low relative humidity during the winter are often unavoidable. Therefore, scrupulous cleaning practices should be adopted to
