INDOOR AIR QUALITY ASSESSMENT

**Needham Public Schools Administration Building
1330 Highland Street
Needham, Massachusetts**

Prepared by:
Massachusetts Department of Public Health
Bureau of Environmental Health
Indoor Air Quality Program
December 2015

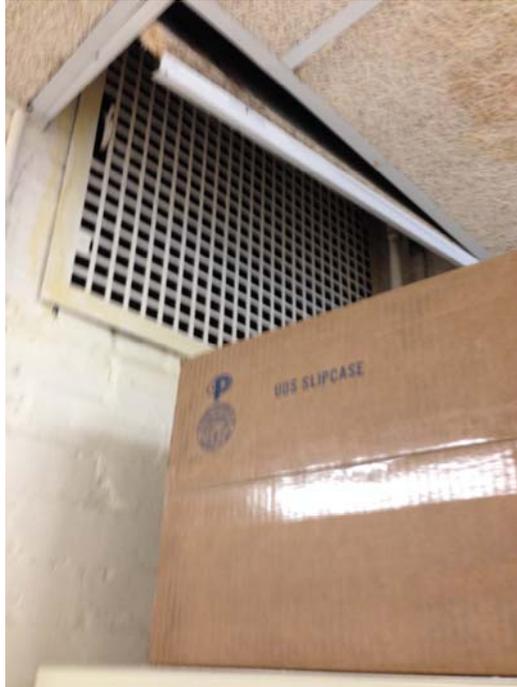
Ventilation was originally provided by grated, louvered, wall vents (Pictures 1 and 2). The wall vents are connected by a ventilation shaft to vault-like "air-mixing" rooms in the basement (Picture 3). The draw of air into these vents is controlled by a draw chain pulley system. The chains of the pulley system were designed to set the flue in the ventilation shaft at a desired angle to adjust fresh air intake. Air movement in such a system is provided by the stack effect. Heating elements located in the base of the ventilation shaft warm the air, which rises up the ventilation shaft. As heated air rises, negative pressure is created, drawing cold air from the enclosed air-mixing rooms in the basement into the heating elements/ventilation shaft. This system was designed to draw outside air into the air-mixing rooms through windows. The percentage of fresh air into the system was controlled by sash windows in the air mixing rooms; these are currently kept closed. This original system has been abandoned and the mixing rooms are used for other purposes, however most of the ducts/shafts and vents are still present, creating pathways for air to migrate between areas of the building.

Original fresh air supply vent

1. Continue with the efforts to remediate the oil spill.
2. Close the door between the air mixing room/storage area and the Production room.
3. Close all dampers in the vents like those shown in Picture 1 to reduce pathways for odors and particulates to travel to other occupied areas.

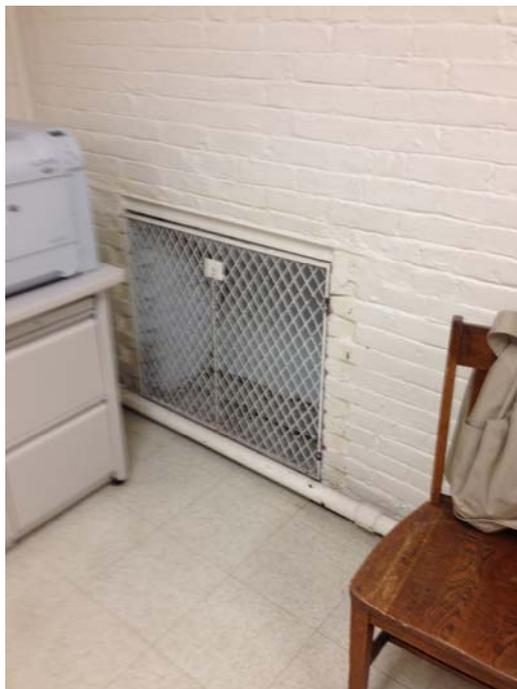
Picture 2

Original exhaust vent

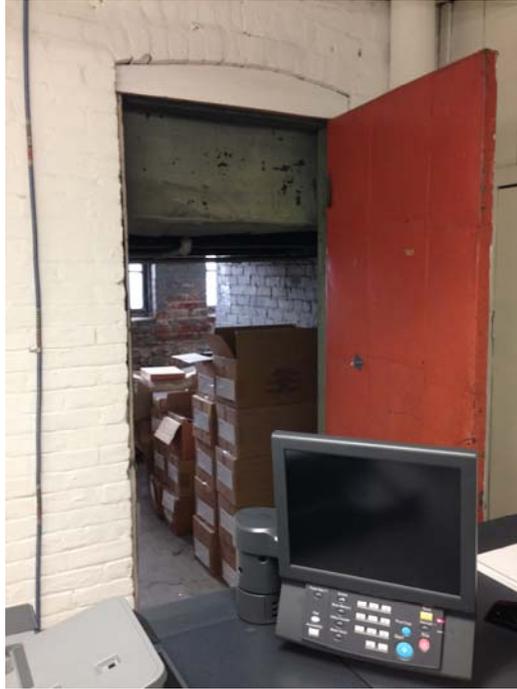
Picture 3

Other conditions that can affect indoor air quality were observed during the assessment. Of note was a photocopier odor in the Production room. This room did not have an operating local exhaust ventilation system. VOCs and ozone can be produced by photocopiers, particularly if the equipment is older and in frequent use. Ozone is a respiratory irritant (Schmidt Etkin, 1992). The production room is adjacent to one of the old air mixing rooms that was part of the original ventilation system of the building (Picture 3). The air mixing room is currently being used for storage and windows in the air mixing room are left closed now that the system has been abandoned. The door to the air mixing room in the Production room was ajar, presumably to

have easy access to stored materials. This practice results in the distribution of basement air and photocopier operation by-products into the upper floors of the building through the stack effect.

Air mixing room in Production room

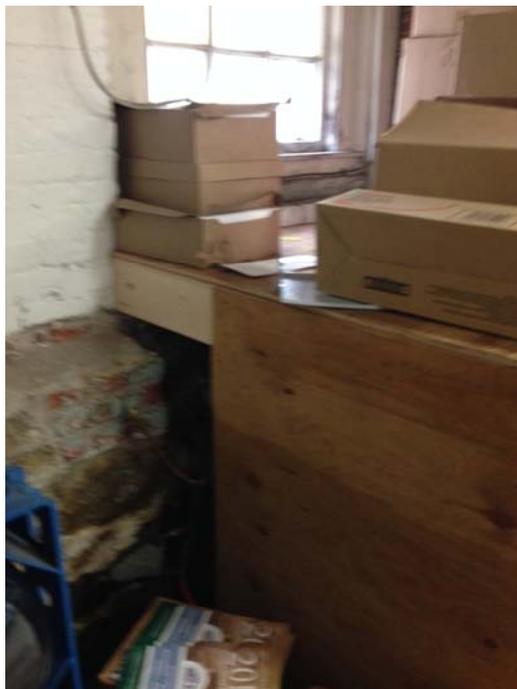
Picture 4

In order to determine if volatile organic compounds (VOCs) were present, BEH/IAQ staff conducted air sampling for total volatile organic compounds (TVOCs) and inspected areas for products containing VOCs. On the day of the assessment, outdoor VOCs were non-detect (ND) (Table 1). No measurable levels of TVOCs were detected in all areas with the exception of the Production room, which had a range of 0.1 to 0.9 ppm at the foundation wall near the outdoor leaking oil tank (Picture 4); air tested at the center of the room had no detectable levels of TVOCs. The oil tank was removed prior to this assessment. The Licensed Site Professional (LSP) was in the process of implementing further methods to reduce/eliminate vapor intrusion from the spill.

Based on TVOC measurements, the oil spill from the underground tank is having no effect on indoor air quality except in the area directly adjacent to the foundation wall in the Production room. Based on observations at the time of assessment, a two-phase approach is required for remediation. The first consists of **short-term** measures to improve air quality and the second consists of **long-term** measures that will require planning and resources to adequately address overall concerns.

Foundation wall with measureable VOC levels behind wooden structure

1. Consider installing an exhaust fan to vent both the base of the foundation wall and the Production room directly outside.
