# **INDOOR AIR QUALITY ASSESSMENT**

**Newbury Town Hall Trailers  
25 High Road  
Newbury, Massachusetts**

Prepared by:  
Massachusetts Department of Public Health  
Bureau of Environmental Health  
Indoor Air Quality Program  
September 2015

**Building:** Newbury Town Hall Trailer (NTHT) complex  
**Address:** 25 High Road, Newbury, Massachusetts  
**Assessment Requested by:** Deborah Rogers, Health Agent, Newbury Health Department  
**Date of Assessment:** May 19, 2015

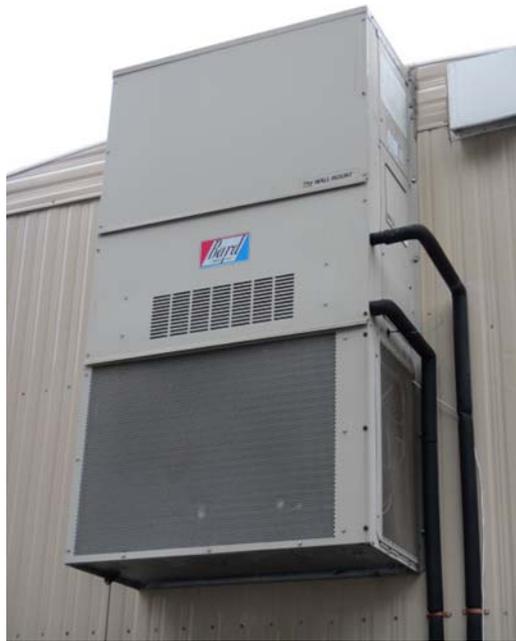
**Picture 1**

Mechanical ventilation is provided by forced hot air (FHA) units mounted on exterior walls (Picture 1), which were deactivated during the assessment. Supply air is distributed via ceiling mounted air diffusers (Picture 2) and returned back to the FHA units through wall/floor-

**Attached forced hot air (FHA) unit**

repairs to attached FHA units and removal/replacement of water-damaged building materials/furnishings with appropriate materials should be considered as well. Given the age/condition of the trailers and the cost estimates, a decision should be made whether to proceed with the work or relocate employees to more suitable office space.

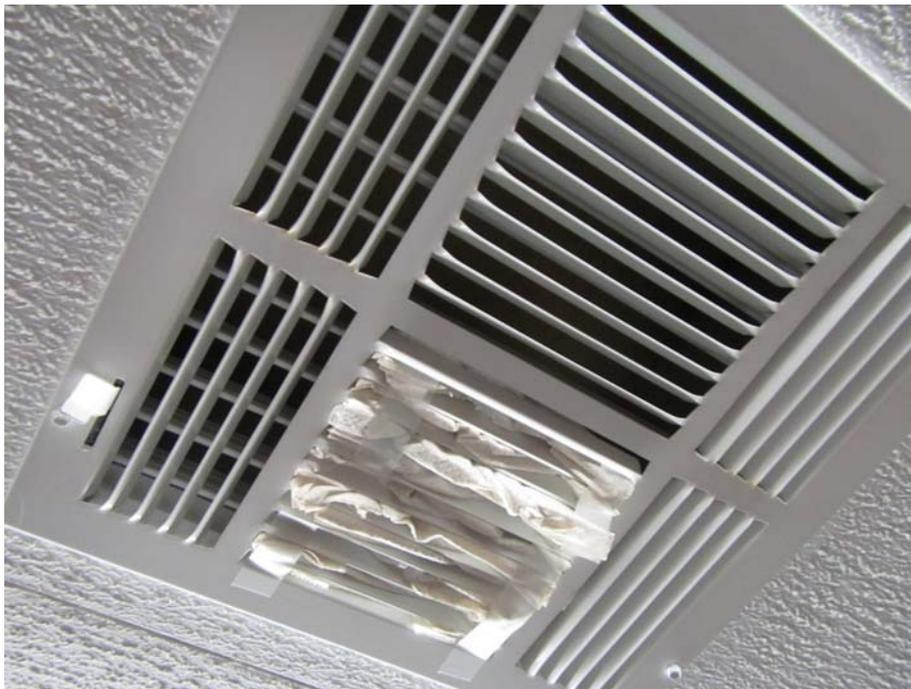
**Picture 2**

**Ceiling-mounted supply air diffuser (partially blocked)**

12. To avoid comfort complaints, consider adjusting or replacing supply diffusers to direct airflow away from personnel.
13. Eliminate rodent infestation, remove pathways/food sources and thoroughly clean space.

14. Remove any obstructions or materials blocking supply and/or exhaust vents.
15. To reduce exposure to VOC's: locate photocopiers in well ventilated rooms and reduce or eliminate the use of dry erase boards, hand sanitizers, air fresheners and cleaners with high VOC content.

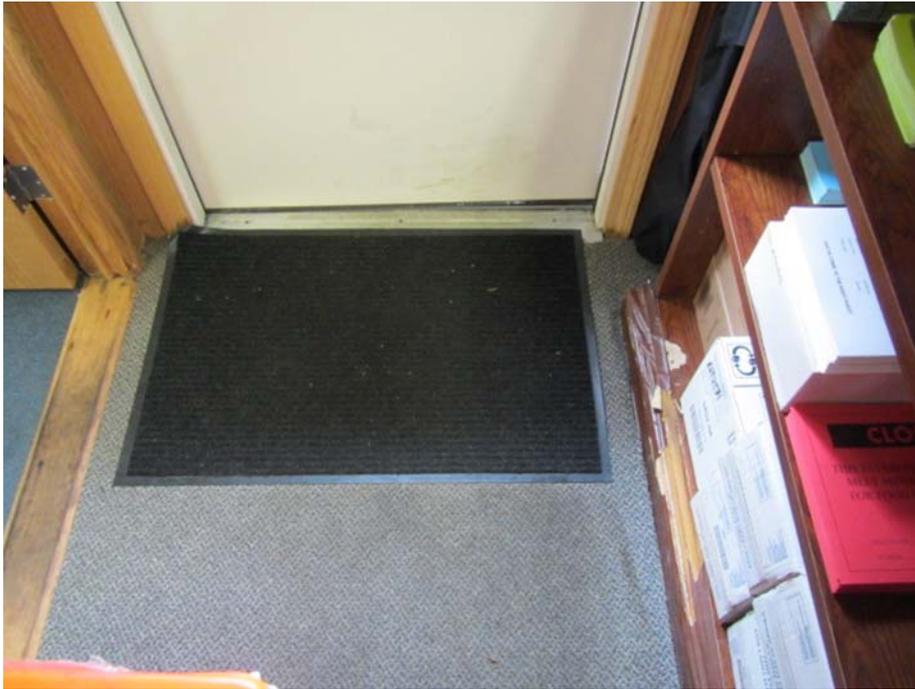
**Picture 3**

At the time of the assessment, BEH/IAQ staff detected a musty odor throughout the NTHT complex. Moisture readings of building materials were taken with a Delmhorst probe. Elevated moisture readings were measured in the carpeting of the entryway to the Health Department. Evidence of water-damaged carpeting, furniture and building materials was observed throughout the NTHT complex (Pictures 3 to 5, Table 1). Water-damaged ceiling tiles were visible in the hallway that connects the trailers. BEH/IAQ staff also noted breaches in the building envelope, which can provide a source of water infiltration (e.g., roof, door/window frame and siding leaks).

**Water-damaged carpeting**

4. Replace water-damaged porous building materials (e.g. ceiling tiles, trim, carpeting, insulation, etc.). Carpeting is generally not recommended in areas subject to chronic moisture. Consider replacing any carpet with tile or other non-porous flooring.

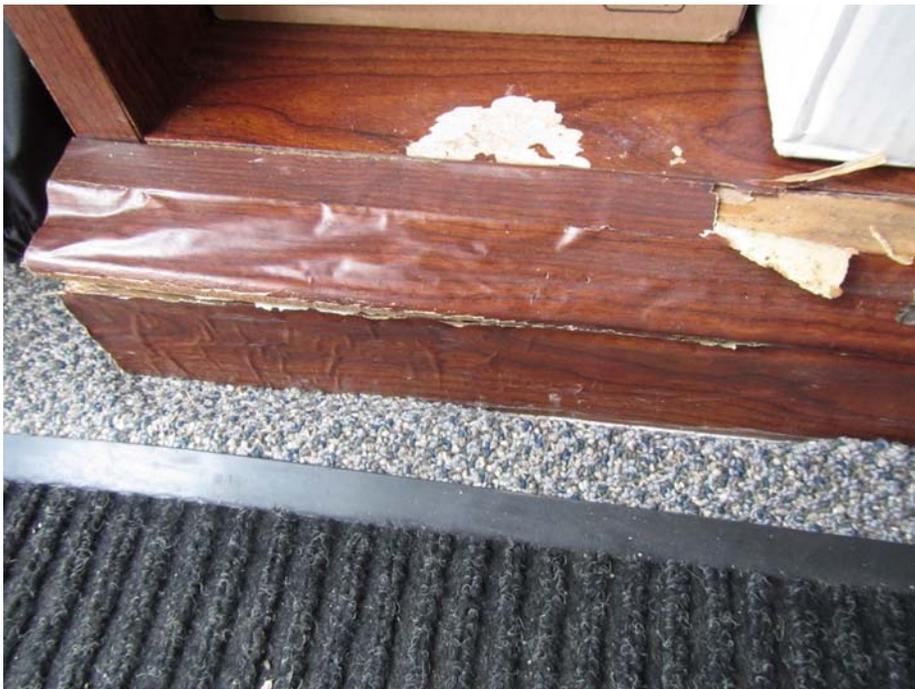
**Picture 4**

**Water-damaged furniture**

2. If the decision is to remediate/renovate trailers, make all necessary repairs to stop chronic water infiltration through the building envelope.
3. Remove any water-damaged porous building materials/furnishings in a manner consistent with US EPA mold/water damage remediation guidelines: “Mold Remediation in Schools and Commercial Buildings” (US EPA, 2001). This document can be downloaded from the US EPA website at: [http://www.epa.gov/mold/mold\\_remediation.html](http://www.epa.gov/mold/mold_remediation.html). Items of importance such as plans or important legal documents could be scanned or copied prior to discarding.

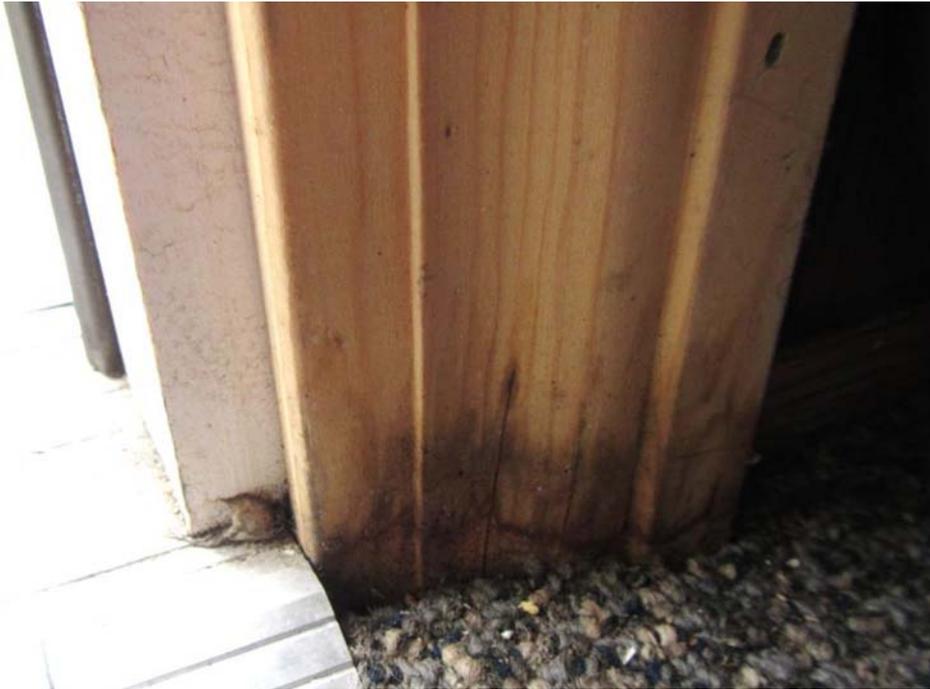
**Picture 5**

**Water-damaged trim**

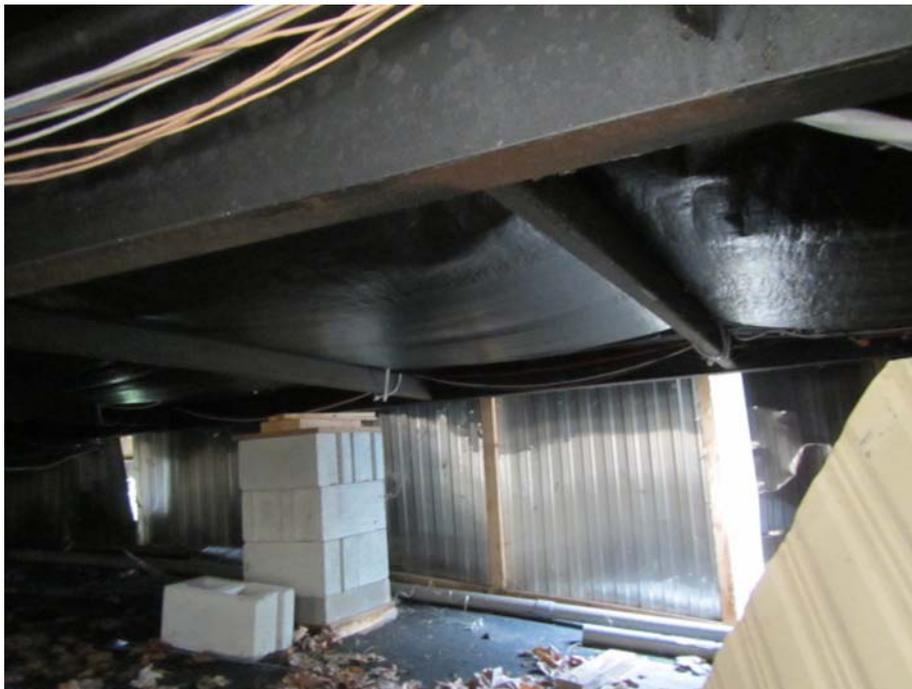
**Picture 6**

Portions of the NTHT complex are sited over an earth foundation with aluminum skirting of the trailers encompassing a crawlspace. BEH/IAQ staff examined the crawlspace and observed a damaged vapor barrier and moist conditions (Pictures 6 to 9). Water vapor from the moist crawlspace enters the trailers through openings in the vapor barrier and other breaches in the floor decking. Water vapor may then condense on surfaces in the trailers that are below the dew point temperature. This chronic moistening of porous building materials and items (carpeting, pressboard furniture, files, etc.) may cause water damage, mold colonization and associated odors. The possibly shifting support structures (Pictures 10 and 11) below the trailers will lead to further breaches in the building envelope due to shifting and settling of the trailers. The aluminum skirting surrounding the crawlspace had numerous openings, which would allow the entry of debris, storm water and pests (Picture 12).

**Damaged vapor barrier**

1. A building engineer should be consulted to determine the extent of work needed to restore the building envelope of the NTHT complex to prevent chronic water infiltration (roof, siding, door/window frames, vapor barrier, crawlspace integrity, supports, etc.). Other

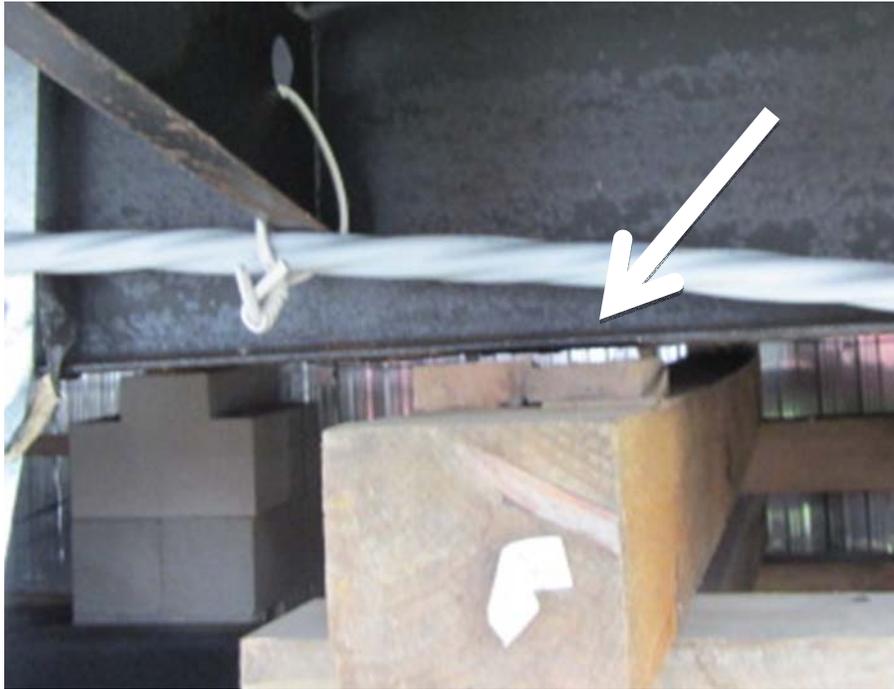
**Picture 7**

**Large gaps beneath supports (arrow)**

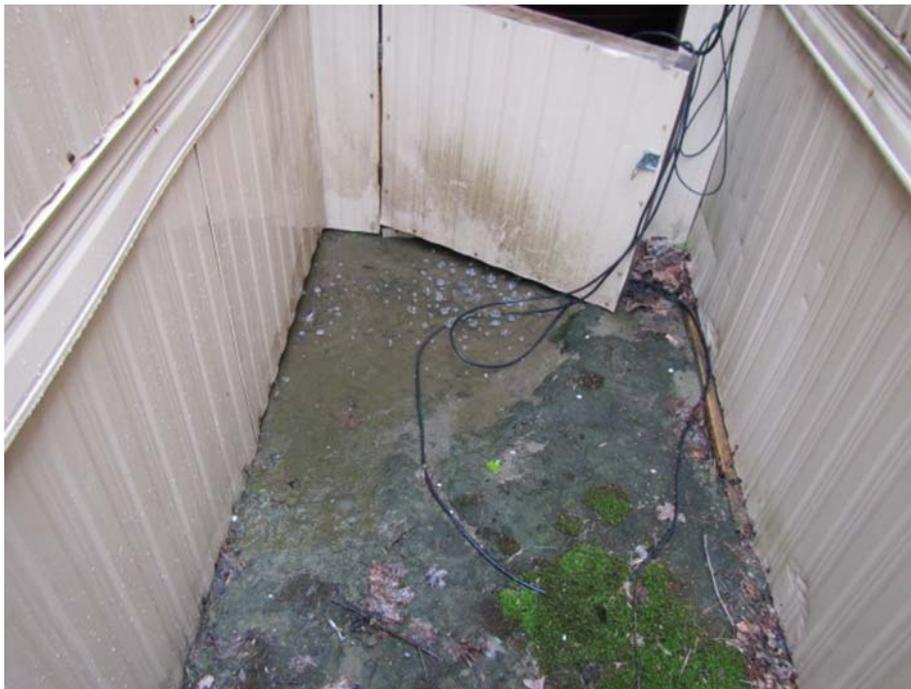
**Picture 8**

**Water pooling under/between trailers**

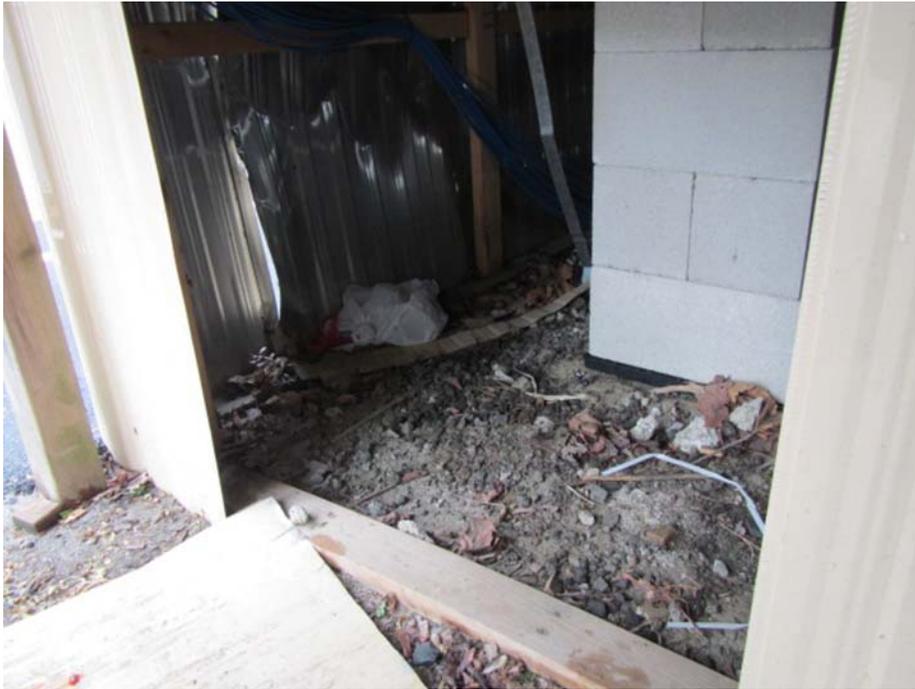
**Picture 9**

**Debris and moist earth in crawlspace**

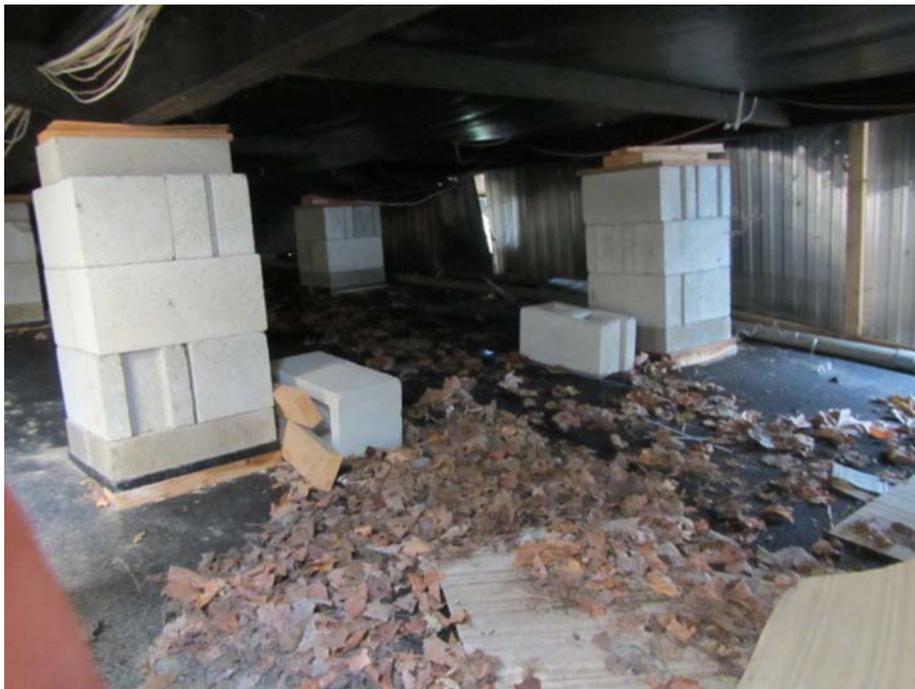
**Picture 10**

**Stacked cement bricks and wood shims used as supports for trailers**

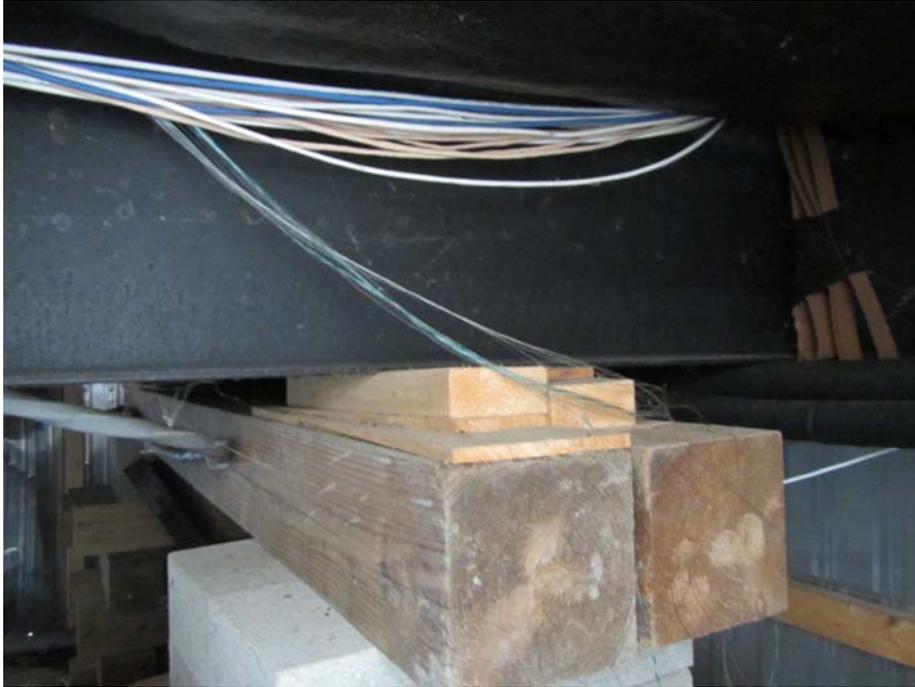
**Picture 11**

**Close-up of wood shims and timber used to support trailers**

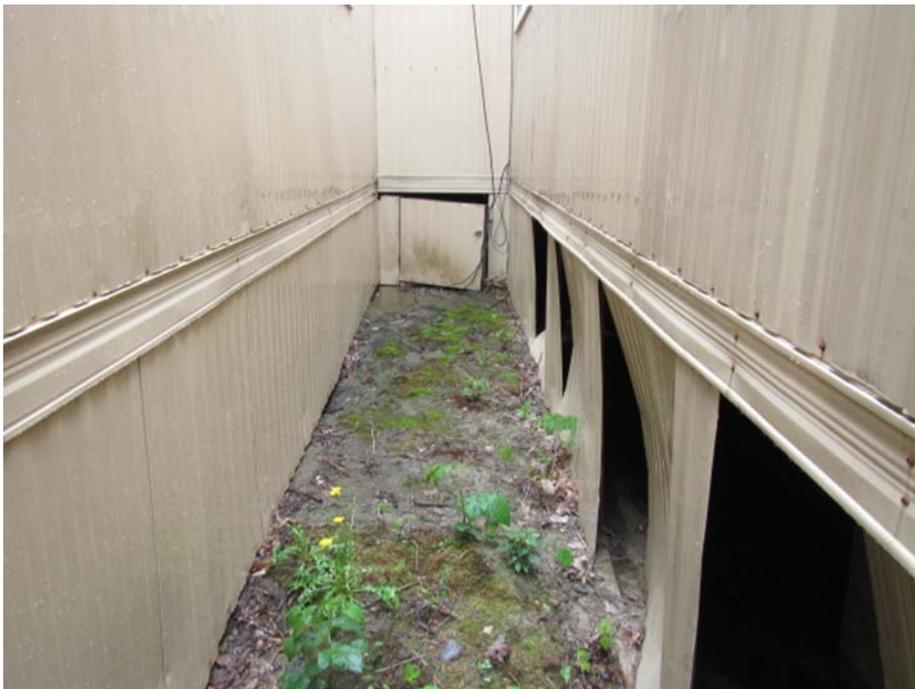
**Picture 12**

**Damaged aluminum skirting around crawlspace**

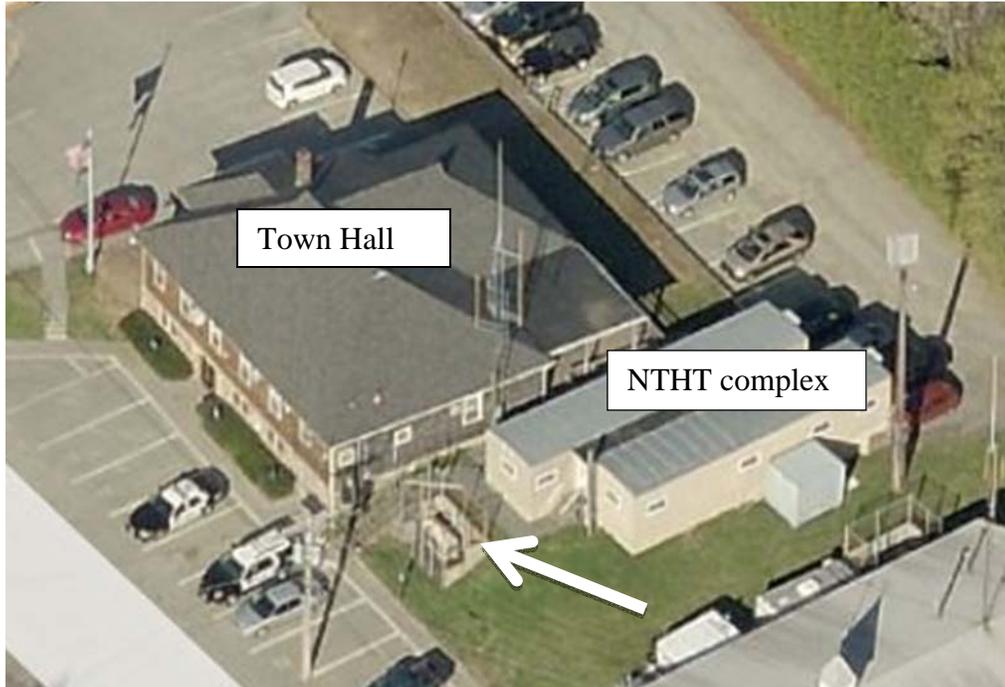
**Picture 13**

It should be noted that the NTHT complex is adjacent to the town's back-up generator (Picture 13). This generator has the potential to create carbon monoxide exposure due to the proximity of the trailers, as well as the Town Hall building. It was reported by Newbury Police staff that the testing schedule was shifted to Friday (most offices closed) to avoid previous complaints from emissions during weekly testing. Care should be taken to close windows in close proximity to the generator and prevent the entrainment of emissions through air intake vents.

**Location of backup generator (arrow)**

7. Continue to minimize impact from weekly generator testing. Close windows and air intakes in close proximity to the generator during testing. Consider raising the exhaust stack height if necessary.

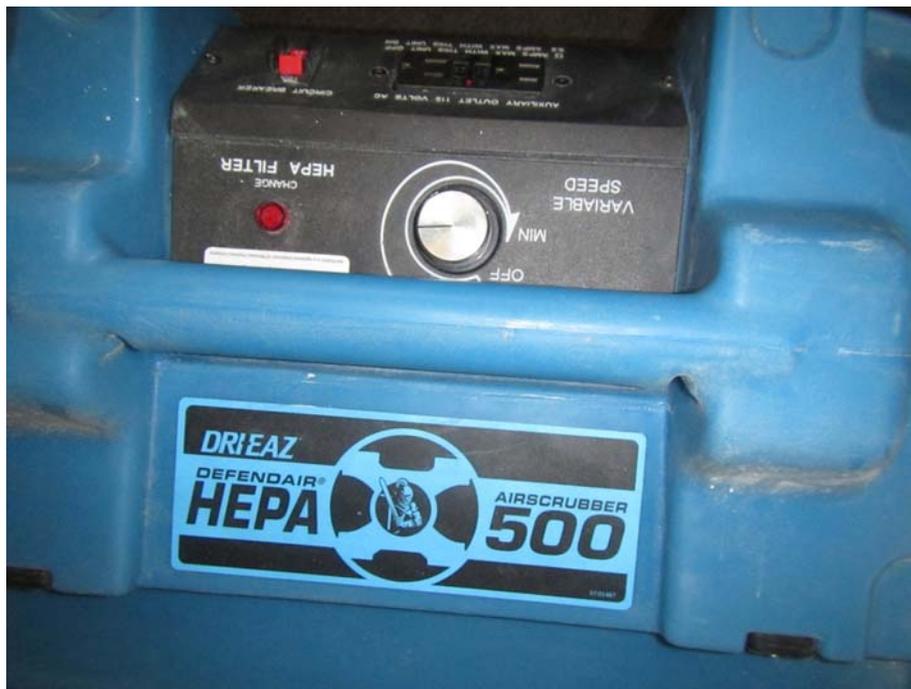
**Picture 14**

The NTHT complex was utilizing several High Efficiency Particulate Arrestance (HEPA) air purifiers (Picture 14) at the time of the assessment, following the receipt of a consultant's report that showed elevated mold spore and particulate matter counts (Indoor Doctor, 2015). It should be noted that these HEPA filters should be maintained according to manufacturer recommendations (e.g., cleaning/changing filters). Although helpful in reducing suspended particulate matter, these filters do not address the root cause of chronic water infiltration, water-damaged materials and possible mold colonization.

**HEPA air filtration unit**

8. Continue to operate HEPA air filters in occupied areas until remediation/relocation is complete. Ensure the HEPA units are maintained according to manufacturer recommendations and that they are removed from remediation/demolition areas to avoid clogging filters with construction related debris.
